The Dye House, Hallthwaites, Millom, Cumbria

Supplemental Archaeological Watching Brief

September 2009

Issue No: 2009-10/981

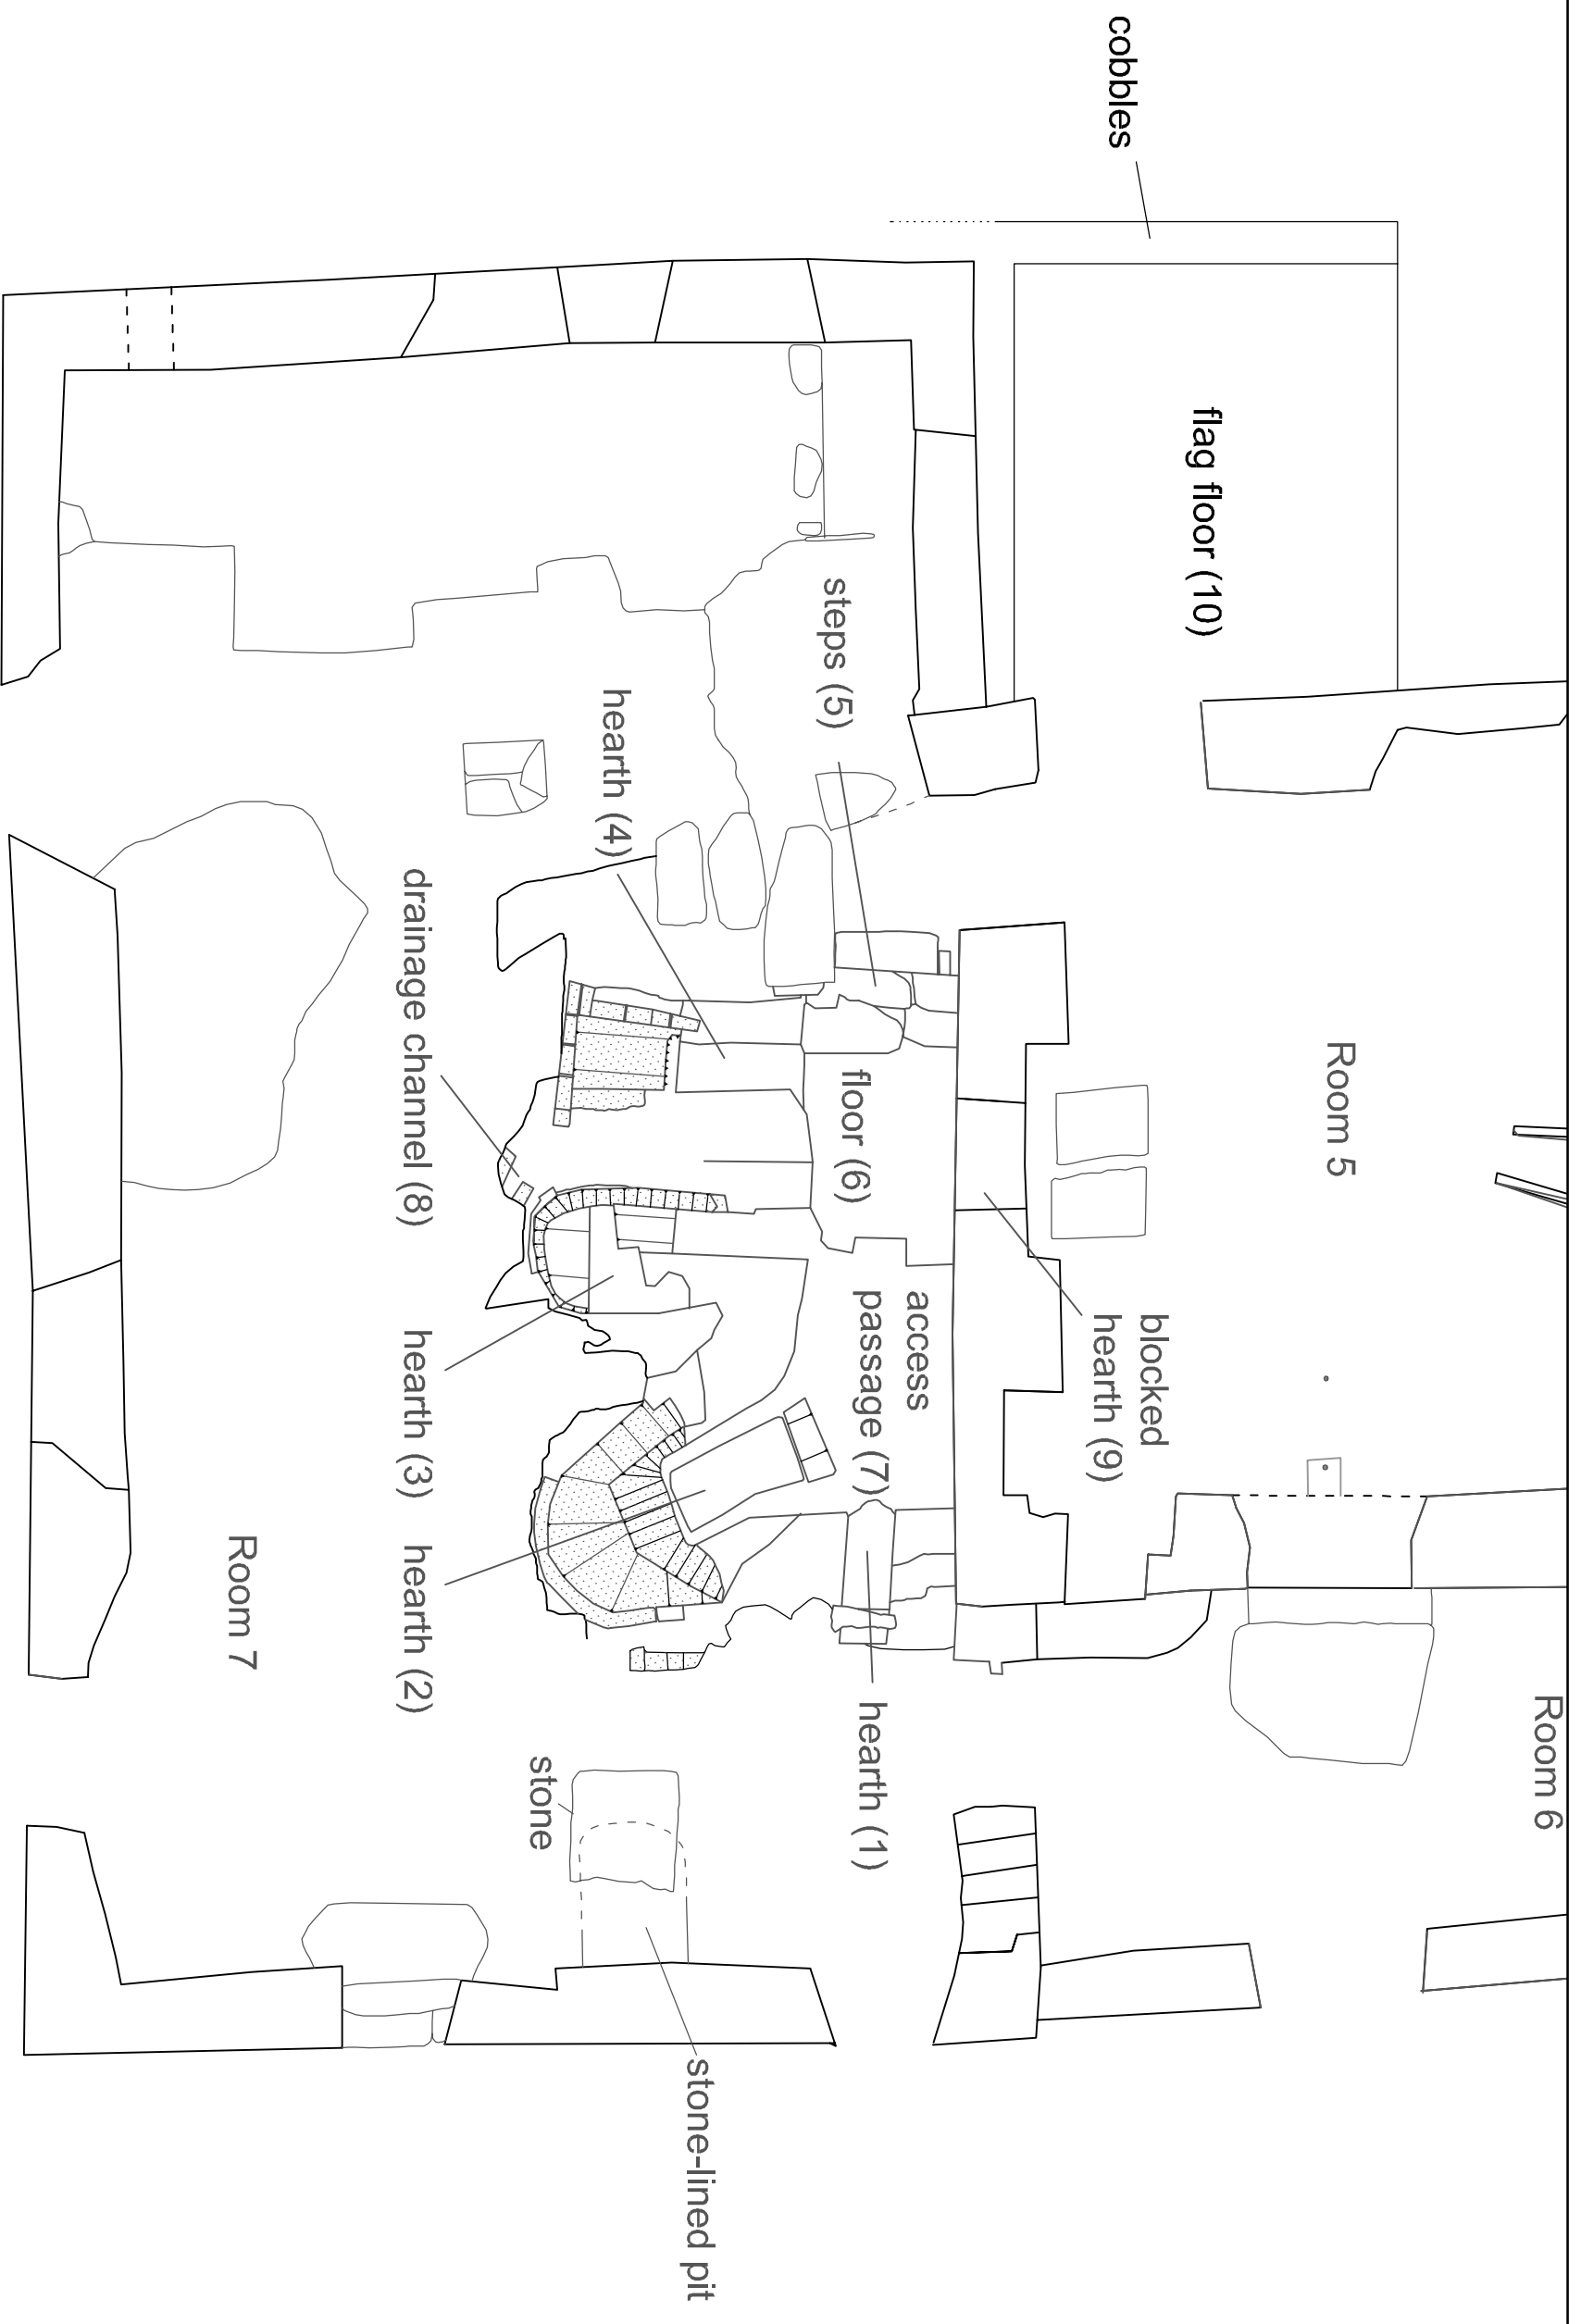
Figure 3: Plan of Watching Brief area in Room 7

- 4.1.1 The watching brief monitored works within the northern extent of Room 7 (Fig 3), which were previously inaccessible due to the presence of scaffolding (Plate 1).
- 4.1.2 Following removal of the scaffolding, this area was excavated and recorded. Manual cleaning revealed a series of sunken features, four of which appeared to be hearths (Plate 3).

- 4.2.2 **Hearth (02)**: this is a second, larger hearth, lying adjacent to hearth **01** (Plate 5; Fig 3). It measures 2ft (0.6m) wide and is approximately 3ft (0.9m) deep at the base, which is approximately 4ft (1.2m) below the current floor level of Room 7. It is of stone and brick construction with a brick-lined round head, which is conical in plan, suggesting that it was used to hold a circular dye vat.

- 4.2.7 **Access Passage (07)**: the access passage was located at the base of the stone steps (05) and along the line of the north wall of Room 7 (Fig 3; Plate 3). For the most part, the floor of the passage comprised cobbles laid in a silty, compacted matrix. The relationship between the cobbles and the flags (06) at the base of the steps (05) is unclear. It is likely that the hearths were fuelled and maintained from this passage.

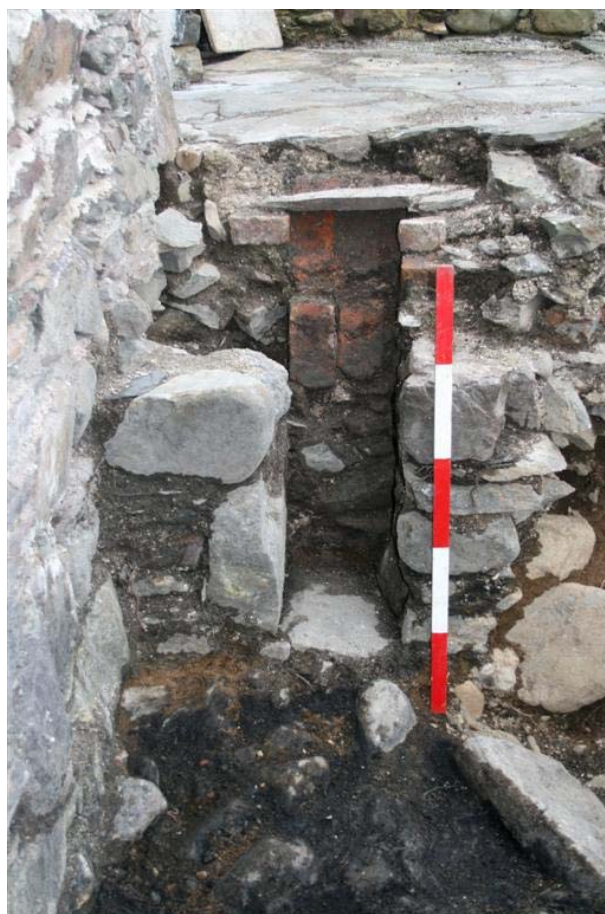
- 4.2.1 **Hearth (01)**: this is located in the north-east corner of Room 7, and comprises a 1ft (0.3m) wide x 2ft (0.6m) deep rectangular-shaped hearth, with a brick and stone-lined angled flue (Plate 4). The bricks are handmade and the mortar is lime-based. The hearth cheeks survive to a height of approximately 2ft (0.6m) and similar bricks as those lining the flue are visible. There is a slate cap to the flue, which was presumably inserted as a cover. There is some damage to the north side of the flue, probably caused by scaffolding (from an earlier repair to the adjacent wall). The base of the hearth is approximately 3ft (1m) below the floor level of Room 7.

Plate 4: The easternmost of the hearths (01)

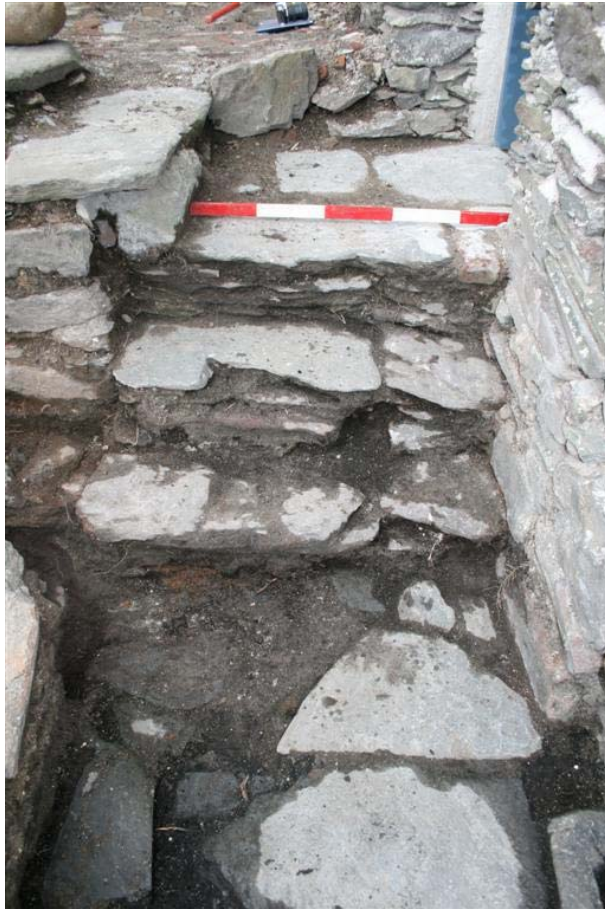
- 4.2.5 **Stone Steps (05)**: a series of stone steps (Plate 7) lead down into the access passage (**07**) (*Section 4.2.7, below*). These are constructed from flagstones of similar appearance to the main floor of Room 7. Access to Room 5 is provided via a small step down at the top of these steps, from the floor level in Room 7, as observed during the watching brief of 2007 (OA North 2007).

Plate 7: Stone steps (05) providing access to the hearths
