Proposed Pipeline, Vyrnwy LDTM, Old Marton, Shropshire

Rapid Archaeological Desk- Based Research and Walkover Survey

Oxford Archaeology North

September 2009

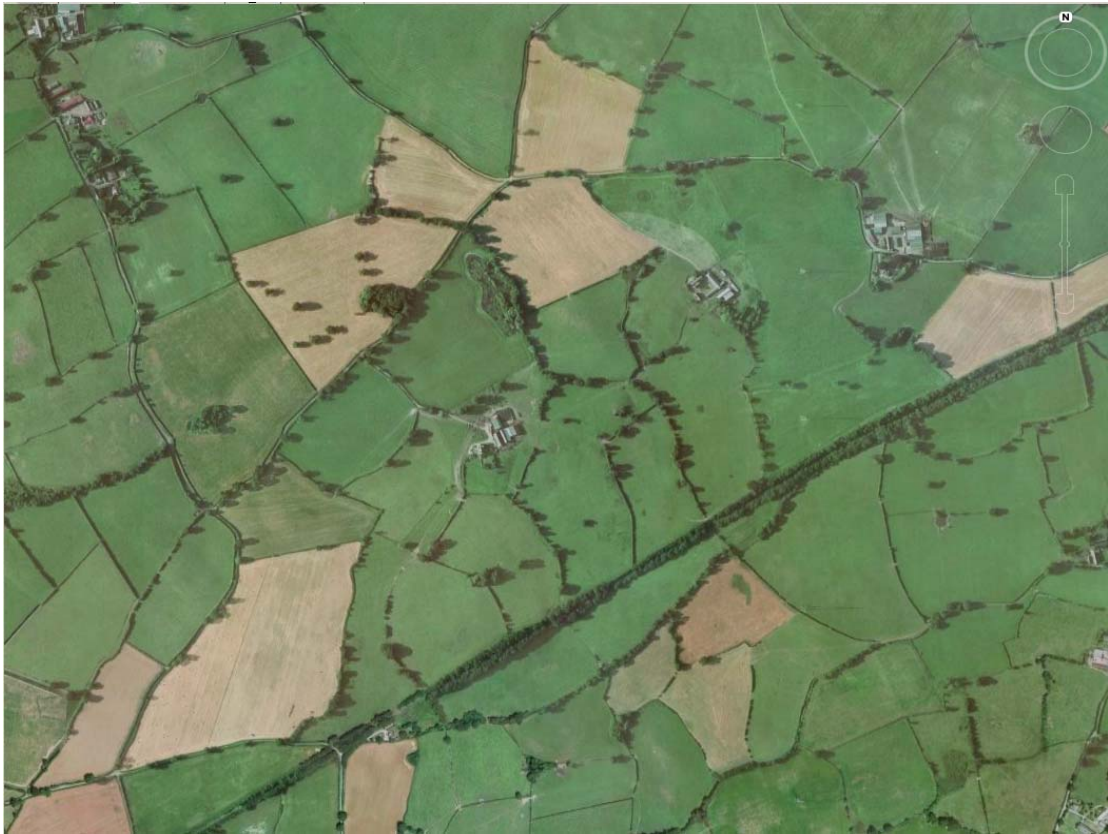
Plate 1: Aerial photograph, showing the study area

Aside from two Listed Buildings, the Old Hall and its barn (Sites **21** and **22**) at Old Marton, no sites of archaeological interest were identified after consultation with the Shropshire County Council Historic Environment Record (SCCHER). Four sites were identified during the assessment of historic maps and documents, which were compiled into a Gazetteer (*Section 5*; Fig 2). Two sites in the study area, a pond and a stone (Sites **01** and **03**), were of unknown date. The third site, an old sand pit, possibly dated to the post-medieval period (Site **02**) and the fourth, a pipeline, to the Industrial Period (Site **04**). Of the four sites, two could be directly affected by the pipeline development. Site **01**, a pond, was identified on the First Edition of the Ordnance Survey (1874) and is still extant, and Site **04**, is the putative line of the Vyrnwy Aqueduct. Its intended route was depicted on the Liverpool Corporation Waterworks map of 1880, and the 1902 and 1929 versions of the Ordnance Survey (Fig 5). Assessment of aerial photography, however, does not reveal any obvious earthworks along the possible route (Plate 1).

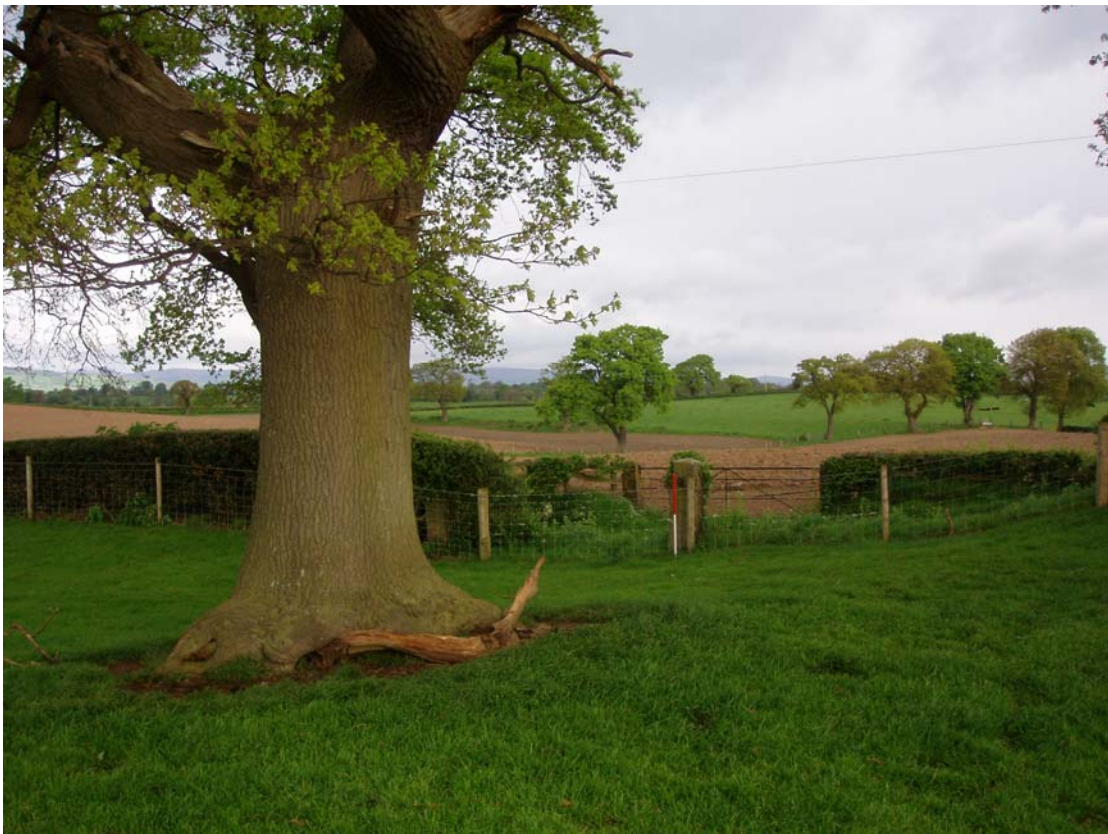
Description A line of three mature oak trees mark the course of a former boundary. The boundary is 50m in length and is aligned in a north-east to south-west direction. At the north east end is a redundant gateway with two gate posts (Site 09). The gateway gave access to the Hindford/Perthy road. At the south-western end of the boundary is a pond that is marked on Ordnance Survey First edition and current mapping.

Plate 2: Site **08**, former boundary marked by oak trees and redundant gate way (Site **09**).

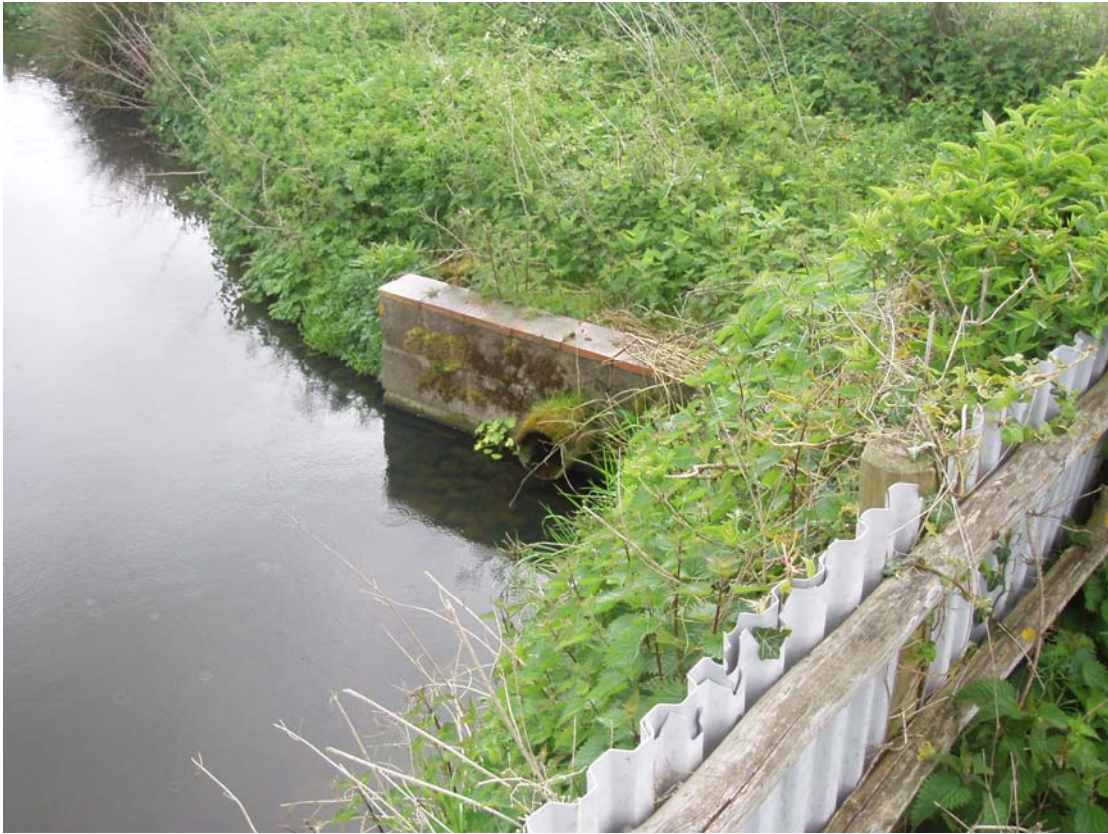
Site number 11
Site name **Pond, Old Marton Farm**
NGR SJ 35367 34433
HER No None
Statutory Designation None
Site Type Pond
Period Uncertain
Sources Ordnance Survey 1874-1877; Ordnance Survey 1889-1891; Ordnance Survey 1902; Ordnance Survey 1929; Ordnance Survey 1959; Ordnance Survey 1979-1985; Walkover Survey.
Description A natural pond that is a result of glaciation and is similar to others in the vicinity of Old Hall, Old Marton Hall and Old Marton Farm. An outlet pipe from farm buildings to the south-east enters the pond. The brickwork and pipe are of modern construction.
Assessment The site lies in close proximity to the pipeline route but will not be affected by the works.

Plate 3: Site **11**, drainage pipe discharging into pond

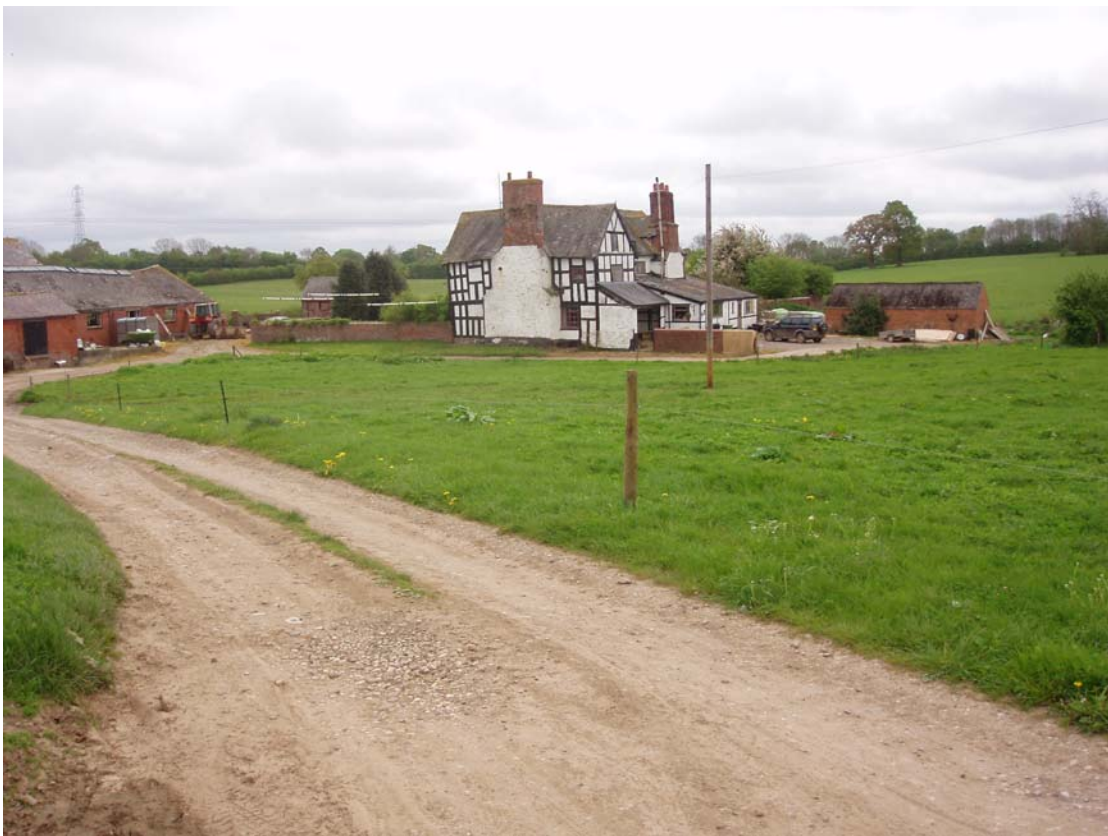
Plate 4: Site **19**, Old Hall at Old Marton

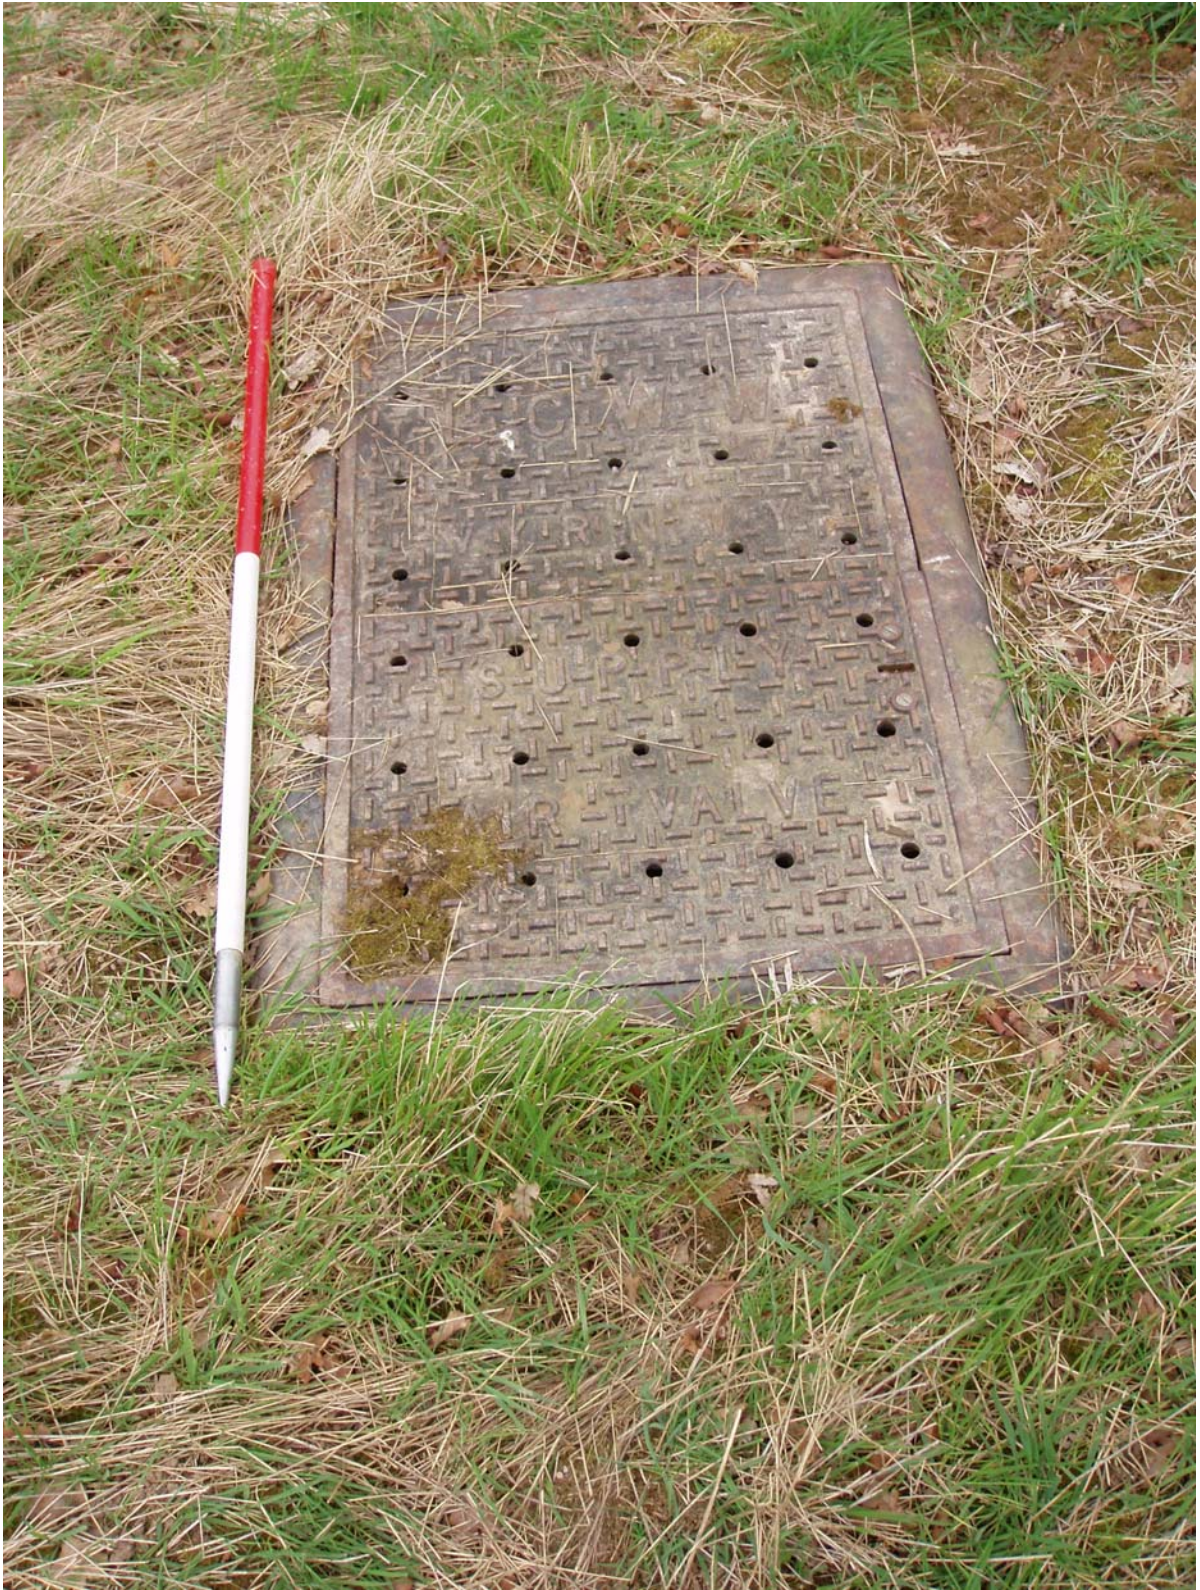
Site number	13
Site name	Water Supply, Old Hall
NGR	SJ 34142 33507
HER No	None
Statutory Designation	None
Site Type	Water supply inspection hatches
Period	Modern
Sources	Walkover Survey
Description	Cast iron inspection hatch covers are located at points along the existing water supply pipeline. At this site there are four hatches that are circular and rectangular shaped. One rectangular hatch is marked L.C.W.W. for Liverpool Corporation Water Works and Vrynwy.
Assessment	The site lies on the route of the pipeline and will be affected by it.

Plate 5: Site **13**, metal inspection cover marked L.C.W.W. and Vyrnwy, of the same style as those at sites **14** and **15**.

- 6.2.1 It is recommended that a targeted watching brief be maintained during ground works along the route of the Vyrnwy Aqueduct (Site **04**), including the metal inspection hatch (Site **14**), in the vicinity of Old Hall (Site **21**). This will provide an opportunity to record relevant information regarding the construction of the Vyrnwy Aqueduct and it is possible that currently unknown medieval/post-medieval sites will be encountered that relate to Old Hall (Site **21**). The targeted watching brief should focus on the section of pipeline 50m to the south-west of the track to Old Hall and 100m to the north-east of it.

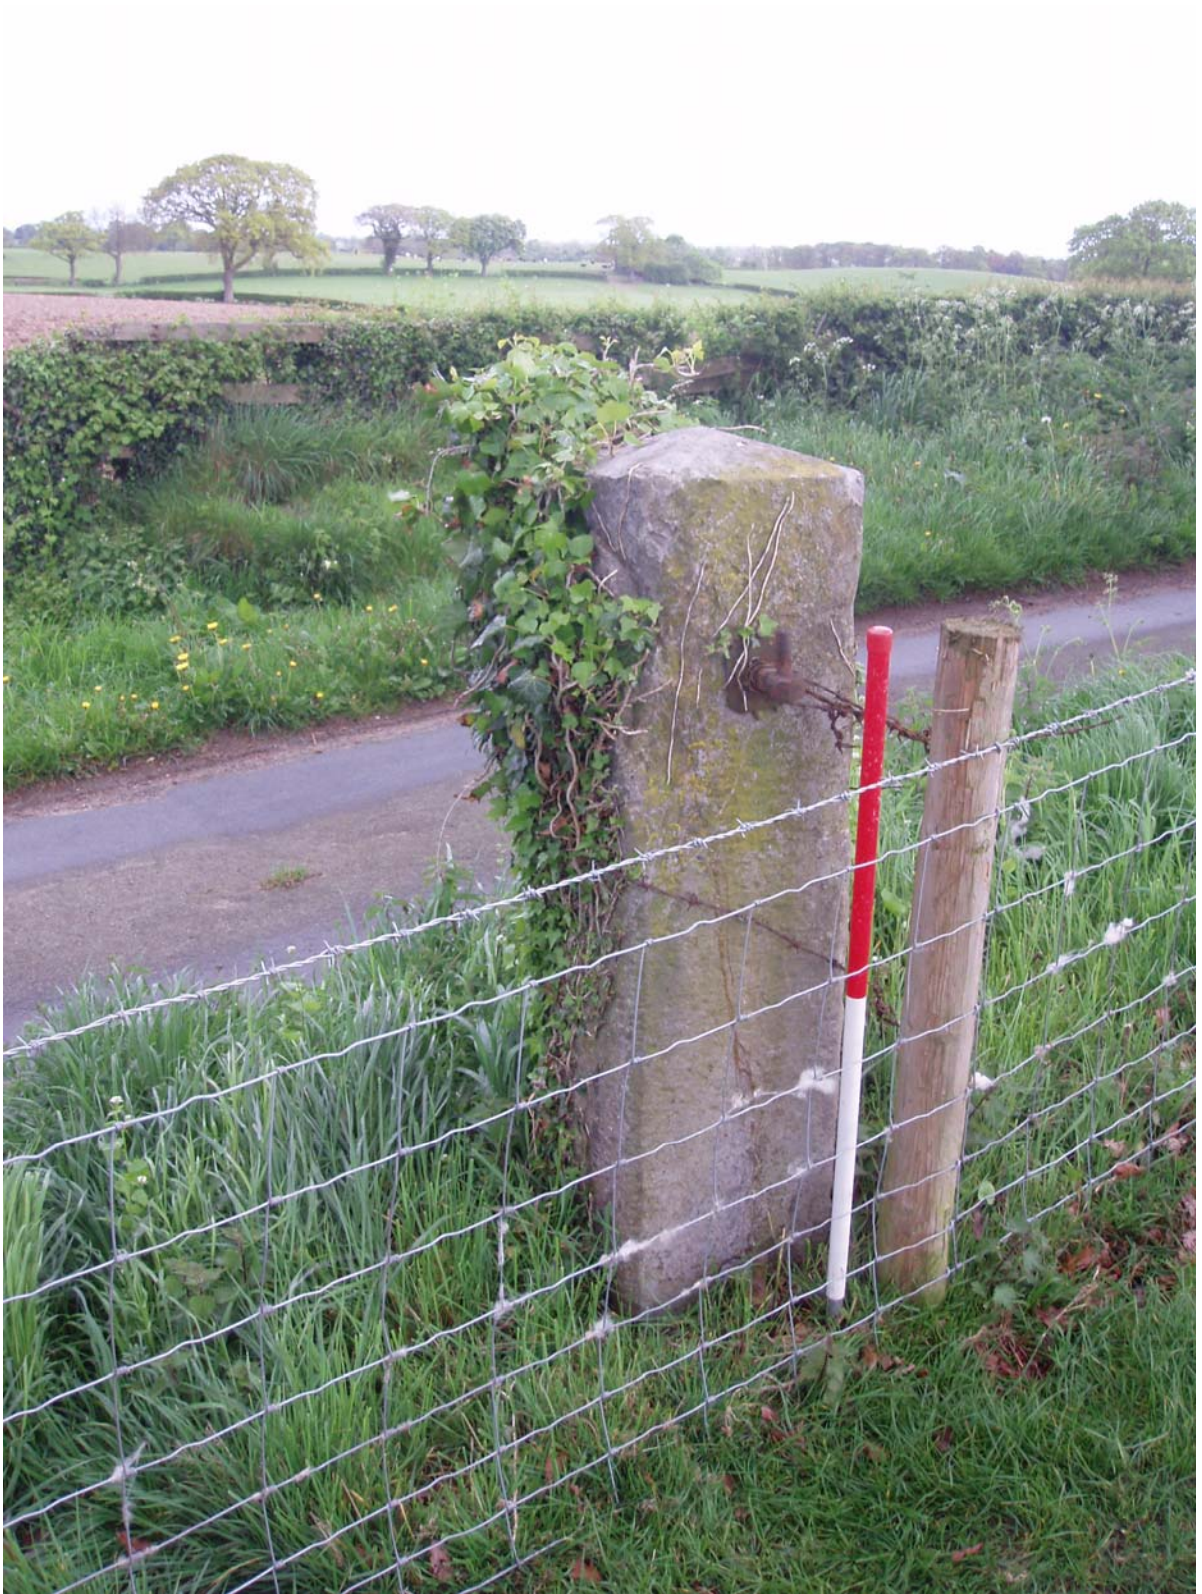
Description A pair of gate posts that mark the location of a redundant gateway that gave access to the Hindford/Perthy road from the field to the north-east of Old Marton Hall. The posts are set within a hawthorn hedge and bank that is 0.5m above the level of the road. There is no evidence of a former track way in the field but a boundary line of oak trees remains (Site 08). The gate posts are 1.3m high with sides 0.3m wide. The tops of the gate posts are

Assessment square pyramidal shape. The posts are the same design as those located at two other sites (**16, 17**) and may mark land belonging to a former estate. The site lies outside of the proposed pipeline route and will not be affected by the proposed works.

Plate 6: Site **09**, redundant gatepost of the same style as those at sites **16** and **17**.
