FURNESS ABBEY PRESBYTERY, FURNESS ABBEY BARROW-IN- FURNESS, CUMBRIA

Archaeological Evaluation

Oxford Archaeology North

May 2009

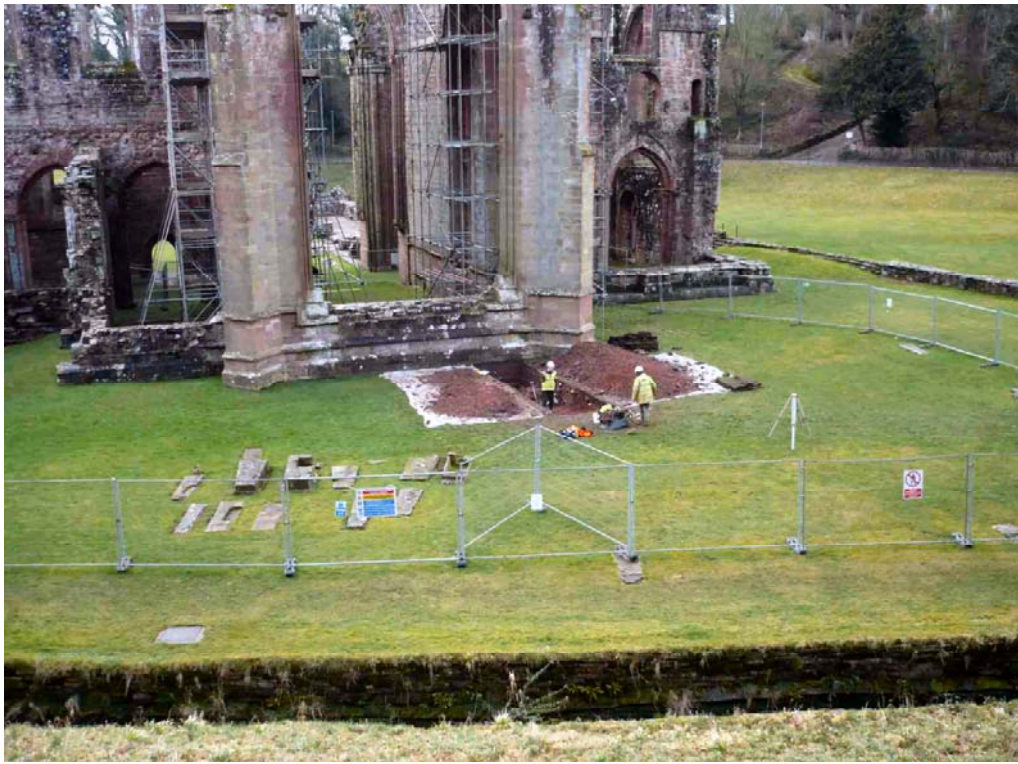
Plate 1: General view of the excavation area viewed from the east, with the presbytery and church in the background.

Plate 1: General view of the excavation area viewed from the east, with the presbytery and church in the background

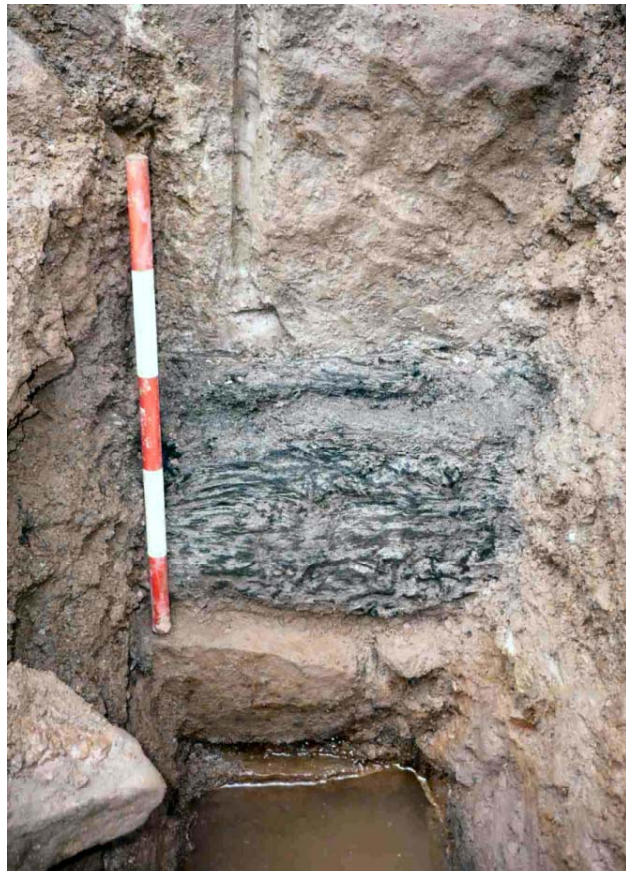
Plate 2: The stone coursing (Phase 1a) below the later Phase 2 timber raft, viewed from the north-east, 0.5m scale.

- 4.1.4 The earliest remains found in the trench from Phase 1a (Fig 4, section 2 and Fig 5; Plate 2), that is structure **131**, gravel layer **147**, and the organic deposits abutting it (**144-145**), have proved difficult to interpret. It was not clear whether structure **131** dates to the Savigniac period, although the conjectural remains would suggest that they did not extend as far as the later presbytery wall, thus it is possible that they date to the first rebuilding of the presbytery in the early Gothic style (Harrison 1998, 4,6). It is also possible that the organic layers **144-145**, and the similar layers **151** and **153** found in the sondage in the north-east of the trench, may be the “waterlogged soil” referred to by Sir Charles Peers in 1928, reported in Dickinson’s 1967 article, and that the result of building on waterlogged ground meant that later building took place at a higher level (Dickinson 1967, 53). Indeed, in the same article it was indicated that the original level of the east of the church was “a yard below that of the later ones” (*op cit*, 57). A similar depth was noted (0.88m) from the top of the presbytery foundation **129** to the top of structure **131**.

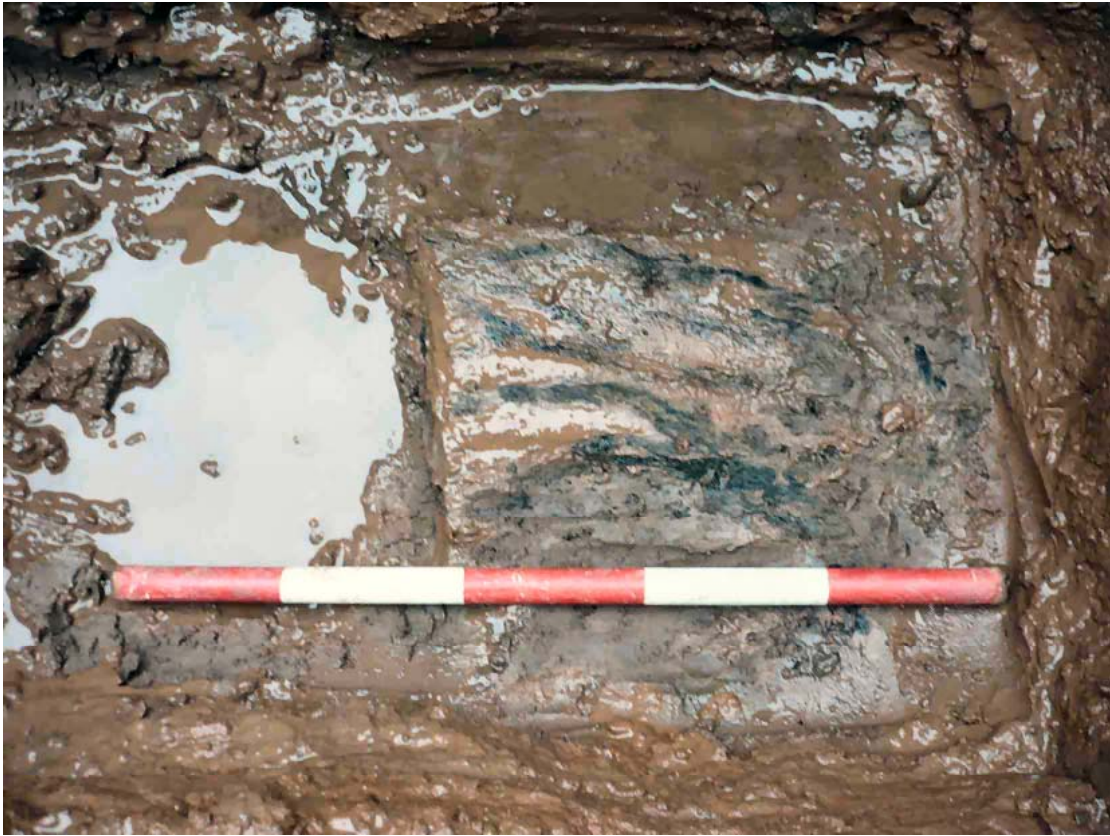
Plate 3: The possible timber plank found within layer *151*.

3.3.5 The sample of wood taken from a plank found in deposit **151** has been identified as being from diffuse porous taxa such as alder, hazel, or birch (*Alnus glutinosa/Corylus avellana/Betula*). Vivianite crystals were identified on its surface, which is used, when found in occupation deposits, as an indicator of the breakdown of anthropogenic material from the movement and redeposition of phosphate (Richard MacPhail *pers com*).

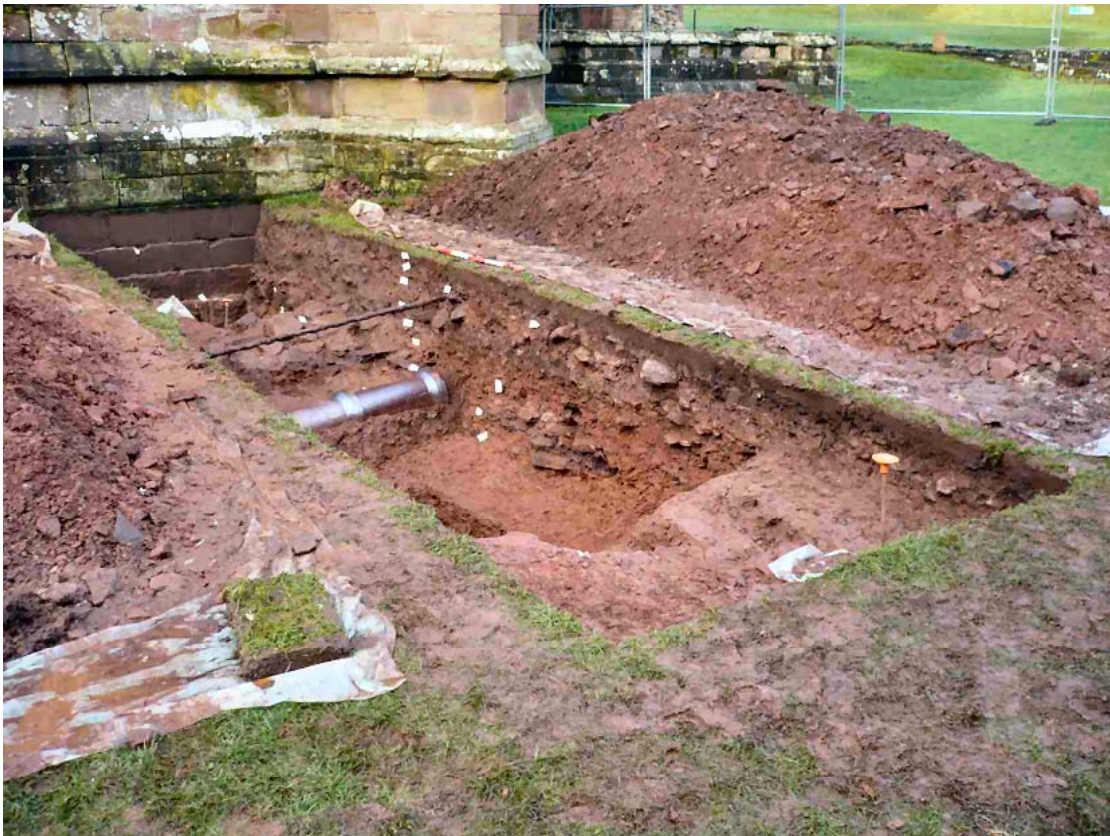
Plate 4: General view of the trench from the east showing the various ground raising events.

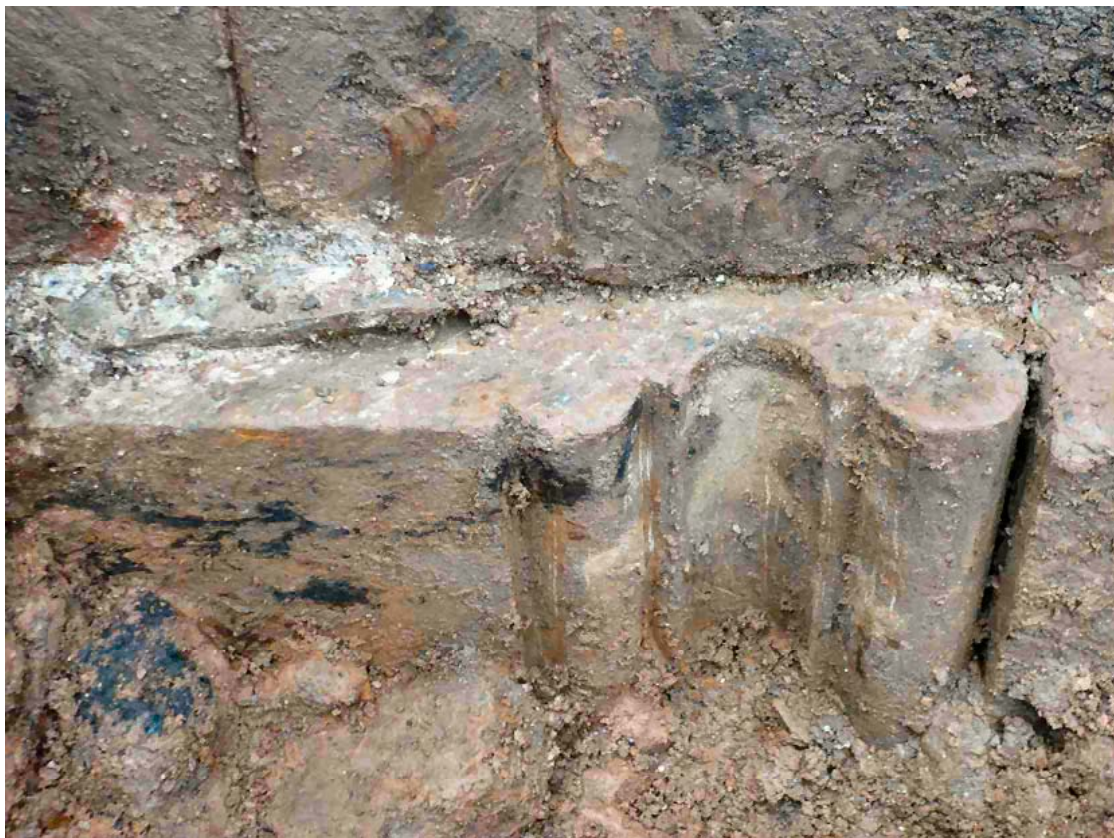
Plate 6: Moulded stone within foundation course *131*, viewed from the north-east.

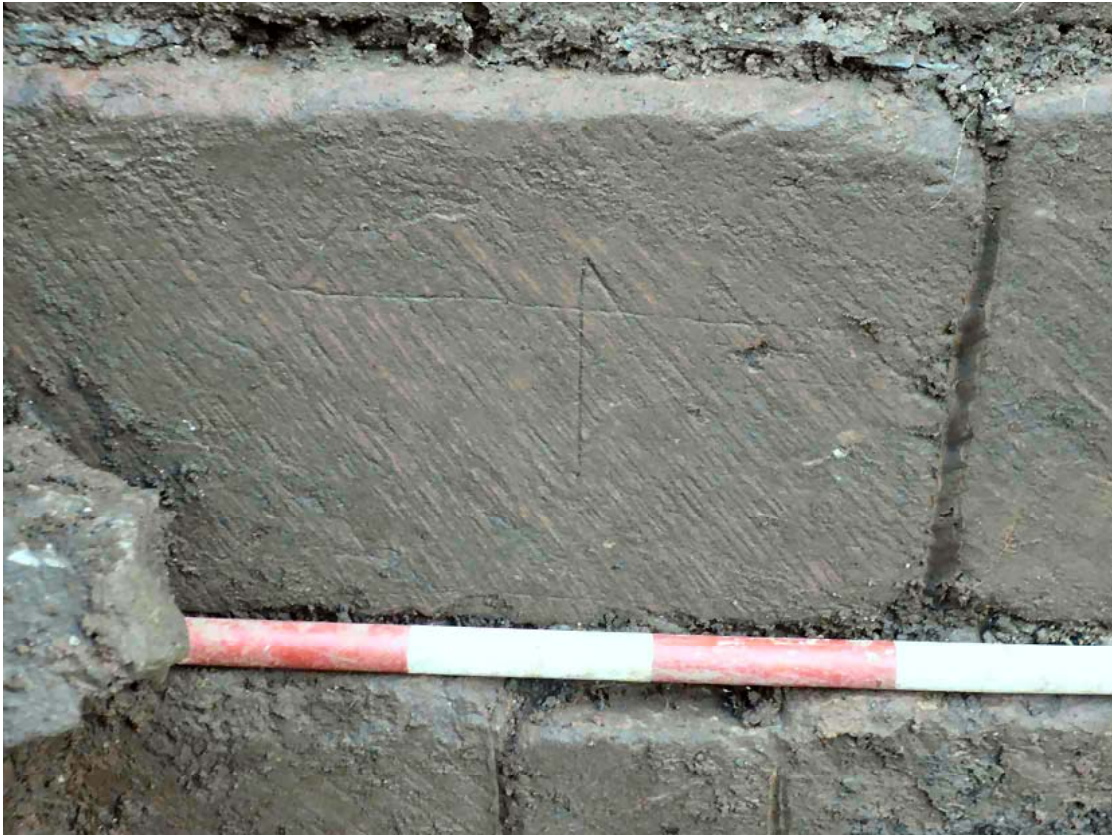
Plate 7: Mason's mark on the lowest course of the presbytery wall (*116*).

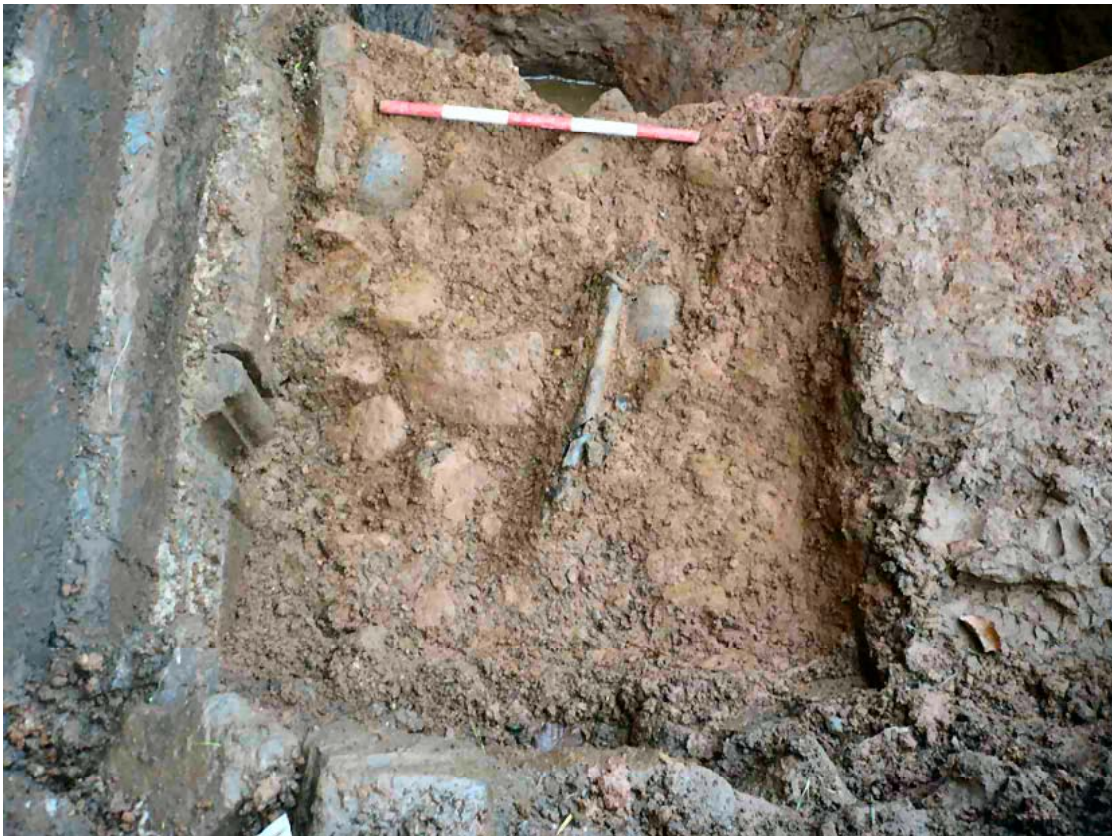
Plate 8: The charnel deposit *141/146* within the top of the presbytery wall construction cut *140*.

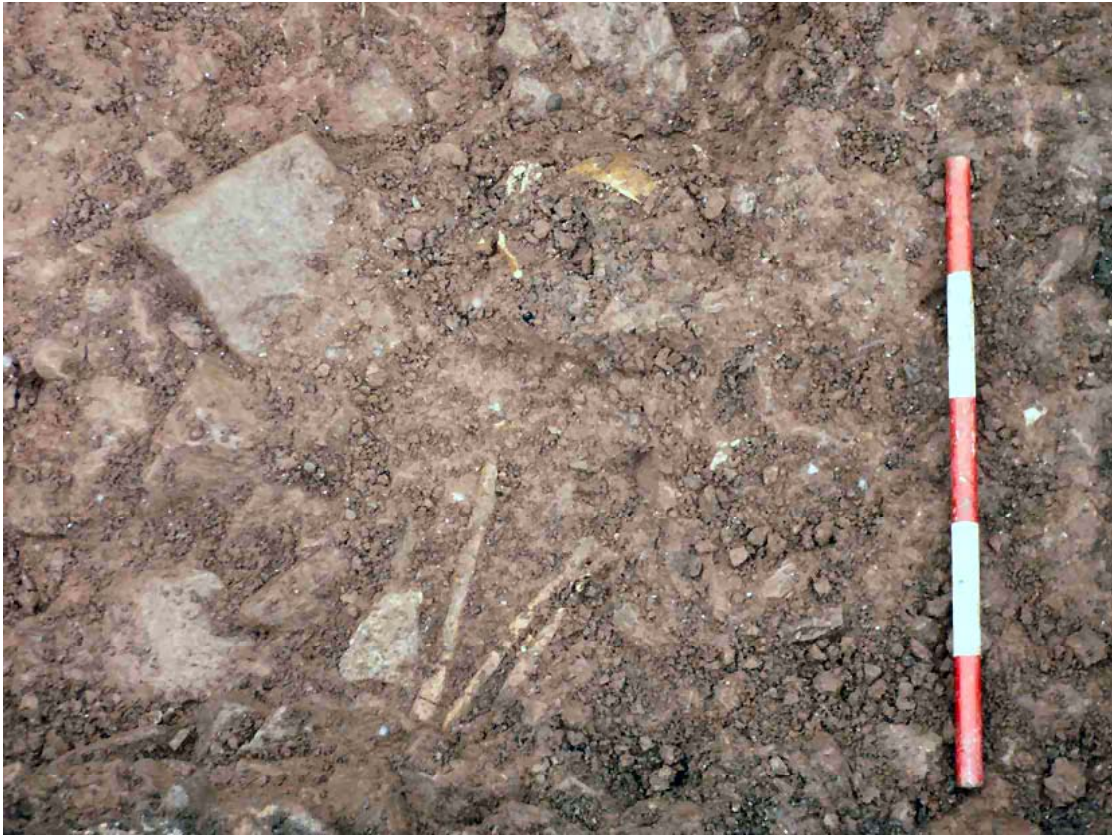
Plate 9: Skeleton *133* within grave cut *134*, with head lying at the south-west end. The graves found within the trench were aligned on the presbytery, rather than with the graves in the cemetery.

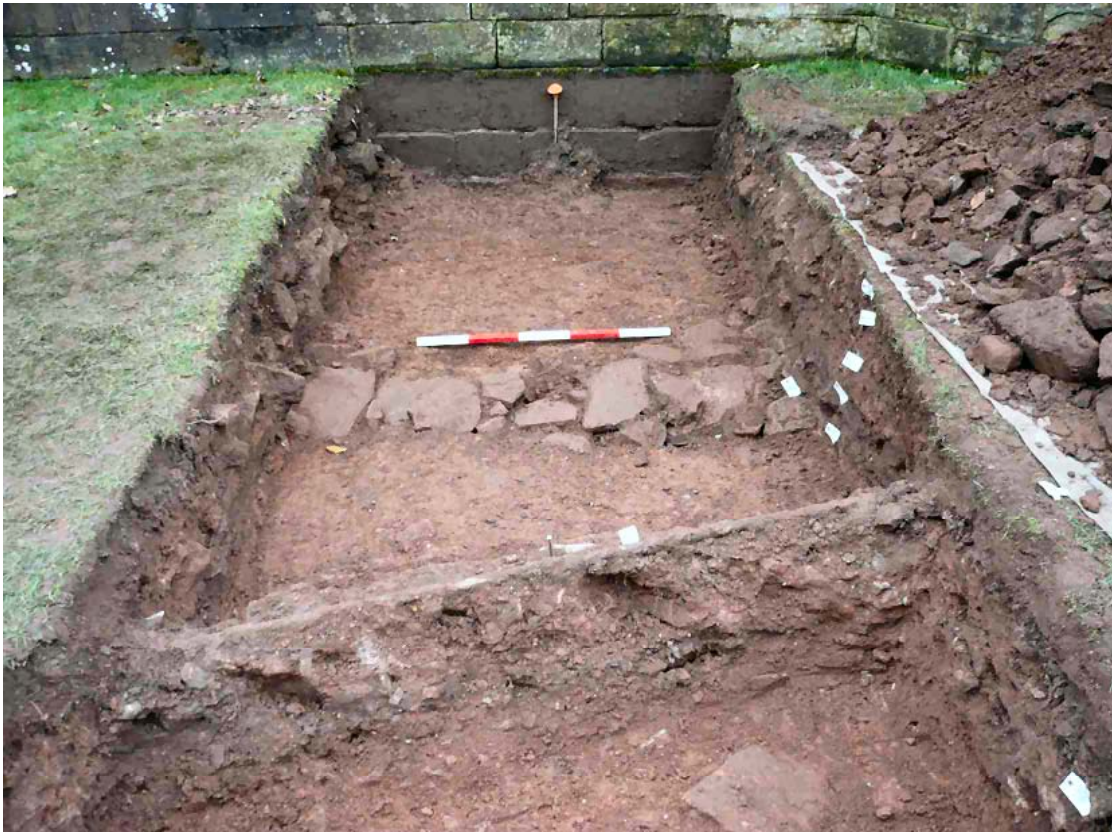
Plate 10: Culvert *115* (centre) and later iron pipe in service trench *105*, both from Phase 3
