SUTTON MILL, COPPULL LANE, WIGAN

Archaeological Evaluation and Watching Brief

Oxford Archaeology North

May 2009

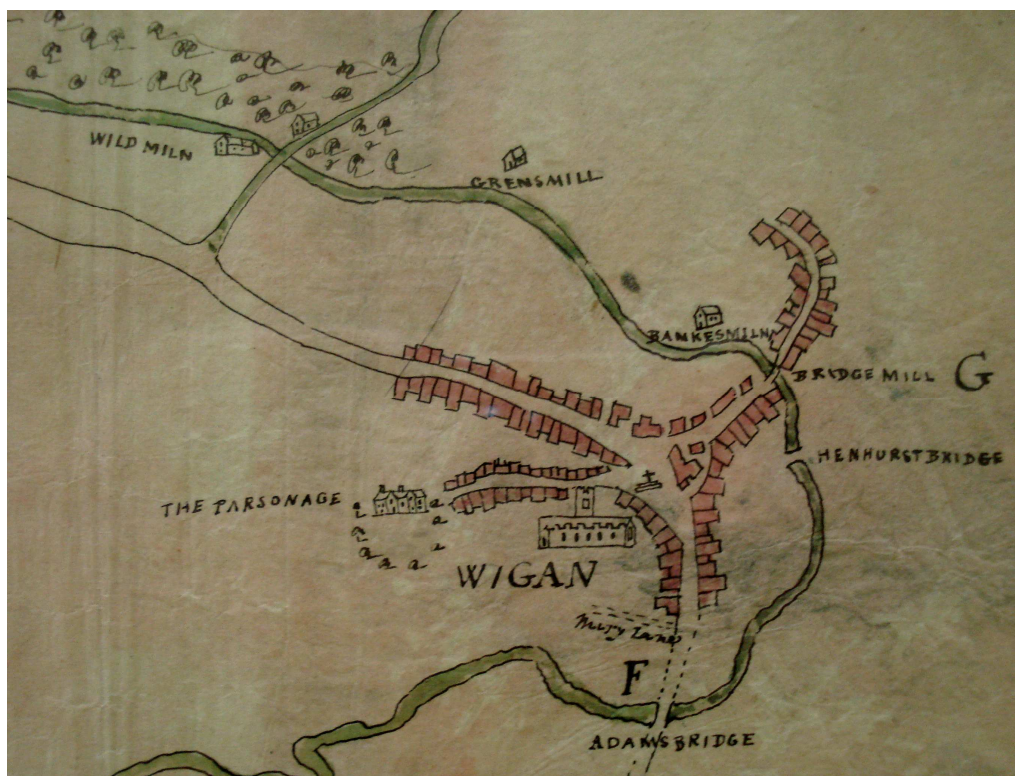
Plate 2: Extract from a map of the River Douglas by Thomas Steers, *c* 1712 (LRO/DP 175)

- 3.1.2 The earliest cartographic depiction of the site is provided by a plan of the River Douglas, which was surveyed by Thomas Steers in *c* 1712 (LRO/DP 175) as part of a proposal to construct the Douglas Navigation between Wigan and the Ribble Estuary. Steers marked the position of water-powered mills on the river, as the construction of the Douglas Navigation would potential have an impact on their water supply. Whilst the plan is essentially schematic, and cannot be considered as an accurate survey, the location of 'Wild Miln' seems to correspond with the position of Sutton Mill (Plate 2).

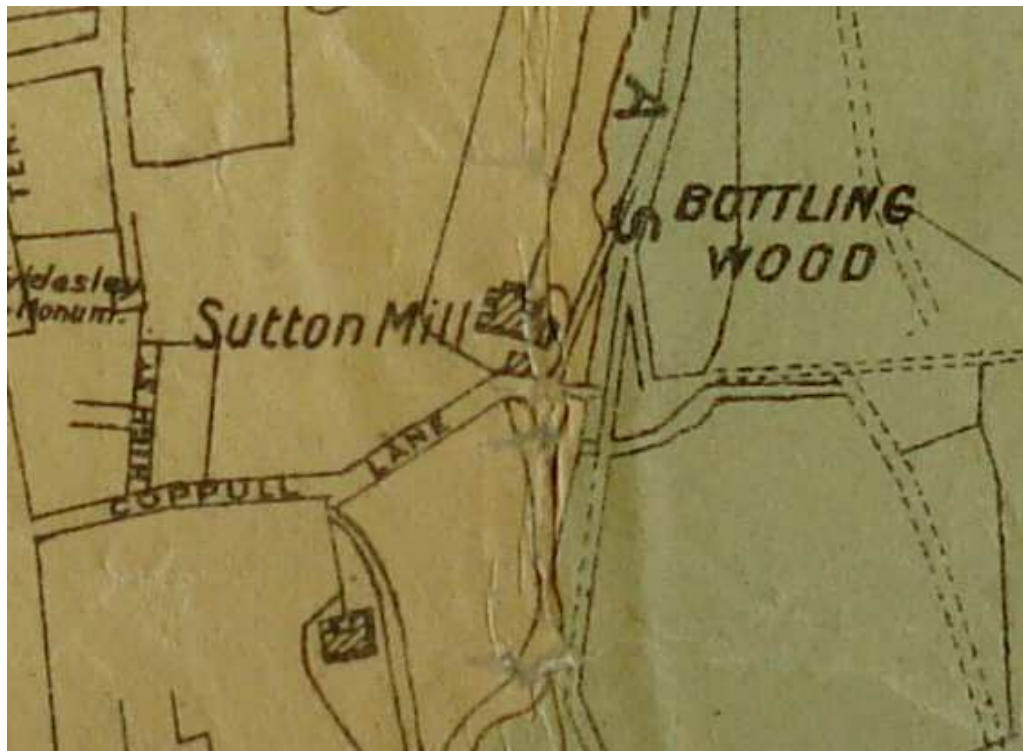
Plate 3: Extract from Platt's map of 1907

- 3.1.5 The next available map of the site is provided by Kellet's *Plan of the Town and Borough of Wigan*, which was published in 1837. This seemingly depicts the mill with additional buildings to those surveyed by Mather. This layout of the mill buildings is shown on subsequent maps from 1849, 1851, and 1856. The detail provided by the Ordnance Survey 25":1 mile plan of 1894 confirms the presence of a weir and mill race, and identified the site as Sutton Mill. The site is similarly marked as Sutton Mill on Platt's Plan of the County Borough of Wigan, published in 1907 (Plate 3), and on the Ordnance Survey 25":1 mile plan of 1909.

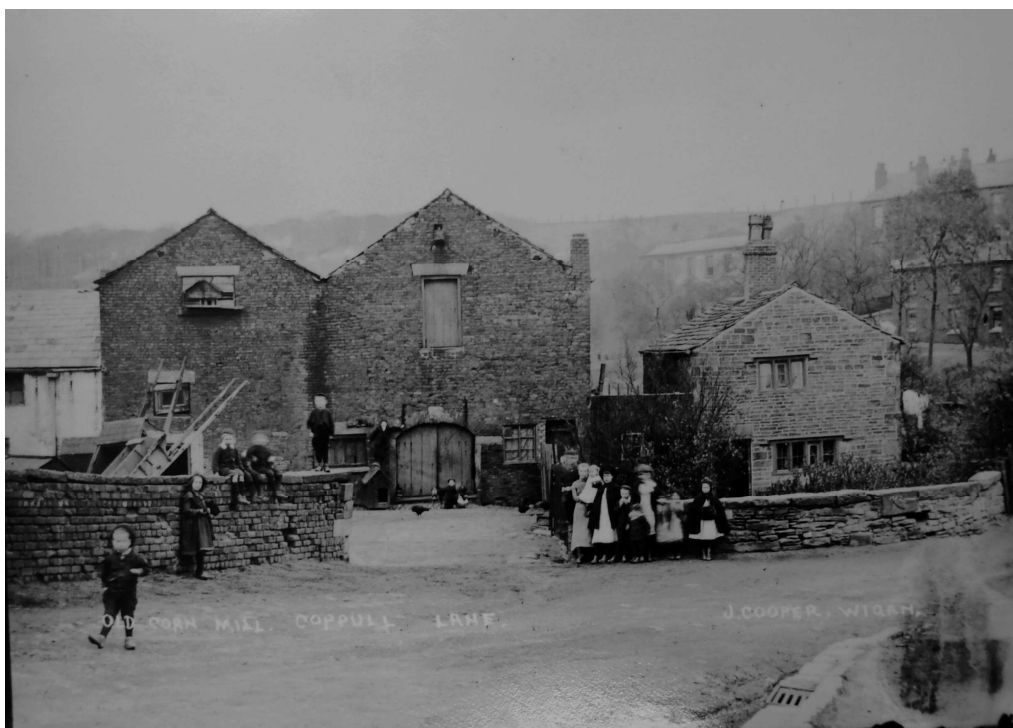
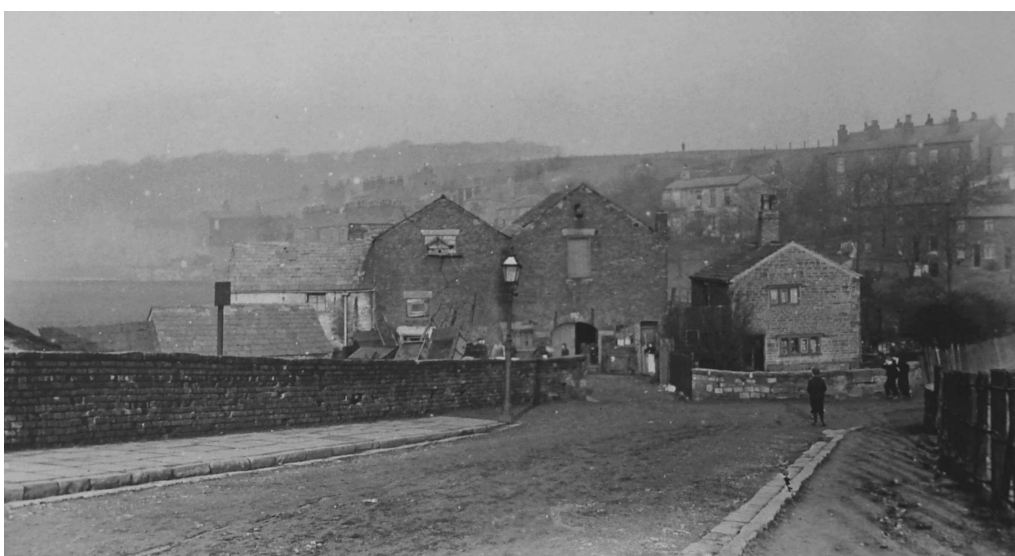
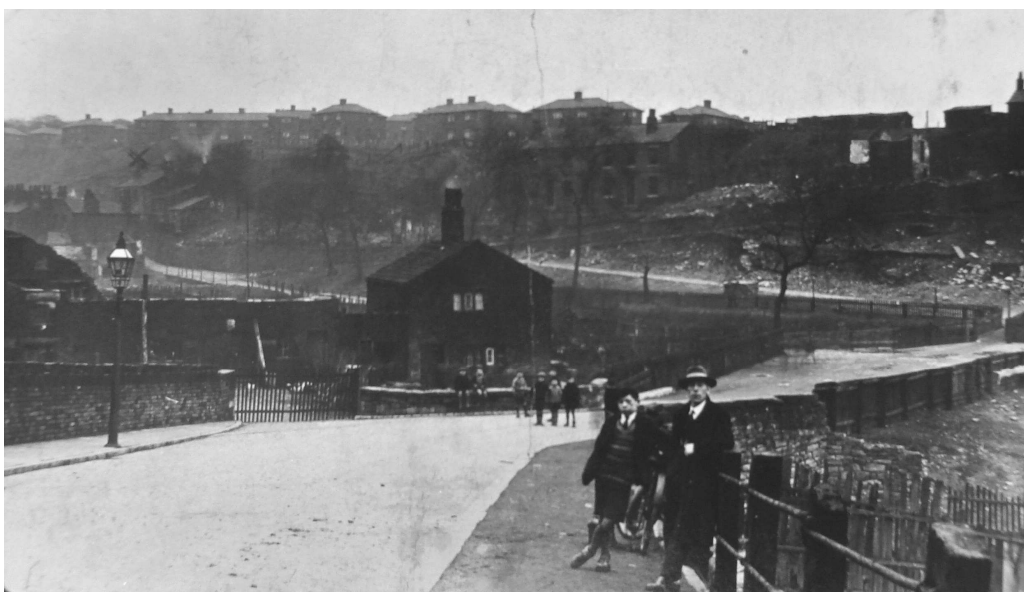
- 3.3.1 Wigan Archives Service holds three photographs of Sutton Mill (Plates 4, 5 and 6). A later note has been made on the back of photograph 671311/2 (Plate 5), which reads 'The old corn mill Coppull Lane, Cooper Photo'. No date is given for the photograph, although the image was reproduced in the *Wigan Observer* in 1958 (W/O 04.07.1958 – ix p.287), with the caption: 'Here is the old corn mill which stood on the bank of the River Douglas at the foot of Coppull Lane off Wigan Lane, Wigan. The buildings along with much of the adjacent property were demolished many years ago. The farm of which the corn mill formed part was last tenanted by Mr Leather. The story goes that there was a water wheel at the corn mill powered by the current of the River Douglas. This picture was taken about half a century ago'.

- 3.3.2 The photographs show that the principal structure of the corn mill comprised a double-pitched gable building, seemingly of brick construction with slate roofing. Conversely, the adjacent building, which appears to have been a dwelling house, is of stone construction. Another building is visible to the west, abutting the main part of the corn mill, although detail is obscured. The photographs do not provide any evidence for the waterwheel or associated water-management features, suggesting that the wheel was housed internally, and the leat was at a lower level to the surrounding ground surface. A subsequent photograph (270/34; Plate 6) also has a note written on the back, which reads: 'old corn mill Coppull Lane c 1930'. This photo is of particular interest as it shows the main element of the corn mill to have been partially demolished, although the dwelling survives extant. This suggests that the photograph was taken in c 1927, providing good evidence for the date of demolition.

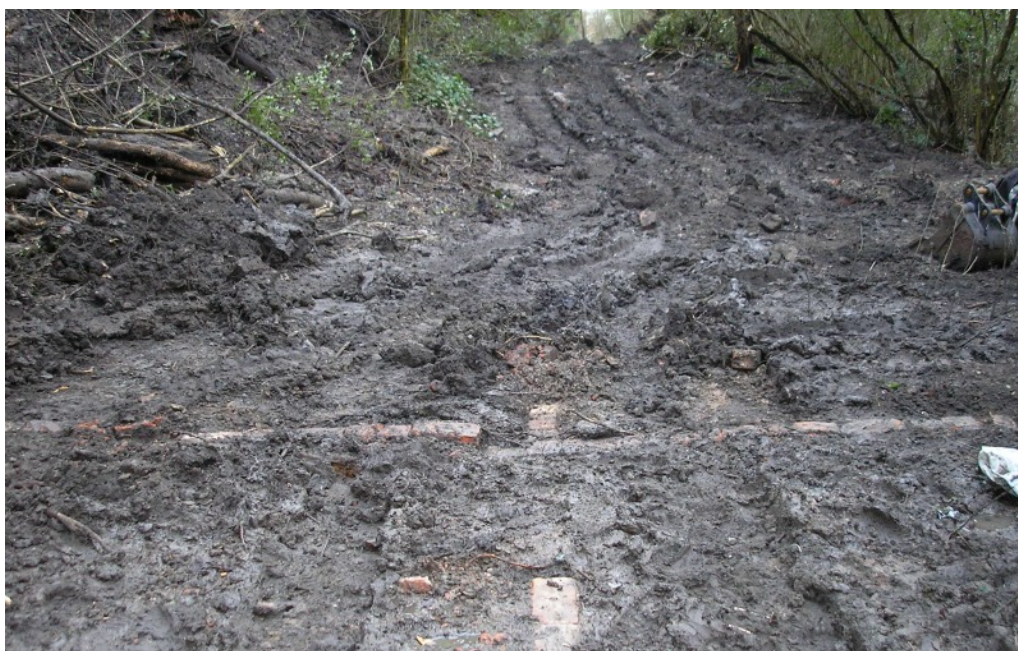
Plate 7: View of the track through Bottling Wood, looking south

- 4.1.2 The test pits and trial trenches along the eastern side of the river were accessed along a track within Bottling Wood. This track formerly provided access to the Bottling Wood properties shown on historical mapping, but since the clearance of houses in the area during the 1920s, the track has become overgrown. A series of brick walls forming a structure (Building **104**) associated with one of the demolished properties was exposed in the northern part of the existing track. These are described in *Section 4.4* below.

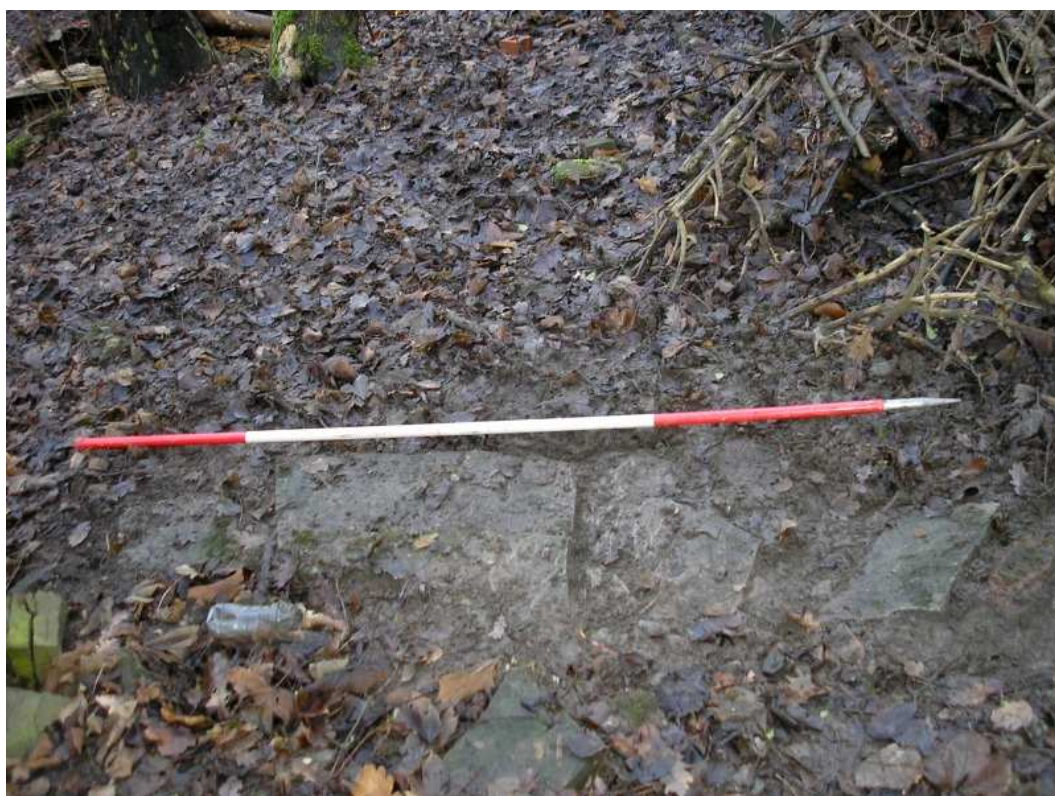
Plate 8: Wall **101**, looking east

- 4.2.1 **Test Pit 111:** this test was placed at the north-eastern boundary of the study area on the eastern side of the river. No remains of archaeological interest were identified in the test pit, although the foundations of a north/south-aligned stone wall (**101**) was exposed immediately below the modern ground surface at a distance of 4m to the west (Plate 8). The wall possibly represented a relict boundary, and its position corresponded broadly with a boundary depicted on the Ordnance Survey map of 1893 (Fig 2).

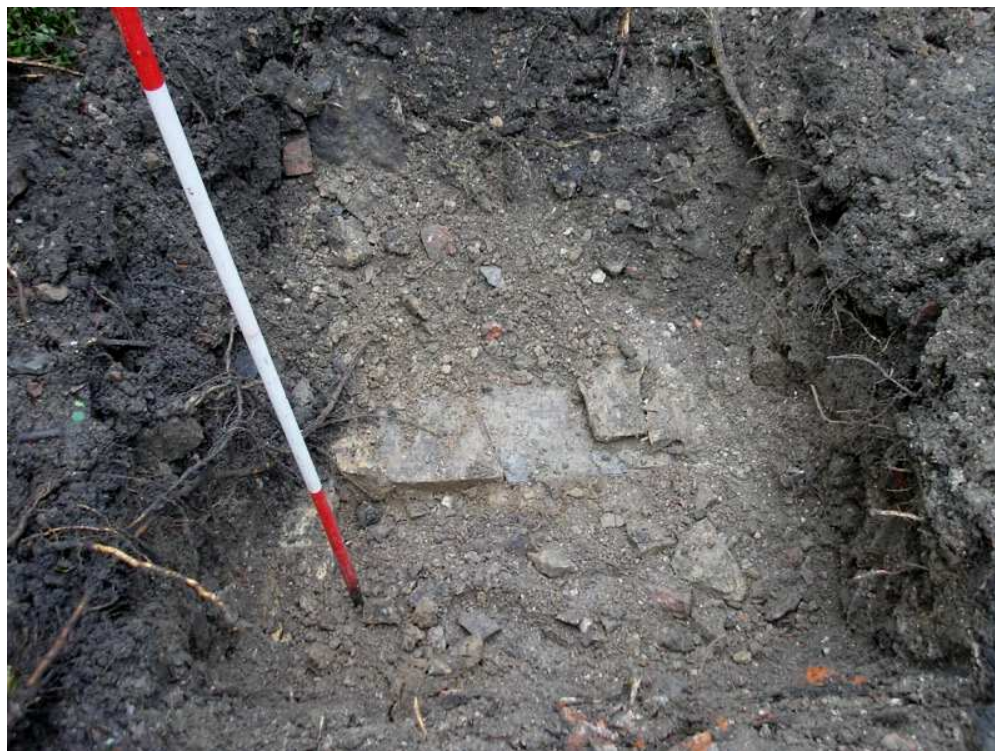
Plate 9: Test Pit 115 looking north, showing fragment of stone wall 107

- 4.2.3 **Test Pit 115:** this test pit was placed in the southern part of the area, and measured 2m²; it was excavated by machine, and was intended to further expose remains identified in AD 2 (Section 4.3.4 below). An east/west-aligned stone wall (**107**), measuring 0.3m wide, was exposed across the northern part of the test pit (Plate 9). This wall may have been associated with the structure identified in AD 2, although firm evidence is lacking. The western end of the wall was abutted by a north/south-aligned brick wall (**108**).

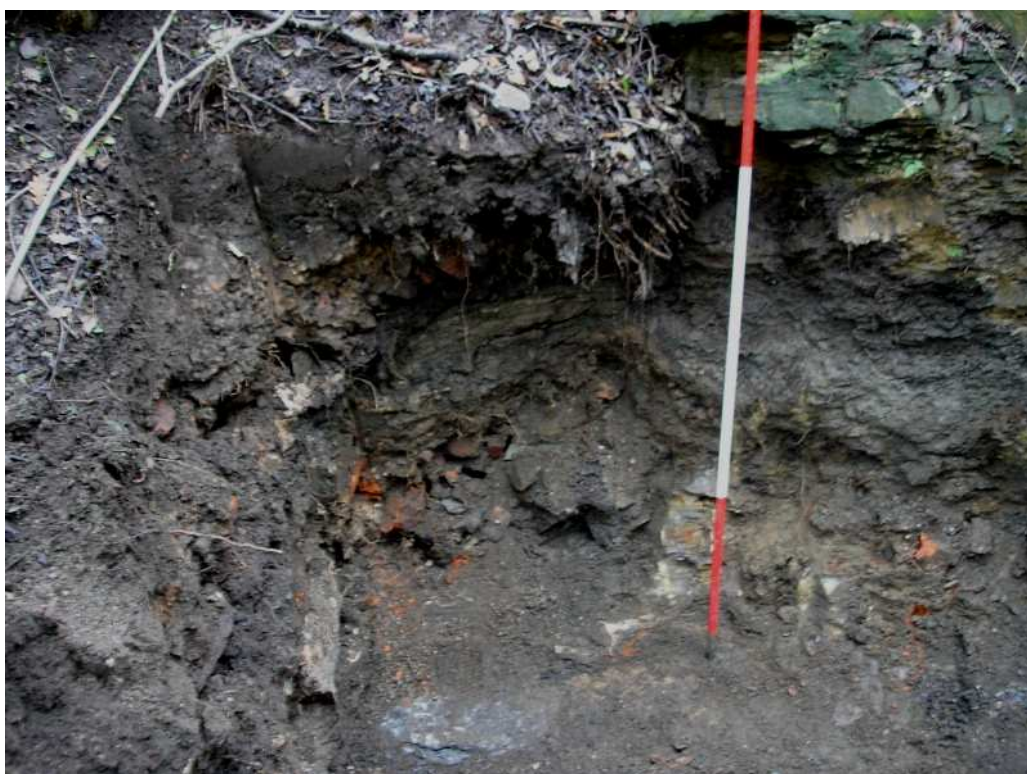
Plate 10: View of cut **III**, facing east

- 4.3.3 A semi-circular cut (**III**) into the rock face along the northern side of the test pit possibly represented mining activity. Feature **III** measured 1.6m high and 0.8m wide, and was cut into a seam of shale and mudstone. No diagnostic evidence of workings around the edge of the cut, such as pick marks, were identified.

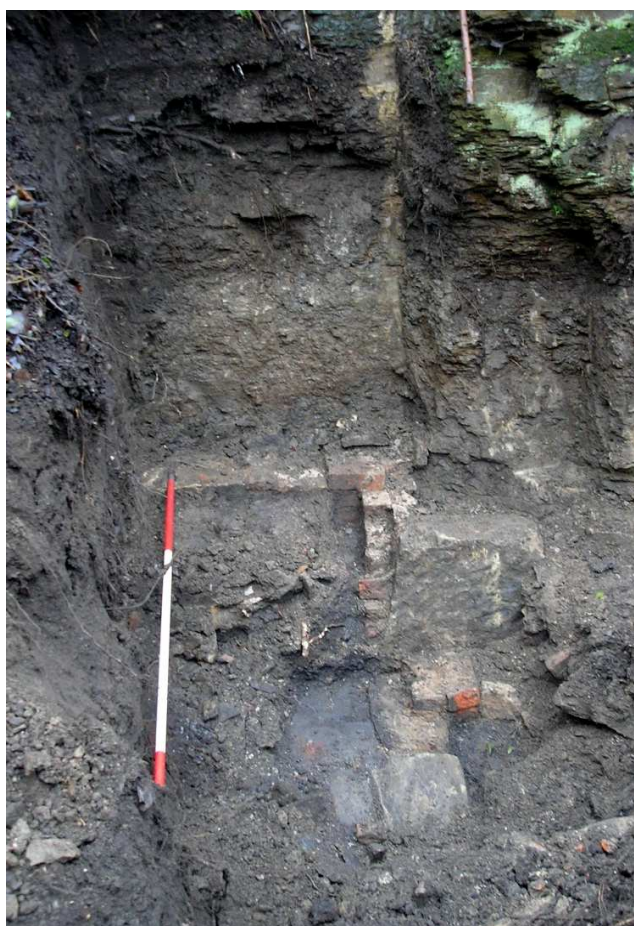
Plate 11: AD 2; showing exposed structural remains

4.3.4 **AD 2:** this east/west-aligned trench measured 2.7m long and 2.3m wide, and was excavated to a maximum depth of 1.6m; the natural geology was not exposed in the trench due to the presence of archaeological features, which were left *in-situ*. The earliest remains encountered included two brick walls (**113** and **114**) and part of a brick floor (**112**), which seemingly represented elements of a single structure that had been built against the cliff face (Fig 4). The position of the structure corresponded with a structure depicted on the Ordnance Survey map of 1893. The structural remains were overlain by a 1m thick band of yellow clay mixed with demolition debris, which was sealed by the topsoil horizon (Plate 11).

4.3.5 The structure comprised a north/south-aligned wall (**114**) of mixed stone and brick construction, which measuring 0.20m wide and was exposed to a depth of three courses in the eastern part of the trench. The bricks were all hand made, and were bonded with a lime-based mortar, suggesting a late eighteenth- or nineteenth-century date for construction. The southern end of the wall was keyed into an east/west-aligned wall (**113**) of the same width, and of similar construction. The western end of wall **113** was seemingly marked by a stone block (**115**), which may have represented the foundation of a doorway (Plate 11). The stone block was abutted by the remnants of an evenly laid stone-flagged floor (**112**), which survived intact for a distance of 0.8m² across the western part of the trench, and seemingly continued beyond the limit of excavation at the northern side of the trench (Fig 5). It seems possible that the remains may have been part of the mine, although it is unclear whether this afforded access to a mine or a standing structure built against the rock face.

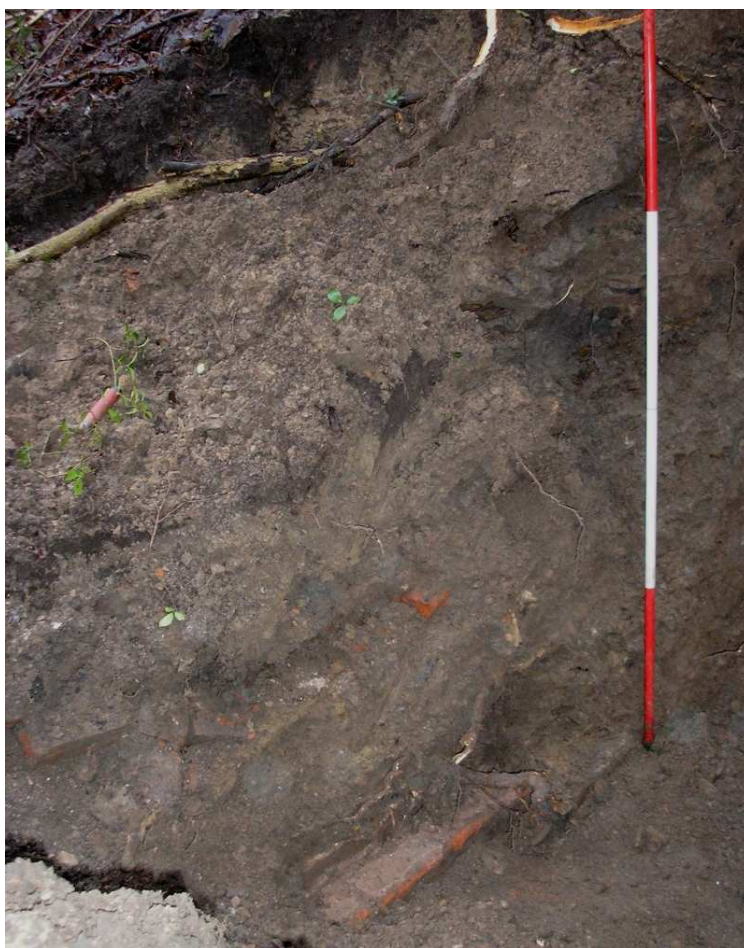
Plate 12: AD 3; view of wall **116**, facing north-east

4.3.6 **AD 3:** this trench measured 2m², and was excavated to a maximum depth of 2.5m against the rock face (Plate 12). No firm evidence for a mine entrance was identified, although the remains of two walls were identified in the northern (**116**) and southern (**117**) sides of the trench. The simple stratigraphic sequence overlying walls **116** and **117** comprised a 1.6m thick band of yellow clay, which was sealed by a layer of topsoil measuring less than 0.10m thick.

4.3.7 Wall **116** was aligned east/west at a distance of 1m from the cliff face, and was cut into the natural yellow clay geology. Wall **116** was composed of machine-pressed red bricks, which were bordered at the eastern end by a thin stone slab, perhaps representing the foundation of a threshold. The bonding material of the bricks and stone slab comprised light red cement based mortar, indicative of a construction date no earlier than the late nineteenth century.

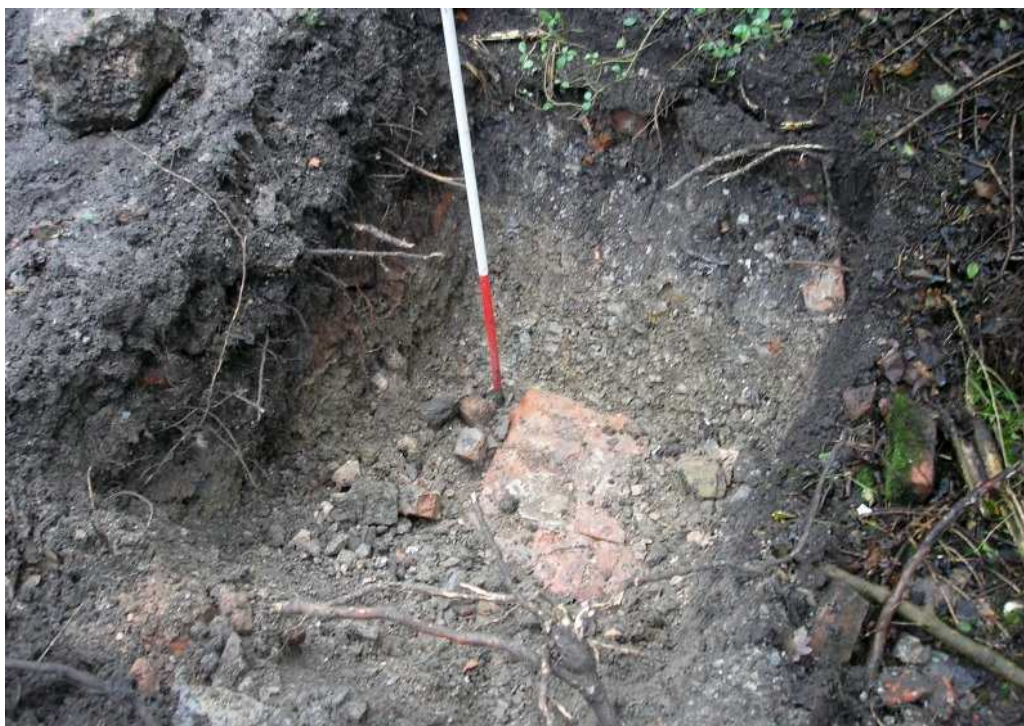
*Plate 13: AD 4; view of brick surface **118**, facing north*

- 4.3.8 Wall **117** was exposed in the north-facing section of the trench, and comprised fragmentary remains of loosely stacked stone blocks that survived to a maximum height of 1m. The wall appeared to be aligned north/south across the trench, parallel and 0.9m to the south of wall **116** (Fig 6). The surviving stone blocks were situated 1m to the west of the cliff face, and had been cut into the natural yellow clay geology.
- 4.3.9 **AD 4**: the trench measured 2m², and was placed within the central part of the access track, south of Test Pit 112 (Figs 3 and 4). It was excavated to a maximum depth of 1m through a thin layer of topsoil and dense rubble, onto a surface of a bricks (**118**). Surface **118** was seemingly aligned north/south across the trench, measured at least 0.60m wide, and was composed entirely of hand-made bricks (Plate 13). The surface was not excavated.

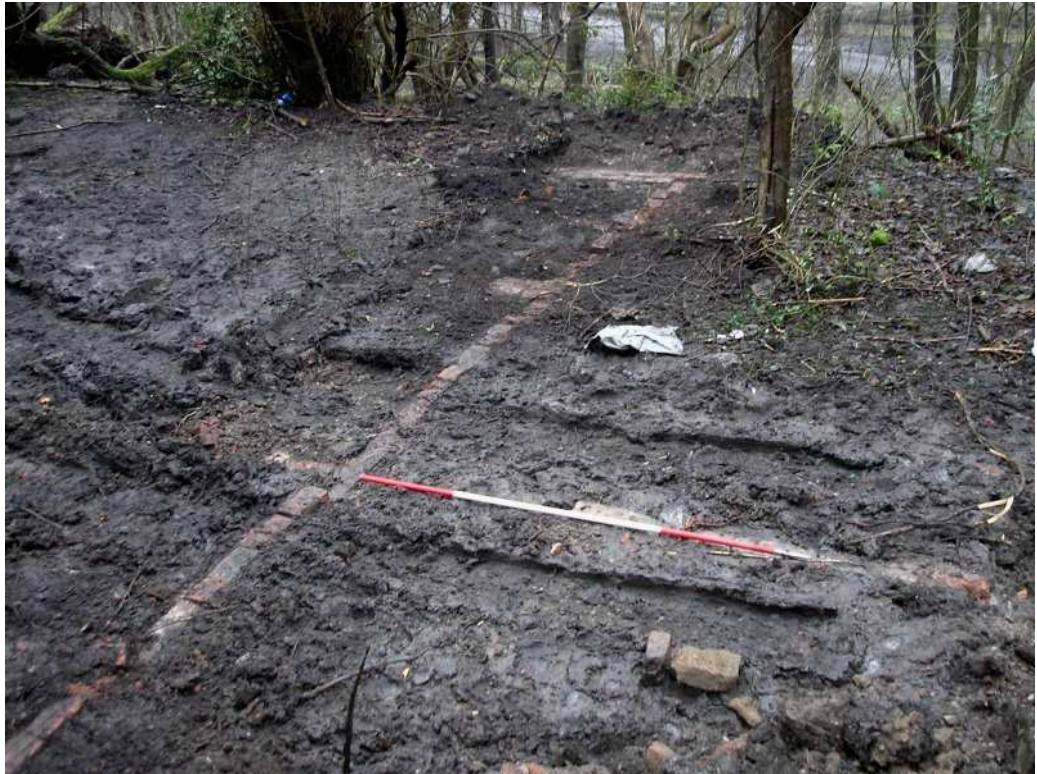
Plate 14: Part of building 104, facing west

- 4.4.1 The remains of a brick structure were exposed immediately beneath the modern ground surface near Test Pits 112 and 113 (Fig 6). The structure comprised a series of single-skin wide (0.26m), north/south-aligned brick walls (**105**, **106**, **119**, and **120**) of varying lengths, which were keyed into a 11m long east/west-aligned wall (**102**) of a similar thickness (Plate 14). Wall **102** abutted a two-skin wide (0.40m) wall (**121**), which represented the external wall of the structure. A short, east/west-aligned wall (**122**) was keyed into walls **120** and **121**, forming a small room that measured 3m x 2.7m. The component bricks of all the exposed walls were mostly hand-made, although some machine-pressed variants were noted. All bricks were bonded with a lime-based mortar. No remains of an internal floor were exposed, although excavation did not proceed beneath the upper surface of the walls.

- 4.4.2 The position of the building corresponds with a structure shown on the 1893 Ordnance Survey map, depicted as a row of square-shaped units. The building is absent from the Ordnance Survey map of 1849, indicating that its construction date was in the second half of the nineteenth century.

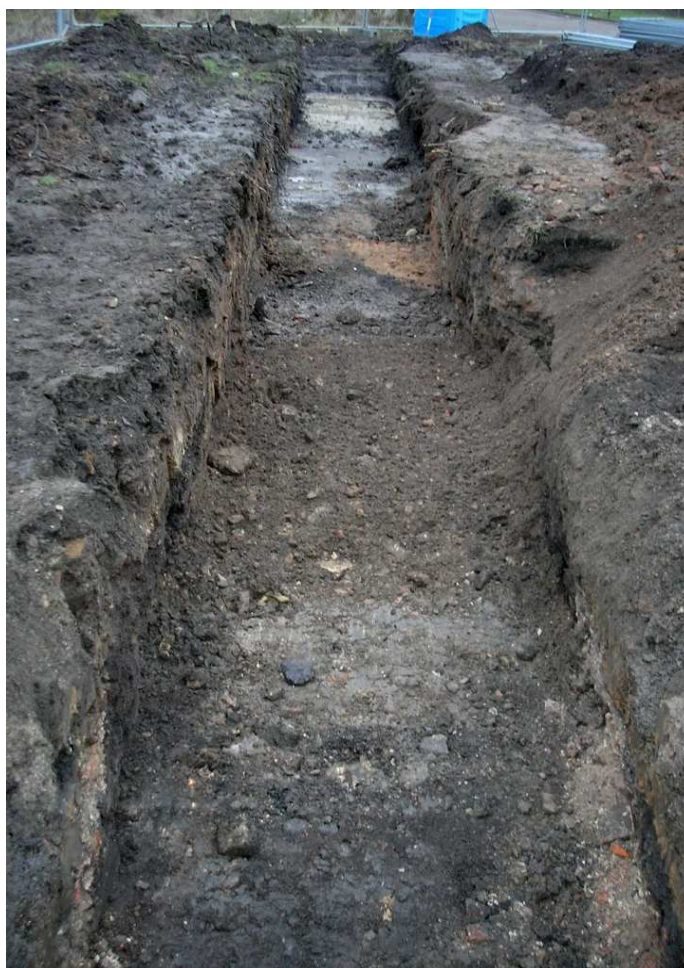
Plate 15: General view of Trench 1, facing north-west

- 5.2.1 Trench 1 was aligned north-west/south-east along the footprint of Sutton Mill and the adjacent mill cottage, and was excavated for a length of 30m (Plate 15). The earliest deposit exposed was a light brown silty-clay, seemingly representing the natural geology, which was exposed at a depth in excess of 2m in a machine-excavated sondage. However, this deposit contained fragments of bricks, indicating that it had been sustained some disturbance. It was overlain by a series of deposits that all contained stone and brick rubble, which appeared to represent made ground derived from the demolition of the building. Several fragments of dressed stone were revealed in the north-western part of the trench, possibly representing elements of the demolished mill. However, none of these fragments were *in-situ*, and there was no indication for any surviving structural remains within the trench. The demolition material was sealed by a 0.4m thick deposit of orange sandy-clay, which incorporated fragments of tarmac and other modern inclusions. This was sealed by a 0.2m thick layer of topsoil.

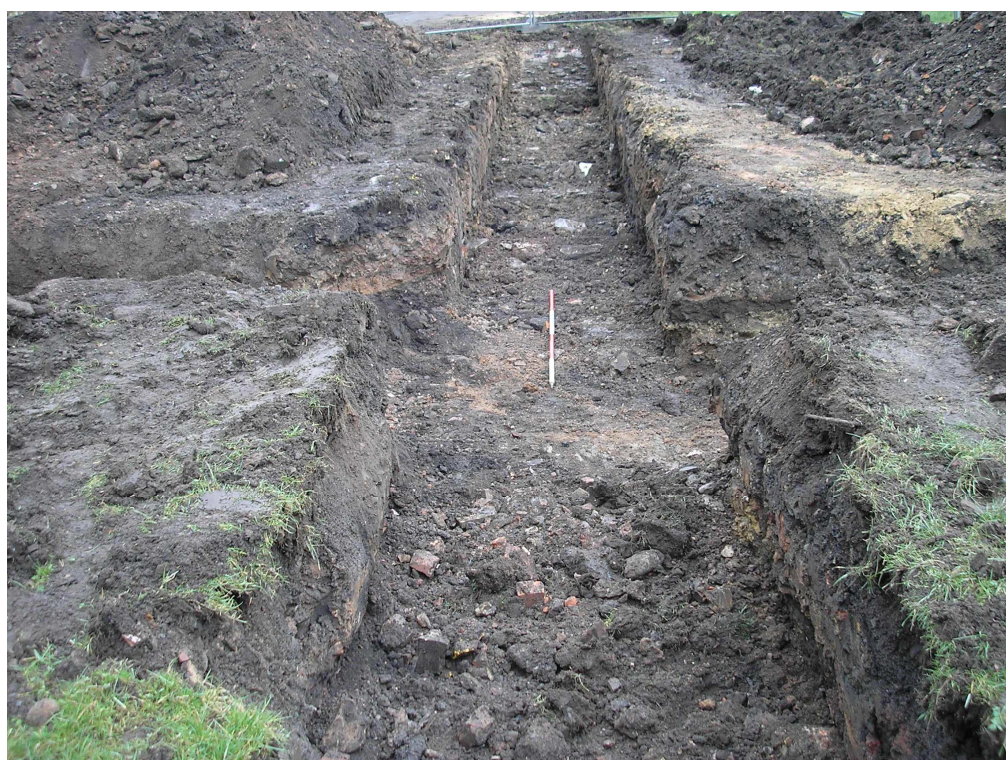
Plate 16: General view of Trench 2, facing south-west

- 5.3.1 Trench 2 was aligned north east/south west across the width of Sutton Mill, and was excavated to a length of 20m (Fig 2). It was excavated initially to a maximum depth of 2.5m, although the natural geology was not encountered. The earliest deposit excavated was a brown silty-clay, which contained numerous inclusions of stone and brick fragments; it is most likely that this deposit represent material derived from the demolition of the mill in the 1920s. This layer was sealed by a 0.2m thick horizon of orange clay, and a 0.4m thick deposit of mid-brown-orange clay, both again containing fragments of brick rubble. The topsoil was the same as that excavated in Trench 1. No structural remains of the mill were exposed in the trench.

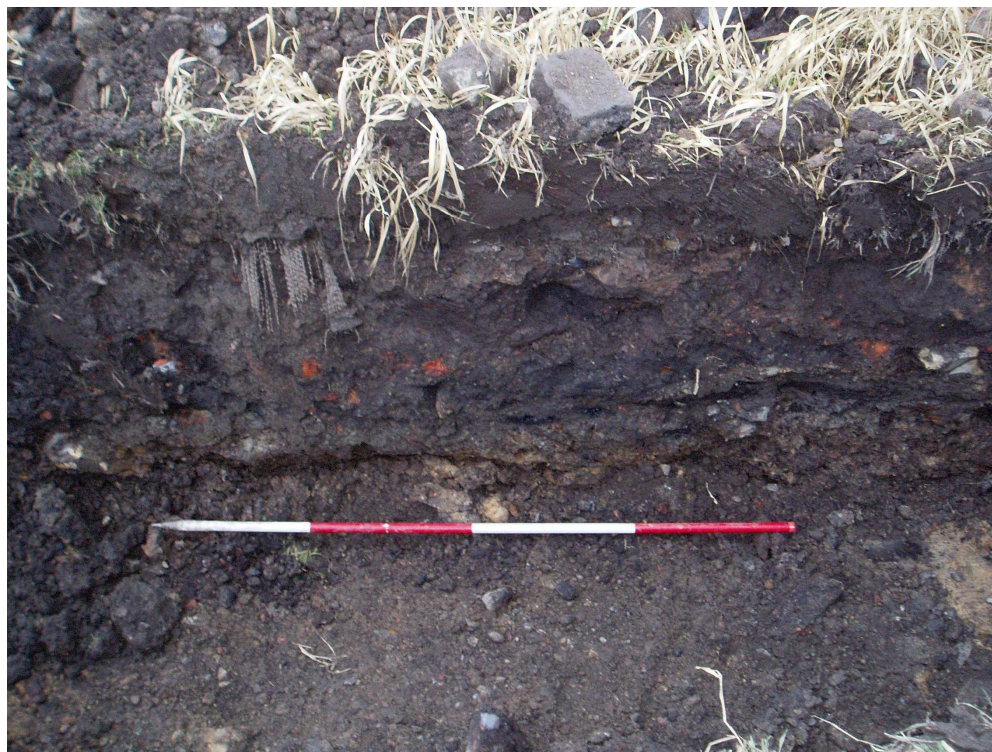
Plate 17: Trench 3, south-west-facing section

- 5.4.1 Trench 3 was placed to the north-east of Trench 1 and Trench 2, and was aligned north-west/south-east across the line of the headrace to the mill. The trench was excavated for a length of 17m, and to a maximum depth of 2.3m. No firm evidence for the headrace was identified, although several large fragments of sandstone within a matrix of yellowish-red clay were exposed at the base of the excavated trench. The sandstone did not form a coherent structure, although the possibility that it represented the vestiges of the headrace cannot be discounted entirely. However, there was no indication of any organic or waterlogged deposits that would usually be associated with a headrace channel.

- 5.4.2 The overlying deposits comprised a thick layer of compacted grey clay, containing fragments of tarmac and rubble inclusions, and a 0.2m thick deposit of mid-brown silty-clay with brick and stone inclusions, again indicative of modern demolition material. The upper horizon comprised a 0.3m thick deposit of topsoil (Plate 17).

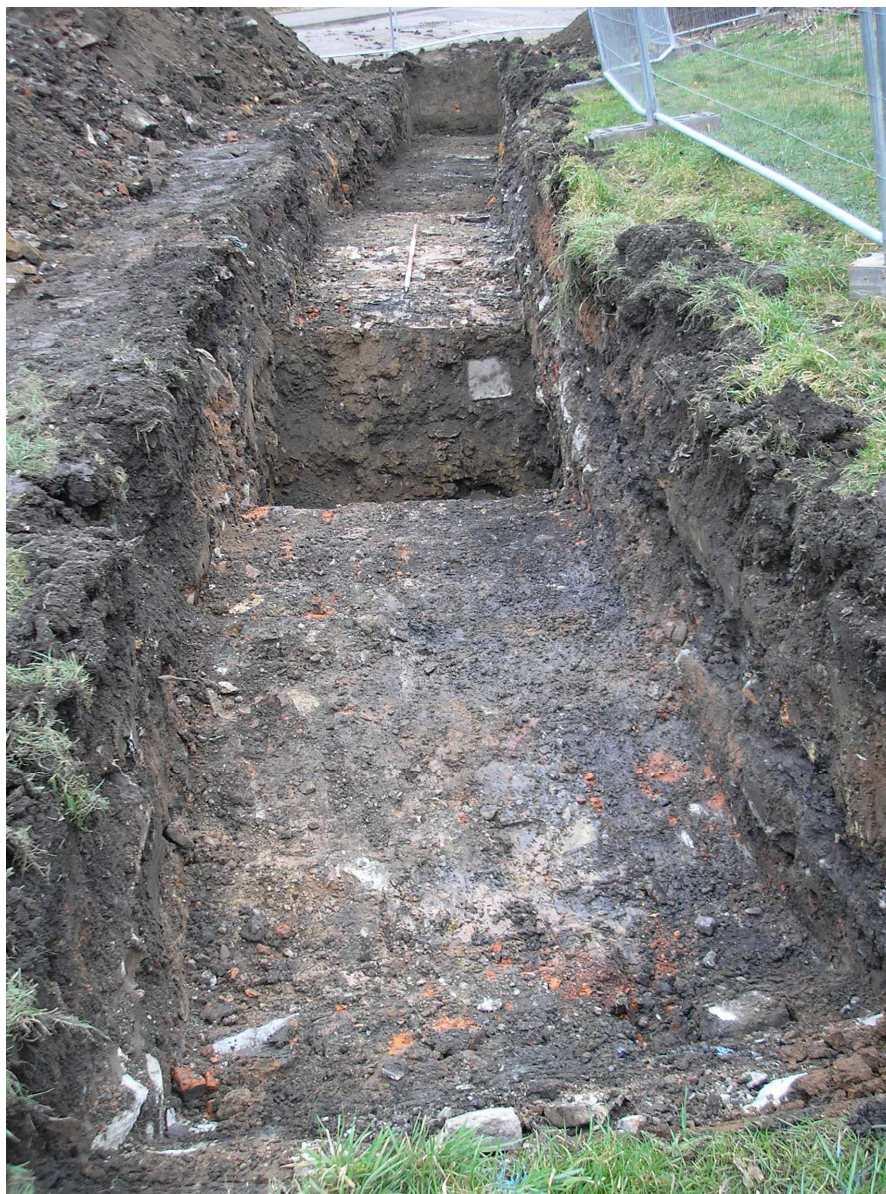
Plate 18: Trench 4; general shot of trench, facing south south-west

- 5.5.1 Trench 4 was placed to the south-west of the mill, and was aligned north-north-east/south-south-west along the footprint of a row of cottages shown on the Ordnance Survey map of 1849. The trench was excavated to a length of 20m, and to a maximum depth of 2.4m in several machine-excavated sondages placed at intervals along the trench (Plate 18). The natural geology was exposed at the base of these sondages, and was overlain by mixed deposits of demolition material. This material contained fragments of brick, tarmac and concrete, indicative of modern deposition. No structural remains survived in the trench, demonstrating that the former cottages had been destroyed entirely, presumably during the documented clearance of the late 1920s. The uppermost deposit exposed in the trench was the topsoil, which had an average depth of 0.2m.

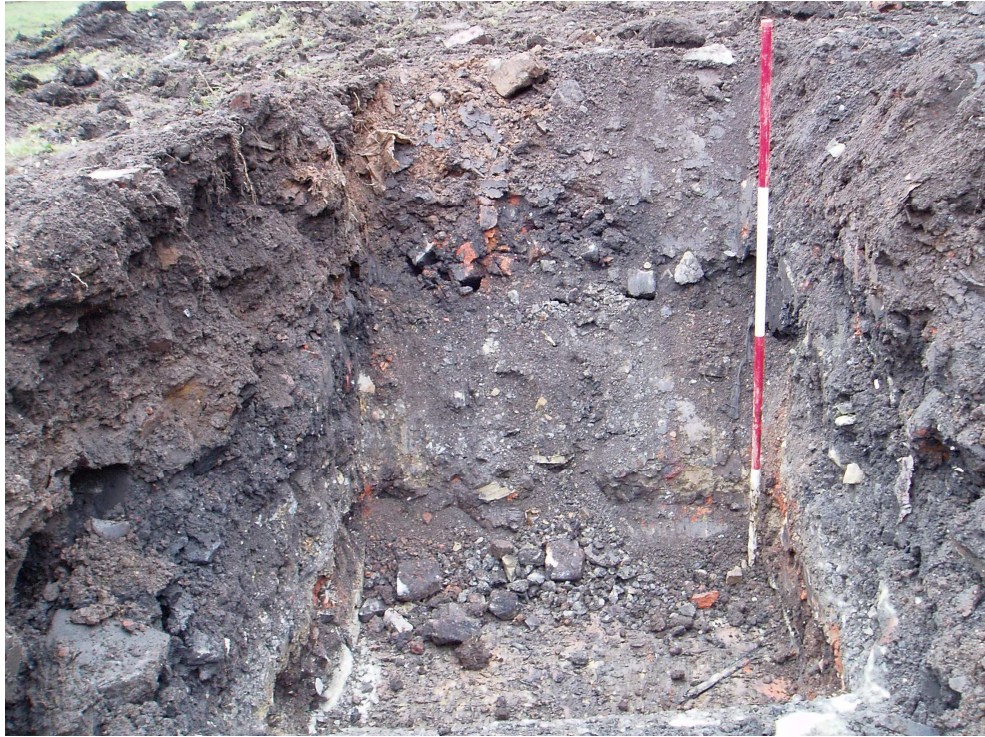
Plate 19: The southern end of Trench 5

- 5.6.1 Trench 5 was aligned north-north-west/south-south-east, and was placed across the footprint of a detached building depicted on the 1851 plan. The trench was excavated to a length of 21m, and to a maximum depth of 2m (Plate 19). The natural geology was exposed in the base of the excavated trench, and was overlain by a thin layer of silty-clay. This was in turn overlain a deposit of brick rubble in an orange clay matrix, and a deposit of compacted stone and brick rubble. The uppermost horizon comprised a 0.2m thick deposit of topsoil.

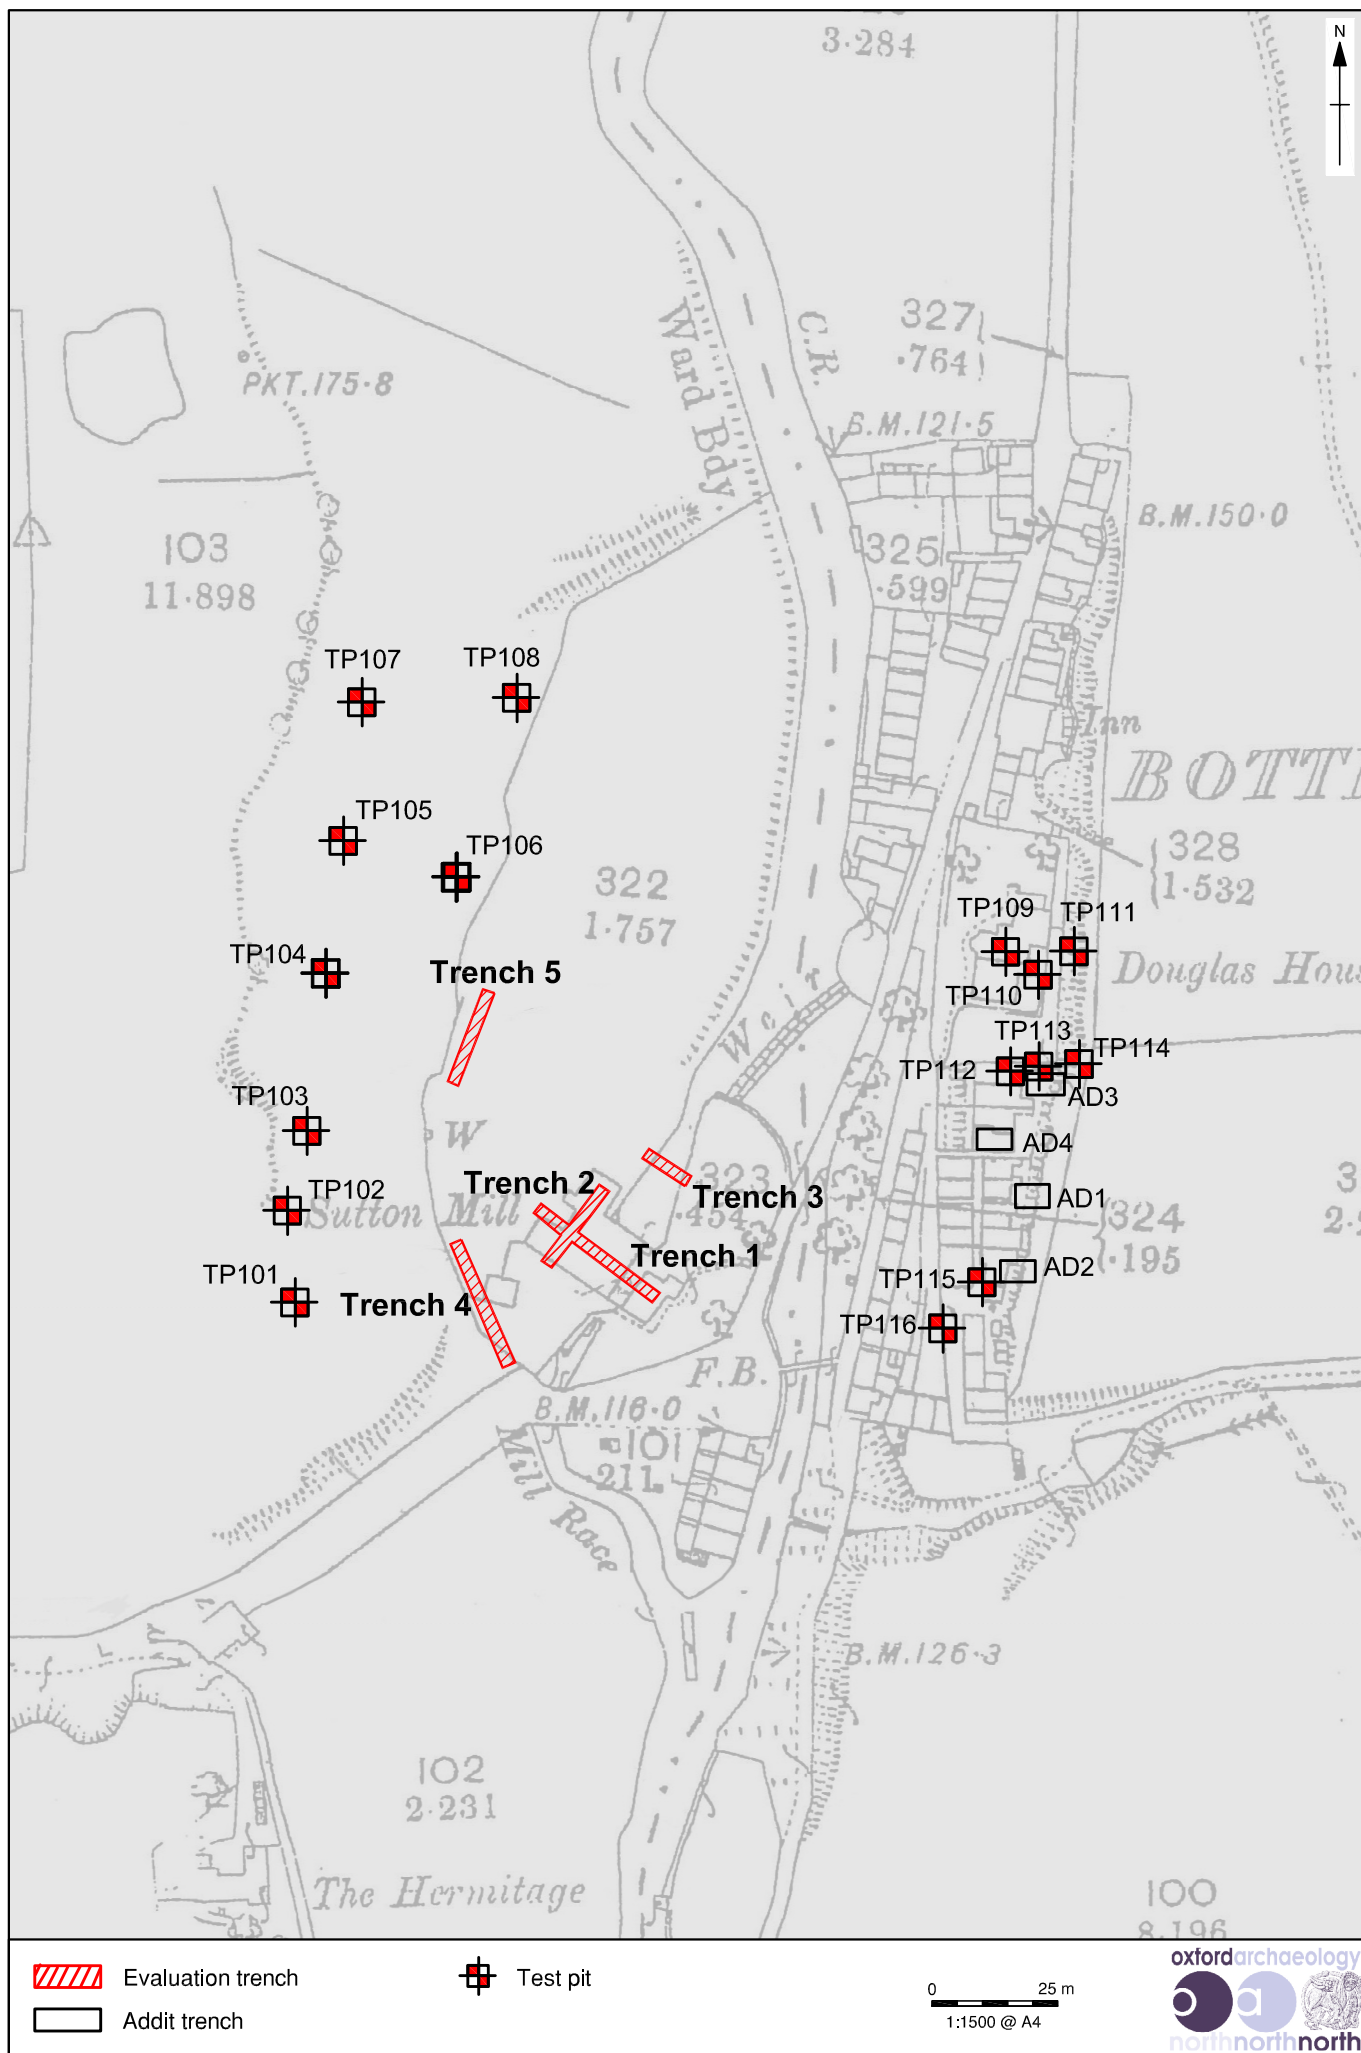
Figure 2: Test pit and trench location plan superimposed onto the 1893 Ordnance Survey map

- 2.2.1 Five targeted trenches of varying dimensions were excavated across the study area, in accordance with the project design (*Appendix 1*). These comprised one trench of 30m length, two of 20m, one of 21m, and one of 17m, providing a combined length of 108m (Fig 2).

- 4.1.1 A watching brief was maintained during the excavation of 16 test pits and four trial trenches across the study area for geo-technical purposes (Fig 2). The test pits along the western side of the site (Test Pits 101 to 108) generally proved to be archaeologically sterile. However, excavation of the test pits (Test Pits 109 to 114) and trial trenches (AD 1, 2 and 3) on the eastern side of the river exposed structural remains of probable late eighteenth- or nineteenth-century date. The position of some of the exposed remains corresponds with buildings depicted on the *Area of the Borough of Wigan* plan of 1851, and the 1893 Ordnance Survey map (Figs 3 and 4), although the remains exposed in Trench AD 2 were possibly associated with an entrance to a mine that is not depicted clearly on historical mapping; mining activity in Bottling Wood is represented on the 1849 Ordnance Survey map, which shows several coal pits in proximity to the present study area. Only those test pits and trenches containing archaeological remains are described below; summary details of the other test pits is presented in *Appendix 2*.
