SUTTON MILL, COPPULL LANE, WIGAN

Archaeological Evaluation and Watching Brief

Oxford Archaeology North

May 2009

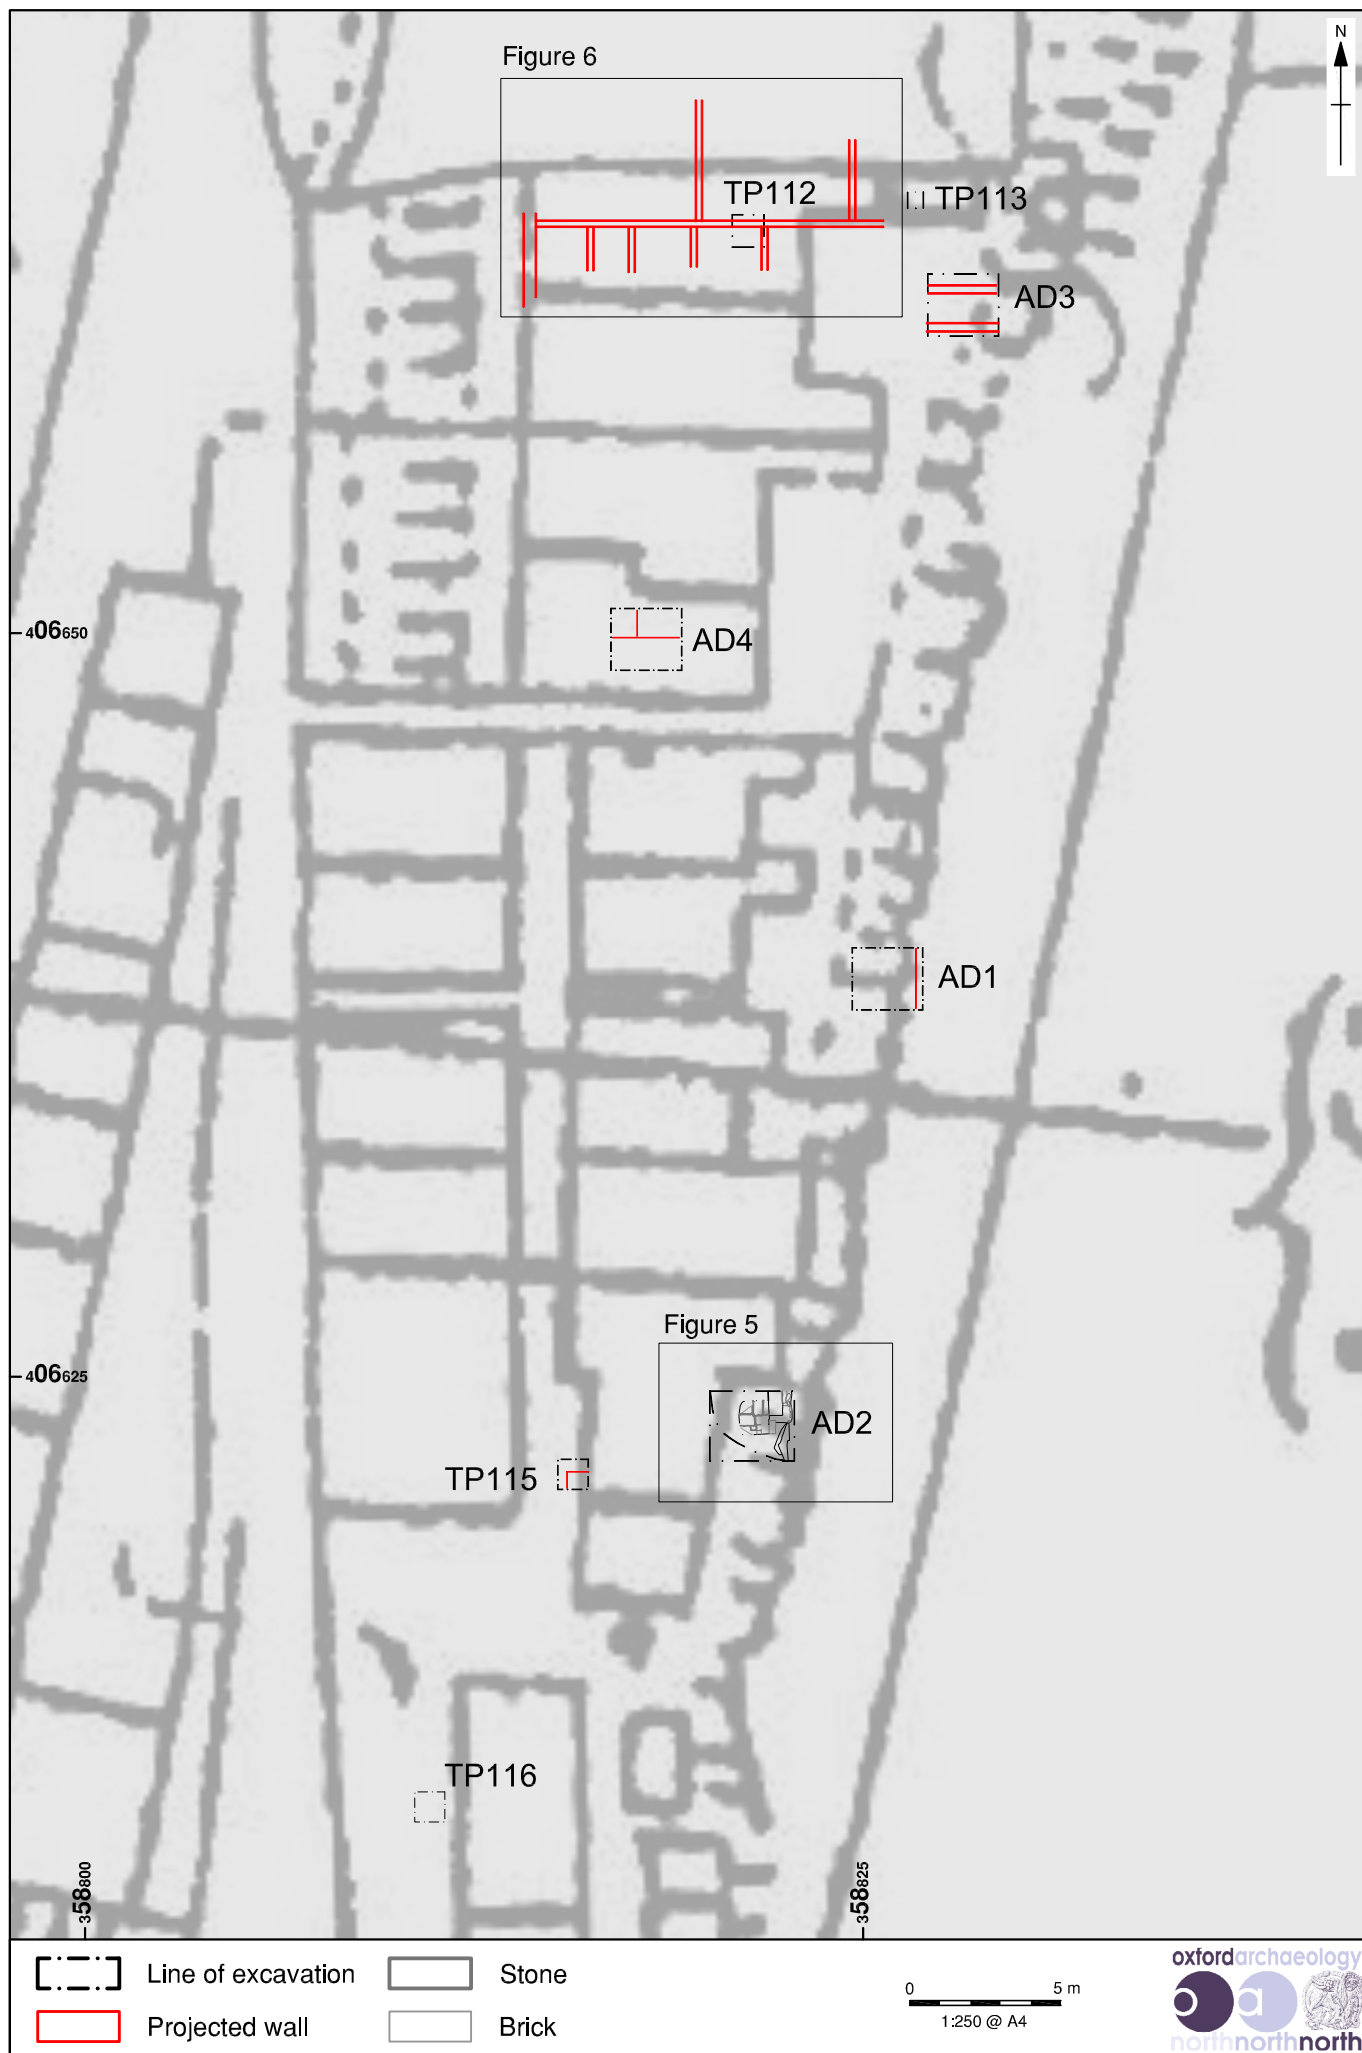
Figure 4: Test pit and additional trench location plan superimposed onto the Ordnance Survey map of 1894

Figure 4: Test pit and mine addit trial trench location plan superimposed on the Ordnance Survey map of 1893

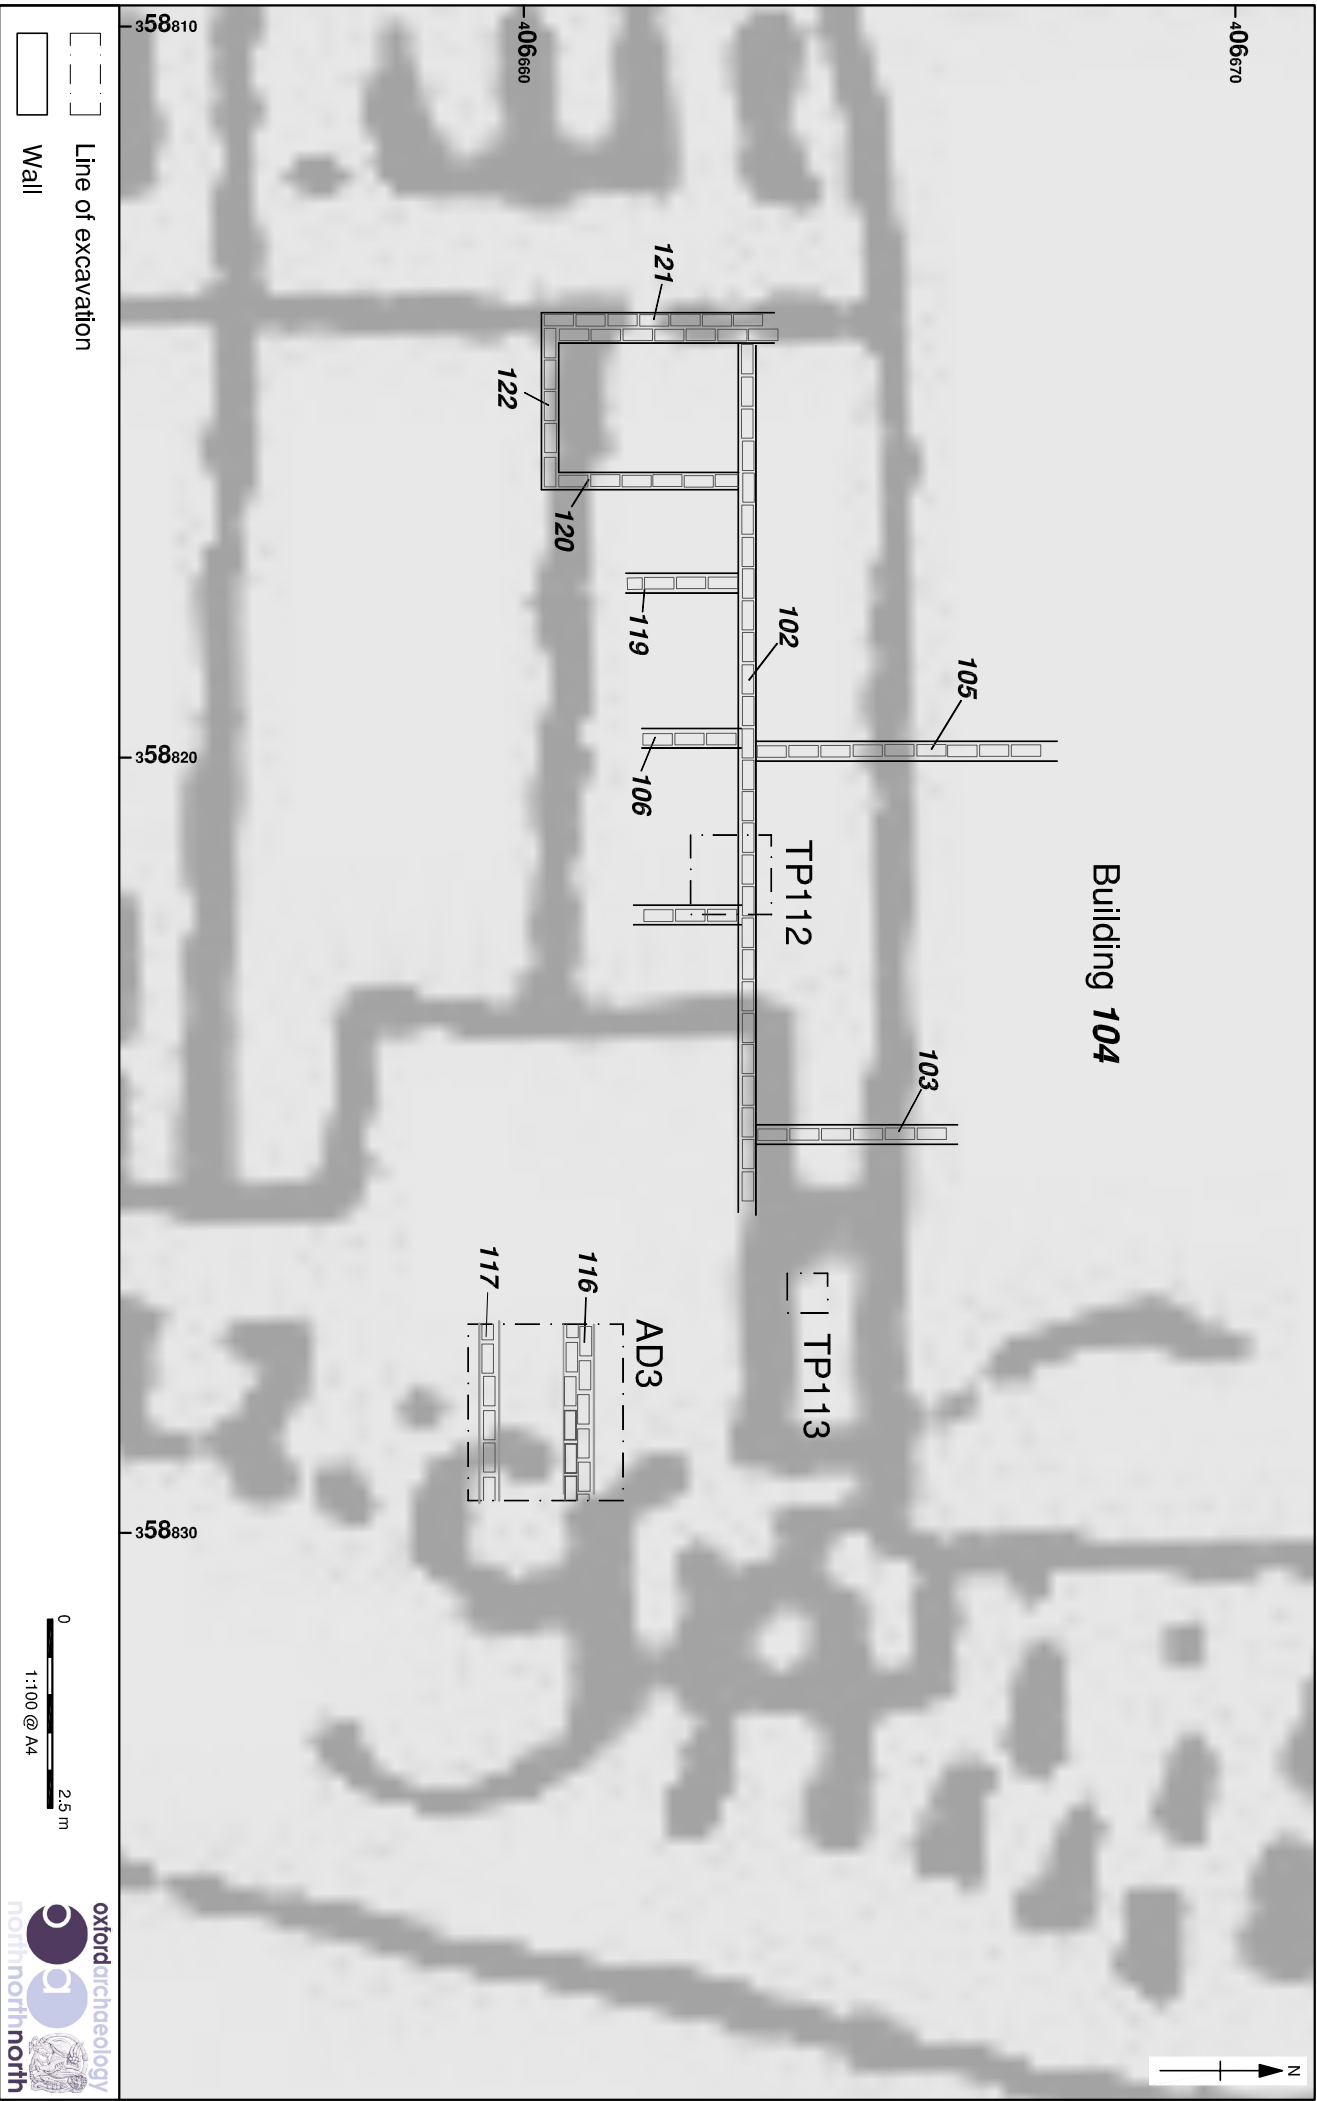
Figure 6: Building **104** superimposed onto the 1893 Ordnance Survey map

- 4.4.1 The remains of a brick structure were exposed immediately beneath the modern ground surface near Test Pits 112 and 113 (Fig 6). The structure comprised a series of single-skin wide (0.26m), north/south-aligned brick walls (**105**, **106**, **119**, and **120**) of varying lengths, which were keyed into a 11m long east/west-aligned wall (**102**) of a similar thickness (Plate 14). Wall **102** abutted a two-skin wide (0.40m) wall (**121**), which represented the external wall of the structure. A short, east/west-aligned wall (**122**) was keyed into walls **120** and **121**, forming a small room that measured 3m x 2.7m. The component bricks of all the exposed walls were mostly hand-made, although some machine-pressed variants were noted. All bricks were bonded with a lime-based mortar. No remains of an internal floor were exposed, although excavation did not proceed beneath the upper surface of the walls.

- 4.4.2 The position of the building corresponds with a structure shown on the 1893 Ordnance Survey map, depicted as a row of square-shaped units. The building is absent from the Ordnance Survey map of 1849, indicating that its construction date was in the second half of the nineteenth century.
