# Morris Garage Building Longwall Street Oxford

Archaeological Evaluation Report

September 2016

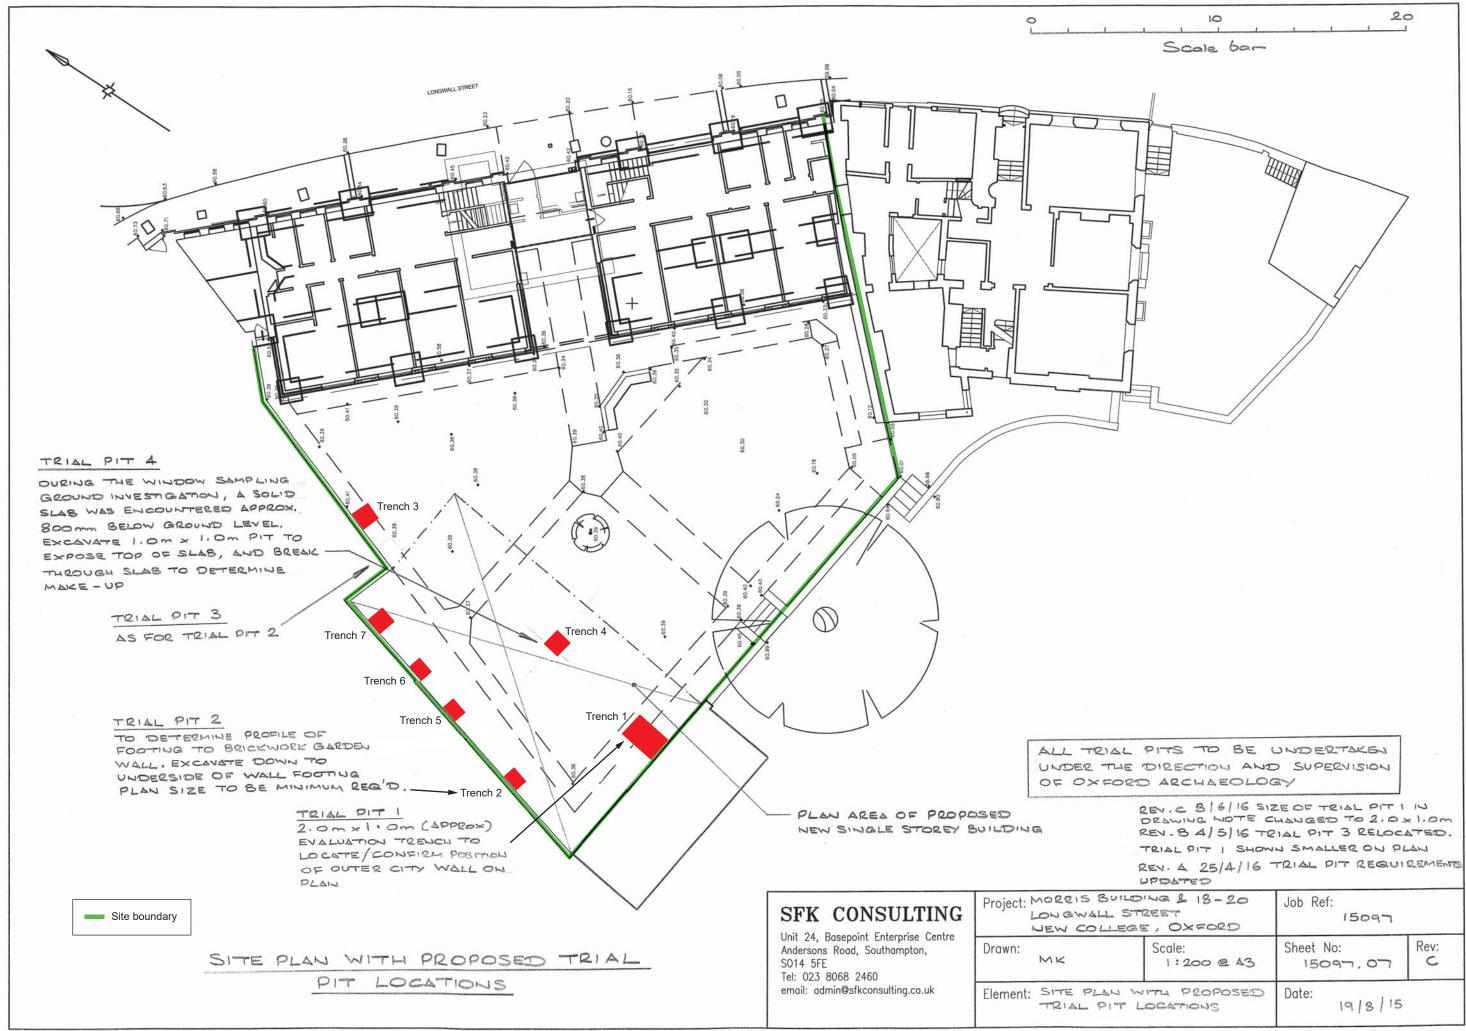
Figure 2: Trench location

- 2.2.1 Four trial holes (Trenches 1–4) were excavated. Trench 1 measured 2m x 1.5m and was positioned against the southern boundary wall of the site. Trenches 2 and 3 measured 1m² and were excavated against the western boundary wall of the site. Trench 4 also measured c 1m² and was excavated in the gravel courtyard. An additional three 1m² test pits were excavated against the western boundary wall (Trenches 5-7) at the request of the OCC arborist. The position of the trenches is shown on Figure 2.

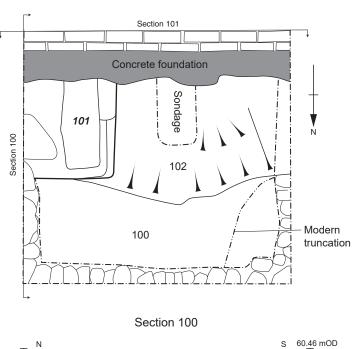
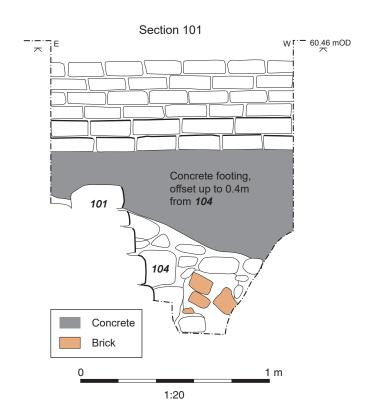
Figure 3: Plan and sections; Trench 1

- 3.1.1 Trench 1 measured 2m x 1.5m and was excavated against the boundary wall defining the southern limit of the site. A modern flagstone path was revealed in the northern half of the trench which was bedded on a c 0.2m thick concrete slab, and consequently, the trench was shortened to 1.35m x 1.5m.

- 3.1.2 The trench revealed the northern face of an earlier stone wall (104) beneath the footings for the standing structure. Structure 104 showed some evidence for a brick repair or blockage, although the nature of this feature was uncertain within the confines of the trench. The face of the wall corresponded to that of the upstanding brick structure, although the footings of the latter extended further to the north.

- 3.1.3 The earliest deposit encountered was a remnant of a possible rudimentary mortar surface (100) in the northern part of the trench. This was overlain by (and possibly truncated by) the deposition of a demolition/construction layer comprising a very loose, mid greyish brown silty sand with brick fragments, limestone rubble, and a predominance of broken roof tile throughout (102). This was in turn overlain by a second layer of compacted mortar (103).

- 3.1.4 Deposits 100 and 102 abutted the face of structure 104, and also the western end of a second stone wall (101) which appeared to be built up against structure 104.

- 3.1.5 The remaining deposits within the trench comprised a *c* 0.2m thick layer of rubble-rich material, containing very modern artefactual material which indicated that it was related to the 1980s' re-development of the site. This was in turn overlain by *c* 0.45m of contemporary landscaping and garden soil deposits. The 1980s' rubble was also contemporary with the mass concrete foundation of the existing brick boundary wall, the lowest two courses of which were offset and abutted by the landscaping deposit.

- 5.1.1 The stone wall revealed beneath the concrete footing of the southern boundary wall of the site in Trench 1 is likely to be on the line of the outer defensive wall. However, as the only excavated deposits associated with this structure were 19th century at the earliest, attributing a definitive, late 13th-century date to the wall is problematic. Additionally, the brick repair encountered within the sondage may suggest a later rebuild on the line of the medieval wall, although this may have been filling a feature in the northern face of an earlier structure.

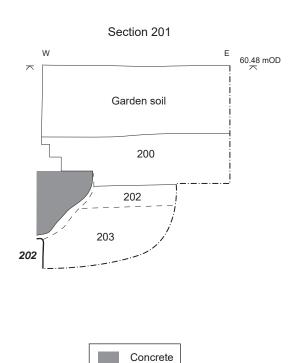
Figure 4: Plan and section; Trench 2

- 3.1.6 Trench 2 measured 1m² and was excavated towards the southern end of the western boundary wall of the site.
- 3.1.7 The stratigraphic sequence revealed within the trench was similar to that recorded within Trench 1. A probable stone wall footing (201) was revealed beneath the concrete foundation of the existing brick wall, and was abutted by a loose rubble-rich material (203) revealed within a sondage excavated to examine the base of the concrete. The loose material was overlain by a c 0.12m thick layer of fairly compacted mortar (202), which was in turn overlain by a loose deposit with brick, tile, and limestone rubble throughout (200). The remaining deposits within the trench represented landscaping and/or garden soil.

- 5.1.3 The stone wall revealed beneath the concrete foundation of the western boundary wall of the site in Trenches 2 and 5 probably represents the boundary wall shown on the OS first edition town plan of 1876 (Fig. 7). The configuration of this boundary appears to remain consistent on later OS mapping up to the re-development of the site in the early 1980s. Prior to this redevelopment, there appears to have been an access from Holywell Street which ran between the property boundries of 100 Holywell Street and 21 Longwall (the Morris Garage), and the southern end of this appears to have been blocked by the dog-leg in the existing boundary wall, with the southern end of the wall being constructed over the foundations of the eastern boundary to 100 Holywell Street, and the dog-leg retaining access to the rear 100 Holywell Street.

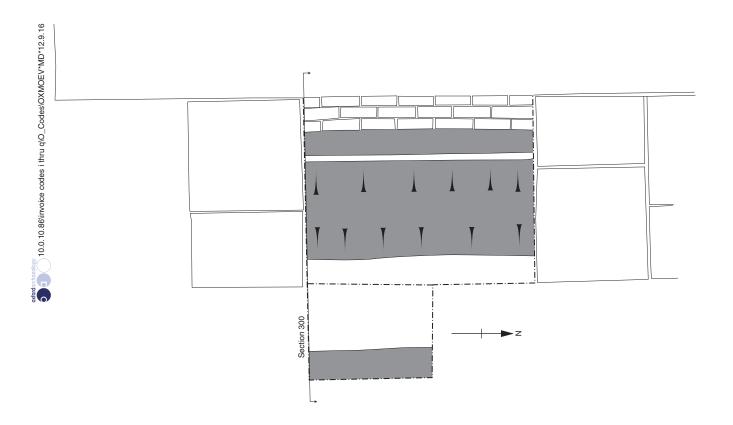
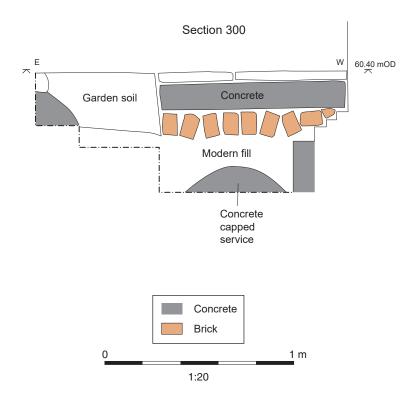
Figure 5: Plan and section; Trench 3

- 3.1.8 Trench 3 also measured 1m² and was excavated against the western boundary wall of the site, just to the north of the dog-leg around the adjacent property.
- 3.1.9 The trench revealed a concrete capped service which appeared to fall from south (59.90m OD) to north (59.82m OD) and ran parallel to the concrete foundation for three offset stepped courses at the base of the standing wall. The base of the concrete was probably encountered at 59.76m OD, although this could not be established with any degree of certainty as further excavation was not possible owing to the proximity of the

concrete capped service. The concrete foundation and the capping of the service were overlain by a *c* 0.3m thick mixed deposit with brick rubble throughout, which was in turn overlain by a flat layer of brick which appeared to form the base of a 0.2m thick concrete bedding layer for the flagstone path.

3.1.10 To the west of the path, the mixed rubble rich deposit was overlain by the garden soil of a flower bed.

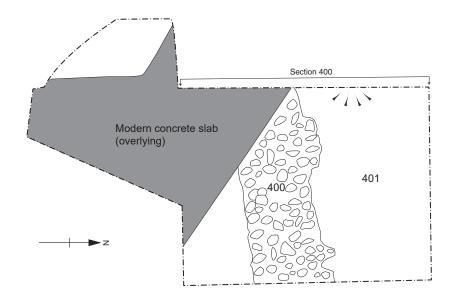
Figure 6: Plan and section; Trench 4

- 3.1.11 Trench 4 originally measured 1m² and was excavated within the existing shingle courtyard. The trench was subsequently extended to reveal the extent of a concrete structure encountered within the trench.

- 3.1.12 The earliest deposits encountered were a layer of compacted mortar (401) which appeared to be overlain by a cobbled surface (400), although it is possible that the two were contemporary and that layer 401 was a variation or repair to 400. It is also feasible that the mortar layer was a bedding deposit for the cobbles.

- 3.1.13 Cobbled surface 400 was directly overlain by the north-eastern extent of a *c* 0.2m thick layer of concrete, and the extension to the trench revealed this to be a 0.7m wide linear configuration on a NW-SE alignment. It also appeared to continue to the south, perhaps suggesting a capped service running from the property at number 20 to the south-west with a branch running from the gardeners hut to the south, and then falling to meet the concrete capped service encountered in Trench 3. The top of the concrete in Trench 4 was at 59.87m OD (c0.65m below ground level).

- 3.1.14 The cobbled surface and the concrete structure were overlain by a 0.22m thick mixed deposit containing brick rubble and tile fragments (402) which was in turn overlain by layers of gravel and sand and Type 1 beneath the existing shingle surface of the courtyard.

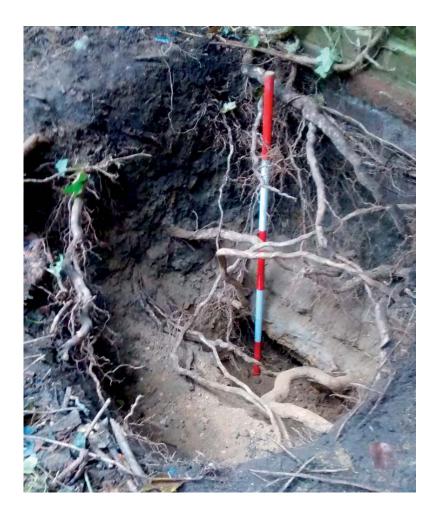
Plate 1: Trench 5

- 3.1.15 Trench 5 measured approximately 0.9m² and was excavated against the western boundary wall of the site. The earliest deposit encountered was a 0.5m+ thick mixed deposit of loose mortar, limestone fragments, brick rubble and tile (500) which appeared to be contemporary with the foundations of the existing wall (ie early 1980s). A possible tarmac surface (503) was partially revealed in the eastern half of the trench, although the relationship between this and the rubble rich deposit was unclear. The top of the concrete foundation of the wall was encountered at 60.5m OD (*c* 0.5m below existing ground level (bgl)), and bottomed out at 59.54m OD (*c* 0.96m bgl).

- 3.1.16 There was a suggestion of an earlier structure below the concrete foundation, which may represent the boundary wall shown on the OS first edition plan of 1876, or a later configuration of the same boundary.

- 3.1.17 The concrete foundation was overlain by two brick offsets at the base of the standing wall. Overlying the rubble rich deposits and the brick offsets was a mid orangey brown sandy silty deposit with *c* 20% sub-rounded gravel fragments. This is likely to be a landscaping deposit associated with the 1980s development of the site, and was in turn overlain by a contemporary mid-dark grey clay loam garden soil.

(which the appearance of the leaves suggested was a willow of some description). The majority of the roots were within the landscaping deposit and garden soils, although two of the more fibrous roots did penetrate the rubble-rich deposit and continue below the concrete foundation.

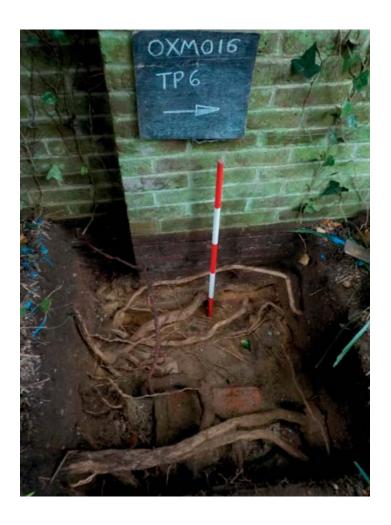
Plate 2: Trench 6

- 3.1.20 In contrast to the foundation revealed in Trench 5, there was a single offset brick course at the base of the standing wall, which appeared to be built directly off a layer of cement based mortar at the base of the trench (605 at 59.8m OD or 0.7m bgl). There was some evidence for a brick surface (603/604) overlying the mortar deposit.

- 3.1.22 Roots were again present throughout, although in this case they appeared to be almost exclusively the fibrous variety noted in Trench 5 and are again likely to belong to the adjacent ?willow. The majority of these were encountered at the interface between the rubble rich deposit and the overlying landscaping deposit.

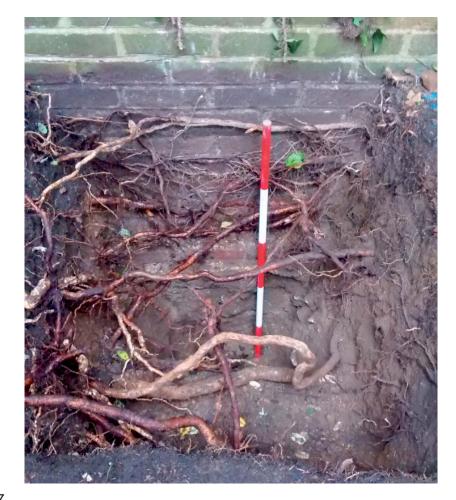
Plate 3: Trench 7

- 3.1.24 The concrete footing of the standing wall was present to a depth of at least 59.42m OD (1.08m bgl) and appeared to be abutted by a loose mid-brownish grey sandy silt with occasional brick fragments (700). No obvious construction cut was visible within this deposit, and it is possible that it represents backfill of a construction cut which extended beyond the edge of the deeper part of the trench. However, it is also possible that it represents an earlier garden soil. This deposit was overlain by the same sequence recorded within Trenches 5 and 6, comprising a rubble-rich deposit (701; here 0.12m thick), which was subsequently overlain by a landscaping deposit (702) and garden soil (703). All of these deposits relate to the 1980s redevelopment.

- 3.1.25 The majority of the roots within Trench 7 were reddish brown in colour and appeared to be associated with the adjacent tree (possibly ash), although one or two of the more fibrous roots noted in Trenches 5 and 6 were also present, in addition to some along the face of the wall which were probably from the ivy growing up the east face of the standing wall.
