CENTRAL YARD, BAE SYSTEMS, BARROW-IN- FURNESS, CUMBRIA

Archaeological Watching Brief

December 2007

Jacobs UK Ltd

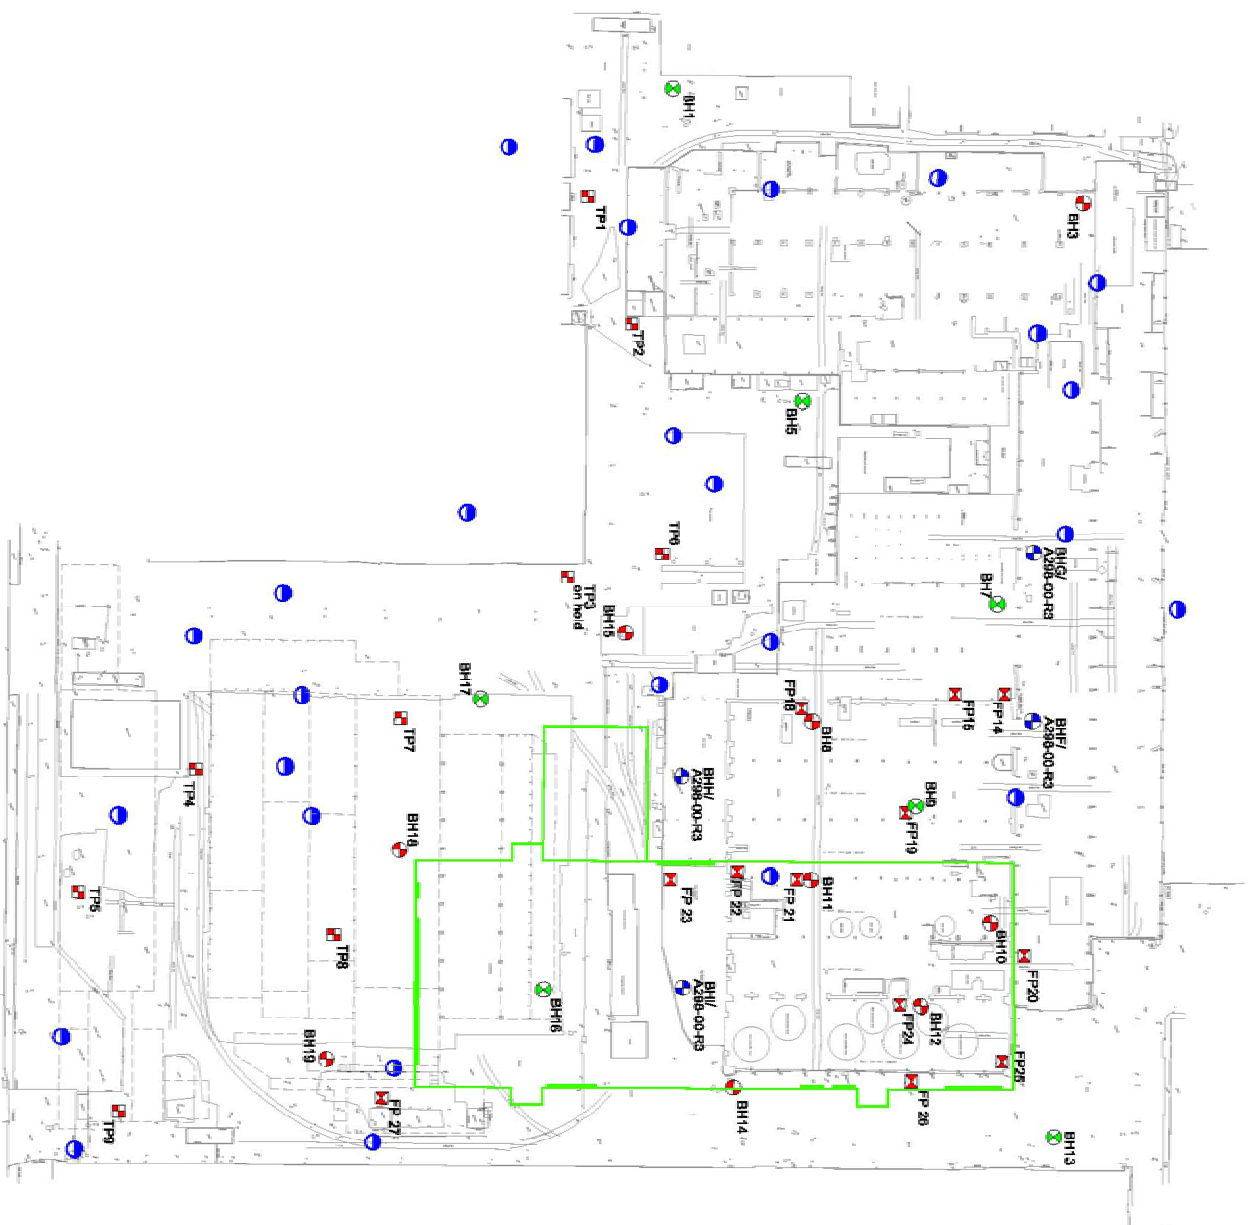
Figure 2: Location map, showing test and foundation pits

- 2.2.1 The programme of groundworks comprised the excavation of foundation pits (FP), largely located against the walls within the standing buildings of the northern part of the development area (Fig 2), and test pits (TP), mostly positioned in external areas and within the footprint of the demolished building to the south. The test pits and foundation pits were excavated using a 360° mechanical excavator fitted with a toothed 0.6m wide bucket and utilising a pecker where necessary. A programme of observation was undertaken to record the location, extent, and character of any surviving archaeological features, artefacts and/or deposits revealed within the excavations. Recording comprised a full description and preliminary classification of features or structures revealed, on OA North *pro-forma* sheets, and their accurate location in plan. An indexed photographic record in colour slide and monochrome formats was also compiled, with digital photographs taken for illustrative purposes.

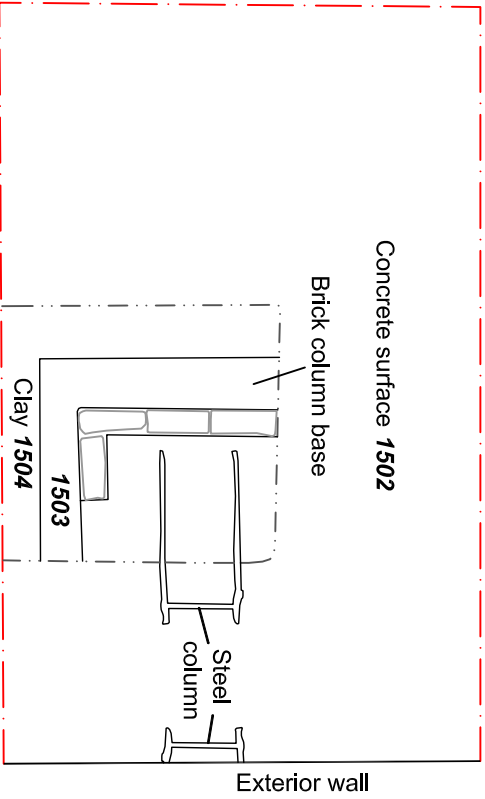
Plan of Foundation Pit 15

- 3.1.8 **Foundation Pit 15:** FP15 lay due south of FP14. Removal of a 3m x 1.9m area of concrete surface **1500** revealed a 0.12m thick make-up layer of loosely laid bricks, **1501**, which in turn sealed concrete surface **1502**, 0.25m in depth. Adjacent to a steel column at the east end of the FP (Fig 3), an area 1.05m by 1m was cut through concrete surface **1502** to reveal firstly a 0.35m thick sandy clay **1505**, then the south-west corner of brick and concrete column base, **1503**, at a depth of 0.95m below the surface. This base was over 1m deep, extending below the limit of excavation, and appeared to have been set into a deposit of heavy clay revealed within the north- and east-facing sections of the FP.

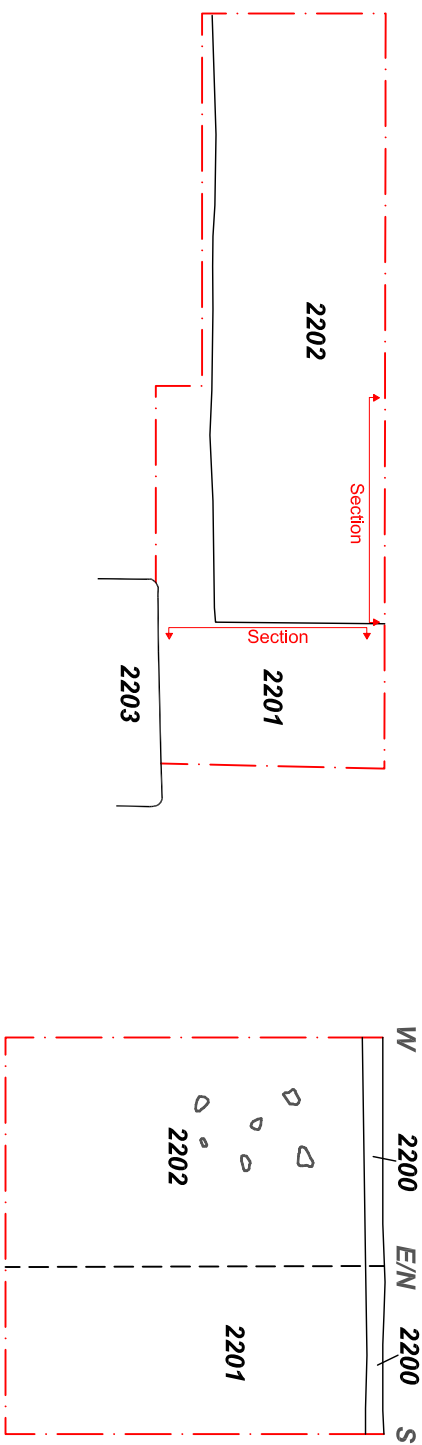
Plan of Foundation Pit 22, with south and west-facing section

- 3.1.13 **Foundation Pit 22:** FP22 measured 4m east/west by 1.1m and 1.9m deep and was located just within the west wall of the proposed new building. Directly below the reinforced concrete floor, **2200**, was a substantial concrete footing, **2201**, extending in an 'L'-shape along the southern and eastern edges of the FP, its depth exceeding the depth of the trench at 1.9m (Plate 6). The deposit, **2202**, below the floor was very loose soil and rubble made ground, and again, exceeded the depth of investigation.

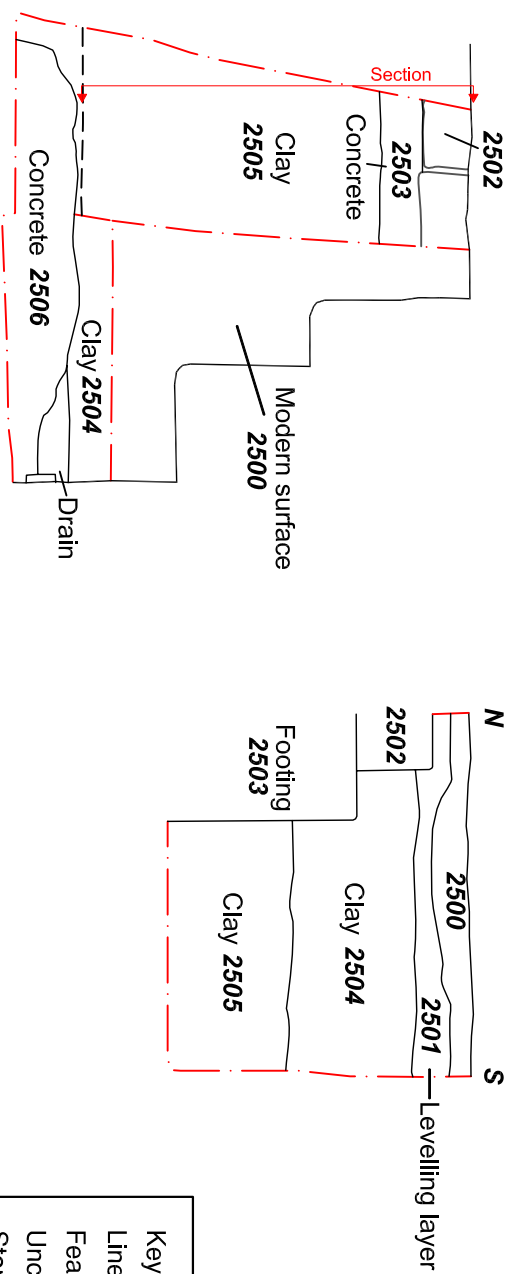
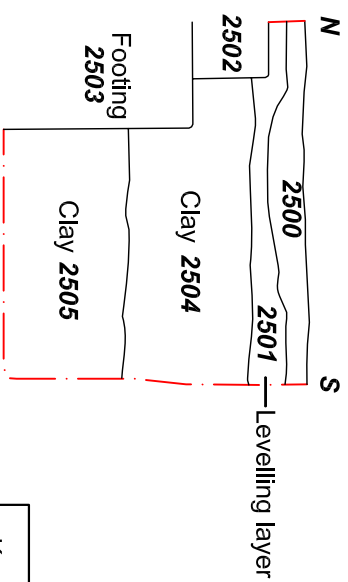
Plan of Foundation Pit 25, with west-facing section

- 3.1.16 **Foundation Pit 25:** FP25 was roughly 'L'-shaped and was situated in the north-east corner of the existing building, adjacent to the corner pier (Fig 5). It ran north/south for 2.5m by 2m, and east/west for 2.5m by 0.55m, and was excavated to a maximum depth of 1.6m. Removal of concrete surface **2500** and underlying make up **2501** revealed the footings of the north wall, comprising a sandstone foundation, **2502**, resting on a concrete footing, **2503**, the depth of which exceeded that of investigation. The footing had been inserted into dark brown compact clay,

2505, which again exceeded the limit of investigation, and had then been backfilled with orange/brown compact clay, **2504**, approximately 0.65m in depth. Along the south edge of the trench beneath the surface layers was a deposit of concrete, **2506**, approximately 0.45m in depth, sealing a service pipe running east/west.

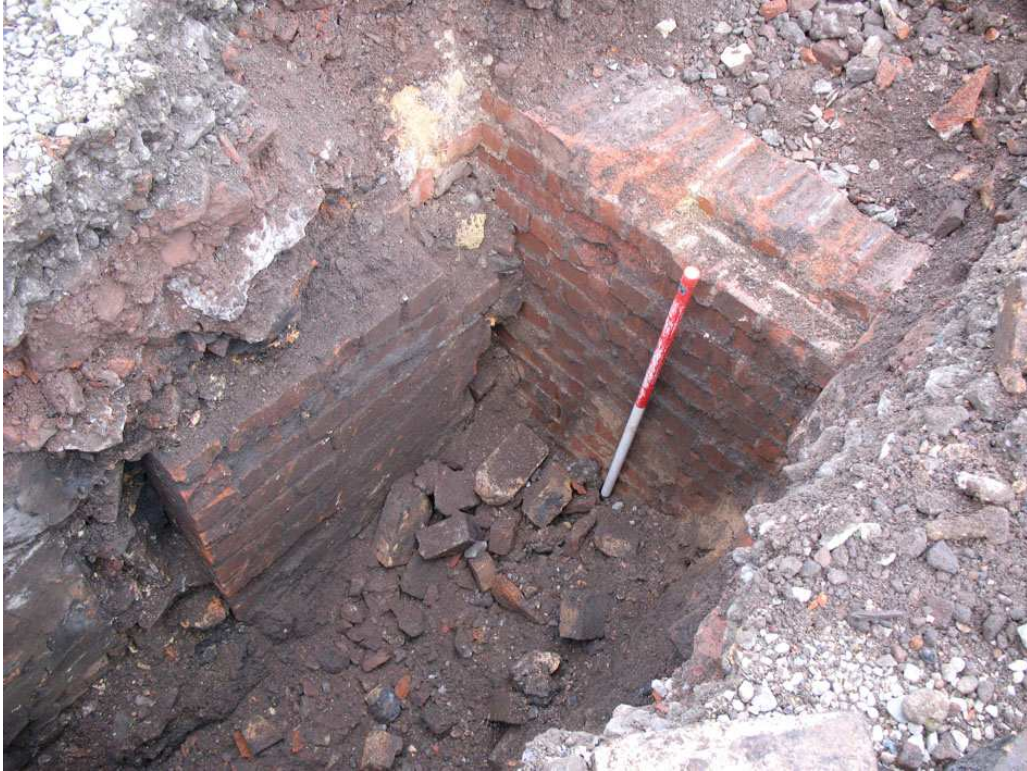
- 3.1.4 **Test Pit 4:** this pit was situated to the south of the site and measured 3.6m east/west by 1.2m, and was 1.6m deep. Removal of gravel carpark surface **400** and redeposited demolition debris **404** revealed structural remains, comprising three brick walls of machine-made frogged red brick in English garden wall bond (Plate 1). Walls **402** and **403** ran parallel to the axis of the trench, whilst wall **401** ran north/south at the east end of the trench (Plate 1). At the base of these walls was a concrete floor, **405**, which marked the limit of excavation at 1.6m below ground level.

Plate 1: Walls **401** and **402**, west end of TP4

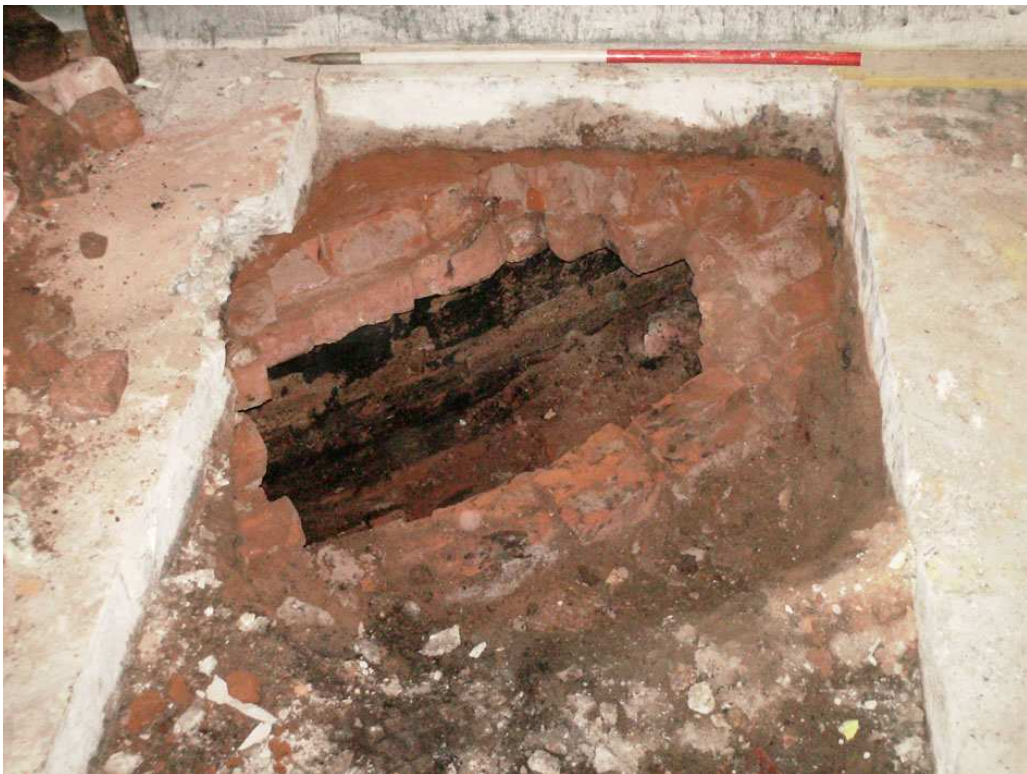
- 3.1.7 **Foundation Pit 14:** FP14 measured 5.1m east/west by 1.4m by up to 1.9m deep and was situated towards the northern end of the site, where it was bound to the north by an east/west aligned wall, **1405**. Directly below the 0.1m thick concrete surface, **1400**, and sealed by sandy clay deposit **1408** at the east end of the trench was an arch-roofed flue, **1403**, built of machine-made red brick laid as double stretchers (Fig 3; Plate 2). This flue was approximately 0.8m wide, 0.9m high and was constructed on a 0.25m thick concrete base, **1404**, which extended 0.3m to the west and also supported a poorly-constructed brick wall, **1407**, which ran parallel with the flue and survived to a similar height. Two metal rods, 1m long and 0.03m in diameter, were set vertically into the wall, 0.9m apart. At a depth of 0.85m below ground level, the north wall footings, **1402**, were revealed along the northern edge of the pit. This concrete footing, which was at least 0.7m wide within the trench, abutted flue foundation **1404** to the east and supported the stepped red brick foundation of wall **1405**. Keyed into wall **1405** was the supporting brickwork for a service pipe exit, **1406**, measuring 0.36m by 0.28m. Between service pipe **1406** and flue **1403** and directly overlying footing **1402** and wall **1405** was concrete base **1401**, which measured 1m by 0.7m by 0.6m deep and supported a single girder steel column. Each of the concrete footings appear to have been inserted into a firm yellow sand, **1409**, which extended below the investigated depth of 1.9m; this deposit is likely to represent imported material, but could potentially be natural in origin.

Plate 2: Brick flue, **1402**, at east end of FP14

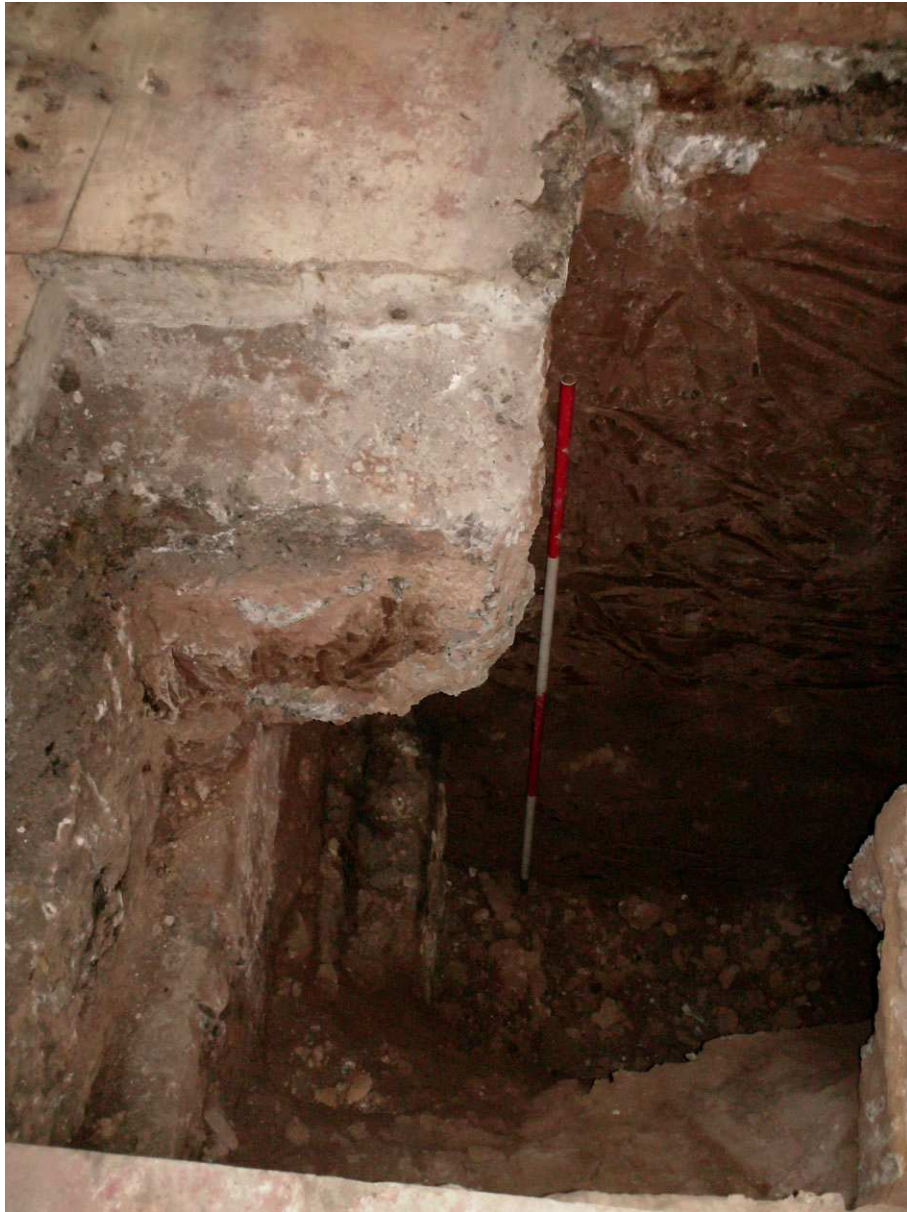
- 3.1.9 **Foundation Pit 18:** located towards the centre of the site, FP18 measured 3m east/west by 1m and 2.2m deep. Removal of 0.15m thick concrete **1800** and underlying 0.2m thick ash and slag levelling layer **1801** revealed footing **1802**, consisting of a coarse concrete and hardcore mix with traces of a brick wall 0.23m wide running along the top (Fig 4; Plate 3). Footing **1802** appeared to run for 2.6m at right angles from a pier of the existing west wall before turning south. These footings had been set within firm reddish-brown clay made ground **1803**, and continued below the investigated depth of the trench.

Plate 3: Footings, *1802*, jutting from west wall, FP18

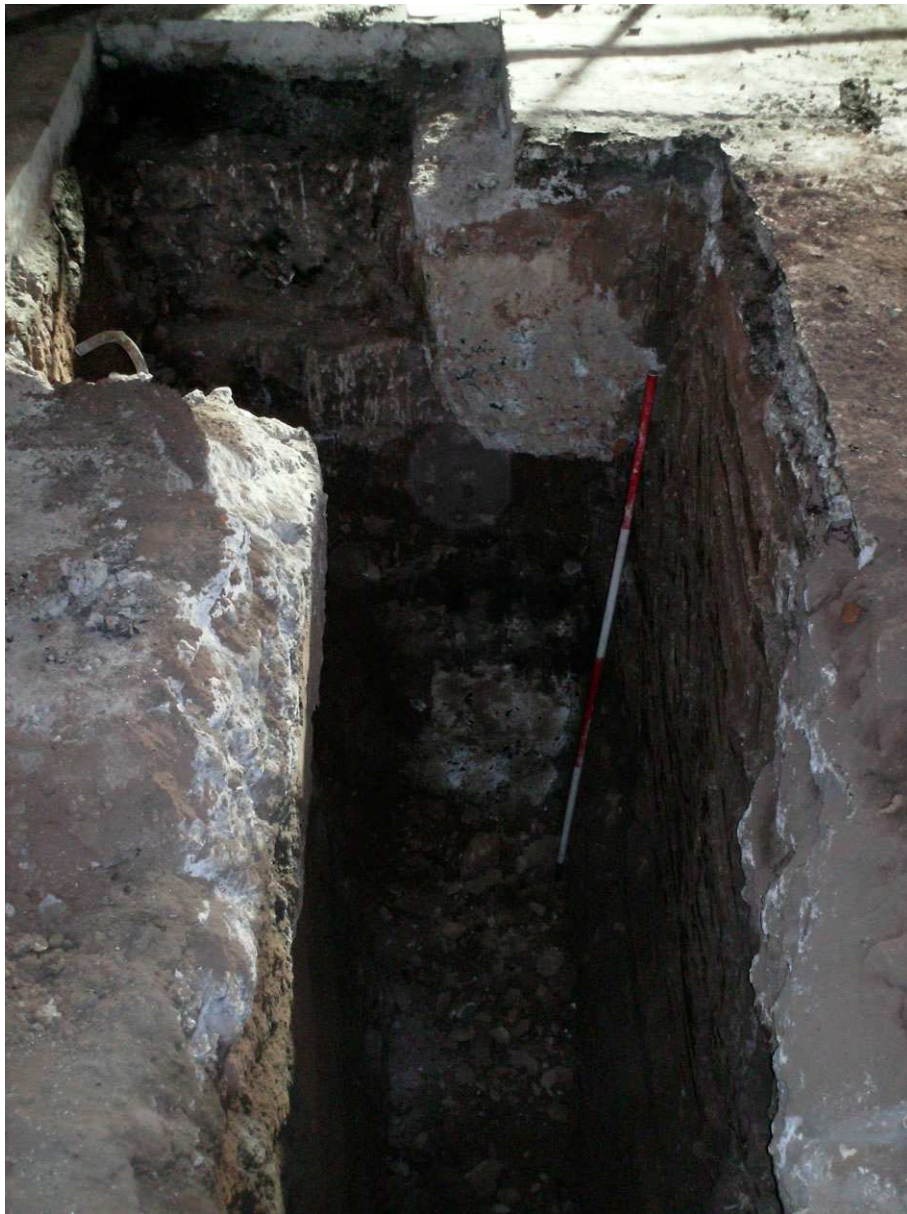
- 3.1.10 **Foundation Pit 19:** FP19 measured 3.15m east/west by 1.6m and 2.8m deep and was situated towards the centre of the site. Lying flush with concrete surface **1900** at the eastern end of the FP was the top of a concrete block, **1903**, measuring 0.65m by 0.25m and 0.87m deep (Plate 4). Directly beneath, and continuing below the limit of excavation, was a substantial stepped footing, **1904**, constructed of large sandstone blocks measuring approximately 0.6m by 0.3m. The footing had been

backfilled with compacted reddish-brown clay, **1905**, the base of which again lay below the limit of investigation.

Plate 4: Sandstone footings, *1905*, east end of FP19

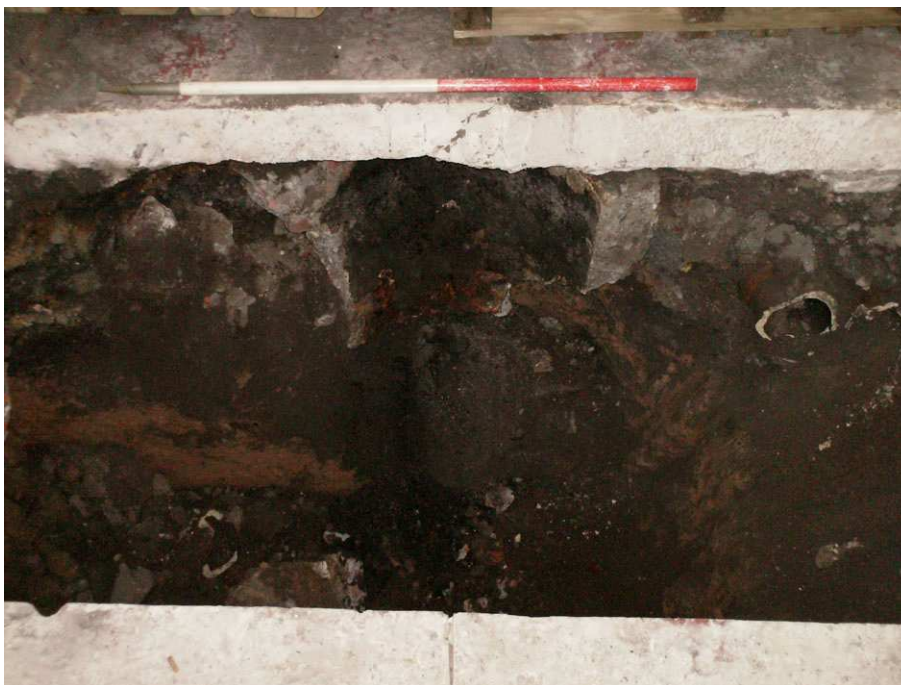
- 3.1.12 **Foundation Pit 21:** FP21 was located towards the centre of the site and measured 4m east/west by 2.4m, with a maximum depth of 1.35m. Removal of 0.15m deep concrete surface **2100** and levelling layer **2101**, also approximately 0.15m in depth, revealed a number of features. At the eastern end of the trench these included westward running brick wall **2104** and, in the north-facing section, the remains of a concrete crucible, **2105**, with 0.2m thick walls (Plate 5). The crucible had been inserted within cut **2107**, which measured 1.4m in depth by 0.98m wide and, like that for wall **2104**, had been made through 0.55m deep rubble levelling layer **2106** and reddish-brown firm clay **2103**, which extended below the base of the trench at 1.35m. At the western end of the trench directly below levelling layer **2101** was the corner of a concrete surface, **2102**. This surface was 0.25m in depth and extended beyond the limit of excavation to the south and east. Directly below this surface, and projecting from its north side across an area 0.96m by 0.55m, was the corner of a concrete base, **2108** with two securing bolts 0.2m apart embedded within its north-east corner. Adjacent to the west side of concrete surface **2102** was a small brick and concrete base, **2109**, measuring 0.38m x 0.35m.

Plate 5: Concrete receptacle, **2105**, in north facing section of FP21

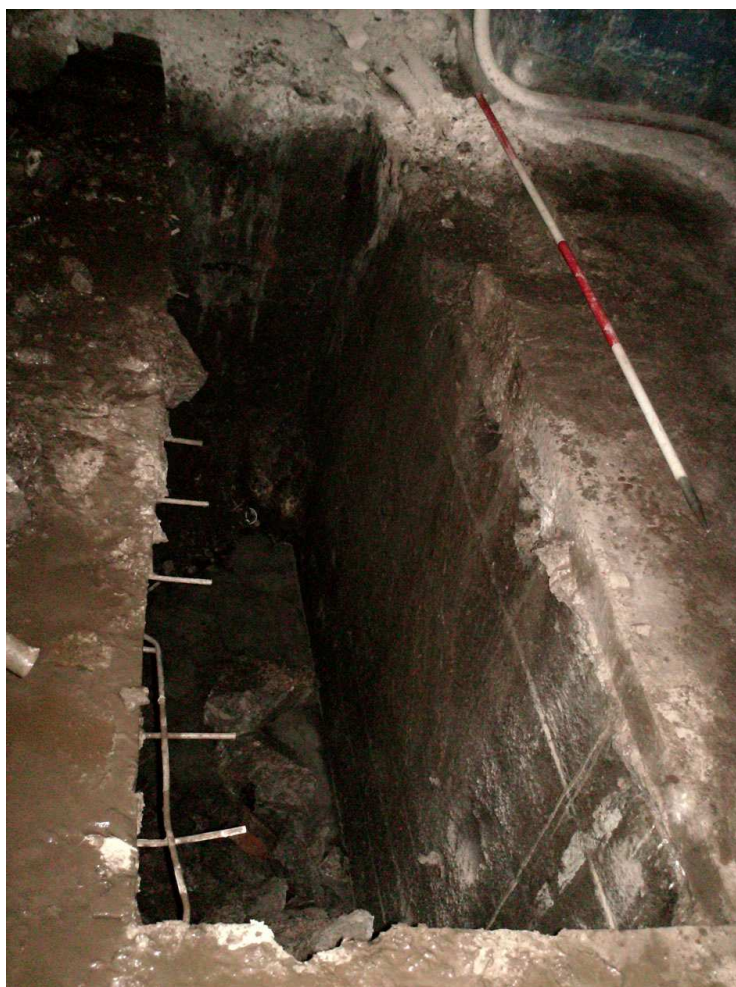
Plate 6: Concrete footings, **2201**, in south and east sections of FP22

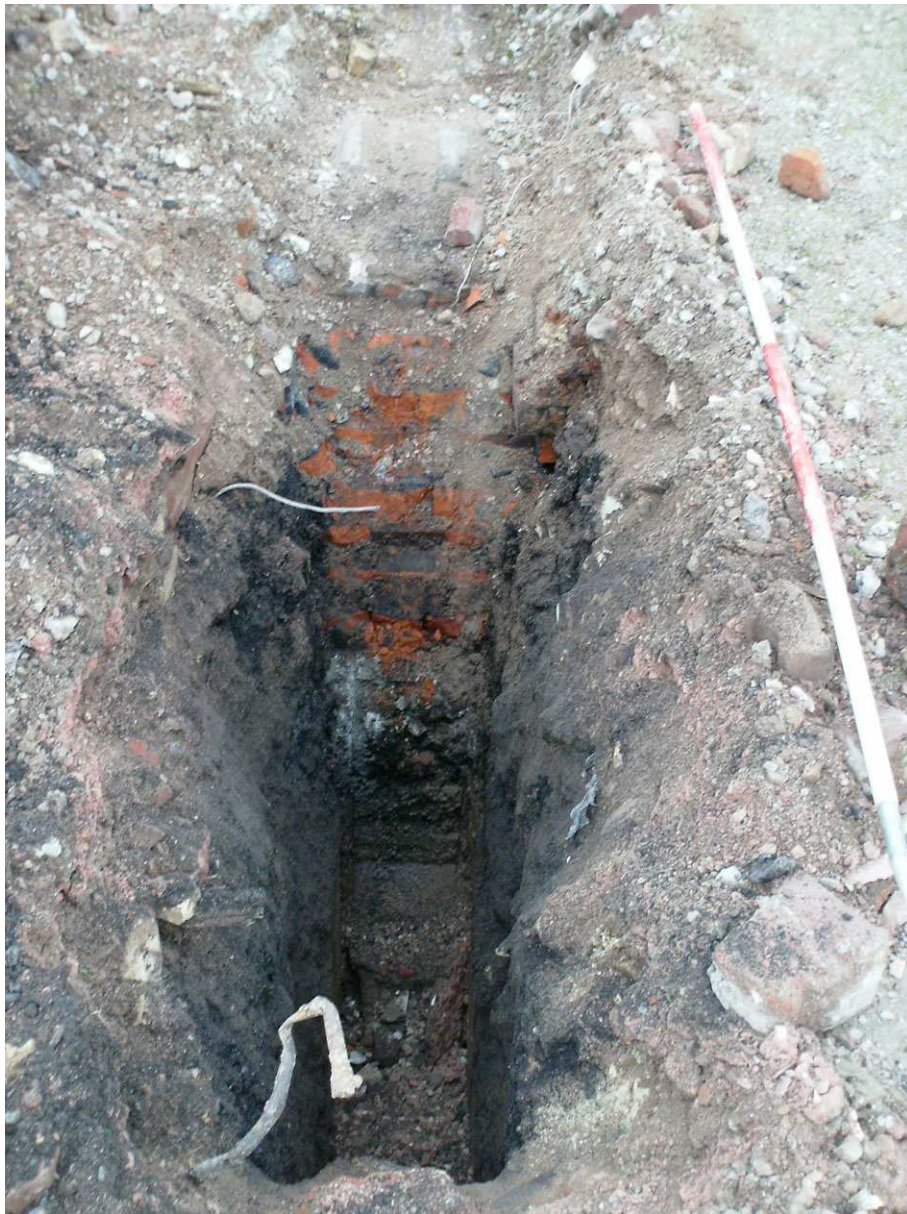
3.1.18 **Foundation Pit 27:** FP27 measured 4m east/west by 0.7m and 1.7m deep at the south-east end of the building. Below the 0.1m thick concrete surface, **2700**, and levelling layer, **2701**, was a substantial brick foundation, **2704**, measuring 2.1m in length (Fig 6; Plate 7). Towards the centre of FP27 the coarsely-faced western edge of foundation **2704** dipped below the limit of excavation and had been backfilled first with firm brown clay, **2703**, and then with a thick deposit of ashy material, **2702**.

Plate 7: Brick foundation, **2704**, at east end of FP27
