# Effluent Disposal Project, Hughenden Manor, Buckinghamshire

## Archaeological Watching Brief Report

July 2018

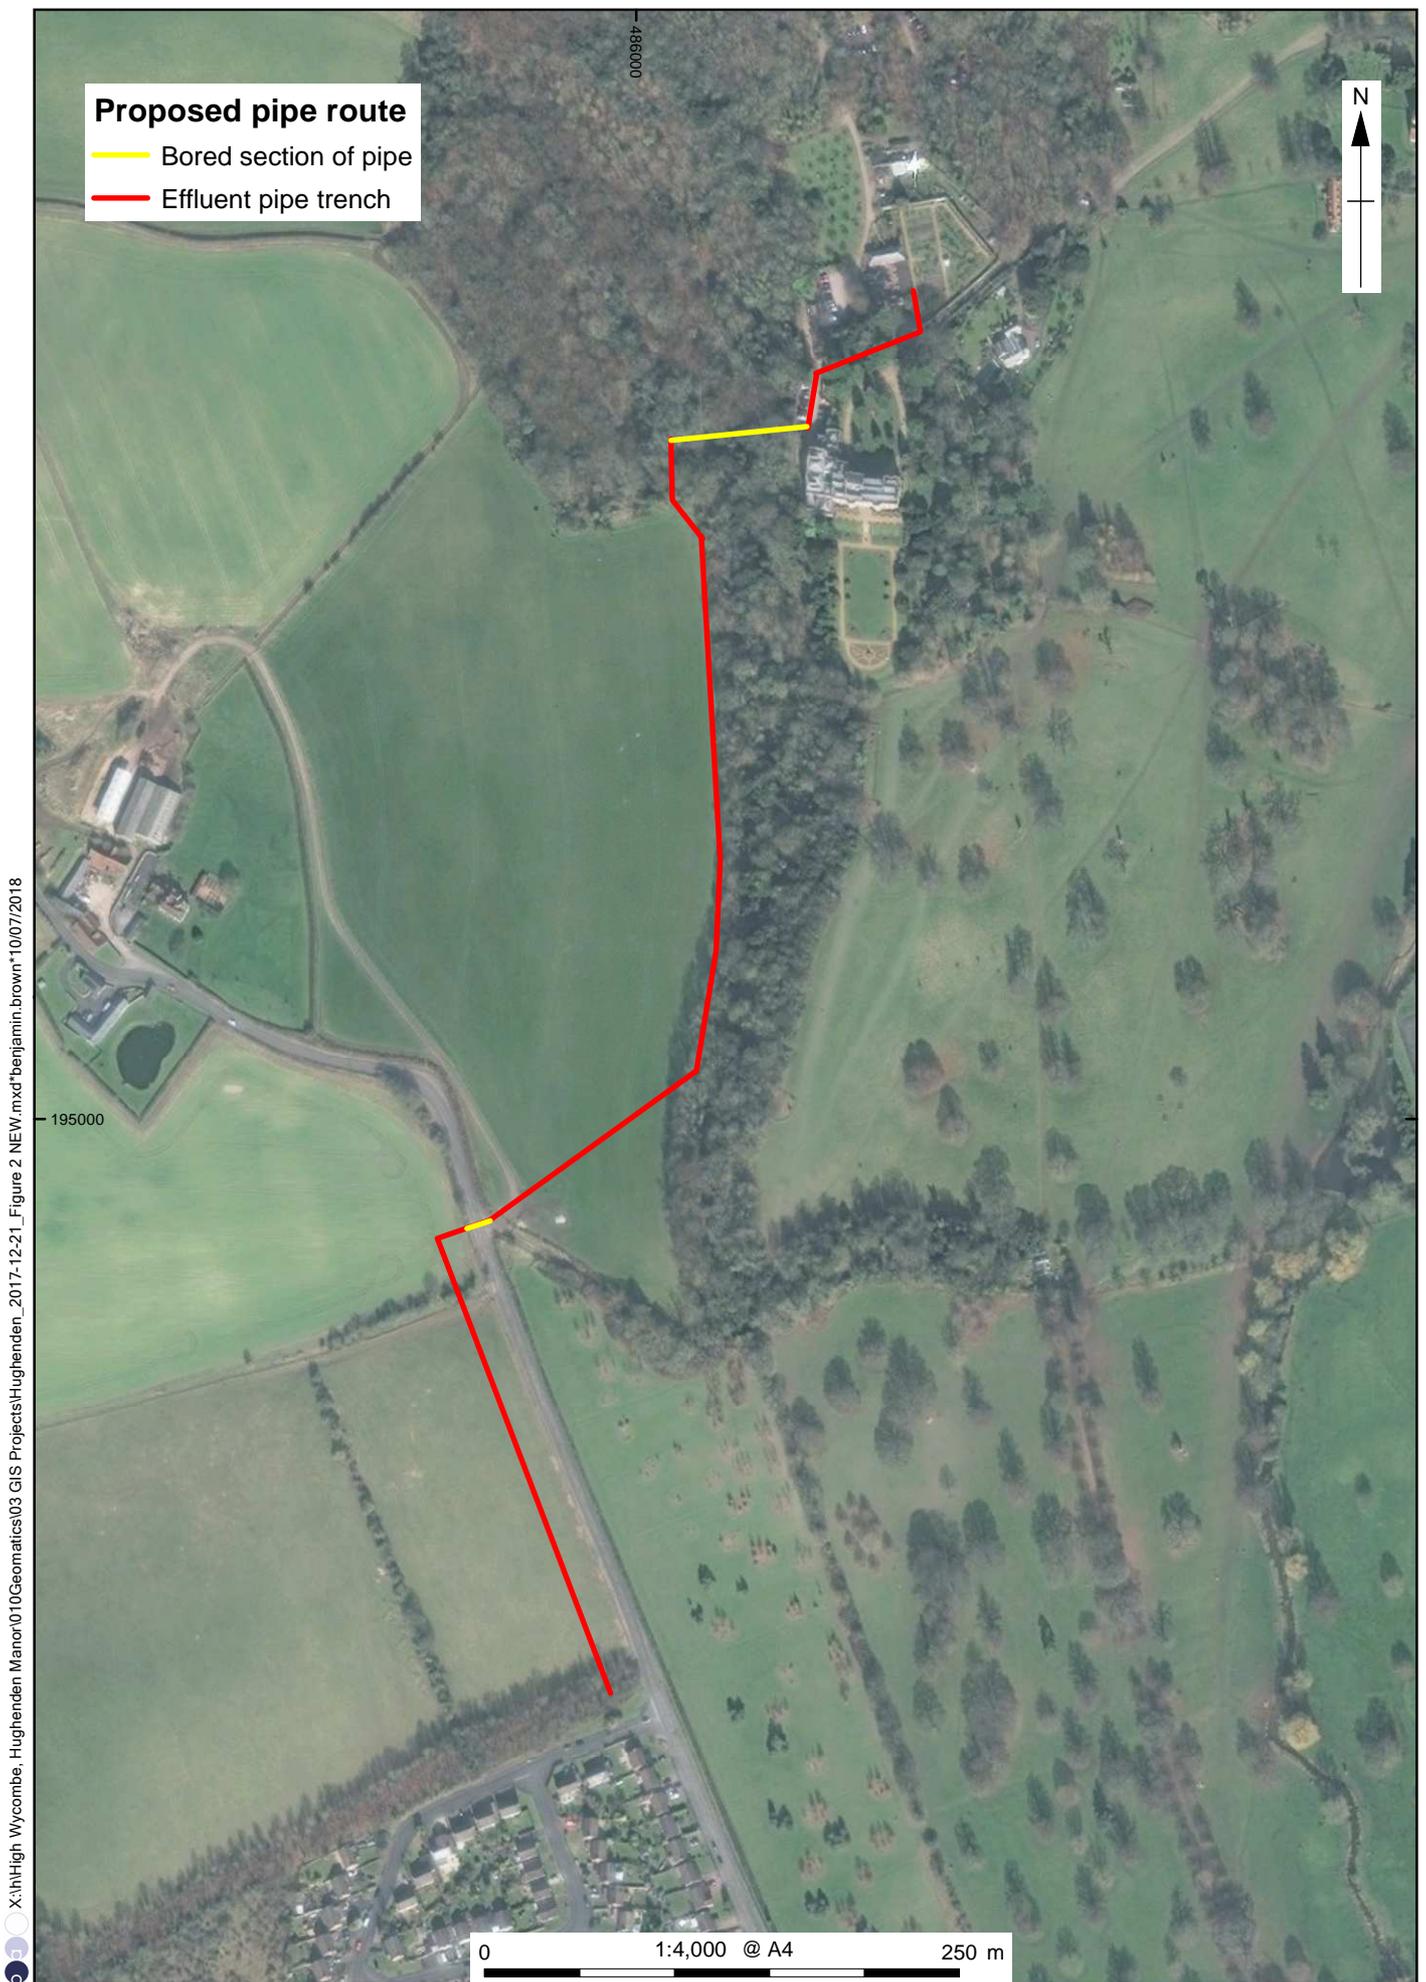
Figure 2: Effluent pipe route

2.3.2 Two segments of the pipe were installed through horizontal boring. These areas were not subject to archaeological monitoring (Fig. 2).

- 3.2.1 The walled garden is located to the north of Hughenden Manor House (Fig. 2) and adjacent to the stable buildings. The pipe trench passed through the gateway and followed the access drive in a south-westerly direction.
- 3.2.2 The 9m of trench within the walled garden measured 0.6m across and between 0.55m and 0.64m deep. The excavation in this area reached the natural geology. A made ground deposit (1002) overlay the mid yellowish brown silty clay natural (1000). The deposit, measuring 0.36m in depth, comprised a friable mid greyish brown silty clay with some fragmented modern brick. Overlying this was modern made ground (1001) 0.45m thick and consisting of a loose, dark brownish black silty clay with frequent brick, tarmac, and stone inclusions. This was overlain by the existing stone pathway.

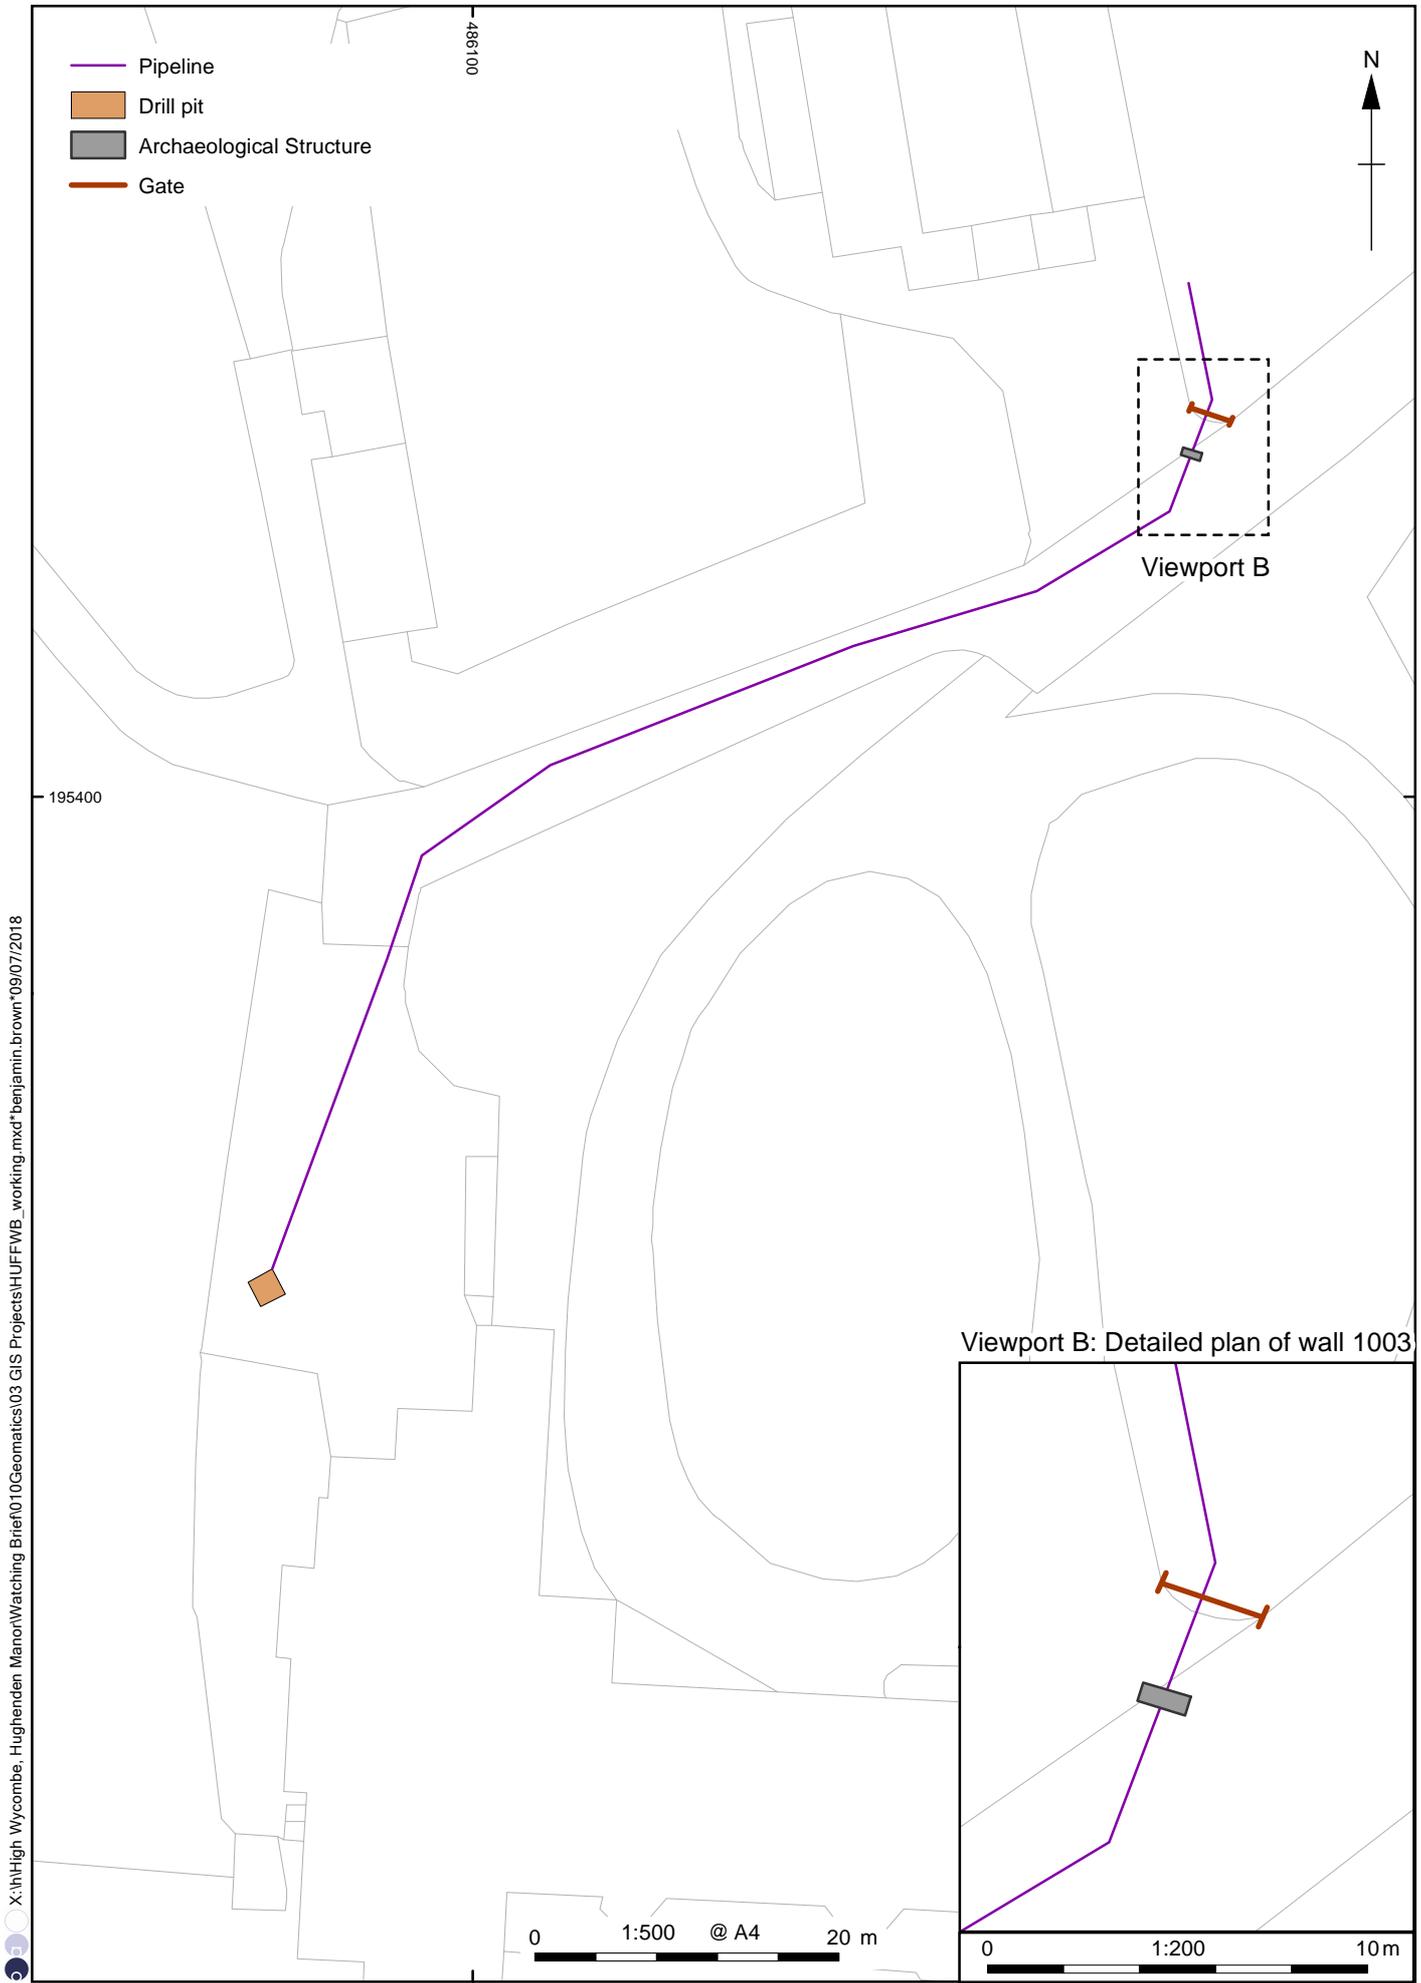
Figure 3: Location of wall 1003

- 3.2.3 The pipe trench passed through the gateway and into the tarmacked access road (Fig. 2 and 3) on a NE-SW alignment.
- 3.2.4 To the south-east of the gateway, a wall (1003) was recorded (Fig. 3, Plates 1 and 2). This was constructed of bright orange-red brick in a herringbone pattern, bonded by a pale yellow sandy mortar. The exposed wall measured 0.5m in width and was 0.4m high, although the base or foundation of the wall were not exposed. The construction of the wall closely resembled the construction of nearby walls enclosing the gardens and the adjacent stable buildings.

- 3.2.10 The next segment of pipe, c 75m in length, was bored underground through woodland and consequently was not subject to archaeological monitoring. In order to facilitate these works a 1.5m by 1.5m drill pit (Fig. 3) was excavated in the car park to a depth of 0.6m. Within the pit chalk geology was overlain by a subsoil and topsoil, both measuring c 0.1m in depth.

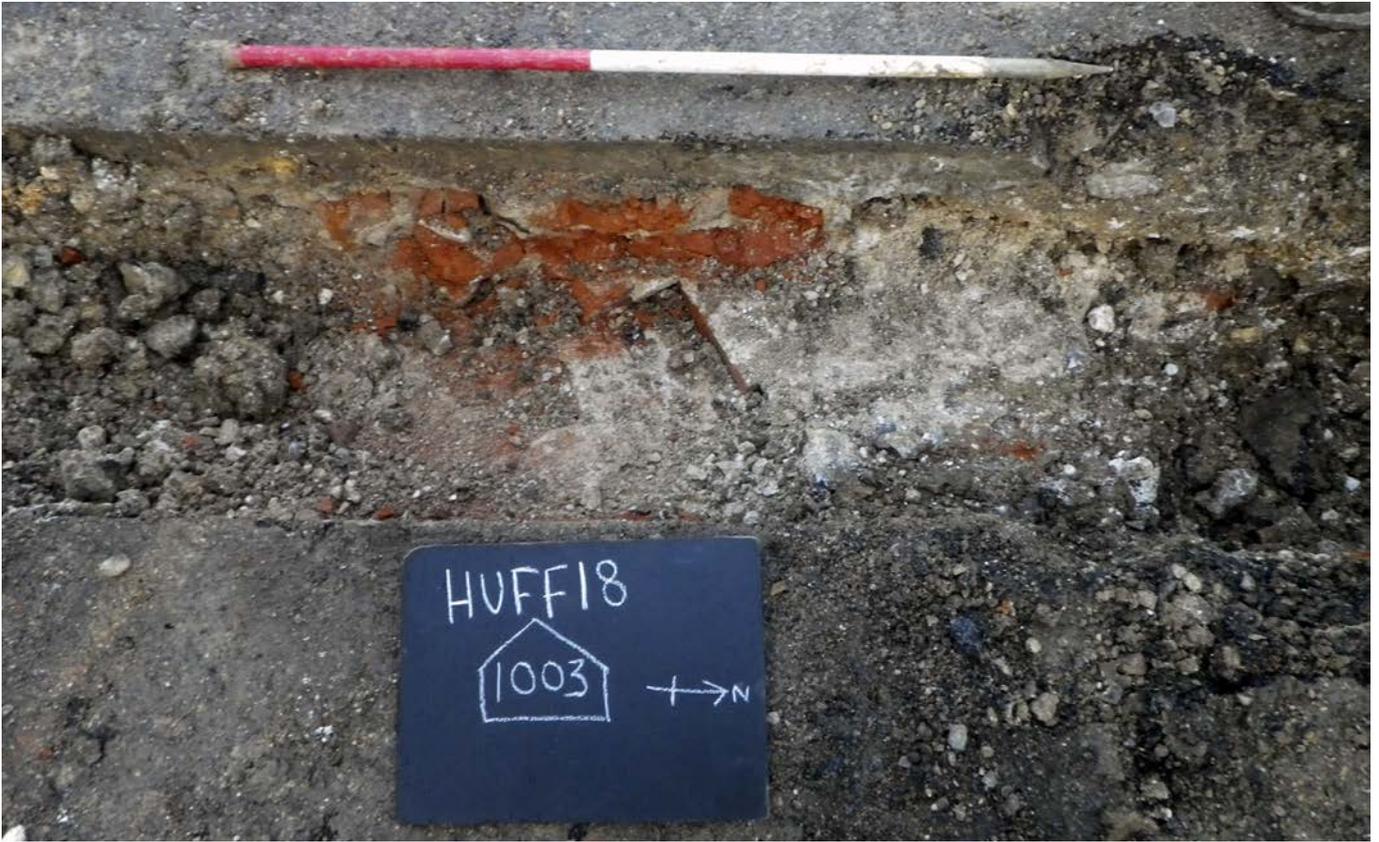
Plate 1: Wall 1003

- 3.2.5 Measuring up to 0.4m in thickness, the previously recorded made ground deposit (1002) was recorded to the north of the wall. To the south of the wall however, a different made ground deposit (1004) was present. This deposit, recorded as directly overlying natural geology, measured c 0.3m thick and consisted of a firm, mid-whitish orangey brown friable silt with frequent chalk inclusions, and contained fragments of broken red house-brick and gravel. This deposit was interpreted as a levelling deposit associated with the construction of the access road.

4.2.2 Wall 1003, located just beyond the walled garden, is of unknown date, although the materials and form suggest it may be of comparable date to the walled garden, which was constructed in the 19th century. It is likely the wall relates to a former boundary that was removed during Disraeli's programme of remodelling. This is reflected by the variation in make-up deposits on either side of the wall.
