Land to the south of Watling Street, Manor Fields, Bletchley, Buckinghamshire

Archaeological Watching Brief Report

December 2017

Client: Anglian Water

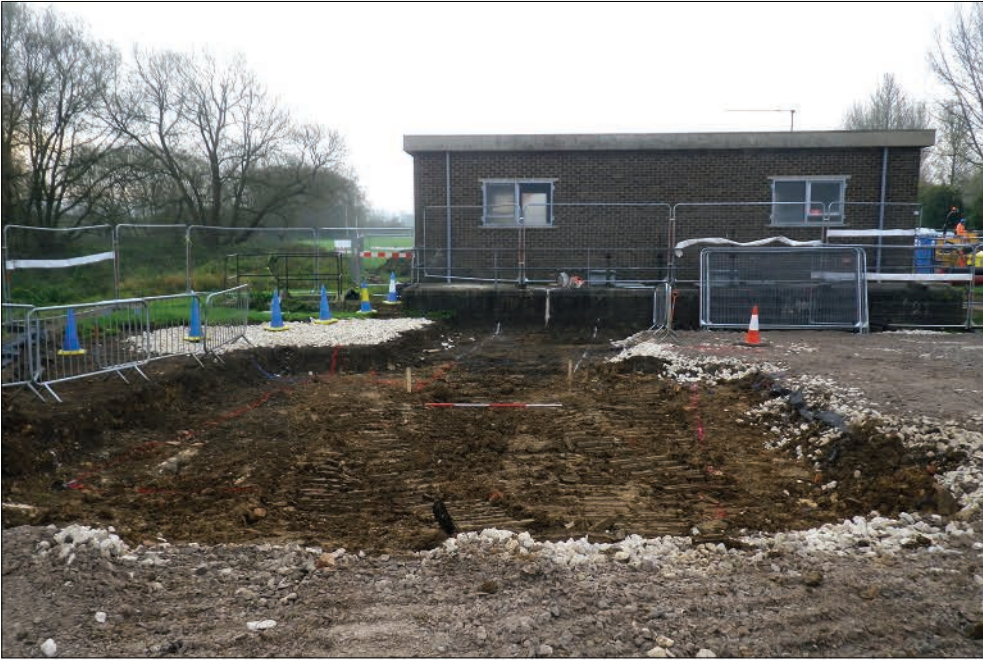
↑ Plate 1: Trench 1, from the north

3.4.1 Trench 1 (Figure 1) was located on the northern edge of the pumping house at Manor Fields. The main area was a 7x7m square, with a 3m wide strip stretching back to the platform at the front of the building. This trench was excavated to a depth of 1.2m and encountered only modern build-up layers.

3.4.2 The layers within this trench consisted of a plastic dark yellow brown silt clay overlain by a friable mid yellow brown clay silt build-up layer that contained frequent machine-cut bricks, and a compact mid grey silt layer with asphalt and frequent stones that was probably part of a former parking area. An area of plastic blue-grey clay was also visible abutting the footings of the pumping house building.

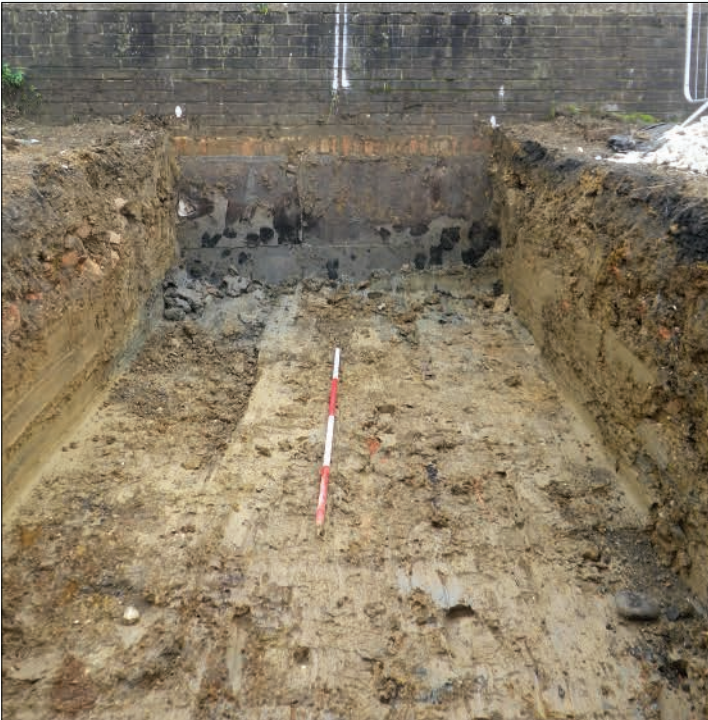
← Plate 2: Trench 1, from the north

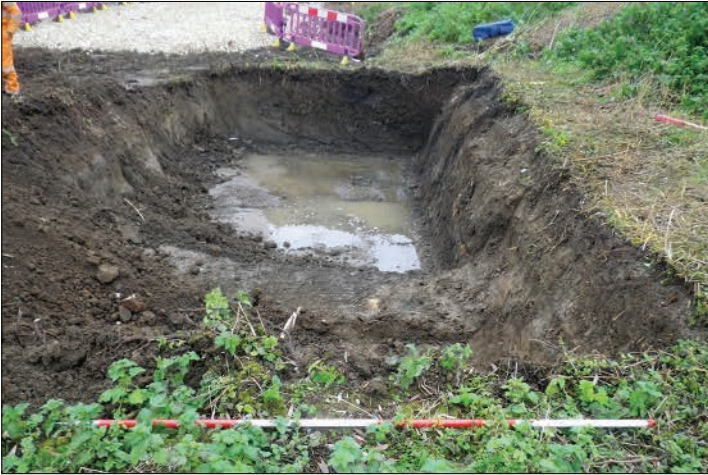
←
Plate 3: Trench 2, from the south-east

3.4.4 Trench 2 was located on the northern side of the River Ouzel, 8.4m to the south of Watling Street. This was excavated as a 9.5x5.2m area, with the location of a sewer pipe inserted in 1971 on its south-eastern side. Where the sewer pipe was not located, the trench was excavated to a depth of 1.6m before natural geology was encountered.

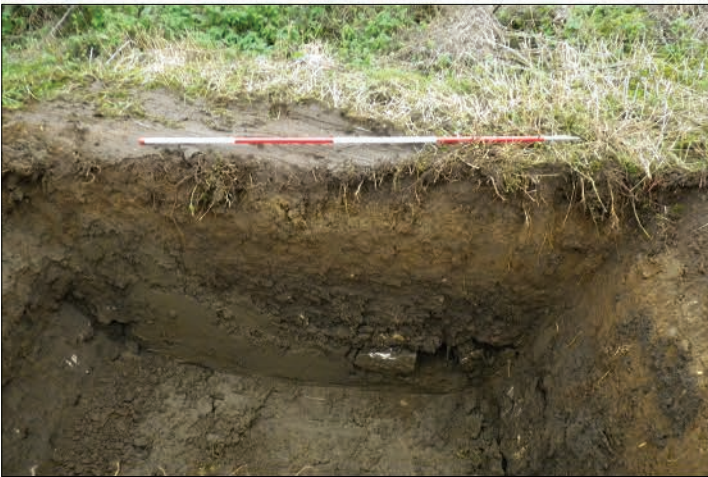
←
Plate 4: Trench 3, from the south-west

- 3.4.5 Trench 3 was located 18.5m to the south-east of Trench 2, and was excavated as a 3.5x1.8m area. This trench was excavated to a depth of 1.62m before the natural geology was encountered. The deposit immediately above the natural geology contained concrete blocks.
- 3.4.6 Trench 4 was located a further 18m to the south-east of Trench 3 and was opened as a 5.6x1.8m area. The south-eastern edge of this trench was located on the side a manhole, with the sewer pipe revealed at a depth of 1.25m. The trench was stepped beyond the edge of the sewer pipe trench cut to a depth of 1.6m.
- 3.4.7 The layers within these trenches consisted of a friable dark brown grey clay silt that was overlain by a friable dark brown silt and a friable dark grey brown silt modern topsoil.

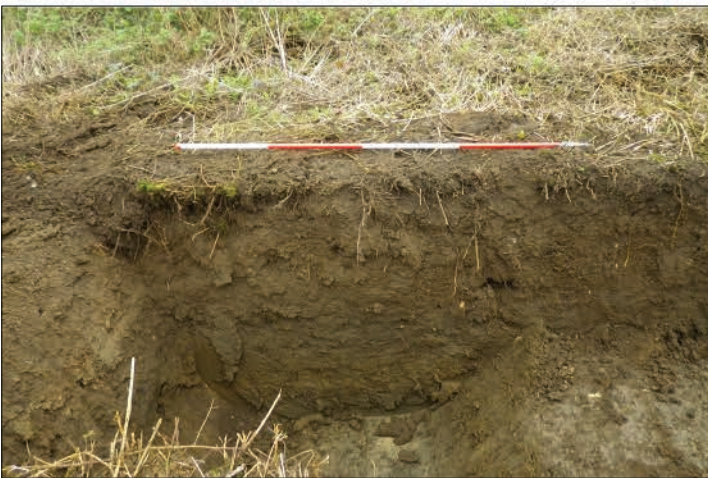
←
Plate 5: Trench 4, from the south-west
