North Boundary Wall

Hampton Court Palace

Historic Building Recording

Document Type: Building Recording and Investigation

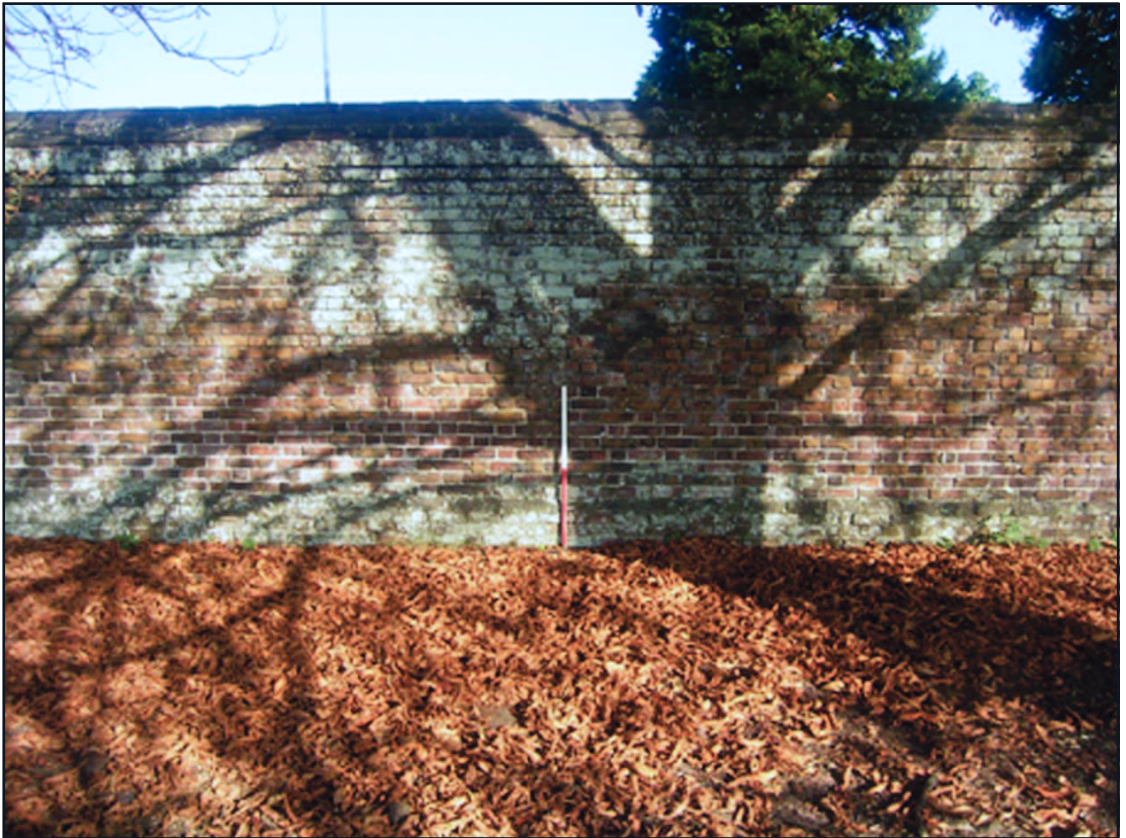
Plate 1 : General view of the section facing south

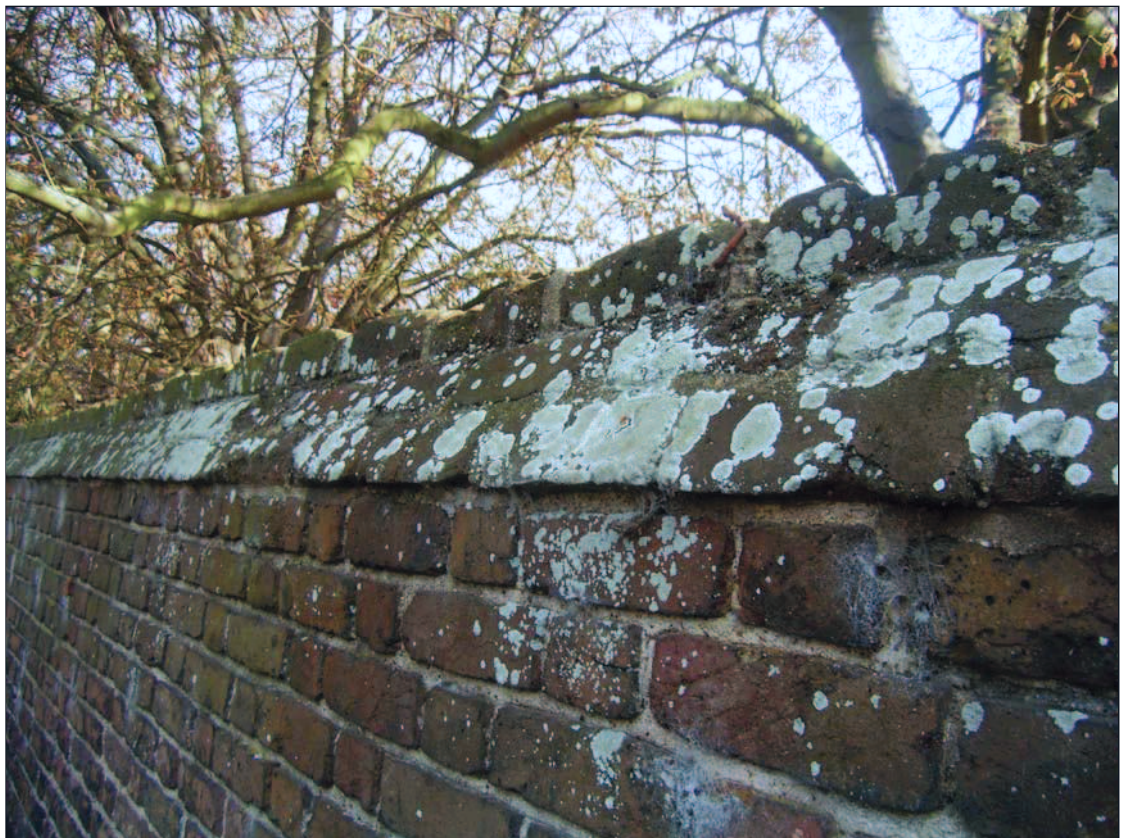
- 3.2.2 The wall has a 0.24m wide brick coping three courses high in a stretcher bond (Plate 2). The brick coping extends out from the face of the wall but returns to a squared apex at the top. The coping bricks are cut to form a flat angled surface.

Plate 2 : Brick coping detail (south face)

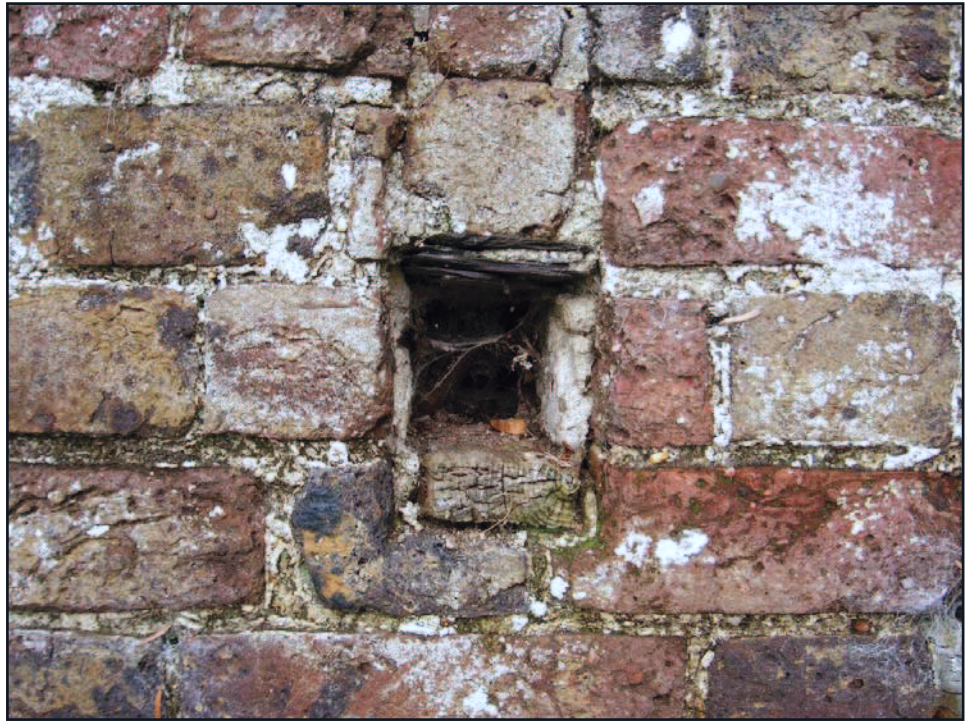
- 3.2.6 The wall has some marks including later inserted holes, grooves and scars (Plates 5 & 6). The holes are cut into the primary phase brickwork and most have some timber and darker grey mortar set within and the scars were also cut into the primary brickwork. It is likely that these probably relate to the paddocks and stables built for the expansion of the Royal Stud by George VI. The plan of Hampton Court by Henry Sayer (1841) clearly shows the paddocks with buildings adjoining the wall.

Plate 5 : Later inserted hole (south face).

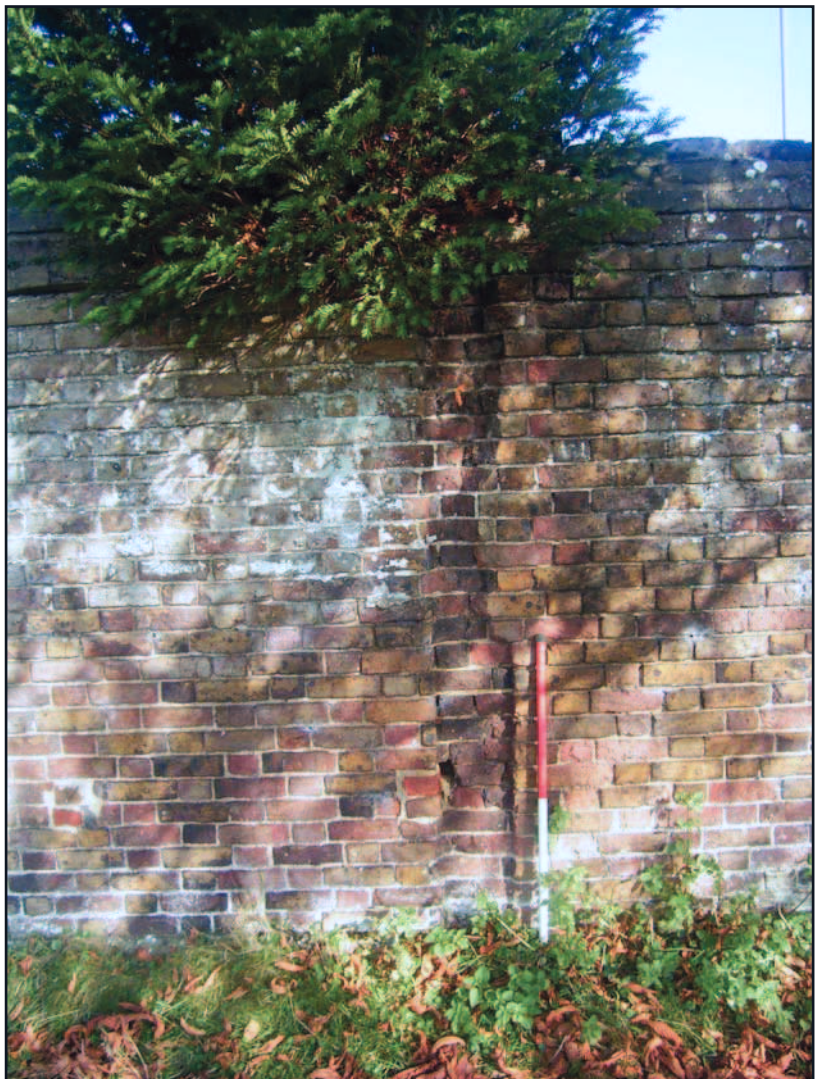
Plate 6 : Scar from later inserted wall (south face)

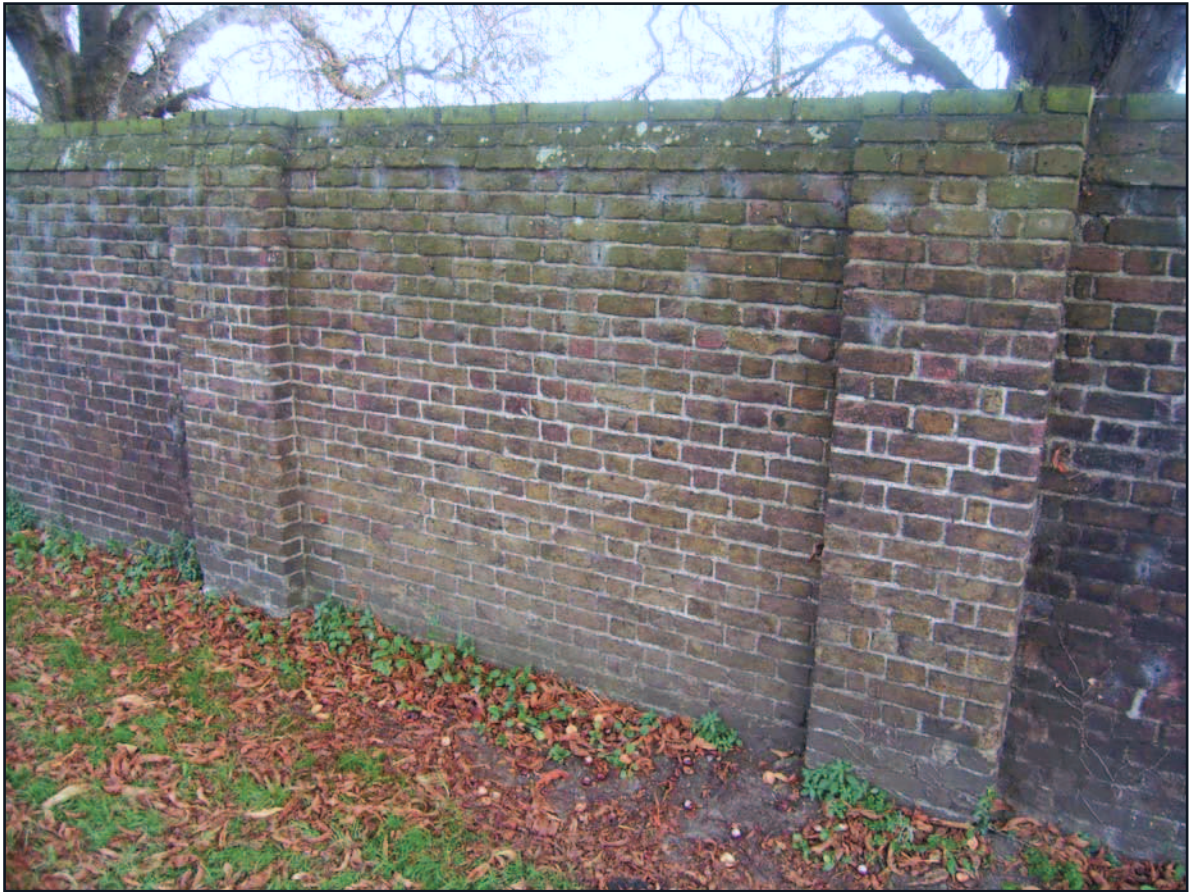
- 3.2.7 On the north side of the wall and not visible from the side in which the intervention was done, there are also some stretches of wall framed by buttresses. These buttresses are 0.58m wide and they are 2.63m one from the other (Plate 7). The south face of these sections of wall between the buttresses present yellow bricks and they look more recent than the rest. They are all out of the boundaries of the section surveyed.

Plate 7 : Buttresses on the north face

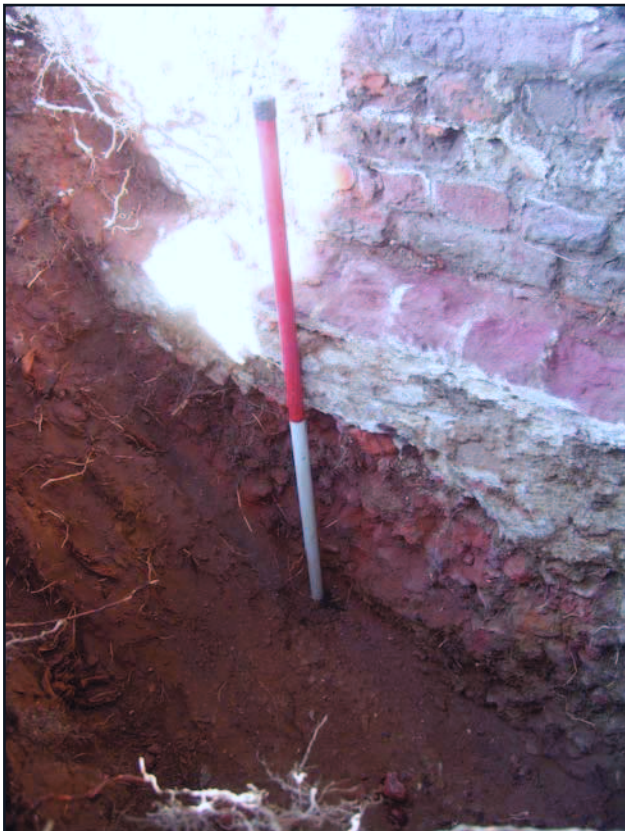
- 3.3.3 The trenches were excavated down to approximately 1.5m below the ground level on the south side (Plates 8 & 9). Once the process of excavation was finished, the full height of the plinth and the foundation of the wall were fully exposed. Once the recording process was finished, the trenches were filled back as requested.

- 3.3.4 The plinth and foundation are 1.2m high consisting of 13 courses with the top 9 courses of the plinth laid in an English bond. The 4 courses of the foundations project half a brick from the face and they are laid in header bond. The brickwork rests on a layer of ceramic building material and rubble of a light red colour. It appeared to be solid while it was compacted in the wall but once it fell off from the foundations it was clearly a loose and friable material. The bottom of this layer is quite irregular although in general is 0.4m thick (which is included in the overall 4 m measurement given for the height of the above and below-ground wall). Therefore, the portion of wall buried including foundations is 1.25m on the southern side and 1.75m on the northern side.

Plate 8 : Foundations in Trench 1

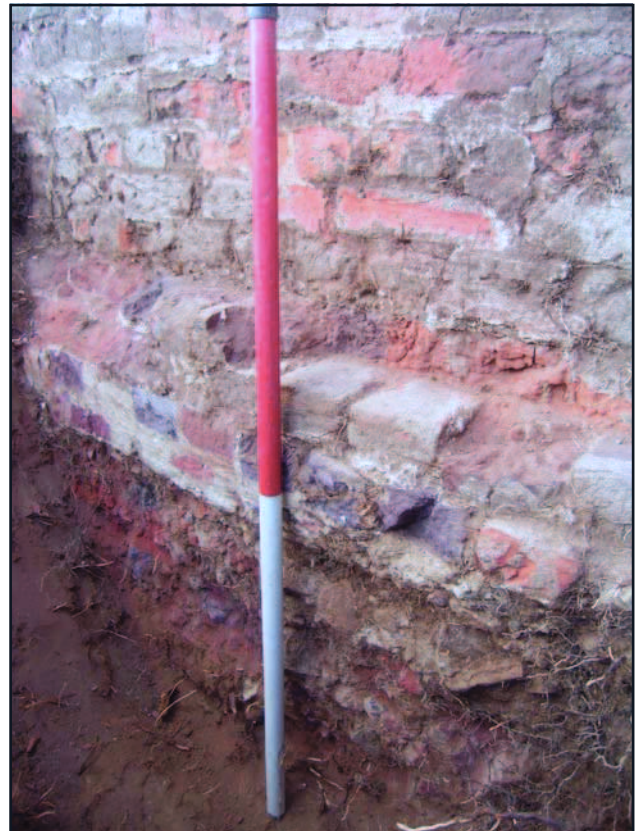
Plate 9 : Foundations in Trench 2
