OAKENROD MILL, ROCHDALE

Archaeological Evaluation

Oxford Archaeology North

November 2006

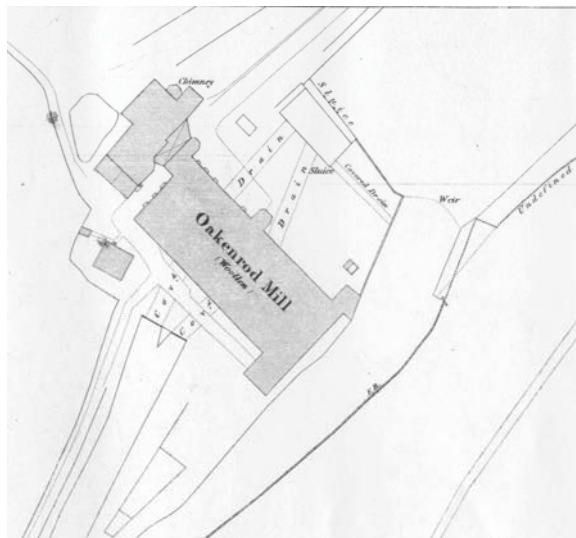
Extract from the Ordnance Survey map of 1851

3.1.4 Oakenrod Mill is first shown on the Ordnance Survey map of 1851 as a Woollen Mill (Fig 3). Although the map only shows a block plan of the main mill structure, it depicts significant detail of the associated water power system, including the weir, lodge, sluice, and two 'Drains', which presumably formed head-race and tail-race tunnels to two waterwheels within the basement of the mill. The flow of water into the head-race appears to have been regulated by a large rectangular feature. This was connected to the river at a point below the weir by a 'covered drain', which presumably provided an overflow mechanism. To the north-east of the main mill building a further range of structures, which included a chimney, appear to represent a steam-power plant, with a small associated reservoir, presumably for the engine and boilers. The site of these elements of the complex lie beneath an access road, beyond the boundary of the present study area.

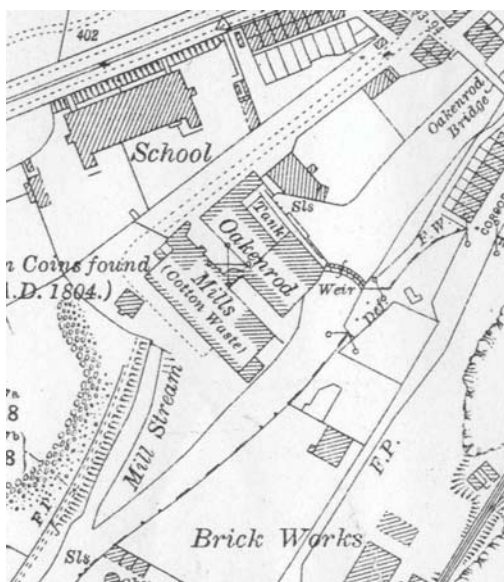
Extract from the Ordnance Survey map of 1890

3.1.5 The next available detailed plan of the site is provided by the Ordnance Survey 25":1 mile map, published in 1890 (Fig 4), which shows a much altered complex. The lodge above the weir was partially infilled, with a new structure placed within its infilled western part. A new block was constructed to the north-east of the earlier mill, similar in overall size and alignment, but apparently comprising distinct northern and southern elements. Whilst the water management tunnels are no longer illustrated, the position of the new building evidently respected the rectangular structure, labelled as a 'Tank', which regulated the flow of water into the head-races. Similarly, the sluice and open section of the tail-race, marked 'Mill Stream', suggest the continued use of water power. Moreover, the engine house associated with the earlier mill also appears to have been demolished by that date. These factors suggest that the power for the mill was derived from the turbines by 1890.

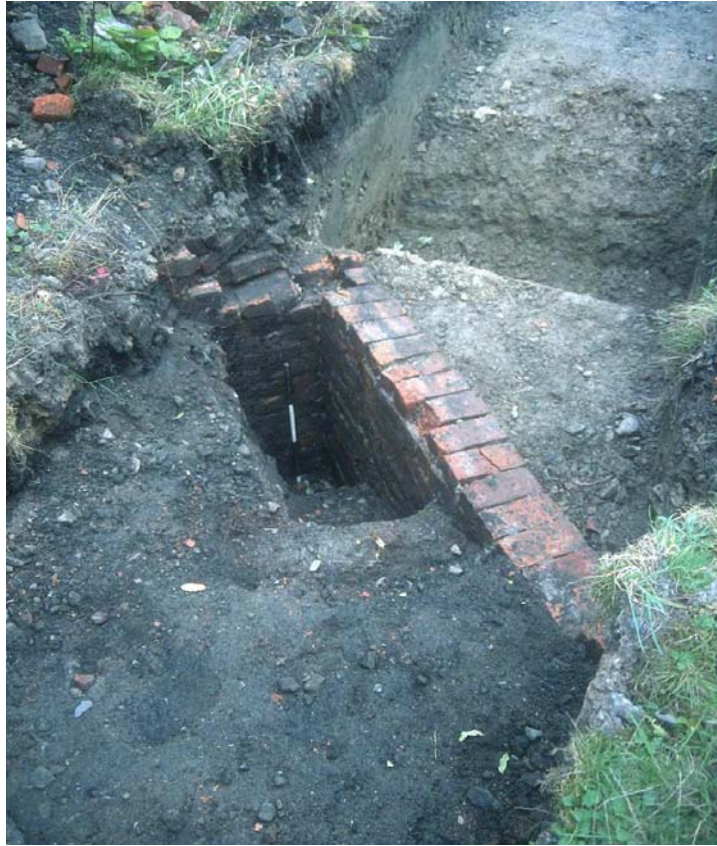
Plate 1: Remains of brick structure at northern end of Trench 1

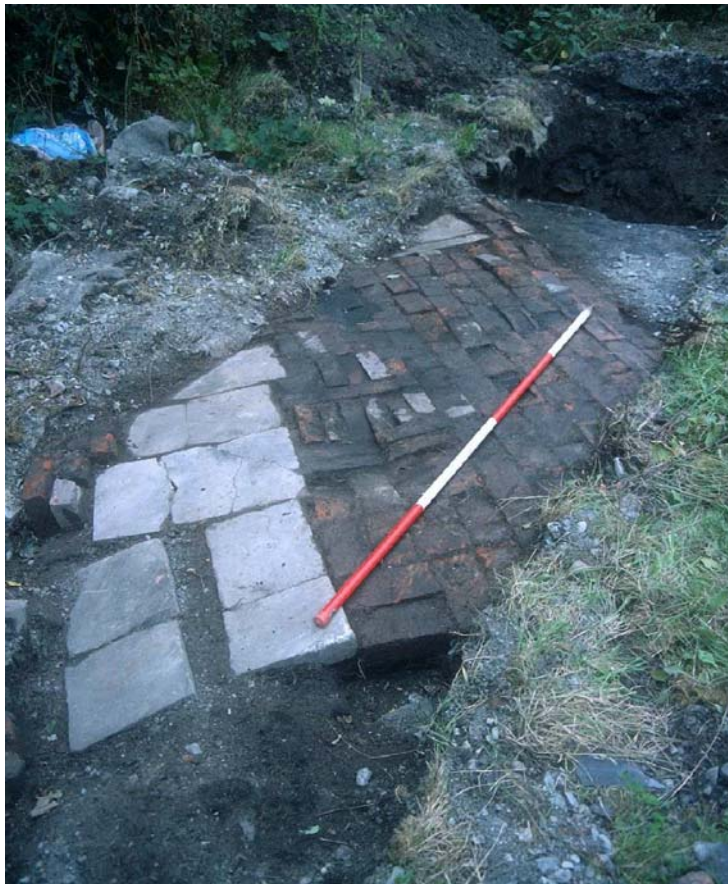
Plate 2: Rough floor / yard surface, Trench 1

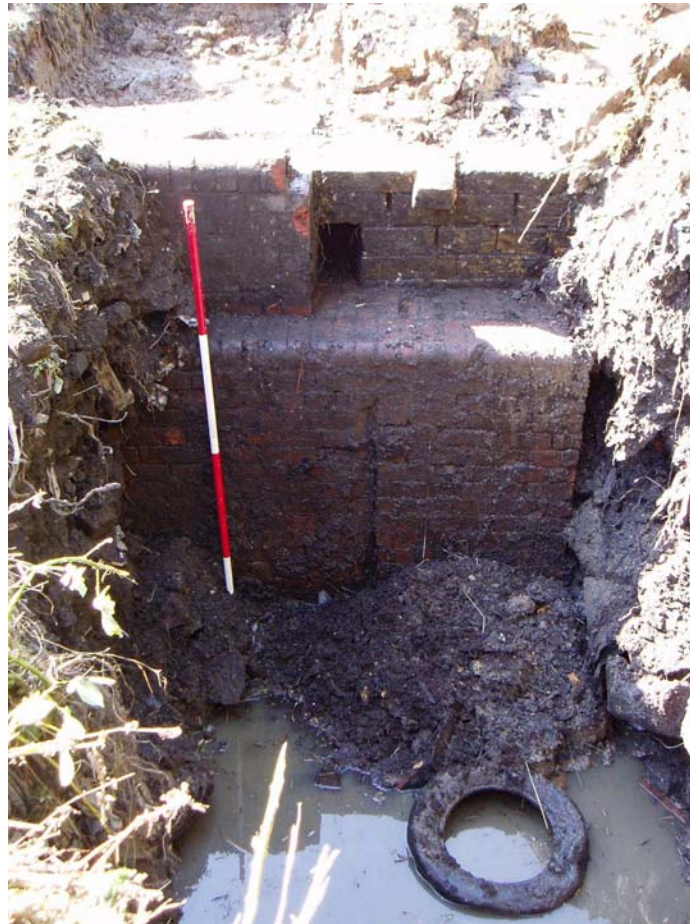
rectangular opening in the stone mill wall. It measured 0.18m wide and 0.27m high, and appears to represent an overflow for the tank (Plate 3).

Plate 3: Brick stopping of southern head-race tunnel

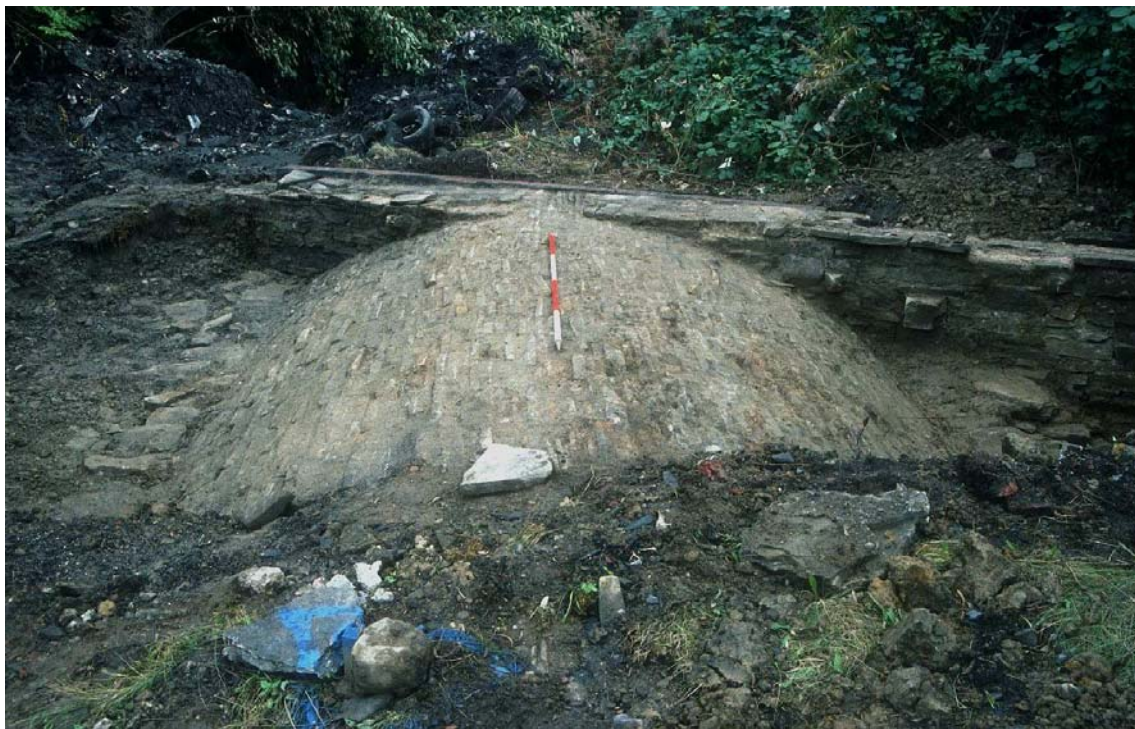
- 4.2.7 Further excavation to the south-west, within the footprint of the late nineteenth-century mill block, revealed the arched capping of a large tunnel, measuring some 4m wide (Plate 4), marked as a '*Drain*' on the Ordnance Survey map of 1851. This strongly suggests that the brick wall observed on the opposite side of the mill wall represents a blocking of the feature, which formed a head-race to a waterwheel, located within the earlier block of the mill. The crown of the arch, which appeared to be segmental in profile, was formed of edge-set narrow sandstone flags, typically 50mm wide and between 0.15 and 0.45m long, bonded with a pale yellow lime mortar. At its northern end the tunnel was continuous through the north external wall of the later mill, which was constructed over the top of its crown (Plate 5). The trench was extended for a distance of approximately 7.5m to the south-east, to expose the entire width of the tunnel, which was oriented on an approximately north/south alignment (Fig 6). The side wall of the tunnel projected a further 0.45m beyond the arch, and appeared to be of dry-stone construction, with a ragged external face, which thickened up to 0.75m wide in parts of the exposed eastern wall. The feature was sealed with re-deposited mid-orangey-brown, slightly plastic silty-clay, containing fragments of brick, slate and small quantities of pottery. The layer may have been deposited, at least in part, as a levelling associated with the construction of the new mill block before 1890.

Plate 4: Crown of southern head-race tunnel

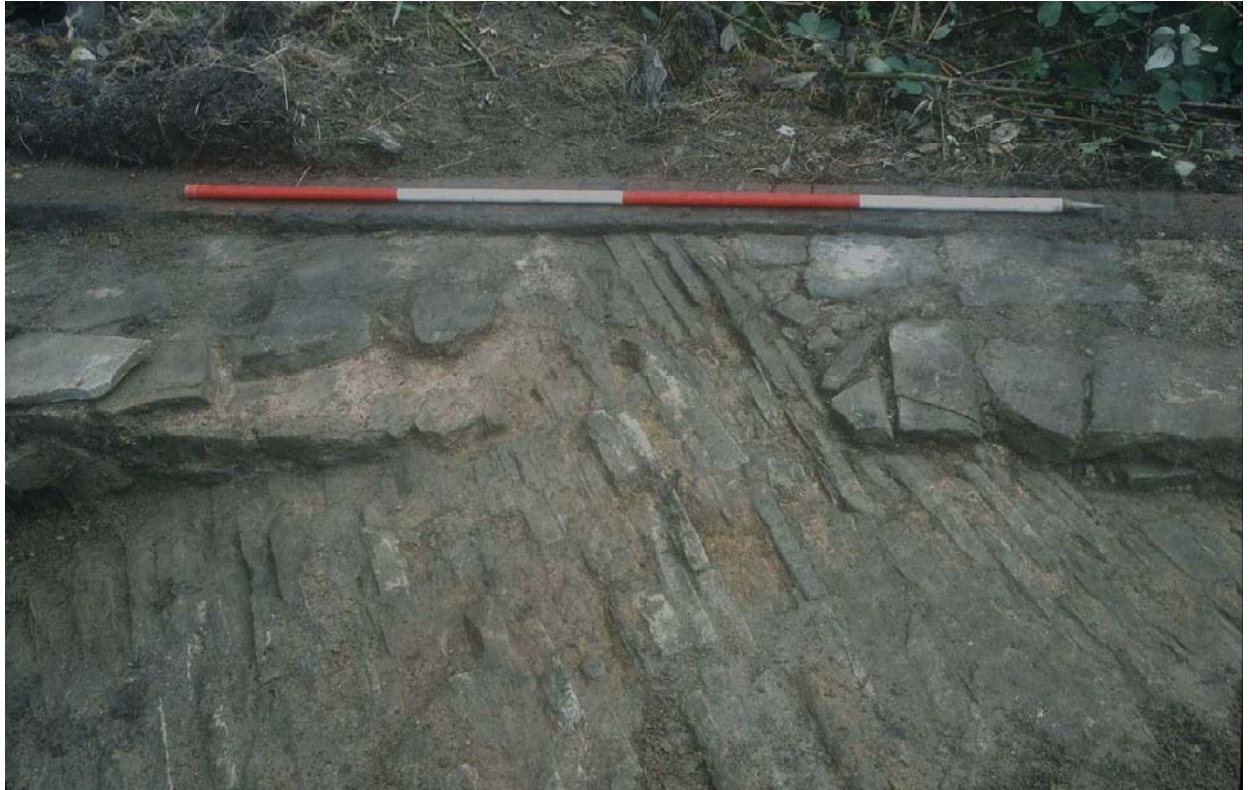
Plate 5: Relationship between head-race tunnel and later mill wall

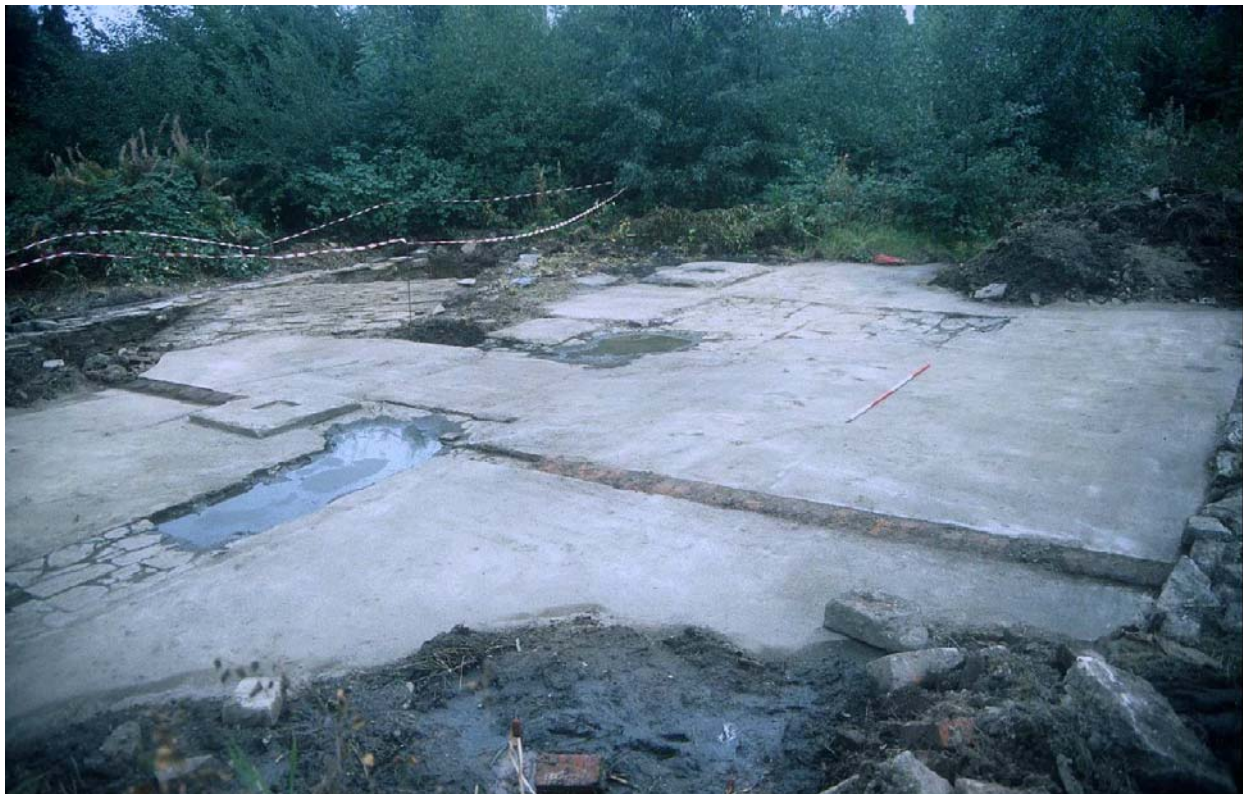
- 4.2.9 A series of four large sandstone blocks was exposed at regular intervals along the trench, with a further example protruding through the vegetation to the north of the trench (Fig 6). All differed slightly in size and style, but each represented the sandstone footing for a column supporting the first floor of the mill. These were positioned centrally within the mill, which was 43'6" (13.26m) wide internally, and formed the divisions between each bay. Within the area of the evaluation trench, the bays were uniformly 12' (3.66m) wide (Fig 6). Three of the blocks, which were typically 1m², and projecting 0.1m above the concrete floor, had square scars/stains, demonstrating the position of the bases of the column feet, whilst the southern and central bases had sockets to house the column feet, cut into their surfaces. Both sockets were 1' (0.30m) square, that in the central block being 25mm deep, whilst that in the much larger southern block (measuring 1.21 x 1.83m) was 31mm deep (Plate 7). The central column base block was also butted on its north-east face by a partition wall, of single brick thickness, surviving only to floor level (Plate 6). It was of

Plate 6: General view, Trenches 3 and 4, from north-west

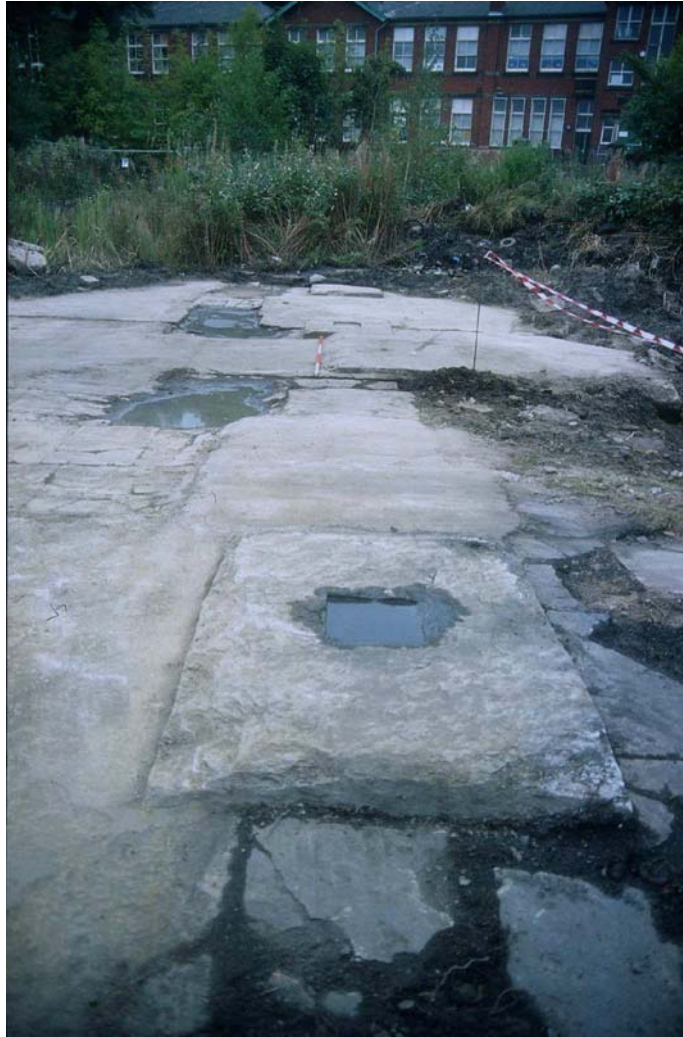
Plate 7: Detail of southern column base, Trench 4

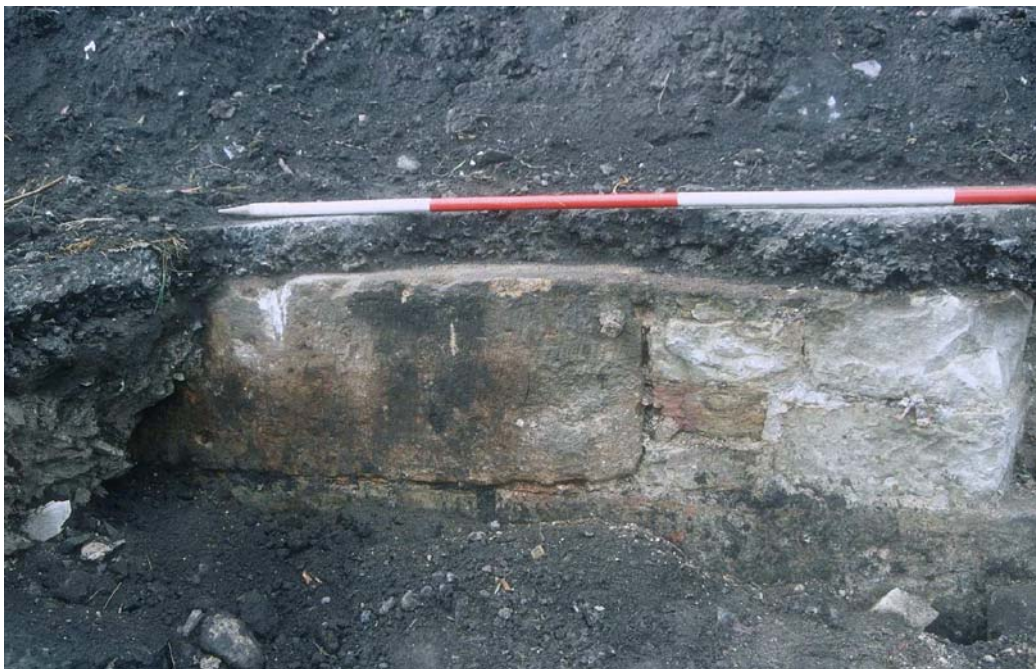
Plate 8: Detail of large sandstone block in north elevation, Trench 5

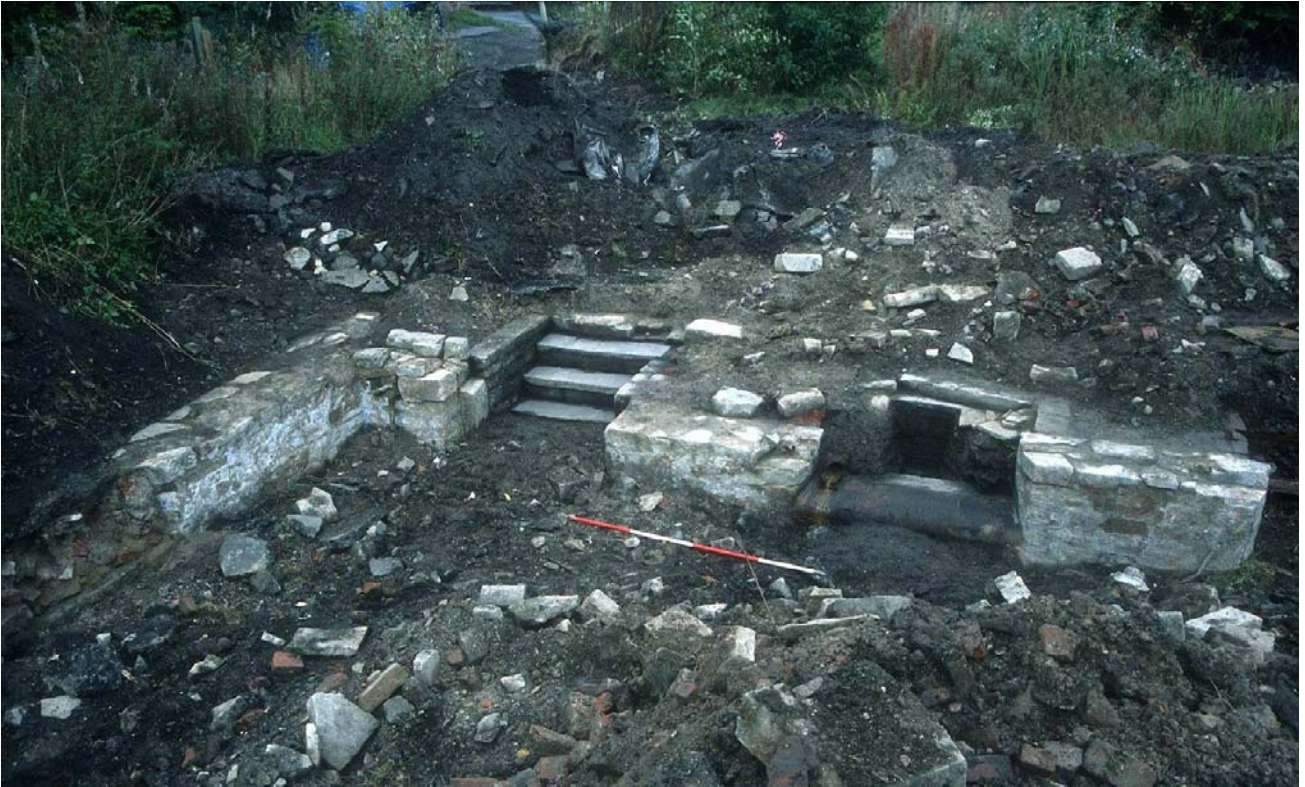
- 4.2.11 The basement was well-preserved, with the northern and eastern walls surviving to a height of 2.1m above the damaged sandstone flag floor (Plate 9). Several features were exposed within the evaluation trench, most notably a straight stair at the northern end of the eastern elevation (Plate 10). This comprised nine sandstone steps, which led from the basement floor up to an almost completely destroyed flagstone floor, approximately 0.3m below present ground level. The four steps beyond the external wall of the mill were enclosed by sandstone stair-walls on either side, comprising a single skin of dressed sandstone blocks, typically 0.24m thick. The stair-walls abutted the external face of the mill, but the door aperture appears to be original, suggesting that the stair was also original, and the side-walls were not keyed into the main structure as they had no structural load.

Plate 9: Well-preserved remains of basement, Trench 5

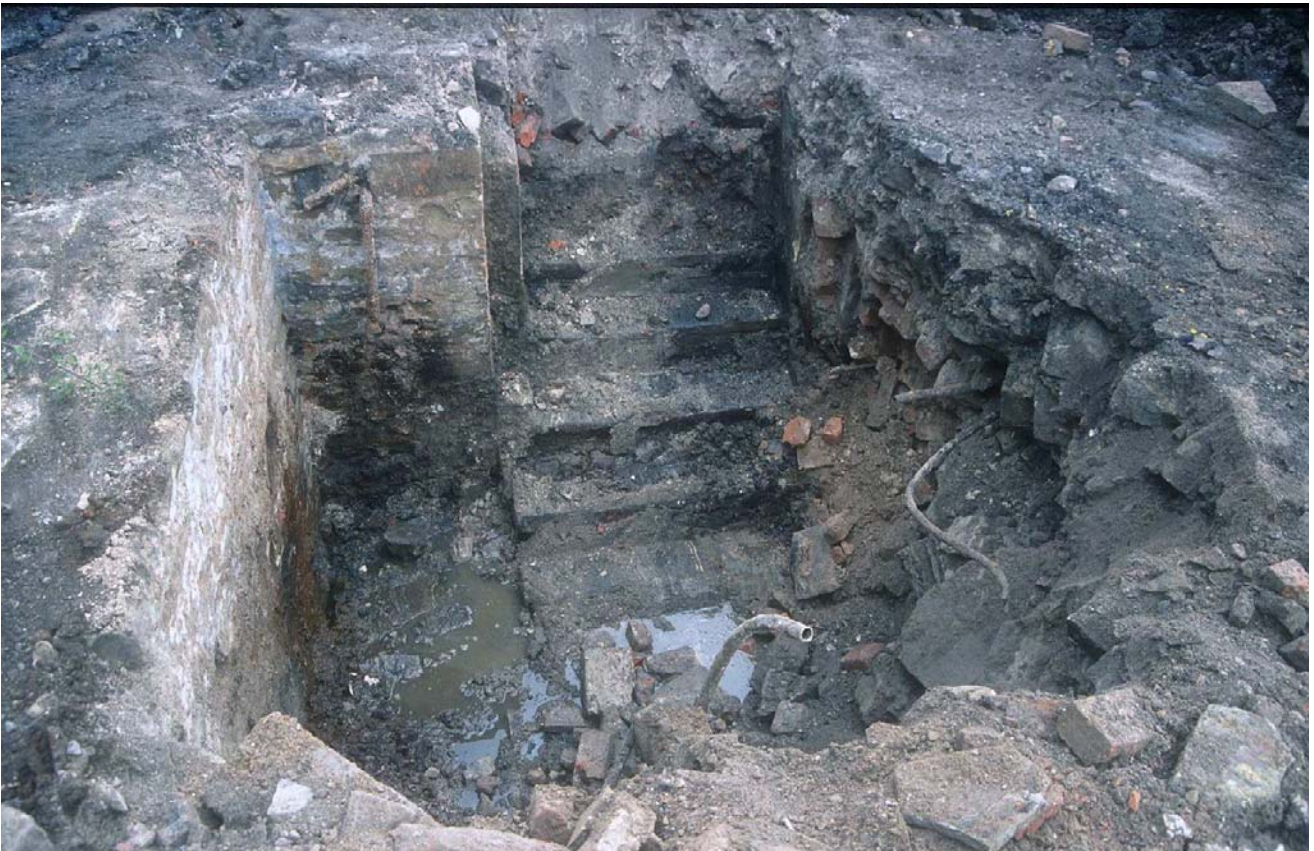
Plate 10: Stair from basement, Trench 5

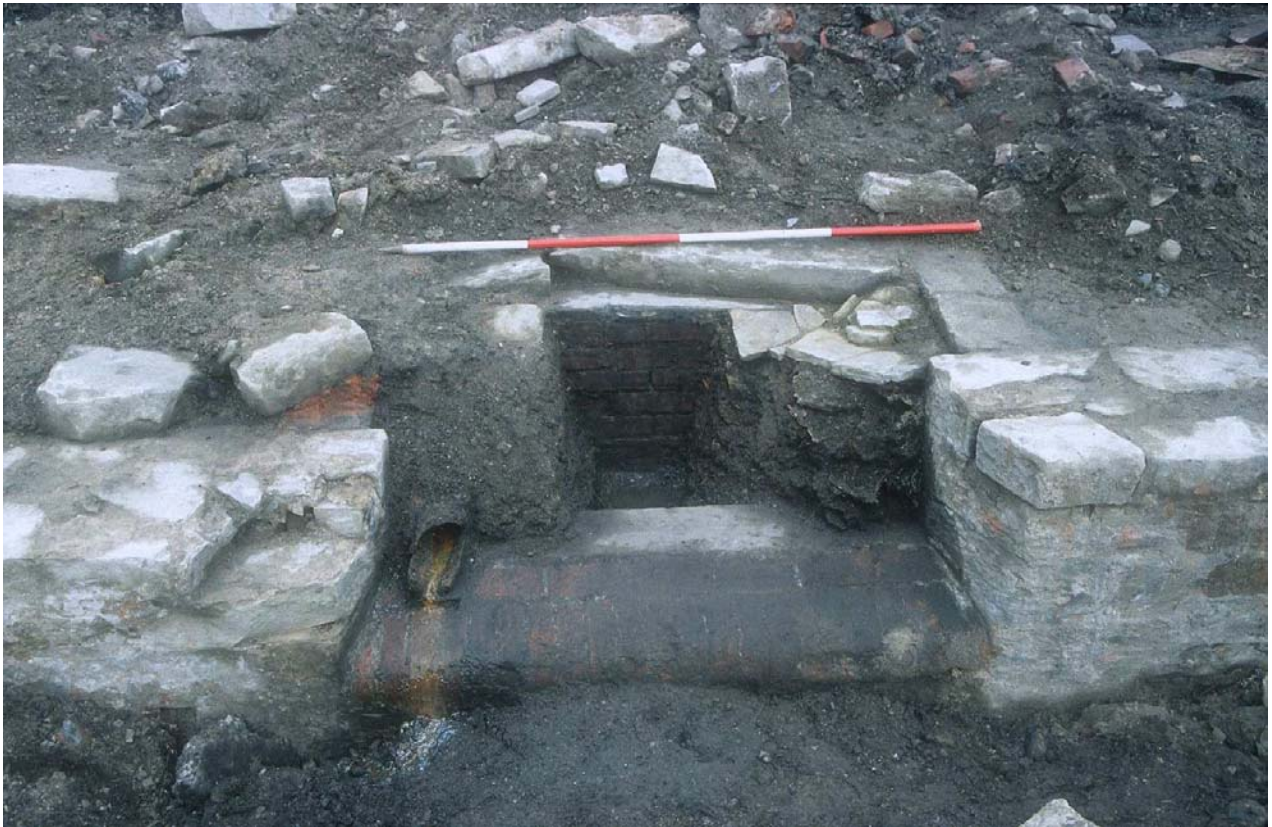
- 4.2.12 To the south-east of the doorway, a 5' (1.53m) wide window with splayed reveals was observed, positioned 5' (1.53m) above the basement floor level (Fig 7). The external sill comprised a flat sandstone block, flush with the wall face, butted on the internal side by a sloping brick sill with bull-nosed internal face (Plate 11). Although this appeared to comprise mould-thrown brick, it most probably represented an early remodelling of the window, as a similarly-sized example in the north elevation, 2.3m from the junction with the east wall, had a flat sandstone internal sill. Another window aperture in the eastern elevation comprised mould-thrown brick walls, butting the external face of the mill, and having what appear to be machine-cut sandstone cappings, 0.75m above an indurated, possibly metalled, base. This was sealed with 0.2m of plastic clay to sill level, below loose ash and rubble backfill.

Plate 11: Window in north-east elevation, Trench 5

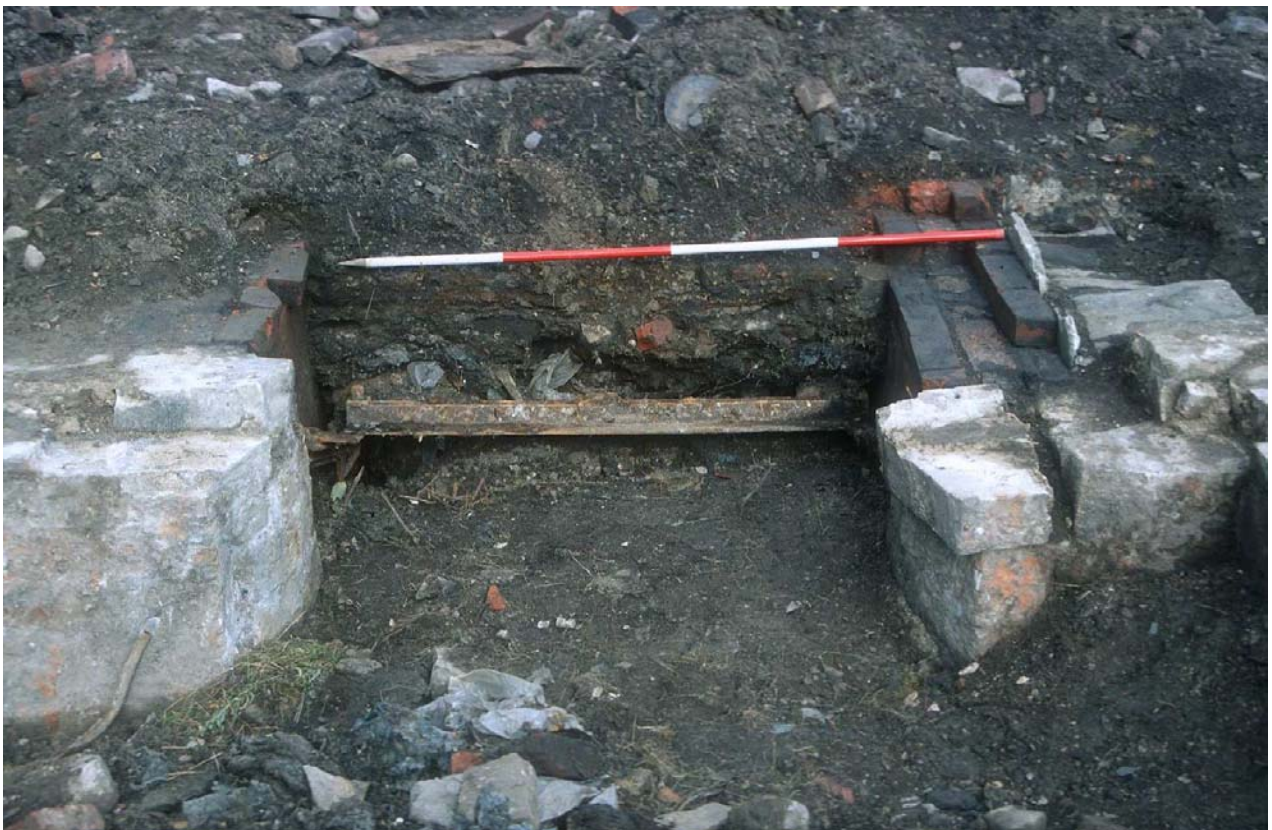
- 4.2.13 Further to the south-east, a doorway was observed in the eastern elevation. It was of similar width to the window to the north, and had moulded splayed reveals, suggesting that it was original, but it was heavily modified subsequently, most probably in the early twentieth century. The remodelling comprised the addition of internal cheek walls in machine-made brick, one-and-a-half-bricks thick, and extending beyond the limit of excavation to the north-east (Plate 12). This suggests that the feature was possibly turned into an underground passage or, more likely, an additional room was created to the north-east. The *in situ* remains of a sturdy metal door frame (Plate 12) also suggest the presence of a fireproof door following the alterations.

Plate 12: Doorway in north-east elevation, Trench 5

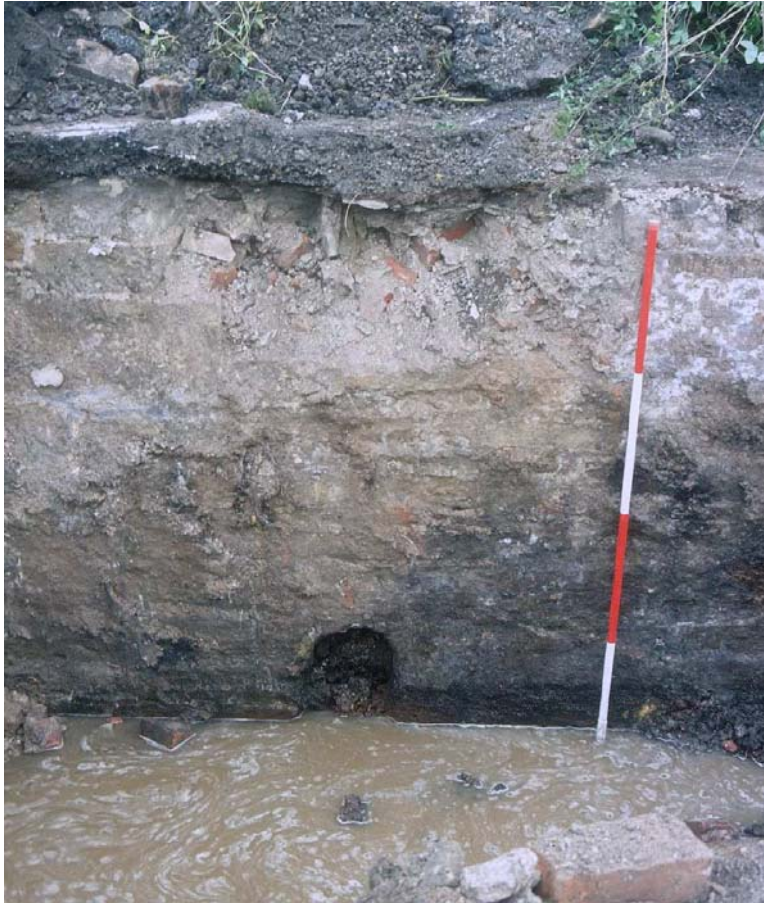
- 4.2.14 A floor level aperture in the northern elevation, approximately 0.3m wide and 0.46m high, with a segmentally arched head (Plate 13) was observed centrally below the window. Given the depth and instability of this part of the trench, it was not possible to examine the feature in detail, and it therefore remains of unclear function, but it possibly relates to a steam pipe from the boilers to the north, used to heat the basement of the mill.

Plate 13: Floor-level aperture, north elevation, Trench 5

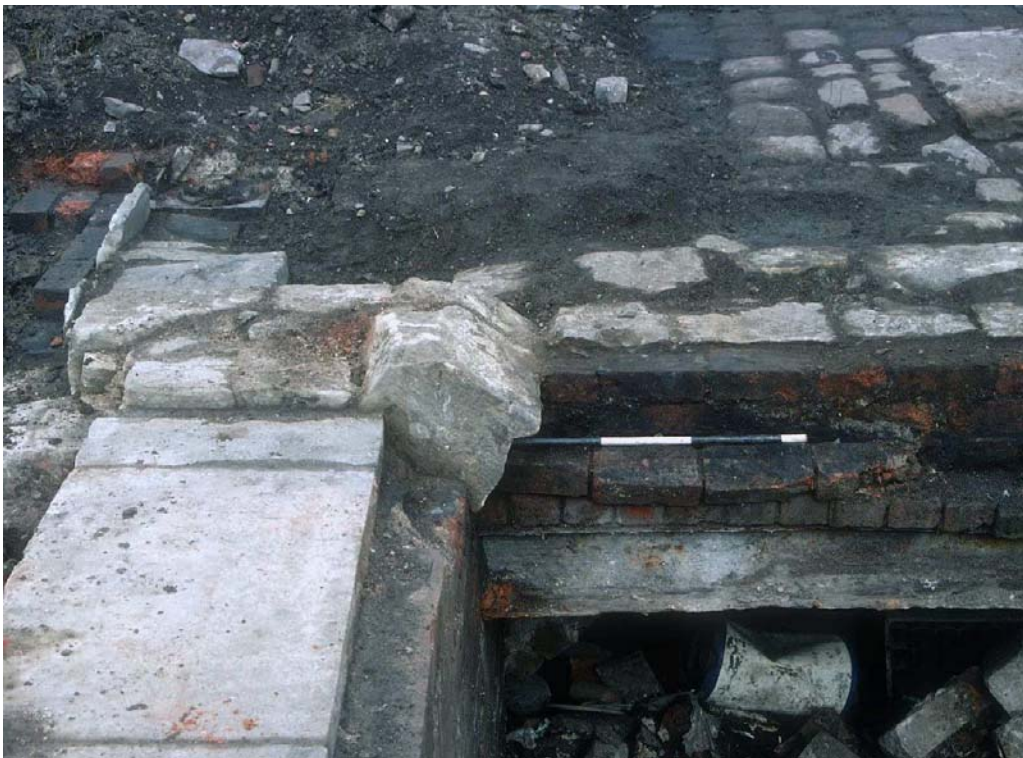
Plate 14: Dressed sandstone springer for head-race tunnel arch

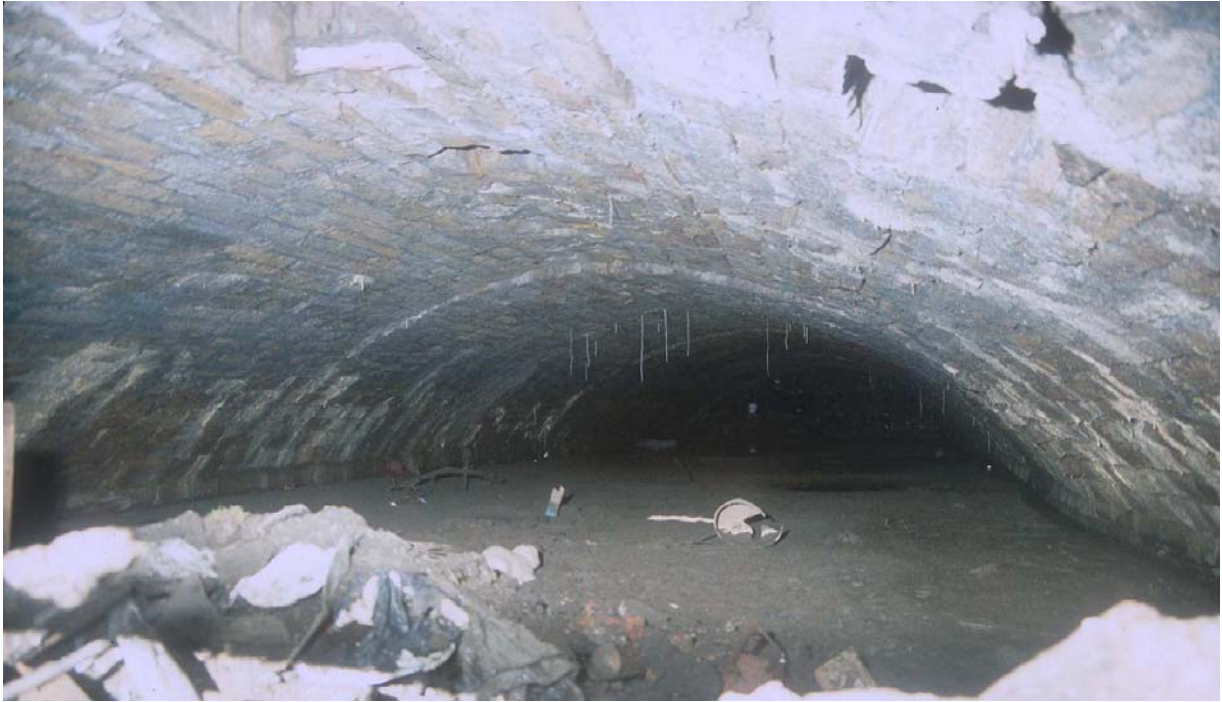
Plate 15: Internal detail of northern head-race tunnel, Trench 5

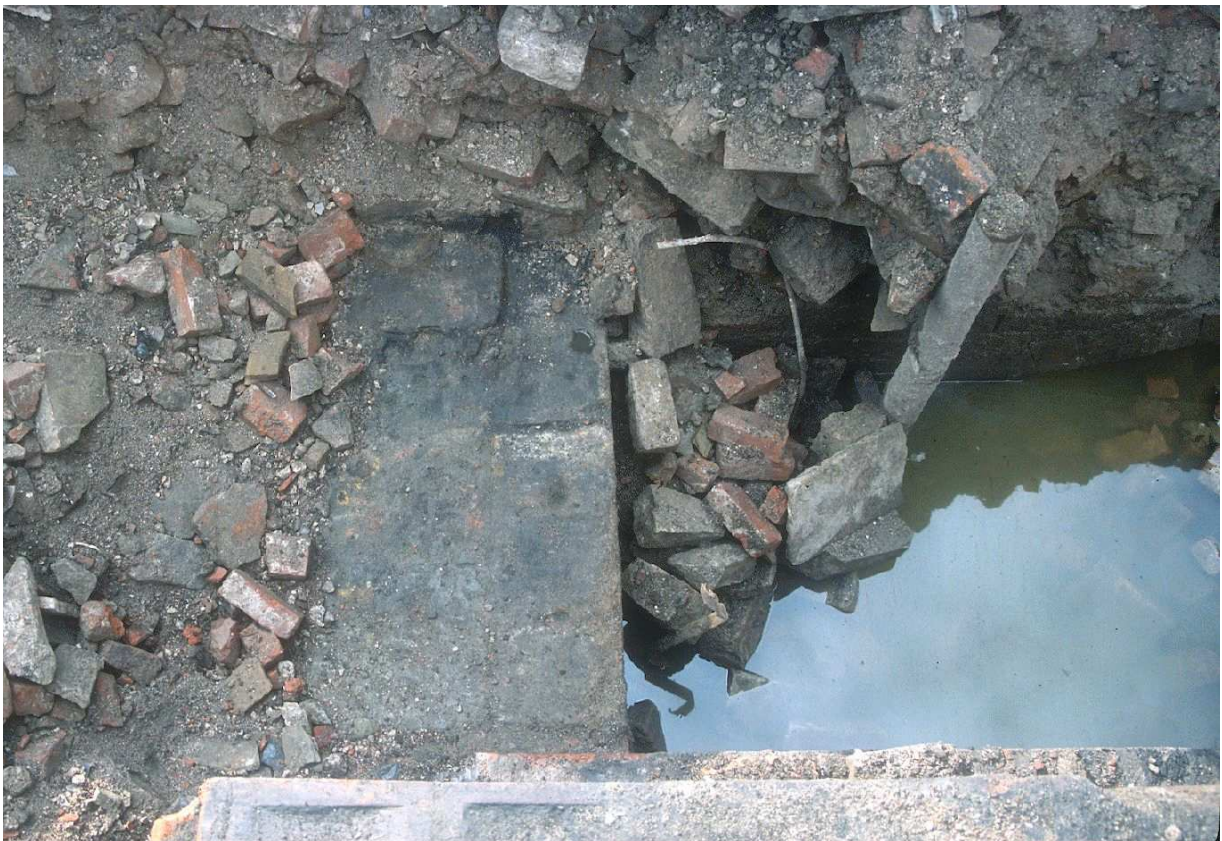
4.2.17 A broken cast-iron vertical pipe, projecting 1.45m above the water level within the pit (Fig 8; Plate 16), represented the remains of a vertical driveshaft from the early twentieth-century turbine to a large horizontal cogwheel, still *in situ* and described by Marshall during his survey of 1966 (*op cit*, 37f). This was the only remnant of machinery relating to either power source exposed during the evaluation, although the inserted turbine pit walls survive almost completely intact. These comprise three-brick thick machine-made brick, in English Garden Wall bond, with black soot and cement mortar. Where visible, the external corners of the pit were observed to be bull-nosed, and the walls were capped with concrete flagstones (Plate 17). The chamber created measured 9'6" (2.90m) by 16'6" (5.03m), and was 7' (2.13m) high.

Plate 16: Detail of features associated with wheel pit, Trench 5

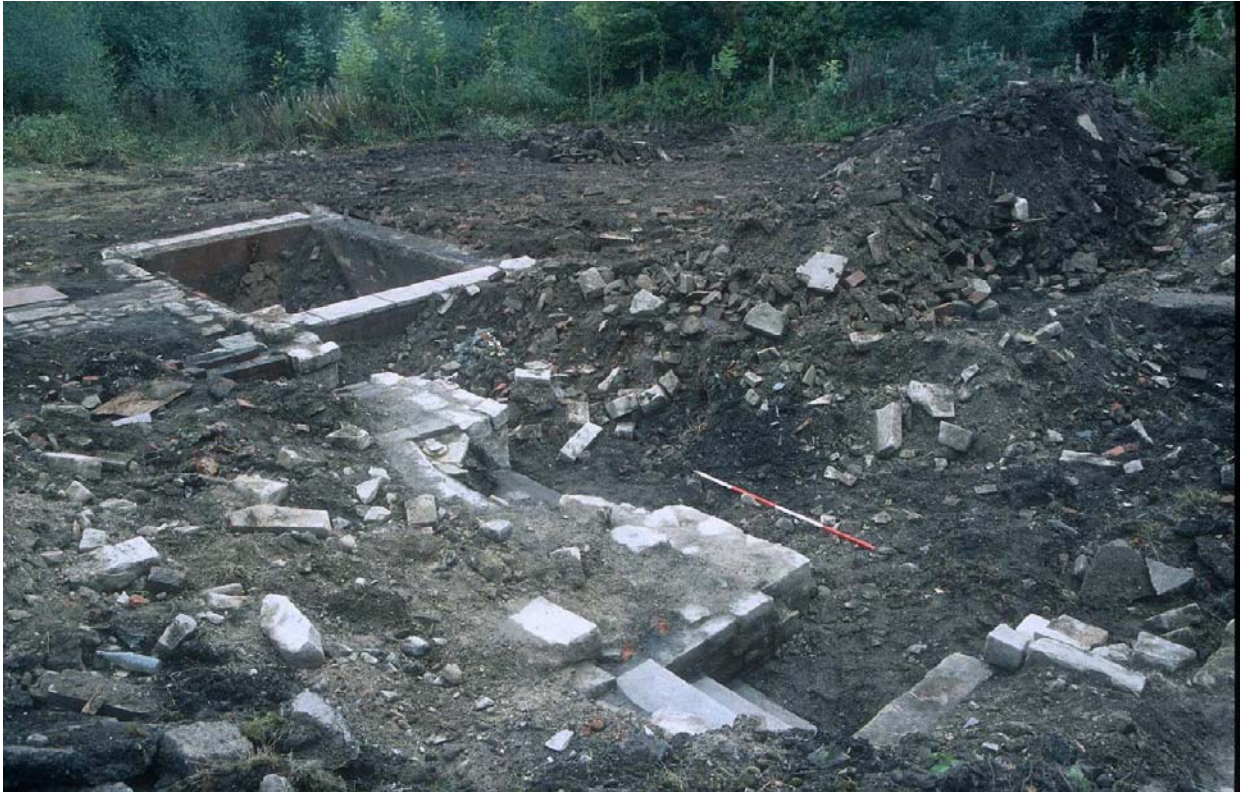
Plate 17: General view, Trench 5, showing turbine pit walls at rear
