# **MANN ISLAND, LIVERPOOL, Merseyside**

## **Archaeological Evaluation Report**

**Oxford Archaeology North**

October 2006

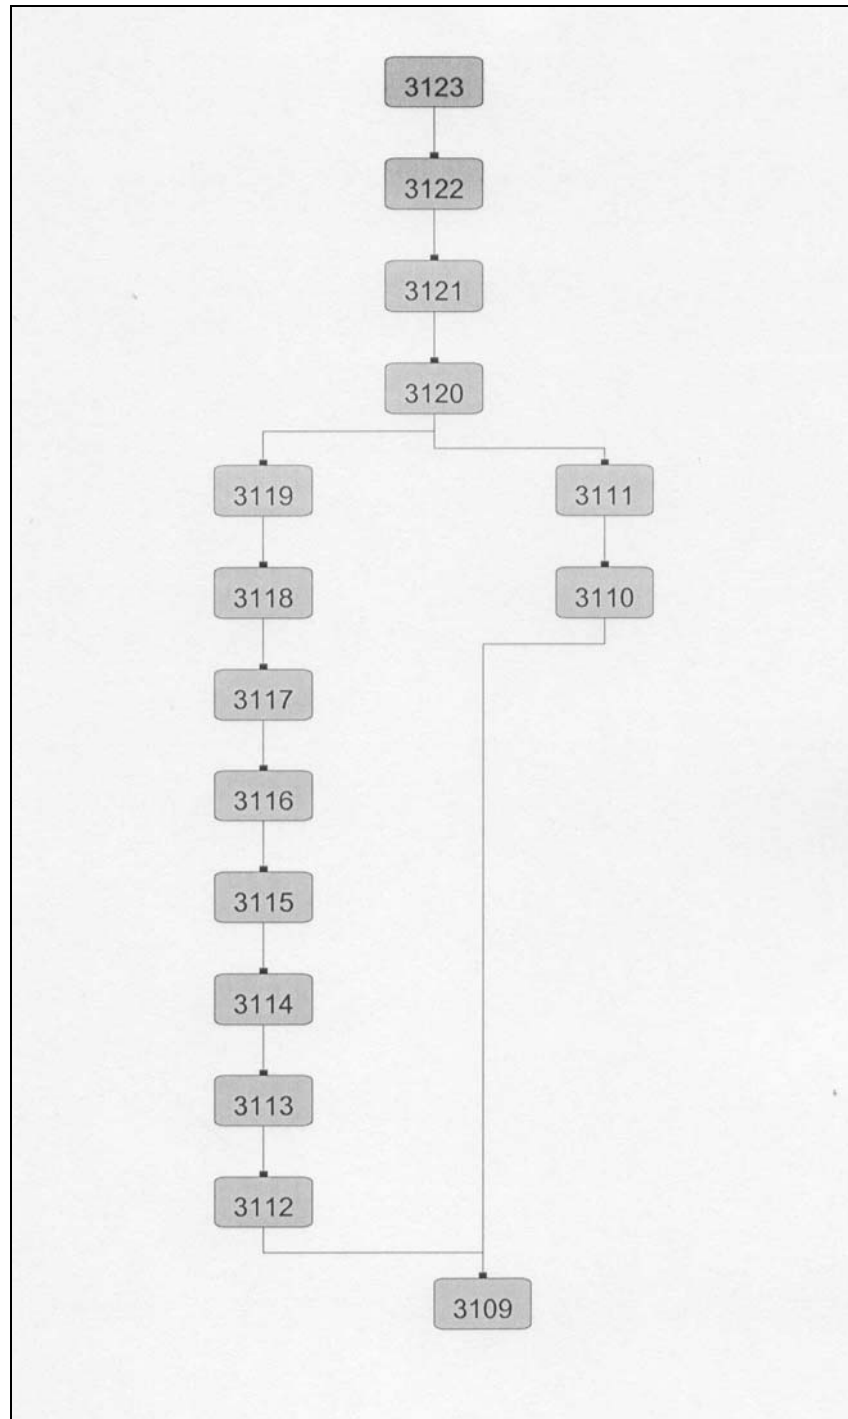
Harris matrix showing Trench 1 stratigraphy

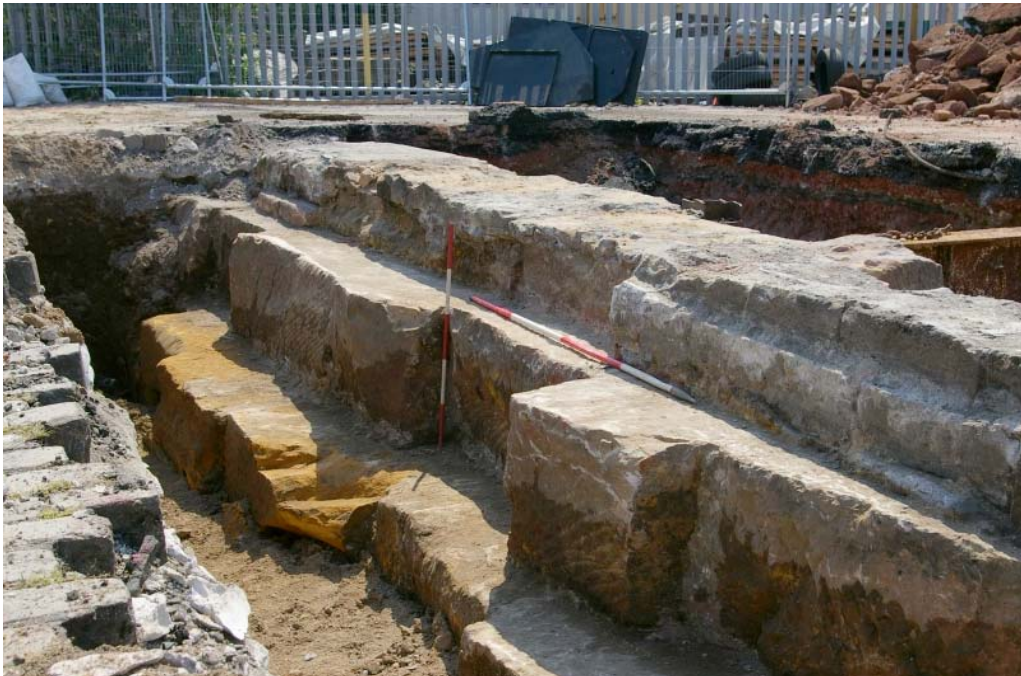
Plate 2: View of Trench 1 showing the rear eastern face of Manchester Dock wall, **3109**, looking south-west

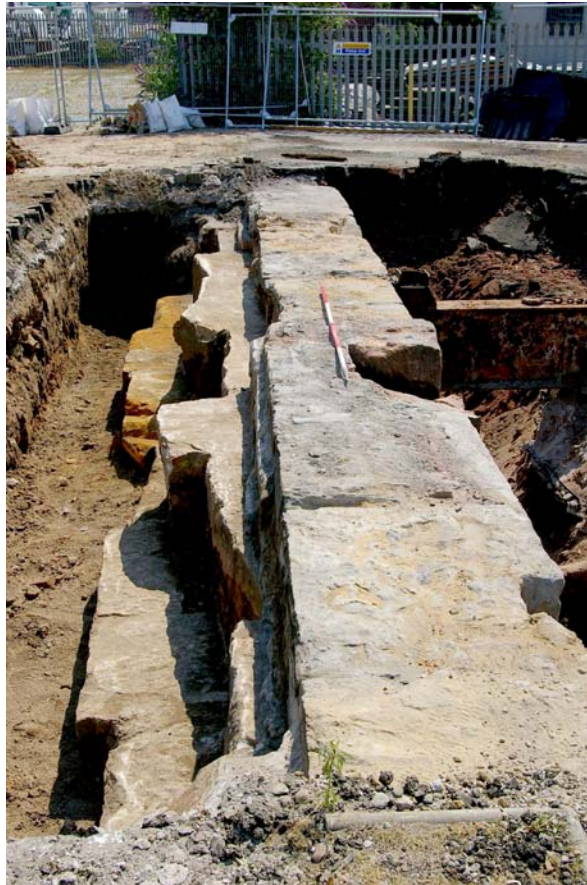
- 4.2.14 Overlying the dock infill **3111**, and the road surface **3119**, was a light grey reinforced concrete base, **3120**, which was laid to support structure **3121**, a series of very substantial iron beams orientated east/west (Plate 3). The beams formed a kind of prefabricated metal frame for a later GWR warehouse on the site of the infilled dock. Overlying this was **3122**, a heterogeneous backfill deposit consisting of loose brick demolition material mixed with mortar dust and a light brown sandy soil, which probably represents the demolition phase of the warehouses after they fell out of use.
- 4.2.15 Above this at the top of the sequence was the current carpark surface **3123**, which was made of black tarmac and aggregates.

Plate 3: View of Trench 1 Manchester Dock wall, *3109* and girders *3121*, looking south

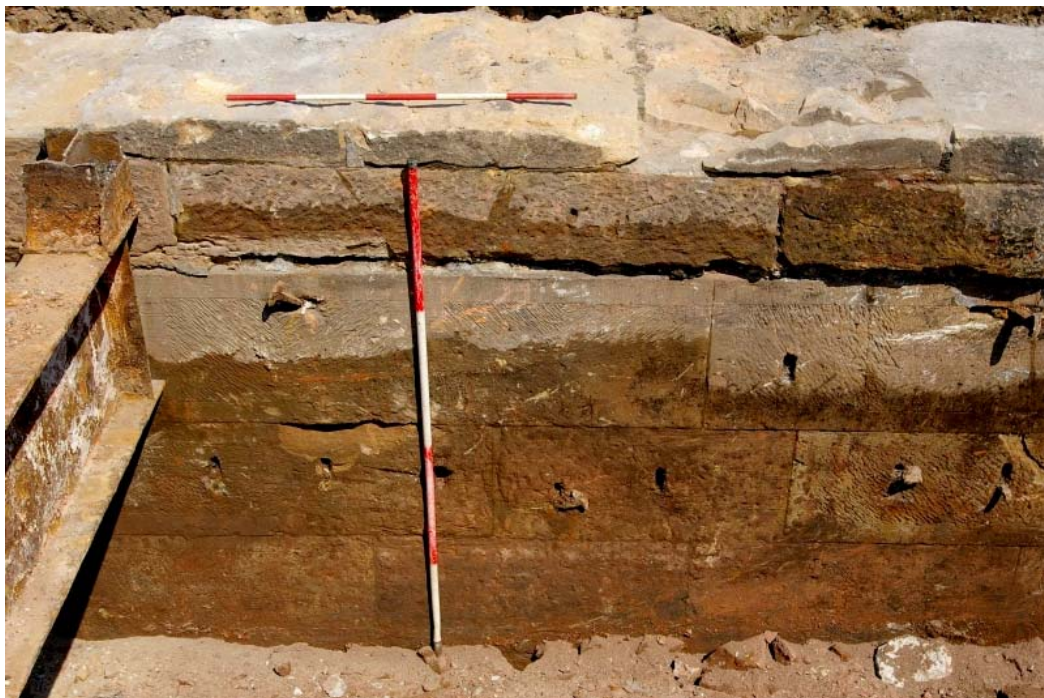
Plate 4: View of Trench 1 showing the front western face of Manchester Dock wall, *3109*, with part of the girder structure *3121*, looking east

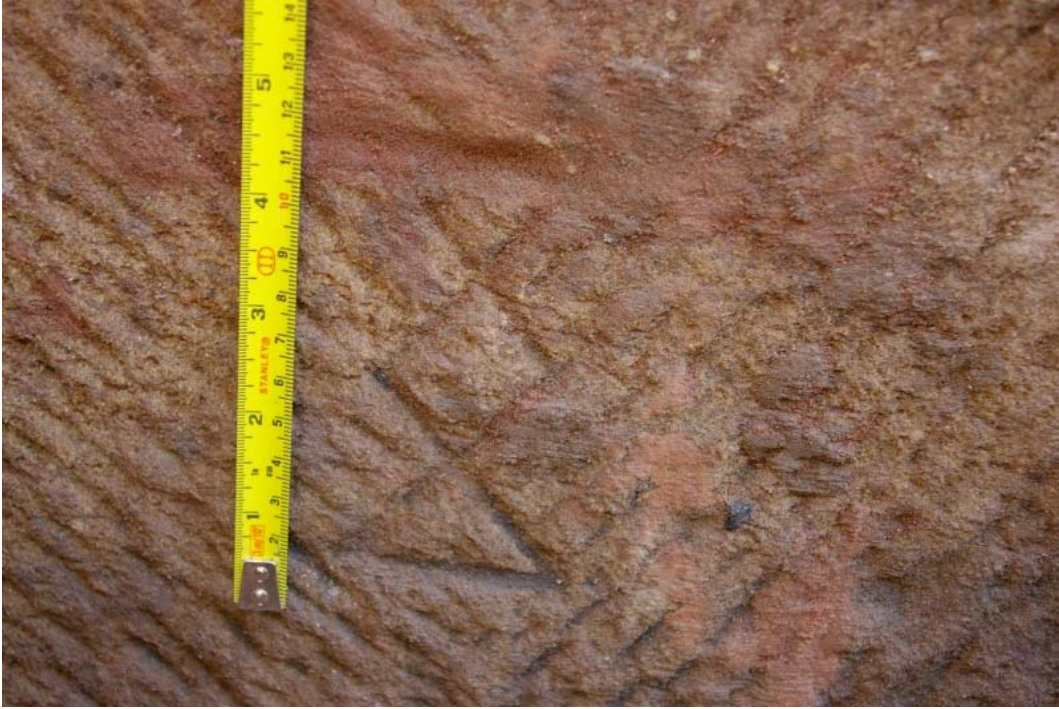
- 4.2.6 The west-facing elevation of the Manchester dock wall also exhibits numerous mason marks (Fig 18; Plate 5), of which four were observed during the course of recording. All were simple geometric shapes which would have been specific to each mason; the fact that there were four individual marks indicate that at least four masons worked the stone blocks that made up the Manchester Dock wall at this point.

Plate 5: View of Trench 1 showing a close up of a mason's mark on the western face of Manchester Dock wall, **3109**, looking east

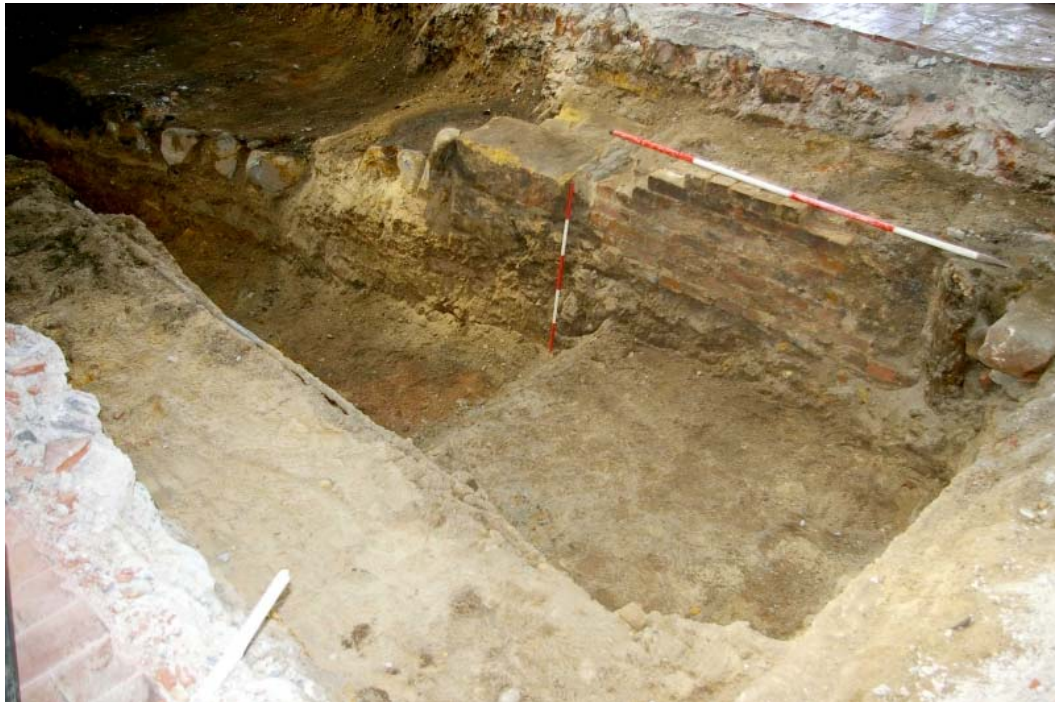
Plate 6: View of Trench 3A showing the western section, including contexts, **3208** cobbles, **3211** yellow sandstone wall and **3213** red brick wall, looking south-west

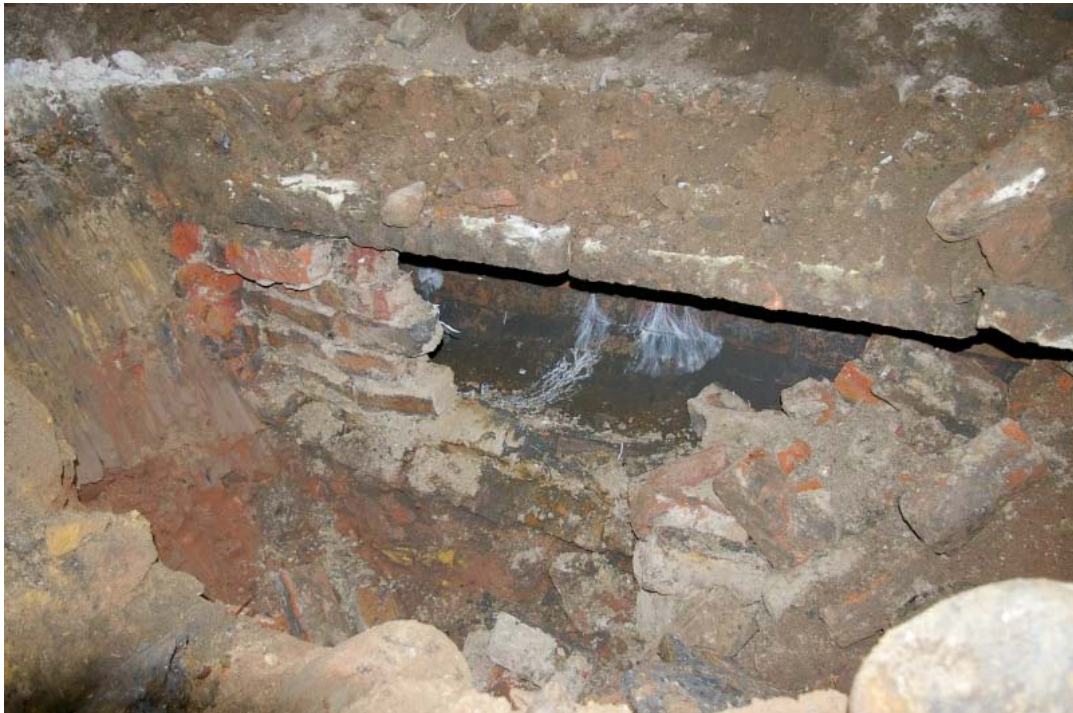
Plate 8: View of Trench 3A showing the culvert located in the sondage at the south end of the trench, looking south-east

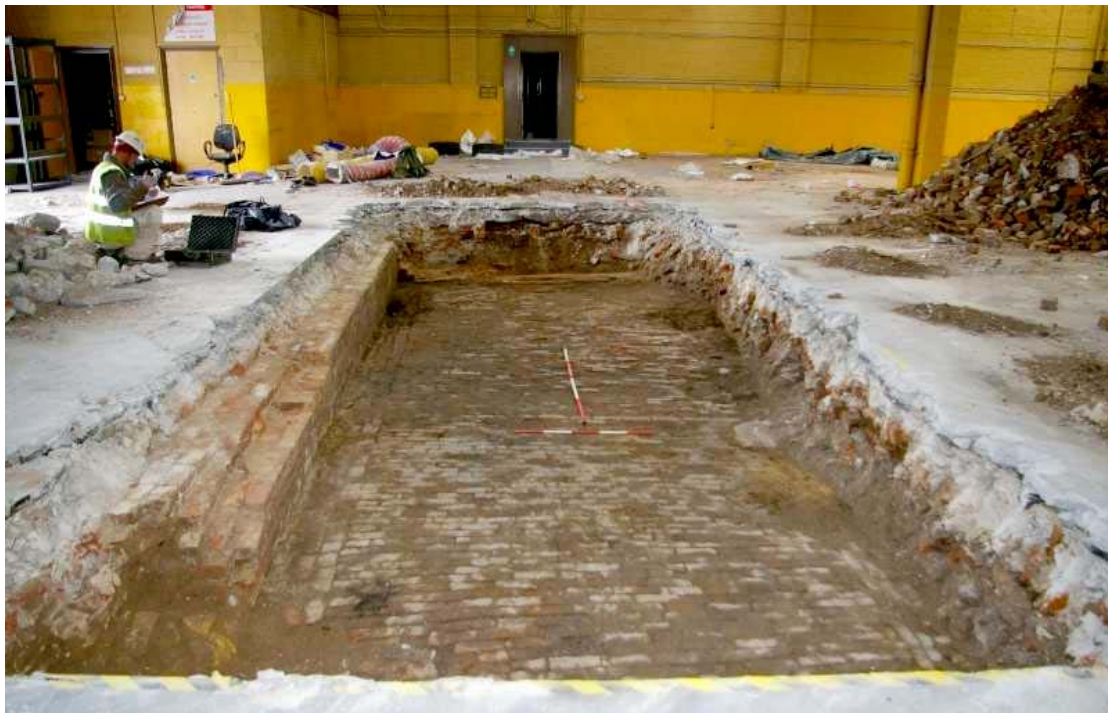
- 4.4.6 Butting walls **3234 / 3237** was an extensive red brick floor surface, **3235** (Plate 10), made of alternating regular patterns of header and stretcher bricks which were set into the underlying deposits without a bond or clearly defined bedding layer. This floor surface respects walls **3234 / 3237** and was therefore contemporary with them although constructed immediately after. These various elements formed part of the same warehouse structure, which was contemporary with the Manchester Dock. This warehouse floor surface had clearly suffered a great deal of wear and tear and the bordered brick edges of the floor had been replaced in section using timber material, **3236** and **3238**, which were possibly recycled railway sleepers or stays from the dock itself.

Plate 10: View of Trench 3B showing brick floor 3235 and wall 3234, looking north

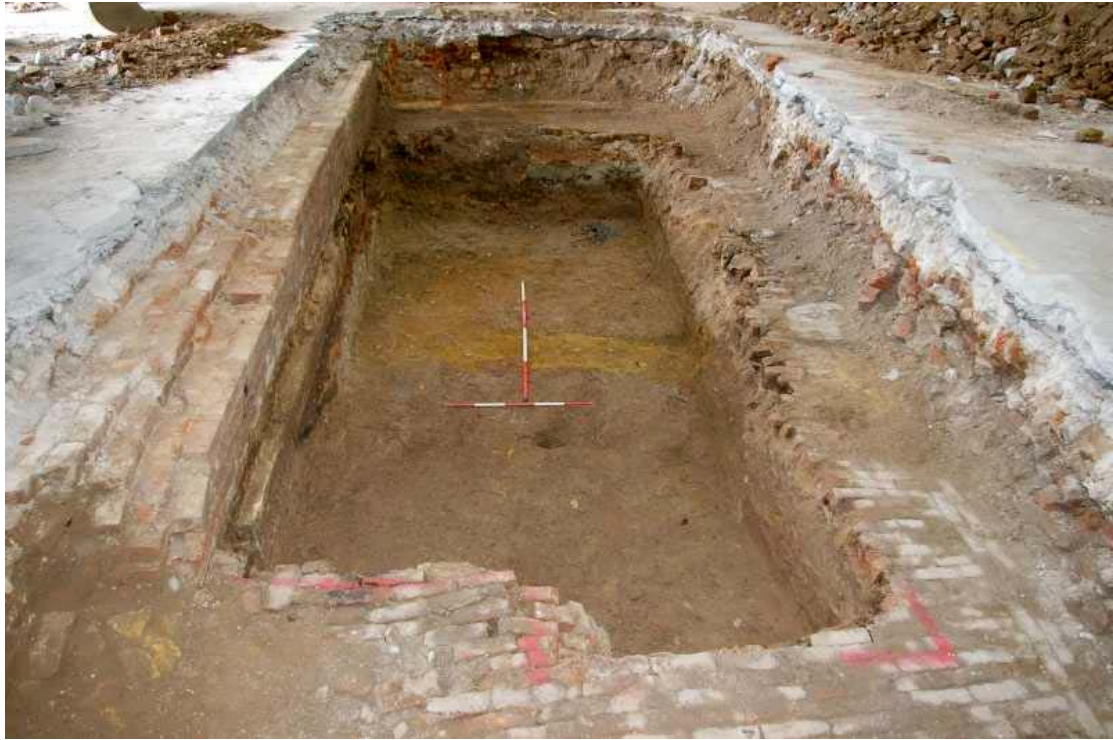
- 4.4.2 The trench contained numerous made ground deposits including; **3250**, a uniform clay deposit observed at the base of the trench (Plate 11), which appears to be one of a series of tip lines and indicates backfilling of the Mersey as part of the ground reclamation. Contemporary with this deposit was a reddish brown clayey deposit, **3247**, and a deposit of crushed homogeneous sterile, yellow sandstone, **3248** (revealed in a small sondage); both also deposited as part of the land reclamation. Overlying these deposits was a mid-yellowish-brown sand layer, **3246**, that was extensive in area and 0.25m thick and represents the uppermost levelling layer in the sequence.

Plate 11: View of Trench 3B showing deposits **3249** and **3250** below brick floor **3235**, looking north

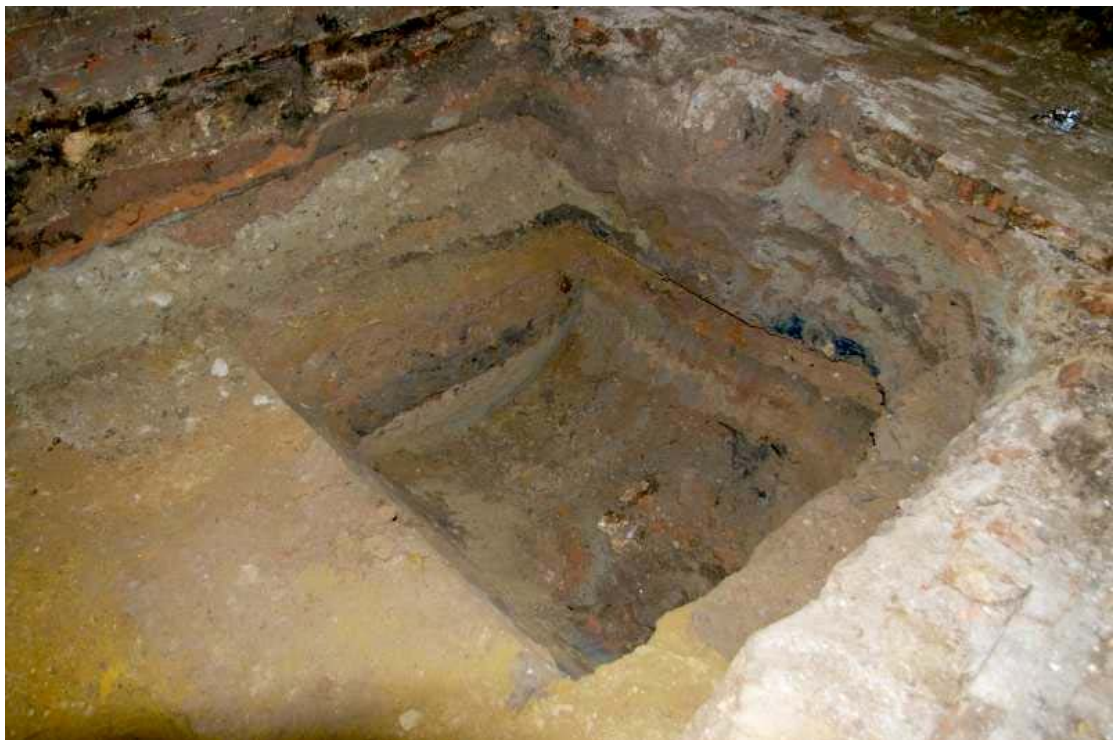
Plate 12: View of Trench 3B showing the makeup and levelling deposits seen in the sondage dug in the southern end of the trench, looking south-east

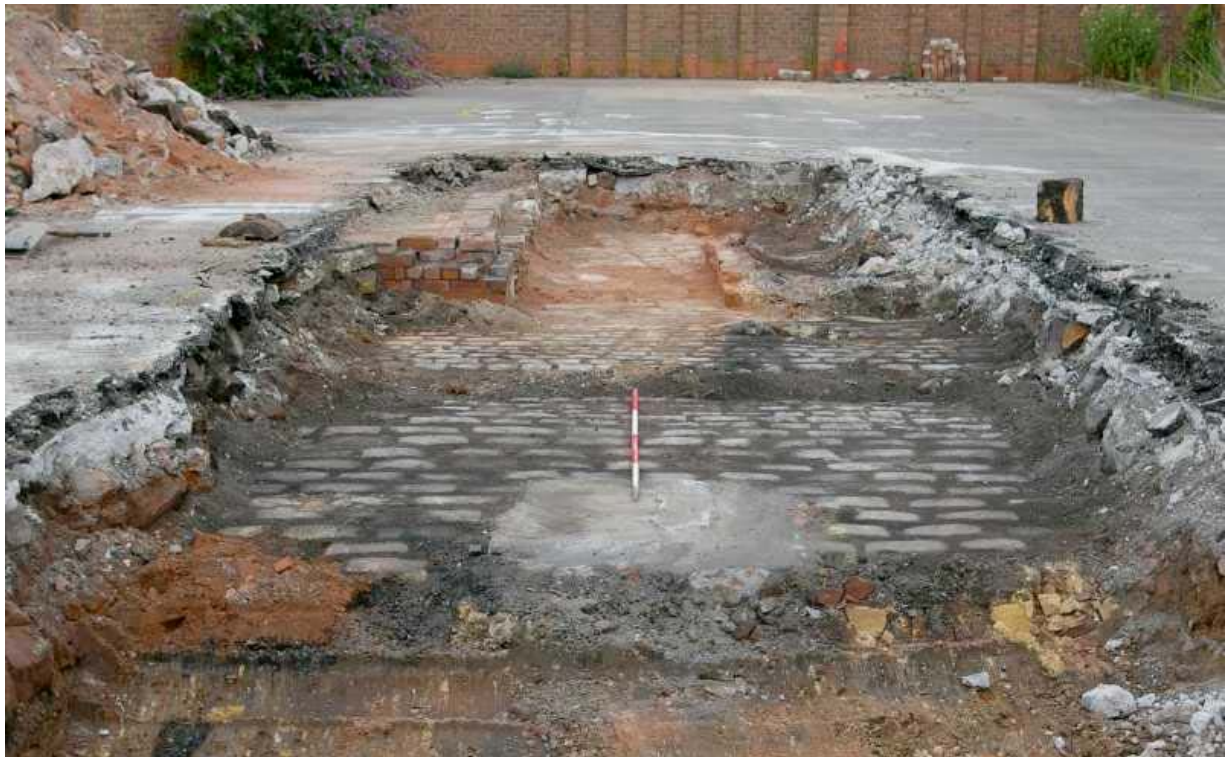
Plate 14: View of Trench 4 showing cobble surface 3202, looking north

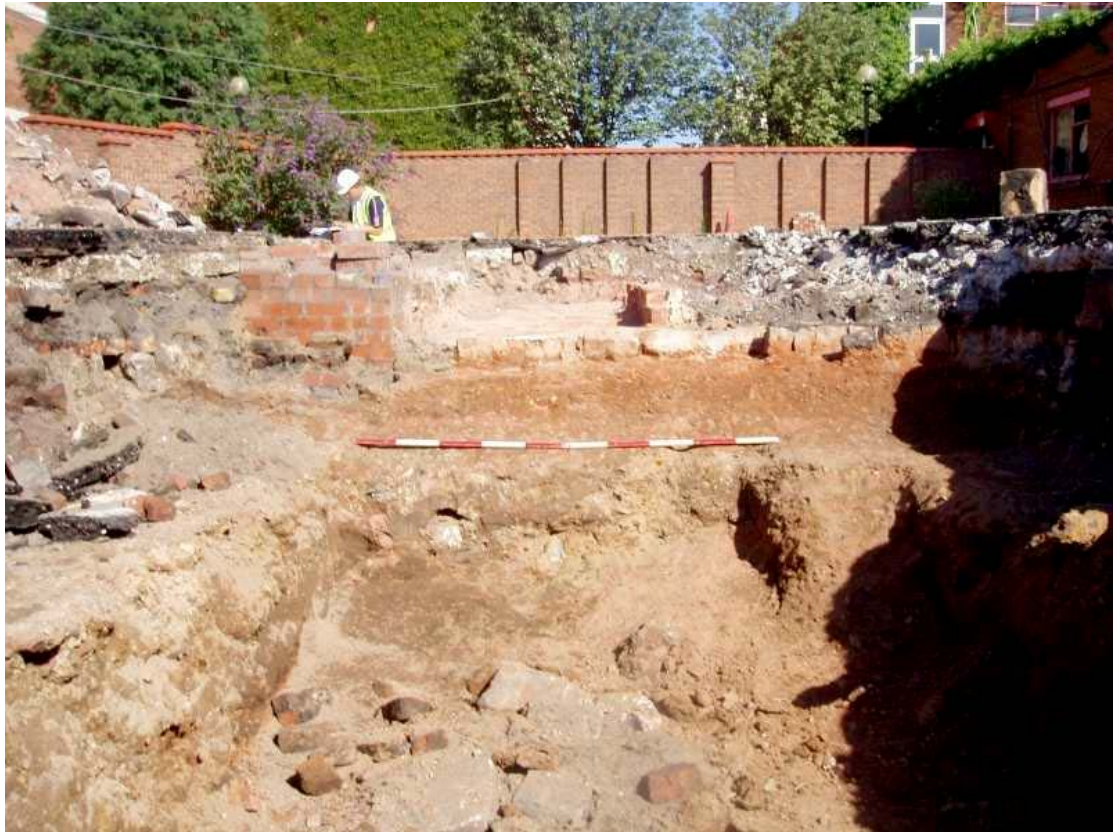
Plate 15: View of Trench 4 showing deposits below cobble surface **3202**, looking north

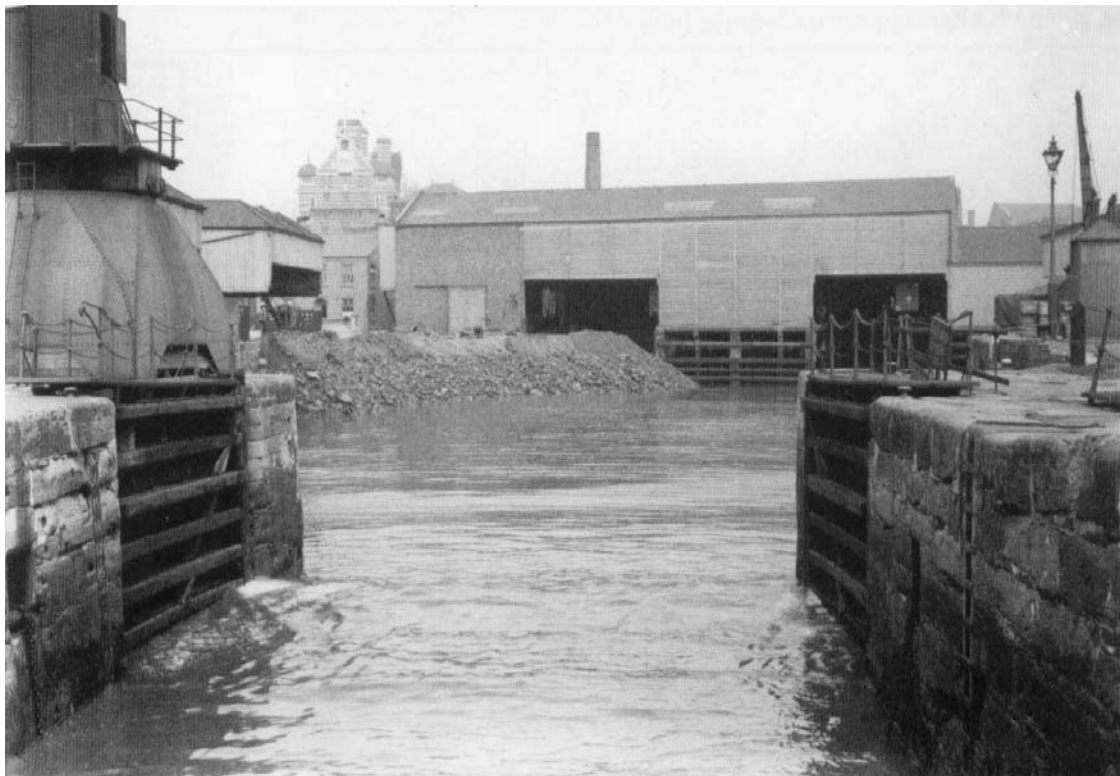
Plate 16: View of Manchester Dock, with overhanging warehouse in 1929, looking east from the dock entrance
