MORECAMBE COMMUNITY CENTRE, MORECAMBE, LANCASHIRE

Archaeological Building Investigation

Oxford Archaeology North

September 2006

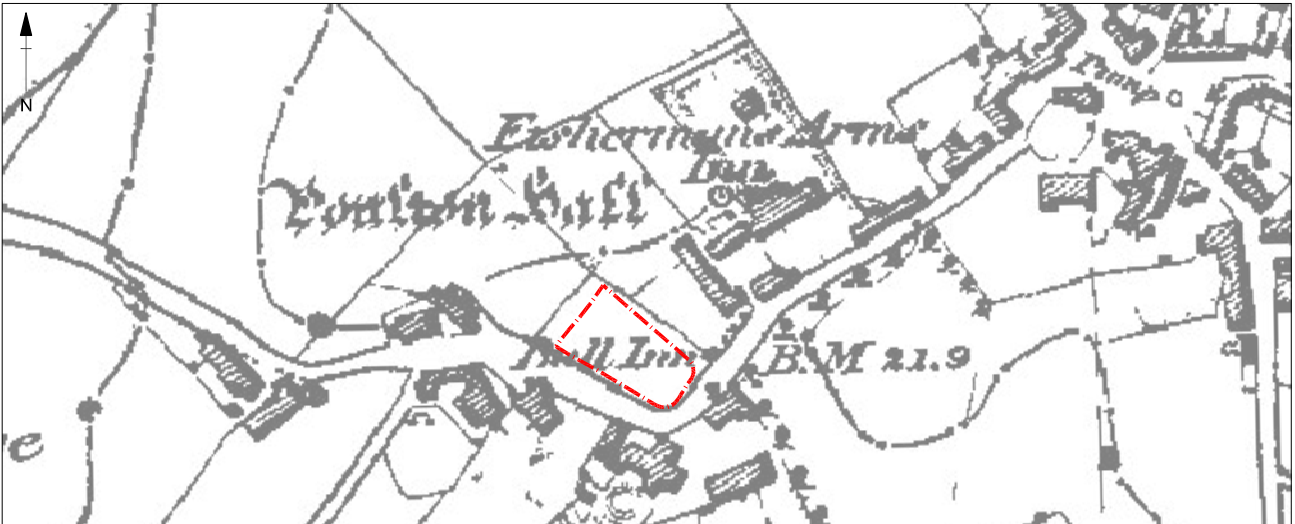
Figure 2: Extract from Ordnance Survey First Edition map, 1848 (1:10,560)

3.2.1 *Ordnance Survey 1848*: the area, known as Poulton Hall, is sparsely built-up, whilst the site of the Community Centre is little more than a bare plot. Main Street and part of Clarence Street are already depicted, but the rows of terrace housing to the immediate north, east and west are not yet built.

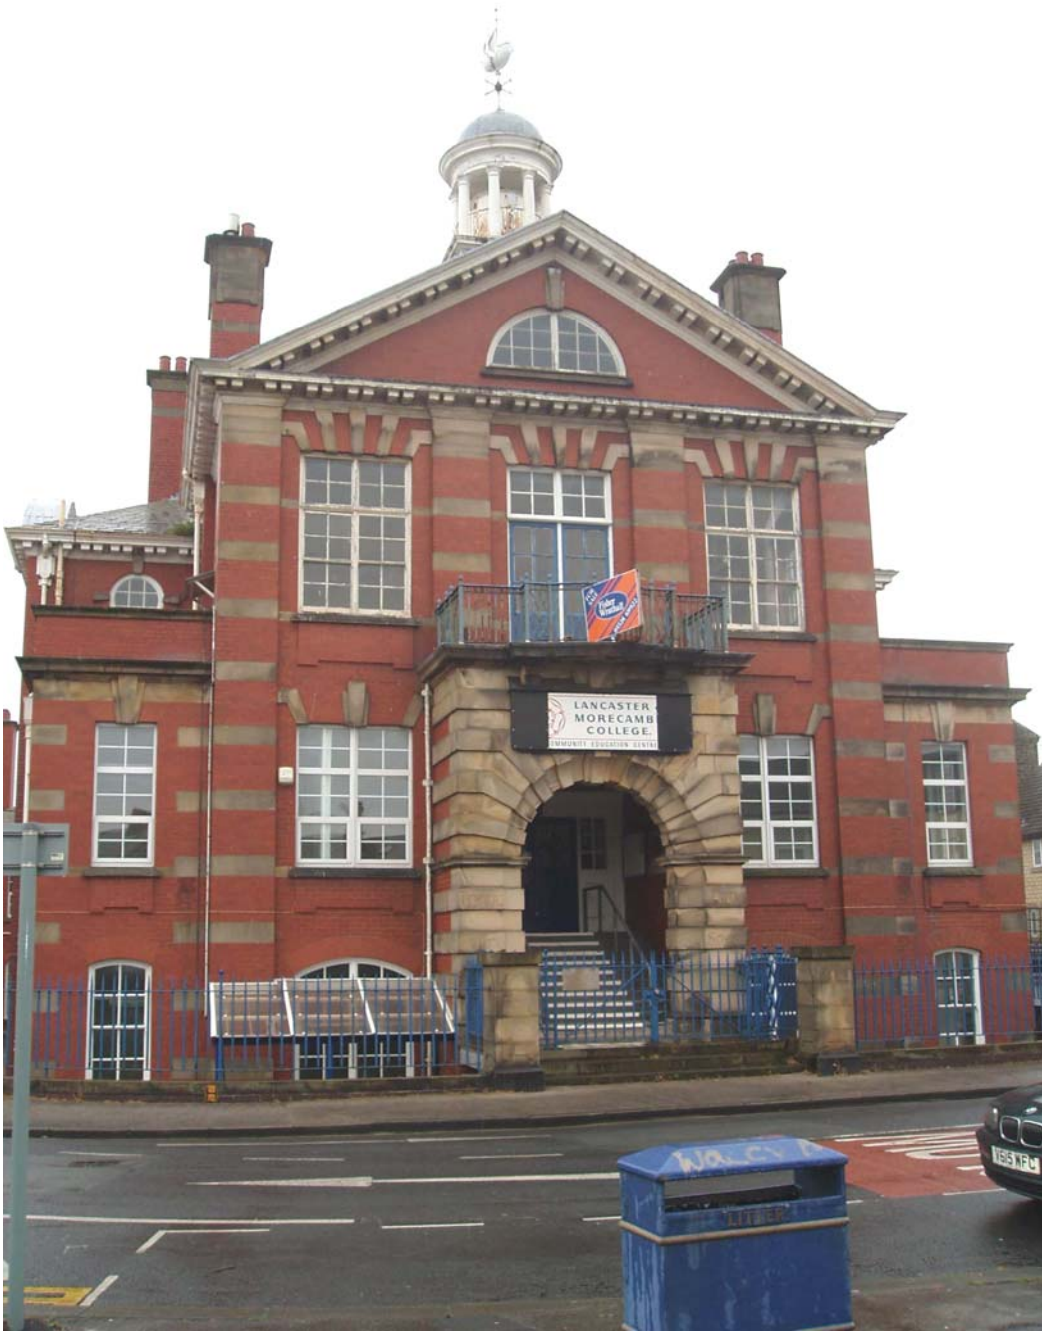
- 4.2.3 The main feature of the frontage is the triangular pediment, which features paired modillions and an unpectinated bracket (Plate 1). Additionally, there is a segmental pediment on the west elevation (Plate 2), and an open-bed segmental pediment on the east elevation (Plate 4). Both of these share the characteristics of their counterpart on the front facade. In contrast, at the rear of the building there are two triangular open-bed pediments (Plate 3), in which the paired modillions are absent. This discrepancy in decoration upon the pediments is also reflected in the cornice. To the front of the building, the cornice has paired modillions and a plain bracket, whilst at the rear of the building the cornice is a plain *cyma recta* moulding.

Plate 1: North-facing-view of the front (south) elevation of the Community Education Centre

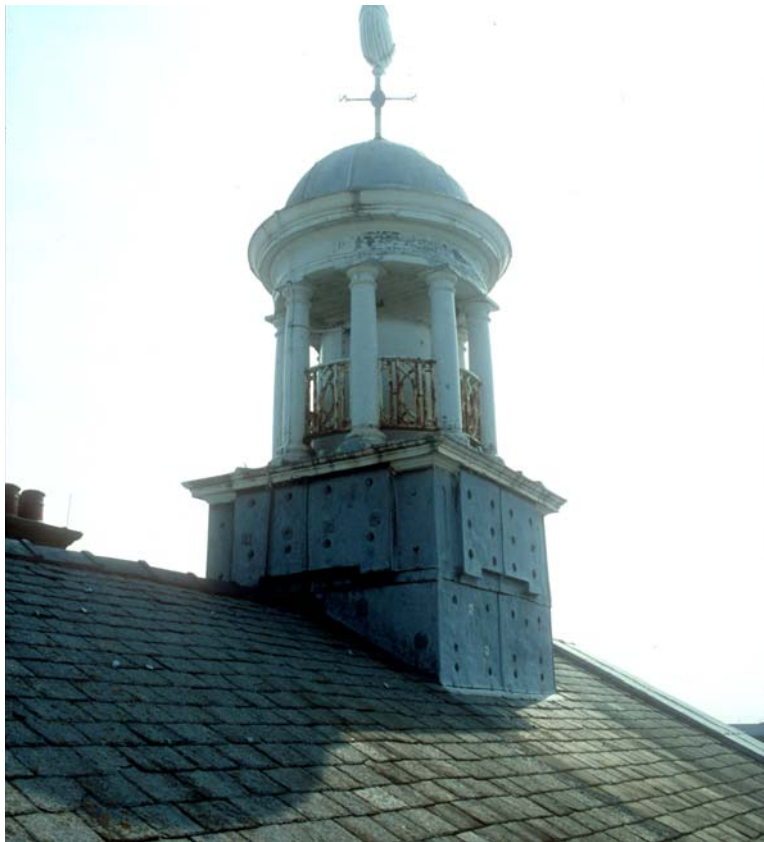
Plate 5: The cupola on the roof of the front façade

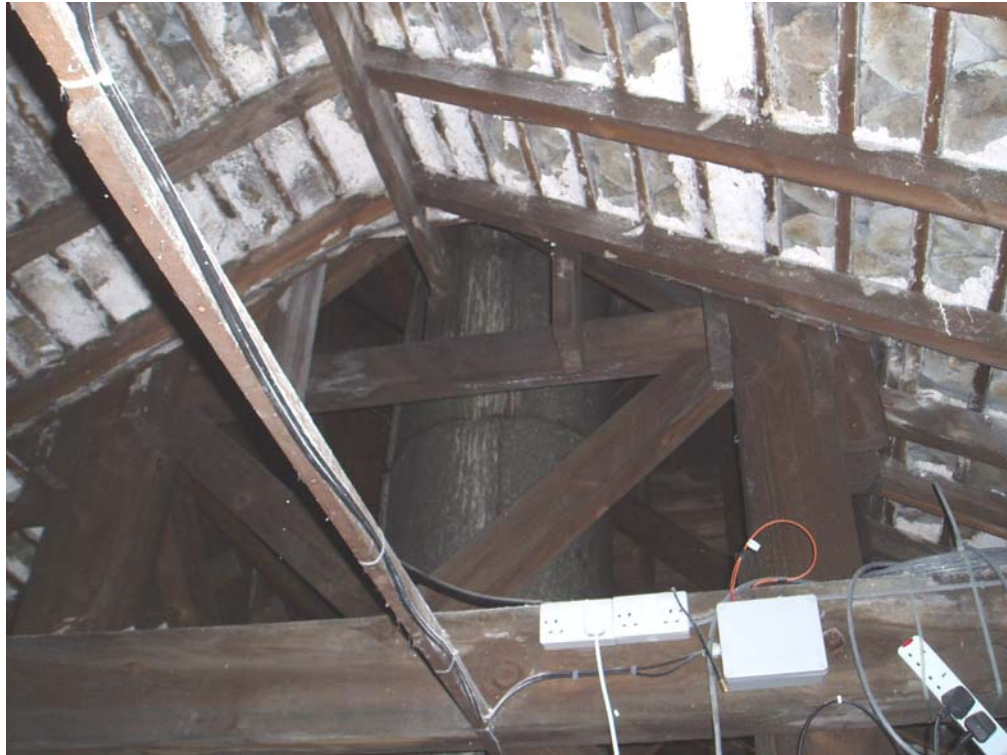
Plate 6: The central ventilation shaft of the cupola, within the roof space of the second floor

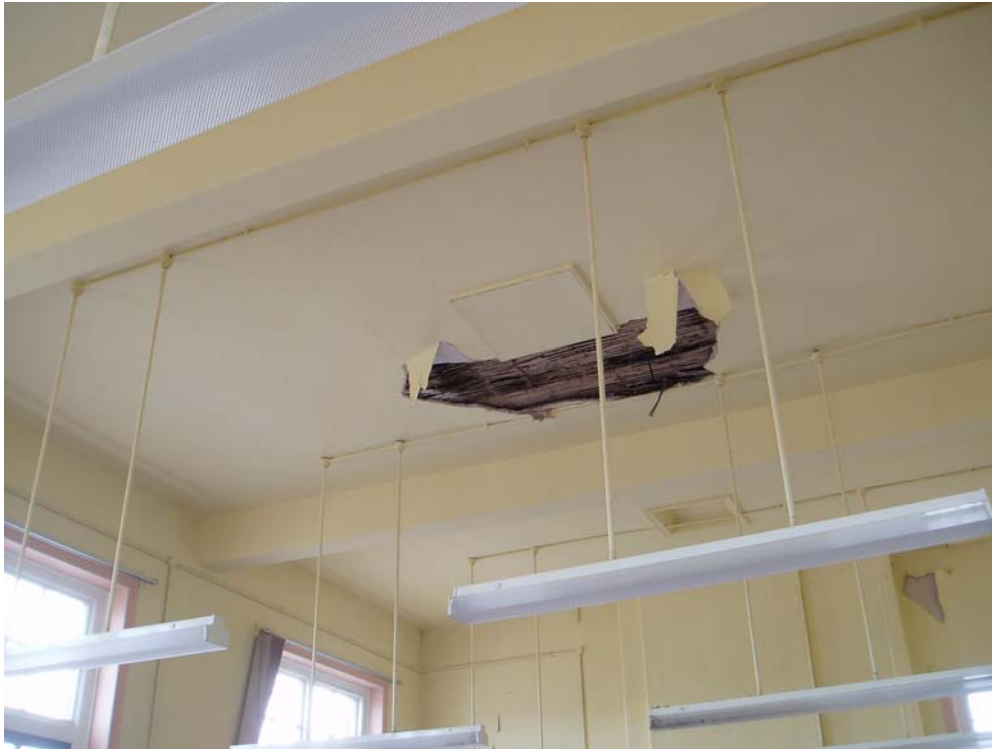
- 4.3.2 The ceilings on each floor are for the most part painted plaster, which by the evidence of room *F1* is likely to be the original lath and plaster finish (Plate 8). There are, however, exceptions to this rule, namely the rooms to the rear (north) of the first floor (*F8* and *F12*), which have modern, suspended ceilings of compressed fibreboard (Plate 9). These include a distinctive slope on their eastern side, in order to accommodate the full height of the sash windows. In each of the other rooms, in which the lath and plaster ceiling has been retained, the original beams are visible. These would appear to be covered in lath and plaster, but are obviously chamfered and run along a north to south axis.

Plate 8: The lath and plaster ceiling in room *F1* on the first floor

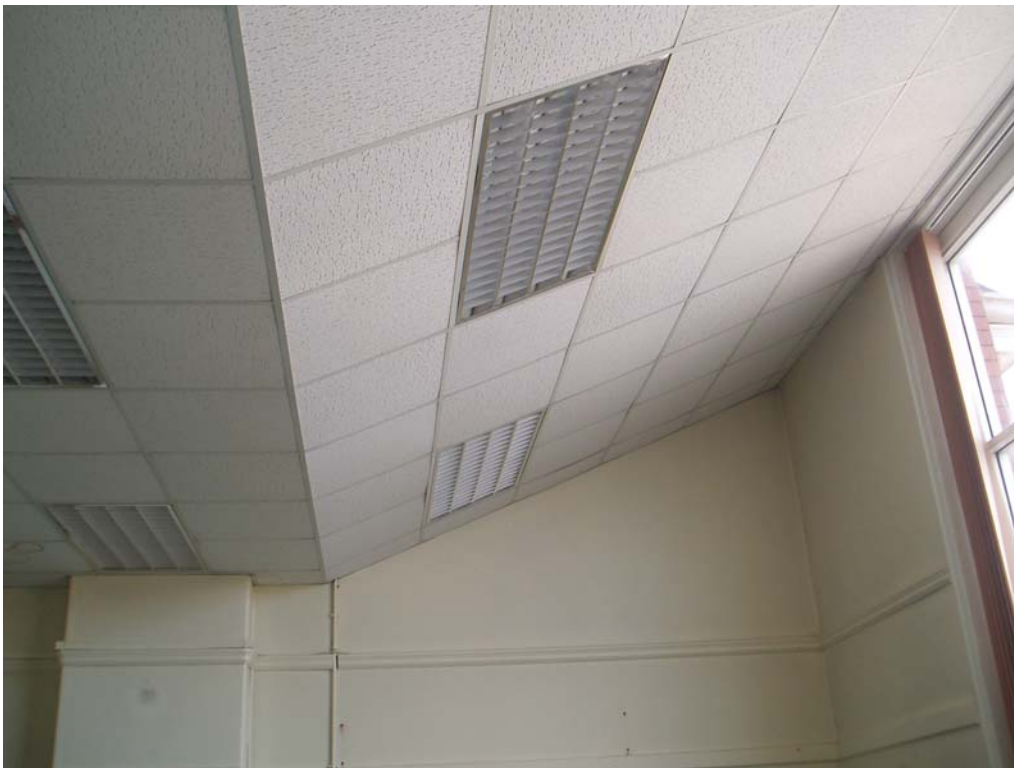
Plate 9: The modern suspended ceiling as seen in rooms *F8* and *F12* on the first floor

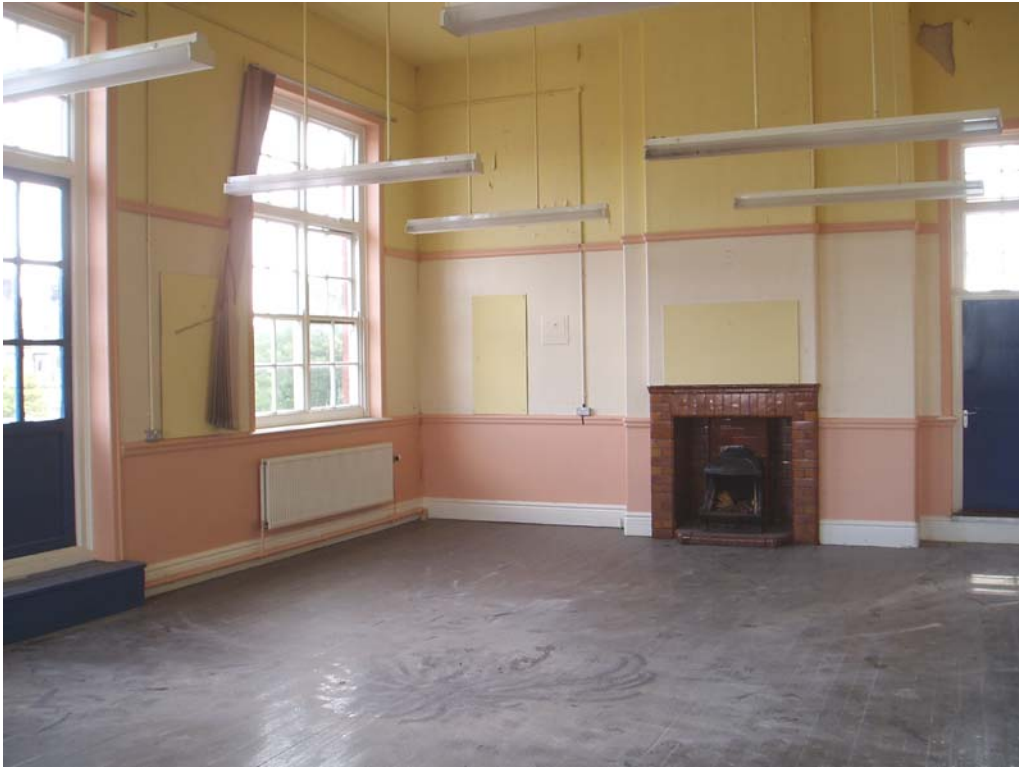
- 4.3.3 The main (structural) walls of the interior are modestly decorated, being plain, painted plaster, with skirting boards, dado and picture rails (Plate 10). The kitchen on the ground floor (*G17*) and most of the rooms in the basement, with the exception of rooms *L18* and *L19*, have exposed brick walls in an English Garden Wall bond (three to one). In some instances, particularly those rooms on the ground floor, the walls beneath the dado rail have been decorated with square and rectangular ceramic tiles in pale yellow and cream, which have been invariably painted to match the present colour scheme of the room. Similarly, the central corridor of each floor retains this functional theme. On the lower ground floor, the corridor is decorated as the main rooms, whilst on the ground and first floors, the base of the corridor walls feature the same square and rectangular ceramic tiles noted above (Plate 11), which are topped by a matching moulded dado. Above this rail, there are large mullioned casements, which include top-hung ventilators and timber sills with roll-moulded edges. Between the windows of each floor, there is a series of decorative boxes, that each have a flat control damper, shaped like a fist, which would appear to be fresh air inlets connected to the ventilation outlets on the roof (Plate 12).

Plate 10: General view of the decoration in *FI* on the first floor

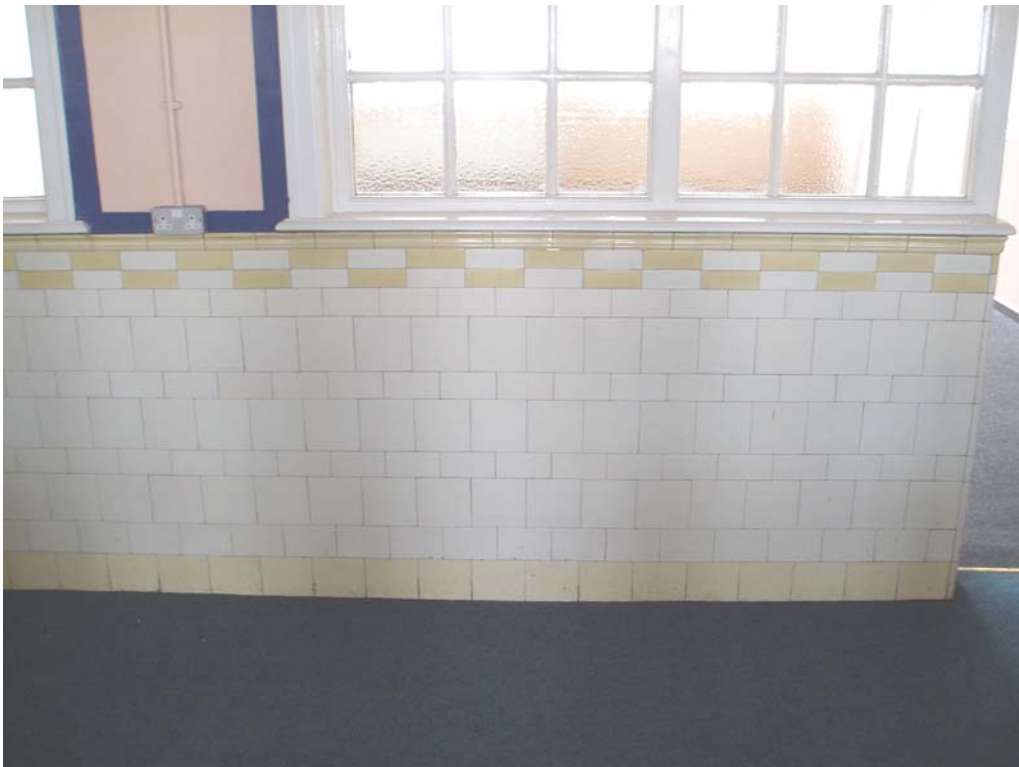
Plate 11: Detail of the tile decoration on the ground and first floors

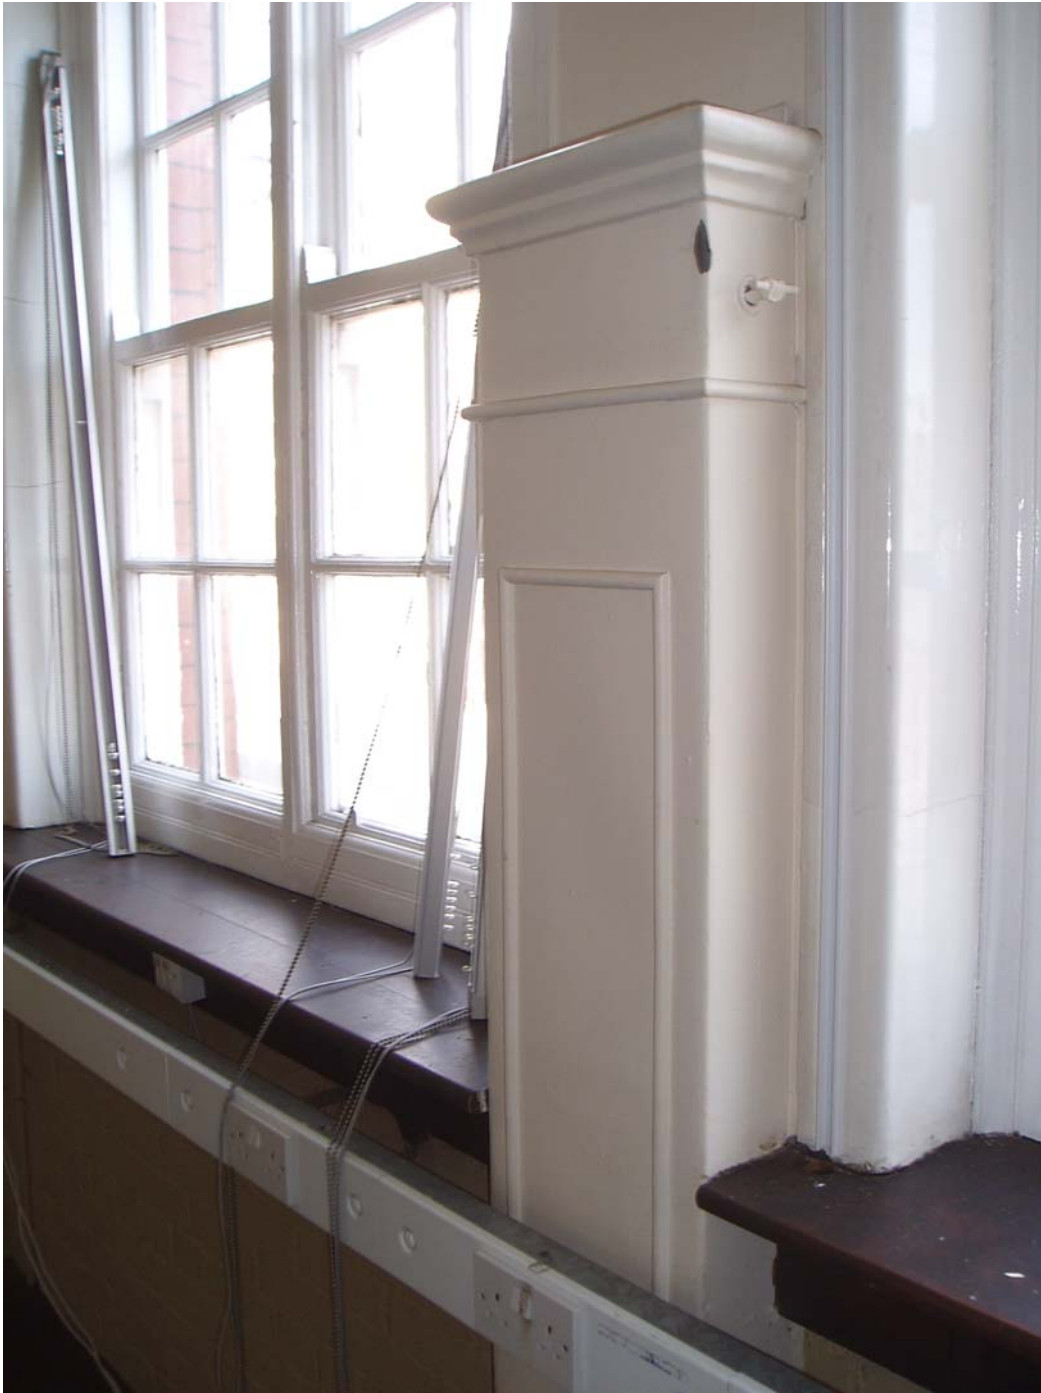
Plate 12: Detail of the fresh air inlets leading to the ventilation system in the roof

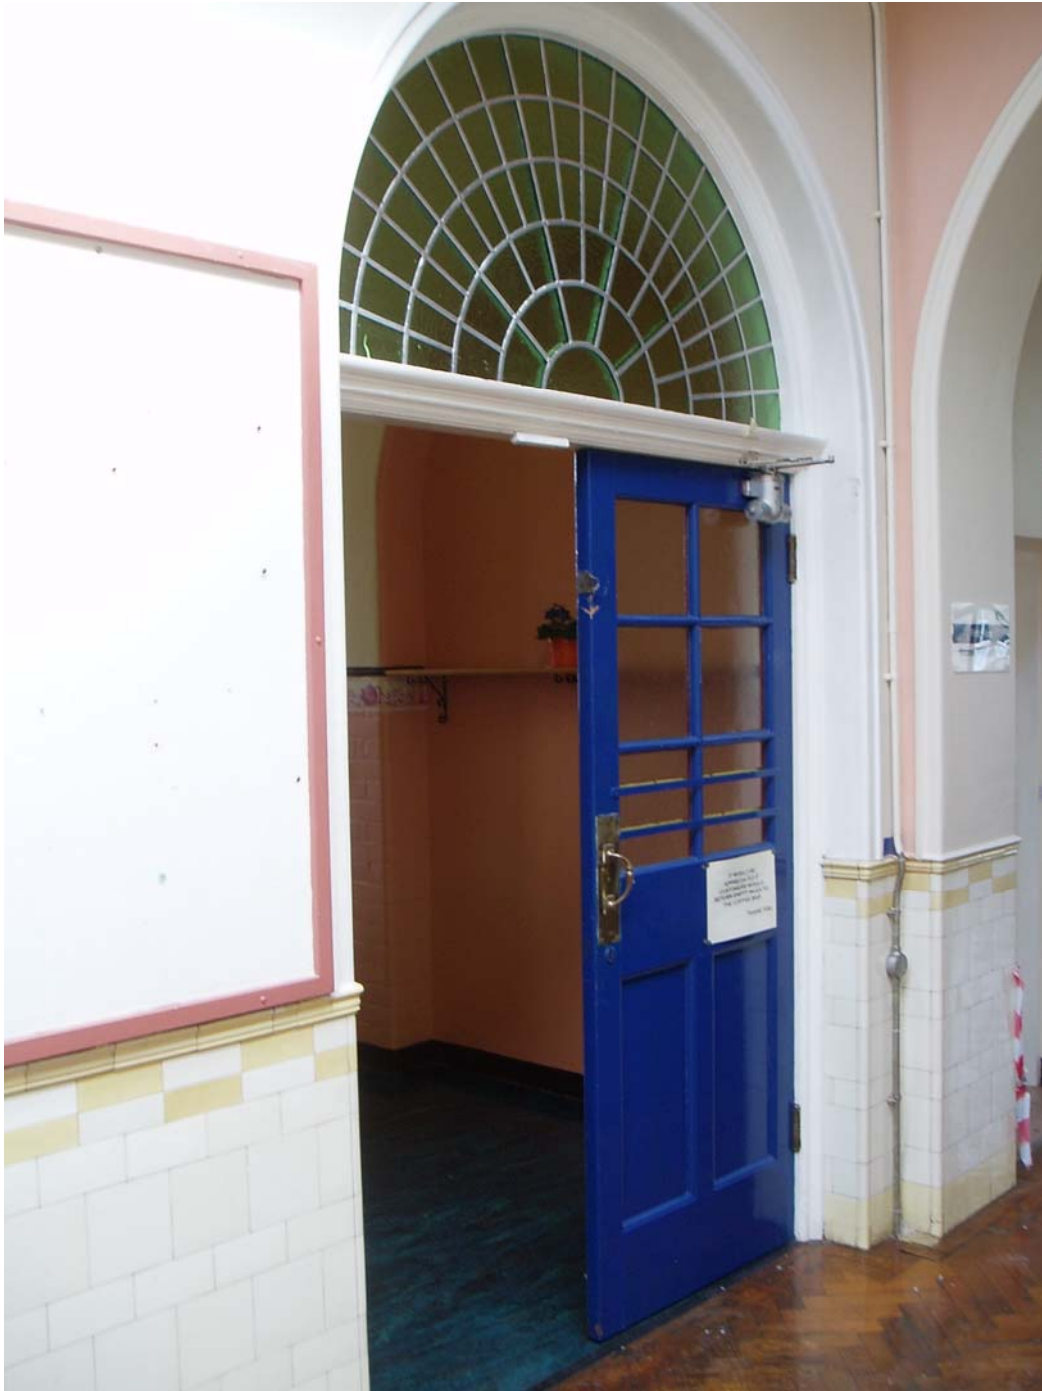
Plate 13: Detail of the doors of room *F7* featuring the sunburst fanlight

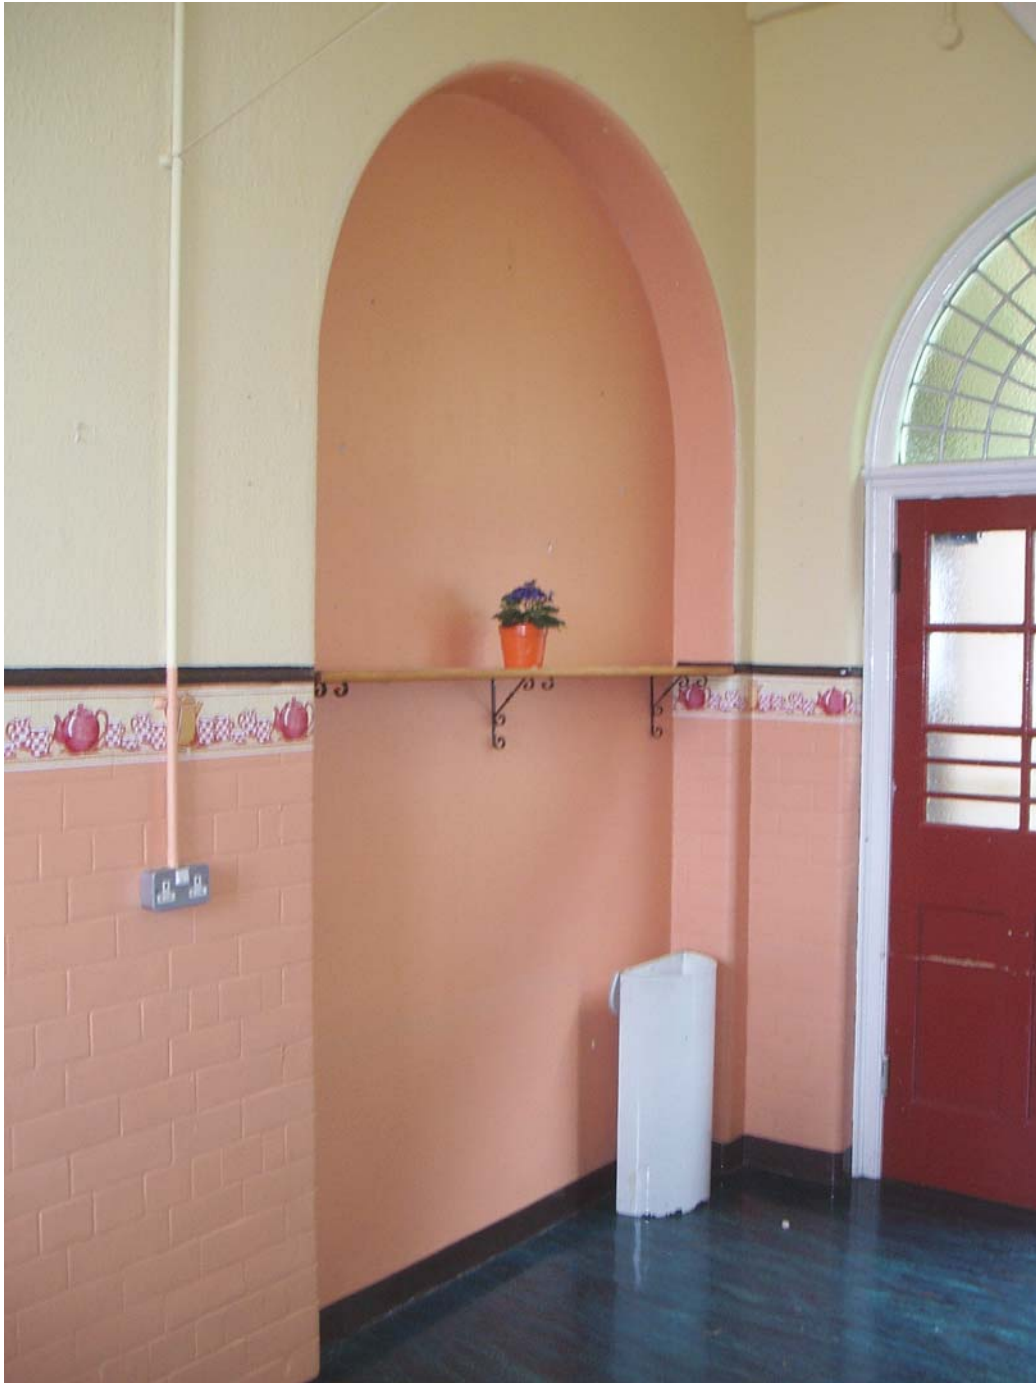
- 4.3.5 The majority of the doors on the corridors are glass-panelled with up to nine lights, but there are notable exceptions. On the ground floor, the doors of the front entrance and those to the main corridor both have substantial hemispherical fanlights with leaded glass in a sunburst design, which is repeated on the first floor for the doors of rooms *F1* and *F7* (Plate 13), as well as on the now empty embrasure at the north end of the corridor. In addition, a variant of this hemispherical window, this time featuring vertical glazing bars sits to the left of the door to the room *F5a* (Plate 14), and is almost certainly, indicative of an earlier blocked doorway. The doors from the staircase have a similar fanlight and chamfered glass in a lozenge design (*F4*). Within room *F7*, there is an arch-shaped alcove adjacent to the main entrance. It is probably an early blocked archway, which has been made to look like an alcove following its infilling (Plate 15).

Plate 15: The blocked doorway in room *F7*

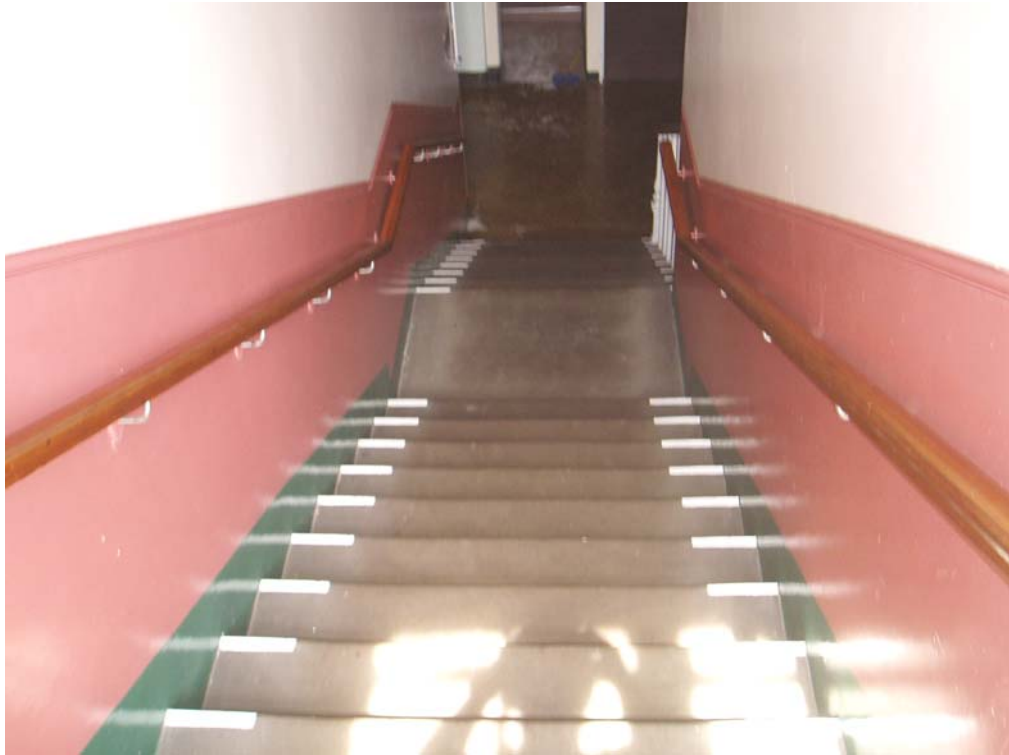
Plate 16: The stairs leading down to the lower ground floor

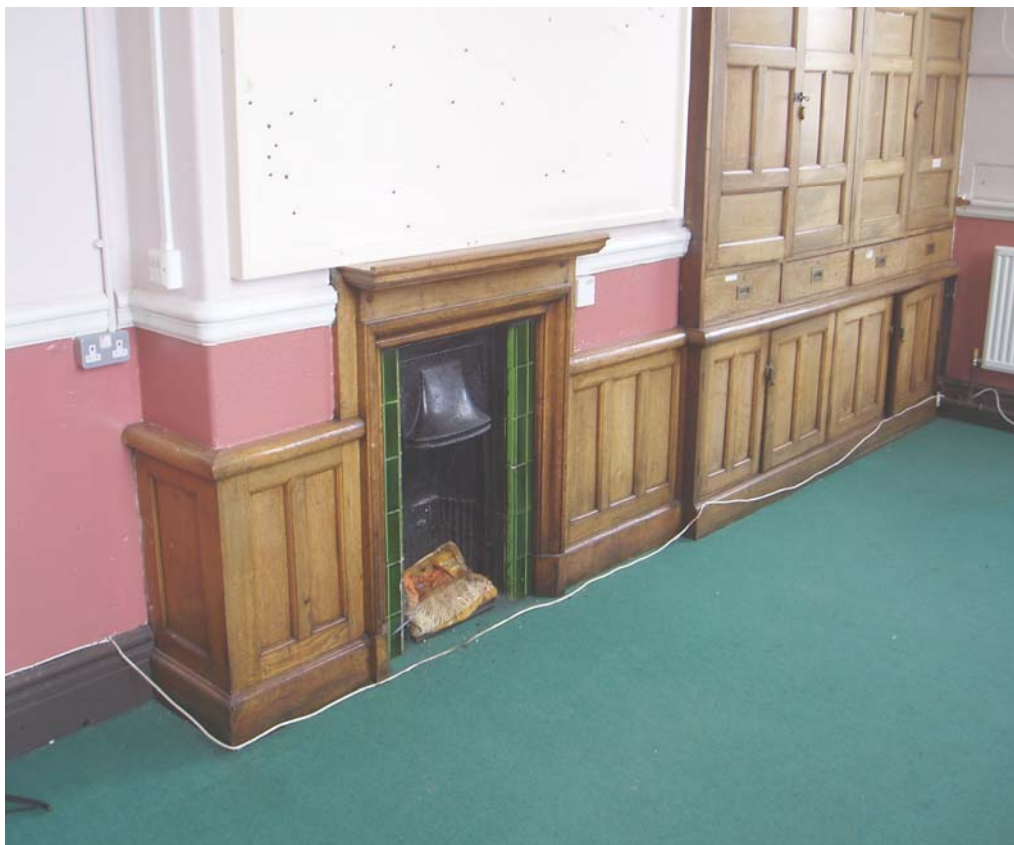
- 4.3.7 The fireplaces within the building typify the Edwardian period and all would appear to be original. In room *G2*, there is a small, cast-iron fireplace, which has a panelled timber surround with a bolection architrave, a projecting *cyma recta* mantel, and glazed tile cheeks (Plate 17). Within room *F1*, there is a further cast-iron fireplace, which features a glazed brick surround with matching moulded mantel and hearth (Plate 18). In the Kitchen on the ground floor (*L17*), there are the remains of two further fireplaces, with only the surrounds still surviving. On the east elevation, there is a brick surround of English Garden Wall (3 to 1) with a flat voussoir head, whilst on the west elevation, there is a stone mantel supported by a bolection console at either end. The embrasures have been filled by a sink and fitted cupboards respectively.

Plate 17: The fireplace in room G2

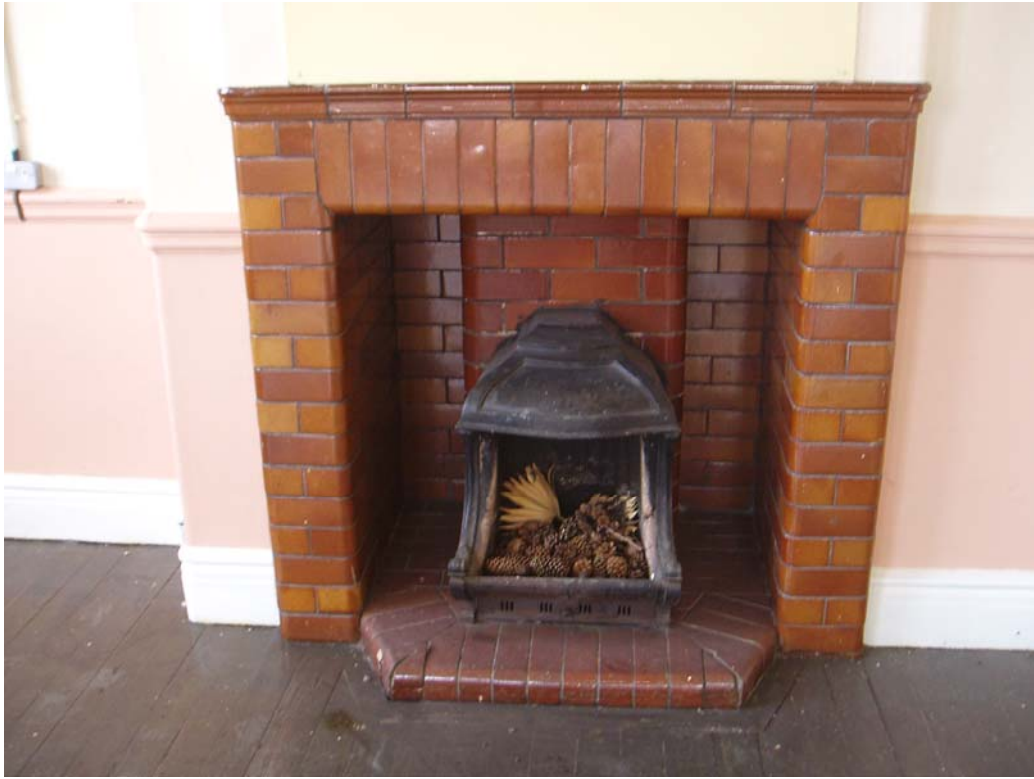
Plate 18: The fireplace in room *FI*
