# Gainsborough Building Bath

## Archaeological Evaluation Report

Issue N<sup>o</sup>: 1  
OA Job N<sup>o</sup>: 2947  
NGR: ST7496 6460

The Proposed Gainsborough Thermal Spa Hotel, Beau Street, Bath  
***ADDENDUM TO AN ARCHAEOLOGICAL EVALUATION REPORT***

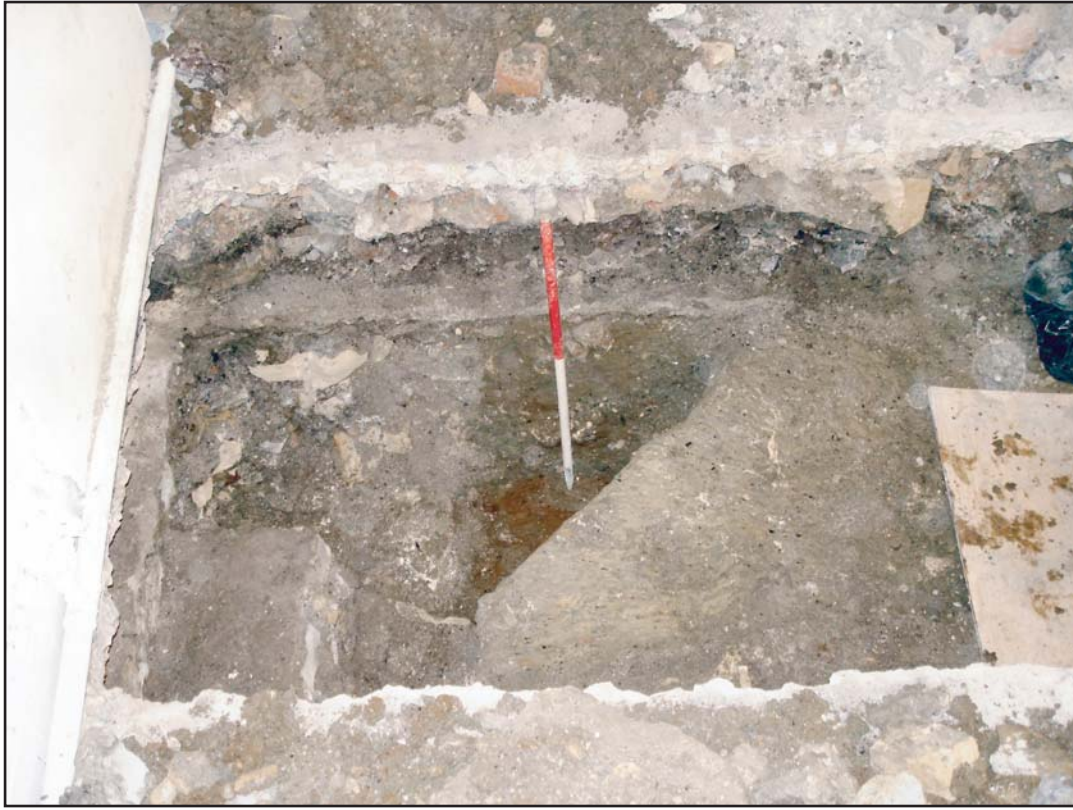
Plate 1: Trench 7 extension after excavation of 712 and partial removal of foundation 716, looking west

- 8.1.4 Cutting across everything at the southern end was a hard mortared rubble foundation, aligned roughly east-west, the same as the current building (Plate 1). This projected north of the internal wall line of the present building by as much as 0.80 m. It could not be proved to run under the wall more than a few centimetres as it obscured any wall face behind it, which it was not safe to cut into. It came to an end at a depth of 1.6 m below cellar floor.

- 8.1.5 It seems very likely that this footing is an earlier structure, perhaps the Bave house front wall, although it appears to either cut or be abutted by the other post-medieval footing 709, now thought to be an internal wall of the Bave house. It has, therefore, not been possible to ascertain the depth of the wall footing of the current building nor the depth of the archaeological deposits, except to say that the latter extend from 0.6 m to at least 1.63 m below the cellar floor.

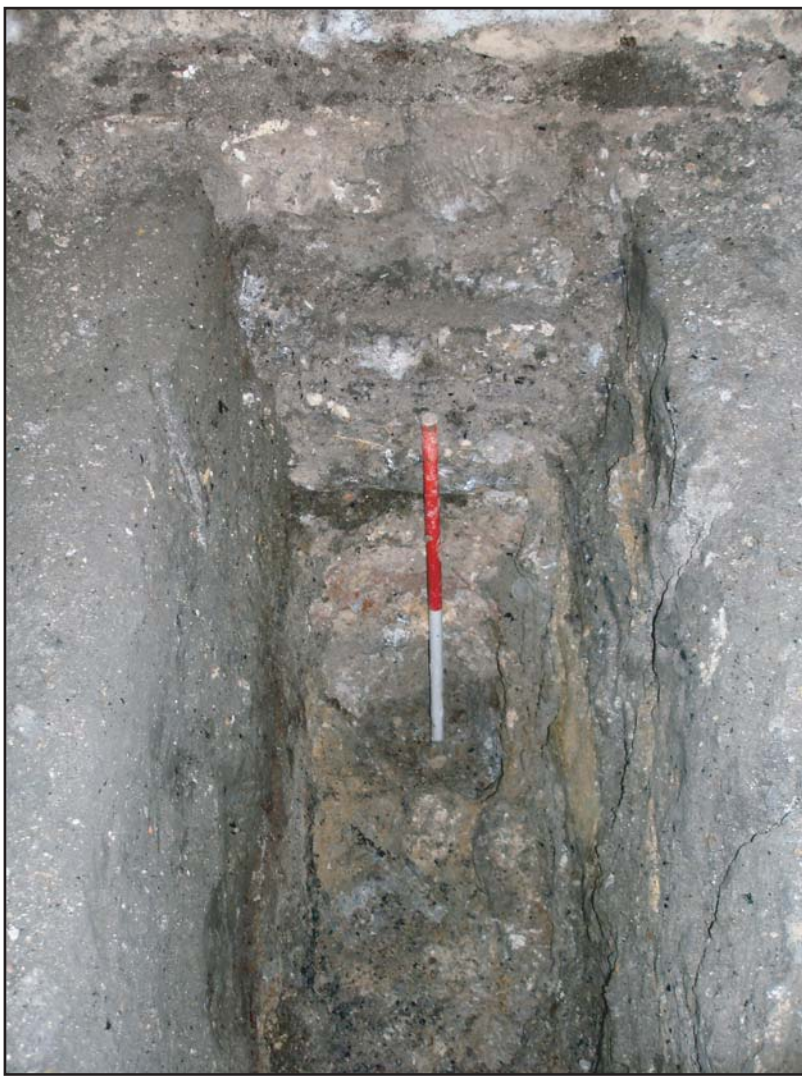
Plate 2: Trench 10, deep wall footings and adjacent deposits, looking north

- 8.2.1 In this area the same dark soils that were seen in the adjacent Trench 8. They were traced to a depth of 1.6 metres below the floor or 1.3 metres below the floor make-up (Plate 2). They seemed to be of medieval origin, although the upper level may well be post-medieval. Below 1.6 metres it appeared that the deposits were Roman, on the basis of sparse finds but also the character of the material, and its depth. The Roman deposit was at least 0.6 m and possibly 0.7 m thick but its base was not found.

- 8.2.2 The foundation of the Victorian wall was of coursed, roughly squared work down to 1.4 metres and below this, consisted of poured, not very coherent, weak mix with a very coarse aggregate with large voids. It too was not bottomed but could be seen to continue past 2.3 metres below the cellar floor.
