Bicester Community
Hospital
Kings End
Bicester
Oxfordshire

**Archaeological
Watching Brief Report**

Bicester Community Hospital, Kings End, Bicester, Oxfordshire

Archaeological Watching Brief Report

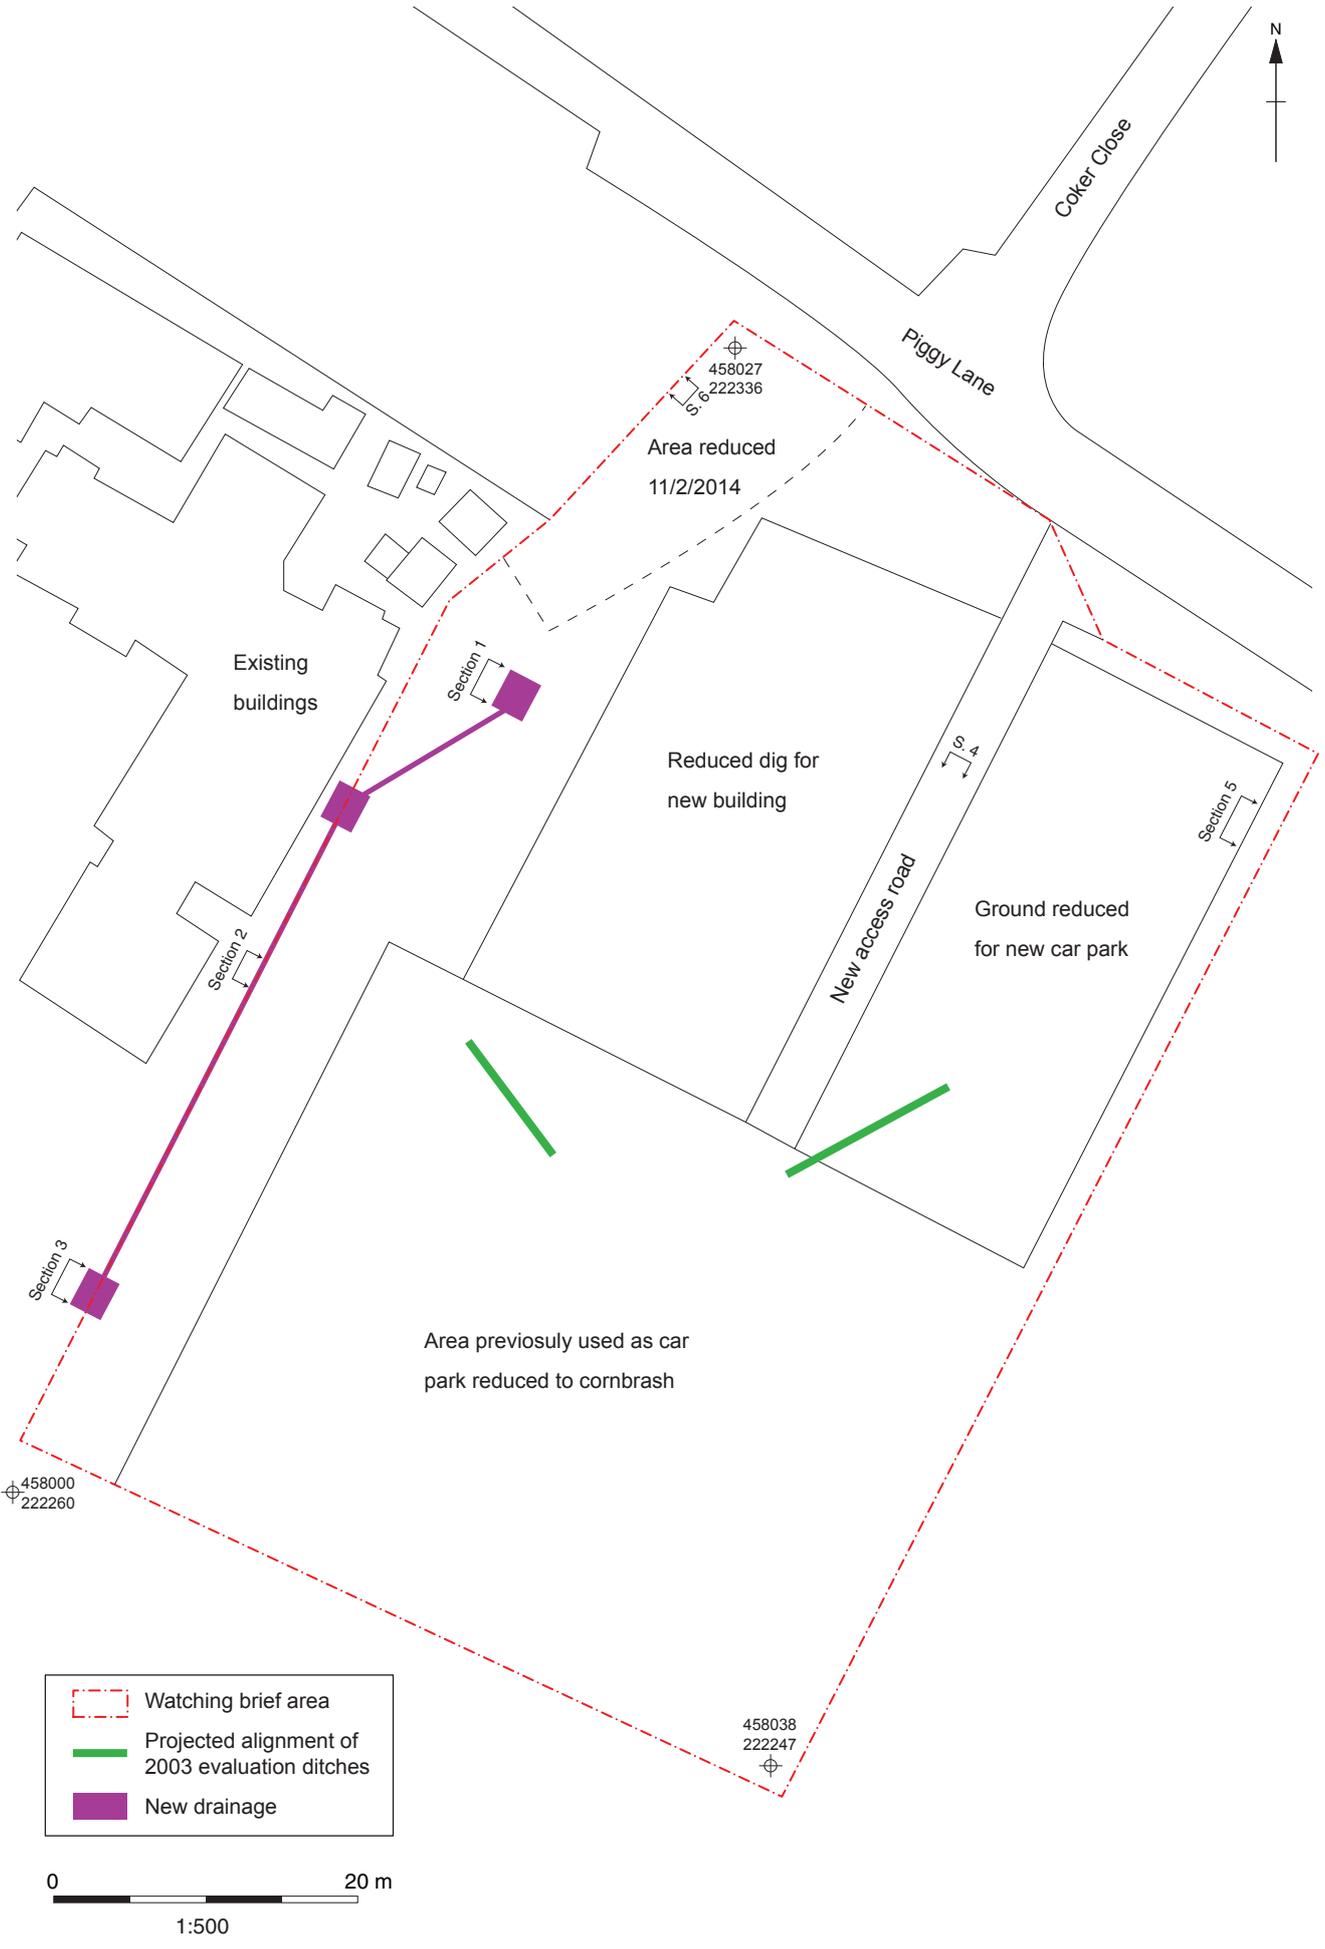
Figure 2: Site plan

- 3.1.21 Following the construction of the main building, an area located in the north-west corner of the site and measuring approximately 24m by 8.5m was reduced by between 0.5m and 0.65m in depth (Fig. 2).

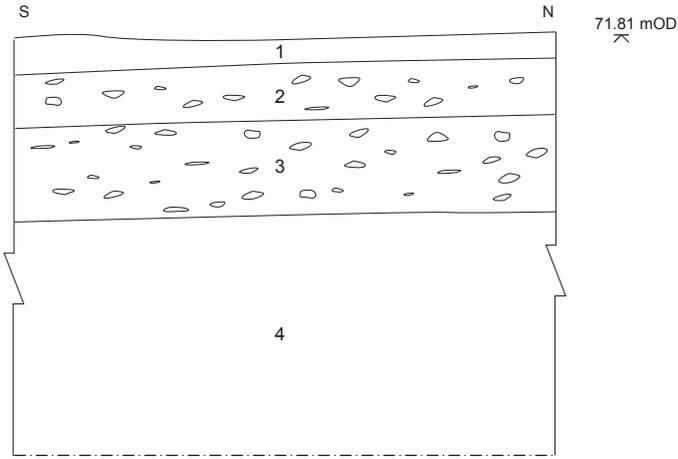
Section 1

- 3.1.4 At the north end of the trench (Fig. 2), the underlying cornbrash (4) was encountered at a depth of 0.6m below ground level (Fig. 3, Section 1). This was overlain by a layer of mixed grey-brown silty clay (3), 0.3m deep, containing numerous sub-angular limestone fragments and occasional fragments of brick. Above layer 3 was a layer of dark grey-brown silty clay loam (2), 0.2m deep. This also produced fragments of brick and occasional shreds of transfer printed creamware.

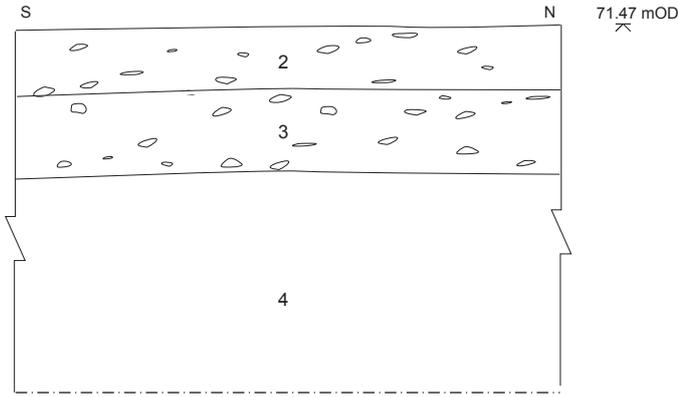
Section 2

- 3.1.5 In places, layer 2 was sealed below a layer of crushed stone (1), 0.15m deep, forming hard standing around the existing hospital buildings.
- 3.1.6 Within the centre of the trench, the cornbrash was recorded at a depth of 0.45m below ground level (Fig. 3, Section 2). Overlying this was a 0.3m deep layer of very disturbed material, a grey brown silty clay mixed with limestone fragments and occasional sub-angular brick fragments, a continuation of layer 3.

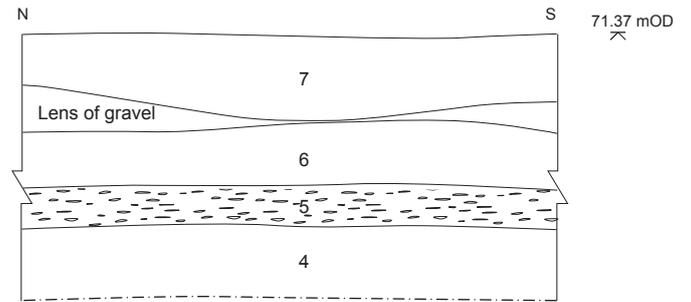
- 3.1.16 Within the higher ground at the north-east corner of the car park, layer 5 was overlaid by a layer of mid brown clayey silt loam containing small sub-angular limestone fragments (6), up to 0.18m in depth (Fig. 3, Section 5 and Plate 2). This was sealed by a layer of made ground up to 0.5m in depth, composed of grey-brown clayey silt with inclusions of brick and crushed stone (7). This deposit produced fragments of bottle glass and creamware pottery.
- 3.1.17 The base for an access road was constructed between the car park and the new building. As part of its construction, the ground was reduced by approximately 0.8m in depth to allow for a hardcore base (Fig. 2, Section 4 and Plate 1).
- 3.1.18 The stratigraphy exposed during this operation was similar to that recorded in Section 5.

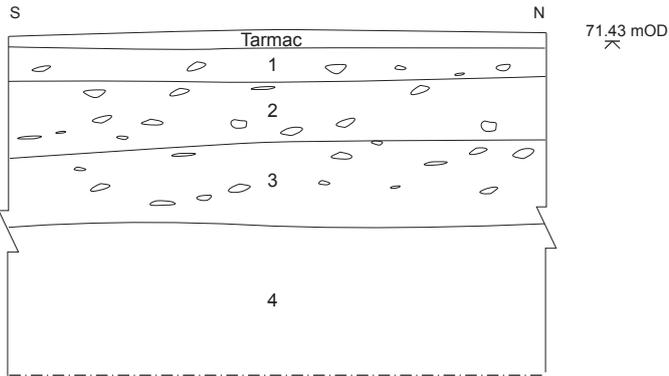
Section 3

- 3.1.7 This was sealed by a second mixed layer of dark grey-brown silty clay loam between 0.2m and 0.25m in depth, a continuation of layer 2.
- 3.1.8 At the southern end of the trench, the cornbrash was also recorded at a depth of 0.5m below ground level (Fig. 3, Section 3). A continuation of the mixed layer 3 measuring up to 0.25m in depth was observed to overlie the cornbrash at this point. This was covered by a 0.2m deep continuation of layer 2.

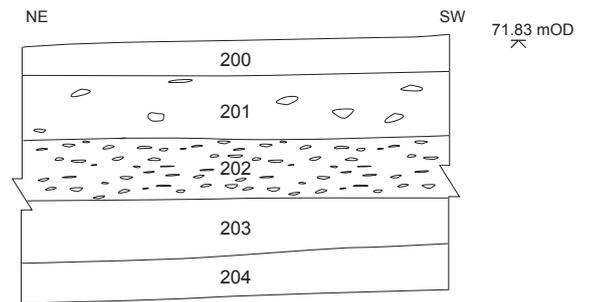
- 3.1.22 The depth of excavation was insufficient to expose the underlying natural deposits and a layer of mid brown silty clay (204) was observed within the base of the excavation (Fig. 3, Section 6 and Plate 3). Visible within the surface of this deposit were two parallel bands of crushed stone hardcore, each 0.65m wide by 12m in length and spaced at 2.5m apart (205).

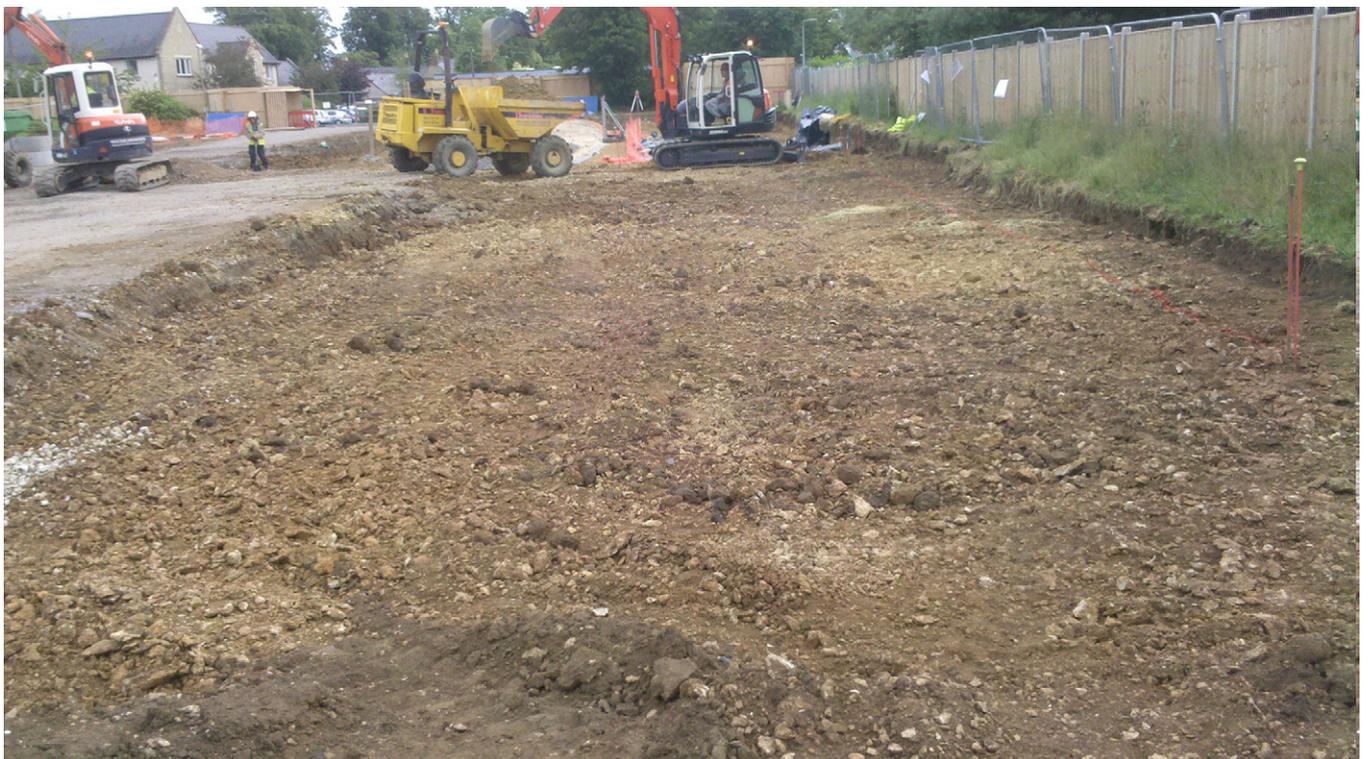
Plate 4: Surface of weathered cornbrash

- 3.1.14 The cornbrash (4), a compact layer of fragmented limestone formed by frost shattering of the top of the limestone beds (Plate 4), was observed at a depth of between 0.3m and 0.5m below the level of the hardstanding.
