**STERNE BRIDGE,  
SOWERBY BRIDGE–  
COPLEY VALLEY  
REGENERATION  
PROJECT,  
SKIRCOAT,  
WEST YORKSHIRE**

**Archaeological  
Photographic  
Building Recording  
and Watching Brief**

**Oxford Archaeology North**

September 2012

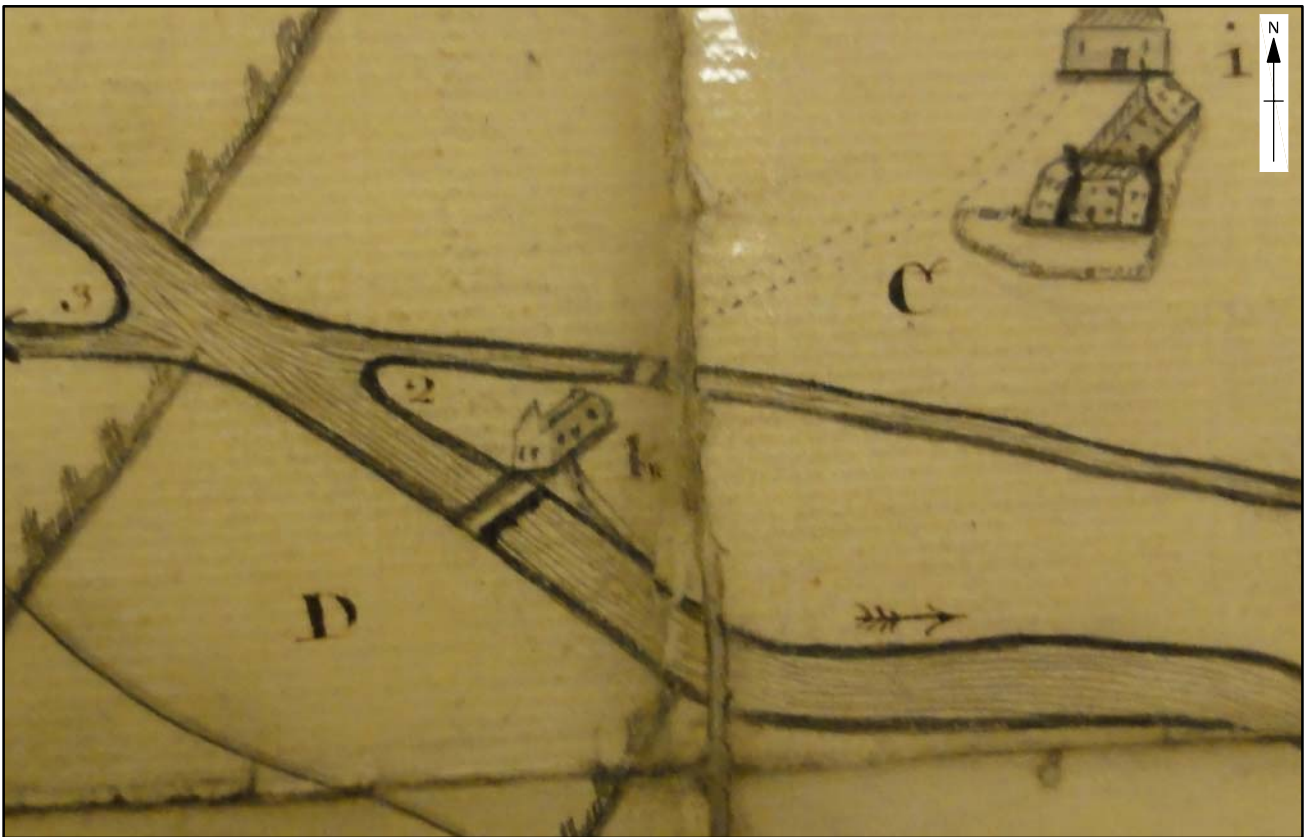
Figure 4: Extract from an anonymous map, 1765

- 3.1.3 A similar depiction of the mill was shown on an anonymous map of 1765 (Fig 4), which showed the river and the course of the Calder and Hebble Navigation canal. Numerous bridges and crossing points were depicted as associated with parallel dashed lines representing track ways leading to and from the rivers edge. No such lines were shown approaching the river Calder at the site of Sterne Mill, although two parallel lines crossing the river adjacent to the mill may represent the presence of the bridge and weir; the key to the map specifically mentioned ‘Stern Mill’ and ‘Stern Dam’ although it does not make any mention of the bridge. Indeed, as late as Baines’ map of 1822 (Fig 5) it is not clear whether the schematic lines shown traversing the river mark a bridge at the site. Other elements associated with the mill are more clearly identifiable, specifically the weir, tail race, and a schematic water-wheel, as well as the canal bridge to the north.

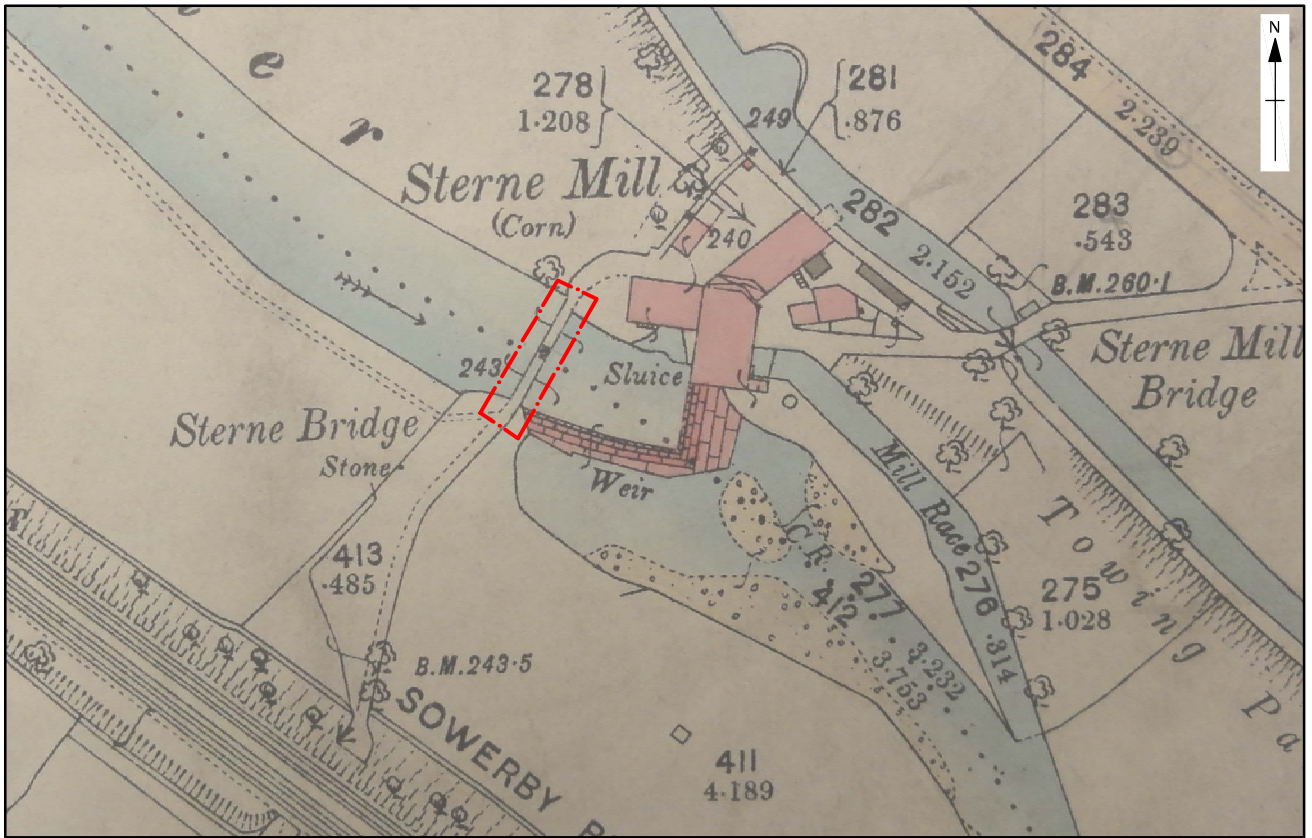
Figure 7: Extract from the First Edition Ordnance Survey 25": 1 mile map, 1894

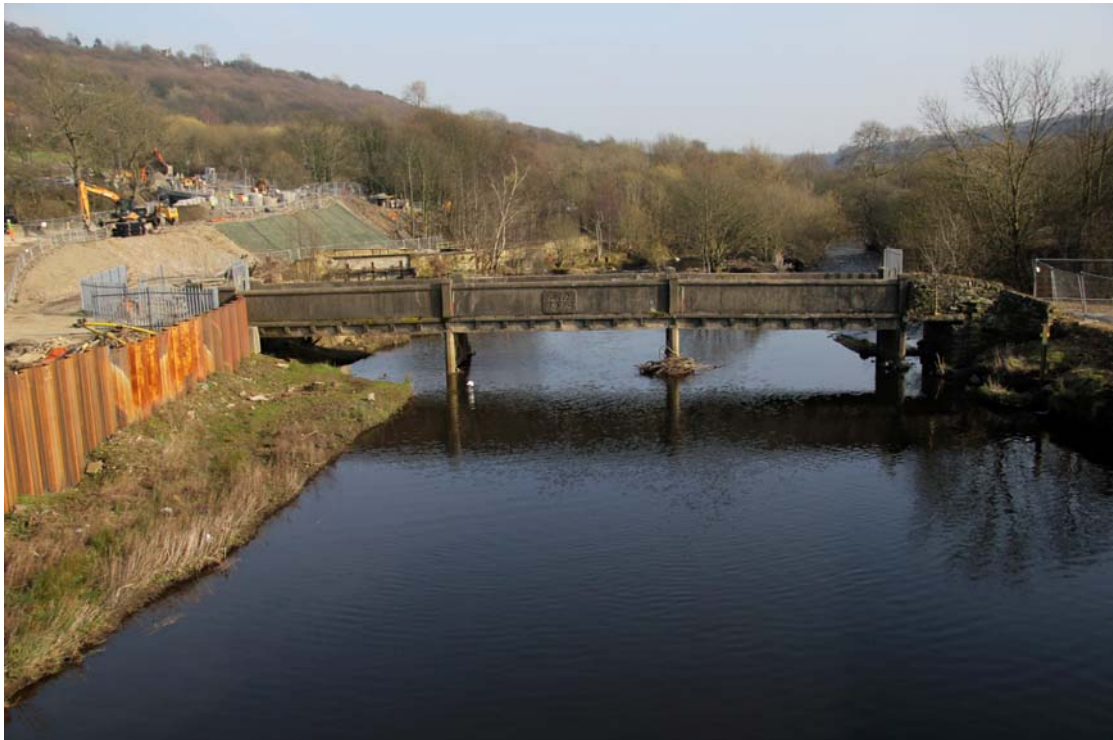
Plate 1: North-west-facing elevation of Sterne Bridge (IMG\_2383)

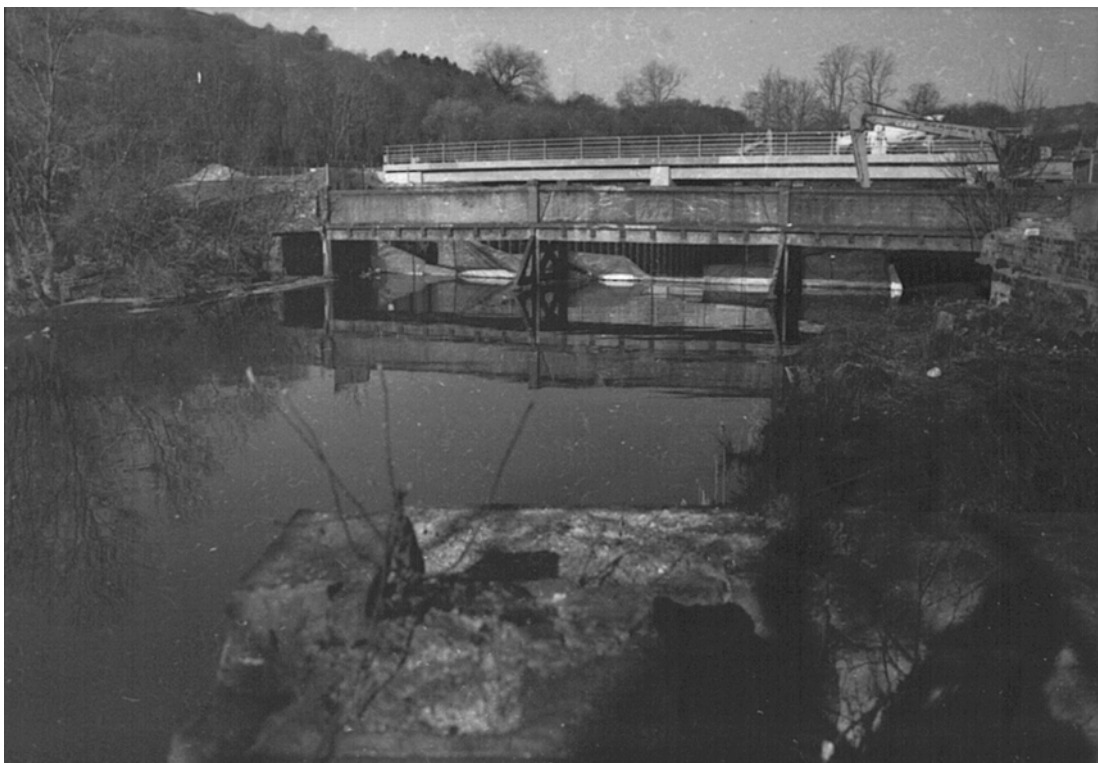
Plate 2: South-east-facing elevation of Sterne Bridge (MF SB01\_01)

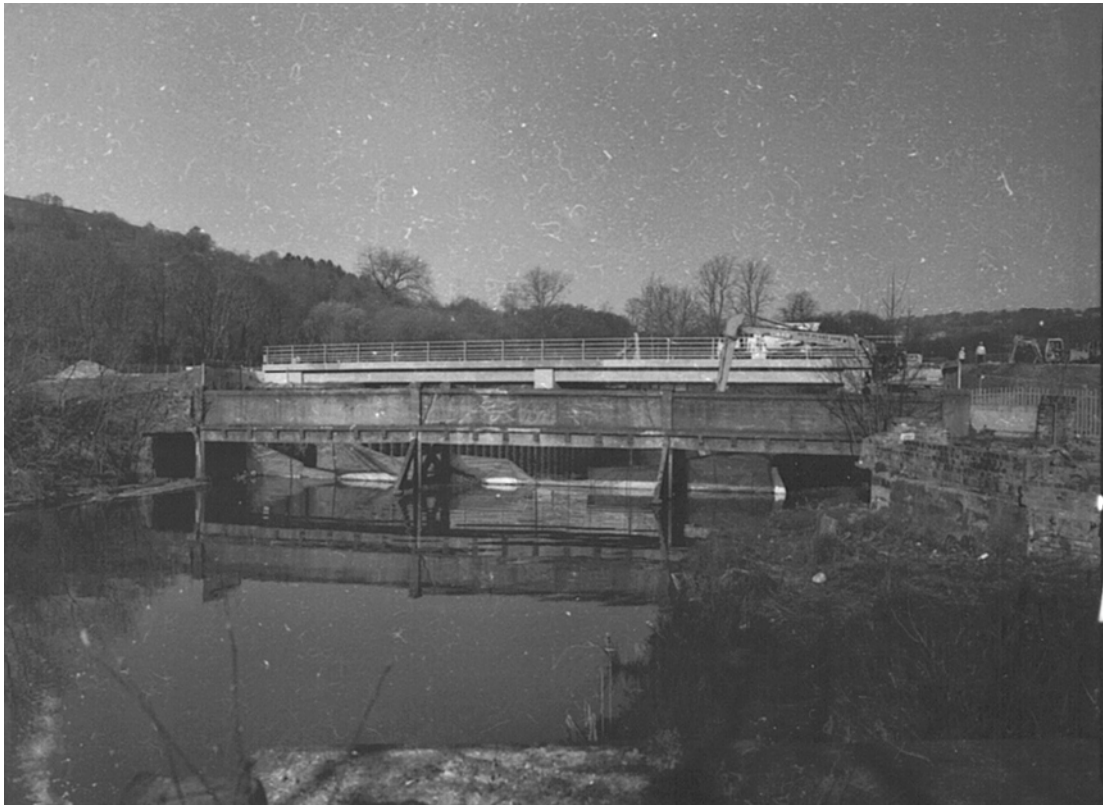
Plate 3: South-east-facing elevation of Sterne Bridge (MF SB01\_02)

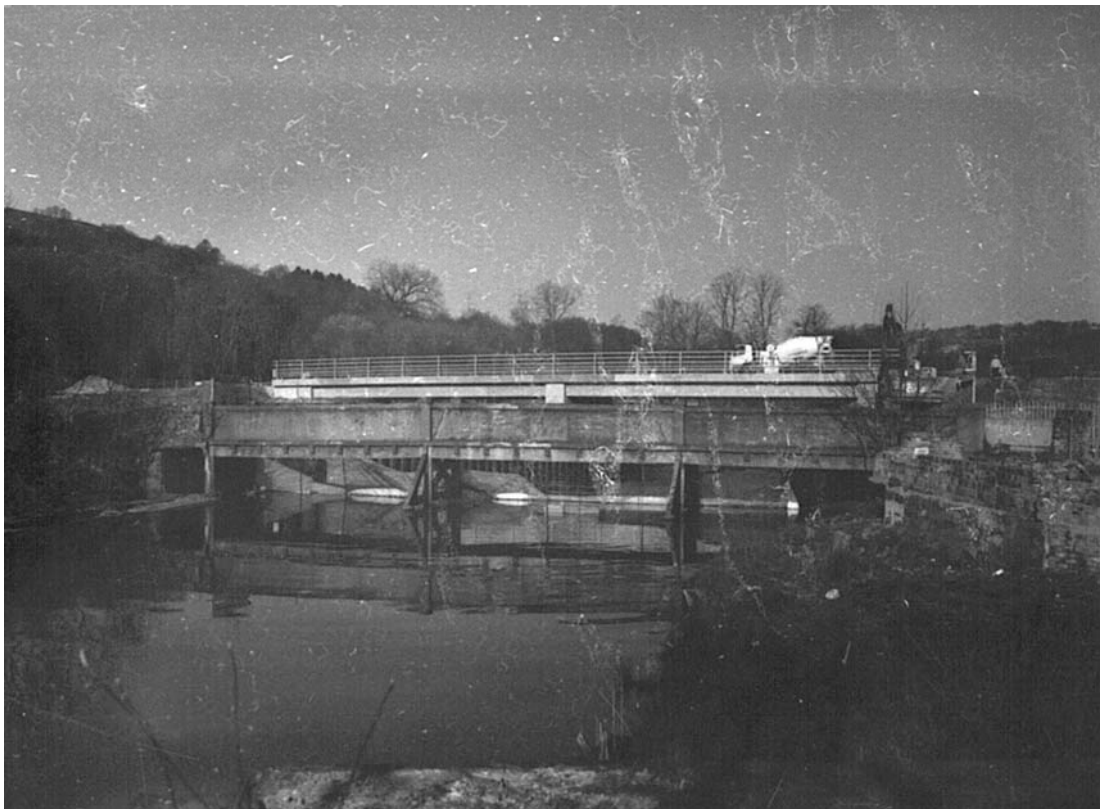
Plate 4: South-east-facing elevation of Sterne Bridge (MF SB01\_03)

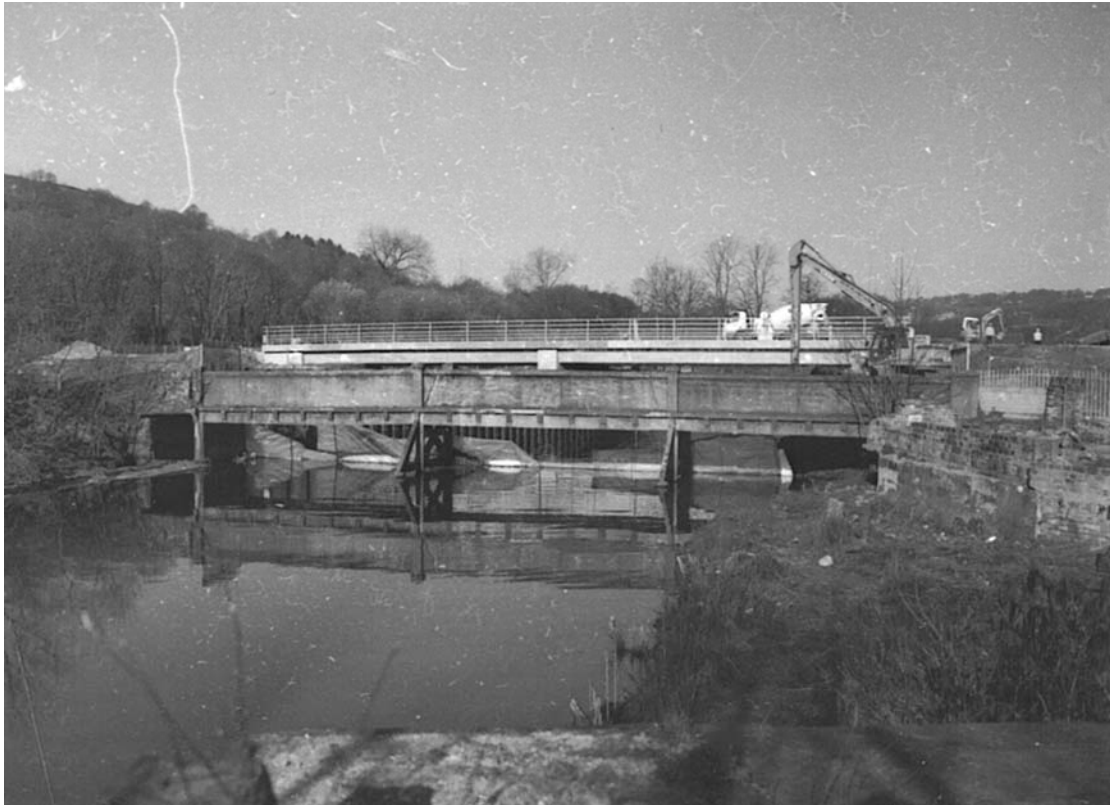
Plate 5: South-east-facing elevation of Sterne Bridge (MF SB01\_04)

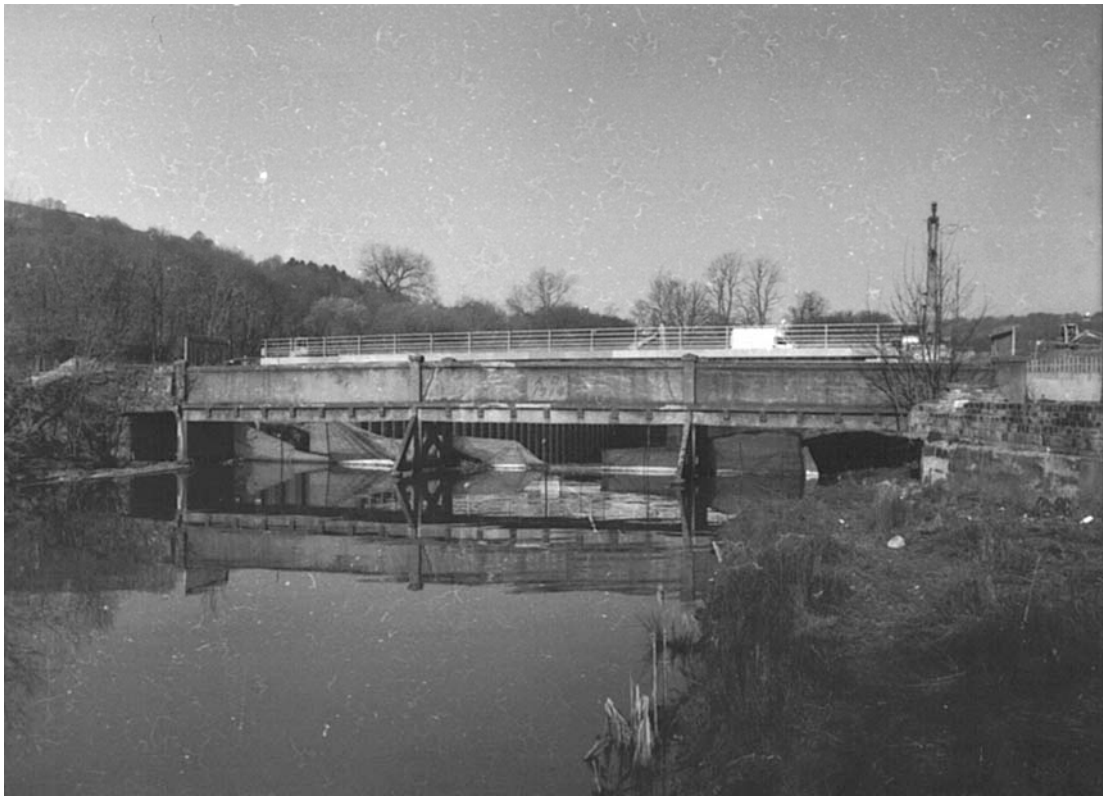
Plate 7: South-east-facing elevation of Sterne Bridge (MF SB01\_07)

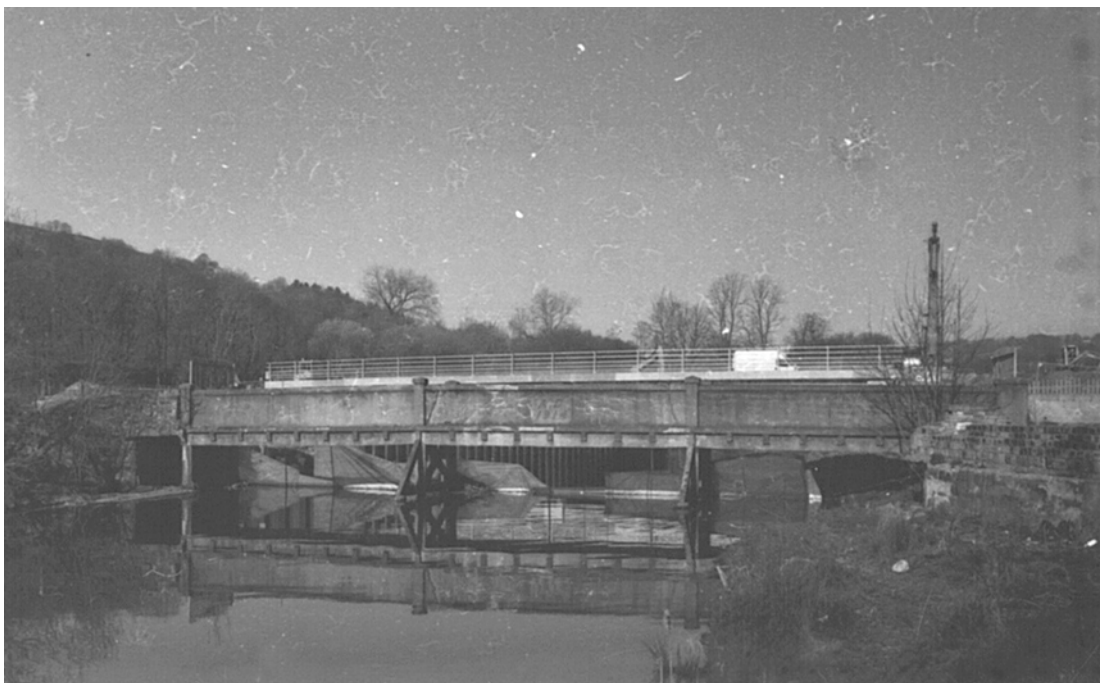
Plate 8: South-east-facing elevation of Sterne Bridge (MF SB01\_08)

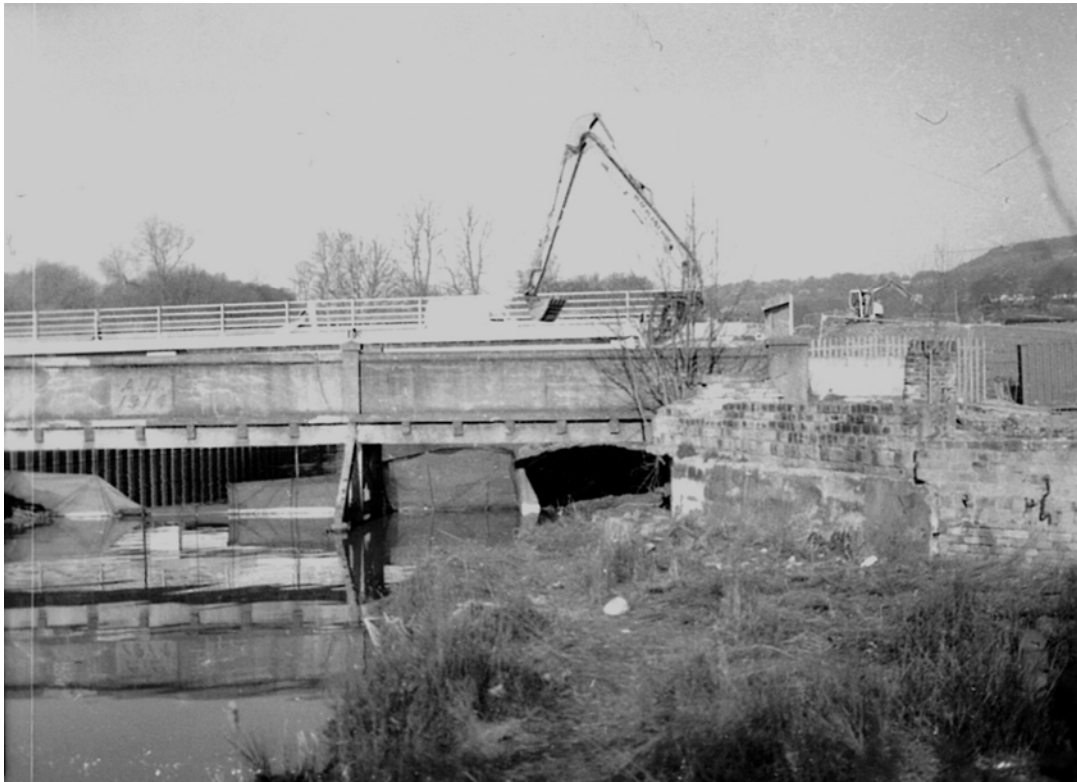
Plate 9: South-east-facing elevation of Sterne Bridge (MF SB01\_10)

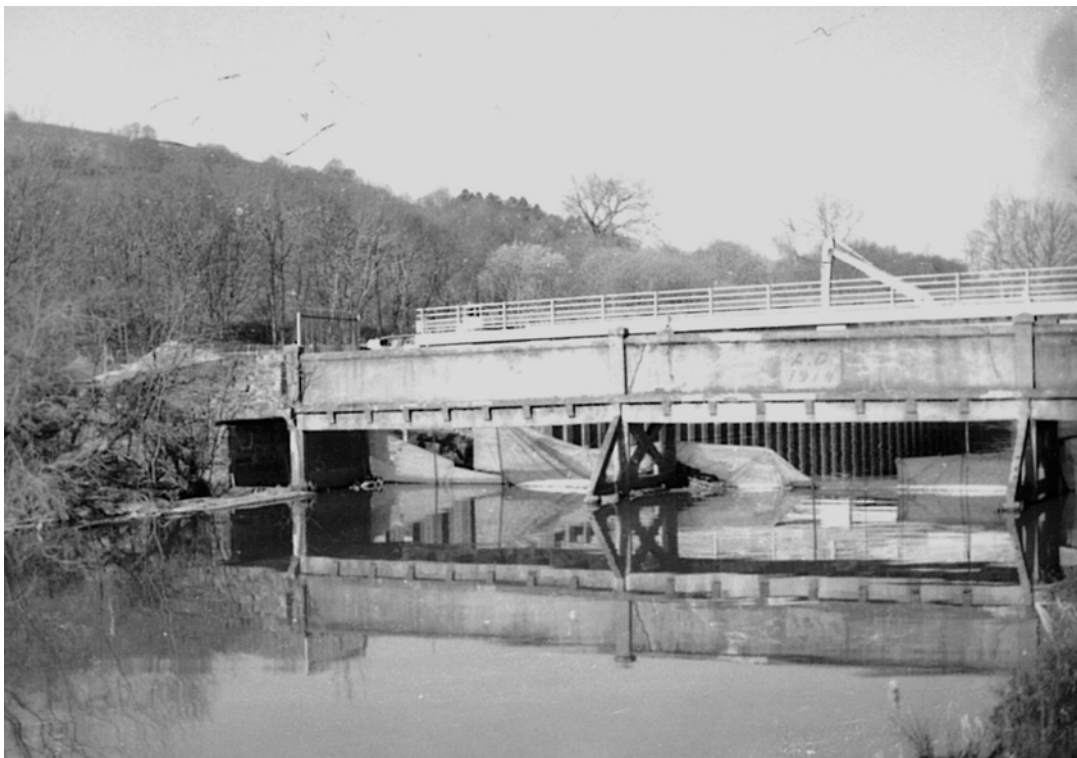
Plate 10: South-east-facing elevation of Sterne Bridge (MF SB01\_12)

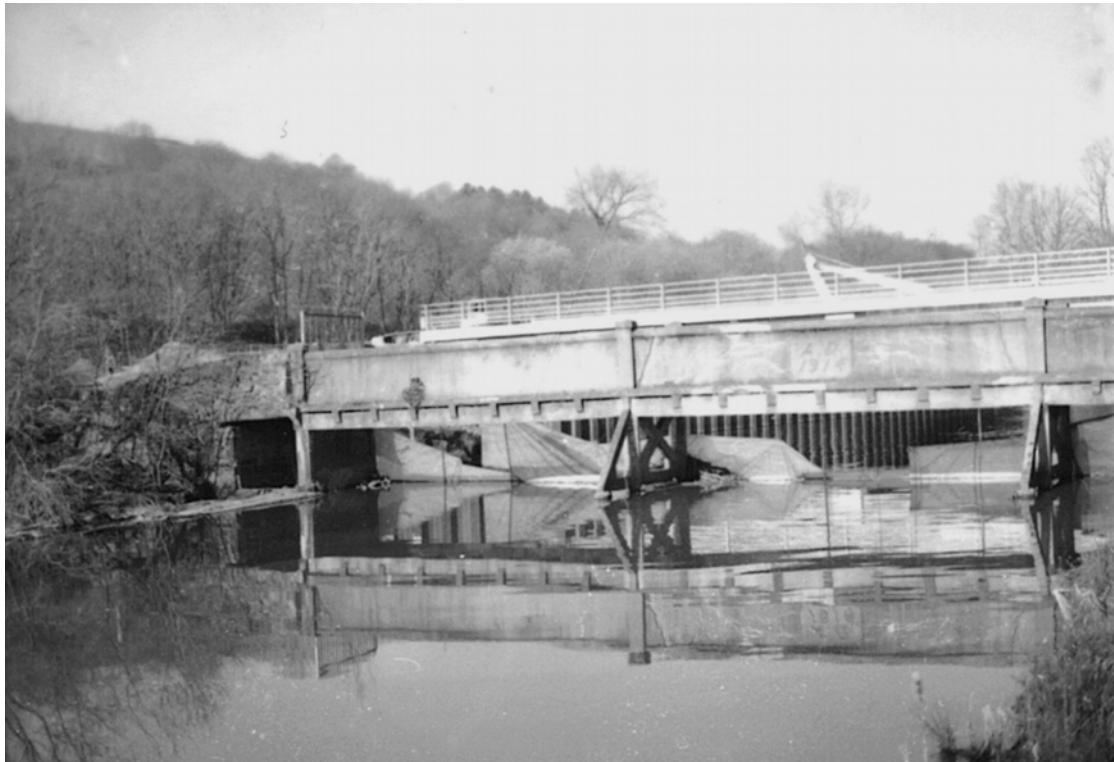
Plate 11: South-east-facing elevation of Sterne Bridge (MF SB01\_13)

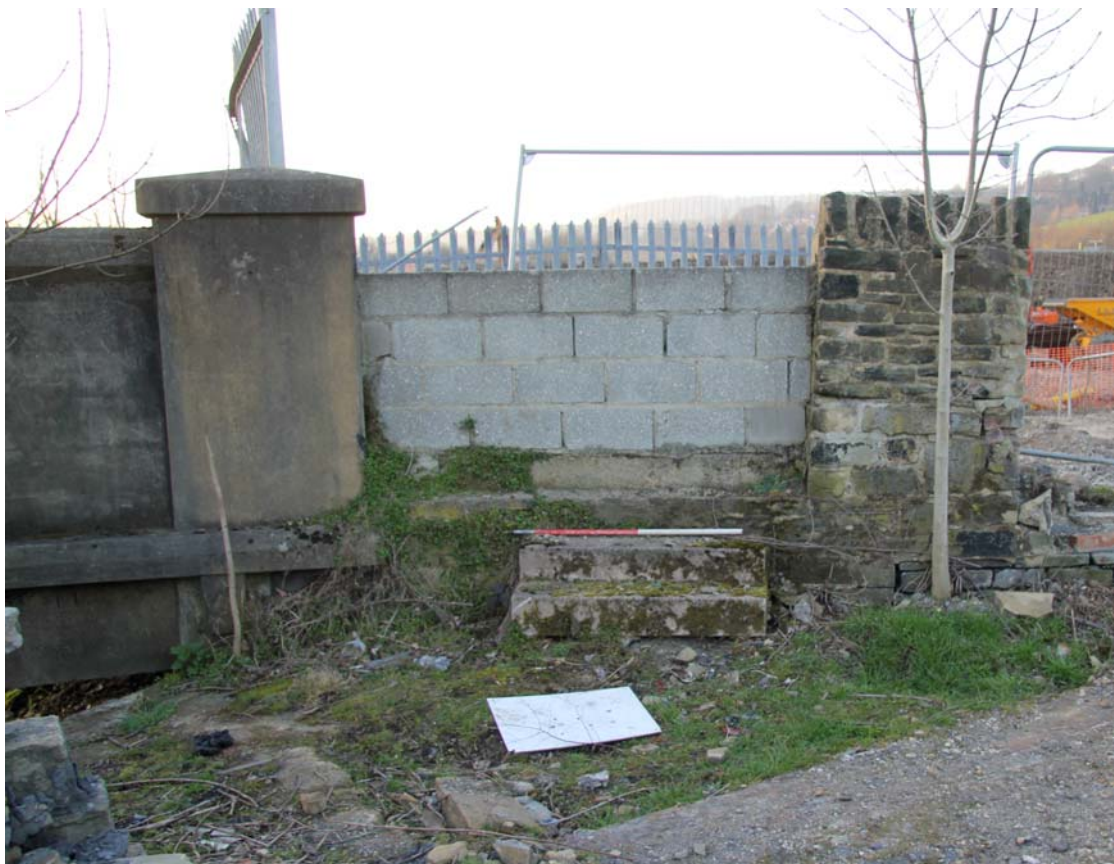
Plate 12: Stepped access (1) (IMG\_2445)

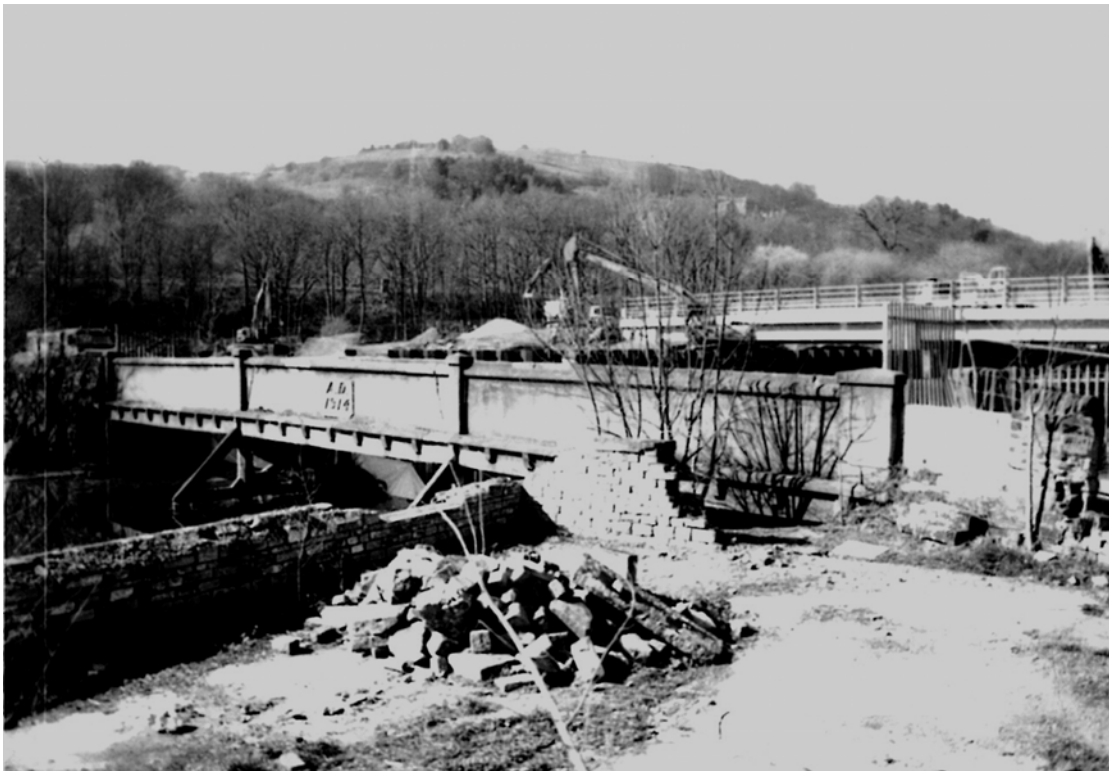
Plate 13: Stepped access (1) and vertical sandstone pillar (2) (MF SB04\_08)

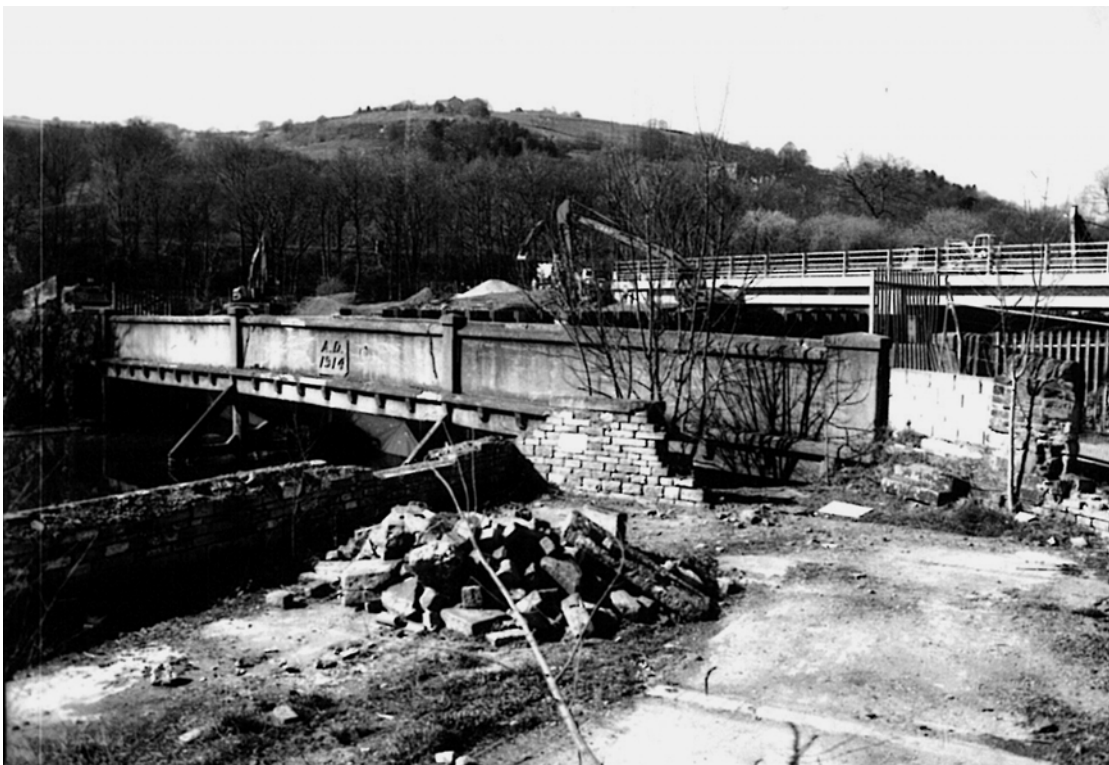
Plate 14: Stepped access (1) and vertical sandstone pillar (2) (MF SB04\_09)

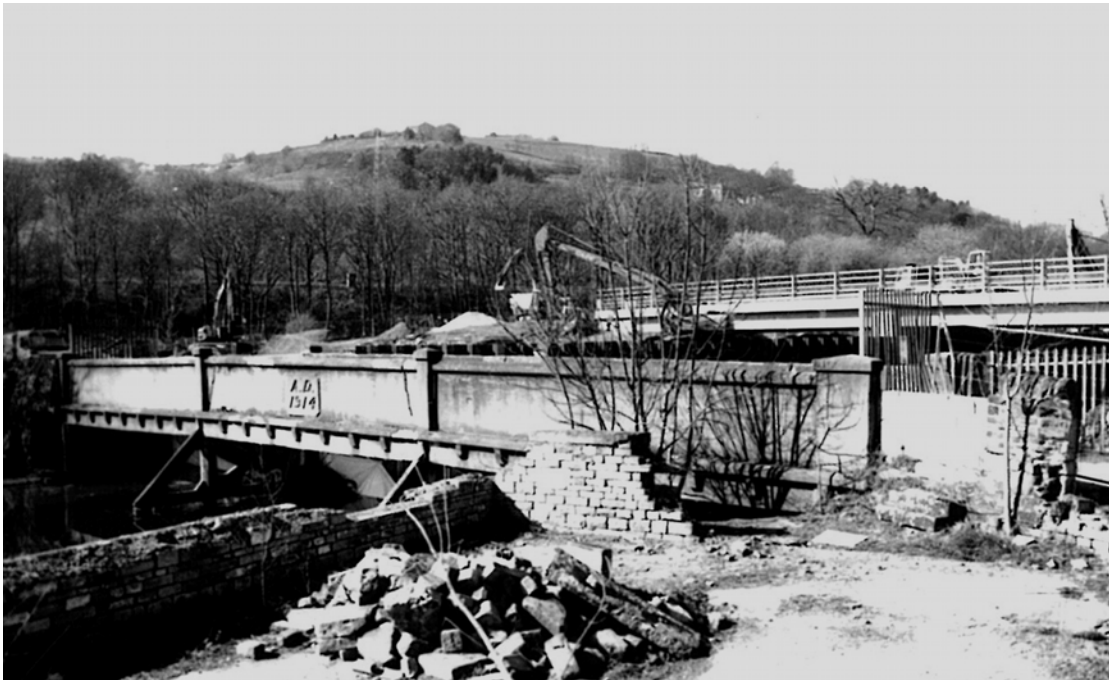
Plate 15: Stepped access (1) and vertical sandstone pillar (2) (MF SB04\_15)

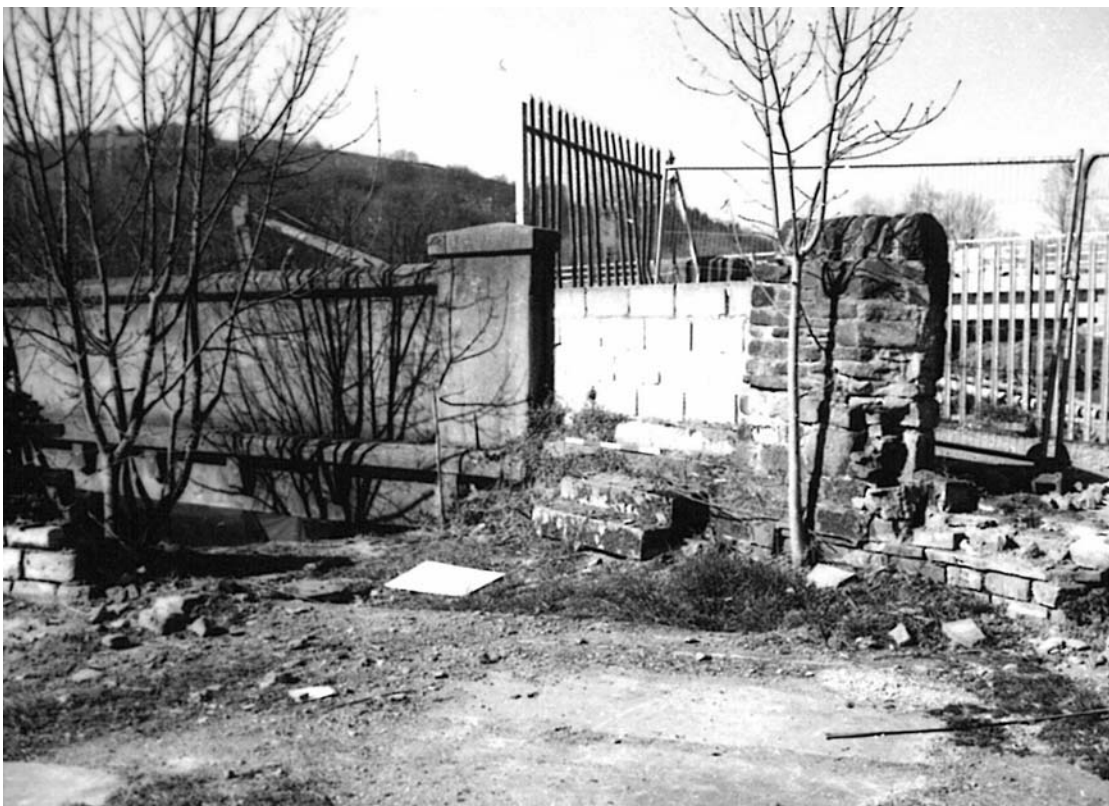
Plate 16: Stepped access (1) and vertical sandstone pillar (2) (MF SB05\_01)

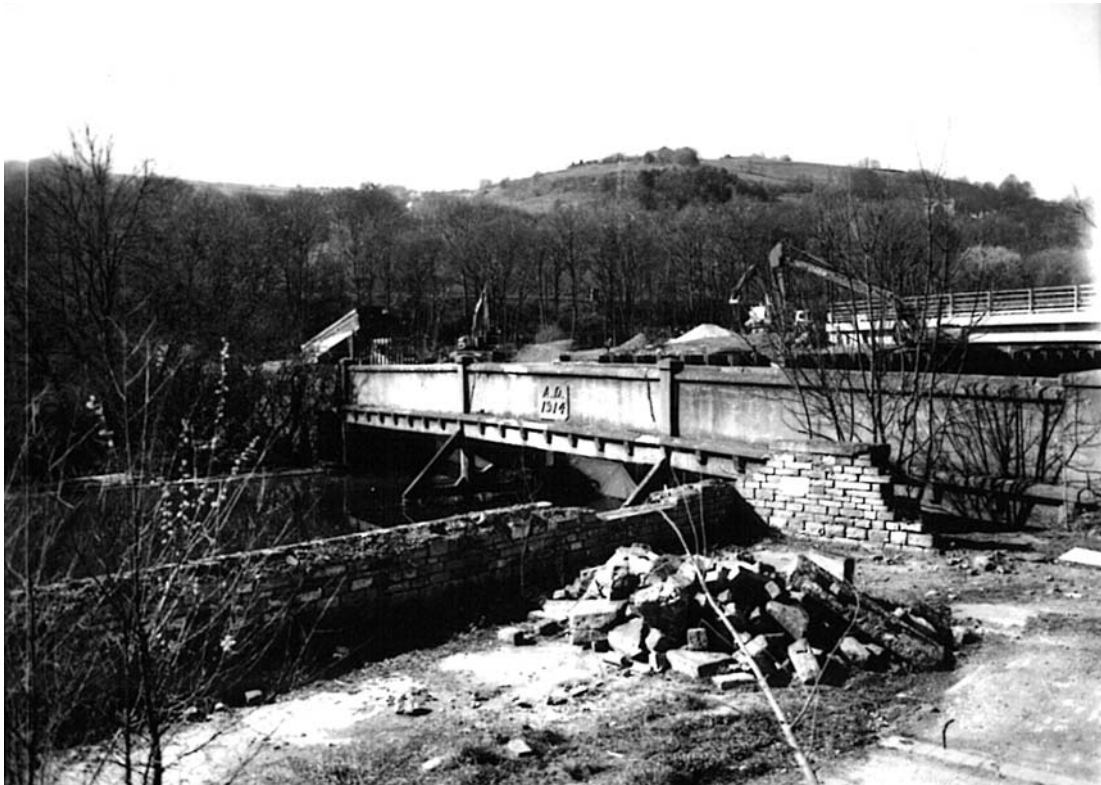
Plate 17: South-facing view across the river Calder, showing the south-east-facing bridge elevation (MF SB04\_04)

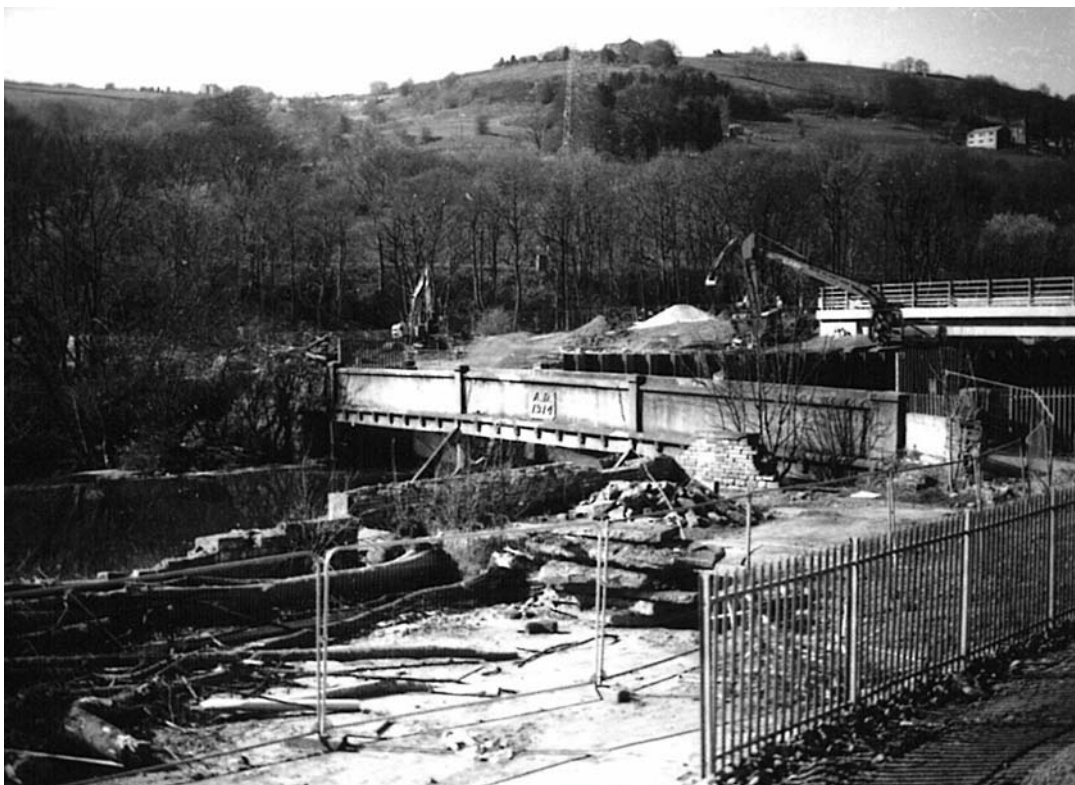
Plate 18: General view across the river Calder showing the south-east-facing bridge elevation (MF SB04\_05)

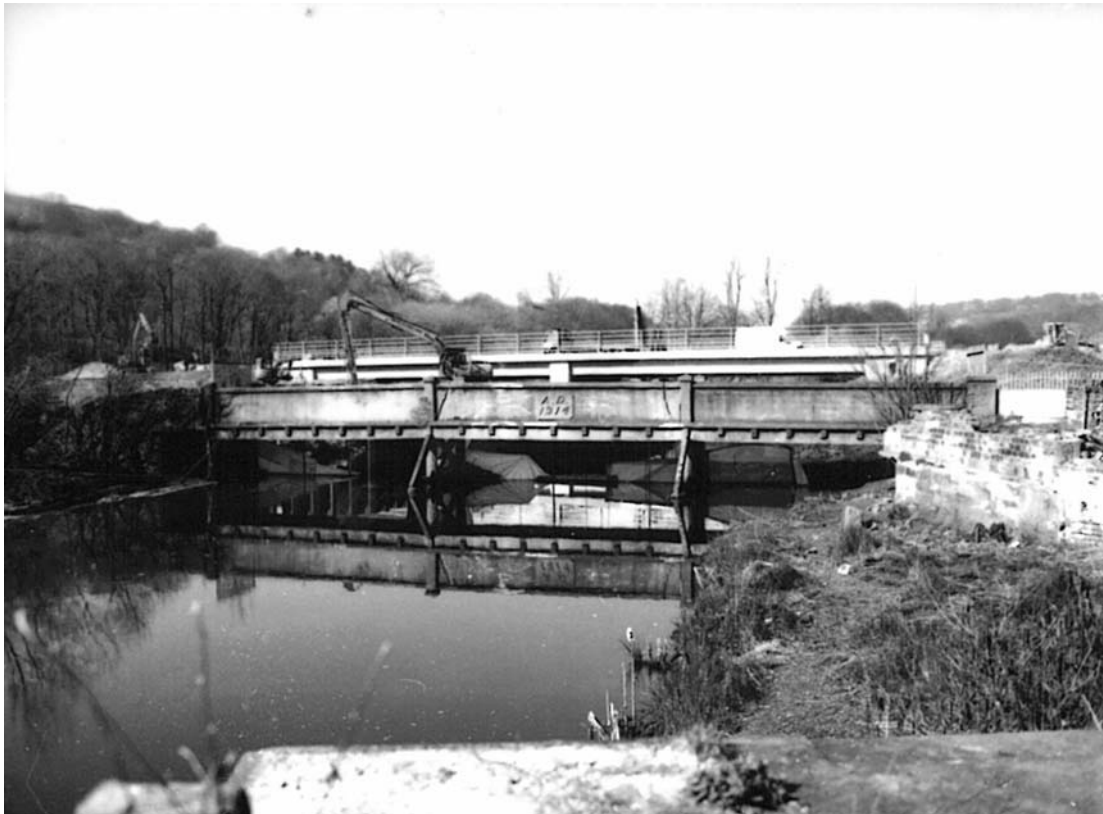
Plate 19: West-facing view across the river Calder showing the south-east-facing elevation of Sterne Bridge (MF SB04\_12)

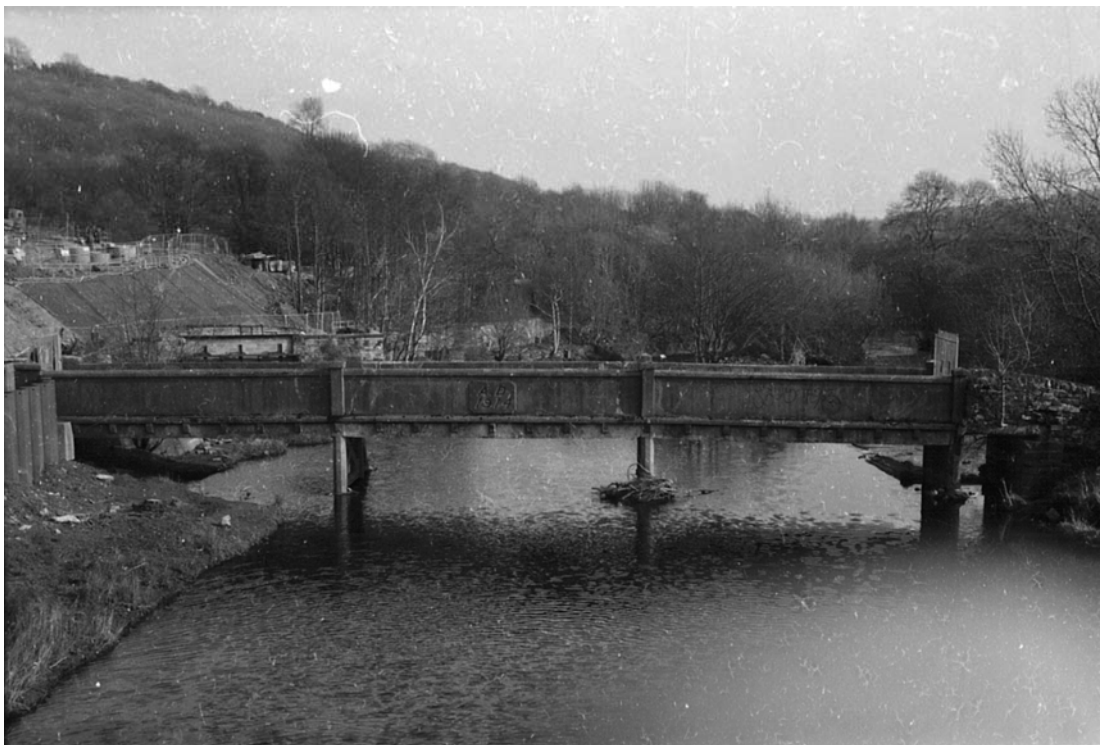
Plate 20: View from the replacement bridge showing the north-west-facing elevation of Sterne Bridge (MF SB07\_01)

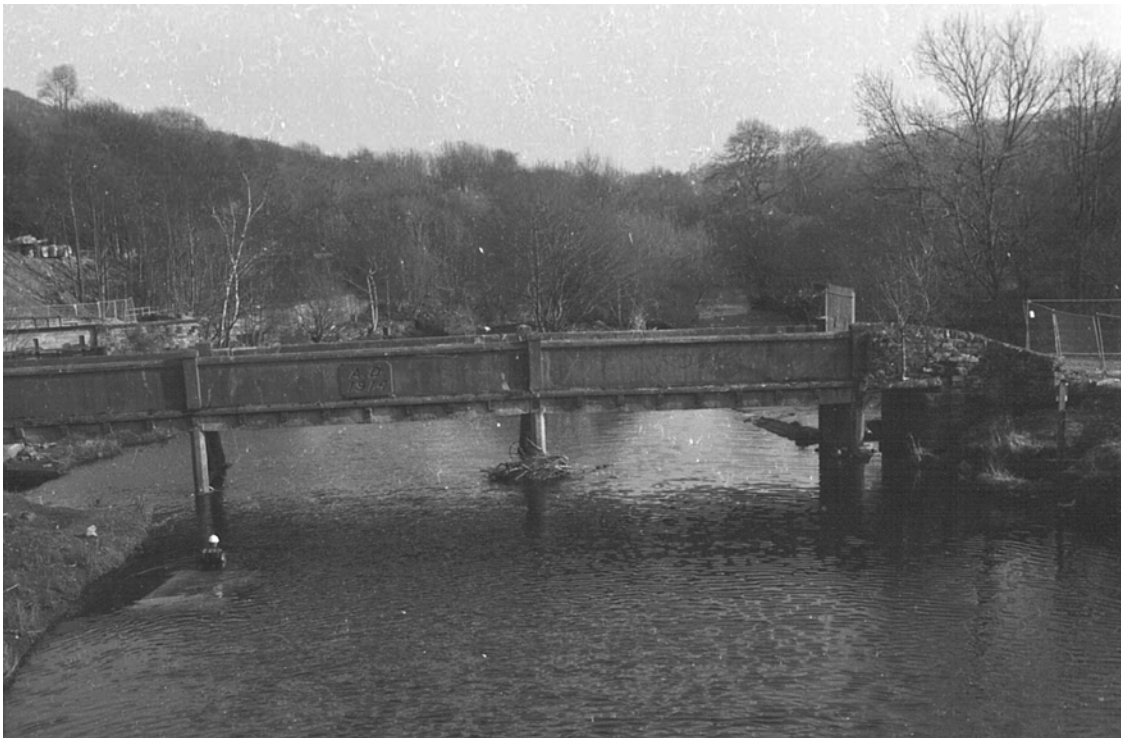
Plate 21: View from the replacement bridge showing the north-west-facing elevation of Sterne Bridge (MF SB07\_04)

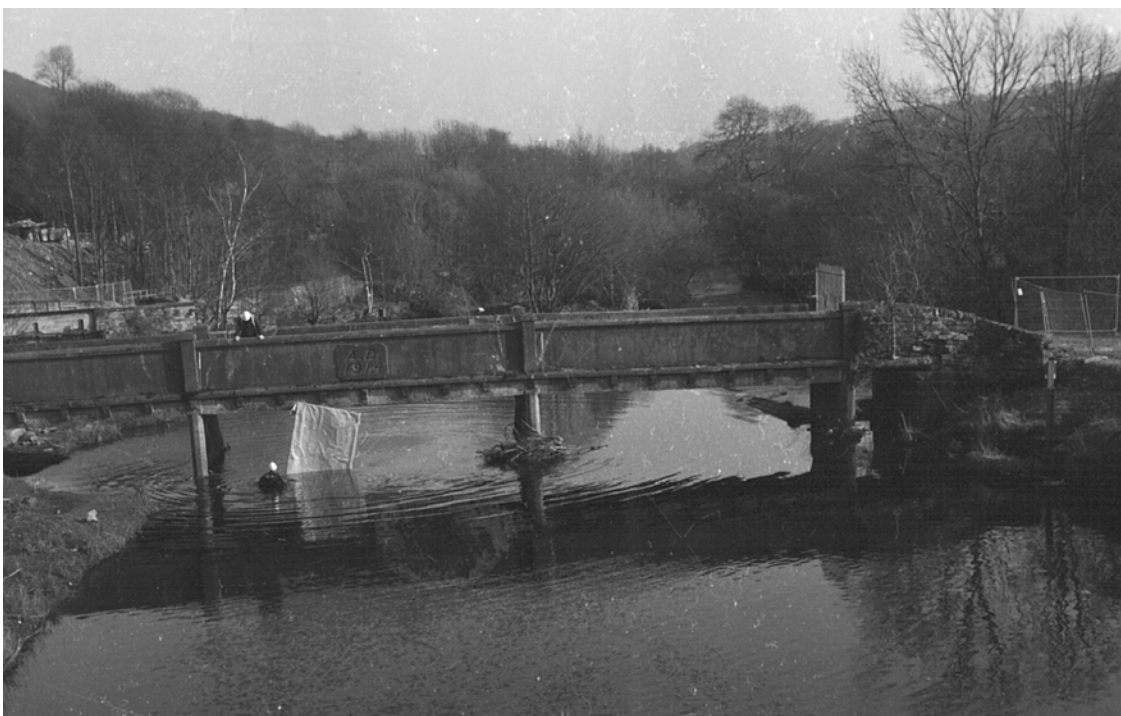
Plate 22: View from the replacement bridge showing the north-west-facing elevation of Sterne Bridge (MF SB07\_06)

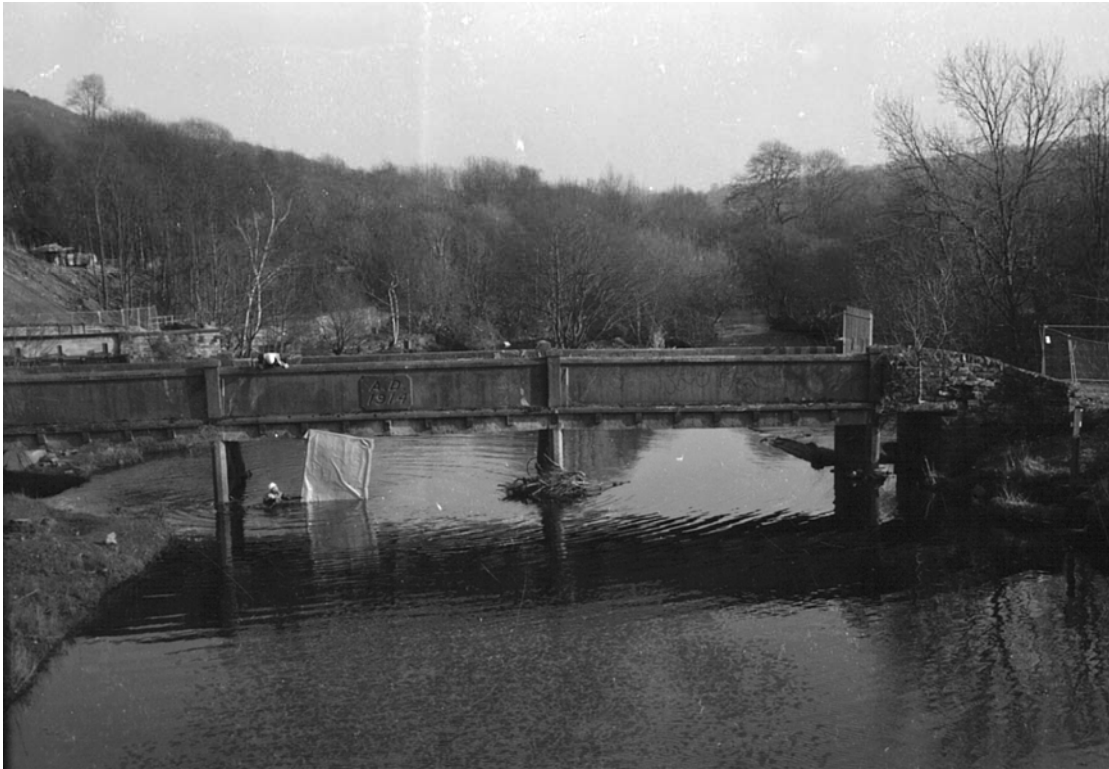
Plate 23: View from the new bridge showing the north-west-facing elevation of Sterne Bridge (MF SB07\_08)

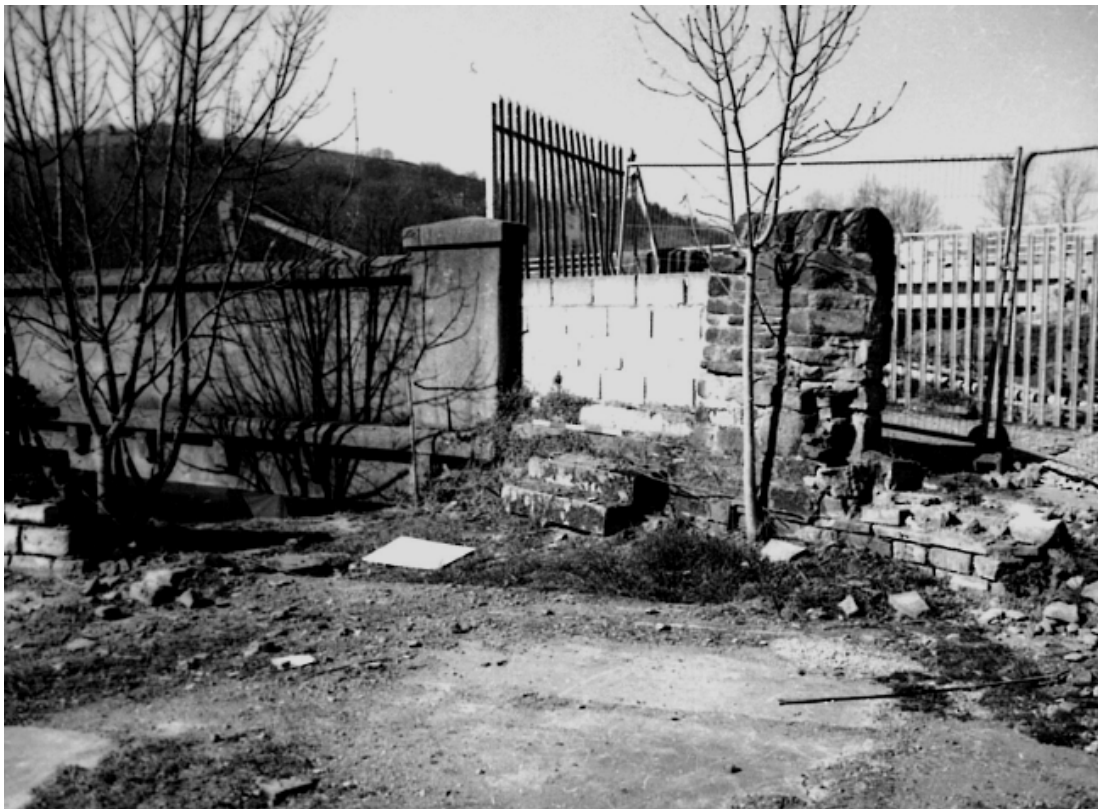
Plate 24: Blocked stepped access (1) and surviving section of eastern wing wall (2) (MF SB05\_02)
