**STERNE BRIDGE,  
SOWERBY BRIDGE–  
COPLEY VALLEY  
REGENERATION  
PROJECT,  
SKIRCOAT,  
WEST YORKSHIRE**

**Archaeological  
Photographic  
Building Recording  
and Watching Brief**

**Oxford Archaeology North**

September 2012

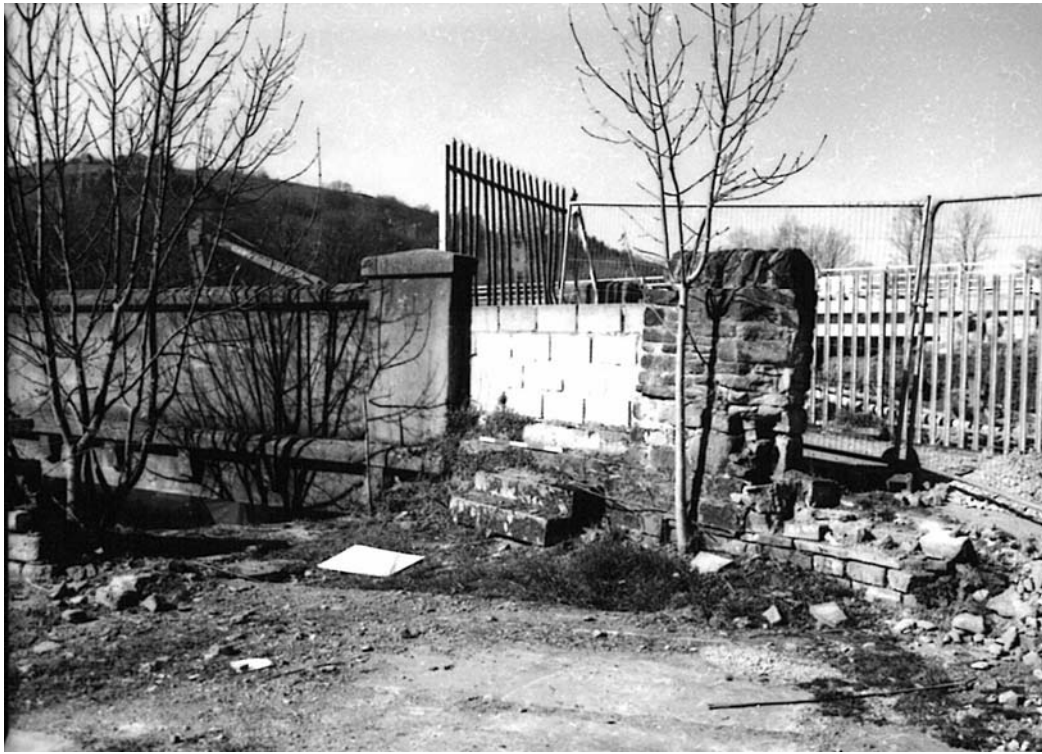
Plate 25: Blocked stepped access (1) and surviving section of eastern wing wall (2)  
(MF SB05\_03)

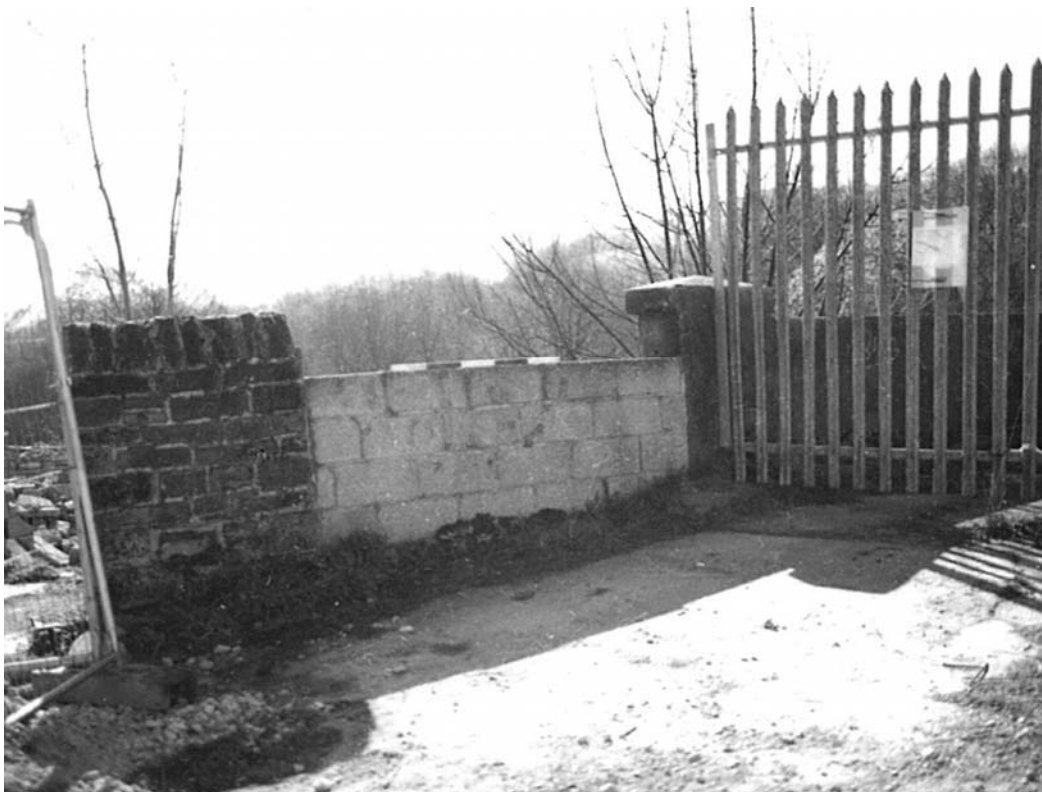
Plate 26: Blocked stepped access (1) and surviving section of eastern wing wall (2)  
(MF SB05\_09)

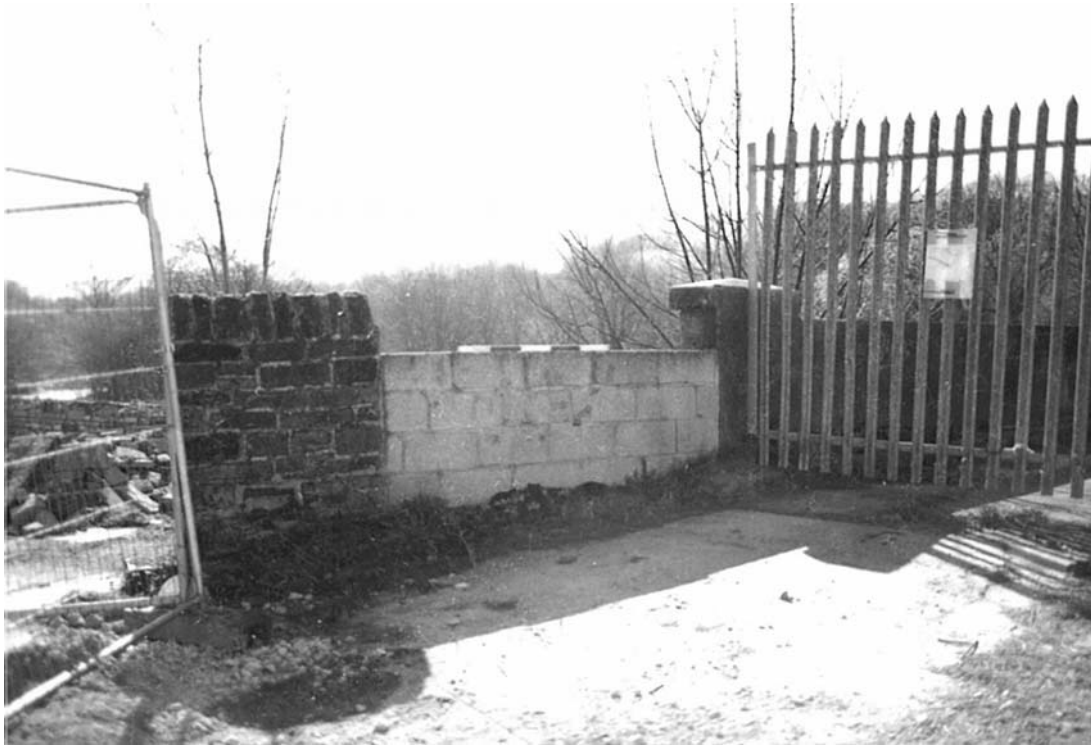
Plate 27: Blocked stepped access (1) and surviving section of eastern wing wall (2)  
(MF SB05\_10)

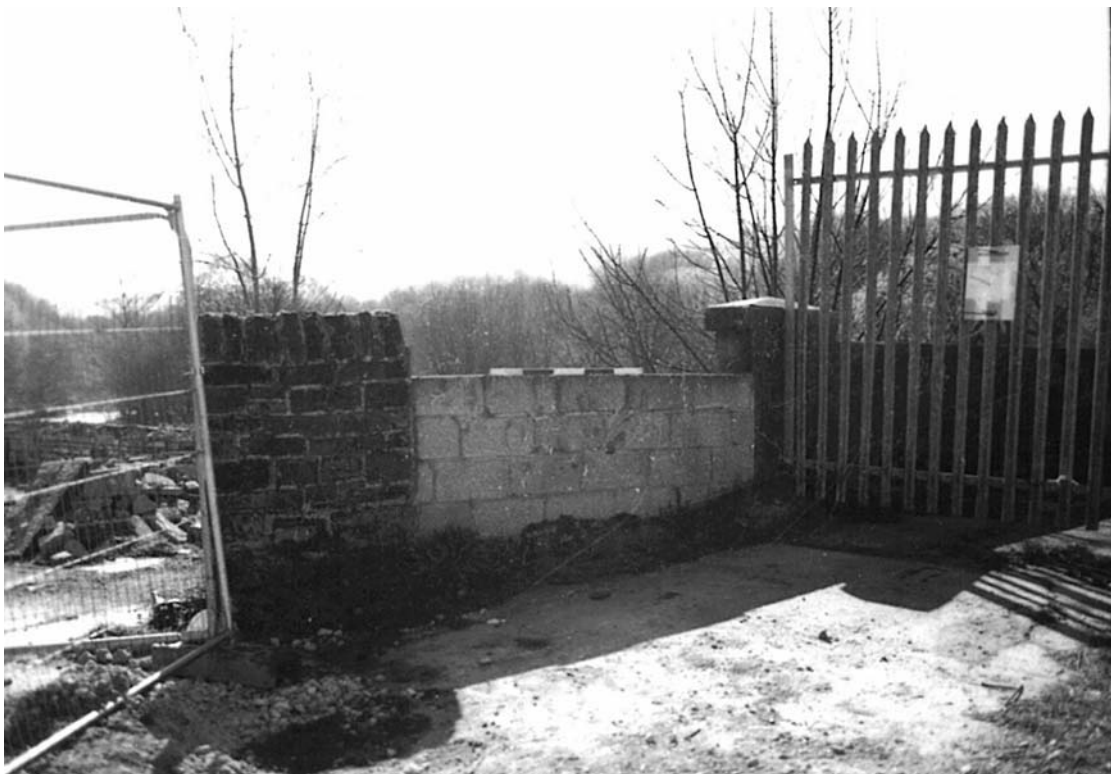
Plate 28: Blocked stepped access (1) and surviving section of eastern wing wall (2)  
(MF SB05\_11)

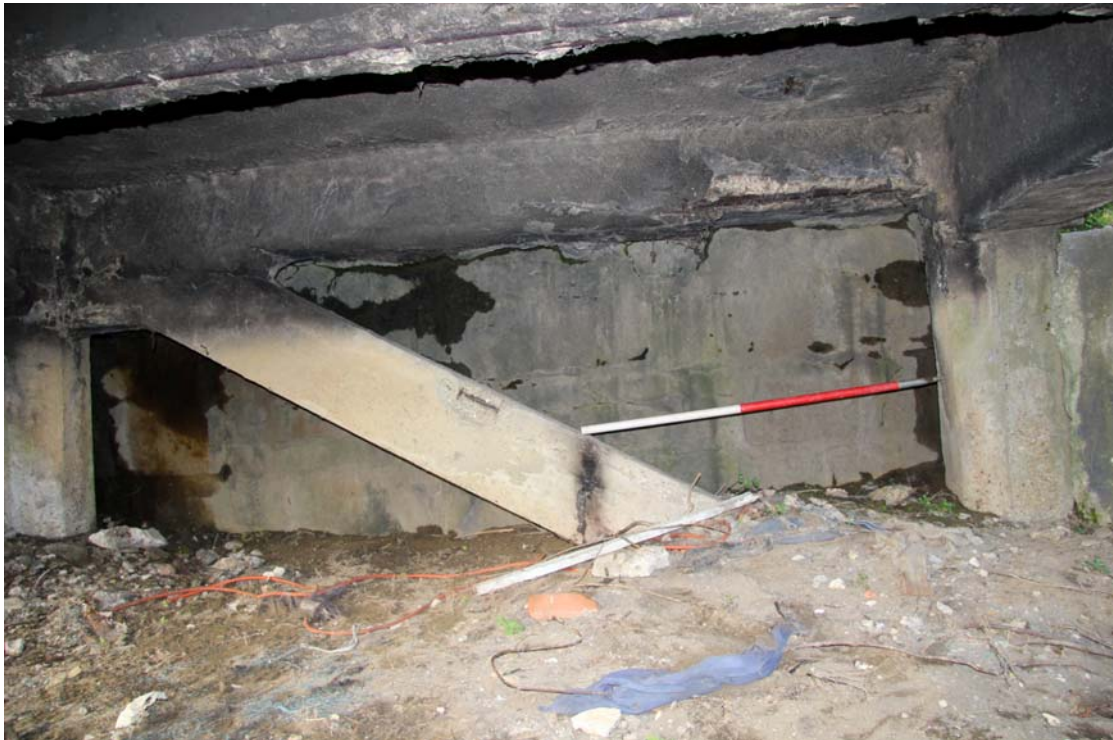
Plate 29: Remainder of earlier bridge barrel (3) behind single trestle (4) (IMG\_2442)

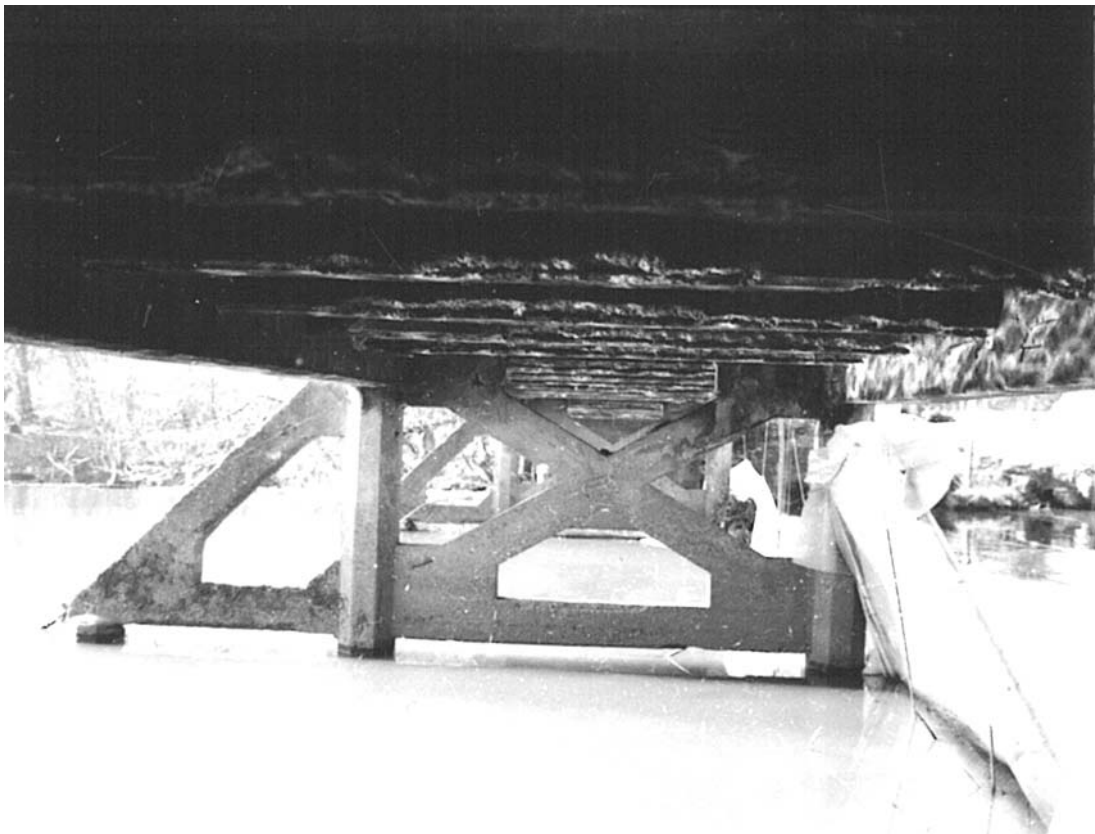
Plate 30: View from the north bank looking south, showing trestles (4a) and (4b) and cut-waters (5) and (5a) (MF SB03\_01)

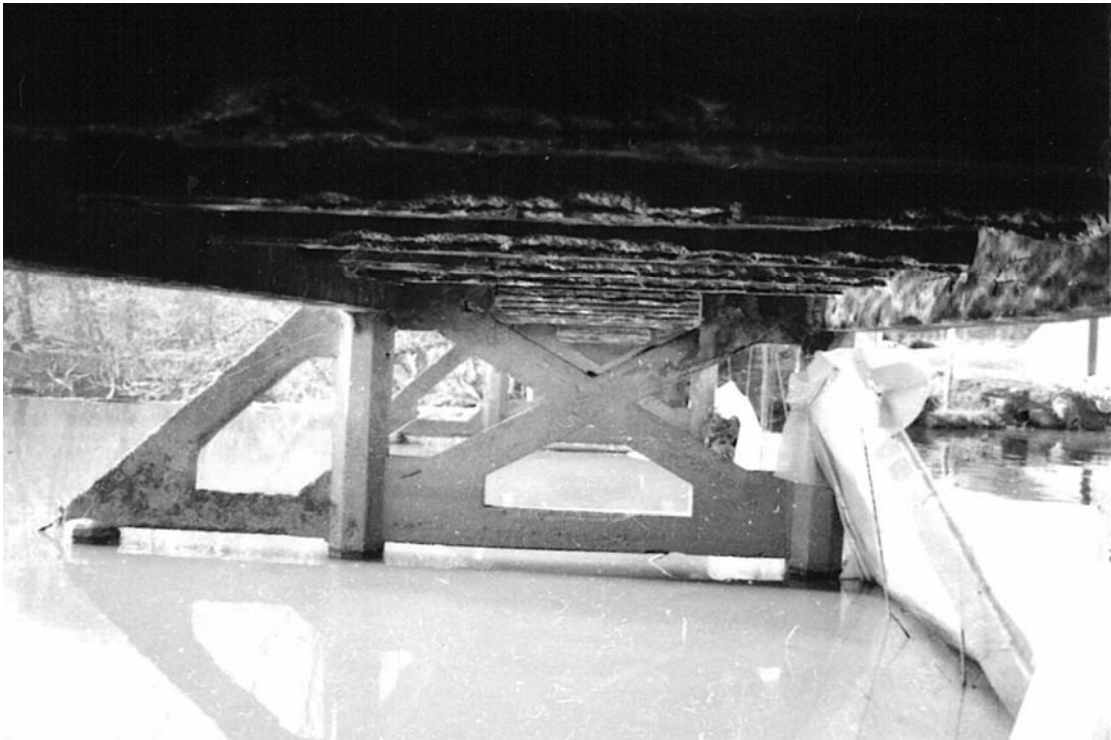
Plate 31: View from the north bank looking south, showing trestles (4a) and (4b) and cut-waters (5) and (5a) (MF SB03\_02)

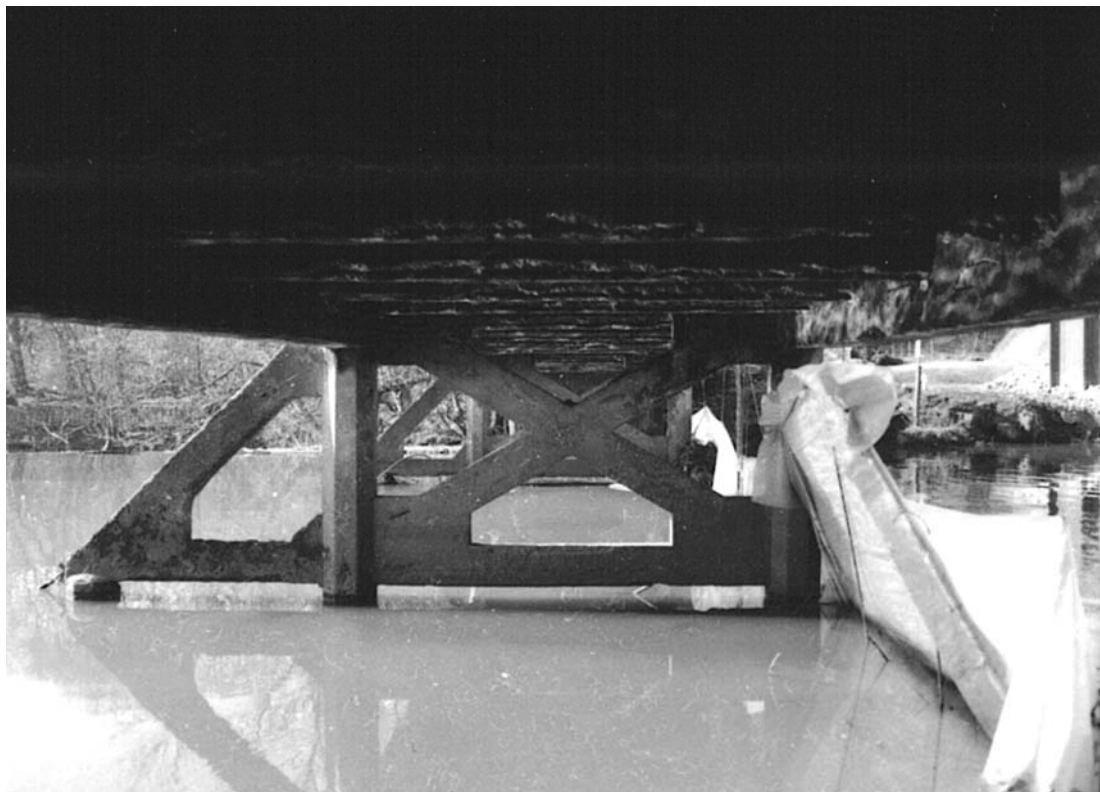
Plate 32: View from the north bank looking south, showing trestles (4a) and (4b) and cut-waters (5) and (5a) (MF SB03\_03)

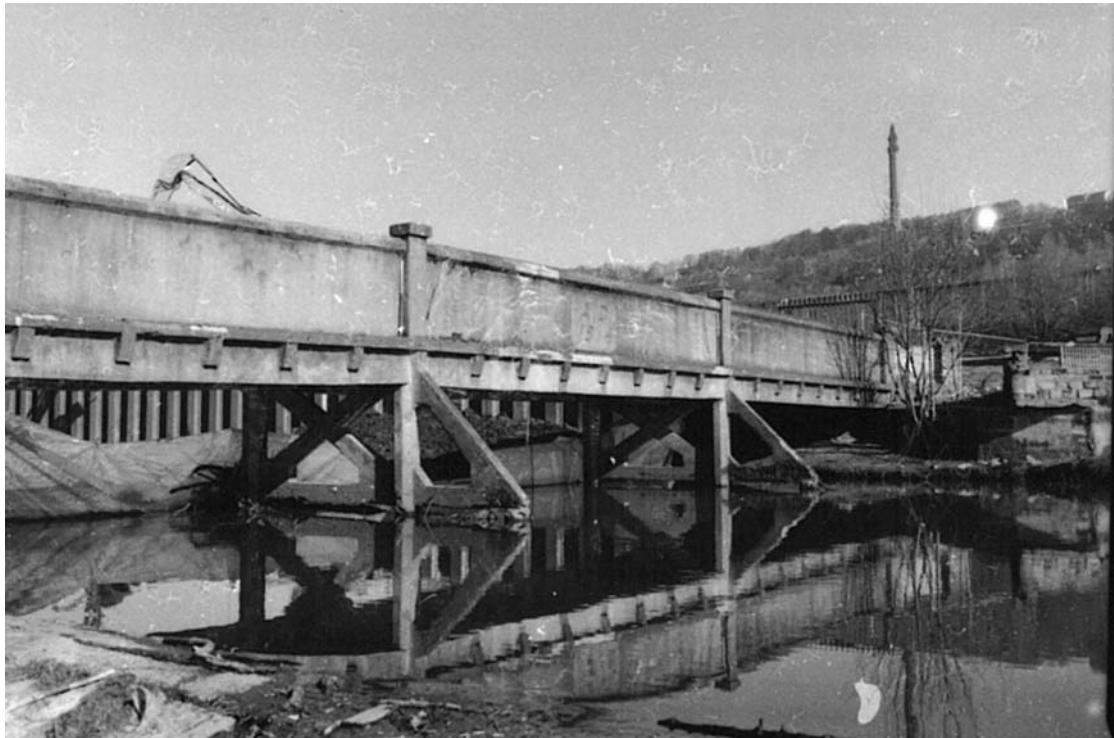
Plate 33: North-facing view showing south-east-facing bridge elevation, trestles (4a) and (4b), and cut-waters (5) and (5a) (MF SB03\_04)

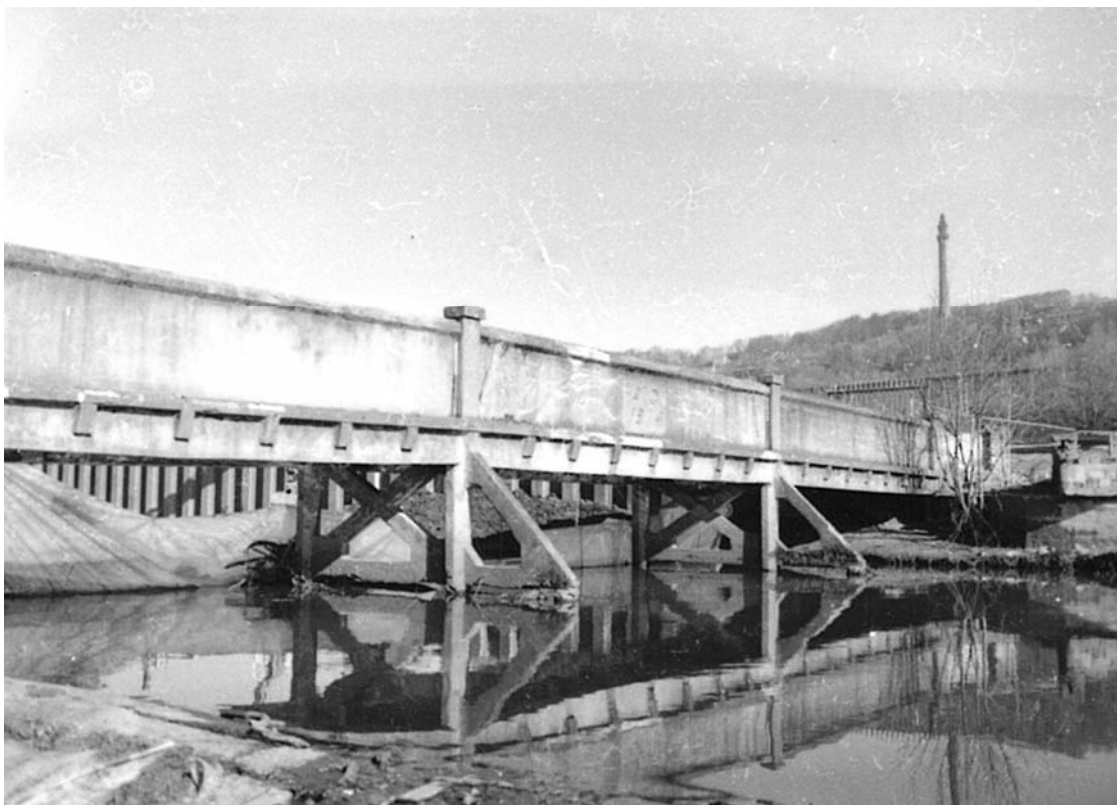
Plate 34: North-facing view showing south-east-facing bridge elevation, trestles (4a) and (4b), and cut-waters (5) and (5a) (MF SB03\_05)

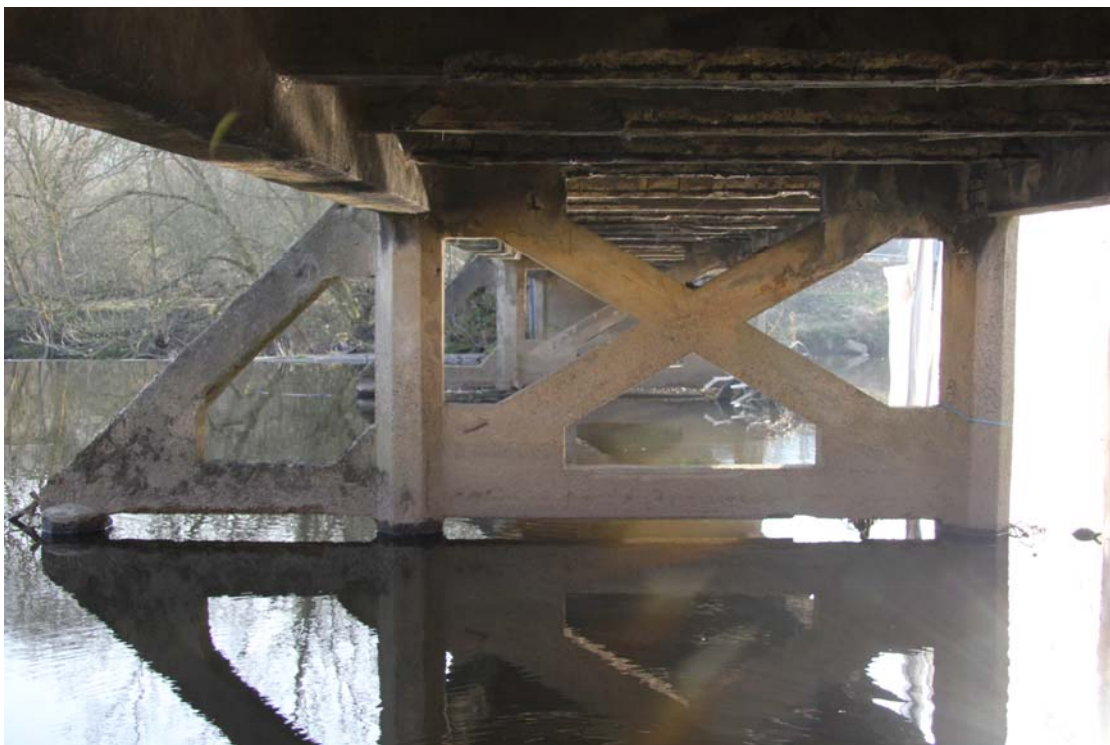
Plate 36: View from the north bank looking south, showing trestles (4a) and (4b) (IMG\_2396)

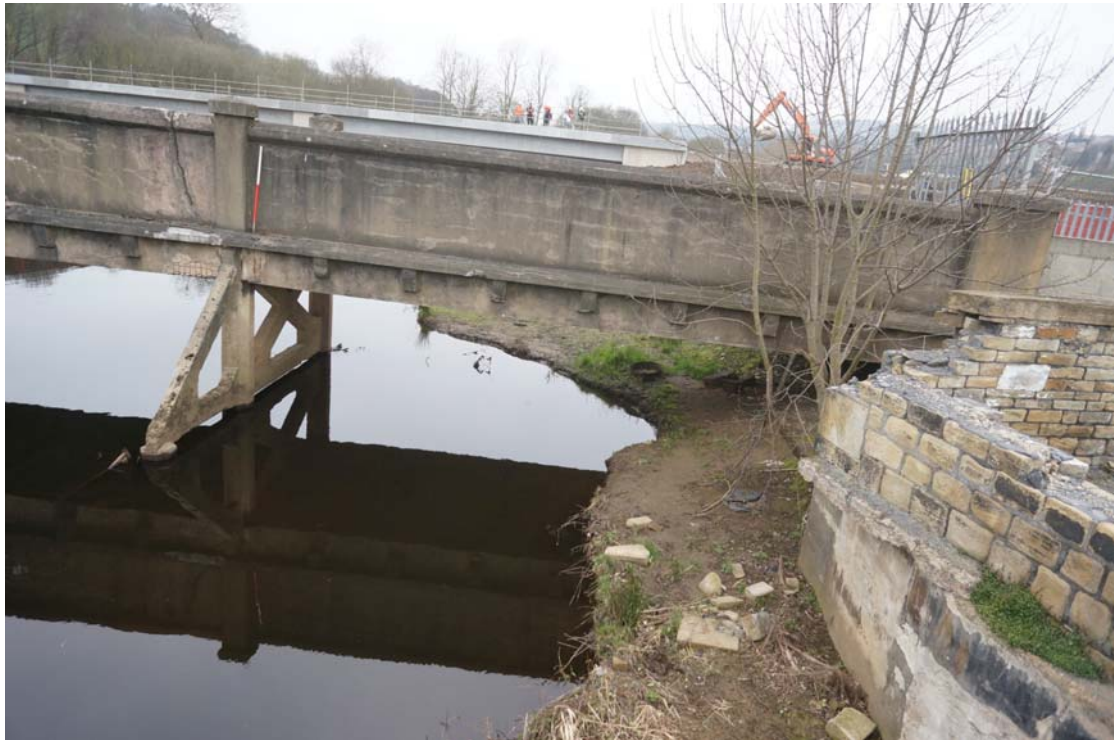
Plate 37: View from the north bank showing south-east-facing elevation and trestle (4a), and cut-water (5) (DSC00486)

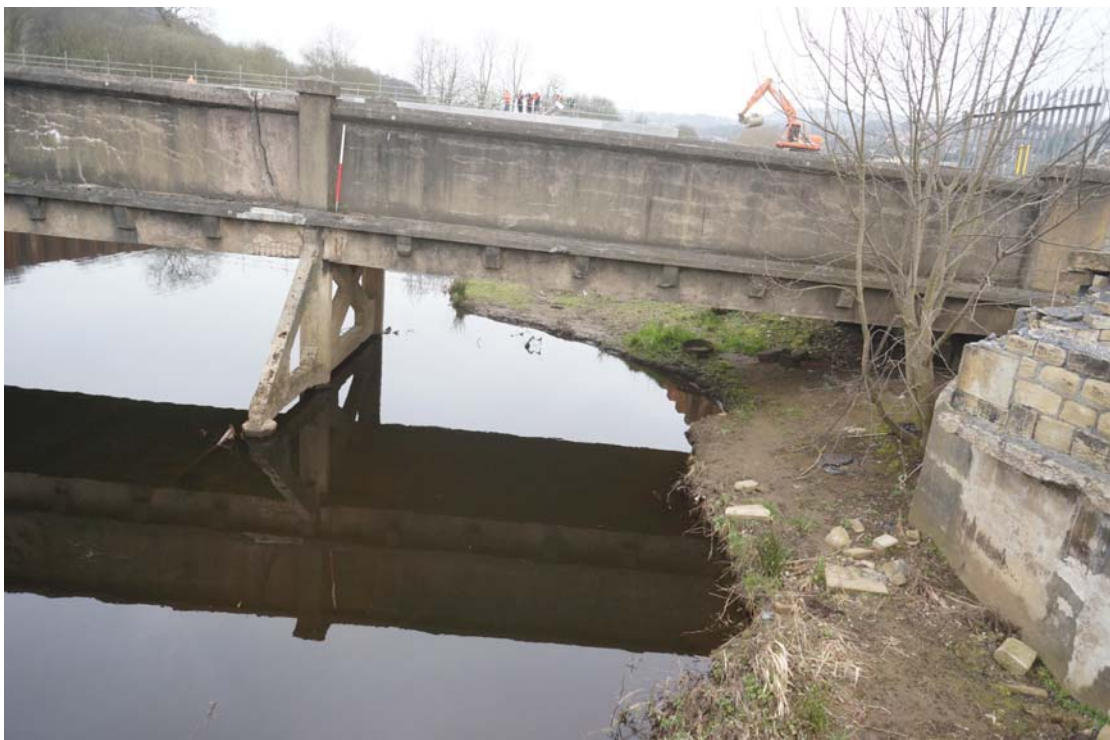
Plate 38: View from the north bank showing south-east-facing elevation and trestle (4a), and cut-water (5) (DSC00487)

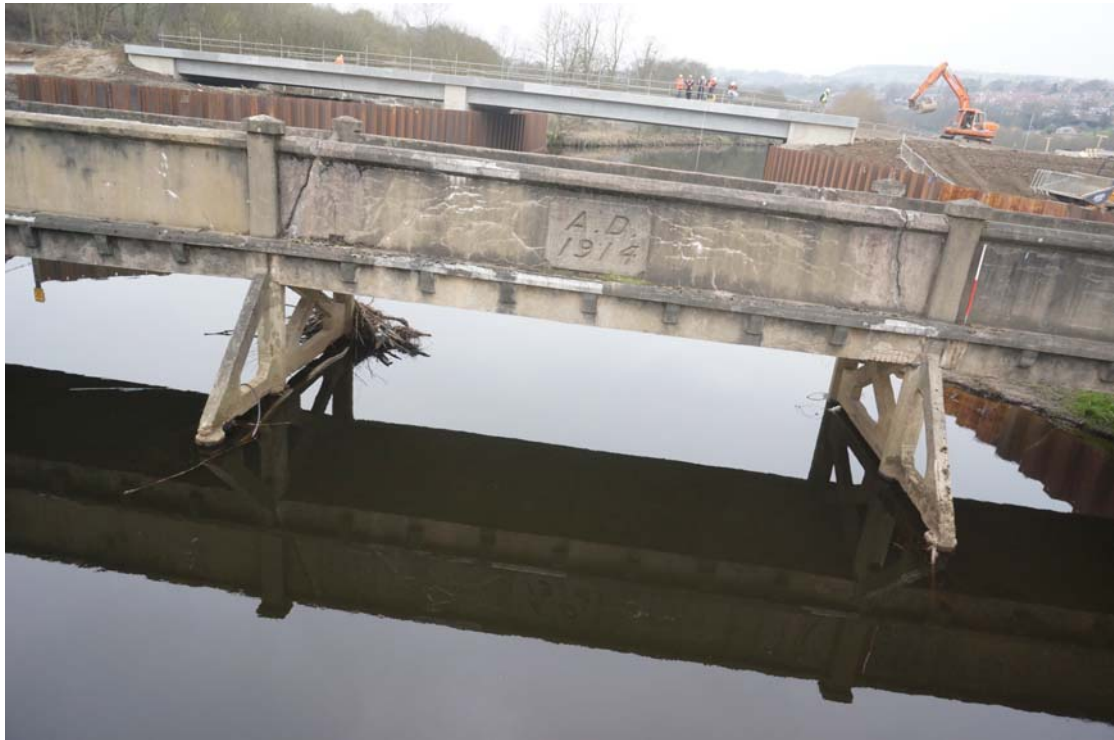
Plate 39: South-east-facing bridge elevation and trestles **(4a)** and **(4b)**; also showing cut-waters **(5)** and **(5a)** (DSC00489)

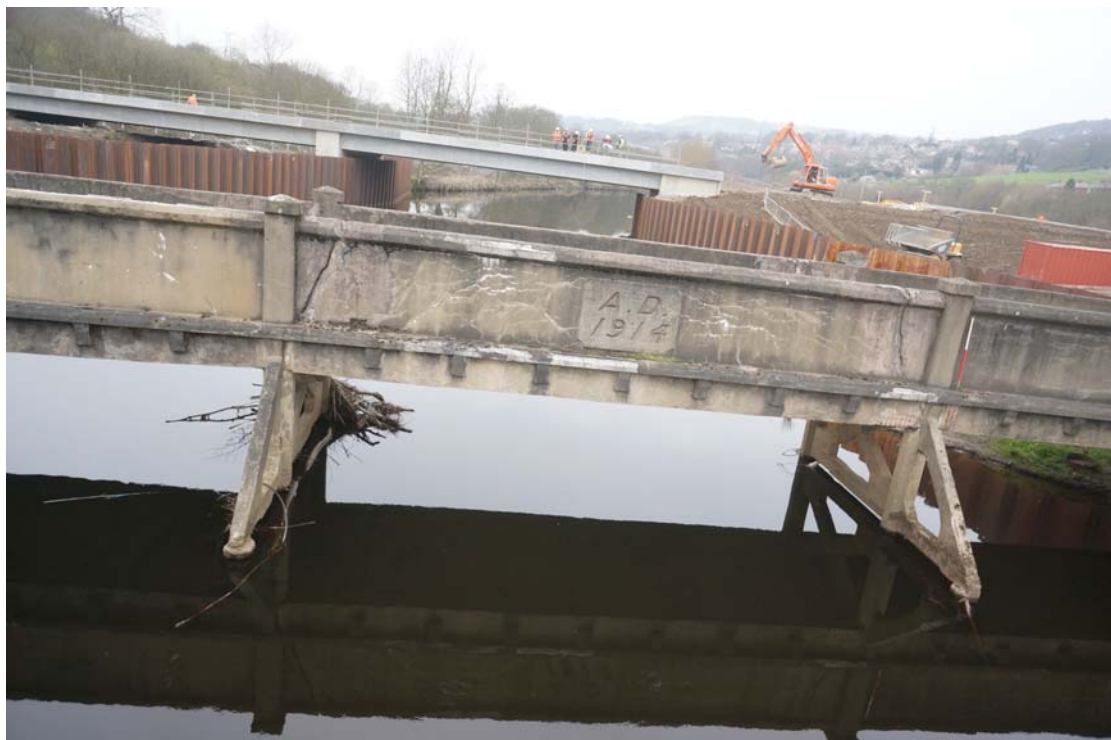
Plate 40: South-east-facing bridge elevation and trestles **(4a)** and **(4b)**; also showing cut-waters **(5)** and **(5a)** (DSC00490)

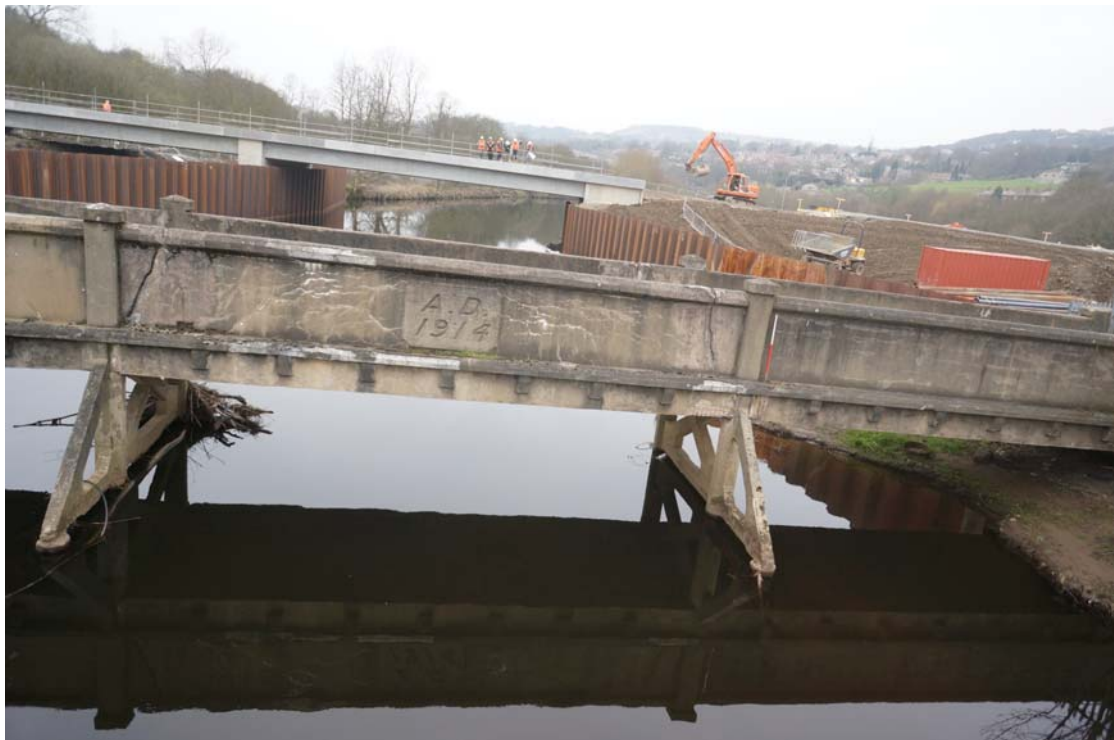
Plate 41: South-east-facing bridge elevation and trestles (4a) and (4b); also showing cut-waters (5) and (5a) (DSC00493)

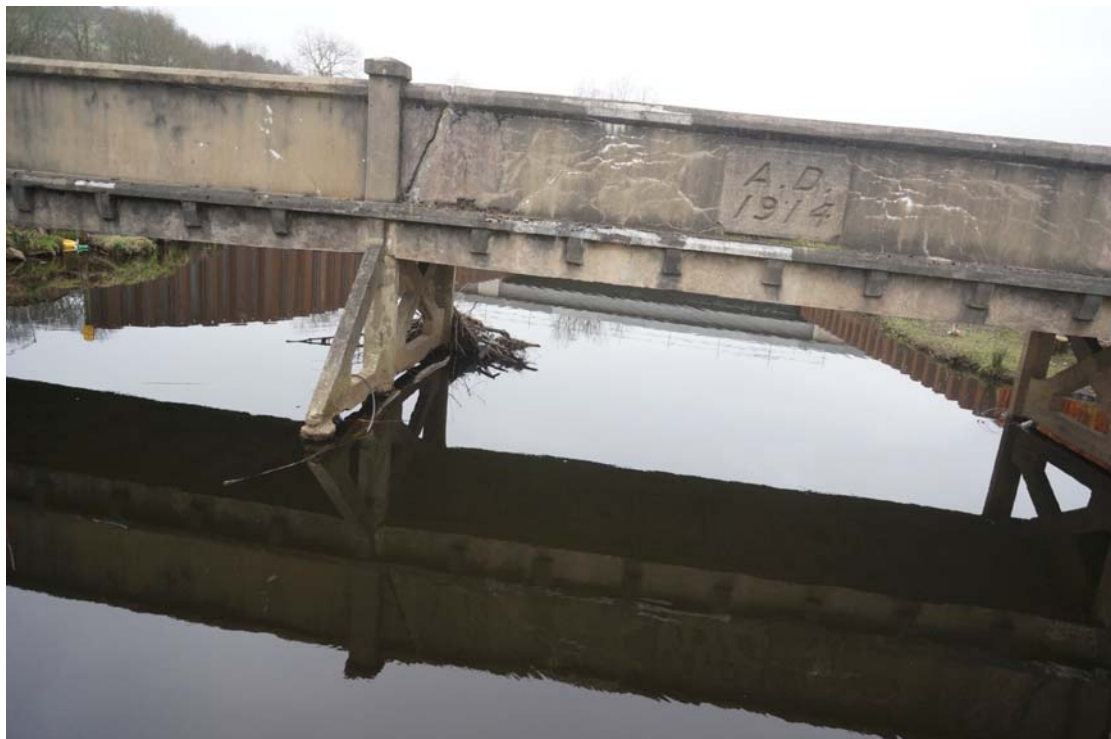
Plate 42: South-east-facing bridge elevation and trestle (4b); also showing cut-water (5a) (DSC00498)

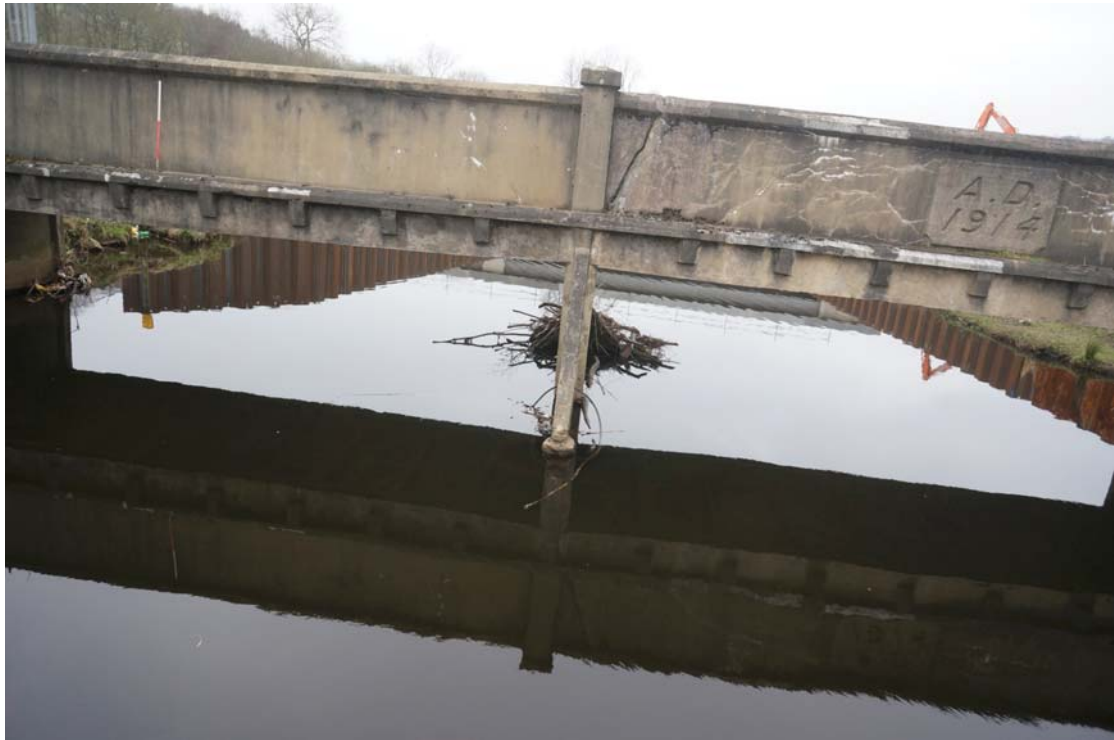
Plate 43: South-east-facing bridge elevation and trestle (4b); also showing elevation view of cut-water (5a) (DSC00499)

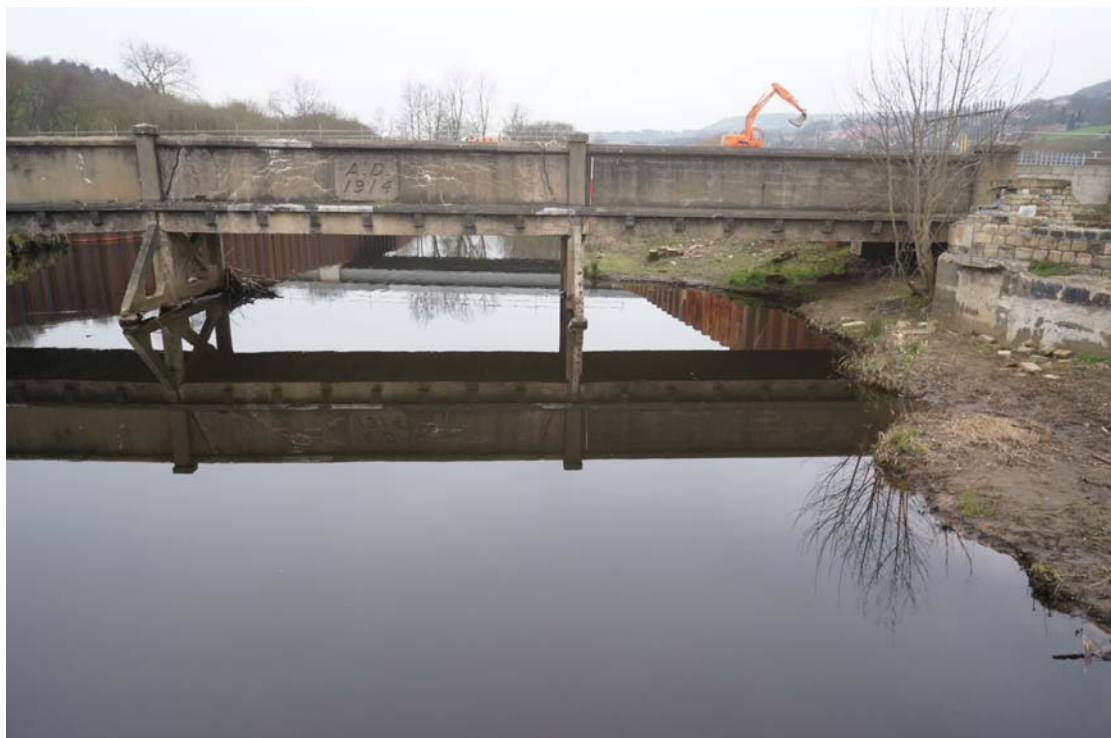
Plate 44: South-east facing bridge elevation showing trestles (4a) and (4b); also showing cut-waters (5) and (5b) (DSC00506)

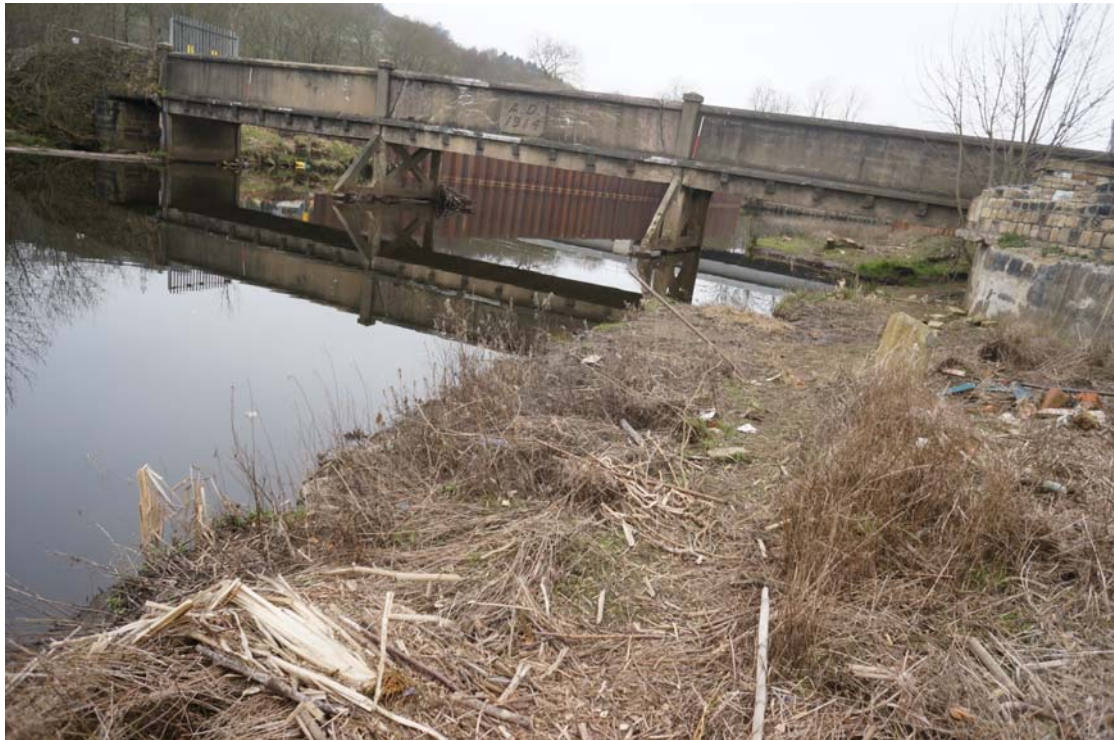
Plate 45: South-east facing bridge elevation showing trestles (4a) (4b) and (4c); also showing cut-waters (5) and (5b) (DSC00507)

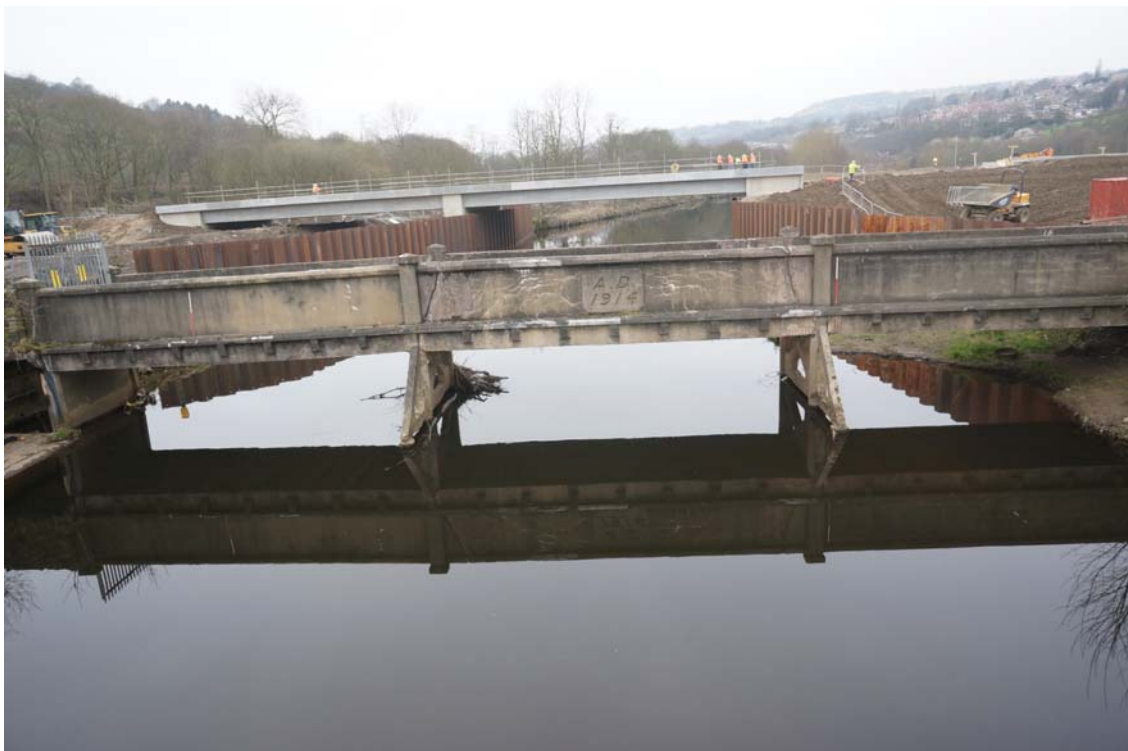
Plate 46: South-east facing bridge elevation showing trestles (4a) (4b) and (4c); also showing cut-waters (5) and (5b) (DSC00510)

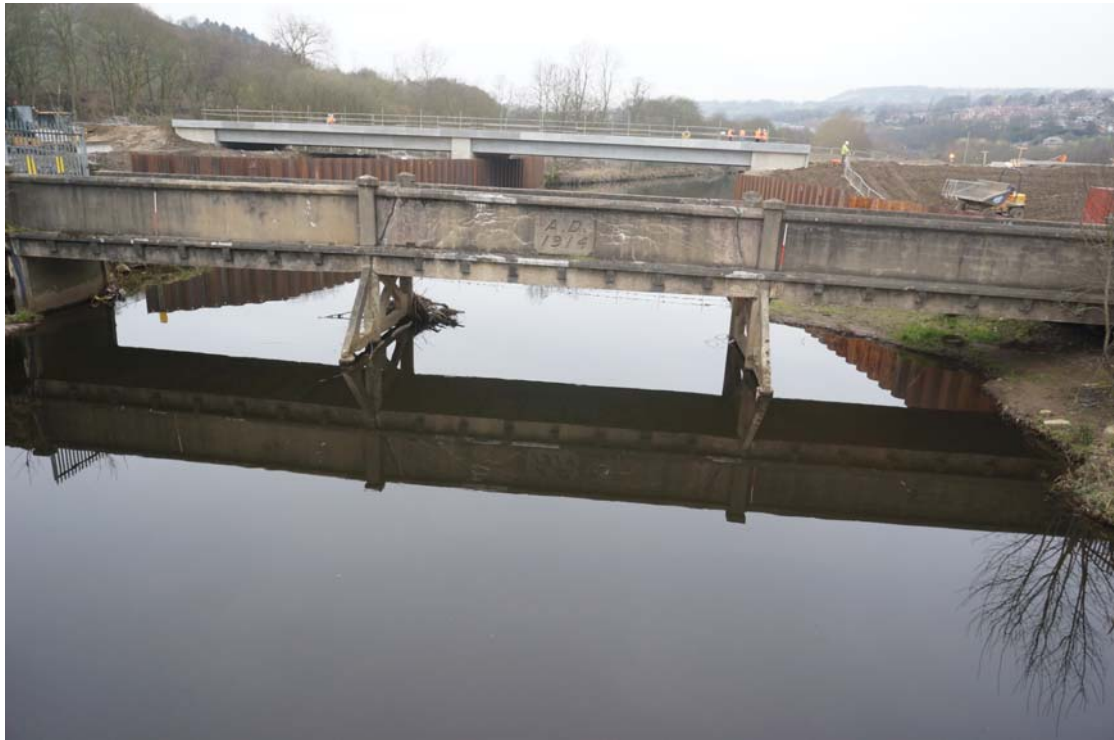
Plate 47: South-east facing bridge elevation showing trestles (4a) (4b) and (4c); also showing cut waters (5) and (5b) (DSC00512)

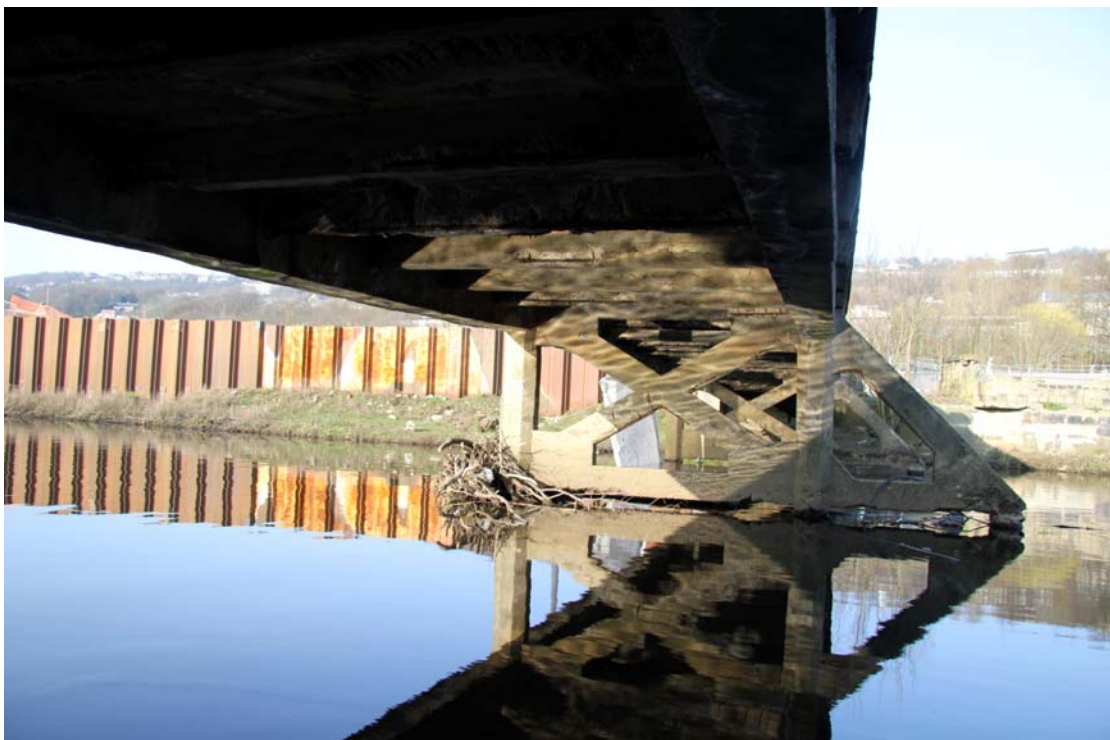
Plate 48: North-facing view beneath bridge showing trestles with diagonal internal bracing (4b) and (4a) and cut waters (5a) and (5) (IMG\_2415)

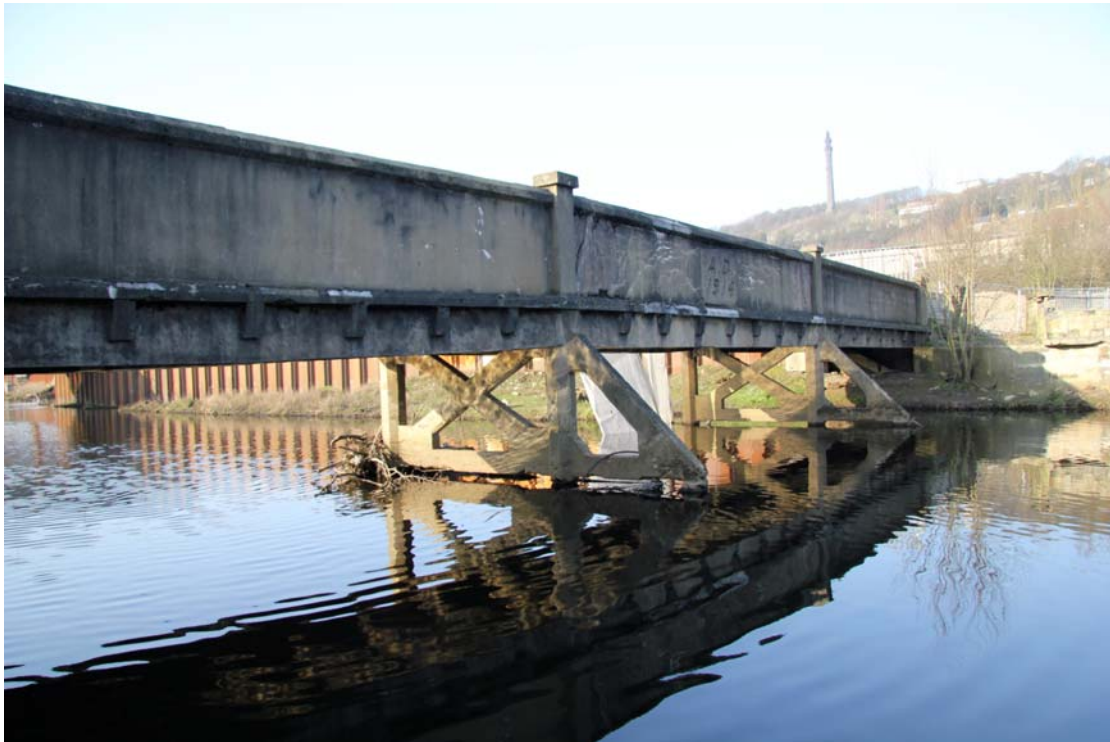
Plate 49: North-facing view showing trestles with diagonal internal bracing (**4b**) and (**4a**), and cut-waters (**5a**) and (**5**) (IMG\_2420)

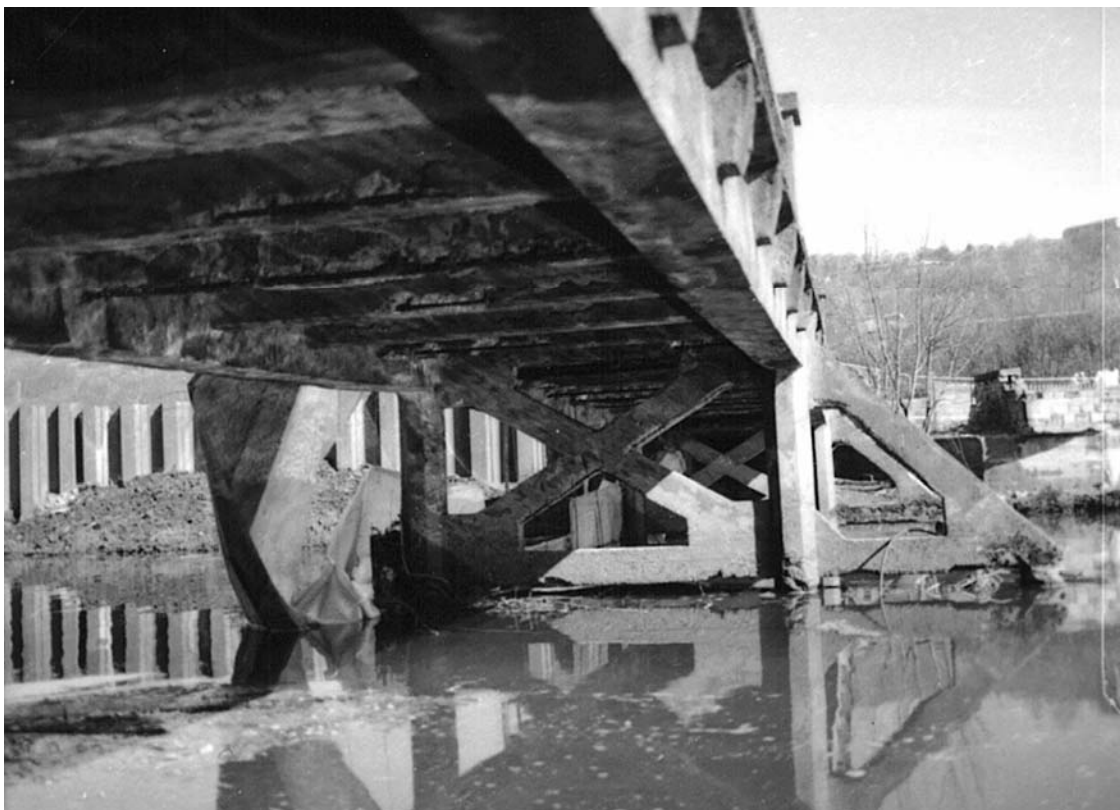
Plate 50: North-facing view showing trestles with diagonal internal bracing (**4b**) and (**4a**), and cut-waters (**5a**) and (**5**) (MF SB02\_08)

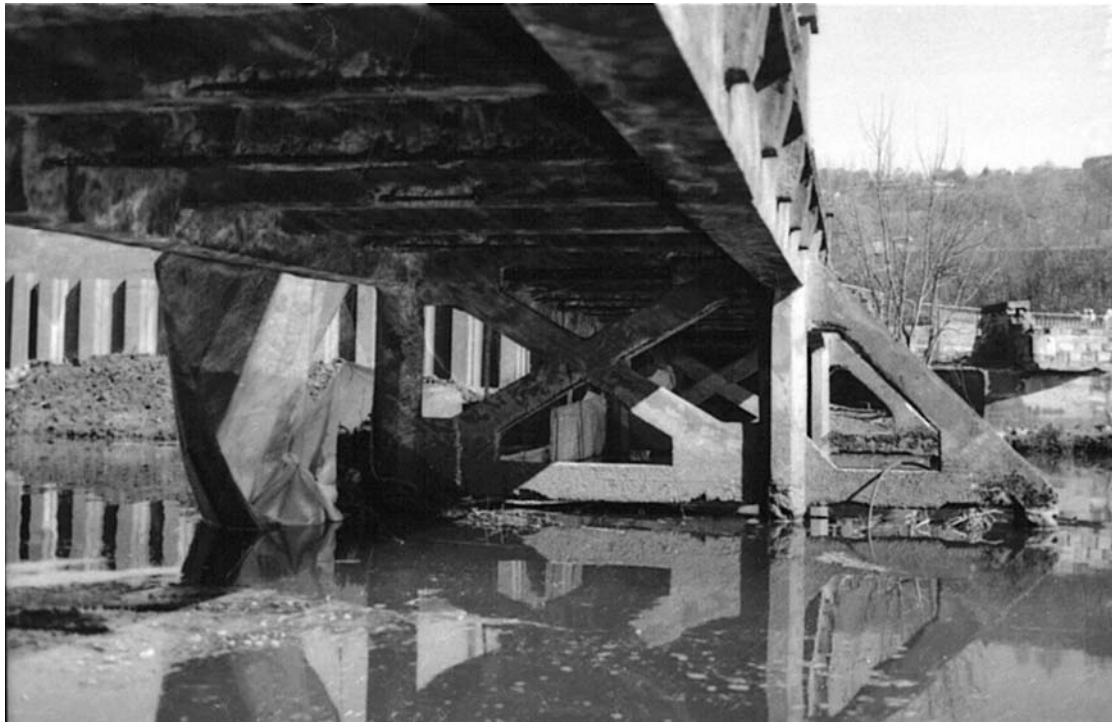
Plate 51: North-facing view showing trestles with diagonal internal bracing (**4b**) and (**4a**), and cut-waters (**5a**) and (**5**) (MF SB02\_09)
