**STERNE BRIDGE,  
SOWERBY BRIDGE–  
COPLEY VALLEY  
REGENERATION  
PROJECT,  
SKIRCOAT,  
WEST YORKSHIRE**

**Archaeological  
Photographic  
Building Recording  
and Watching Brief**

**Oxford Archaeology North**

September 2012

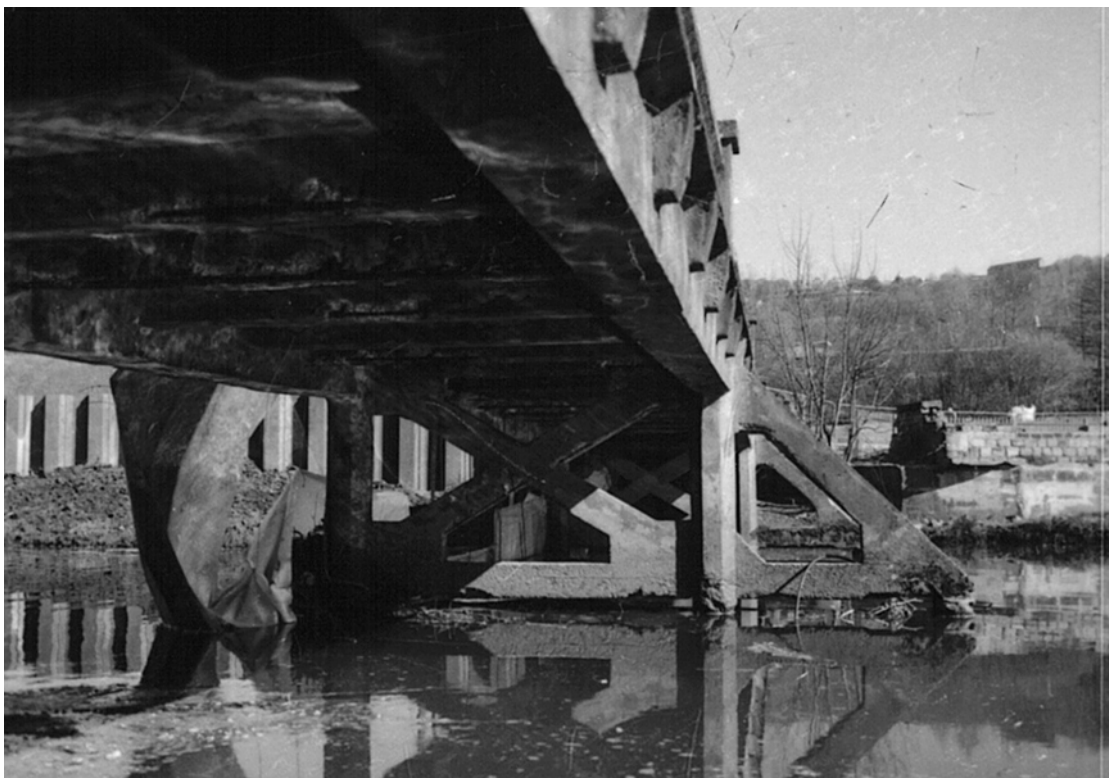
Plate 52: North-facing view showing trestles with diagonal internal bracing (**4b**) and (**4a**), and cut-waters (**5a**) and (**5**) (MF SB02\_10)

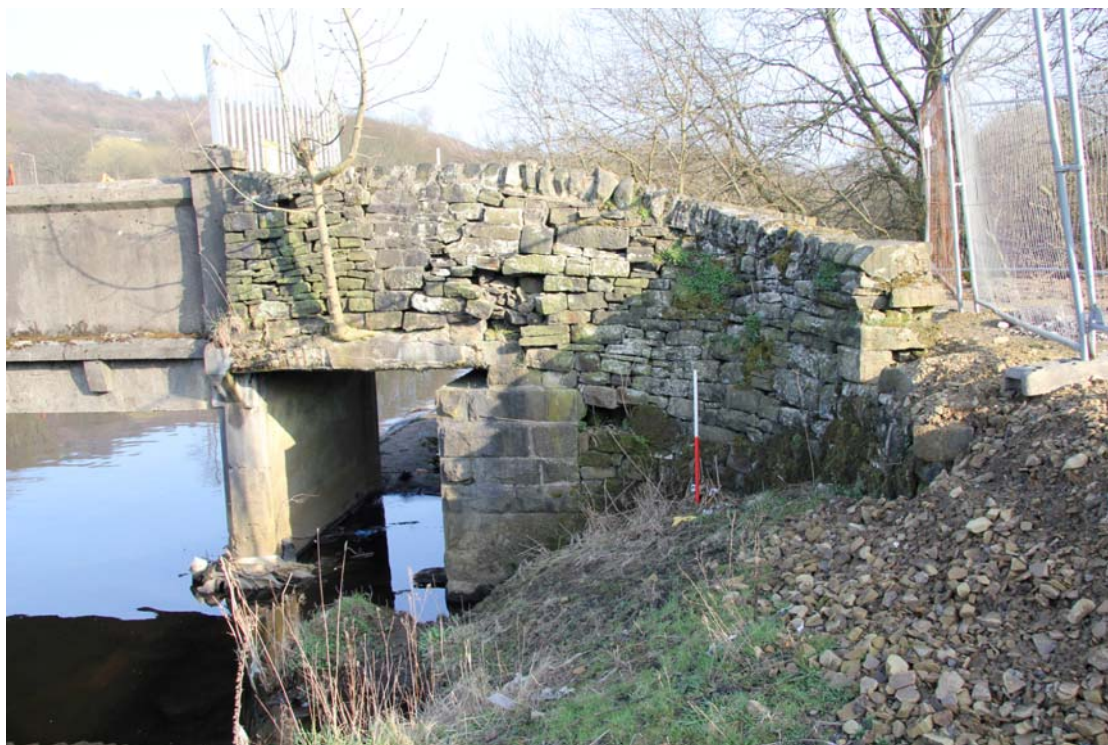
Plate 56: East-facing view showing the southern trestle (**4c**), parapet (**10**), and western rubble wing wall (**11a**) (IMG\_2423)

Plate 56: East-facing view showing southern trestle (**4c**), parapet (**10**), and western rubble wing wall (**11a**) (IMG\_2423)

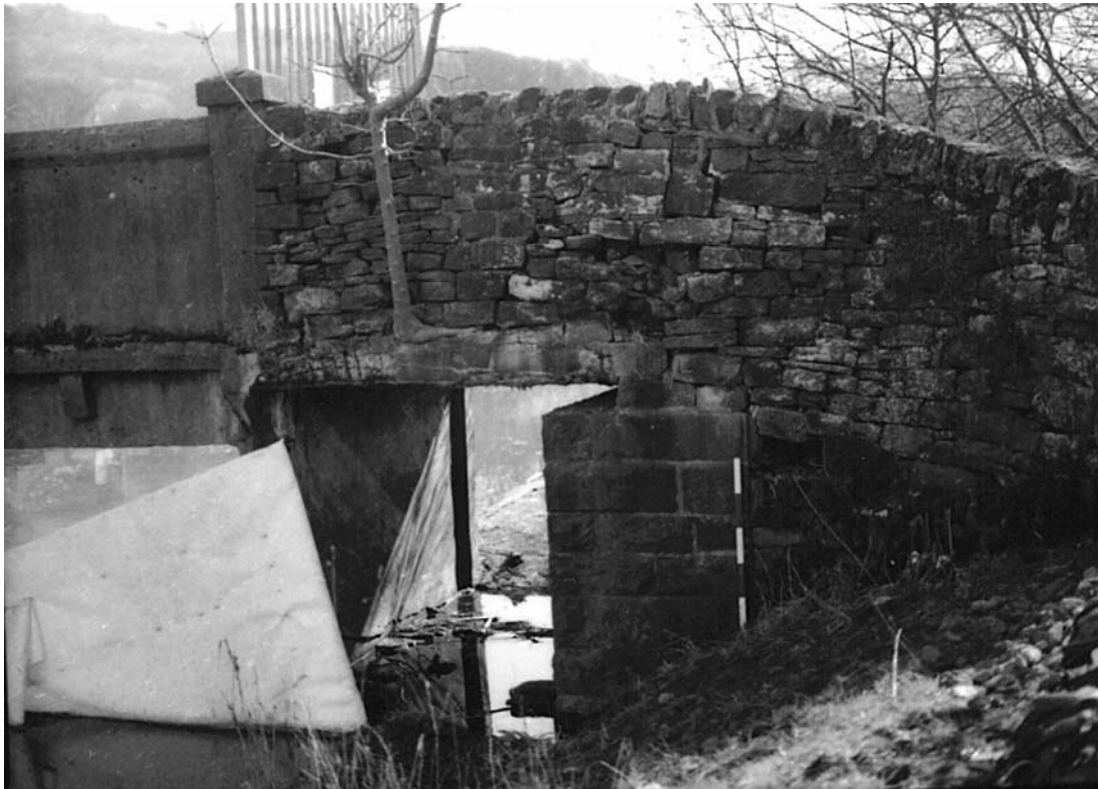
Plate 57: East-facing view showing the southern trestle (**4c**) and western rubble wing wall (**11a**) (MF SB02\_02)

Plate 57: East-facing view showing southern trestle (4c) and western rubble wing wall (11a) (MF SB02\_02)

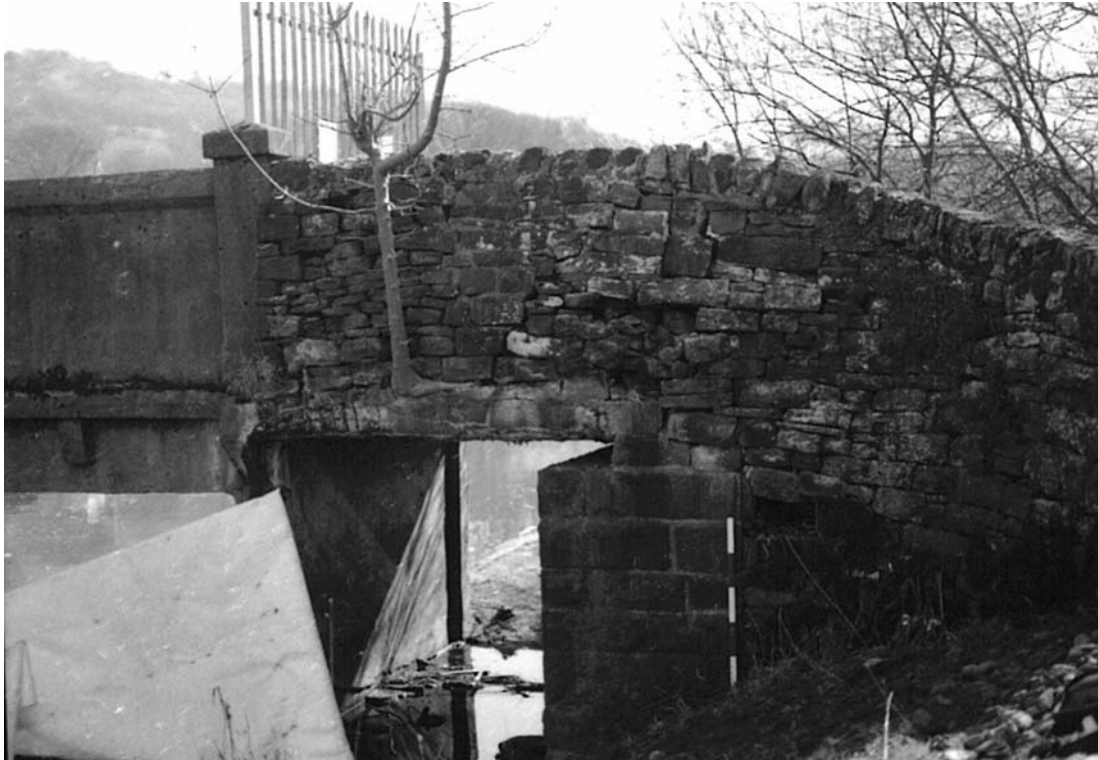
Plate 58: East-facing view showing the southern trestle (**4c**) and western rubble wing wall (**11a**) (MF SB02\_03)

Plate 58: East-facing view showing southern trestle (4c) and western rubble wing wall (11a) (MF SB02\_03)

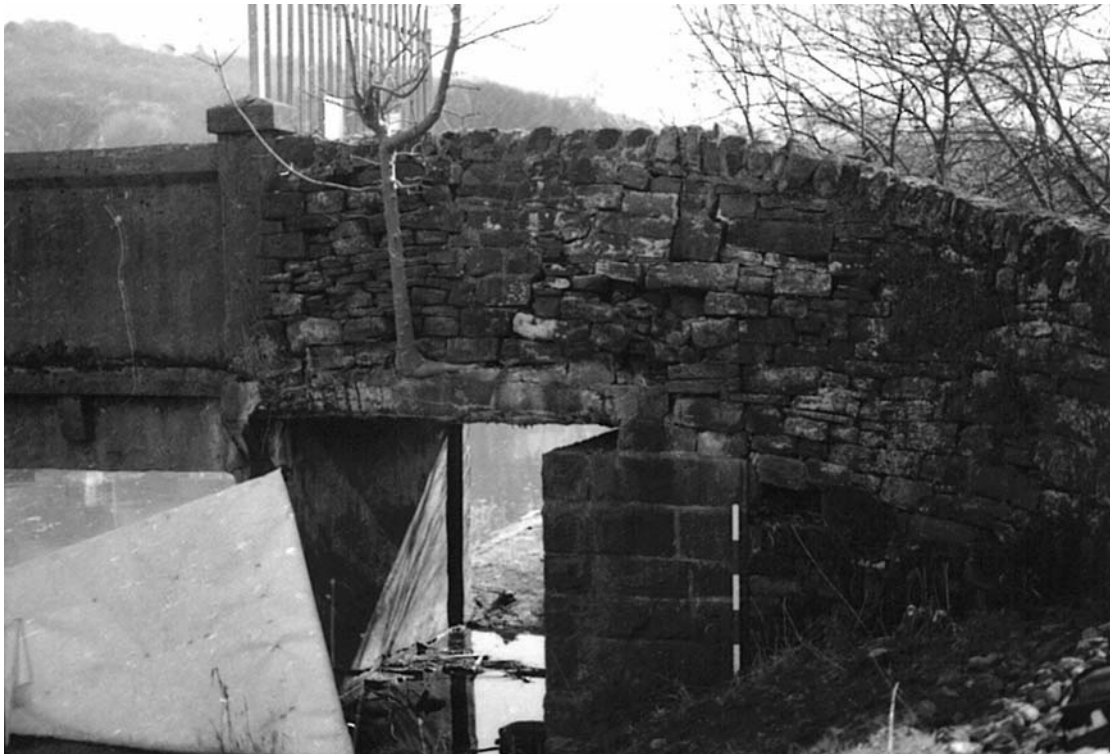
Plate 59: East-facing view showing southern trestle (**4c**) and western rubble wing wall (**11a**) (MF SB02\_04)

Plate 59: East-facing view showing southern trestle (4c) and western rubble wing wall (11a) (MF SB02\_04)

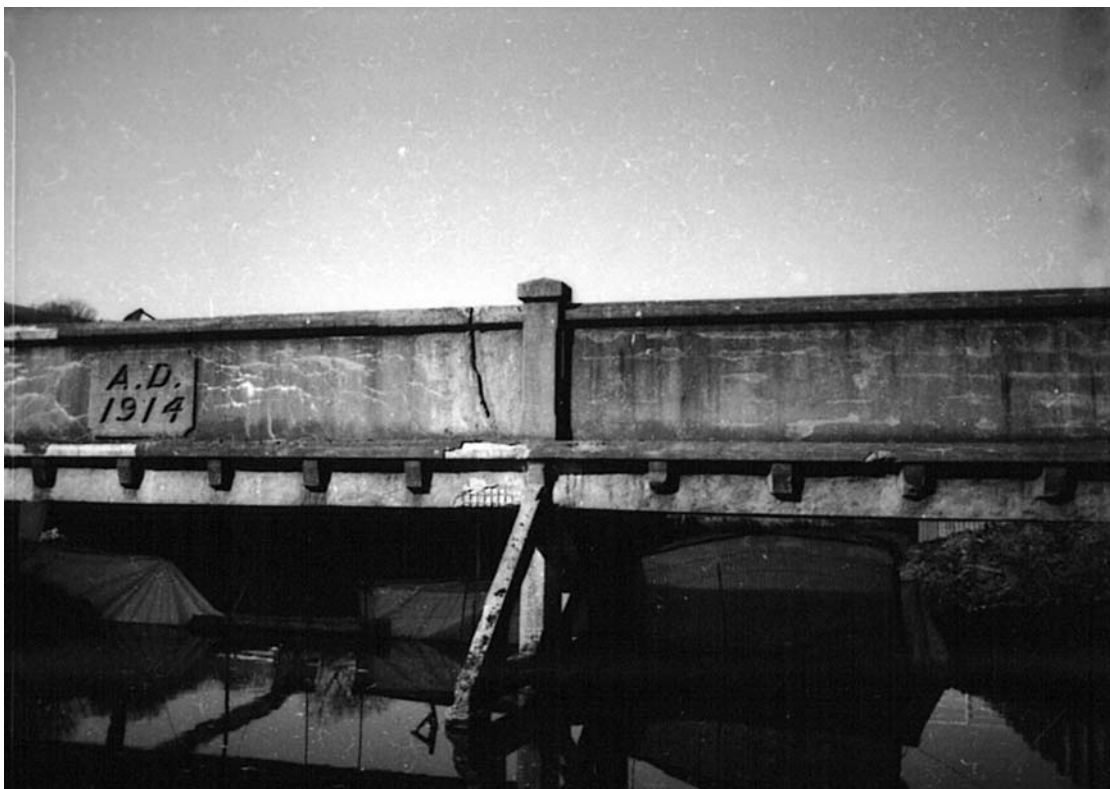
Plate 60: West-facing view showing parapet and parapet sill (**10**), over cross beams (**8**) (MF SB06\_04)

Plate 60: West-facing view showing parapet and parapet sill (10) and over cross beams (8) (MF SB06\_04)

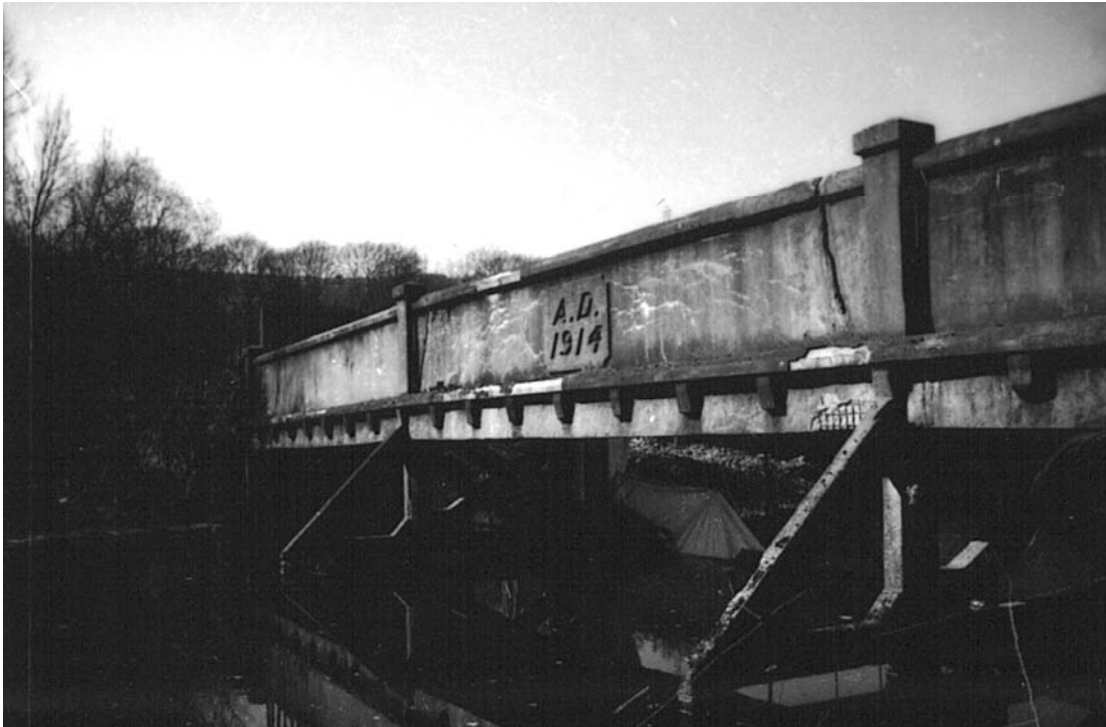
Plate 61: South-facing view showing parapet and parapet sill (**10**), over cross beams (**8**) with vertical pillars (**9a - 9c**) (MF SB06\_08)

Plate 61: South-facing view showing parapet and parapet sill (10) over cross beams (8) with vertical pillars (9A - 9C) (MF SB06\_08)

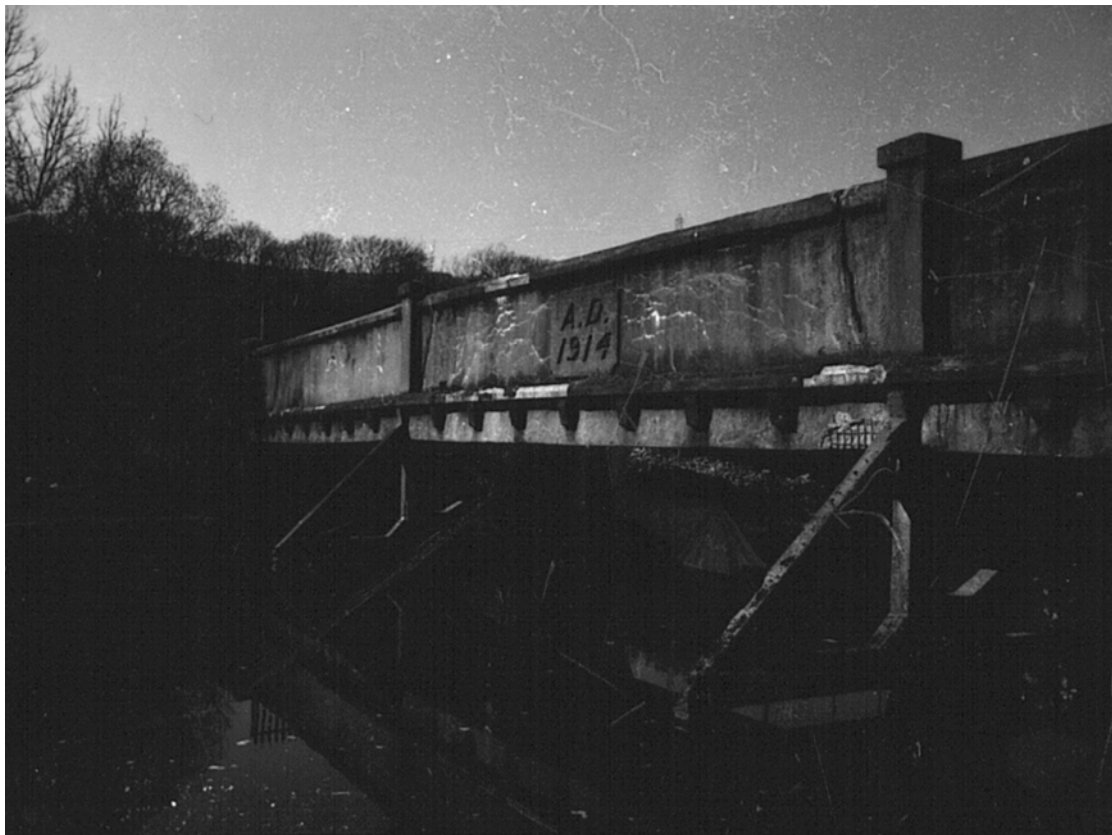
Plate 62: South-facing view showing parapet and parapet sill (**10**), over cross beams (**8**) (MF SB06\_09)

Plate 62: South-facing view showing parapet and parapet sill (10) over cross beams (8) (MF SB06\_09)

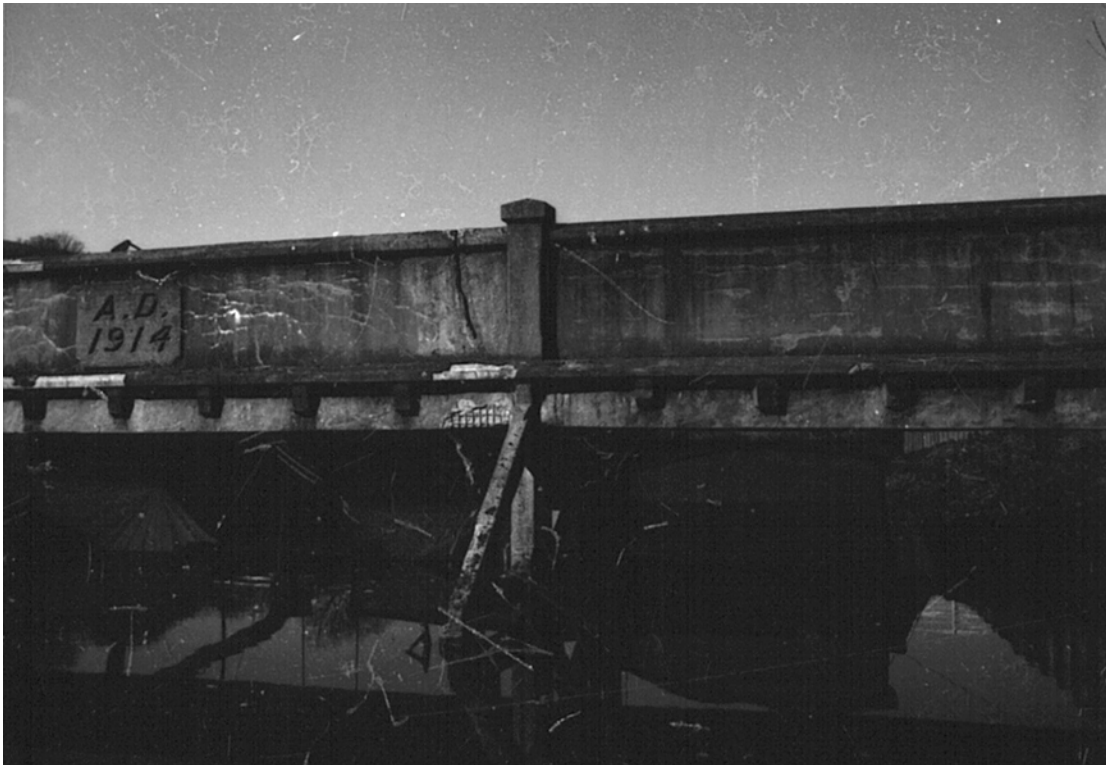
Plate 63: West-facing view showing parapet and parapet sill (**10**), over cross beams (**8**) with vertical pillar (**9a**) (MF SB06\_10)

Plate 63: West-facing view showing parapet and parapet sill (**10**) over cross beams (**8**) with vertical pillar (**9a**) (MF SB06\_10)

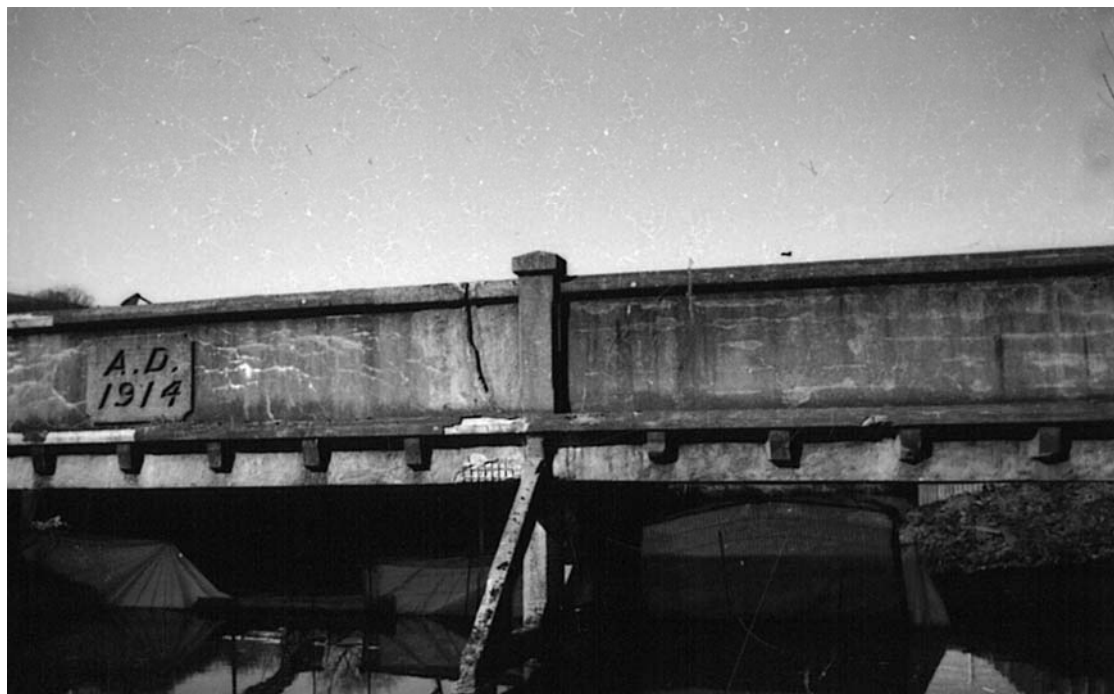
Plate 64: West-facing view showing parapet and parapet sill (**10**), over cross beams (**8**) with vertical pillar (**9a**) (MF SB06\_11)

Plate 64: West-facing view showing parapet and parapet sill (**10**) over cross beams (**8**) with vertical pillar (**9a**) (MF SB06\_11)

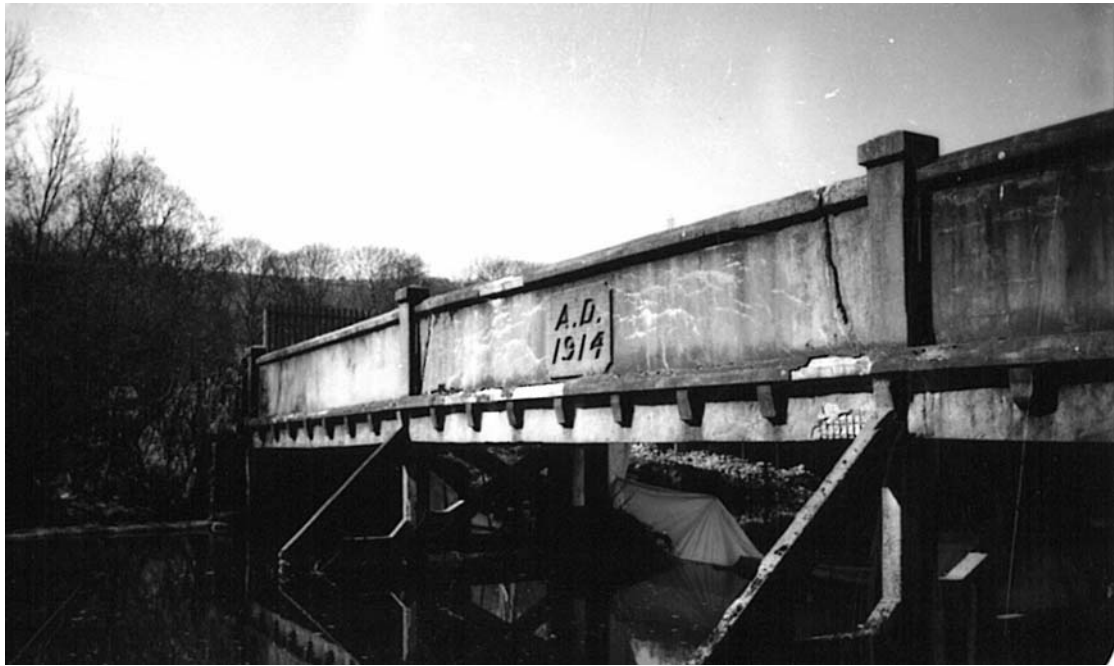
Plate 65: South-facing view showing parapet and parapet sill (**10**), over cross beams (**8**), with vertical pillars **9a-9c** and date stone (**13**) (MF SB06\_15)

Plate 65: South-facing view showing parapet and parapet sill (10) over cross beams (8) with vertical pillars (9a-9c) and date stone (13) (MF SB06\_15)

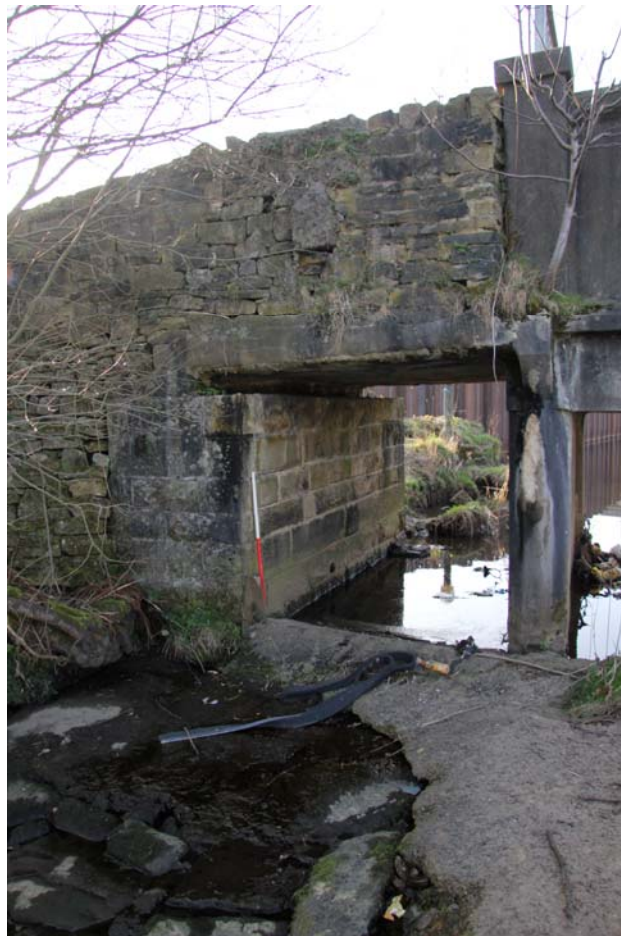
Plate 66: Interface between the south-east wing wall (**11**), stone abutment (**12**) and the later concrete parapet wall of the bridge (IMG\_2407)

Plate 66: Interface between the south-east wing wall (11), stone abutment (12) and the later concrete parapet wall of bridge (IMG\_2407)

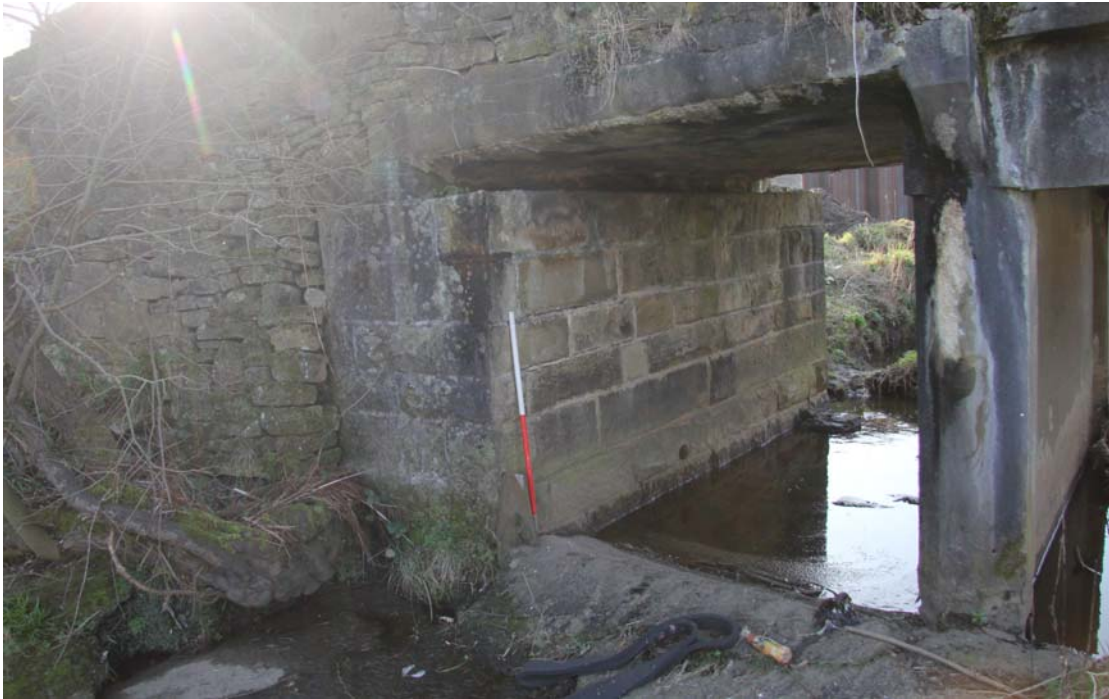
Plate 67: Interface between the south-east wing wall (**11**), stone abutment (**12**) and the later concrete parapet wall of bridge with chamfered cross beam (**8**) (IMG\_2408)

Plate 67: Interface between the south-east wing wall (11), stone abutment (12) and the later concrete parapet wall of bridge with chamfered cross beam (8) (IMG\_2408)

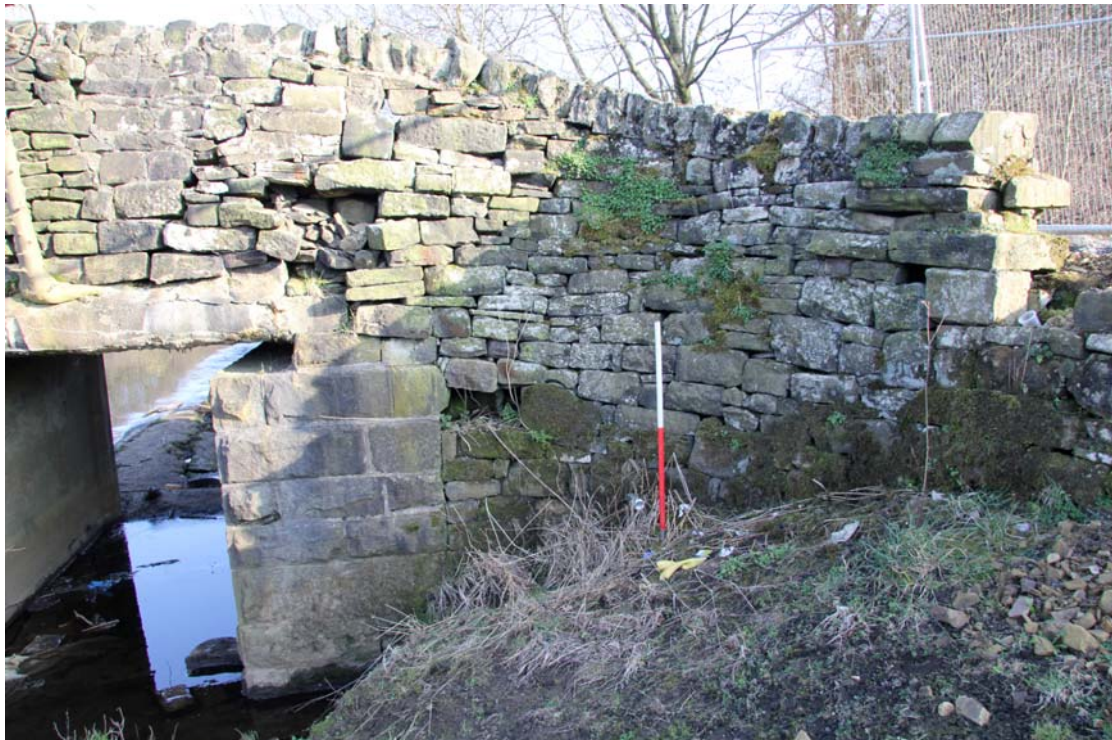
Plate 68: Interface between the south-east wing wall (**11**) and stone abutment (**12**) (IMG\_2424)

Plate 68: Interface between the south-east wing wall (11) and stone abutment (12) (IMG\_2424)

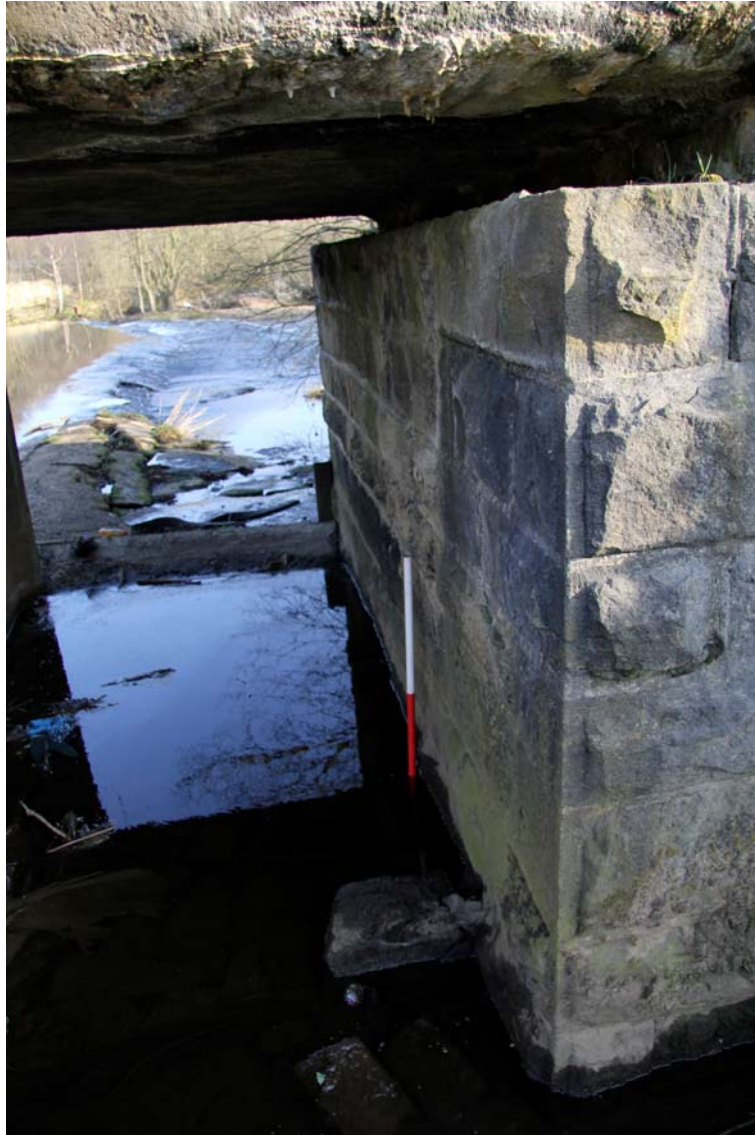
Plate 69: East-facing shot showing a close-up of the ashlar sandstone southern abutment (12) (IMG\_2406)

- 4.2.11 To the rear of the dressed face of the abutment (**12**; Figs 11-12), the wing wall (**11**; Figs 11-12) is of dry stone rubble construction, butting up to the rear face of the abutment (**12**; Plates 66-69). It was built of roughly-squared sandstone blocks, built to course with double-faced construction and a loose rubble core, and was battered slightly for greater strength (Plates 79-80). The wing walls splayed out on both the eastern and western faces, suggesting that access to the bridge was required from both directions, although the splay was more exaggerated on the west side (Plates 79-80), suggesting that this had formed the principal access. Much of the stone parapet wall represents a rebuild associated with the earlier bridge, but the southern part of the extant western wing wall appears to extend in its original form to parapet height, where it had edge-set copings of similar proportions to those used in the wall faces (Plates 56-59). At its very southern extent it retained three dressed and chamfered capstones, with two relatively well-dressed stones beneath (Plate 56), forming the end of the surviving wall, possibly suggesting that the parapet wall at the terminus of the wing wall was dressed, and that the bridge therefore almost certainly had some ornamentation.

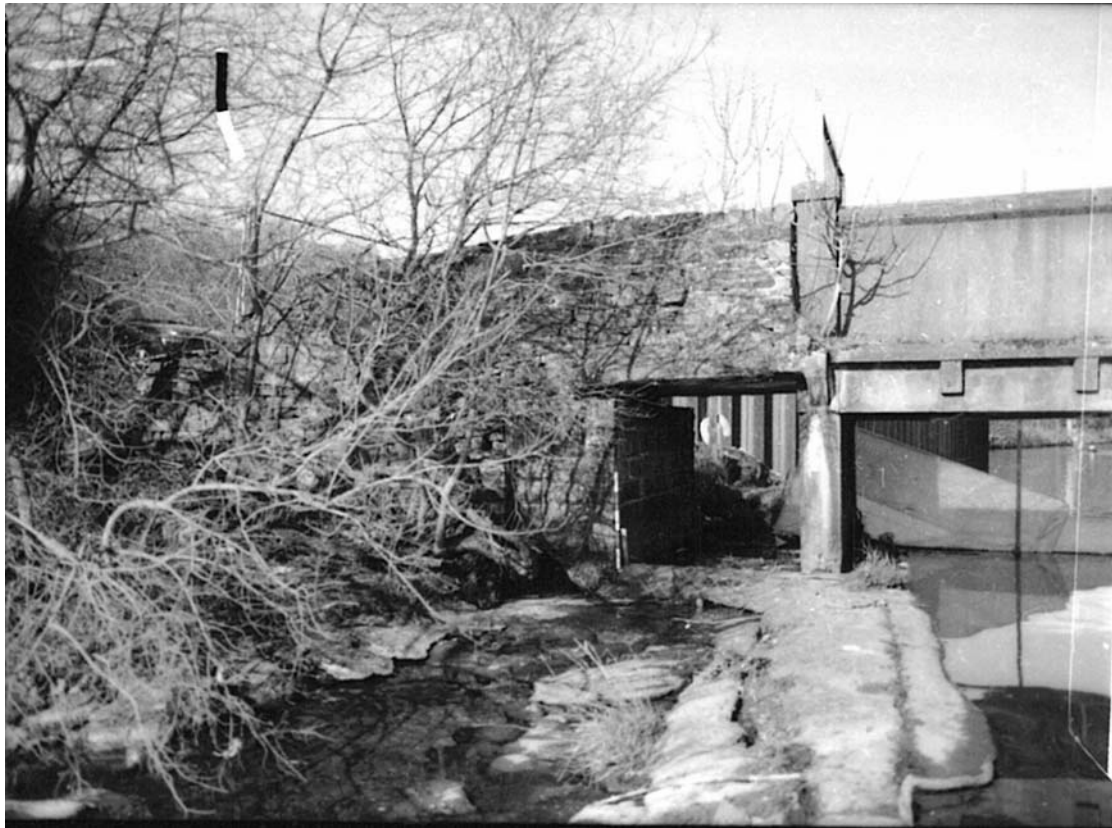
Plate 70: View from the edge of the weir showing wing wall (**11**), abutment (**12**) and trestle **4c** (MF SB03\_07)

Plate 70: View from the edge of the weir showing wing wall (11), abutment (12) and trestle (4c) (MF SB03\_07)

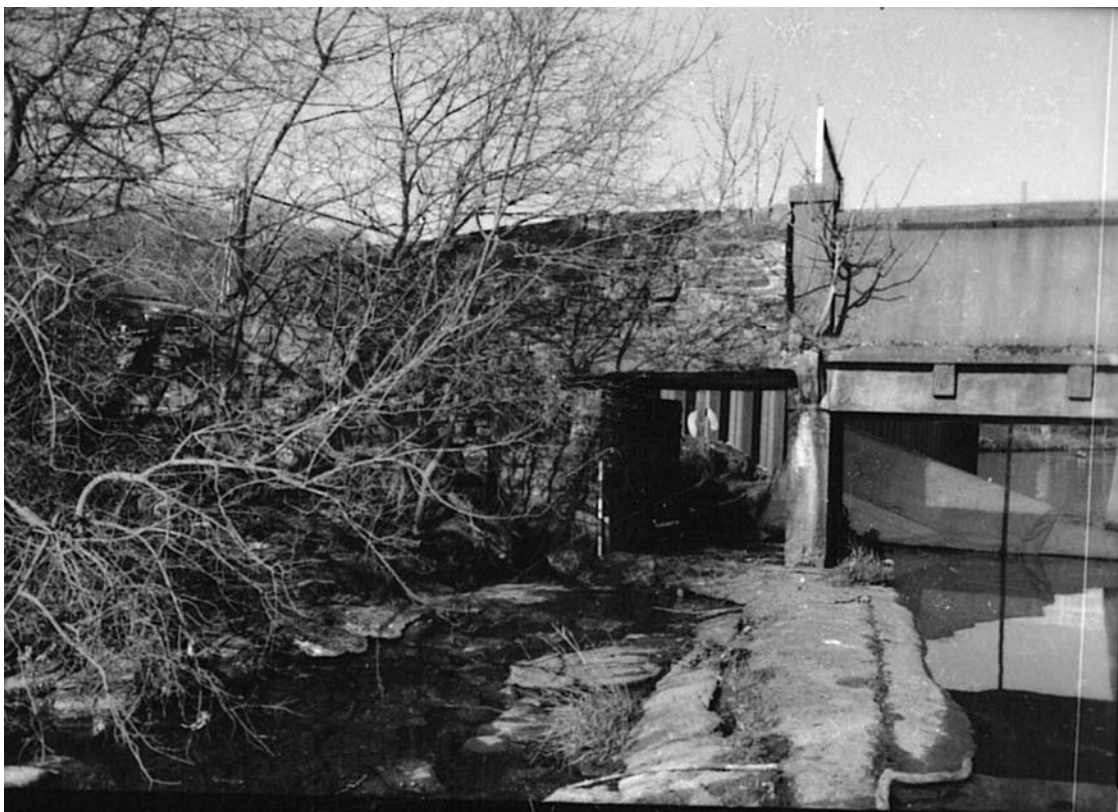
Plate 71: View from the edge of the weir showing wing wall (**11**), abutment (**12**) and trestle **4c** (MF SB03\_08)

Plate 71: View from the edge of the weir showing wing wall (11), abutment (12) and trestle (4c) (MF SB03\_08)

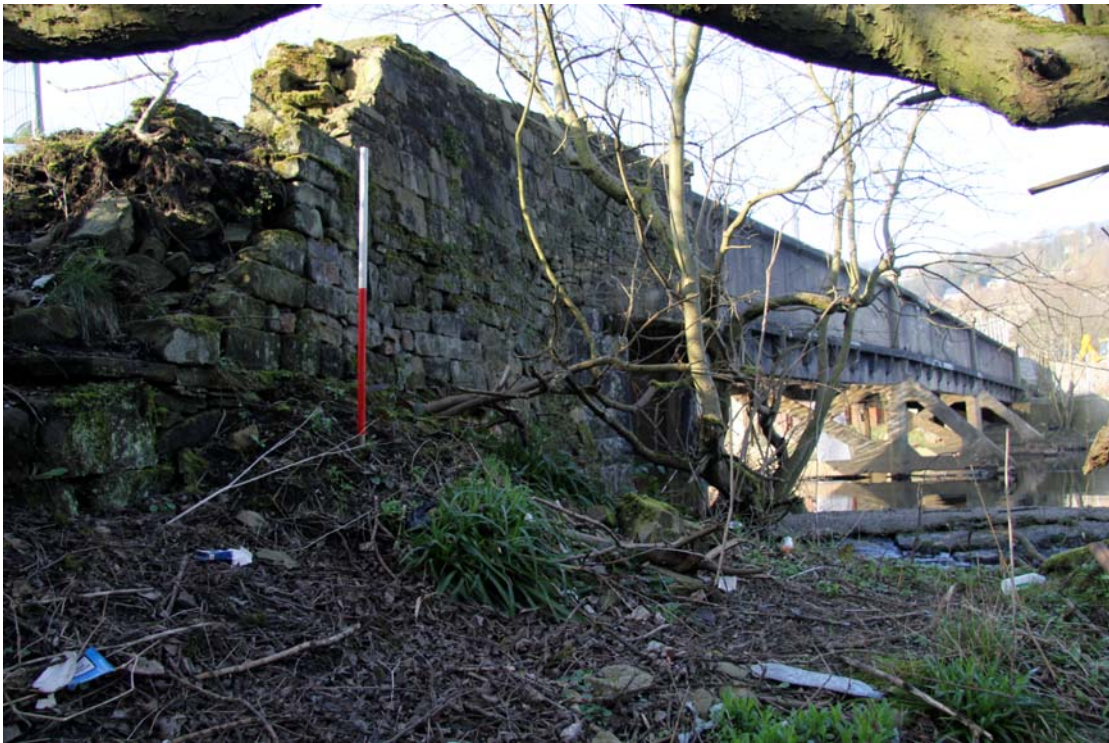
Plate 72: South-eastern wing wall (11) showing truncation and root damage (IMG\_2417)

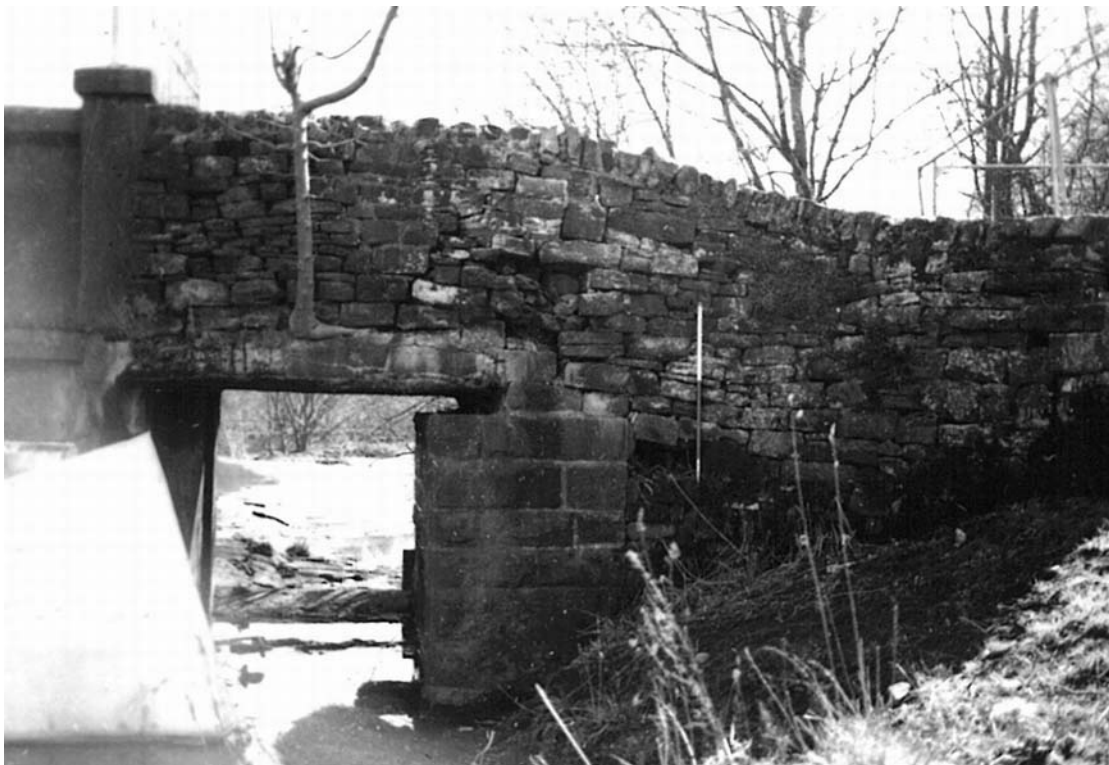
Plate 73: South-western wing wall (**11**) and sandstone abutment (**12**) (MF SB06\_01)

Plate 73: South-western wing wall (11) and sandstone abutment (12) (MF SB06\_01)

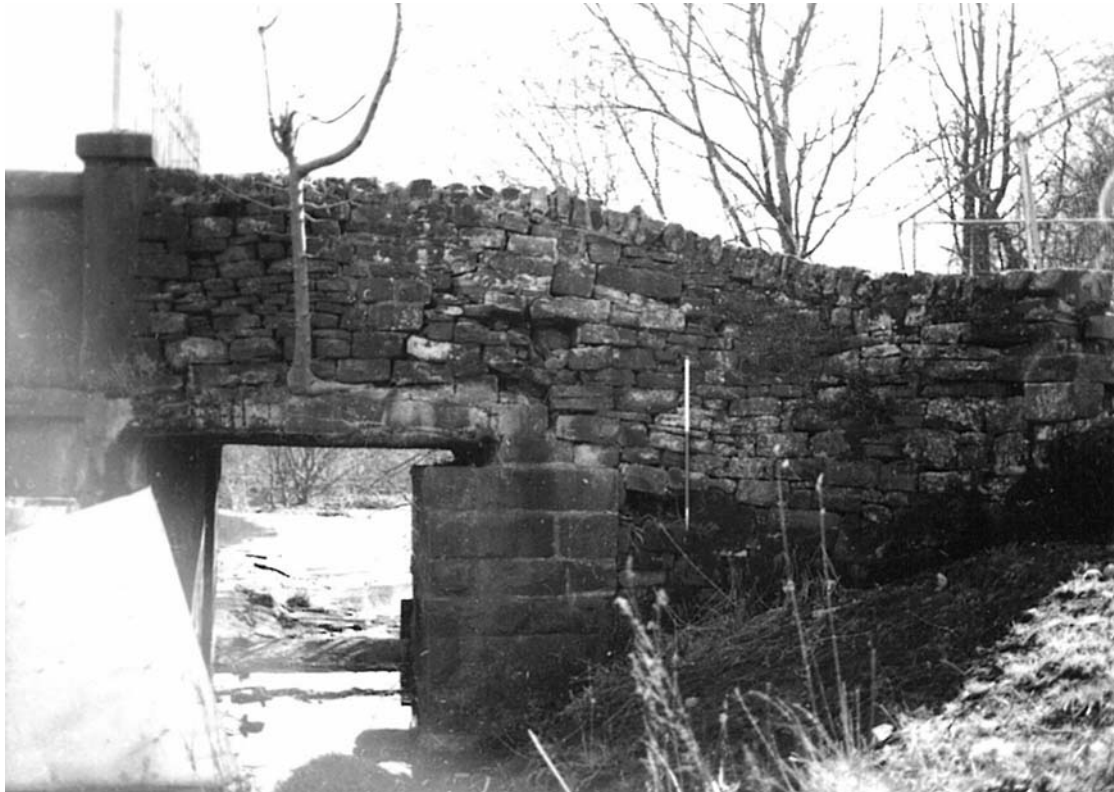
Plate 74: South-western wing wall (**11**) and sandstone abutment (**12**) (MF SB06\_02)

Plate 74: South-western wing wall (11) and sandstone abutment (12) (MF SB06\_02)

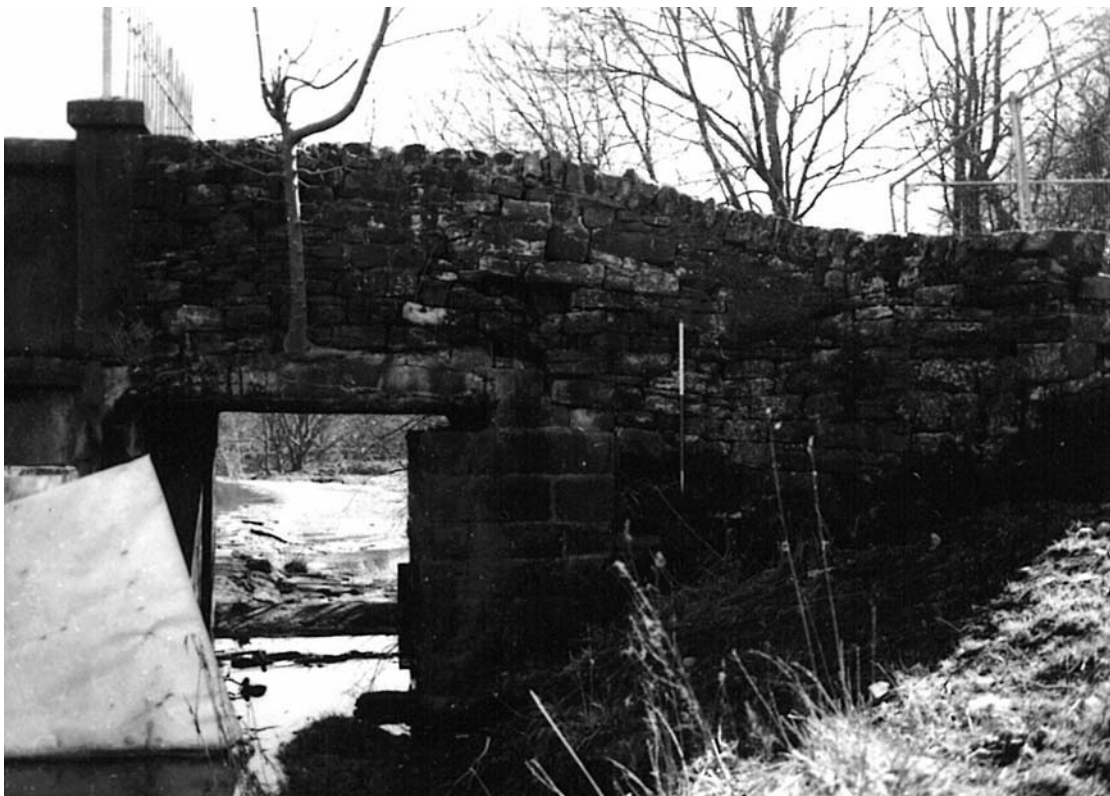
Plate 75: South-western wing wall (**11**) and sandstone abutment (**12**) (MF SB06\_03)

Plate 75: South-western wing wall (11) and sandstone abutment (12) (MF SB06\_03)

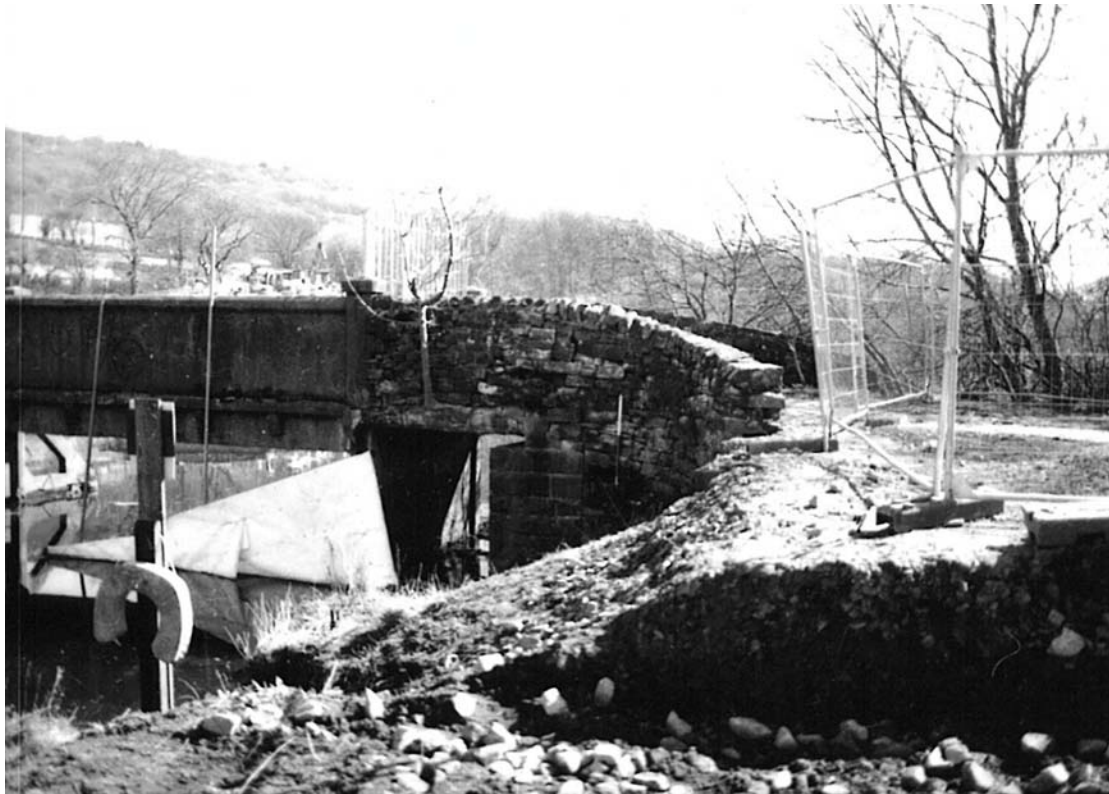
Plate 76: South-western wing wall (**11**) and sandstone abutment (**12**) (MF SB06\_05)

Plate 76: South-western wing wall (11) and sandstone abutment (12) (MF SB06\_05)

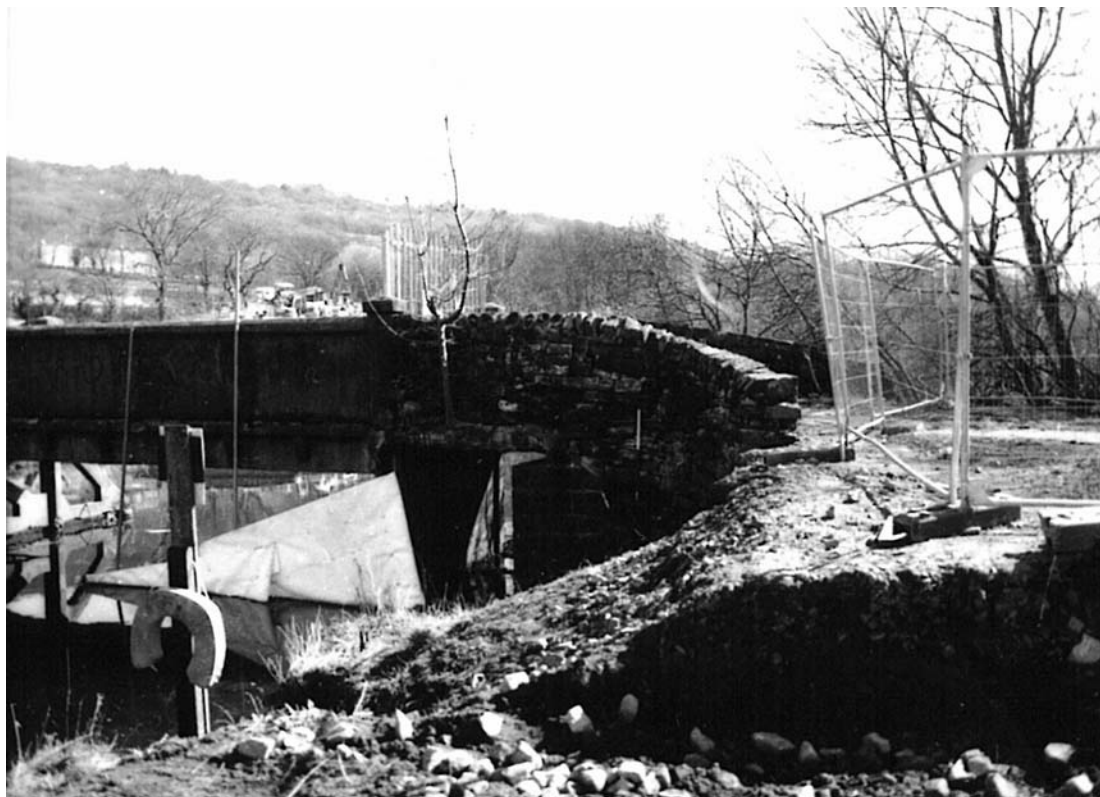
Plate 77: South-western wing wall (**11**) and sandstone abutment (**12**) (MF SB06\_06)

Plate 77: South-western wing wall (11) and sandstone abutment (12) (MF SB06\_06)

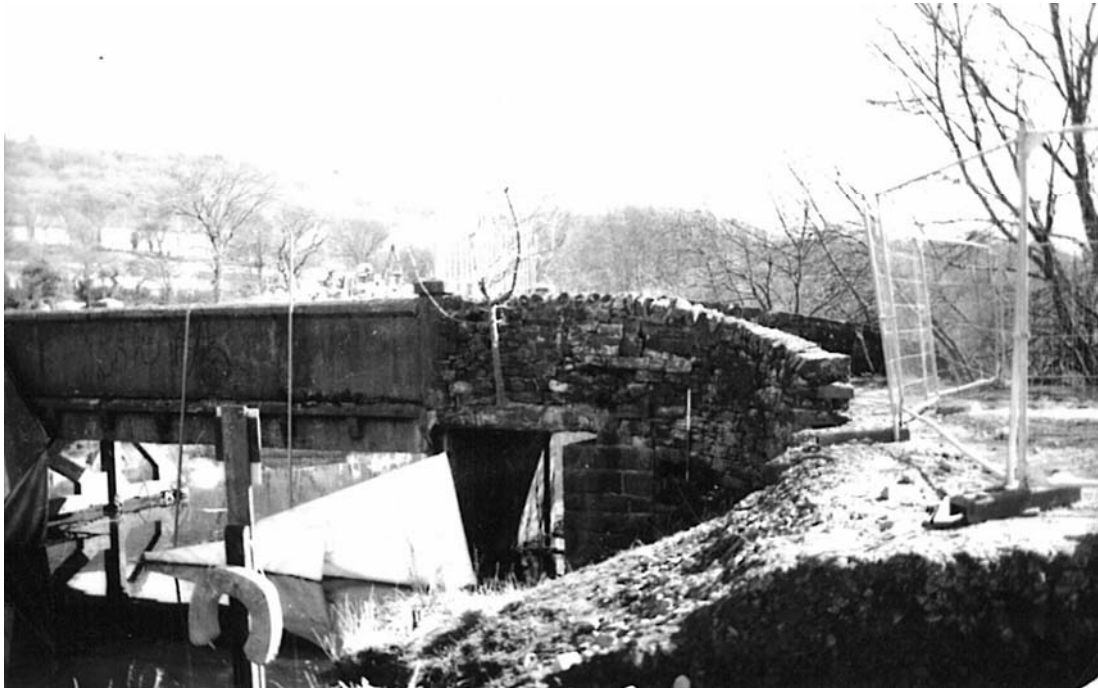
Plate 78: South-western wing wall (**11**) and sandstone abutment (**12**) (MF SB06\_07)

Plate 78: South-western wing wall (11) and sandstone abutment (12) (MF SB06\_07)

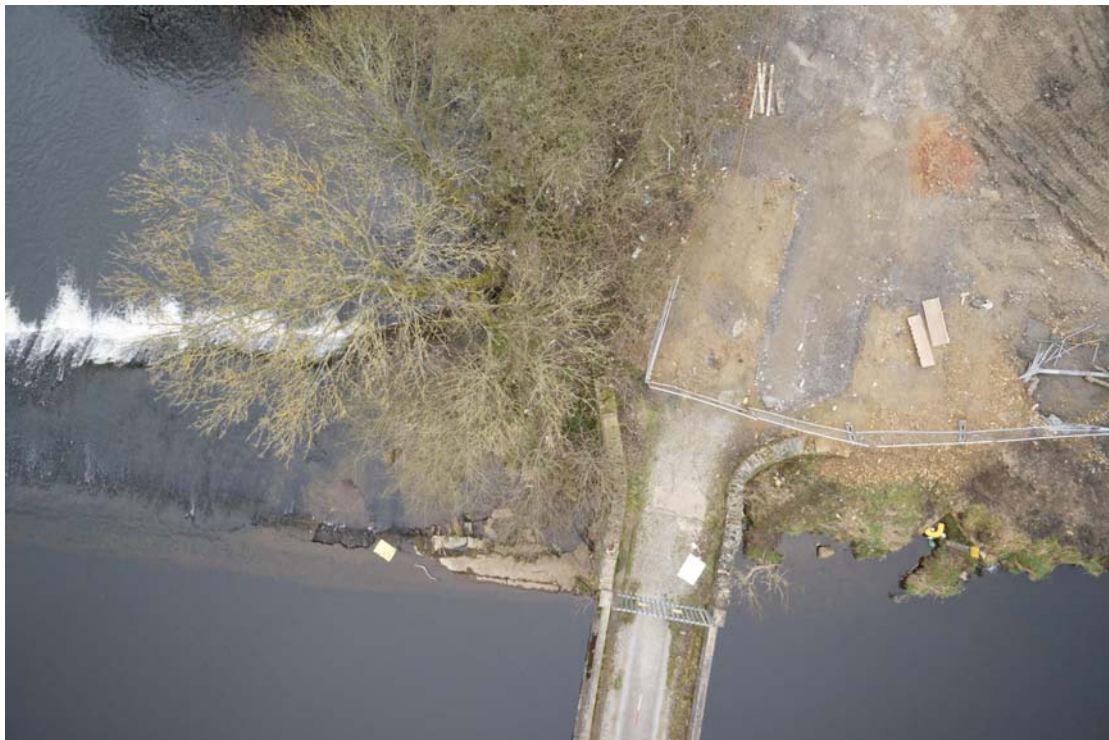
Plate 79: Aerial view showing southern bank and wing walls (**11**) (DSC00479)

Plate 79: Aerial view showing southern bank and wing walls (11) (DSC00479)
