**STERNE BRIDGE,  
SOWERBY BRIDGE–  
COPLEY VALLEY  
REGENERATION  
PROJECT,  
SKIRCOAT,  
WEST YORKSHIRE**

**Archaeological  
Photographic  
Building Recording  
and Watching Brief**

**Oxford Archaeology North**

September 2012

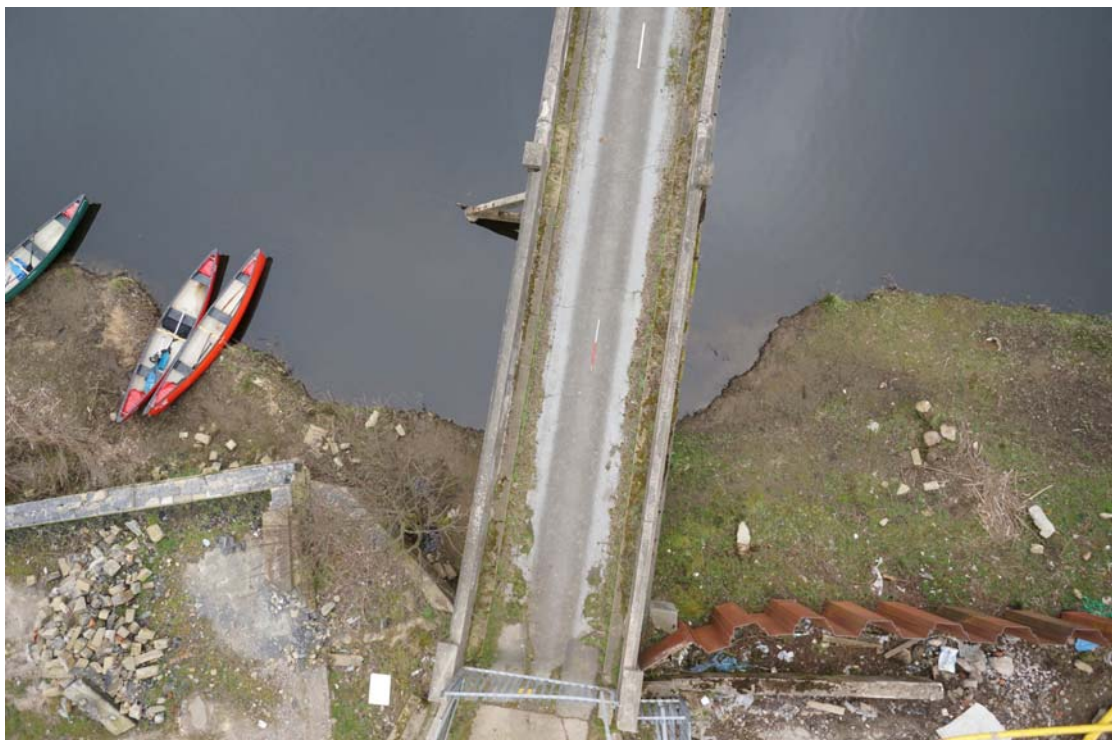
Plate 81: Aerial view showing bridge deck **14**, flanked by parapet walls (**10**) (DSC00475)

Plate 81: Aerial view showing bridge deck (14) flanked by parapet walls (10) (DSC00475)

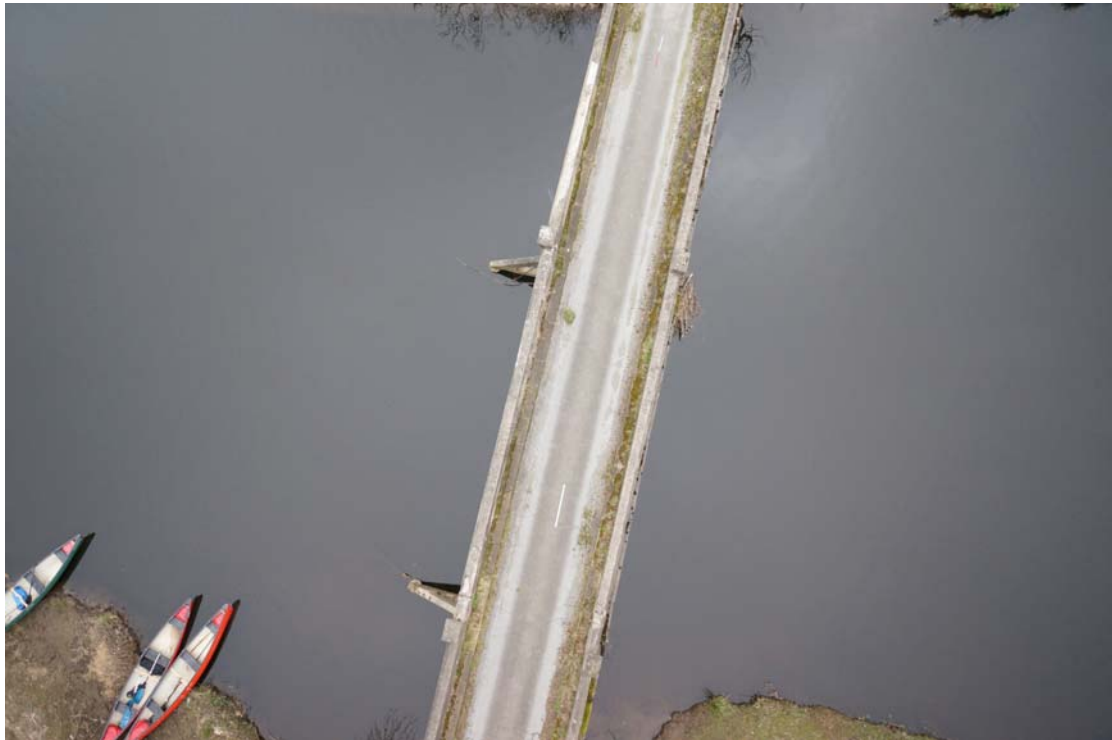
Plate 82: Aerial view showing bridge deck **14**, flanked by parapet walls (**10**) with projecting cut-waters **5** and **5a** on the south-eastern side (DSC00477)

Plate 82: Aerial view showing bridge deck (14) flanked by parapet walls (10) with projecting cut-waters (5) and (5a) on the south-eastern side (DSC00477)

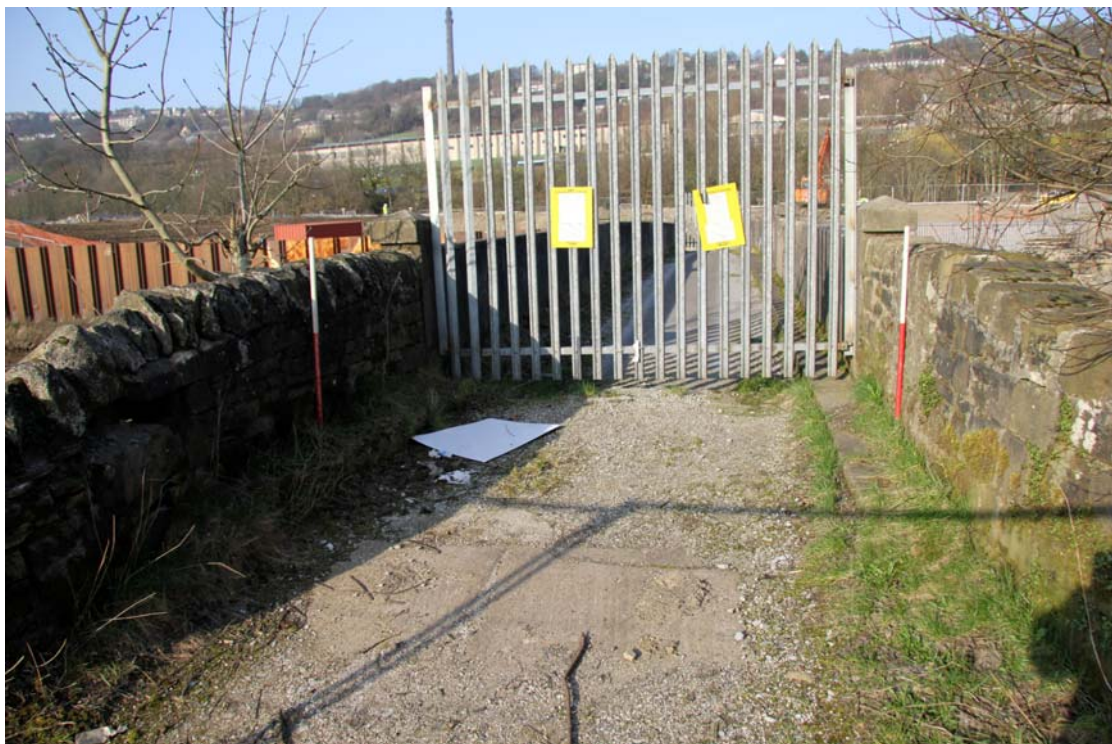
Plate 83: View to north bank, showing modern bridge deck **14** flanked by stone parapet wing walls (**11**) (IMG\_2397)

Plate 83: View to north bank showing modern bridge deck (14) flanked by stone parapet wing walls (11) (IMG\_2397)

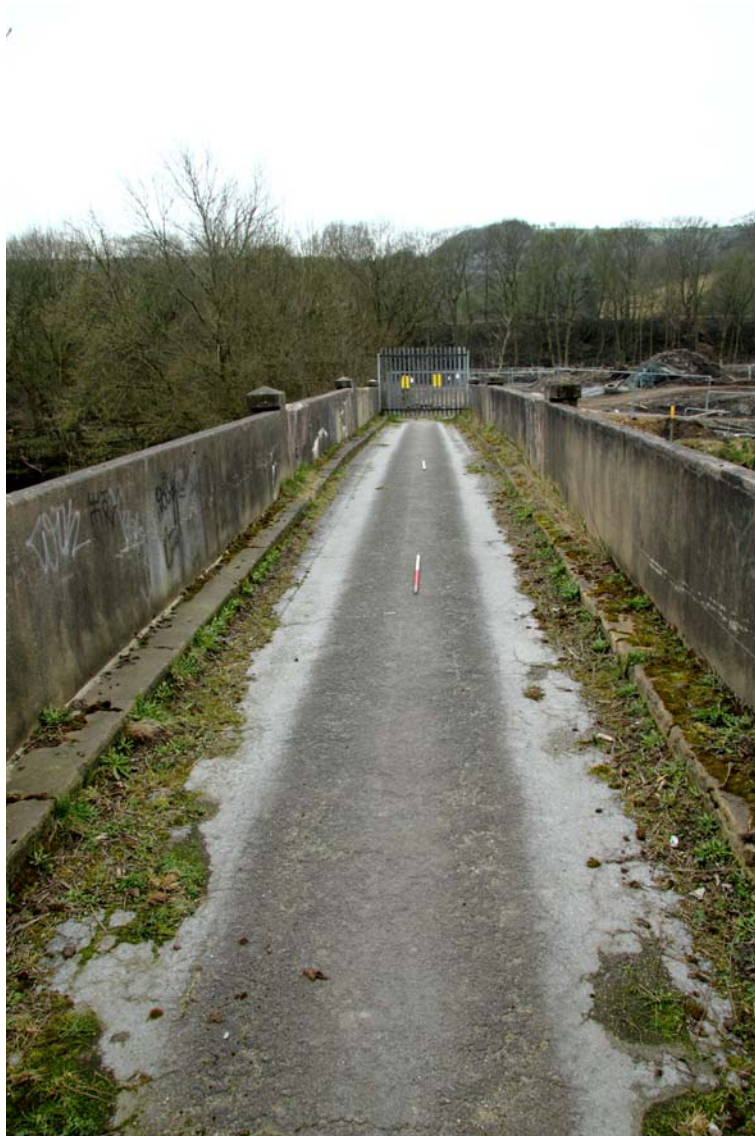
Plate 84: View across the bridge to the southern bank, showing bridge deck **14** flanked by concrete parapet walls (**10**) (IMG\_2361)

Plate 84: View across the bridge to the southern bank, showing the bridge deck (14) flanked by concrete parapet walls (10) (IMG\_2361)

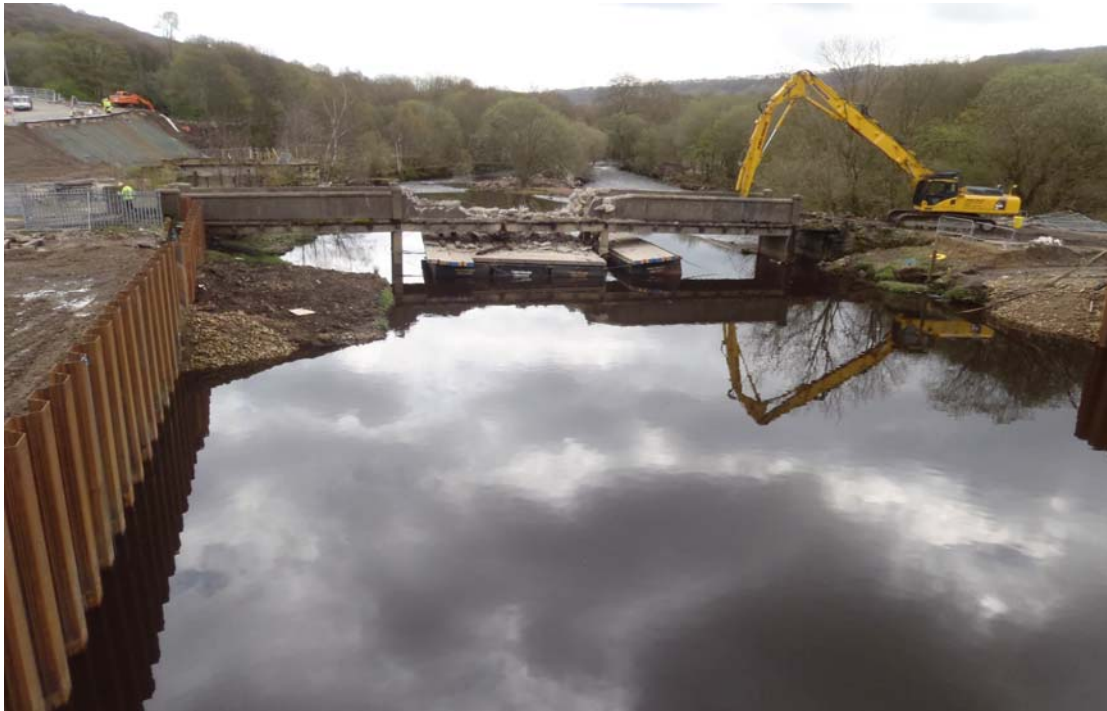
Plate 85: Sterne Bridge during the demolition process, with central section of concrete parapet (10) removed (P3020740.JPG)

- 4.2.15 The demolition of the bridge was undertaken using a tracked mechanical excavator fitted alternately with pneumatic breaker, and a grab-and-shear attachment, which was utilised to carefully cut back discrete sections of the concrete bridge deck, parapet, trestles and associated piers (Plates 85 and 86). Prior to the commencement of the demolition work, pontoons were installed beneath the bridge deck to limit contamination of the river Calder and damage to the nearby weir.

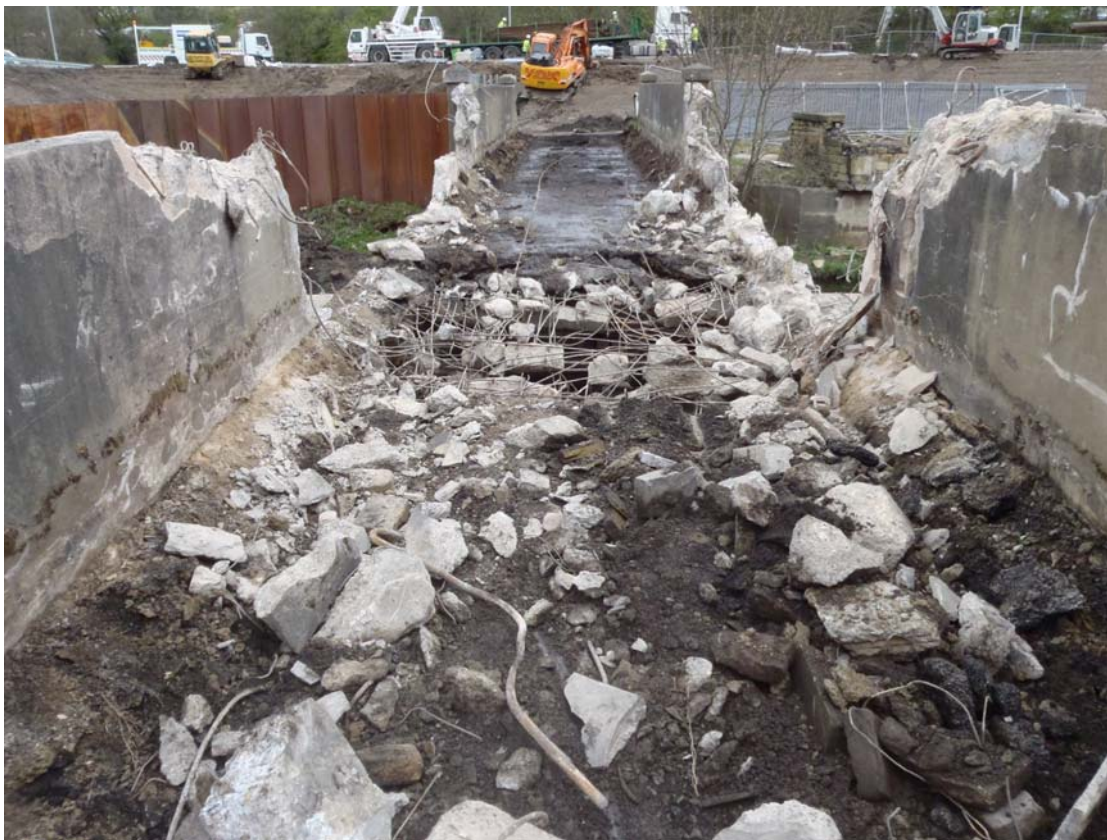
Plate 86: North-east-facing view across the bridge deck ,showing reinforcing in the deck and parapet walls (P3020744.JPG)

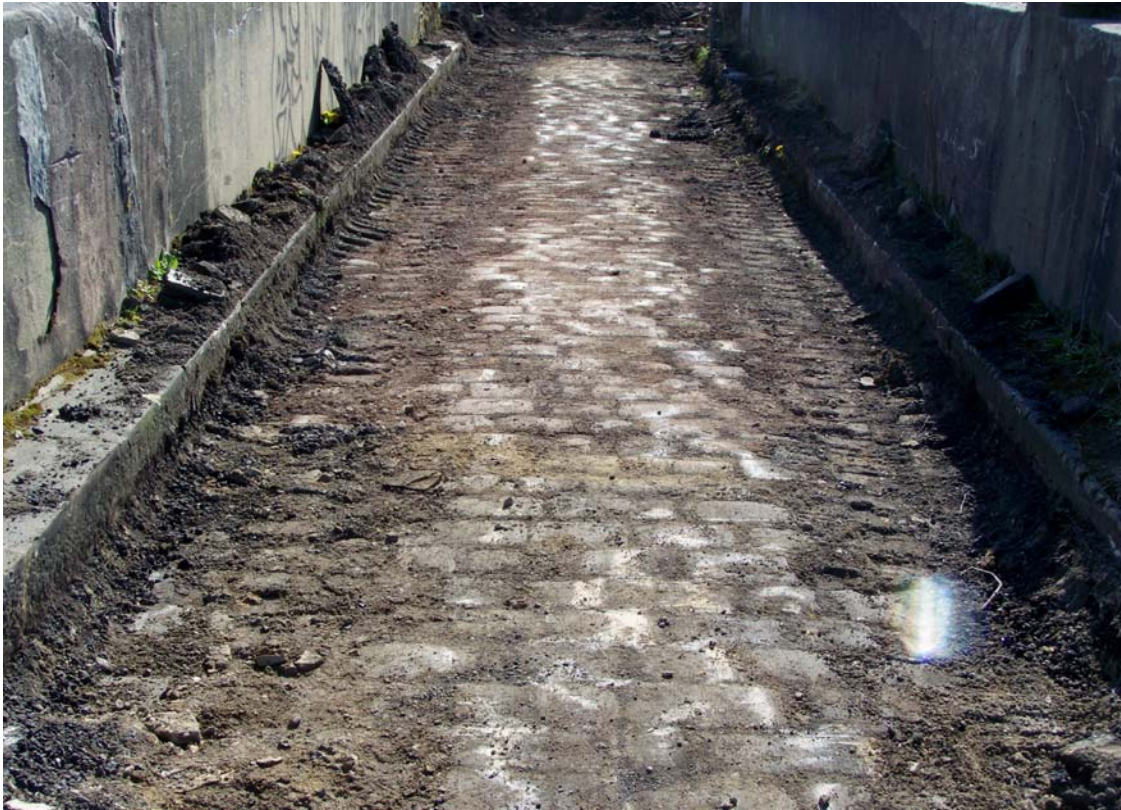
Plate 87: Cobble sett surface (15) exposed during the course of demolition  
(100\_3611.JPG)

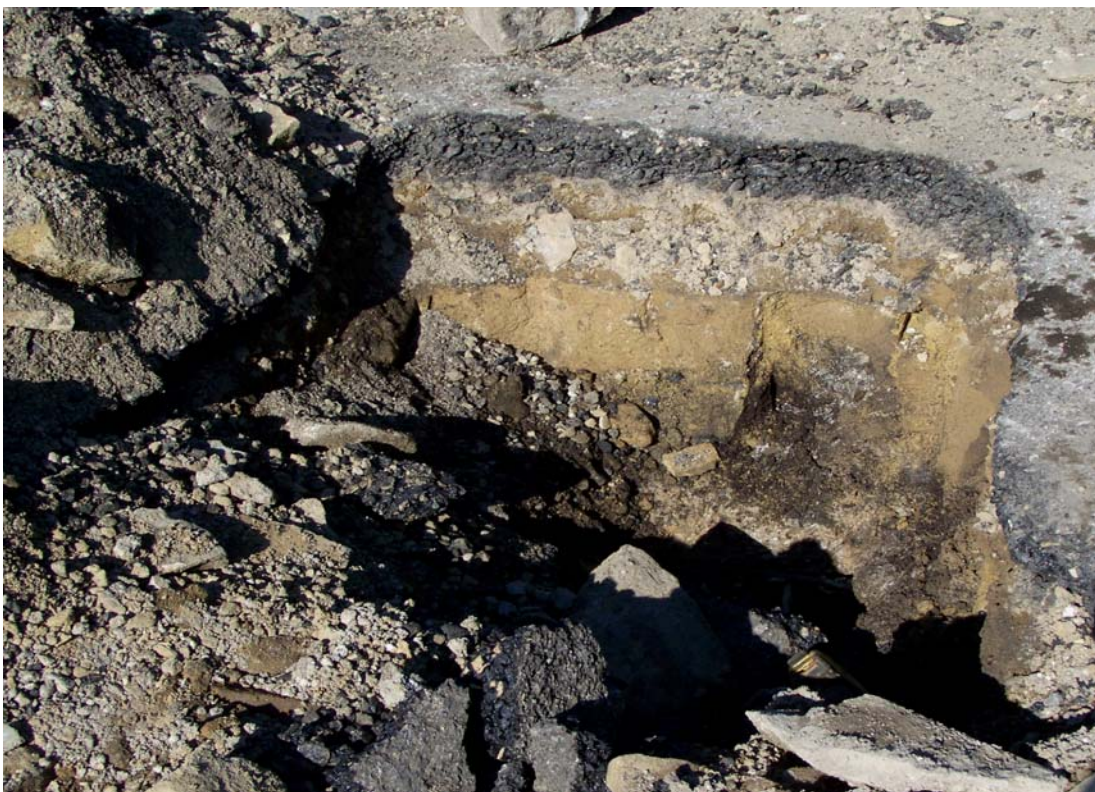
Plate 88: Bedding and made-ground layers between the cobble setts (15) and modern  
surface (14) on the bridge deck (100\_3619. JPG)

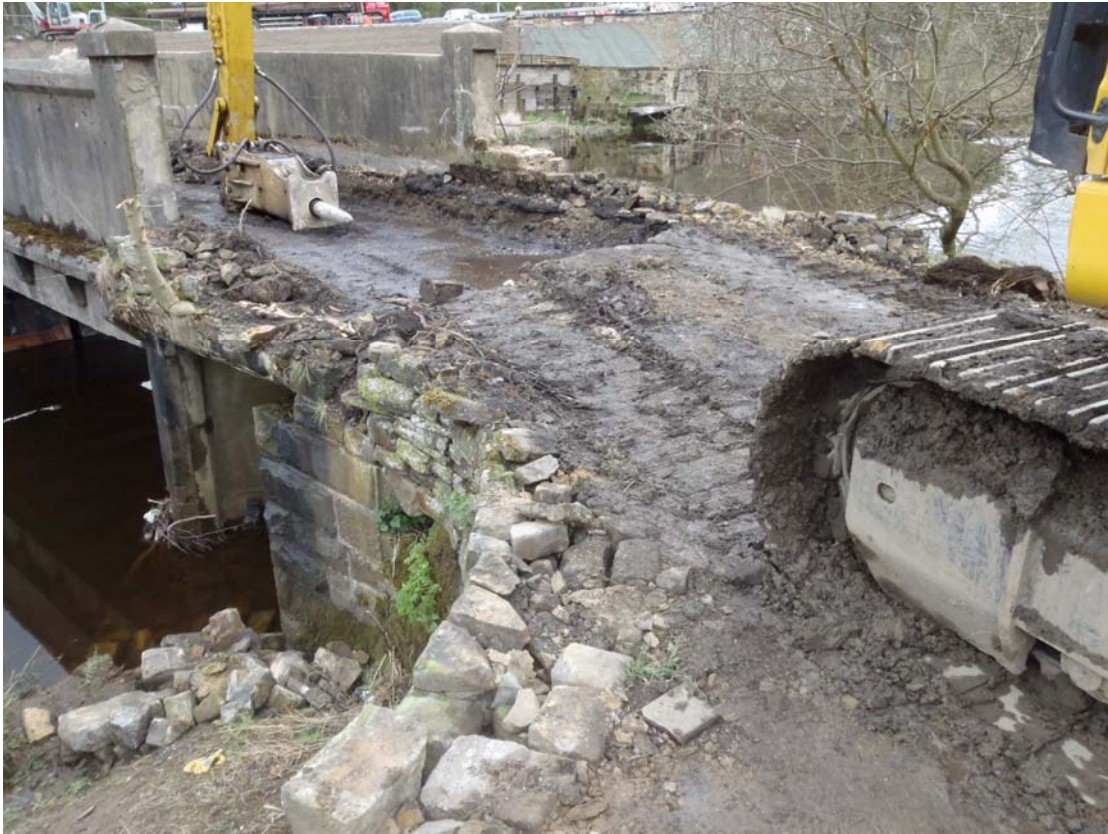
Plate 89: East-facing view across the demolished parapet and wing walls (11)  
(P3020745.JPG)

- 4.2.20 The partial removal of the upper parapet section of the wing wall on the southern side of the bridge (Plate 89) did not provide any new information about the construction techniques or phasing of the bridge, but confirmed previous observations from during the initial bridge recording (discussed above). Where the seven-course high, dressed sandstone abutment of the earlier stone bridge (Plate 90) had been retained and incorporated into the present concrete bridge structure, the masonry comprised rusticated blocks measuring typically 2'6" x 1' (0.76 x 0.3m). Demolition of the parapet wing wall showed that it was constructed of roughly-hewn sandstone blocks laid in an irregular pattern, with no mortar bond.

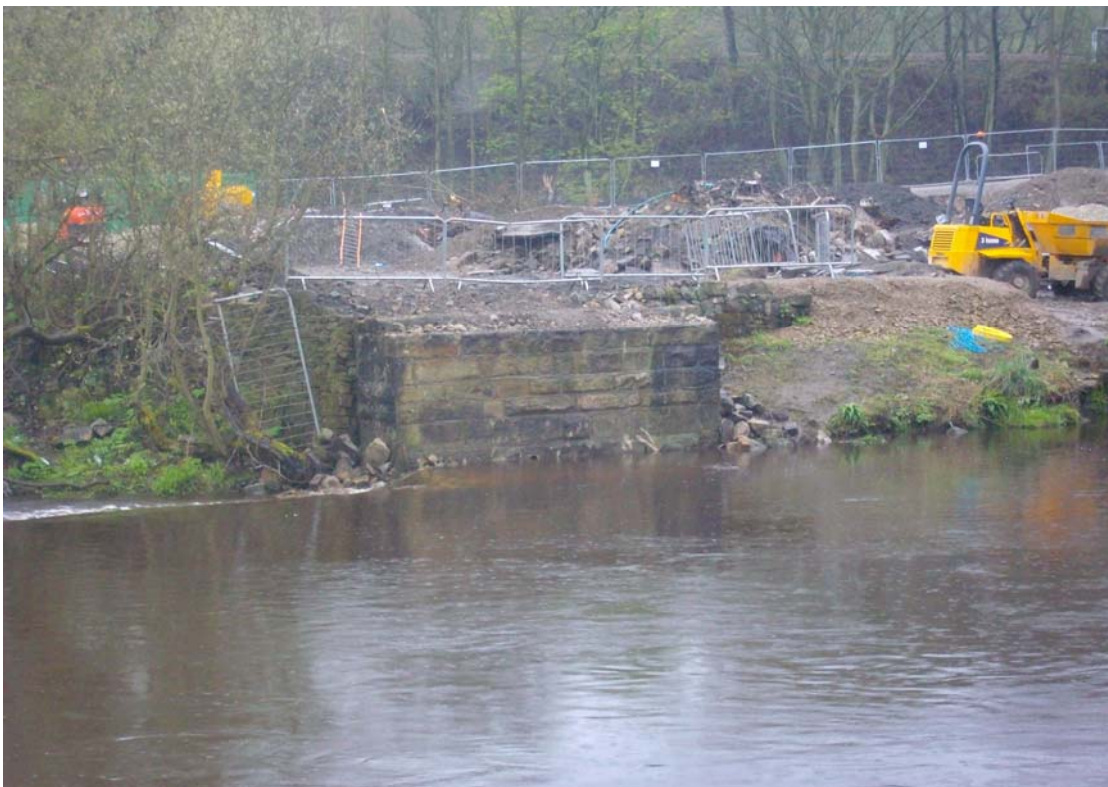
Plate 90: South-facing view across the river Calder showing southern abutment after  
the completion of the demolition process (IMP\_8733)

- 4.2.24 The surviving original element was approximately 2.15m tall and a seven-course high, dressed sandstone abutment (Plates 90 and 92), which was incorporated into the later bridge structure. It comprised rusticated blocks, typically 2'6" x 1' (0.76 x 0.3m), and was pointed in a hard cement mortar, obscuring the original, almost certainly lime-based mortar beneath. The

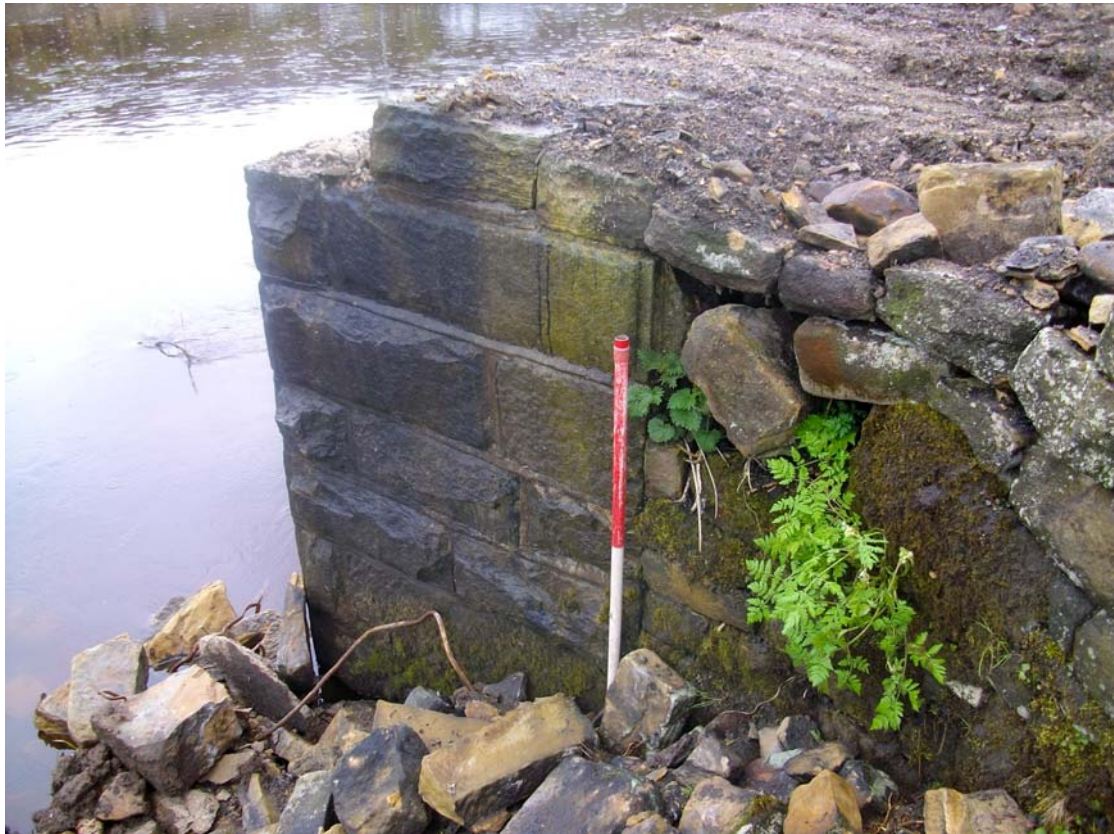
Plate 91: Close-up of interface between southern abutment (12) and remains of rubble wing wall (11) after main phase of demolition (IMG\_8754)

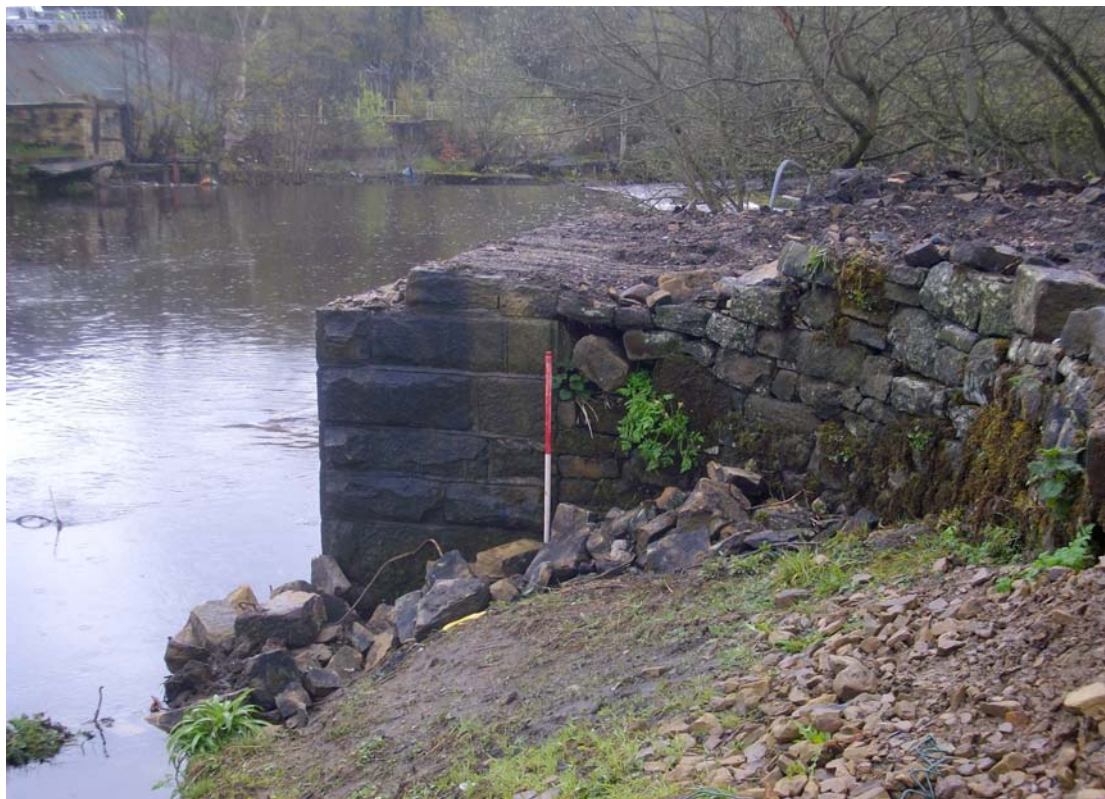
Plate 92: Interface between southern abutment (12) and remains of rubble wing wall (11) after main phase of demolition (IMG\_8757)

abutment was truncated by the replacement bridge, and there is no evidence for the springing of the original arch. To the east and west of the surviving abutment (Plate 92) were the lower sections of the wing wall, the upper section having been demolished to facilitate access during the main phase of works. Although the western wing wall appeared to be an early structure in that it was constructed in a more rudimentary drystone and rubble-wall style, it was probably contemporary with both the surviving abutments, and may have been rebuilt or repaired on more than one occasion.

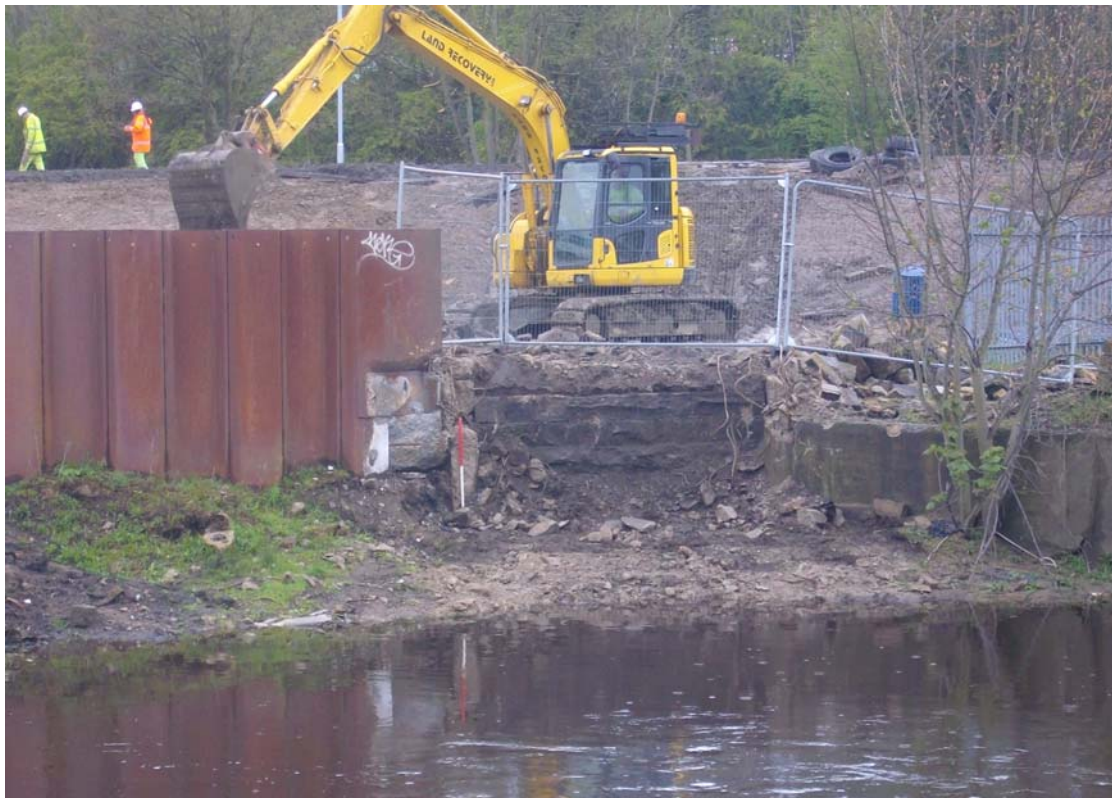
Plate 93: North-facing view showing the remains of the northern abutment (3) following the main phase of demolition (IMG\_8751)

- 4.2.21 On the northern side of the river Calder, the remnants of the north abutment, along with a number of elements of the concrete bridge constructed in 1914, were still visible following the completion of the main demolition process. The earlier stone bridge abutment was partially obscured by a combination of concrete and river silt, although the surviving upper four courses of ashlar sandstone masonry were clearly visible. A 3.5m wide section of the stone abutment was visible, with each row comprising nine courses of rusticated stone work with an average measurement of 0.34 x 0.35m. The stone work was pointed with a hard white-cream lime mortar. The depth and thickness of the abutment remains unknown.

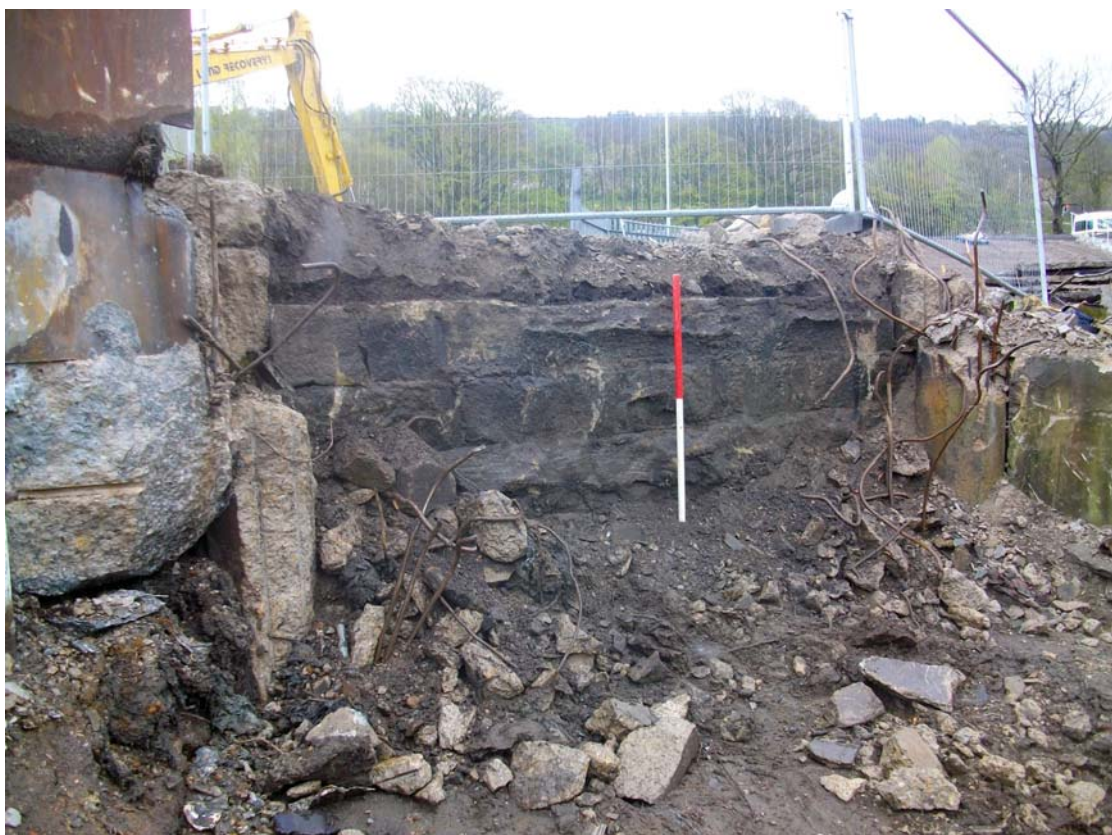
Plate 94: South-east-facing view showing the remains of the northern abutment (3) and octagonal section pillars on the east and west sides (IMG\_8743)
