**OMG Works,
Openshaw West,
Clayton,
Manchester**

**Archaeological
Excavation**

December 2012

**Buckingham Group Contracting
Ltd**

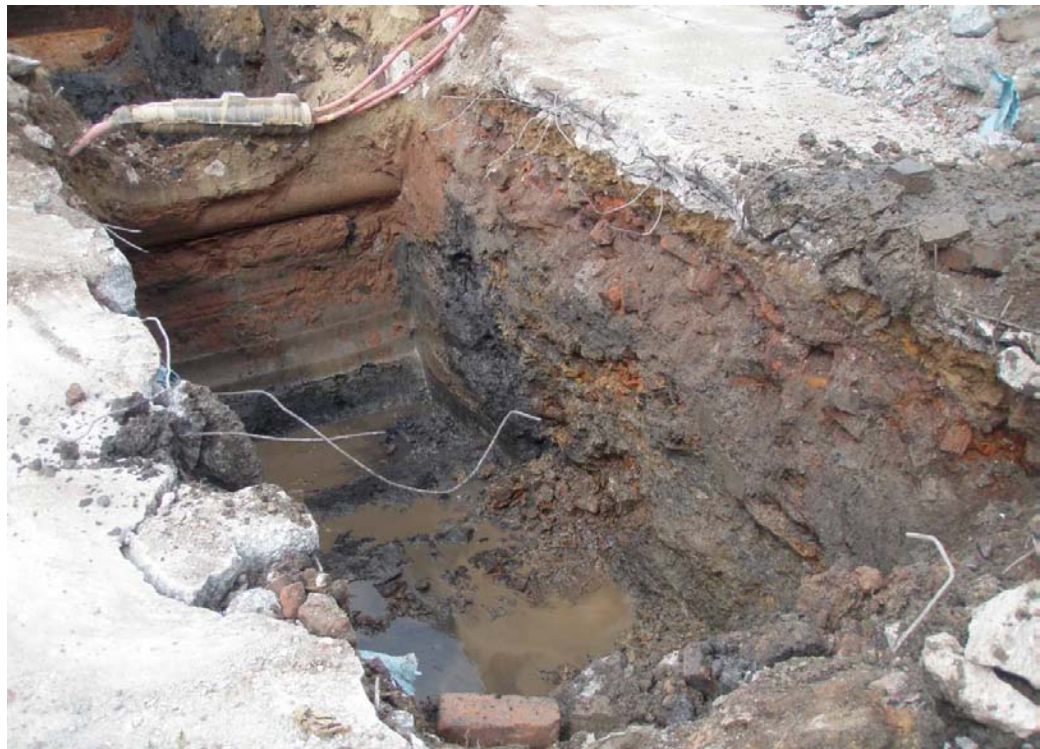
Plate 2: View across Trench 8 looking south-east, showing modern deposits and interventions in the former canal

- 1.3.2 **Trench 8:** this trench was placed across the line of a short north/south-aligned branch of the Ashton Canal, known as the Clayton Arm, in the south-eastern part of the site (Fig 3). The trench measured 13 x 2m, and was excavated to a maximum depth of 2.9m (Plate 2). The results obtained from the trench demonstrated that the area had been subject to considerable modern disturbance, which appeared to have destroyed all structural elements of the former canal.

- 1.3.3 The earliest deposit exposed in the trench was a very dark grey layer mixed silt and rubble (**07**), which had clearly been disturbed by modern interventions (Plate 2). It seems likely that layer **07** derived originally from silting within the canal, although no physical remains of the canal walls survived *in-situ*. Layer **07** was overlain by 0.45m thick deposit of compacted rubble, containing fragments of bricks, slate and stone (**06**), which had almost certainly been laid as levelling material following the abandonment and infilling of the canal arm.

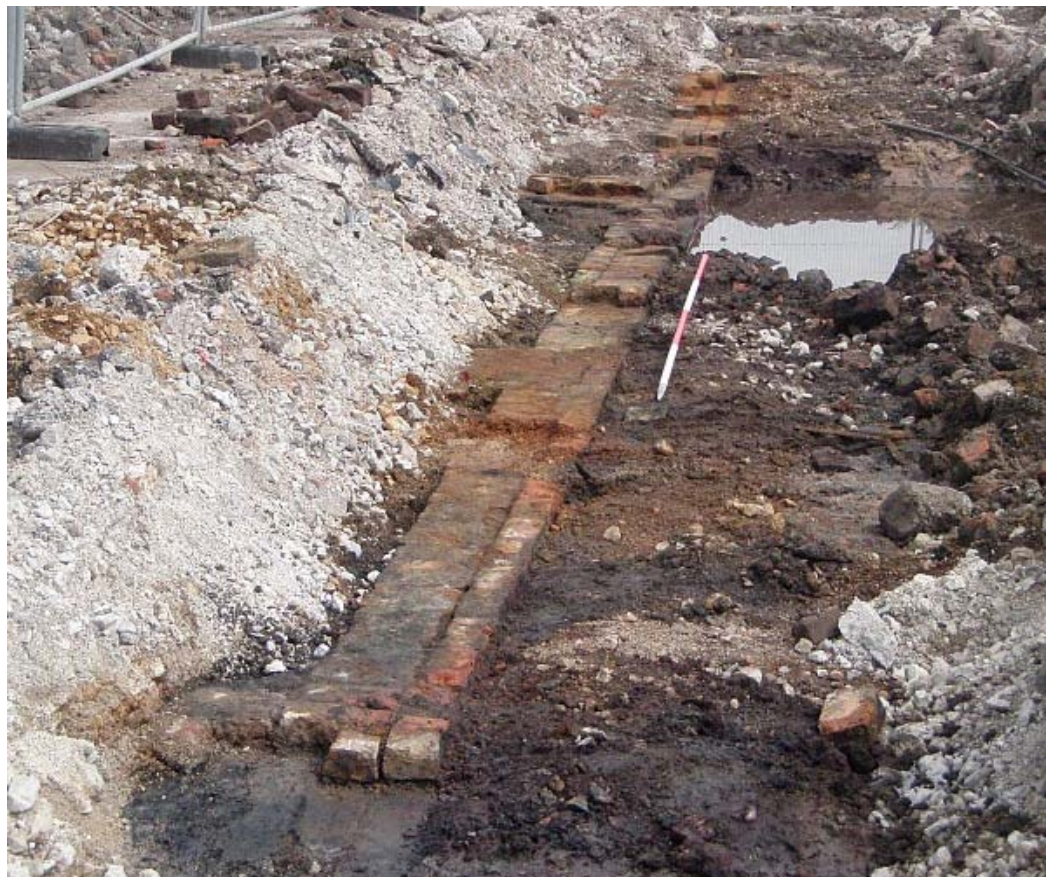
Plate 3: General view of Trench 11, showing wall 12

- 1.3.6 The principal element of the foundations was an east/west-aligned wall (**12**) composed of hand-made bricks set in lime-based mortar, indicative of an early/mid-nineteenth-century construction date (Plate 3). Wall **12** incorporated three short brick-built piers or buttresses on its northern side, which had probably abutted the northern wall of the building (Fig 4). Two detached brick-built structures (**13** and **14**) were also exposed to the north of wall **12**. These were both rectangular, and incorporated vertically set cast-iron bolts, which had almost certainly been intended for securing an item of machinery. Structures **13** and **14** had seemingly been placed on the bank of the canal arm, and may have formed part of a small crane used for loading and unloading cargoes from boats.

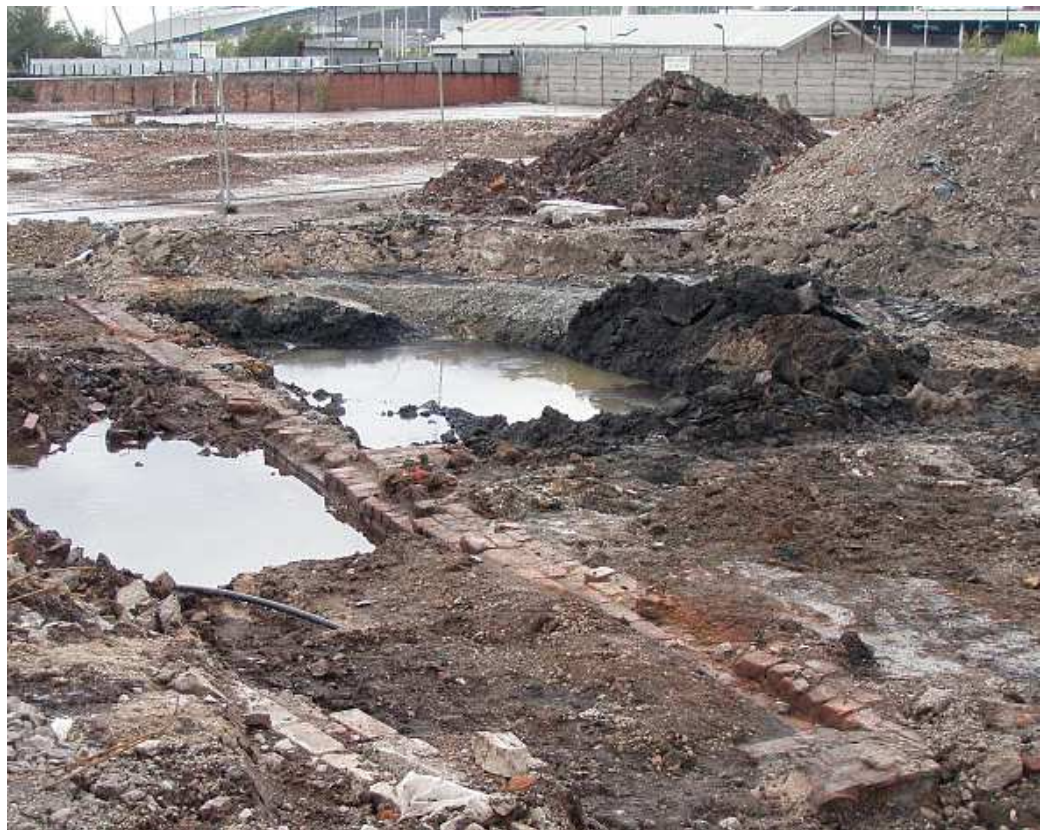
Plate 4: General view of Trench 11, showing wall **12**, and a sondage excavated in the interior of the building that rapidly filled with water contaminated with petrochemicals

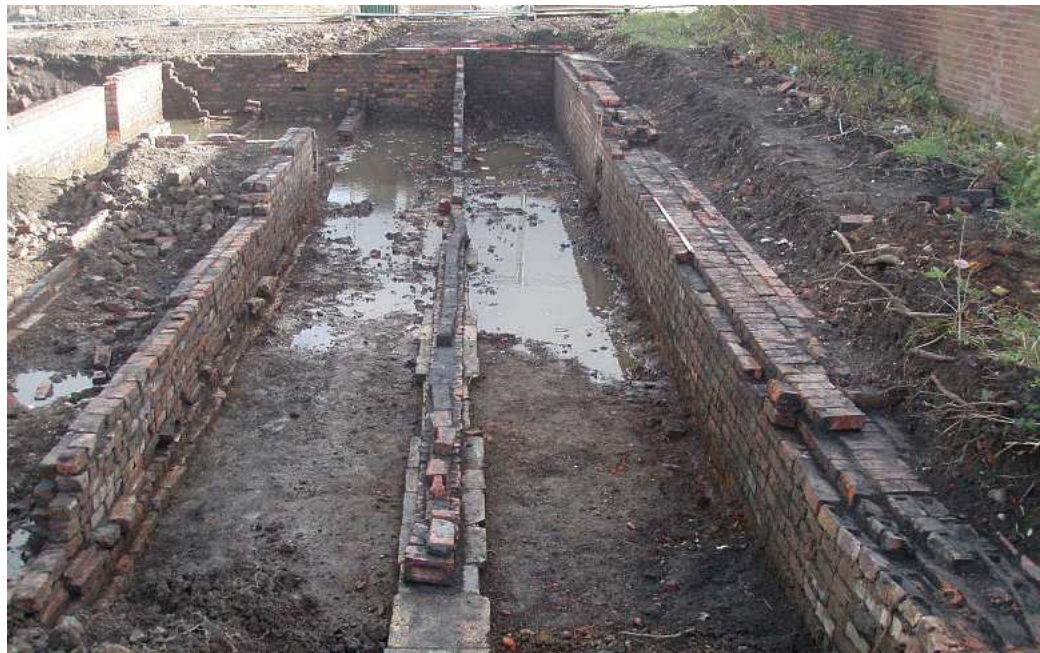
Plate 4: Trench 13 fully excavated

1.3.9 **Trenches 12 and 13:** these trenches were targeted on the site of the former firebrick works. Trench 13 was aligned east/west along the northern boundary of the site, and was targeted on the footprint of one of the circular kilns depicted on historical mapping, together with adjacent ancillary buildings situated to the east. It was proposed that Trench 13 was aligned north-west/south-east across the site of the second kiln, and the steam-power plant associated with the shaft situated to the south of the kilns. Trench 13 was excavated in November 2011 and revealed structural elements of the ancillary buildings, although remains the actual kilns were not encountered (Plate 4).

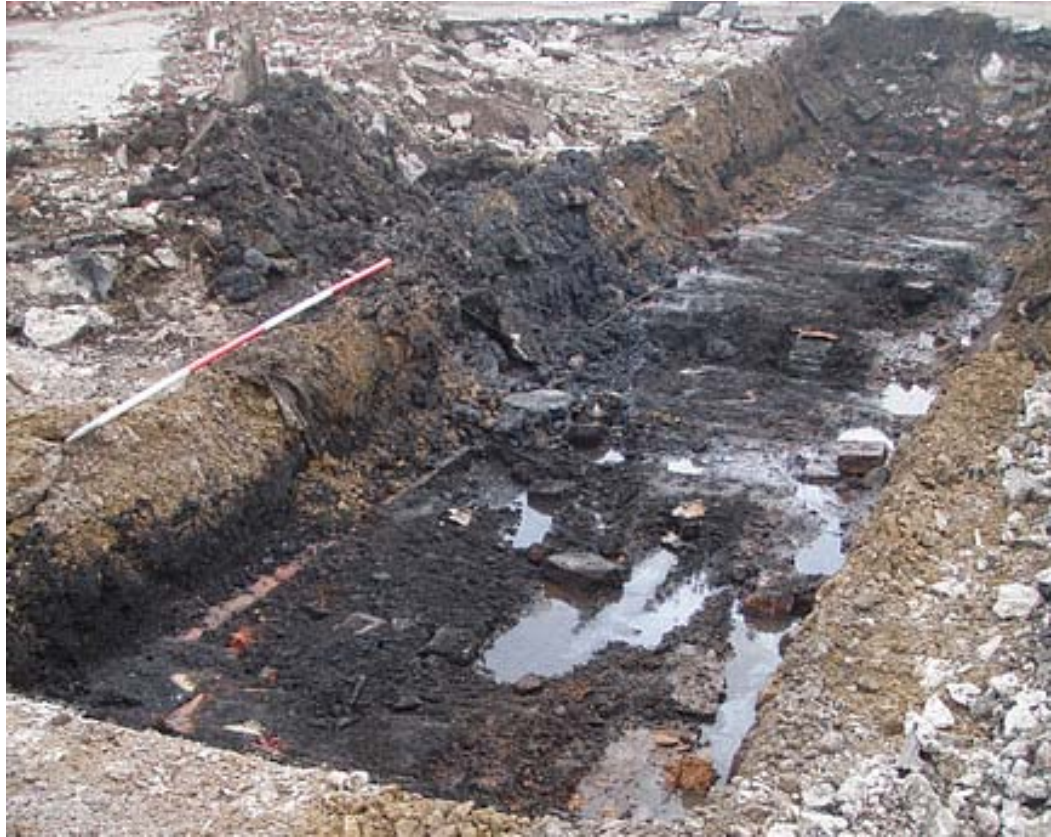
Plate 5: Trench 19, looking east

1.3.11 **Trench 19:** this trench was targeted on the footprint of a former size works depicted on the Ordnance Survey map of 1893. The trench measured 30 x 2m, and was excavated to a maximum depth of 3m (Plate 5). A deposit of black silty clay (**18**) was encountered at the base of the trench. However, this material was saturated with a black, oily liquid that had an overpowering aroma of petrochemicals. Further investigation of this area was thus precluded for Health and Safety considerations.

1.3.12 Several structural elements were set within layer **18**, including three rectangular-shaped pads (**19**, **21** and **22**) composed of refractory bricks. These all appeared to abut a wall (**25**) composed of hand-made bricks set in a lime-based mortar, consistent with a mid-nineteenth-century construction date. Against the northern side of the trench was another pad composed of refractory bricks (**20**), abutted by two ceramic half-pipes set into layer **18**. These lay with the open side upwards, as if to form run-off channels.

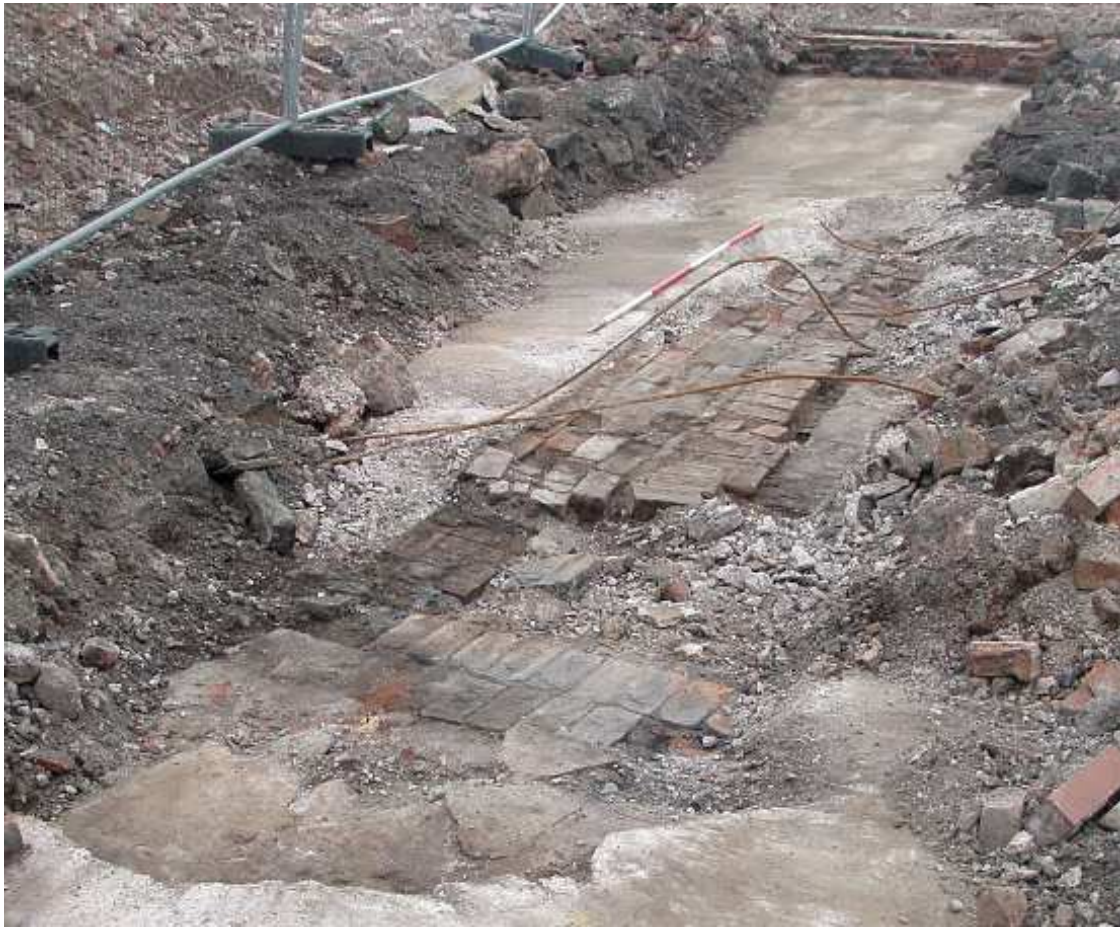
Plate 6: Structural remains exposed in Trench 20

- 1.3.15 Buried remains of the eastern building of the chemical works were similarly exposed in the Trenches 20 and 22. These trenches were aligned north/south, and were targeted on the footprint of a chemical works shown on the Ordnance Survey maps of 1848 and 1893. Trench 20 contained structural remains of the mid-nineteenth-century building (Plate 6), whilst excavation of the northern part of Trench 22 revealed a basement. These areas were subject to further excavation (Area B; *Section 4.3 below*), whilst the southern part of the Trench 22 contained a large rectangular tank (**27**) of reinforced concrete (Plate 7). This clearly associated the latest phase of industrial activity on the site, dating to the late twentieth century. It was backfilled with demolition material (**29**), which was composed largely of crushed bricks.

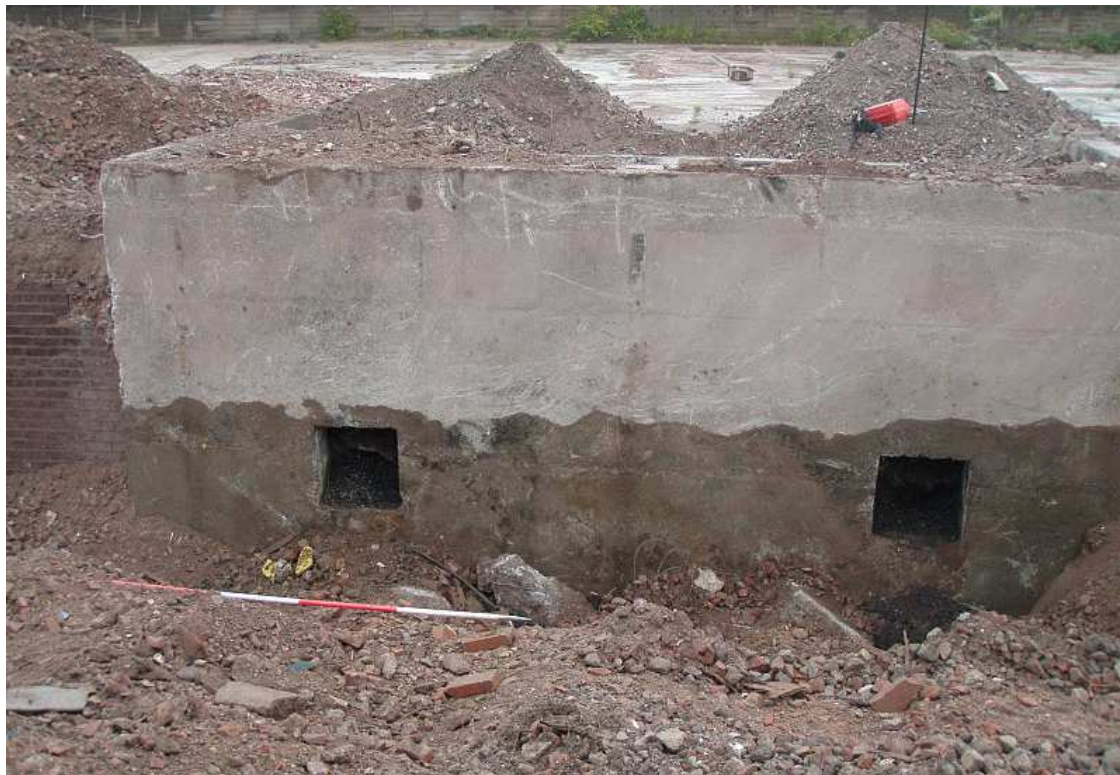
Plate 7: Concrete tank 27 exposed in the southern part of Trench 22, looking east

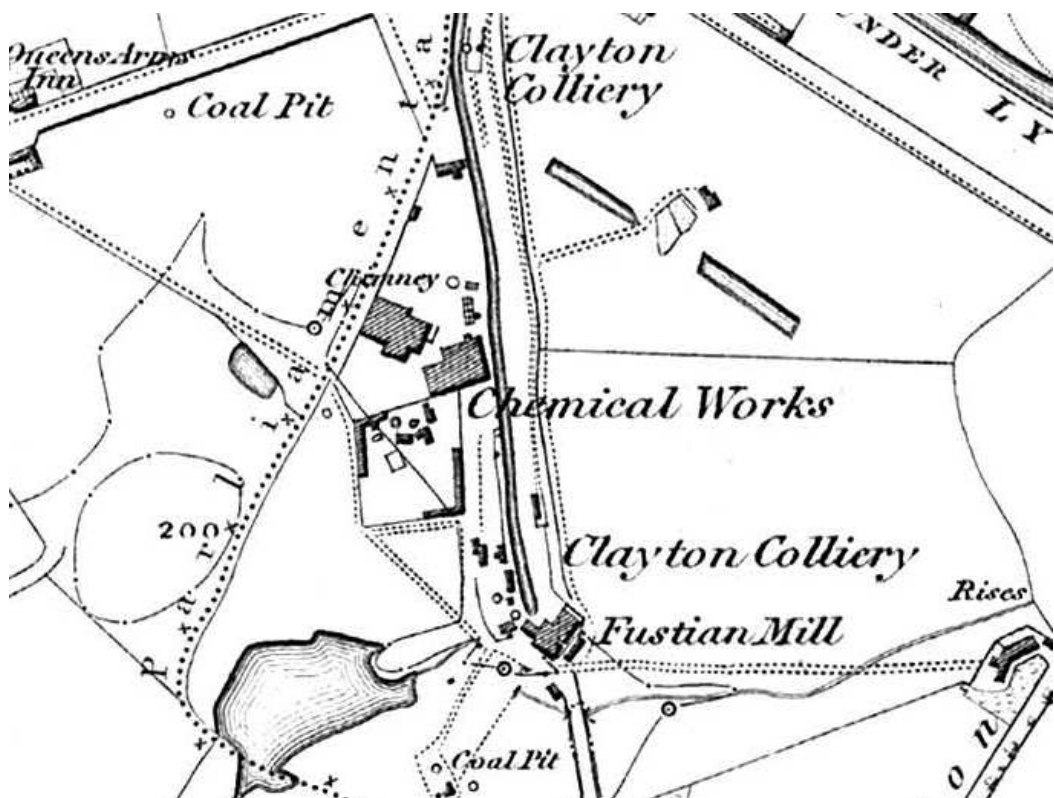
Plate 10: Extract from the Ordnance Survey 6": 1 mile map of 1848 (surveyed 1845)

- 3.3.3 The first detailed map to show the works is the Ordnance Survey 6": 1 mile map, which was surveyed in 1845 and published in 1848 (Plate 10). This depicts the works to have comprised two large buildings and several small ancillary structures occupying a plot of land on the western bank of the Clayton Arm of the Ashton Canal.

- 4.2.1 The Clayton Chemical Works is shown on the Ordnance Survey map of 1848 to have comprised two principal buildings, and several ancillary structures, situated on the western side of the Clayton Arm of the Ashton Canal (Plate 10). Area A was targeted on the north-western part of the former works, incorporating the footprint of one of the buildings depicted on the Ordnance Survey map of 1848. However, much of the area was only excavated to reveal the upper surface of structural walls due to the presence of cyanide and other dangerous chemical contamination covering the whole area. In particular, the south-eastern and western parts of the excavated area contained high levels of ground contamination, and were thus not excavated below the upper level of buried structures.

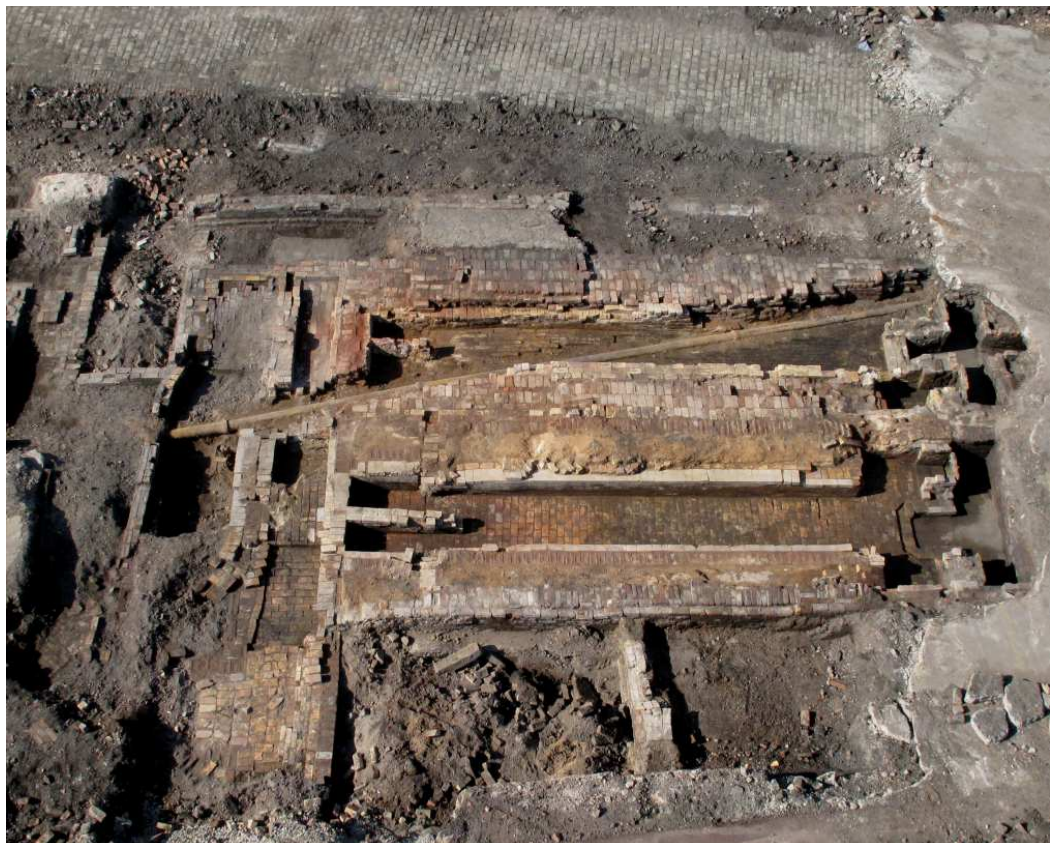
Plate 15: Looking west across the excavated remains of the boiler house

- 4.2.2 Excavation of the northern part of Area A revealed the well-preserved remains of a boiler house, which contained the bays (**1071** and **1072**) for two Lancashire boilers (Plate 15). The boiler seating walls each measured 10.4m long, and comprised a combination of refractory and machine-made bricks, with a lining of refractory bricks on their inner faces. The seating walls survived to a height of 0.46m, equivalent to five brick courses, above the 1.1m wide flame bed (Plate 16). The flame beds were of refractory bricks, laid with the stretchers aligned north/south. Some of the bricks forming the flame bed of the western boiler bay (**1071**) had 'HAMMOND' stamped on them, indicating a post-1890 construction date (*Section 4.6.8 below*). However, the eastern boiler bay (**1072**) incorporated 'NETTLE' firebricks, which probably post-date 1930 (*Section 4.6.4 below*).

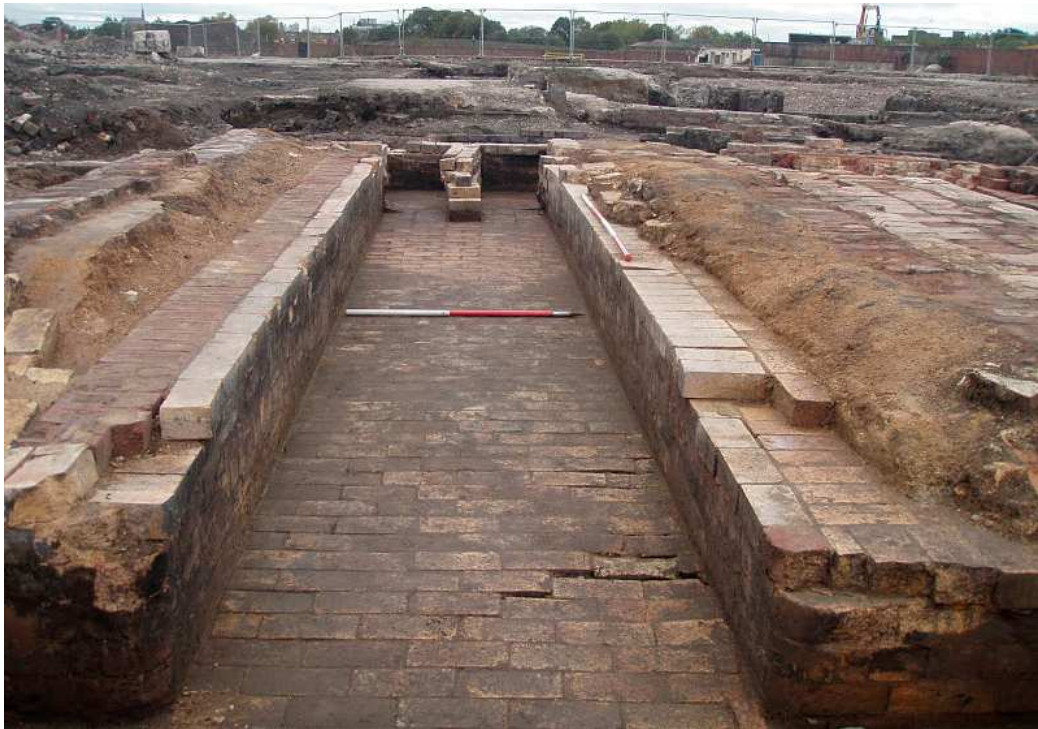
Plate 16: Looking south along the flame bed in the eastern boiler bay (1072)

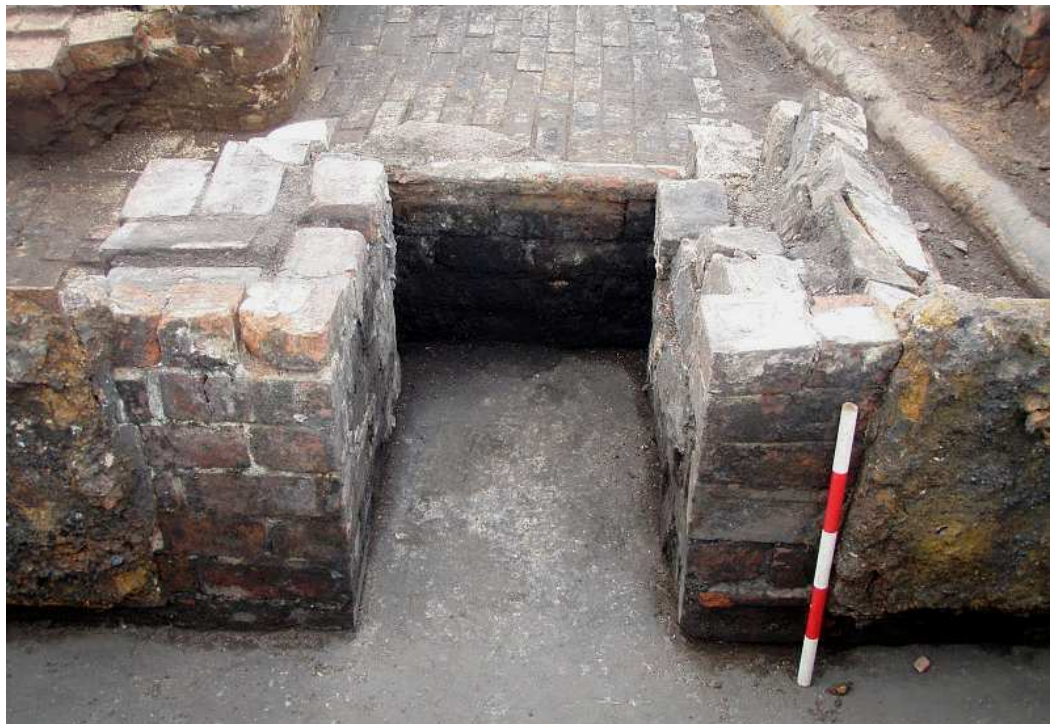
Plate 17: Housing for the blow-down valve in the western boiler bay (1071)

- 4.2.3 Both boiler bays retained elements of the brick-built housing for the blow-down valves at their northern end, although that in the western bay (**1071**) was better preserved (Plate 17). The location of the blow-down valves indicated that the charging area for the boilers had been at the northern end. The blow-down housing in bay **1071** comprised machine-made bricks, and survived to a maximum height of 0.6m, equivalent to seven courses of bricks.

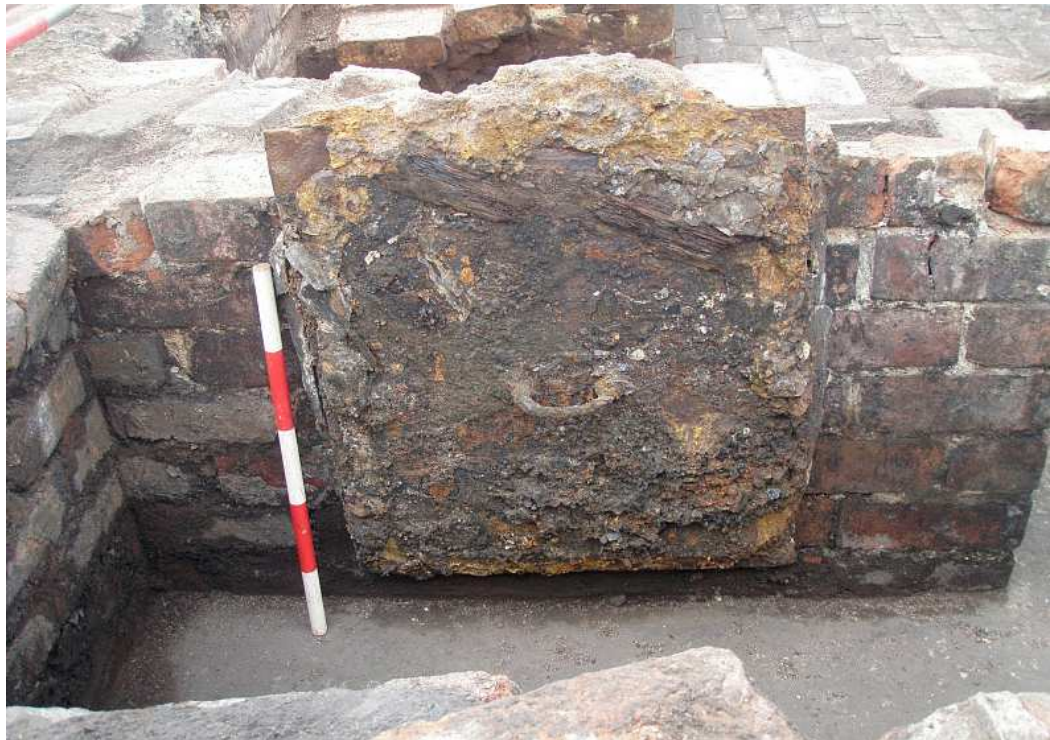
Plate 18: Housing for the blow-down valve in the eastern boiler bay (1072)

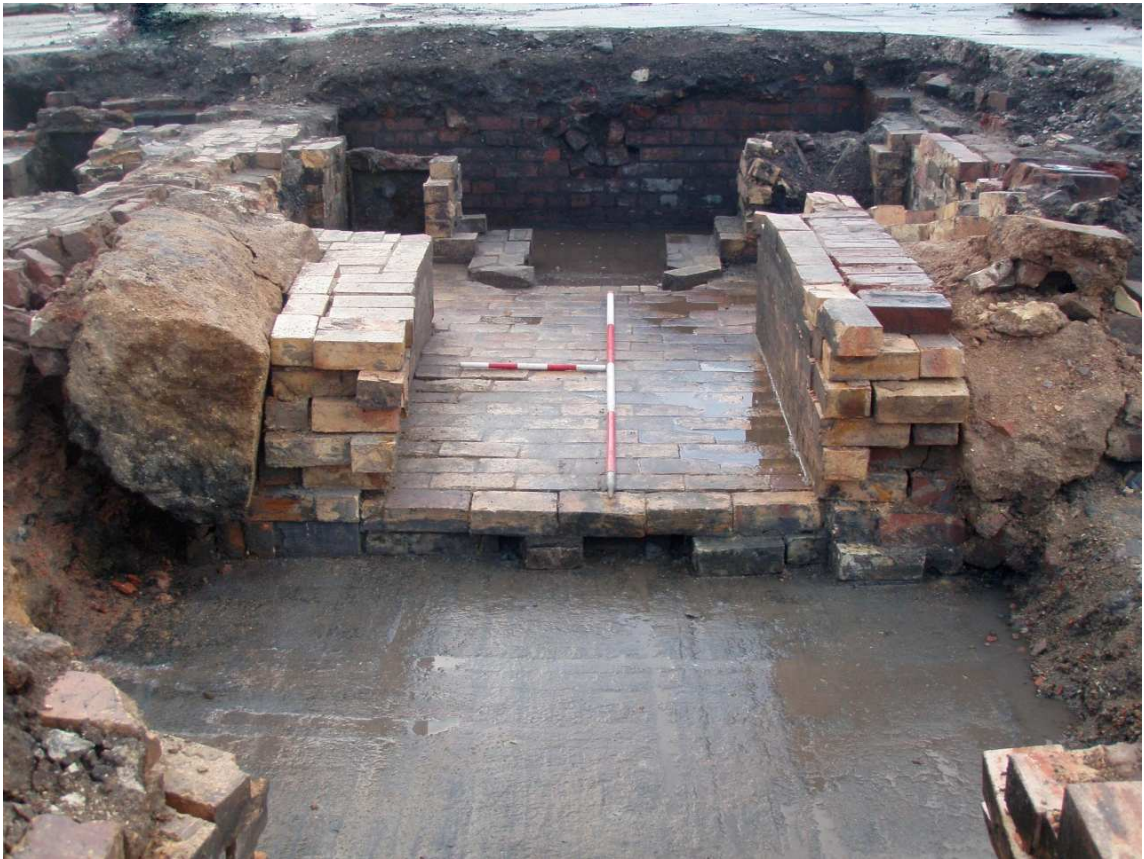
Plate 19: Section excavation across the flame bed of the eastern boiler bay (1072)

- 4.2.5 A section was excavated across the eastern boiler bay (1072). This concluded that the flame bed was two-brick courses thick, and had been placed on a concrete foundation (1081). The exterior elevations of the boiler seating walls had been insulated with a 0.5m thick deposit of sand (Plate 19), which had partially solidified through prolonged exposure to high temperatures.

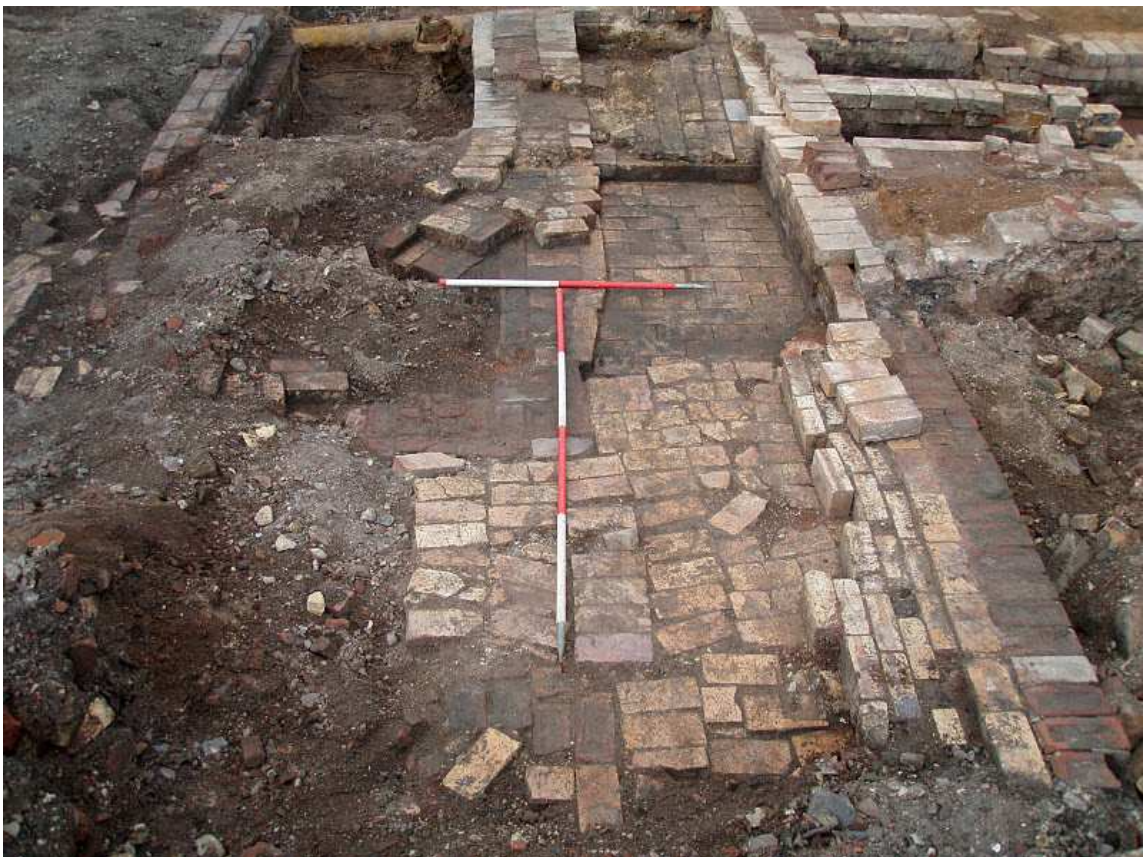
Plate 20: The remains of the main flue and the putative economiser to the rear of the boilers

- 4.2.7 The main flue was aligned east/west across the rear of the boiler bays, although part of it had been destroyed by the installation of a steel pipe (1059), which cut diagonally across the western boiler bay (Fig 6). The flue passed into the remains of a rectangular-shaped structure that was composed of refractory bricks (Plate 20) and was situated against the south-eastern corner of boiler bay 1072. It is likely to have been an economiser, also known as a feed water heater, which would utilise the waste heat in the gases passing from the boiler.

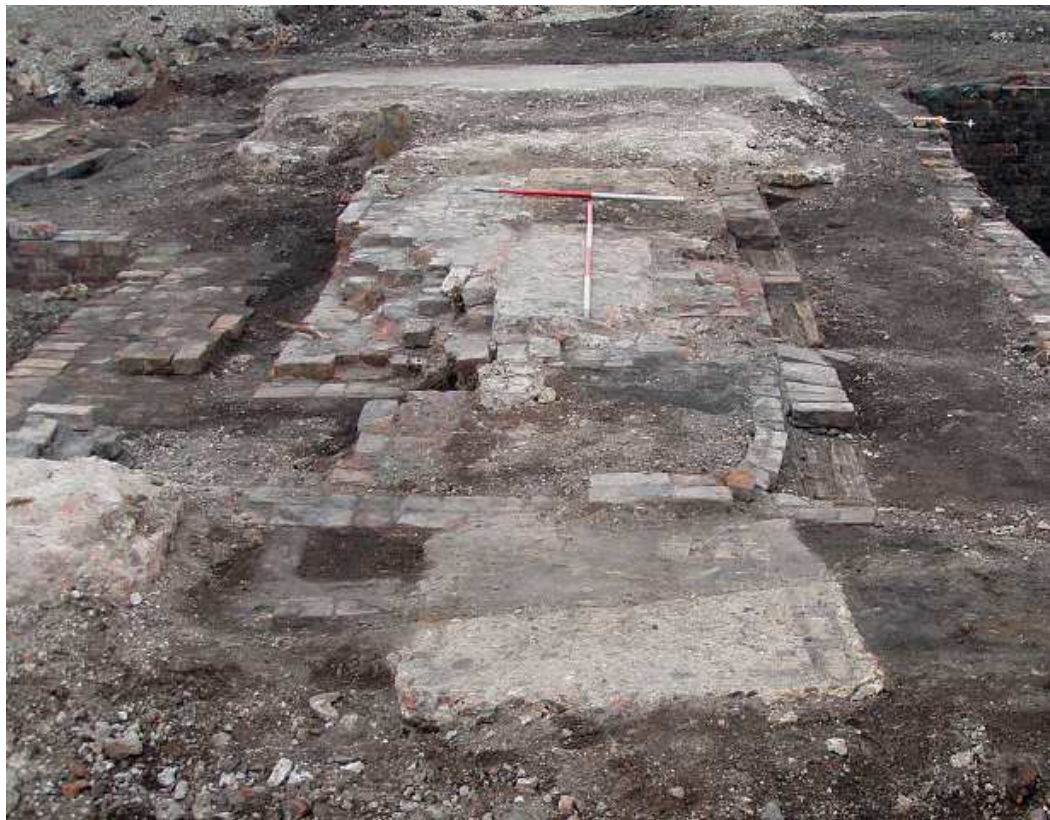
Plate 21: View looking east across engine foundation blocks **1044** and **1047**

- 4.2.9 The southern elevation of wall **1049** was abutted by a small surface (**1048**) composed of hand-made bricks. This covered an area measuring 3.7 x 0.65m, and appeared to be associated with a large foundation block (**1044**) situated immediately to the south (Fig 6). This measured 3 x 2m, and contained a series of six steel bolts that had almost certainly been intended to secure a large item of machinery. The foundation bed comprised a combination of concrete and hand-made bricks, and appeared to have been laid on timber planks, which were presumably intended to reduce the level of vibration from the machine. Another foundation block (**1047**) was exposed immediately to the north-west of **1044**. This measured 1.5 x 0.95m, and similarly comprised a combination of concrete and bricks, although all of the bricks had been machine made. This block also contained steel bolts (Plate 21) that had probably been intended to secure a large item of machinery. It seems likely that foundation blocks **1044** and **1047** may have housed a small horizontal steam engine that furnished the motive power requirements in the chemical works.

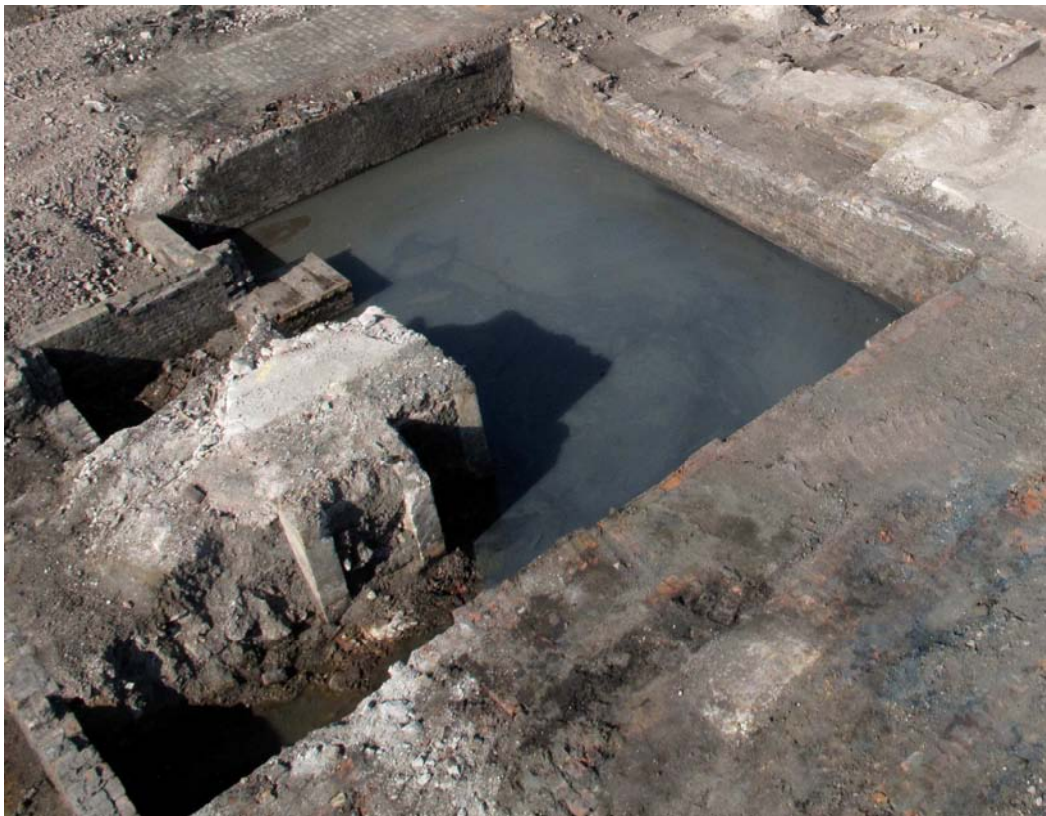
Plate 22: The remains of the basement exposed in the southern part of Area A

- 4.2.10 Excavation to the south of engine foundation block **1044** exposed the remains of a large basement, which had maximum dimensions of 11 x 11.8m, and was at least 2.2m deep, although the base was not exposed as it was inundated with contaminated water (Plate 22). The northern and eastern walls (**1036**) of this basement comprised machine-made bricks, and were three-courses wide. The south-facing elevation of wall **1036** was abutted by a brick surface (**1041**), situated at a level some 2m lower than the top of wall **1036**. Surface **1041** was aligned east/west, was 1.3m wide, and comprised machine-made bricks.

- 4.2.12 Two structures were identified within the interior of the basement. Structure **1040** abutted the eastern end of wall **1039**, and measured 1.1 x 1.1m (Fig 8). It comprised hand-made bricks, and a metal capping to which were attached two short wooden planks. These had perhaps been intended as a foundation for a small item of machinery, such as a pump. The removal of the metal excavation demonstrated that the underlying structure was composed entirely of brick.

- 4.2.13 The second structure within the basement was a large block of concrete (**1042**), which measured 4.1m at its longest point, and 3.8m at its widest point. This may also have housed an item of machinery, although there was no evidence for restraining bolts.

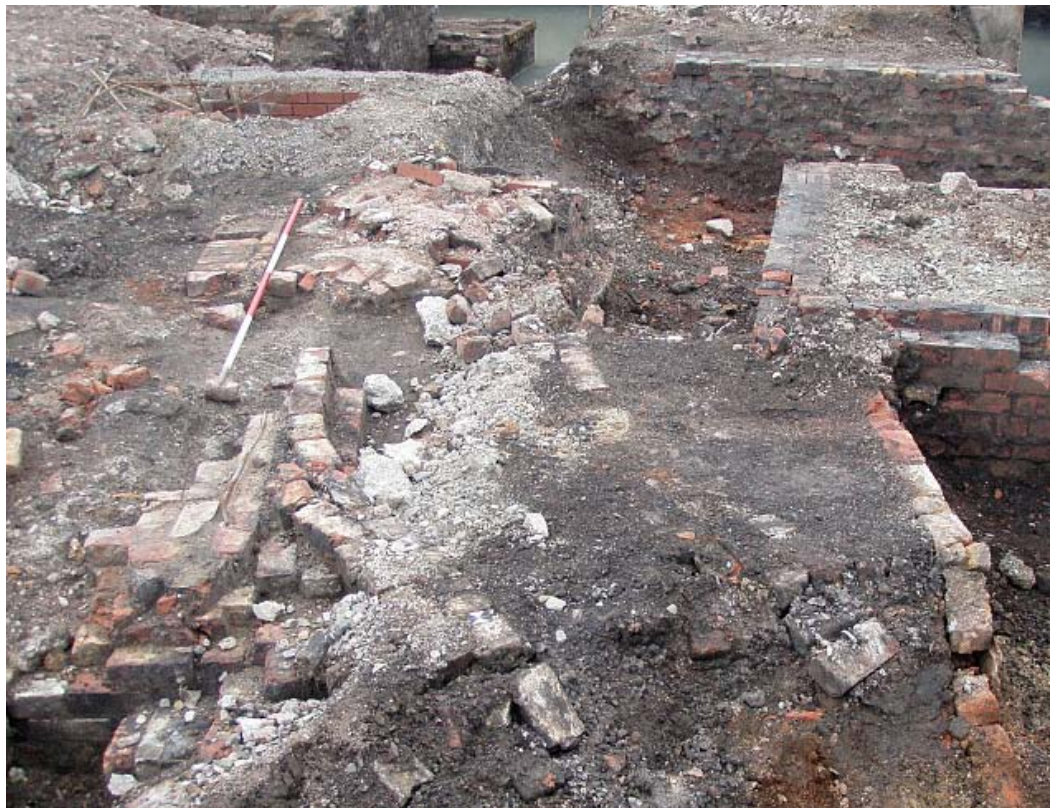
Plate 23: The fragmentary remains of the flues exposed in the southern part of Area A

- 4.2.14 The area to the south of the basement contained the fragmentary remains of several walls (**1028**, **1029** and **1030**) constructed from refractory bricks, suggesting that they had been intended as flues (Plate 23). All of the flue walls were two-courses wide, and survived to a height of at least 0.65m, although their bases were not exposed due to contaminated ground. A thick deposit of clinker (**1031**) was noted between the various sections of walls.

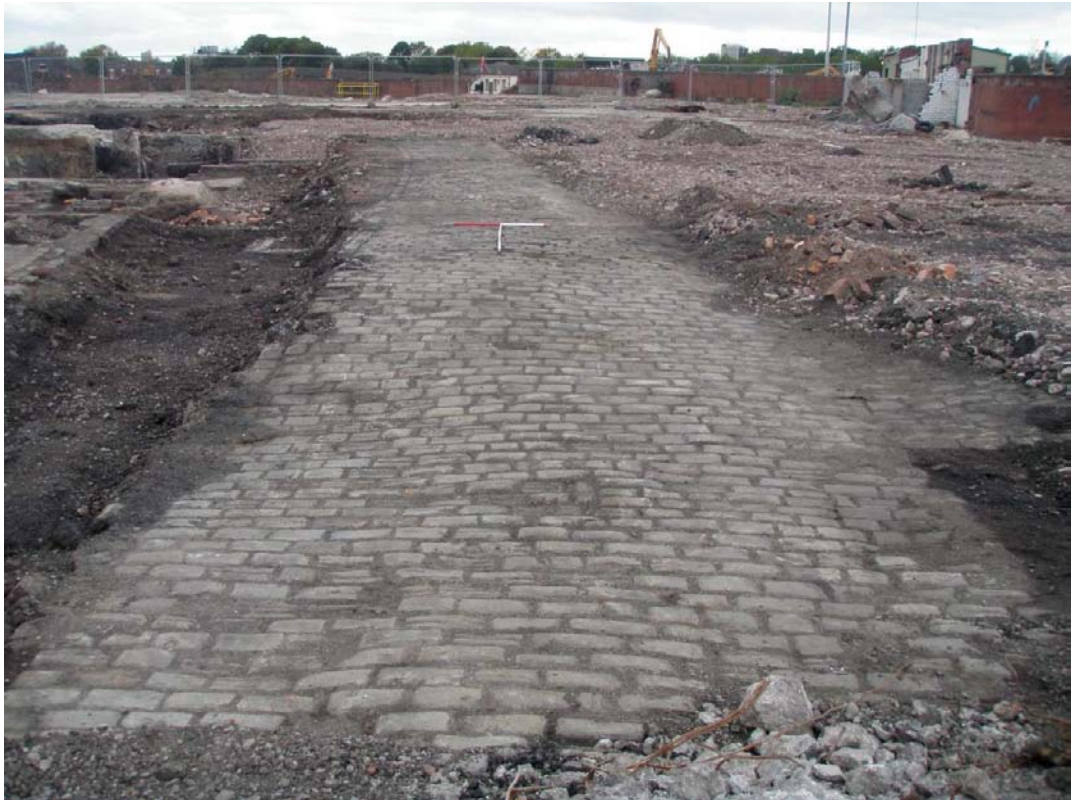
Plate 24: The well-preserved remains of surface **1078**

- 4.2.17 The removal of modern concrete in the central part of Area A revealed the well-preserved remains of an historic surface (**1078**) composed of rectangular granite setts (Plate 24). The surface was 4.2m wide, and was excavated to a length of 25.4m. The eastern edge of the surface had brick-built kerb (**1079**), composed of hand-made bricks that were bonded with lime-based mortar, consistent with a mid-nineteenth-century construction date.

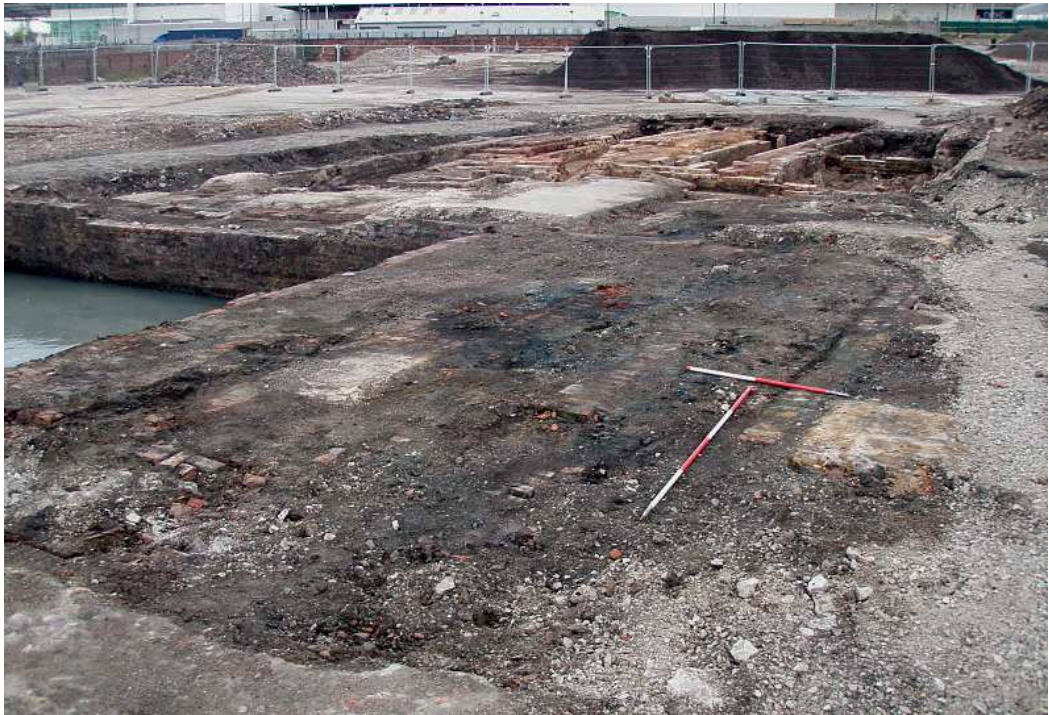
Plate 25: The limited depth of excavation in the south-eastern part of Area A, where significant concentrations of cyanide were encountered

- 4.2.18 Initial excavation in the south-eastern part of Area A revealed the remains of several brick-built walls. However, further excavation in this area was precluded by high levels of ground contamination (Plate 25). Nevertheless, it was clear that most of the walls in this part of the site were constructed from hand-made bricks, and appeared to have been bonded with lime-based mortar, suggesting that the walls pertained to mid-nineteenth-century construction.

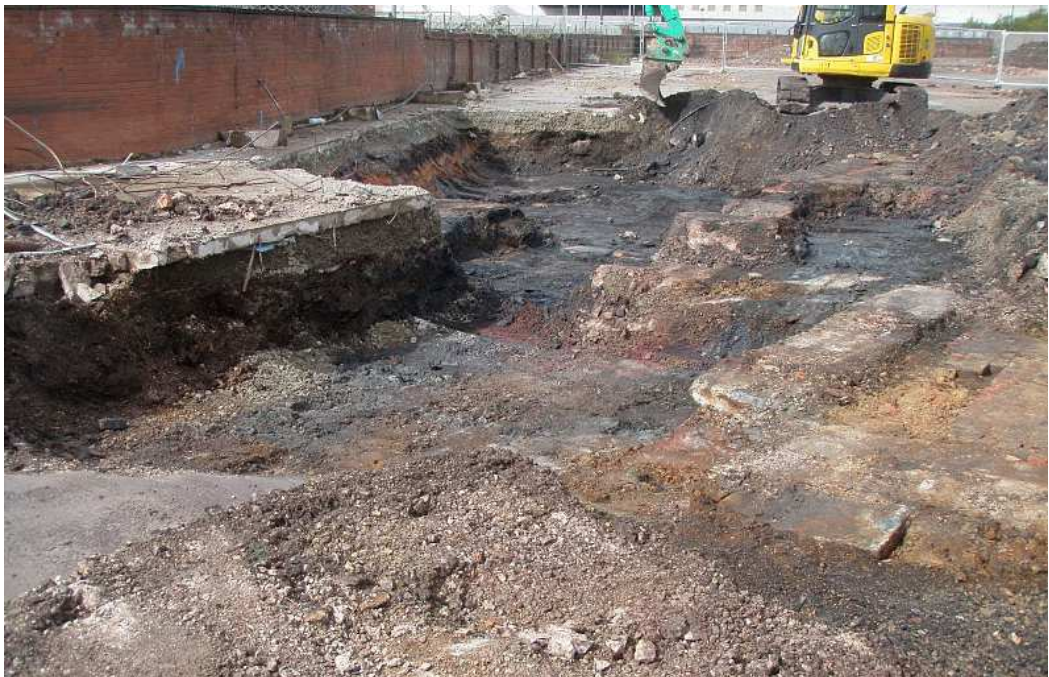
Plate 26: Excavation in the western part of Area A encountered significant ground contamination

4.2.21 Initial excavation in the western part of Area A also revealed some structural remains. However, further investigation in this area was again precluded by high levels of ground contamination (Plate 26).

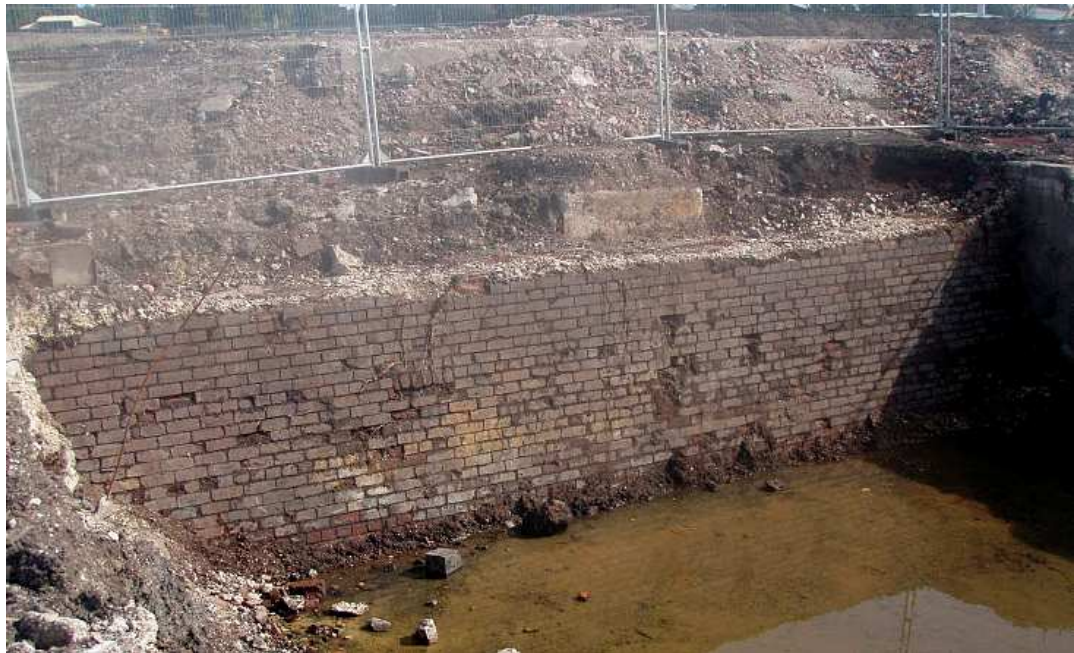
Plate 27: The west-facing elevation of basement **1500**

- 4.3.2 The basement (**1500**) measured 13.8m long, 9.6m wide and was 2.6m deep (Plate 27). Each of the component walls were 0.66m wide, equivalent to six courses of bricks. The basement incorporated a brick floor (**1501**) at the base, constructed from machine-made bricks. However, the floor could not be cleaned manually due to the high level of contamination. No interior fixtures or fittings were identified to provide an indication of the intended function of the tank, although it seems possible that it was used for the storage of liquids as part of the chemical manufacturing process. The basement had probably fallen into disuse by the late 1880s, as it is not shown on the Ordnance Survey map of 1893.

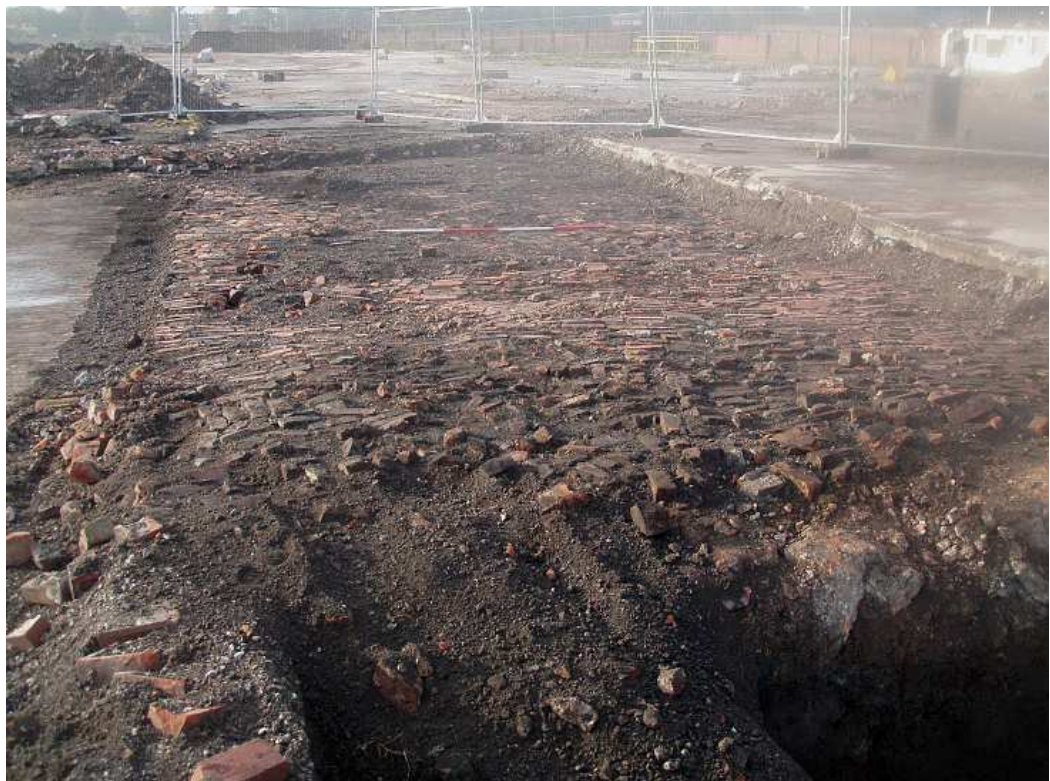
Plate 28: Brick surface **1510**

- 4.3.6 Two brick surfaces were also exposed in the south-western part of the excavated area (Fig 7). Surface **1509** measured 8.4 x 2.1m, and comprised machine-made bricks laid on their side. Surface **1510** measured 11.2 x 5.5m, and comprised a combination of hand-made and machine-made bricks (Plate 28). Some of the machine-made bricks had a 'BC' stamp within the frog, indicating that they had been manufactured at the Bradford Colliery brickworks, which was in operation from 1874 until the early 1900s (Miller 2011). Surface **1510** also contained several 'HAMMOND' refractory bricks, which were manufactured post-1890 (Section 4.6.8 below).
