**OMG Works,
Openshaw West,
Clayton,
Manchester**

**Archaeological
Excavation**

December 2012

**Buckingham Group Contracting
Ltd**

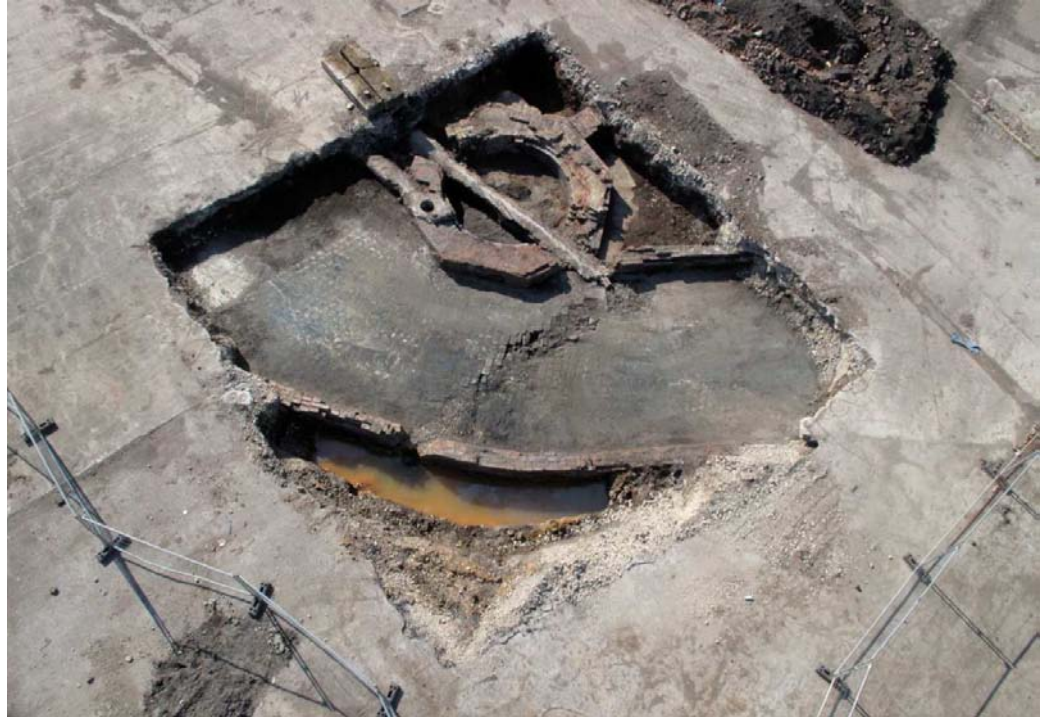
Plate 29: Area C fully excavated, showing the foundations of the chimney stack

- 4.4.1 Area C was targeted specifically on the site of the chimney for the chemical works, which is first depicted on the Ordnance Survey map of 1848. The excavation revealed the well-preserved foundations of the chimney stack, together with brick and stone sett surfaces (Plate 29).

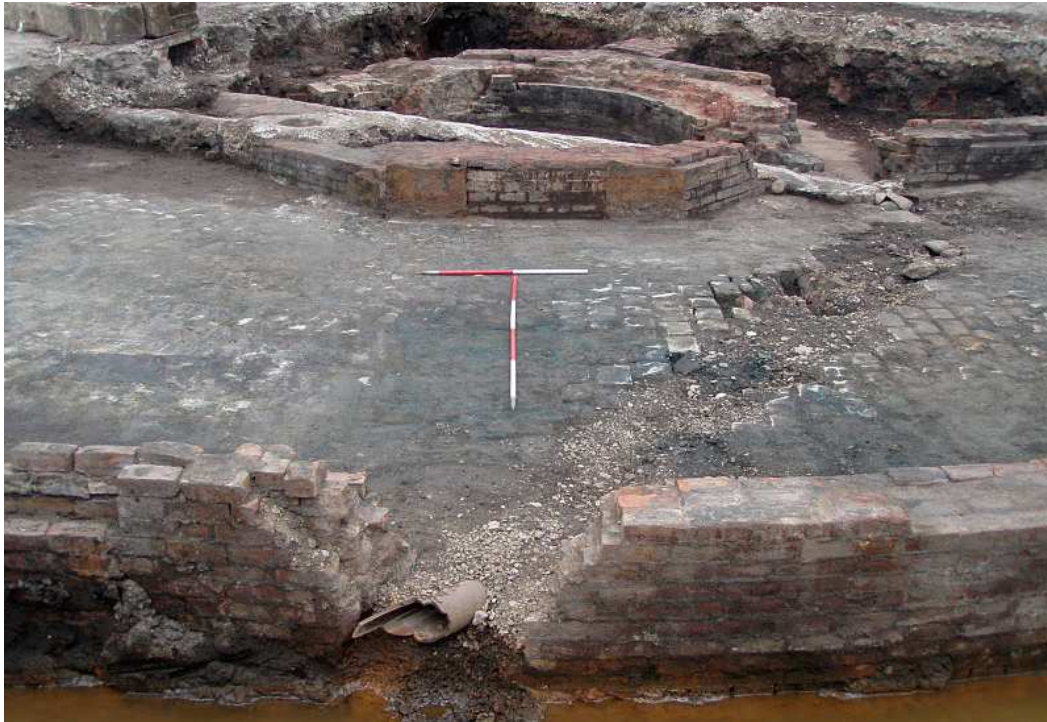
Plate 32: Drain 2010 continuing eastwards from the foundations of the chimney stack

- 4.4.5 The foundations of the chimney stack had been cut across its centre by the foundation trench (2009) for a modern drainpipe, which passed north/south across the centre of the chimney, and then turned through a right angle and continued eastwards (Plate 32). It seems possible that the foundation trench for this drainpipe utilised the existing flue aperture into the chimney stack, as there was no surviving physical evidence to demonstrate firmly where the flue had entered the stack. The foundation trench for a second modern drain (2010), aligned east/west, cut the south-eastern corner of the chimney stack (Plate 32).

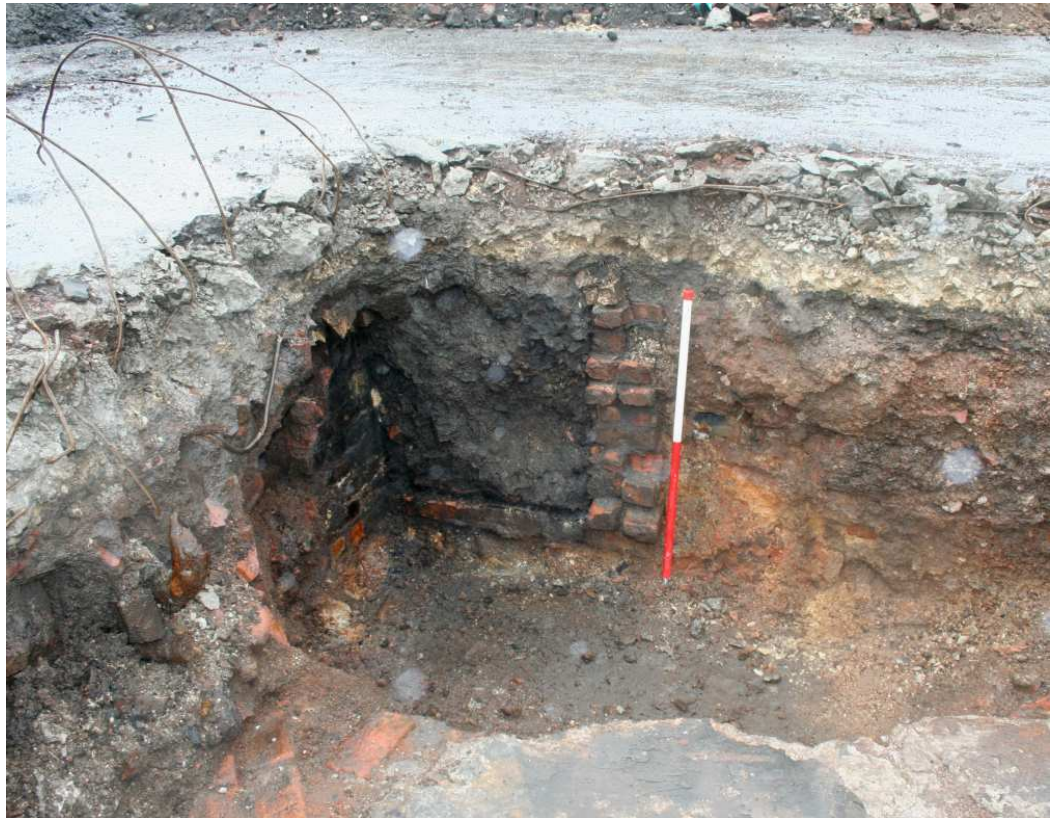
Plate 33: The remains of flue 2005 exposed in the south-west corner of the excavated area

- 4.4.7 The remains of a second flue (2005) were revealed in the south-western corner of the excavated area (Fig 8). This flue was aligned east/west, and comprised machine-made bricks, each measuring 0.23 x 0.115 x 0.07m (9.05" x 4.5" x 2.75") and bonded with a black cement-based mortar, indicative a late nineteenth-century construction date. The walls of the flue were two-courses thick, and survived to a height of 1m (Plate 33). The base of the flue was also formed from bricks, creating a surface that was a single-course deep. The internal elevations of the flue were degraded and discoloured, indicating that they had been subject to high temperatures.

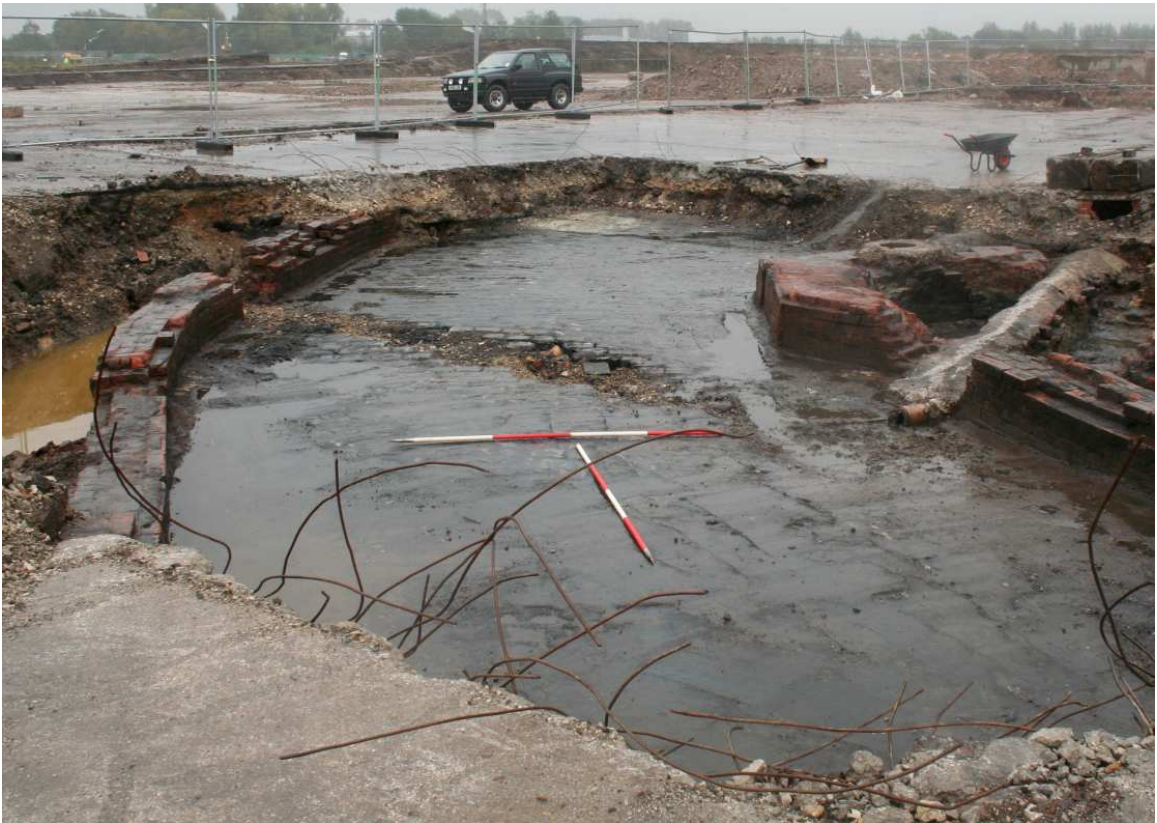
Plate 34: The excavated remains of surface 2001, looking south-east

- 4.4.9 The area surrounding the chimney stack was characterised by two historic surfaces (Plates 34 and 35). The earliest of these appeared to be a brick surface (**2000**), which was exposed in the south-west corner of the excavated area. The surface comprised hand-made bricks laid on their side, with an average measurement of 0.2 x 0.11 x 0.075m (7.9" x 4.3" x 3"). This surface was abutted by a substantial surface (**2001**) composed of square granite setts that were bonded with tar. Surface **2001** curved around the chimney (Plate 34), leading into the north-western corner of the excavated area. The surface was flanked on both sides by walls that survived to a maximum height of 0.5m. Both walls were four-courses thick, and comprised machine-made bricks bonded with cement-based mortar, consistent with a twentieth-century construction date. The position of these walls corresponds with features shown on the Ordnance Survey map of 1922, but are absent from the previous edition of 1909.

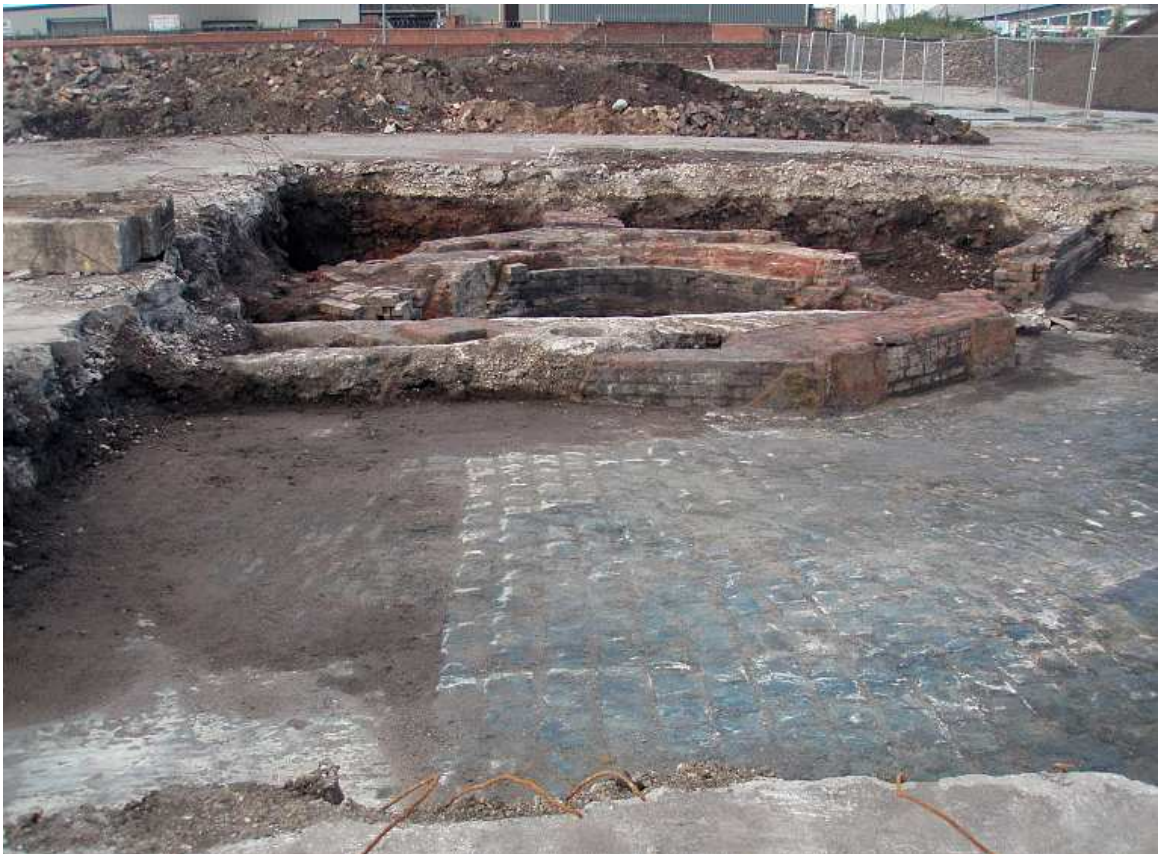
Plate 35: The excavated remains of surface 2000 and surface 2001

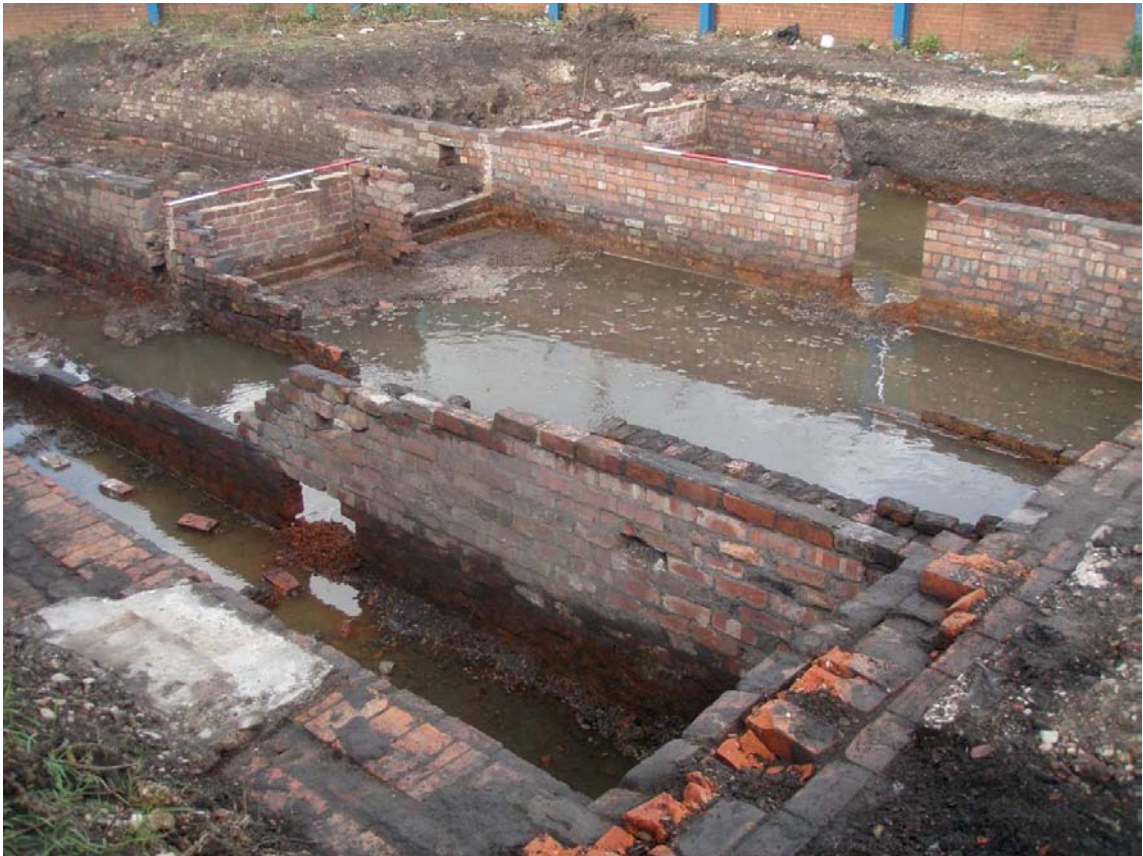
Plate 36: View looking north-west across the excavated remains in the northern part of Area D

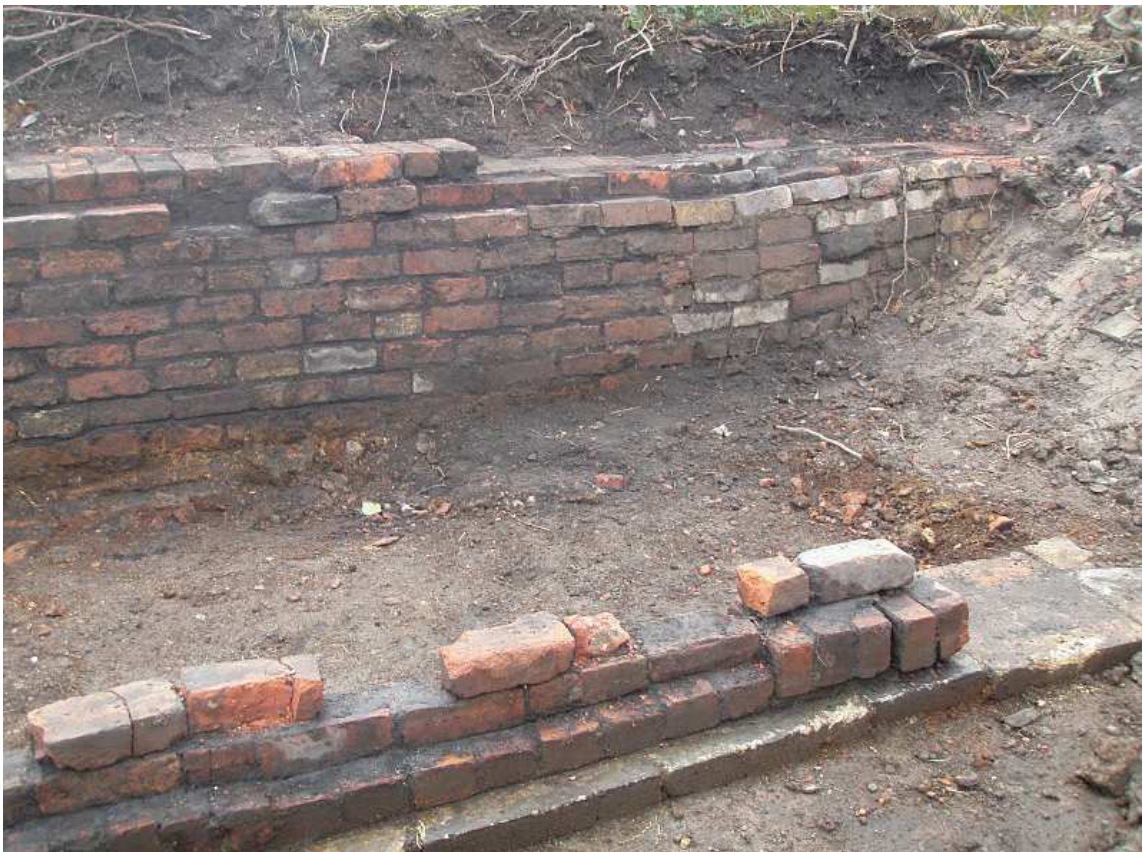
Plate 37: Refractory tiles forming a foundation course for partition wall 3001

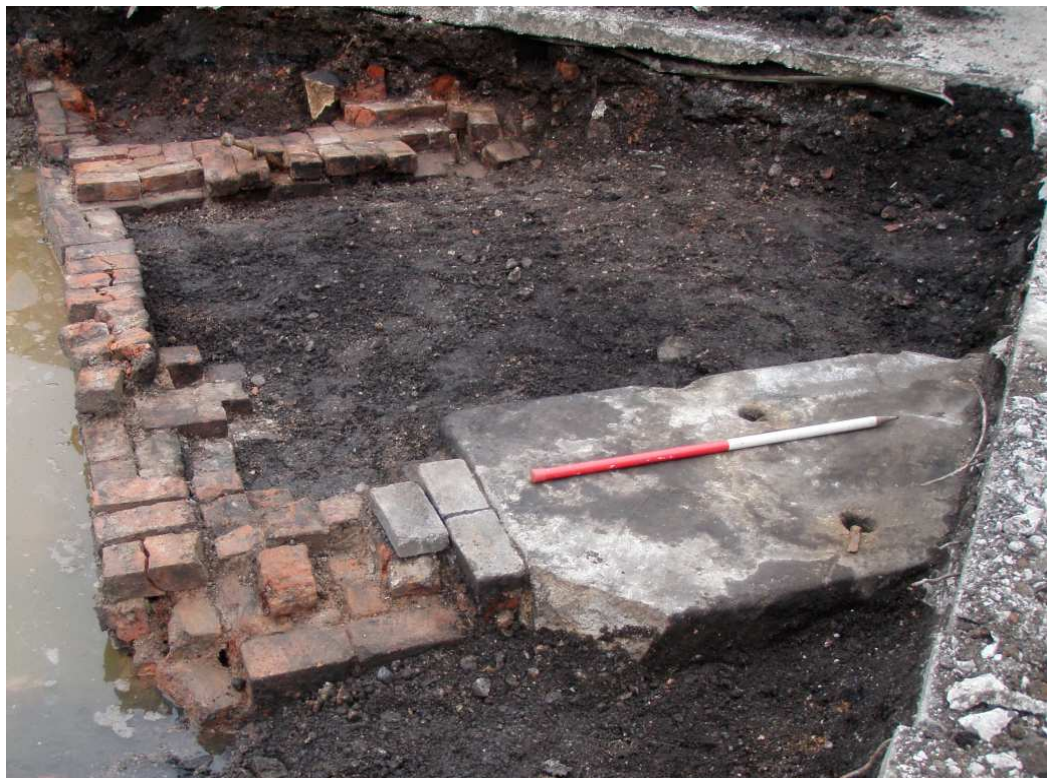
Plate 38: The remains of walls **04**, **05** and **06**, partially excavated

- 4.5.8 Excavation in the south-western corner of the former firebrick works site exposed the fragmentary remains of three adjoining buildings that formed an L-shaped range depicted on the Ordnance Survey map of 1893 (Fig 9). A structure (**09**) comprising three walls (**04**, **05** and **06**) was revealed in the southern corner of the building's footprint (Plate 38). The walls all comprised hand-made bricks, each measuring 230mm x 110mm x 70mm (9.1" x 4.3" x 2.75"), and bonded with a lime-based mortar, consistent with a mid-nineteenth-century construction date. Walls **05** and **06** were all two-courses wide, and survived to a height of six courses. Wall **04** was more substantial, being eight-courses wide at its foundation. Wall **06**, forming the south-western wall of the building depicted on historical mapping, retained the remains of two metal rods that had probably been used for securing an item of machinery to the wall (Plate 39).

- 4.5.9 The area enclosed by the walls contained mixed rubble in a dark grey sandy clay matrix. This material also contained a significant level of ground contamination, precluding detailed excavation. However, mechanical excavation revealed that wall **04** survived to a height in excess of 1.5m, although no floor surfaces were encountered at depth.

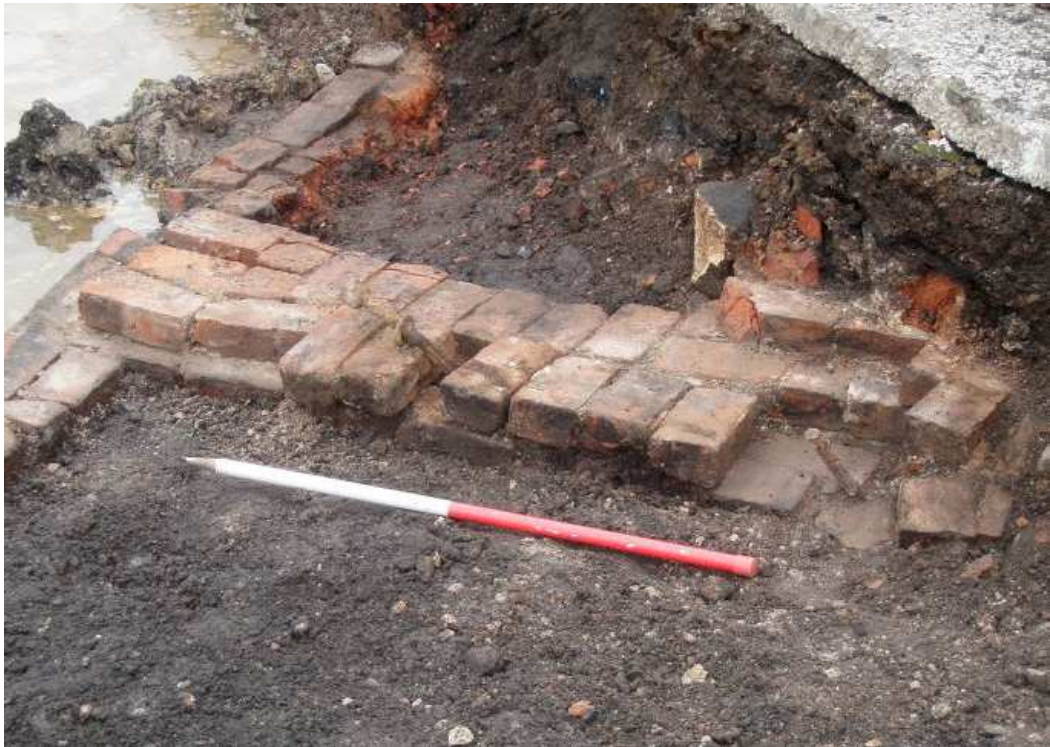
Plate 39: The remains of restraining bars set in wall **06**, with wall **07** to the rear

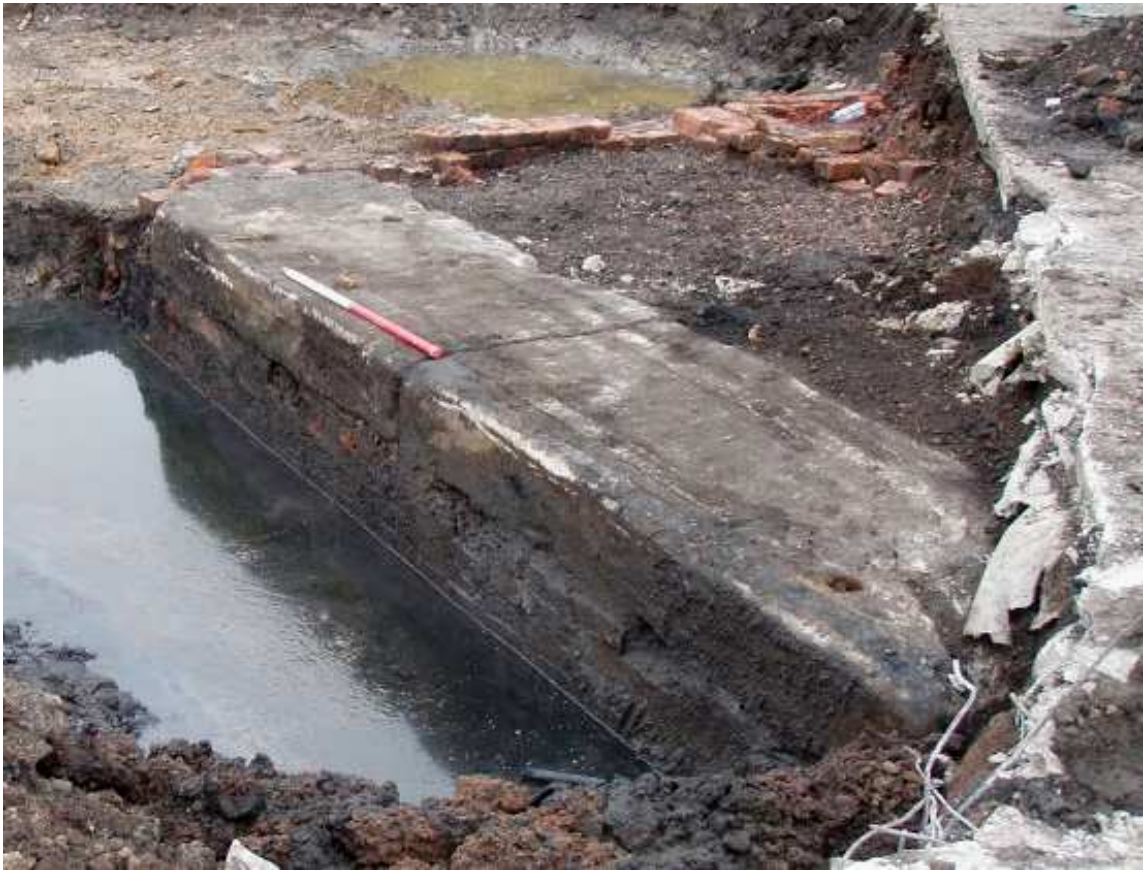
Plate 40: Stone-built machine bed 03

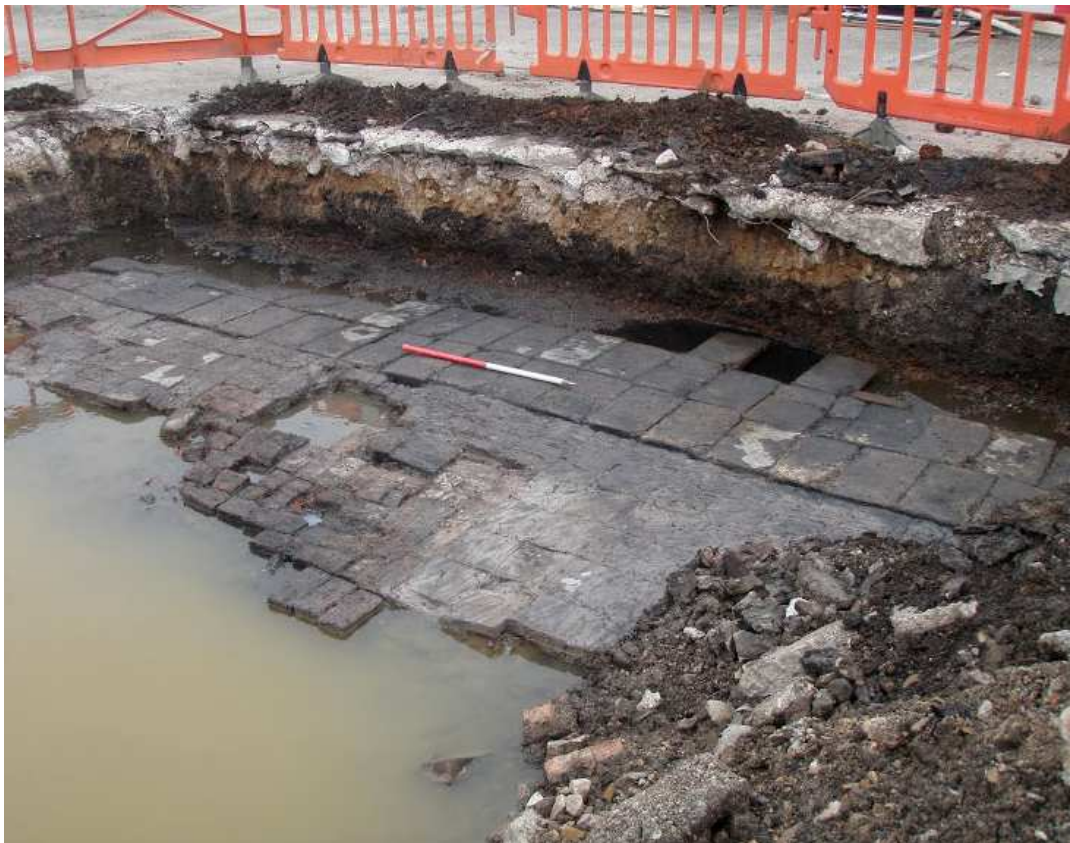
Plate 42: Floor **21**

- 4.5.14 A floor (**21**) composed almost entirely of refractory tiles was revealed in the interior of the building (Plate 42). Each of the tiles measured 230 x 230 x 50mm (9.1" x 9.1" x 2"), and appeared to have been bonded with a lime-based mortar. The floor had been repaired several times using refractory bricks of standard dimensions. The removal of floor **21** demonstrated that it had been laid on a deposit of cinders, similar to that exposed beneath yard (**11**), which directly overlay the natural clay geology.
