Malthouse Bungalow, East Hanney, Oxfordshire Archaeological Evaluation Report

February 2017

Client: BHP Harwood Architects

Archaeological Evaluation Report

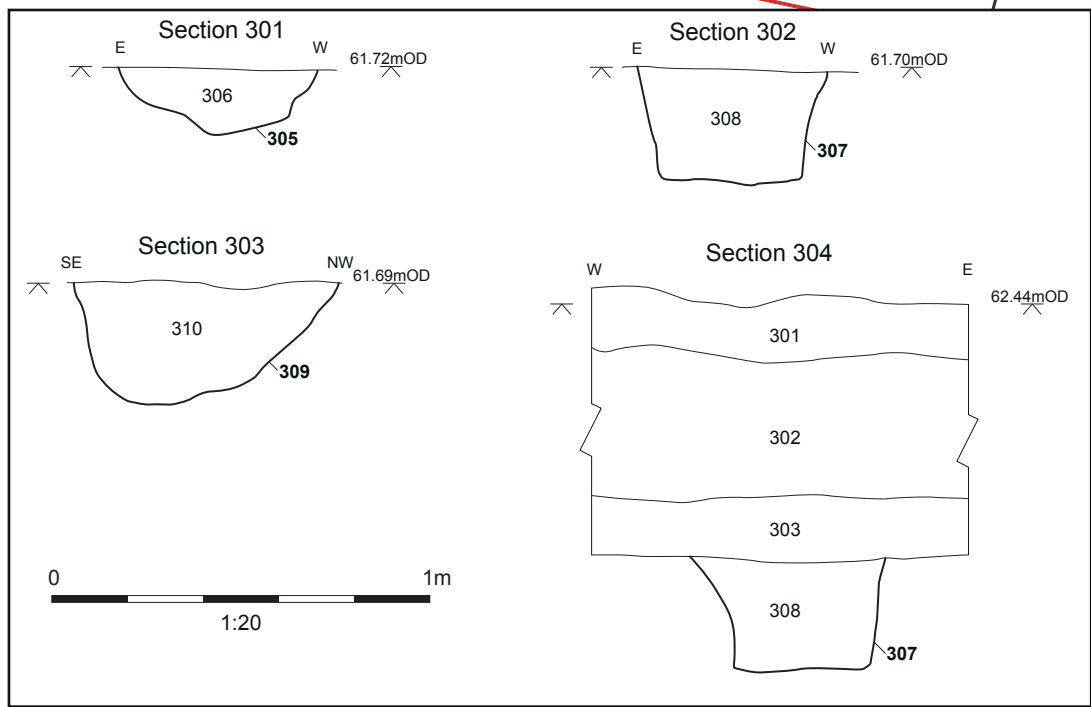
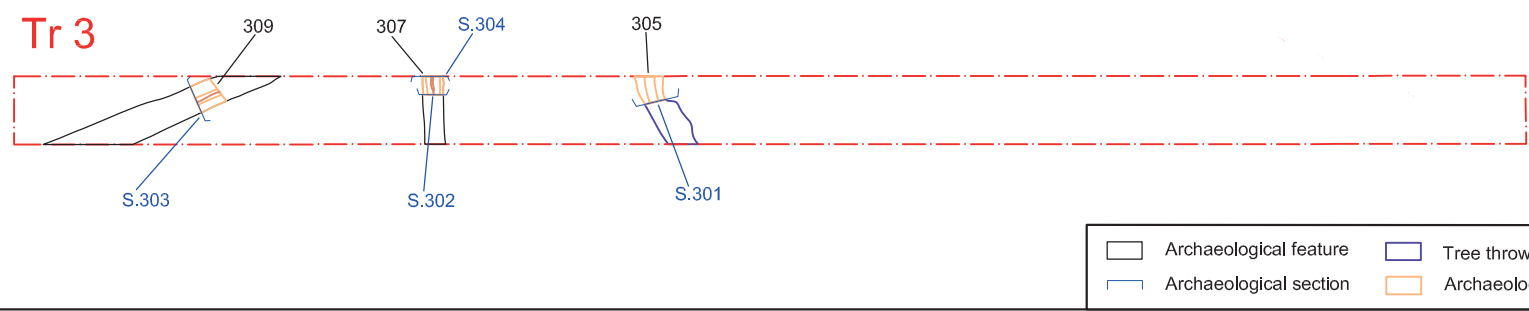
Figure 4: Trench 3 plan

3.5.1 This trench was excavated on an ESE-WNW alignment and was 40m long.

3.5.2 The geological horizon (304) was encountered at a depth of 0.55m (61.89m aOD). Two shallow gullies, one aligned north-south (307), the other aligned east-west (309), cut the geological horizon. An amorphous soilmark (305) was also investigated but proved to be irregular in form and was clearly formed by root-disturbance.

3.5.3 Gully 307 was 0.52m wide and 0.31m deep with irregular, near-vertical sides and a flat base (Plate 2). It contained a single fill comprising friable, dark grey-brown silty clay with 5% chalk particles, which did not produce any finds.

3.5.4 Gully 309 was identified towards the western end of the trench and lay on a NE-SW alignment. It measured 0.71m wide and 0.33m deep. The profile was somewhat irregular, the south-eastern side being near-vertical and the north-western side sloping at 45°, and the base was gently curved. It contained a single fill (310) comprising friable, mid to dark grey-brown silty clay. No finds were recovered.

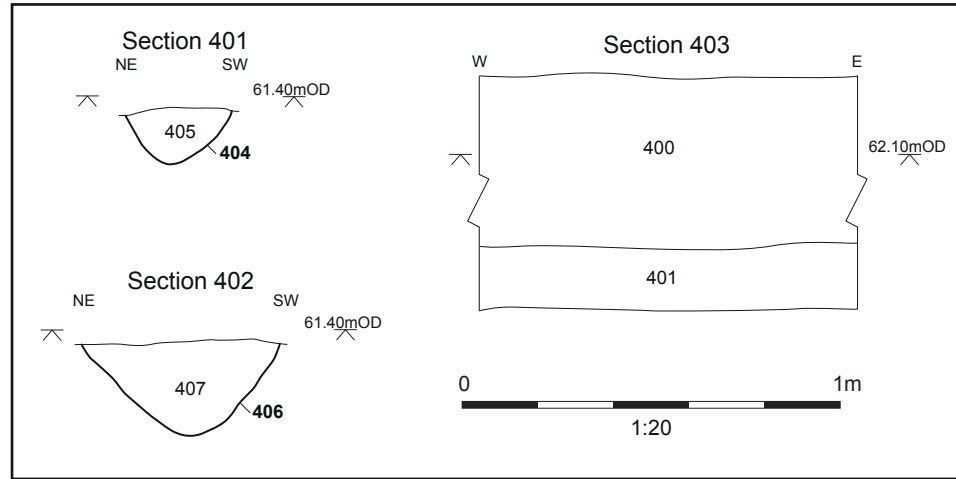
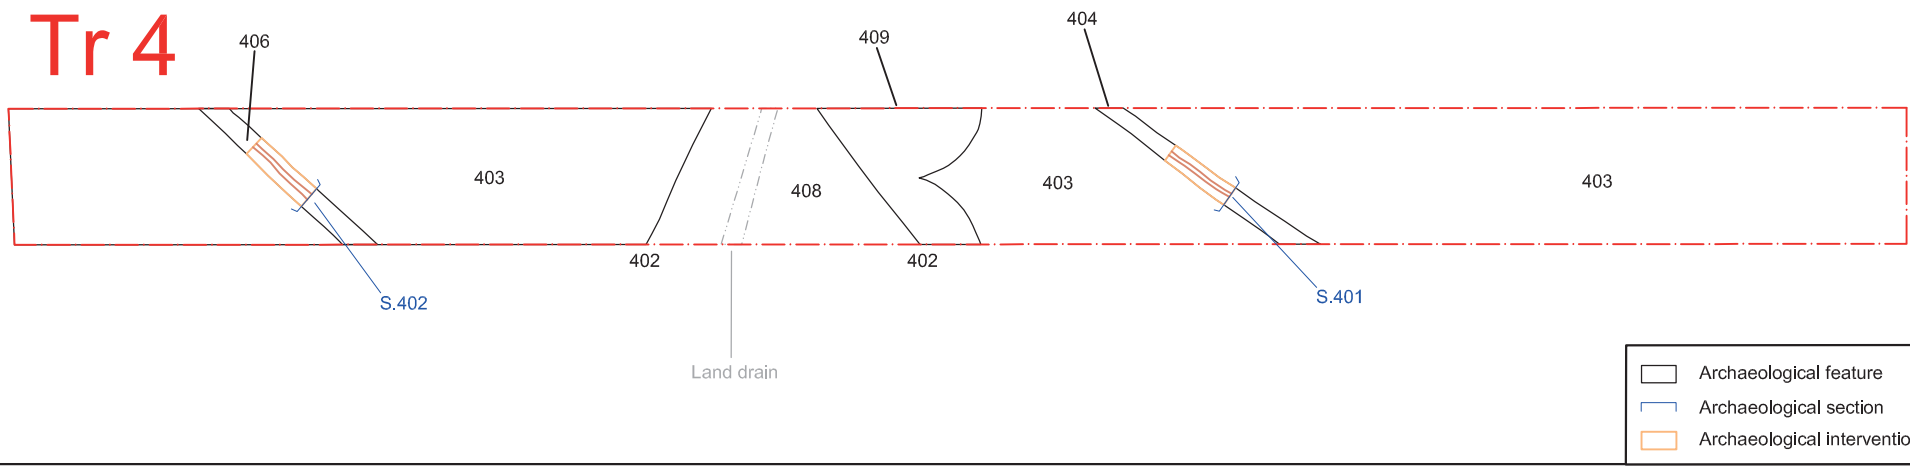
Tr 4

3.6.1 This trench was excavated on an ENE-WSW alignment in the south-western part of the site and was 25m long (Plate 3).

3.6.2 The geological horizon (403) was encountered at a depth of 0.64m (61.34m aOD). Two parallel gullies (404, 406), both aligned WNW to ESE, cut the geological horizon. In the middle of the trench at least two pits (402 and 409) were also revealed; it is possible that cut 409 in fact represented two intercutting pits.

3.6.3 Gully 404 was located toward the eastern end of the trench. It was 0.27m wide and 0.14m deep with 45° sides and a gently rounded base (Plate 4). It contained a single fill (405) comprising soft, light grey gravelly silt with no notable inclusions. No finds were recovered.

3.6.4 Gully 406 was located towards the western end of the trench. It measured 0.53m wide and 0.25m deep, with 45° side and a gently rounded base. The gully contained a single fill (407) comprising soft, grey gravelly silt with no notable inclusions. No finds were recovered.

3.6.5 The subsoil (401) that overlay these features was cut by pits 402 and 409, although this relationship was not realised during machining due to the similarity of their fills to the subsoil and was only evident in section. The features were not excavated but clay pipe and animal bone were recovered from the surface of pit 402. Pit 409 comprised two curving edges, appearing to represent two rounded pits, although these were under water and difficult to define clearly. The west side of the pit was truncated by pit 402. Only part of this pit was revealed within the trench, but its straight edges strongly suggest the pit was either square or sub-rectangular in plan. Its defined dimensions were 3.6 x 1.8m. Since post-medieval finds

had been recovered from pit 402, and as these pits were situated within a slight dip in the topography and were under c 0.1m of water, it was agreed with Hugh Coddington at a site visit that they need not be excavated.

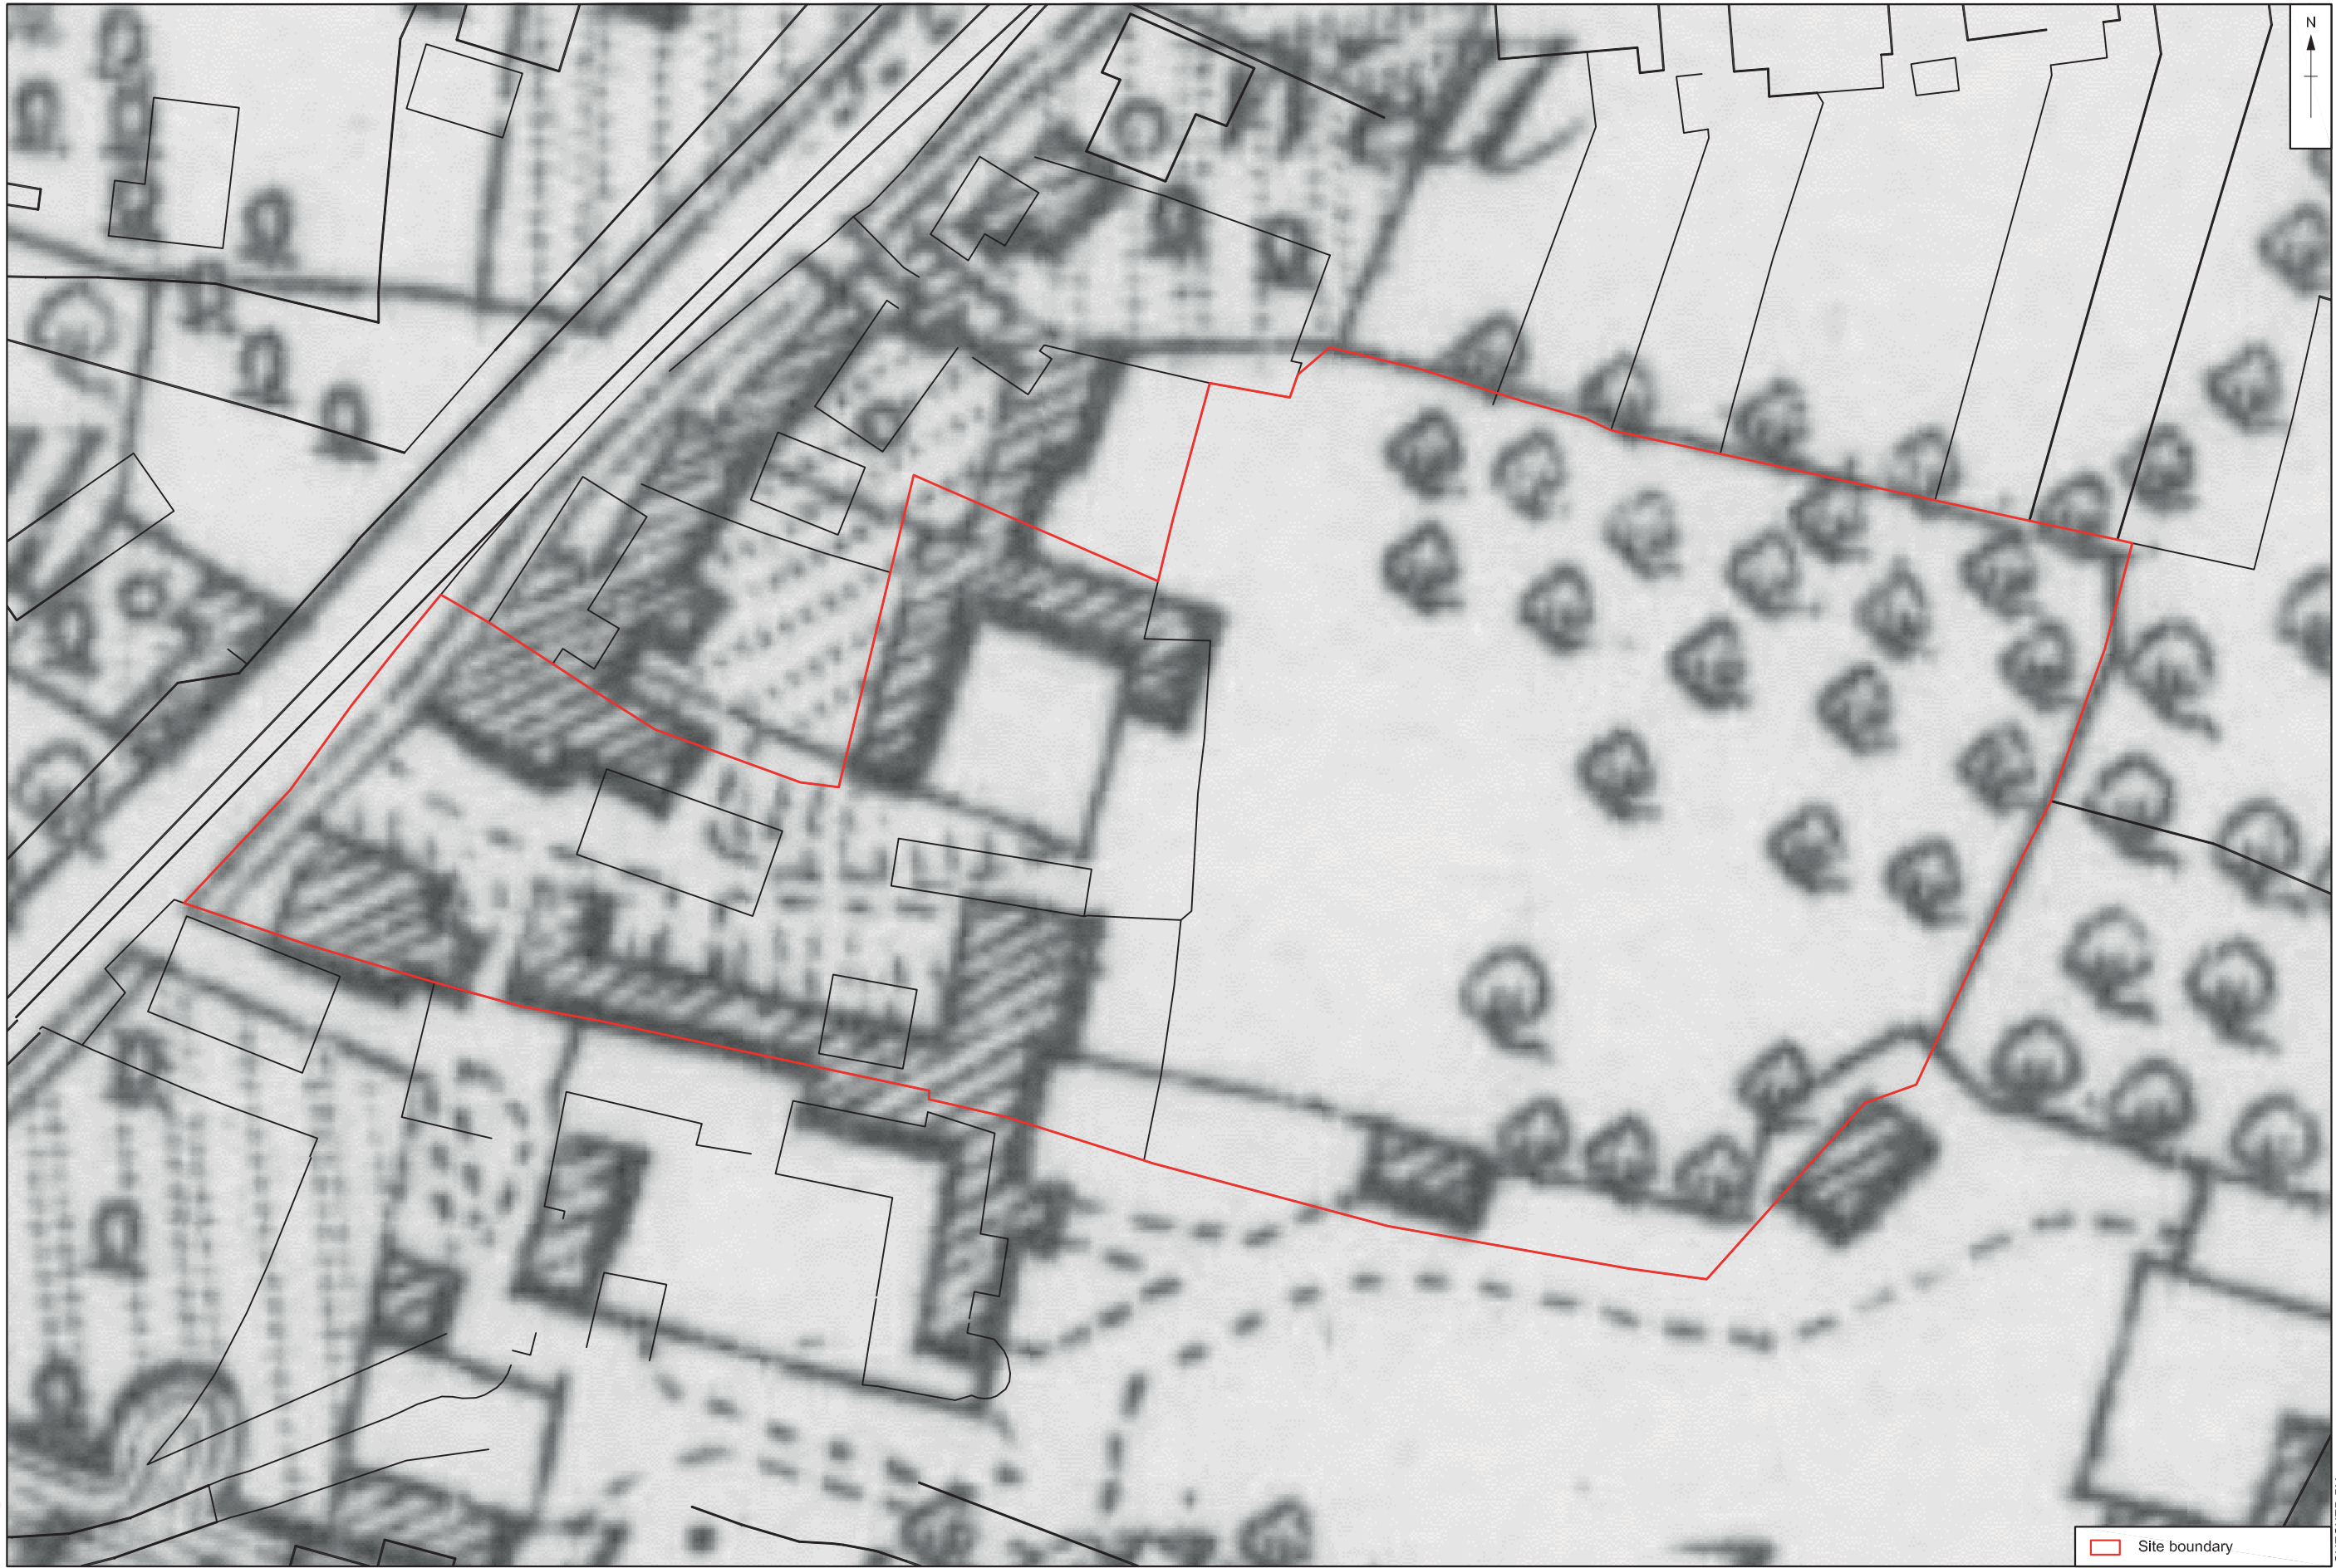
Figure 7: Site boundary overlaid on the OS Six-inch map of 1883

4.2.3 The Ordnance Survey maps published in 1875 and in 1883 (Fig. 7) show a boundary generally corresponding with the current eastern boundary to the site, but deviating from the current boundary towards the south-east corner. Here the 1883 boundary begins further westwards (very close to Trench 5), and runs north for around 7m, then turns to the north-east for about 10m before turning NNE and following the current boundary. This would strongly suggest feature 504 at the east end of Trench 5 represents the boundary line mapped in 1883.

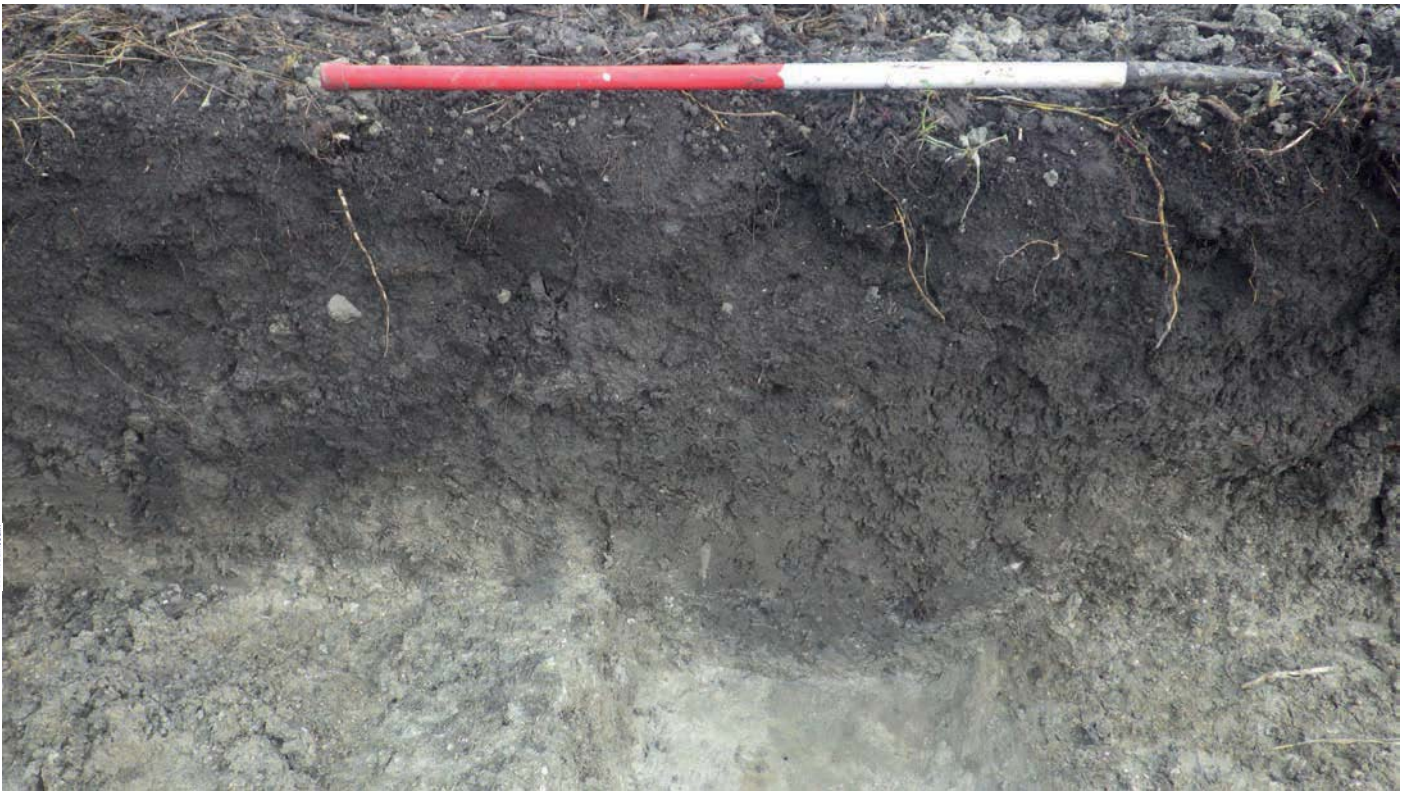
3.4.3 Gully 105 lay towards the south end of the trench. It was 0.63m wide and 0.26m deep with a U-shaped profile (Plate 1). The gully contained a single fill (106) comprising soft, grey silty clay with no notable inclusions. No finds were recovered.

Plate 1: Gully 105, looking south-east

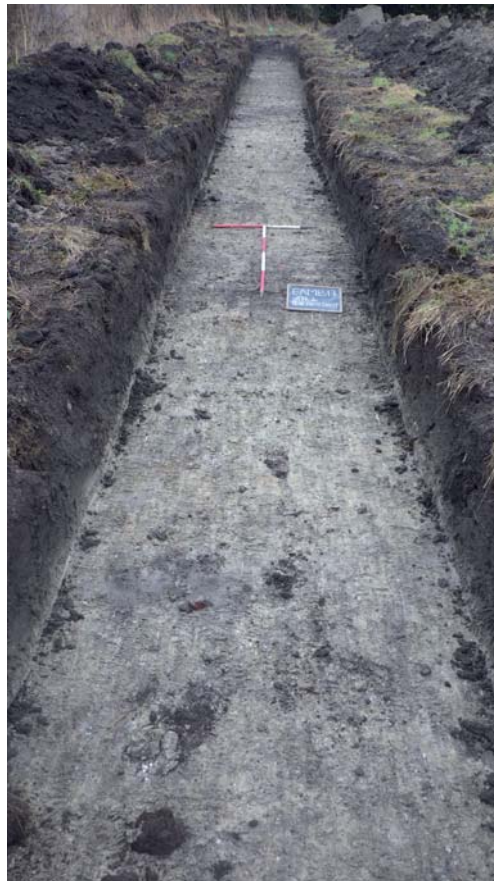
Plate 2: Trench 2 looking west

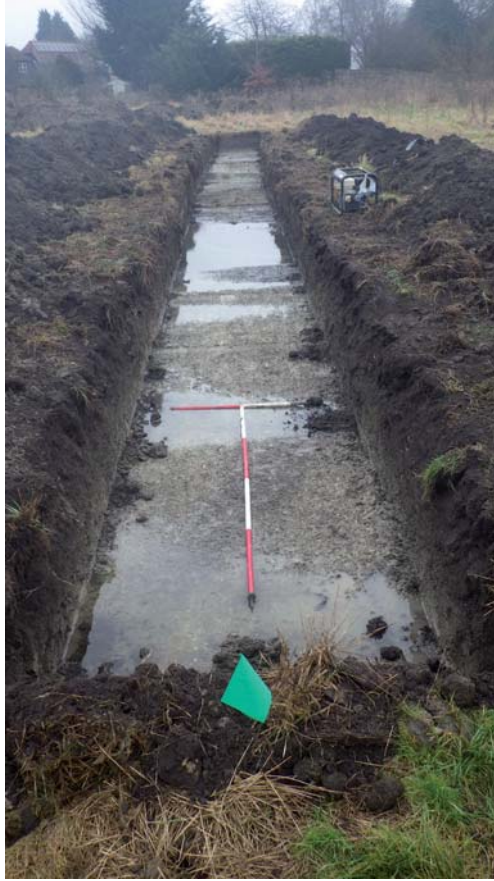
Plate 3: Trench 4 general shot,
looking east

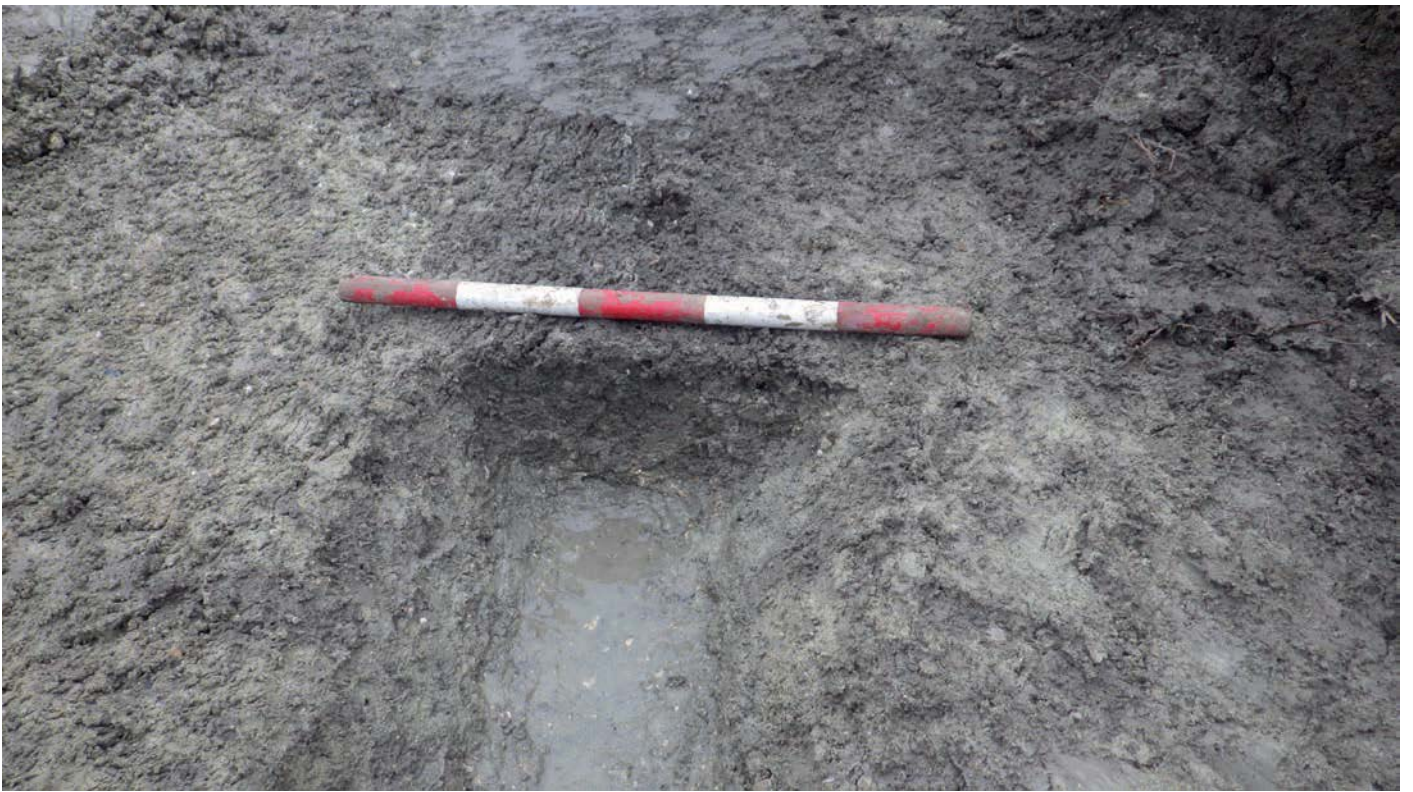
Plate 4: Gully 404, looking south-east

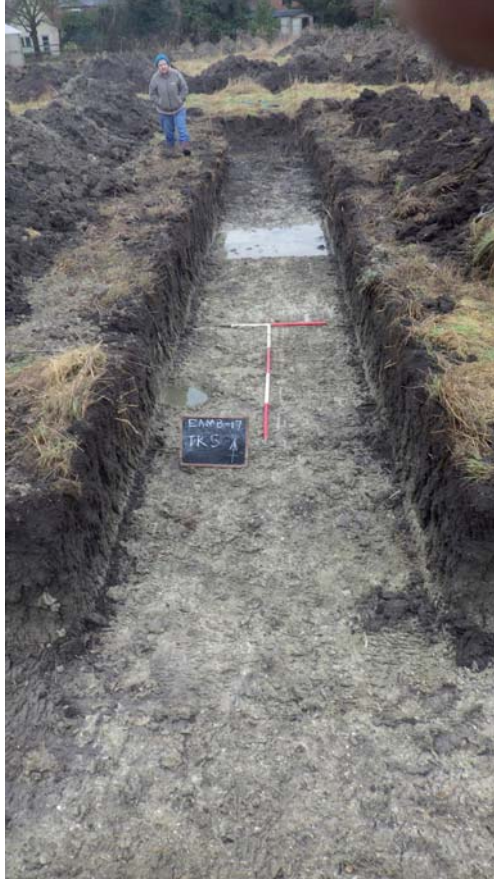
3.7.1 Trench 5 was excavated in the south-eastern part of the site and was T-shaped in plan, orientated north-west to south-east and north-east to south-west (Plate 5). The geological horizon (501) was encountered at a depth of 0.64m (61.52m aOD), and was cut by a shallow gully (502) and a large feature, possibly a ditch (504). An area of tree-root disturbance (513) was recorded in plan but not excavated.

Plate 5: Trench 5 general shot,
looking north-west

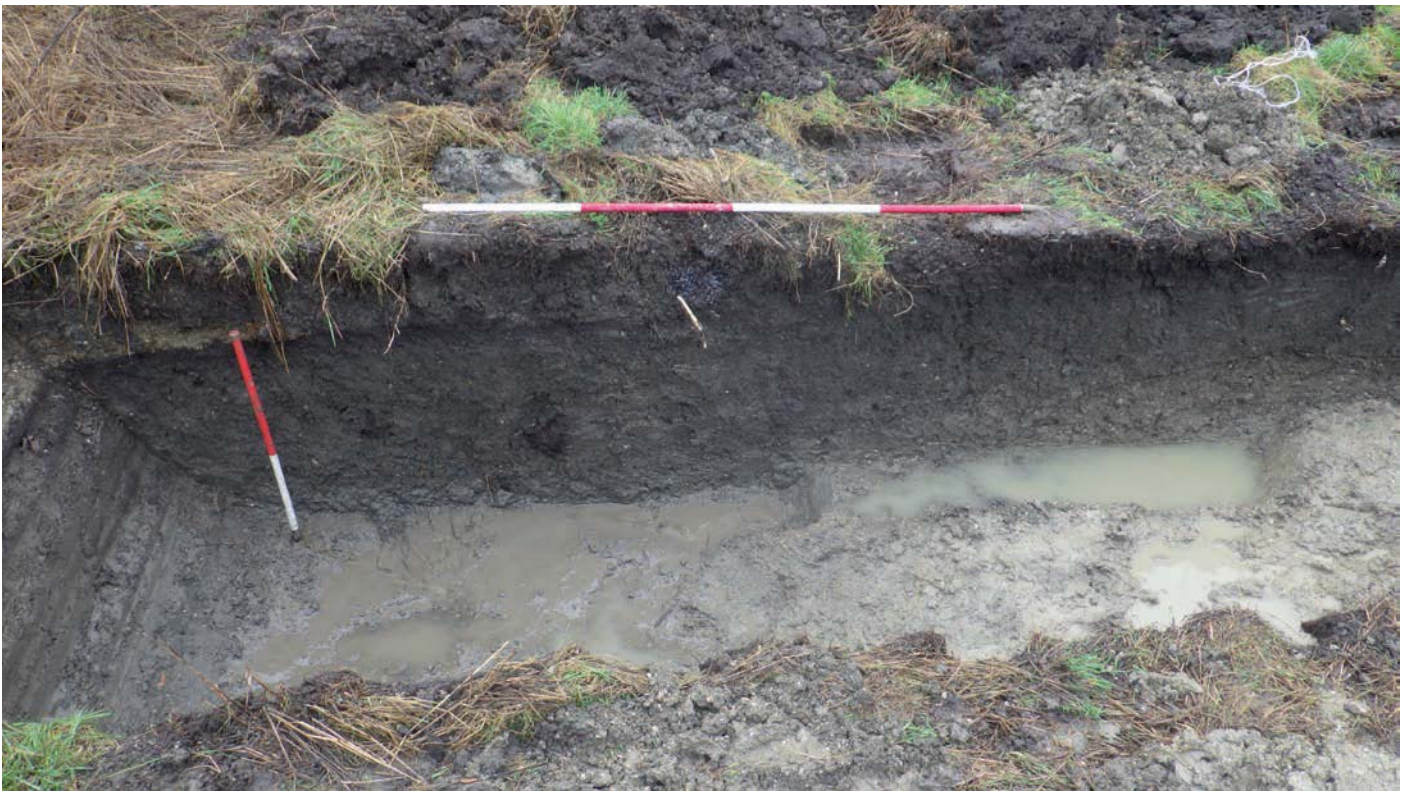
3.7.2 Feature 504 (Plate 6) was partially revealed at the north-eastern end of the trench. It occupied the whole of the last 4m at this end of the trench, and continued beyond it. It was excavated by machine to a depth of 1.2m below the ground surface without reaching the base but could not be excavated further due to ingress of ground water. Due to the flooding of the feature only the upper 0.3m could be recorded, which revealed that the western side appeared to be aligned N-S and sloped at an angle of c 40° (Fig. 6 Section 501).

3.7.3 The feature contained three fills (505, 506, 507), all of which were moderately compact. Fill 505, which tipped in from the western side of the cut, was 0.28m thick and comprised grey sandy silt with 10% gravel inclusions. This was overlain by a similar deposit (506), again tipping into the feature from its western edge, which was 0.3m thick and comprised a grey-brown sandy silt with 15% gravel inclusions. Both deposits appeared to be derived from the geology and may represent upcast material eroded from a bank on its western side. Most of the feature was filled by layer 507, which overlay 506 and was revealed to a depth of 0.6m. It consisted of dark grey-brown clayey silt with 2% gravels and was a generally homogeneous deposit, which may indicate the deliberate backfilling of the feature in a single event. A single fragment from a Brill Boarstall jug handle manufactured between AD 1400 and 1550 was recovered. A number of rotted roots extended into the fill, perhaps indicating that a large tree has been removed from the area.

Plate 6: Ditch 504 part-excavated, looking south-east

4.2.1 The character of the large feature 504 in Trench 5 was uncertain. The western edge appeared to be straight and it is therefore possible that it represented a large ditch on a north-south alignment, but it could instead have been a large, straight-sided pit. It was not identified within Trenches 2 or 3, where it would have been present had it been a straight ditch.
