# **Lyme Park, Cheshire**

## **Detailed Survey of Aspects of the Historical Landscape Development**

**Volume 1: Survey Reports**

**Oxford Archaeology North**

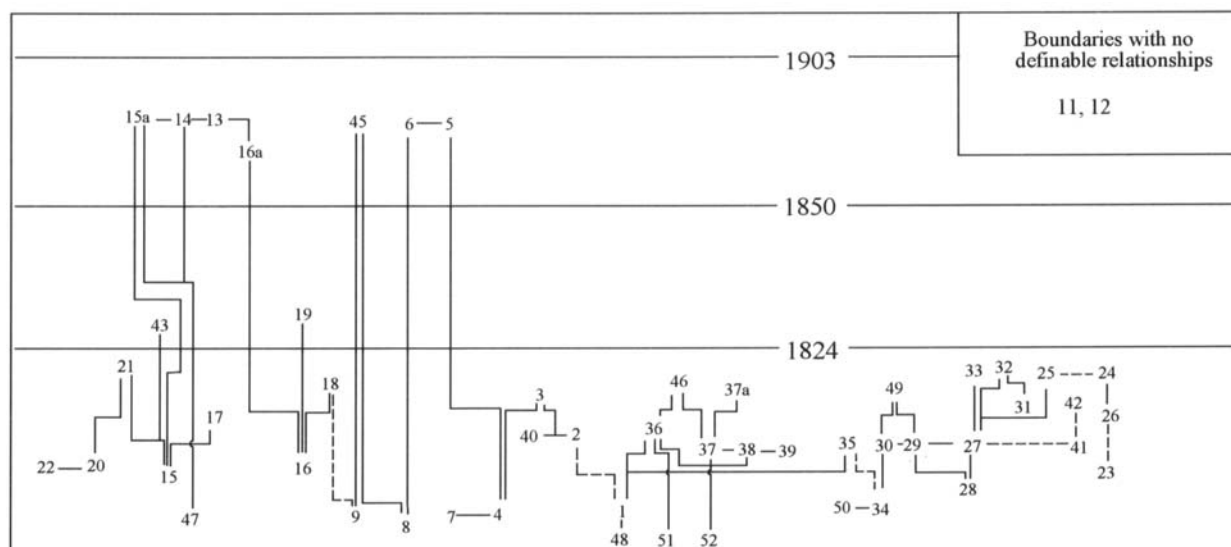
**Table 2 Boundary Development Matrix**

- 2.4.1 **Matrix:** the Matrix (see below) illustrates the relationships between the various elements of the boundary system. The matrix defines a sequence of constructional events and is based upon the butt/bond junctions between wall sections; however, some of these junctions show evidence of repair, which could obscure evidence for the original relationship or the wall junctions are too decayed to provide a reliable indication of the wall relationships. As a consequence only wall junctions with clearly defined relationships are shown with a solid line on the matrix, the more tentatively interpreted relationships are marked as a dashed line.

- 2.4.3 The matrix numbers are groups of wall sub-sectors, in-between primary wall junctions, that were of a broadly consistent build. The purpose is to provide a more

simplified and usable format for relational analysis. The form of the No. grouping is shown in Appendix 3.

- 2.4.4 **General trends:** the survey has established a number of areas where the development of the boundaries can be charted (Fig 6), but, as a result of many obscured or unclear relationships between the various elements, and a severe lack of dating evidence, it has not proved possible to provide a detailed chronological summary of the development of the Park boundaries. In some areas, such as the north-eastern end of the Park, boundary divisions were extensively rebuilt and newly constructed during the development of the railway and the construction of reservoirs, and can thus supply no evidence for the early development of the Park. These late boundaries, therefore, have been excluded from the development sequence, as their history can be tied to a specific phase of modern activity. In other parts of the Park, particularly around Paddock Lodge and Drinkwater Meadow, some walls are now almost completely destroyed, surviving only as tumbled footings which are difficult to relate to the surrounding boundaries.
