# LOWER GREYSTONELEY CHIPPING LANCASHIRE

## Archaeological Building Investigation

**Oxford Archaeology North**

June 2006

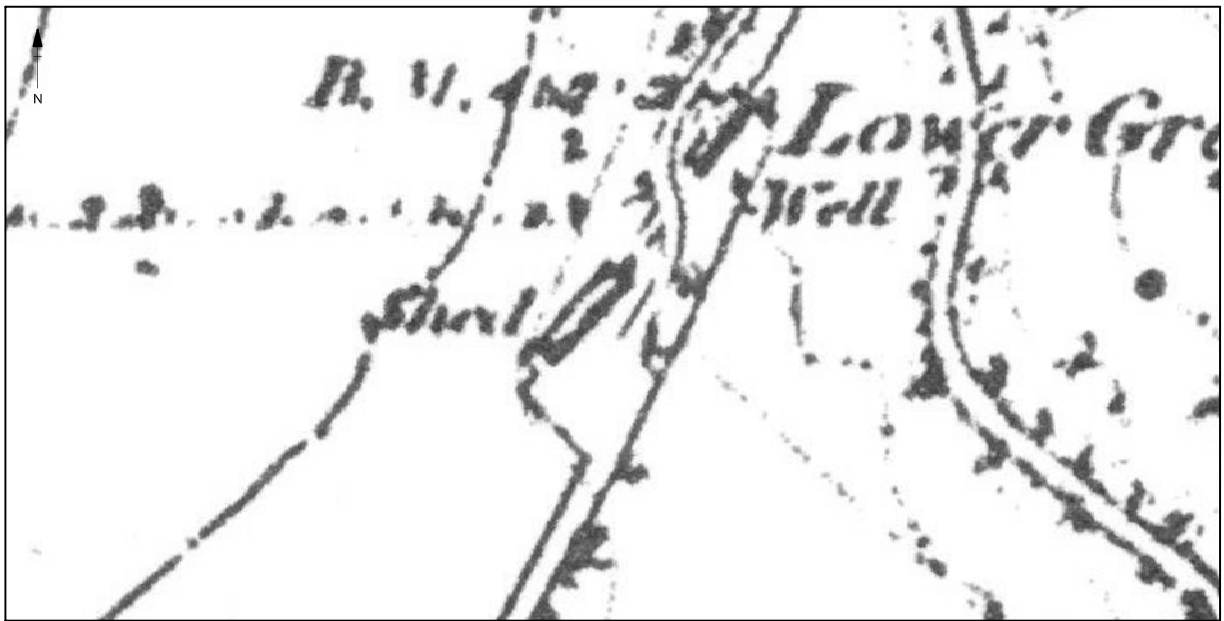
Figure 2: Extract from Ordnance Survey First Edition map, 1844 (1:10560)

3.2.1 *Ordnance Survey Map 1844*: the map shows the area of Lower Greystoneley, but the buildings appear to be unrecognisable compared to the existing structures (Fig 2). An inverted T-shape building is depicted, as is a well, but no other buildings are present.

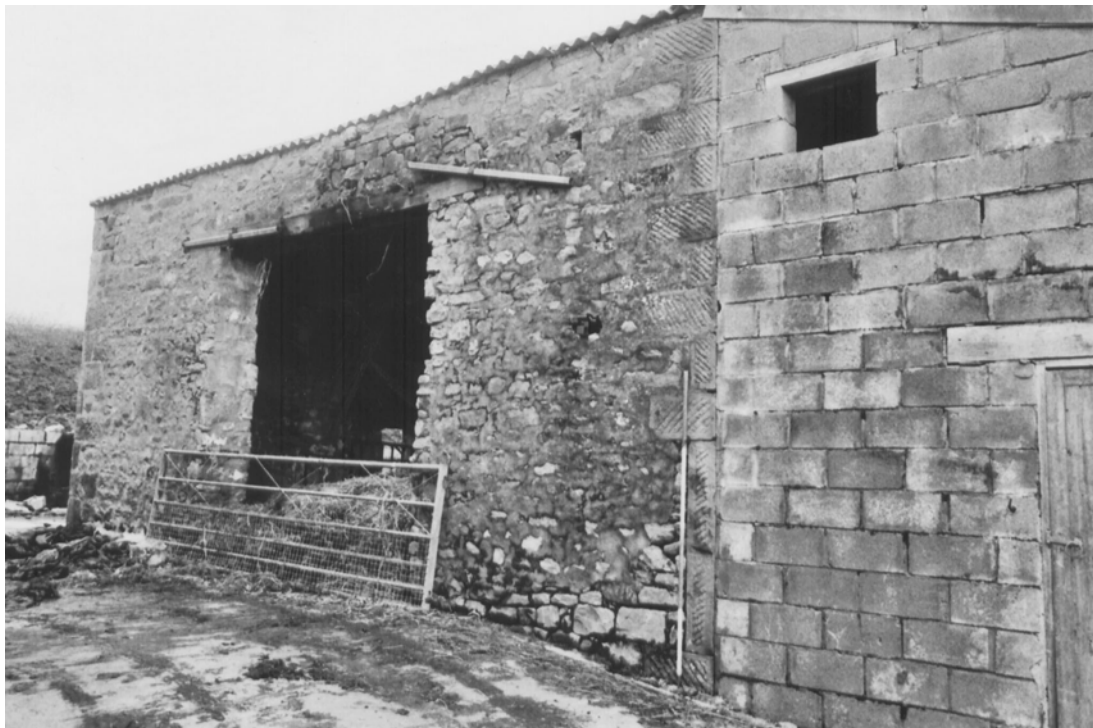
- 4.2.1 As noted above, the main build of the barn (Plates 1-4) would appear to be a mixture of both limestone and sandstone rubble, with better quality stonework and coursing towards the base of the structure. Included within this build are a series of circular vent holes arranged into three rows, which have been lined with ceramic pipe. In addition, there are discrepancies in the quality and materials of the dressings featured in the build. At the front (east) of the building, there are well-dressed sandstone quoins, projecting sills and deep, flush lintels, which feature a “rusticated” finish and pronounced diagonal ridges (Plate 5). This is repeated on the lintels at the rear of the building. The

Plate 2: The south elevation of the barn with the modern shed to the right of the picture

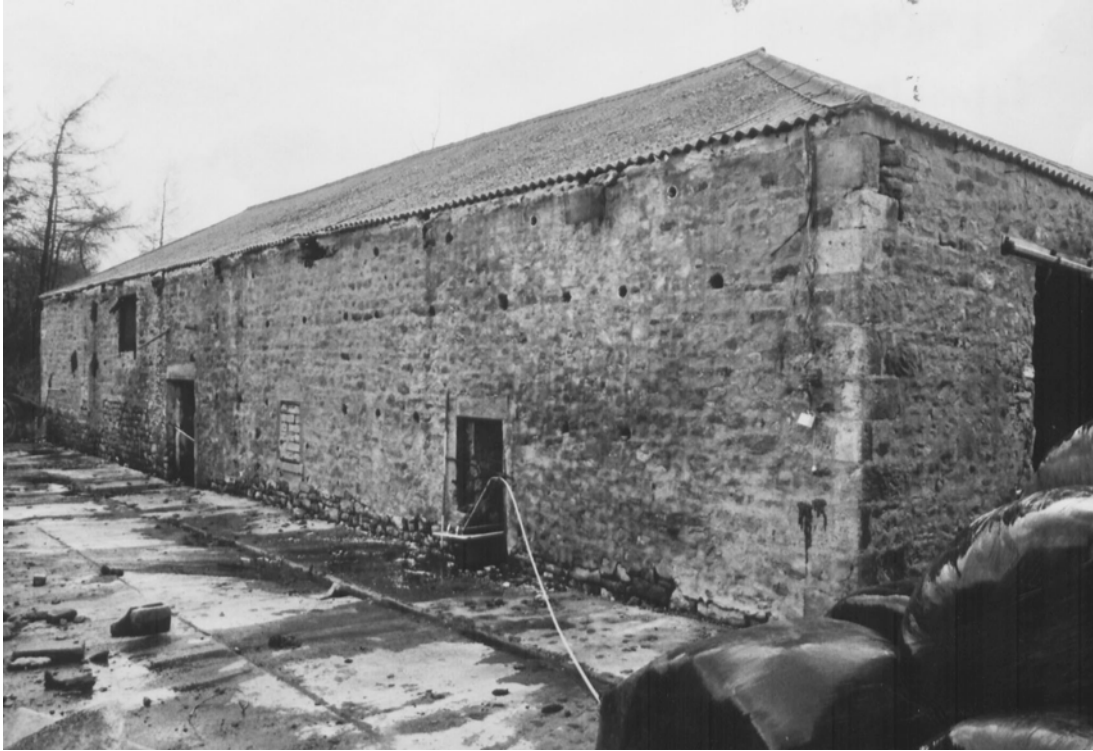
Plate 3: The west elevation of the barn

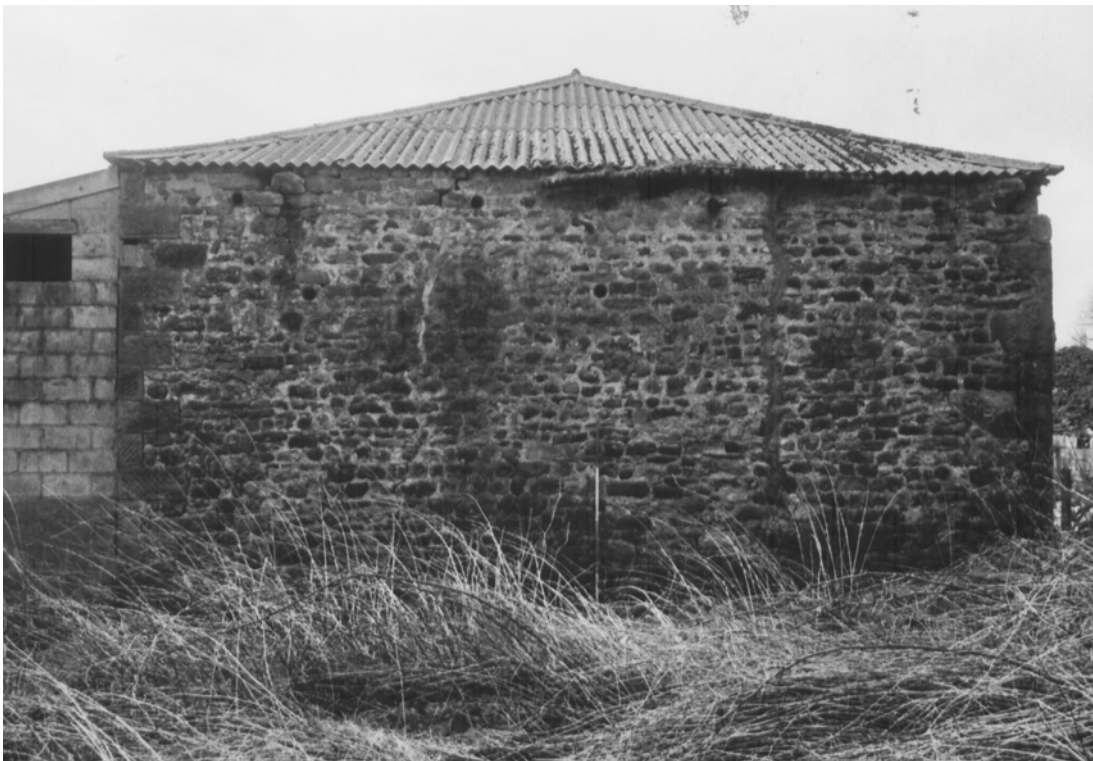
Plate 4: The north elevation of the barn

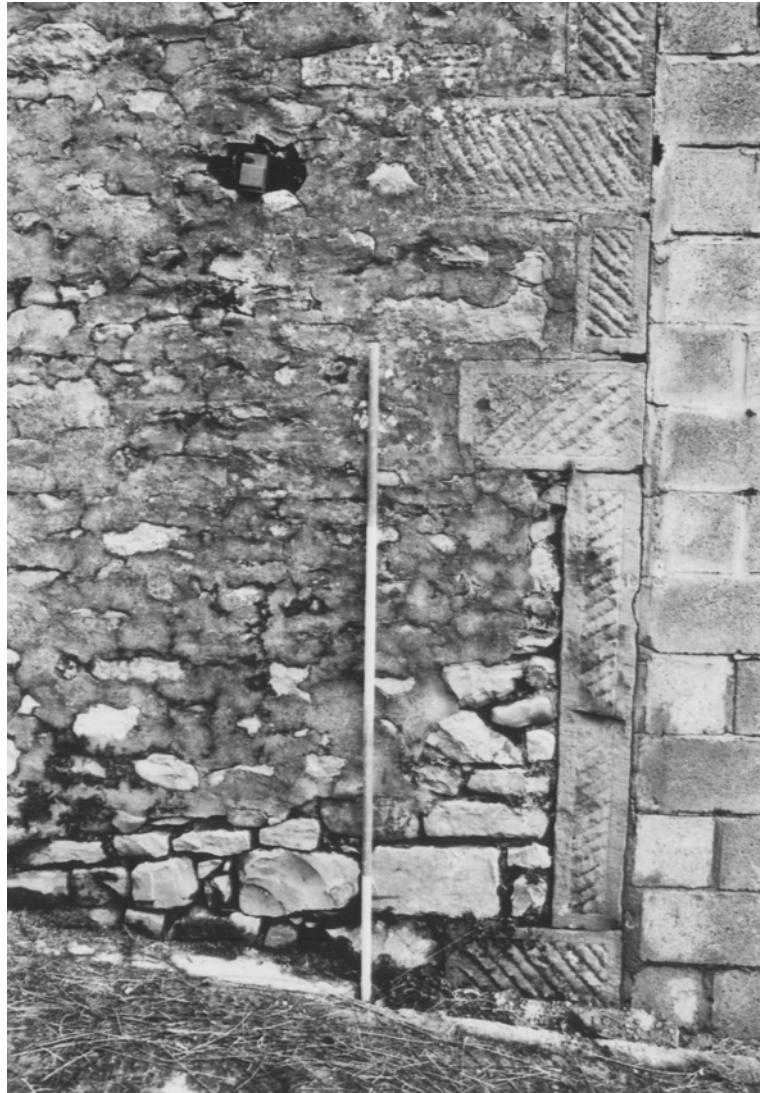
Plate 5: Detail of the “rusticated” sandstone quoins on the south elevation

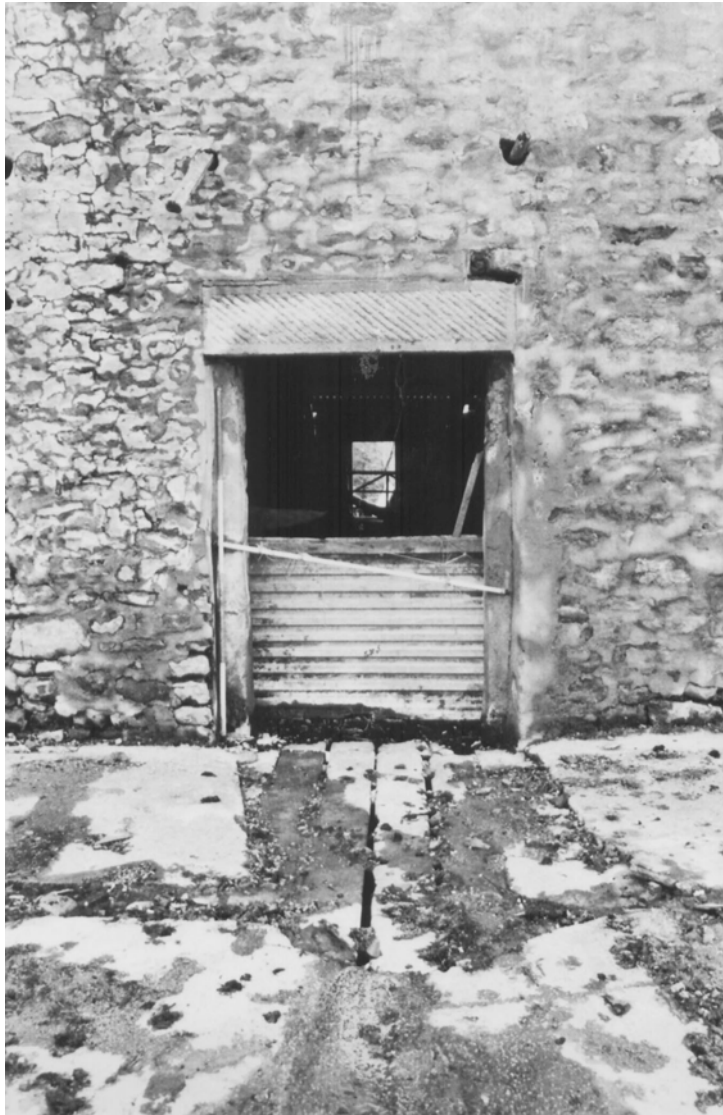
Plate 6: Detail of a partially blocked door on the west elevation, featuring a “rusticated” sandstone lintel

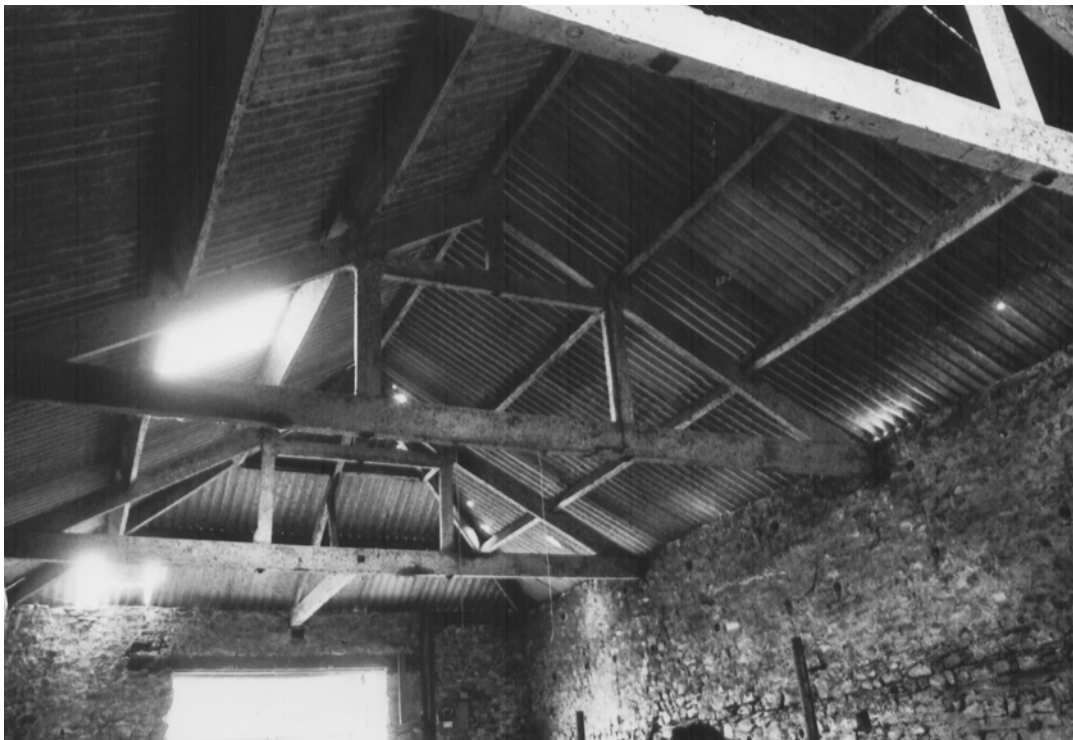
- 4.1.2 The roof of the barn is a shallow-pitched, hipped roof of corrugated iron sheeting, which includes a pair of perspex skylights on the east pitch. Internally, the roof features trusses of collar and tie beam construction, with queen struts and an upper king tie on each (Plate 8). These are modern machine-cut timbers, as are the five trenched, through-purlins and the rafters.

Plate 8: Detail of the roof trusses at the south end of the building

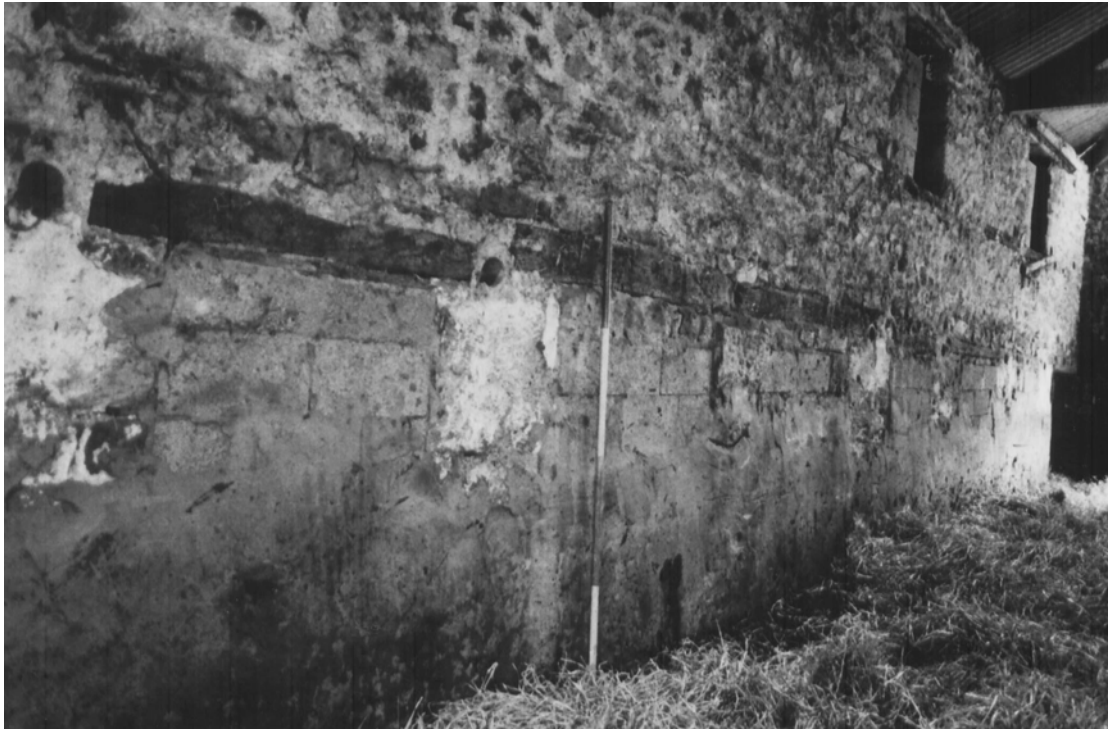
- 4.1.4 All of the windows, of which the majority are located on the front (east) elevation, have been either been partially or fully blocked (Plates 7 and 9).

- 4.3.1 The walls are as described above (*Section 4.1.1*) with a render of cement around their base and a limewash finish elsewhere. At the south end of the east elevation, there are six blocked windows, which have shallow timber lintels and are in-filled with clinker block. Above these are two additional windows, which have been partially blocked in the same material. Moreover, the windows, which have been noted above (*Section 4.2.2*) are also visible from the interior of the building. The presence of so many windows is rather unusual in a threshing barn, but may reflect the conversion of the building to a milking shed, which would require a more airy and well-lit environment Brunskill (1987: 141). Certainly, this would be supported by the ephemeral traces of internal partitions on the east elevation. These would appear to be only visible towards the north end of the building.

Plate 9: Detail of the blocked windows on the east elevation

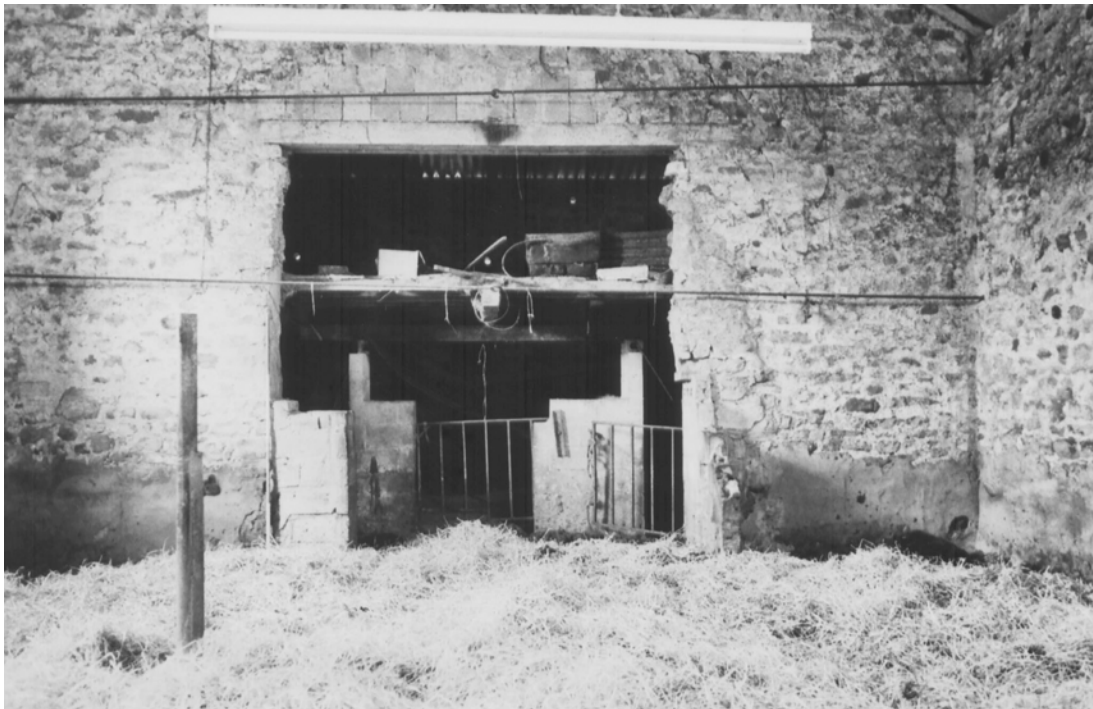
- 4.3.3 At the east end of the barn is a modern shippon featuring three stalls, which are divided by single-skin partitions of clinker block built up on a concrete floor. These are accessed by a wide doorway within the stone partition, which features a lintel of three machine-cut timbers with clinker block repairs to the surround and above the lintel (Plate 10). Above the stalls, there is a hayloft of machine-cut joists and beams, which is accessed by a small wooden ladder on the east side of the building (Plate 11).

Plate 10: The entrance to the shippon at the north end of the barn

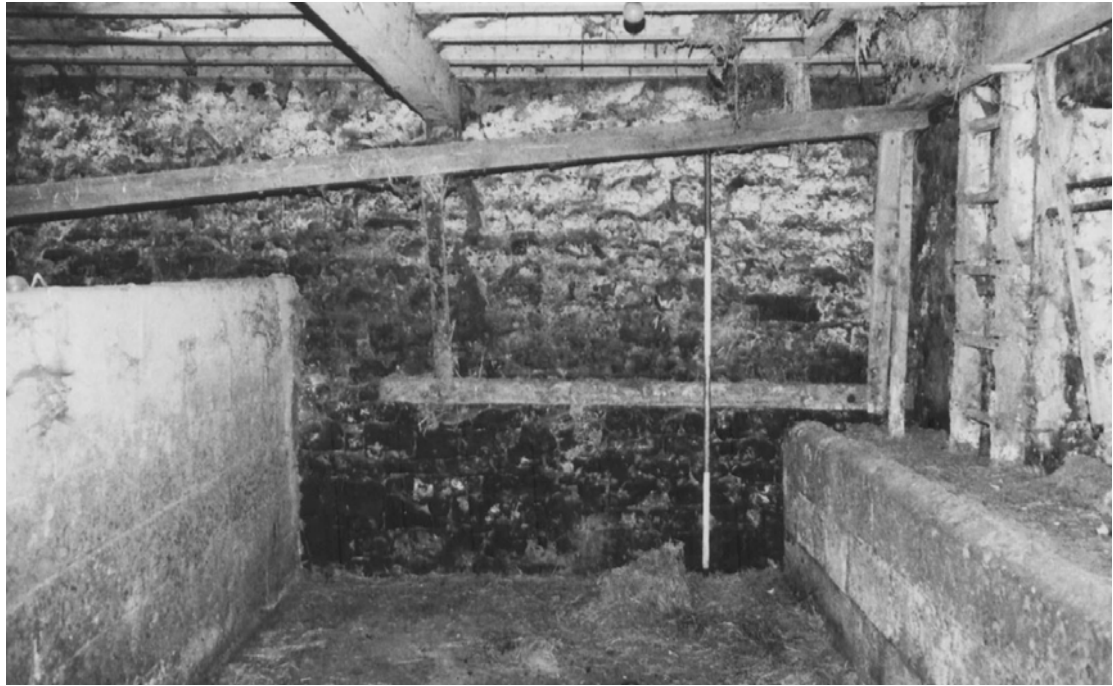
Plate 11: Detail inside the shippon at the north end of the barn
