New Sewage Scheme at Tilbury, Grays, Essex

Archaeological Watching Brief Report

November 2018

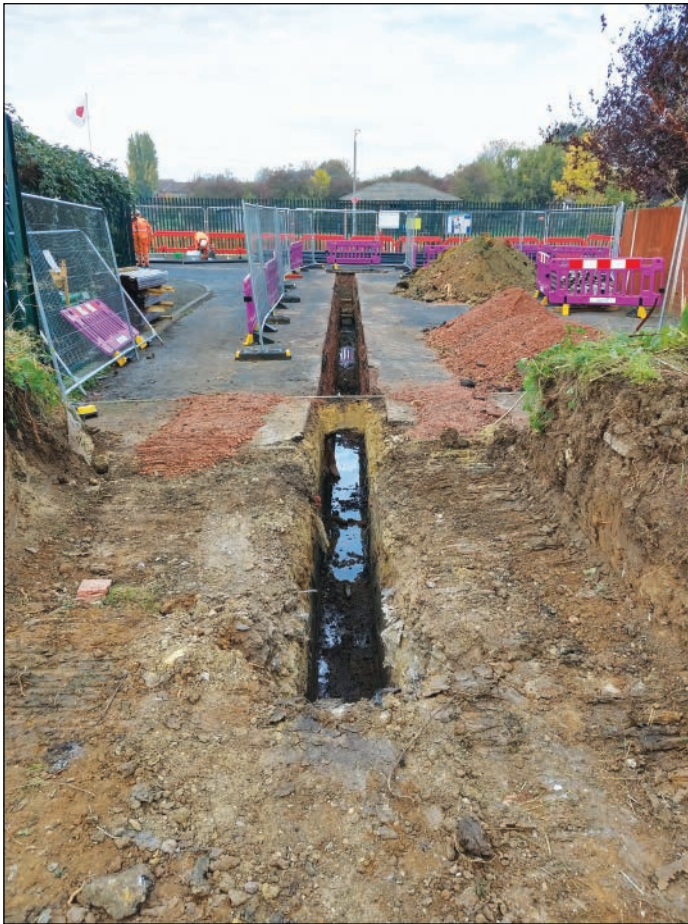
Plate 1: View north-west into Churchill Road at the start of the pipe trench

- 1.1.1 OA East was commissioned by Anglian Water Services to undertake an archaeological watching brief on a new rising main which ran from the southern edge of Churchill Road in Tilbury (TQ 62804 77556; Plate 1) south-east to the edge of Tilbury's commercial zone (TQ 62977 77236). The route was approximately 370m long and passes through an area of known heritage assets (Fig. 1).
- 1.1.2 A Brief was set by Richard Havis of ECC HET (Havis 2018) and a Written Scheme of Investigation (WSI) was produced by OA East (Bush 2018) detailing the Local Authority's requirements.

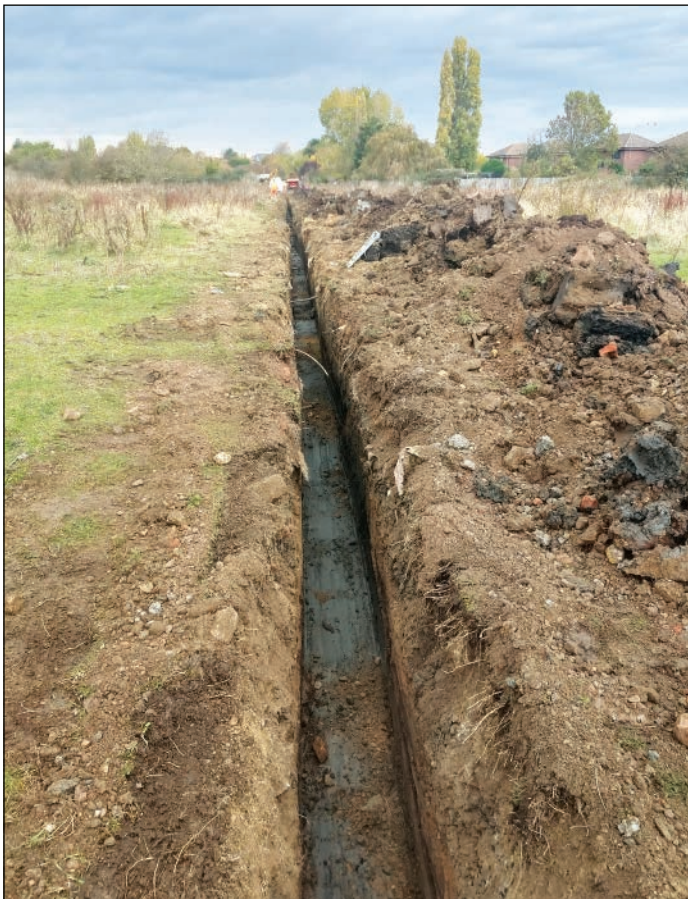
Plate 2: View south-east down the pipe trench, with modern debris evident in the spoil

- 3.1.3 Overall it is clear that this location has been utilised in the past either for groundworks associated with the construction of the docks and industrial estate or as a general disposal area for modern debris. No evidence for the WWII remains recorded in the EHER were seen (see paragraph 1.3.4). The similar findings during an evaluation to the west (EHER 14568) which identified made ground to a depth of 1.2m would indicate that this entire area has been disturbed to a considerable depth.

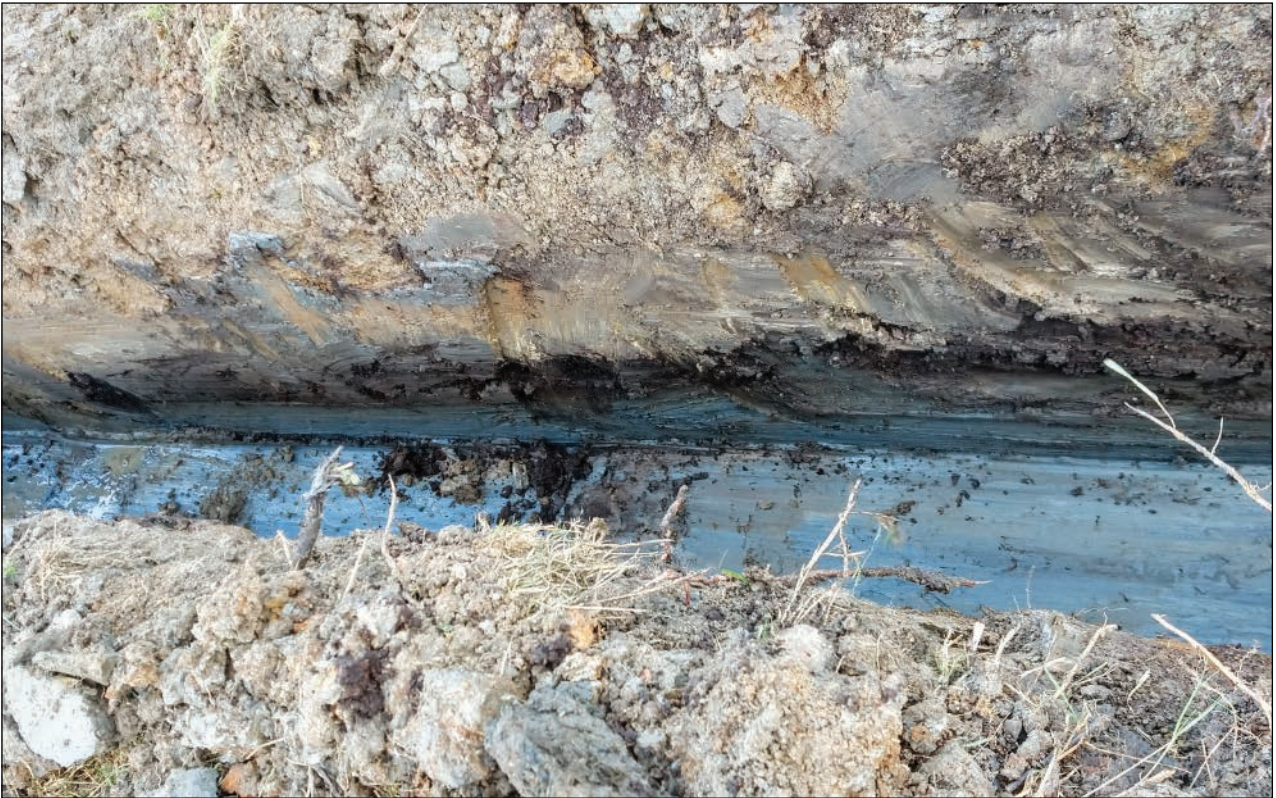
Plate 3: Section of pipe trench showing the peat layer

- 3.1.1 No archaeological remains or artefacts were identified during the monitoring works.
- 3.1.2 Two layers of overburden were identified as overlying the natural alluvial blue grey clay geology. The upper layer, which varied in thickness from 0.25m to 0.7m, consisted of a mid grey silty clay containing high levels of modern debris including bricks and other building waste, curb stones, sections of old electric cabling and large pieces of plastic (Plate 2). This sealed a layer of very dark brown peat which measured 0.1m in thickness, which overlay the natural geology (Plate 3).

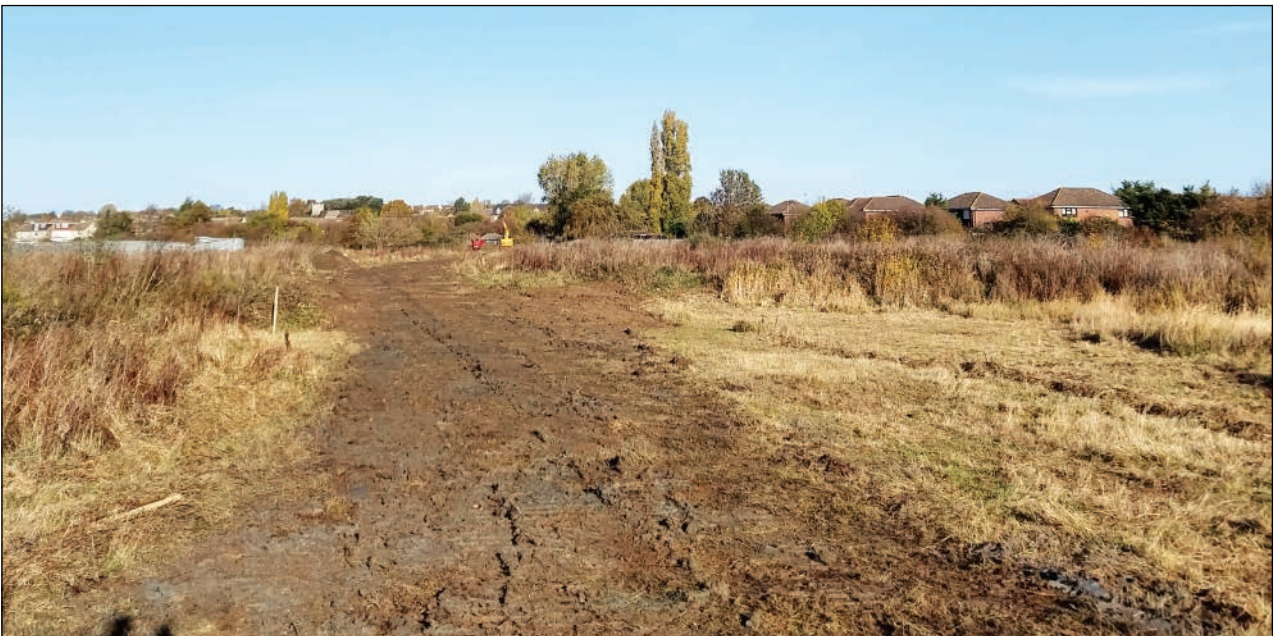
Plate 4: View north-west across backfilled pipe trench
