Calthorpe Street, Banbury, Oxfordshire

Archaeological Watching Brief Report

May 2017

Client: Thames Water

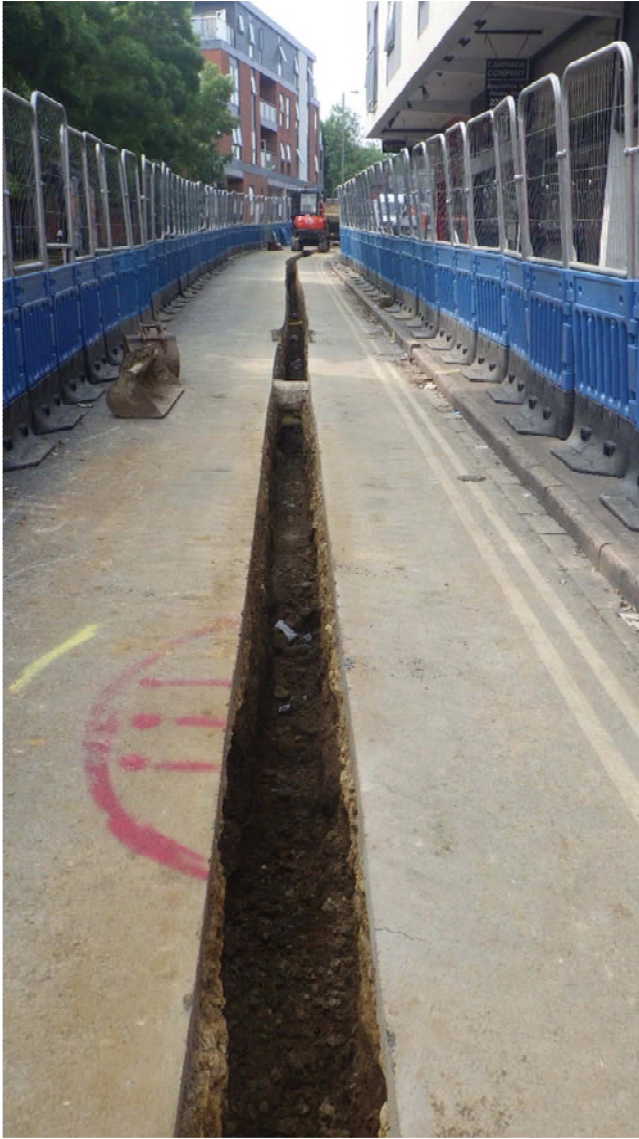
Plate 1: Excavations for the new water main

- 3.1.1 The results of the watching brief are presented below and include a stratigraphic description of the deposits identified.
- 3.1.2 The water main trench was excavated to depth of c 1.2m and revealed a large number modern service trenches throughout its length that extended to below its base (Plates 1-2). Natural levels were not revealed.

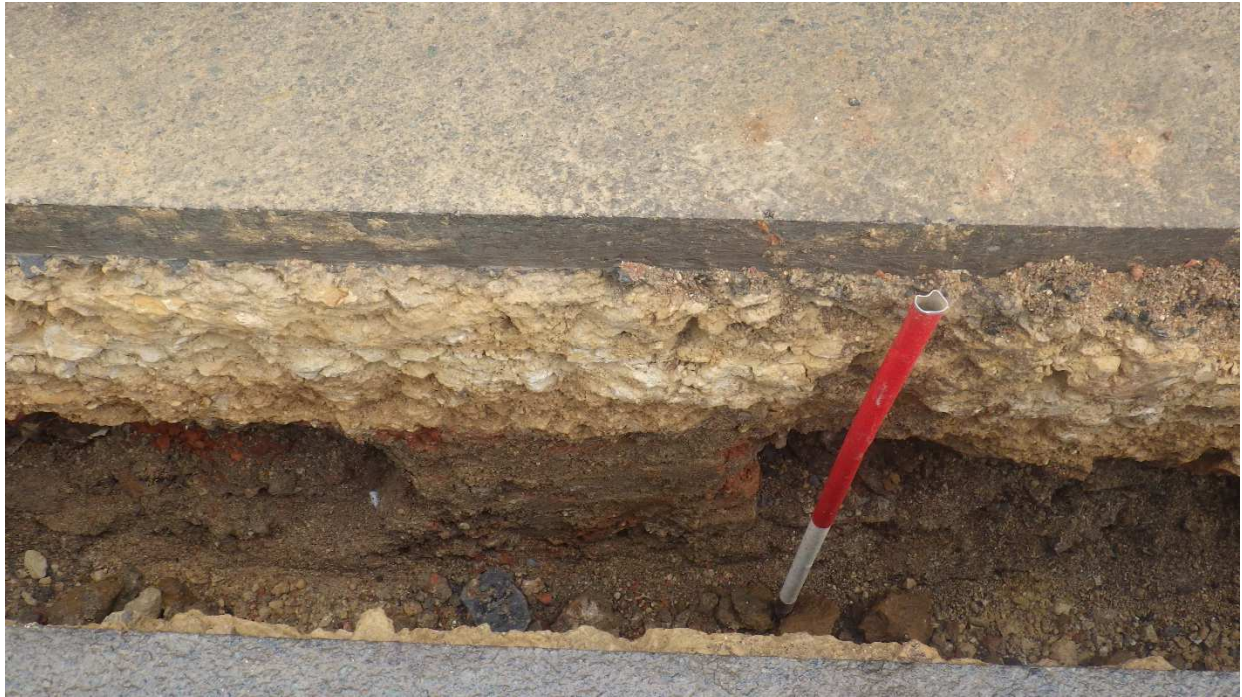
Plate 3: Brick structure 3 looking east (1m scale)

- 3.1.3 The earliest feature revealed was a red brick wall (3) that extended c 8.30m along the trench in front of Calthorpe House (Fig. 2; Plate 3). It was founded upon concrete and at least three brick pillars or wall returns were observed, spaced every c 3.20m.

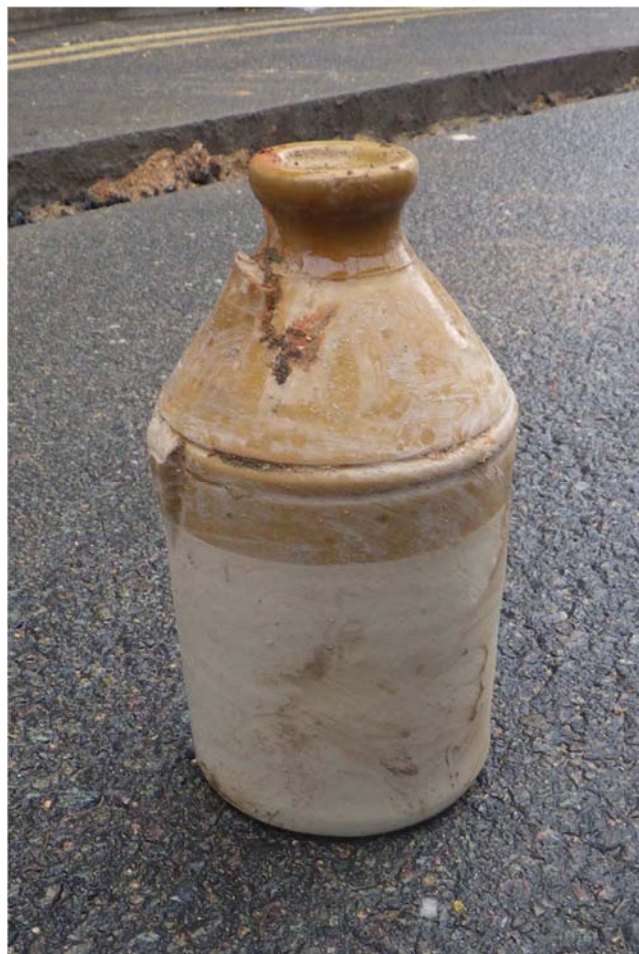
Plate 4: 19-20th century stoneware flagon

- 3.1.4 Abutting the wall was a thick deposit brick and gravel rubble (5) that probably represented demolition associated with the structure that the wall pertained to. A complete stoneware spirits flagon dating to c 1880-1950 was recovered from the rubble (Plate 4).

- 4.1.1 Description: A single complete vessel (1461g). A fairly small cylindrical spirits flagon in English stoneware with a Bristol-type glaze (Fabric code: ENGS BRST). Complete and in pristine condition, apart from a missing handle originally attached to the shoulder (Plate 4). The upper part of the vessel is conical and tapers to a narrow neck with a pulley-like rim. The inside of the rim and neck has a screw-thread which dates it after c 1880, and probably after c 1890. It is in a pale grey or off-cream stoneware with a clear Bristol-type glaze all over externally and internally. The upper third of the vessel has been dipped in an iron-rich slip appearing light brown under the glaze. No maker's mark present, but a London or Bristol source is likely.
- 4.1.2 Vessel height 218mm; body diameter 114mm; rim diameter 49mm.
