Bollinhurst Reservoir, Disley, Cheshire East

Topographic Survey and Building Assessment - Supplementary Report

Oxford Archaeology North

January 2010

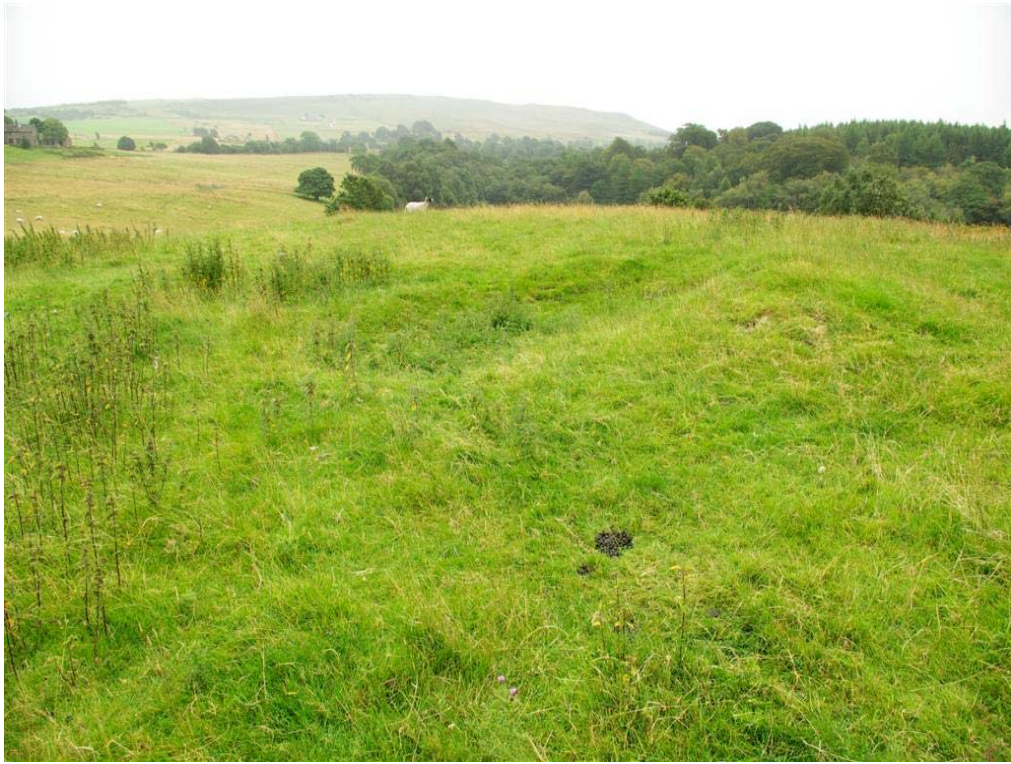
- 3.1.2 The former quarry (Site **28**) is visible on a slight rise to the north of the Bollinghurst Reservoir (Fig 2; Plate 1). There are several shallow, round and semi-circular pit-like features, in which outcrops of sandstone are visible. Whilst the site is relatively small, it formerly might have been part of a larger outcrop, for which the quarry evidence has been filled in.

Plate 1: Earthwork evidence of sandstone quarrying (Site **28**), facing north

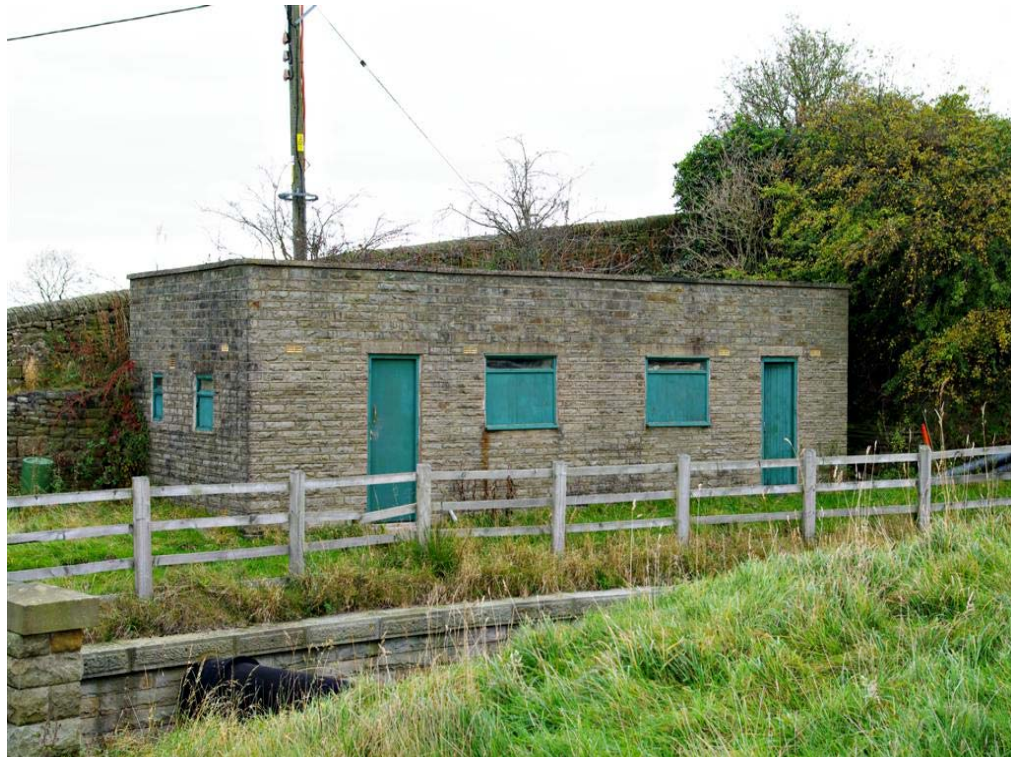
4.2.1 The Fisherman's Hut is a small, rectangular-shaped building, measuring approximately 10.5m in length by 4.3m in width, and it is 3.1m in height. It is constructed from brick (internally) with a facing of narrow courses of worked sandstone, which is rock-faced and ribbon pointed. Each elevation has a concrete coping and the roof is of pent construction, sloping to the rear. The roof covering is of modern felt. Each of the end walls project upwards to hide the sloping roof, giving it a flat appearance. The whole structure sits on a concrete plinth, approximately 0.15m thick, although the true depth is not clear. The building platform is cut into the hillside.

4.2.2 The building is divided into two halves, each having its own doorway, located at opposing ends of the front elevation. There are two wide windows in the front (south) elevation, two smaller windows in the west elevation, and a single wide window, in the east elevation. All are of modern timber construction. There are no apertures in the rear of the building.

Plate 2: General appearance of the Fisherman's Hut, showing the symmetrical layout of the windows and doorways. The Bollinghurst Reservoir outflow can be seen in the foreground.

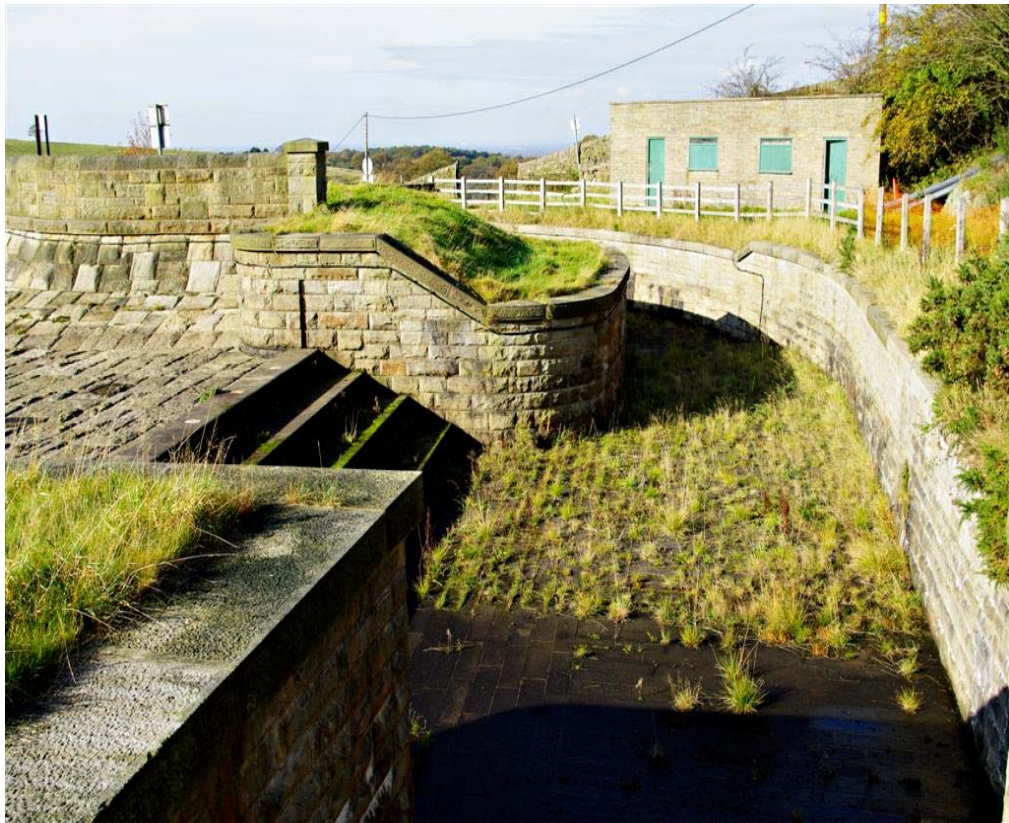
4.1.1 A building assessment was undertaken of the Fisherman's Hut, which had been the subject of an earlier desk-based assessment (OA North 2008). The hut is located to the north-east of Horse Coppice Reservoir, to the north of the overflow outlet from Bollinghurst Reservoir (Plates 3 and 4).

Plate 3: General location of the Fisherman's Hut, showing the close proximity of the Bollinghurst Reservoir overflow.

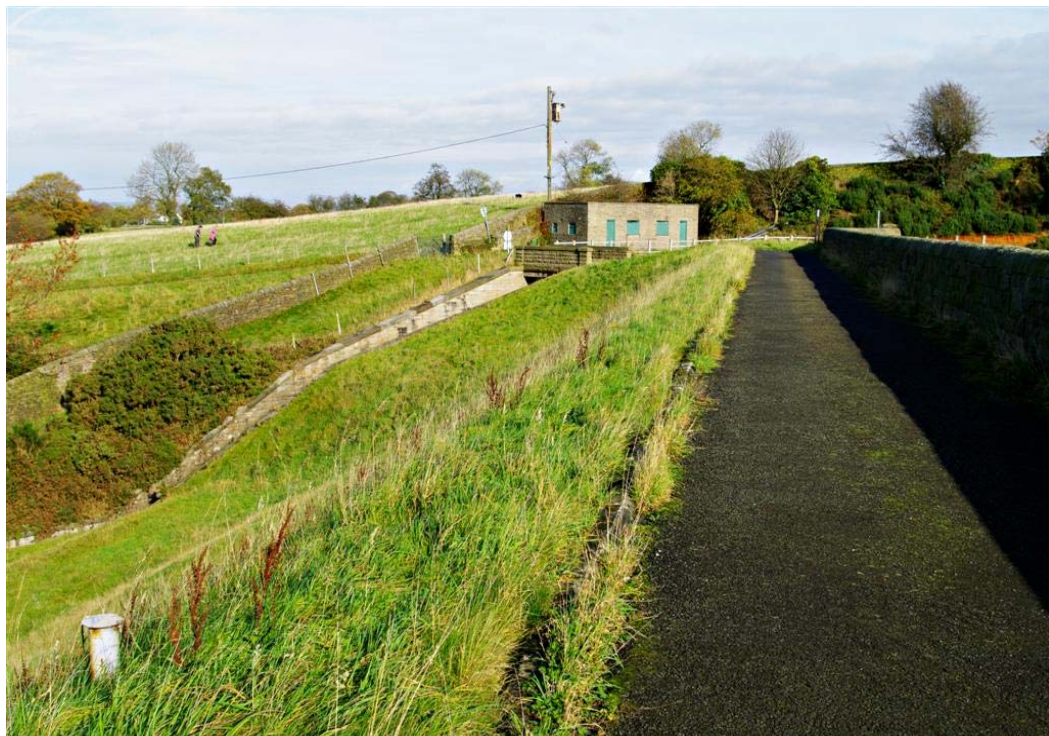
Plate 4: General view of the area around the Fisherman's Hut, with the Bollinghurst Reservoir wall in the foreground.

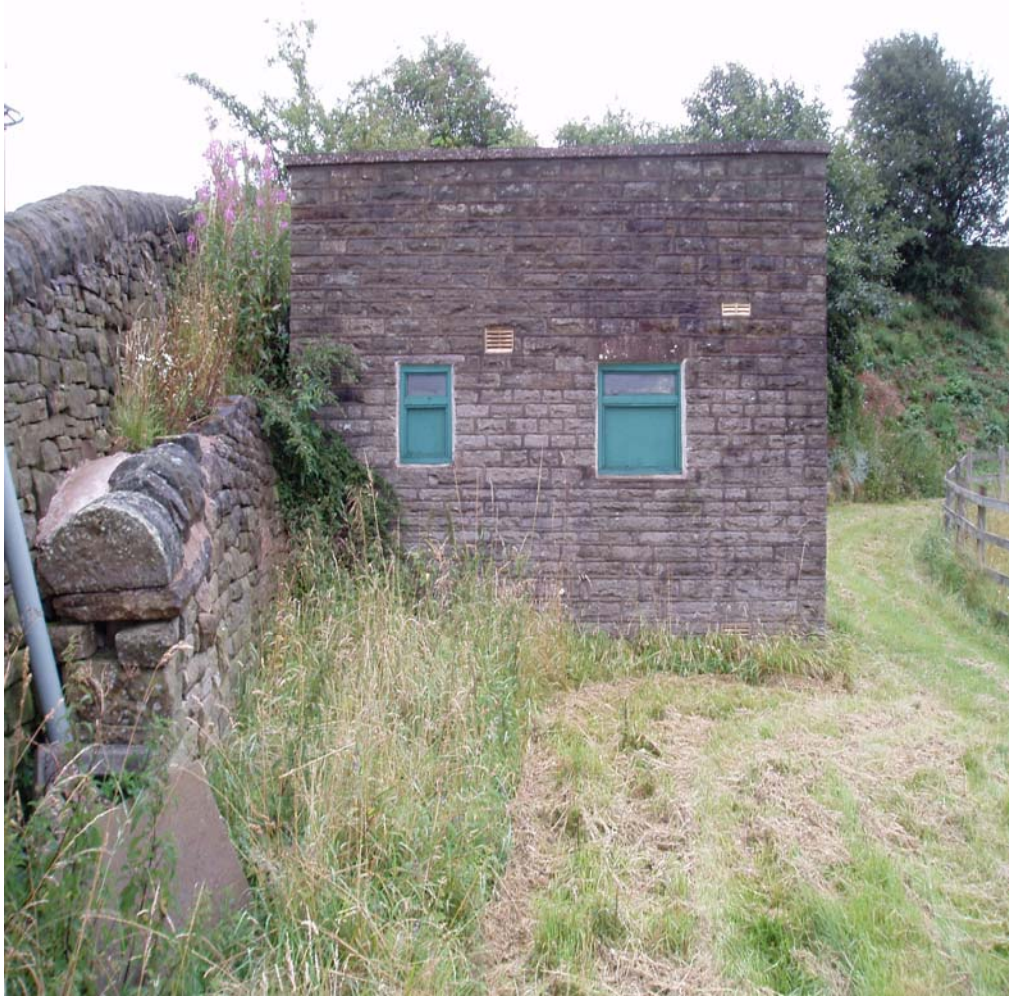
Plate 5: West elevation of the Fisherman's Hut, illustrating the difference in window size.

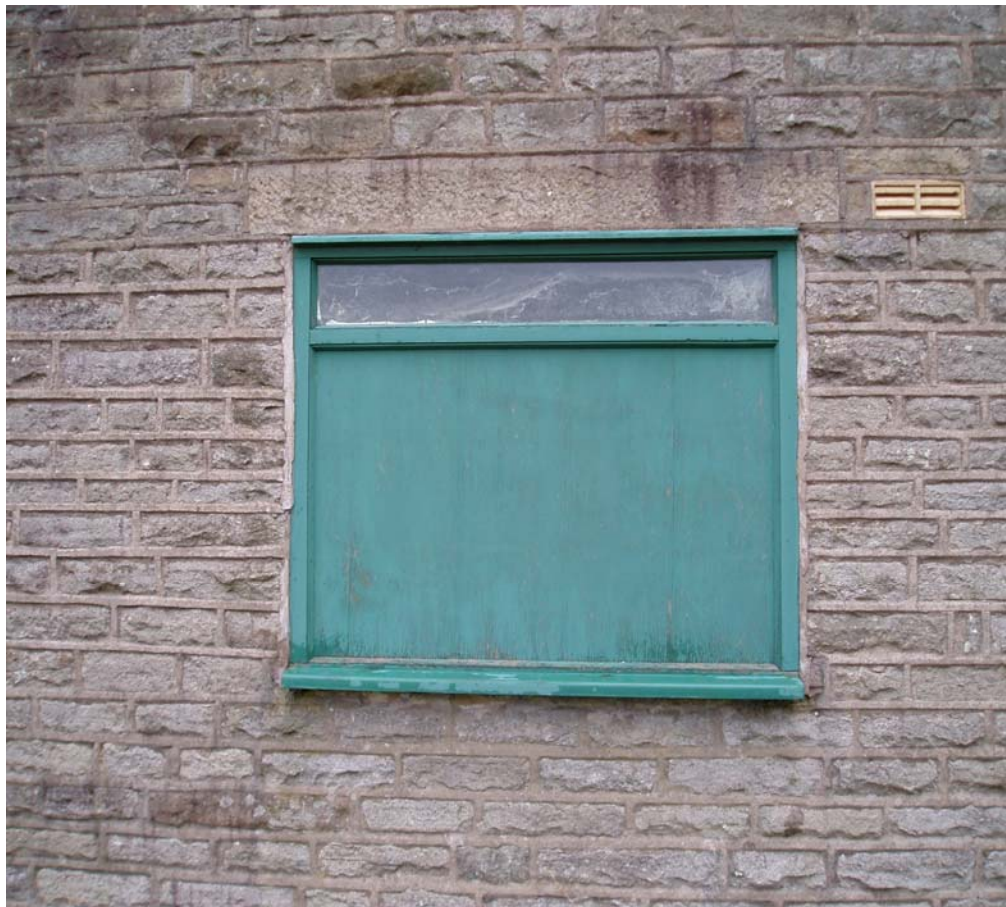
Plate 7: Window detail in the front elevation of the Fisherman's Hut.

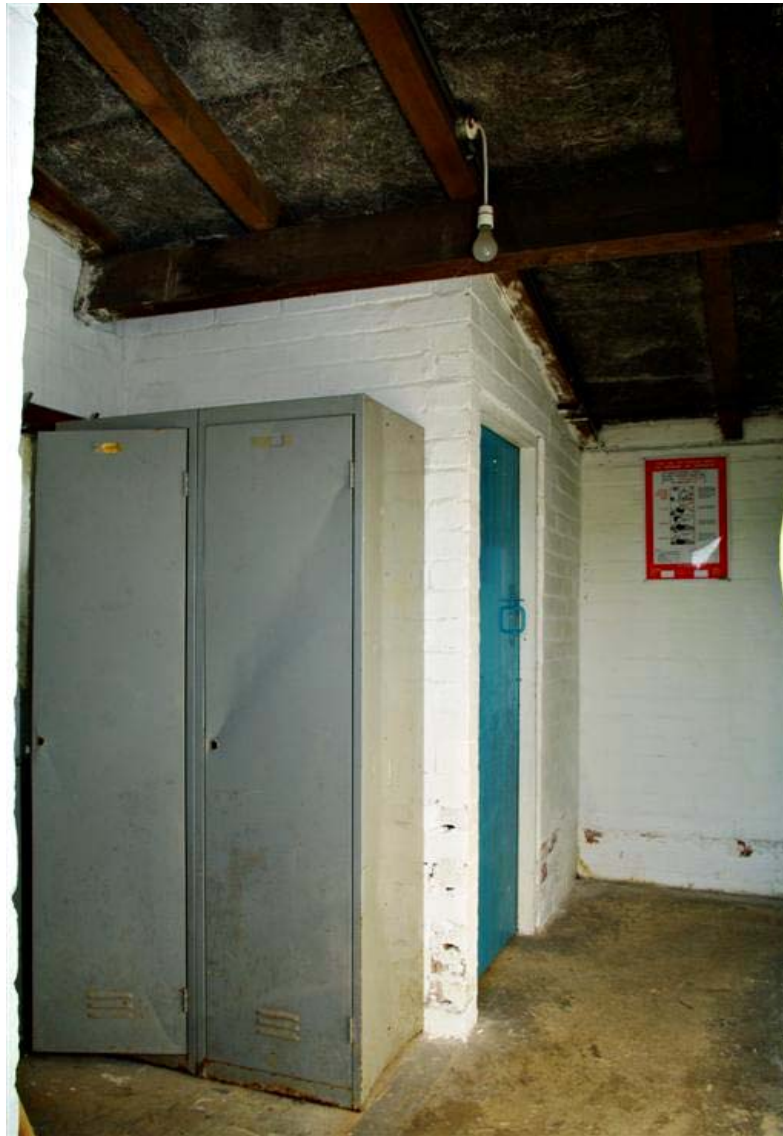
4.2.3 Internally, the west half of the building is divided into three areas: a main entrance lobby or corridor (Plate 5); a small toilet cubicle within the lobby; and a larger, main room, being used as an office. All the internal walls are of brick construction, being laid in stretcher bond. This includes the main walls, which are stone-faced externally. Corbels are present along the top of the south wall. The internal doors are ledged and braced, and the floor is concrete throughout. The roof is of common rafter and purlin construction, with fibre panels laid above the timbers. Internal fixtures and fittings include a ceramic sink and a high-level toilet cistern, probably of 1930s date. The eastern half of the hut comprises one room, which is of the same construction as the western half of the building, but is larger in size. All the walls are white-washed internally.

Plate 8: General appearance of the interior of the west end of Fisherman's Hut, with the toilet cubicle in the corner.
