SANDIFORD WATER TREATMENT WORKS, CHESHIRE

Archaeological Walkover Survey and Evaluation

Oxford Archaeology North

November 2005

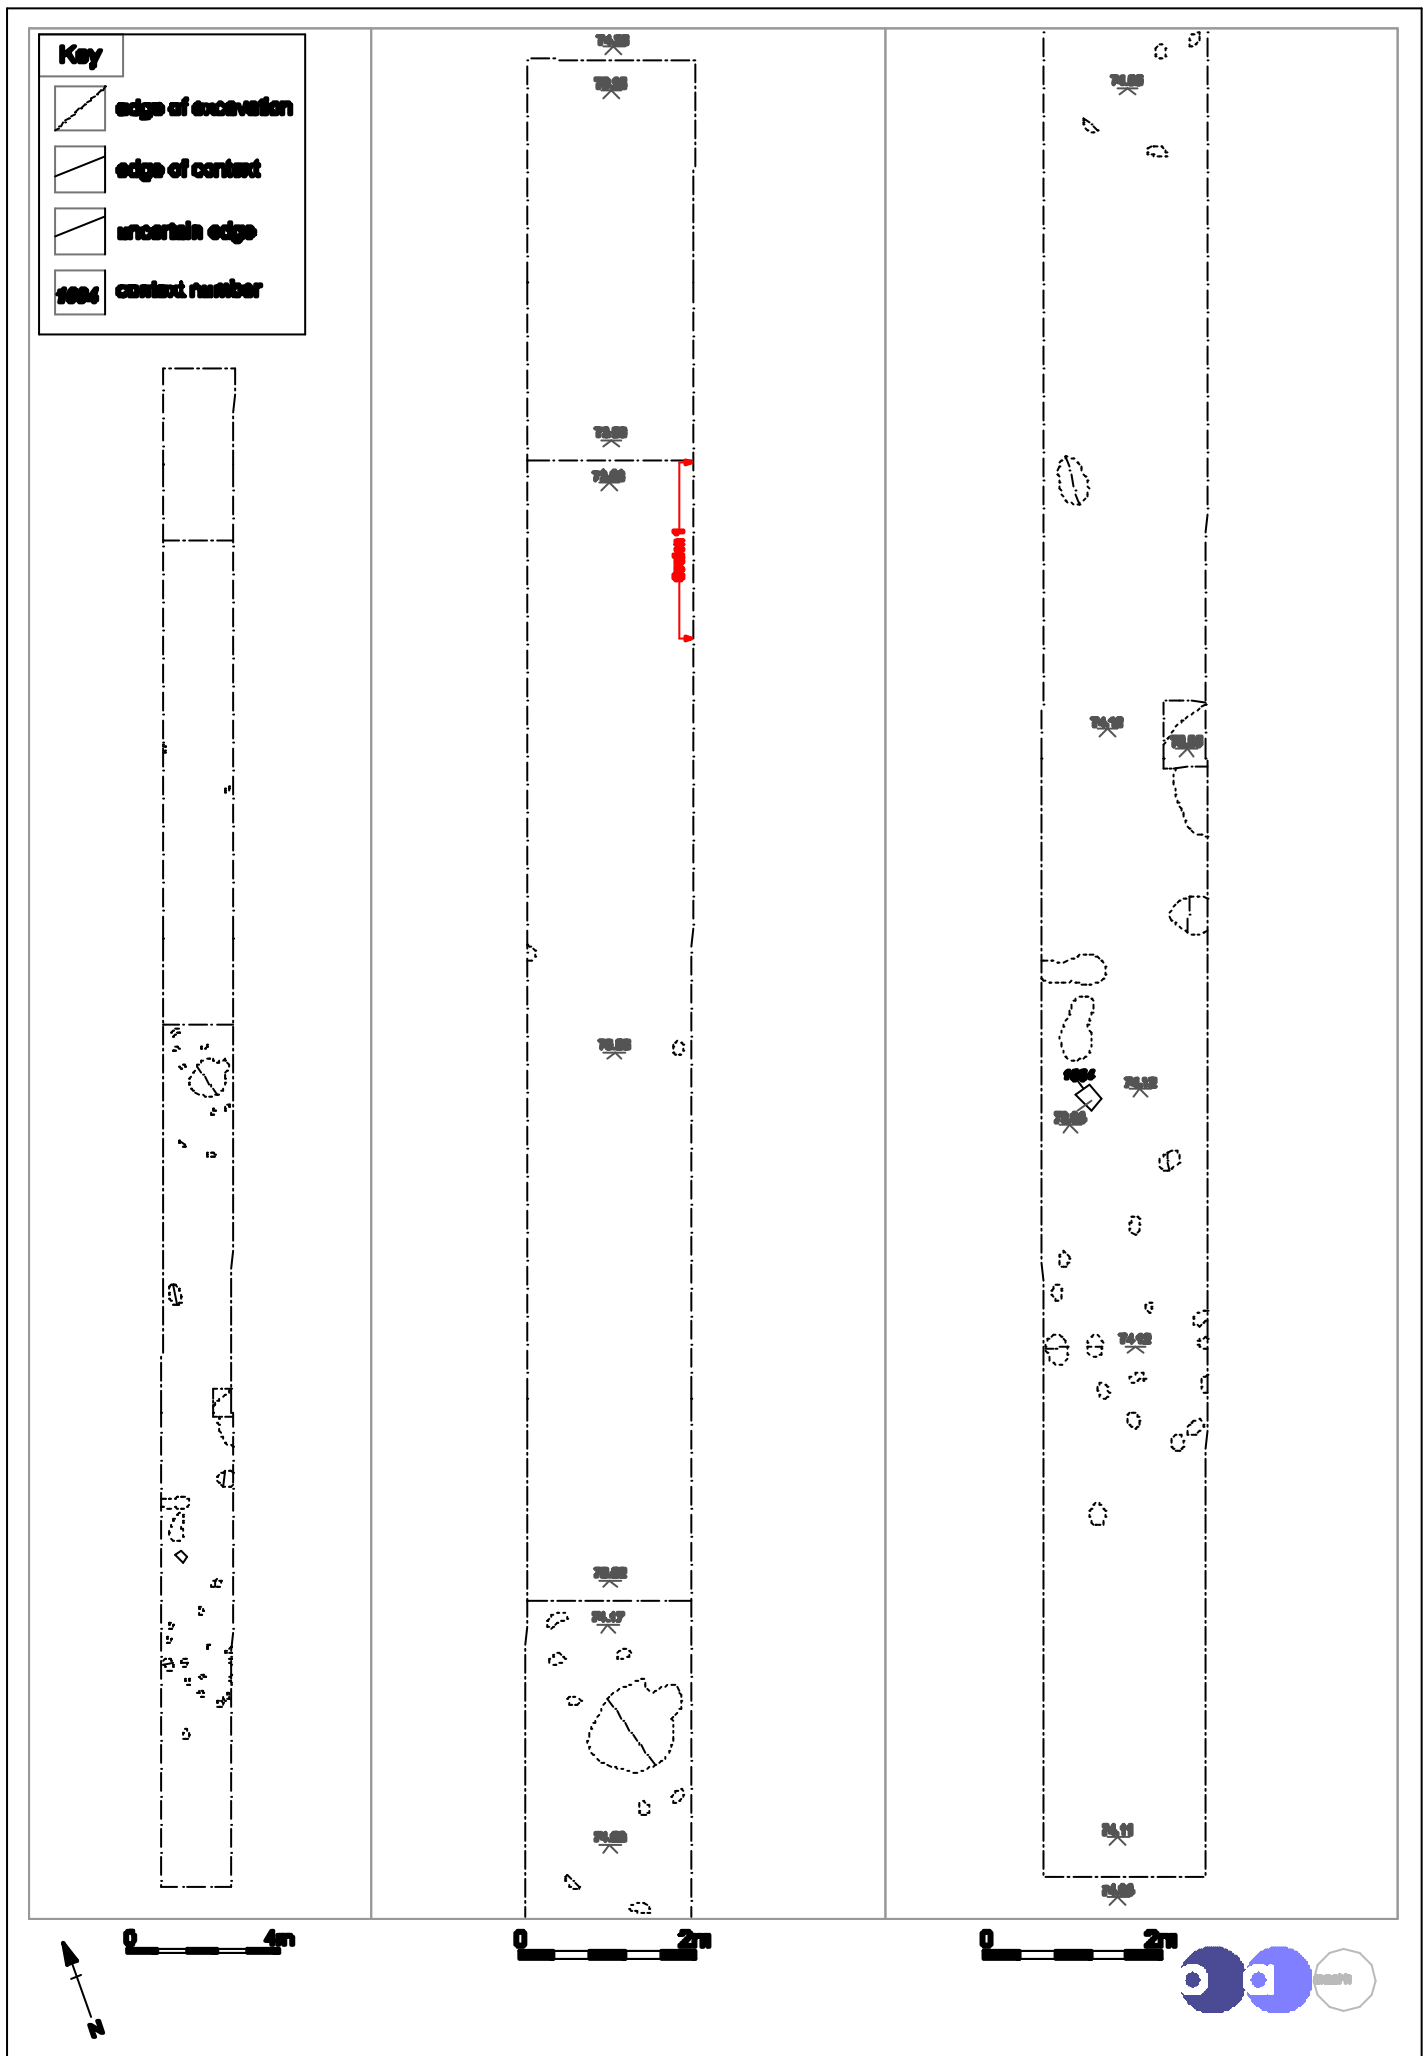
Figure 3: Plan of Trench 1

- 4.1.4 **Trench 1:** located *c.*30m to the north-west of the existing pumping station, it was positioned within the footprint of the proposed membrane building. The trench was aligned north-east/south-west (Plate 2) and was excavated to a maximum depth of 1.07m at the north-eastern end to ascertain the natural geology. The remainder of the trench was excavated to a depth of 0.56m. The plan is shown in Figure 3 and the section in Figure 4.

- 4.1.5 The trench revealed 0.30m of mid-brown silty-sand topsoil, **1002**, 0.20m of dark orange-brown subsoil, **1001**, and a mid-light orange sand natural, **1000**. Within the trench a solitary small square posthole, **1004** (Fig 3 and Fig 4), 0.22m by 0.2m and 0.1m deep with vertical sides, was located. The fill was a mid-blackish-grey silty-sand, **1003**. The trench had frequent irregular features containing a compact black soil, these were identified as tree boles and rooting. Within the topsoil, **1002**, a piece of flint typical of that occurring naturally in the area was found, it appears not to have been worked.

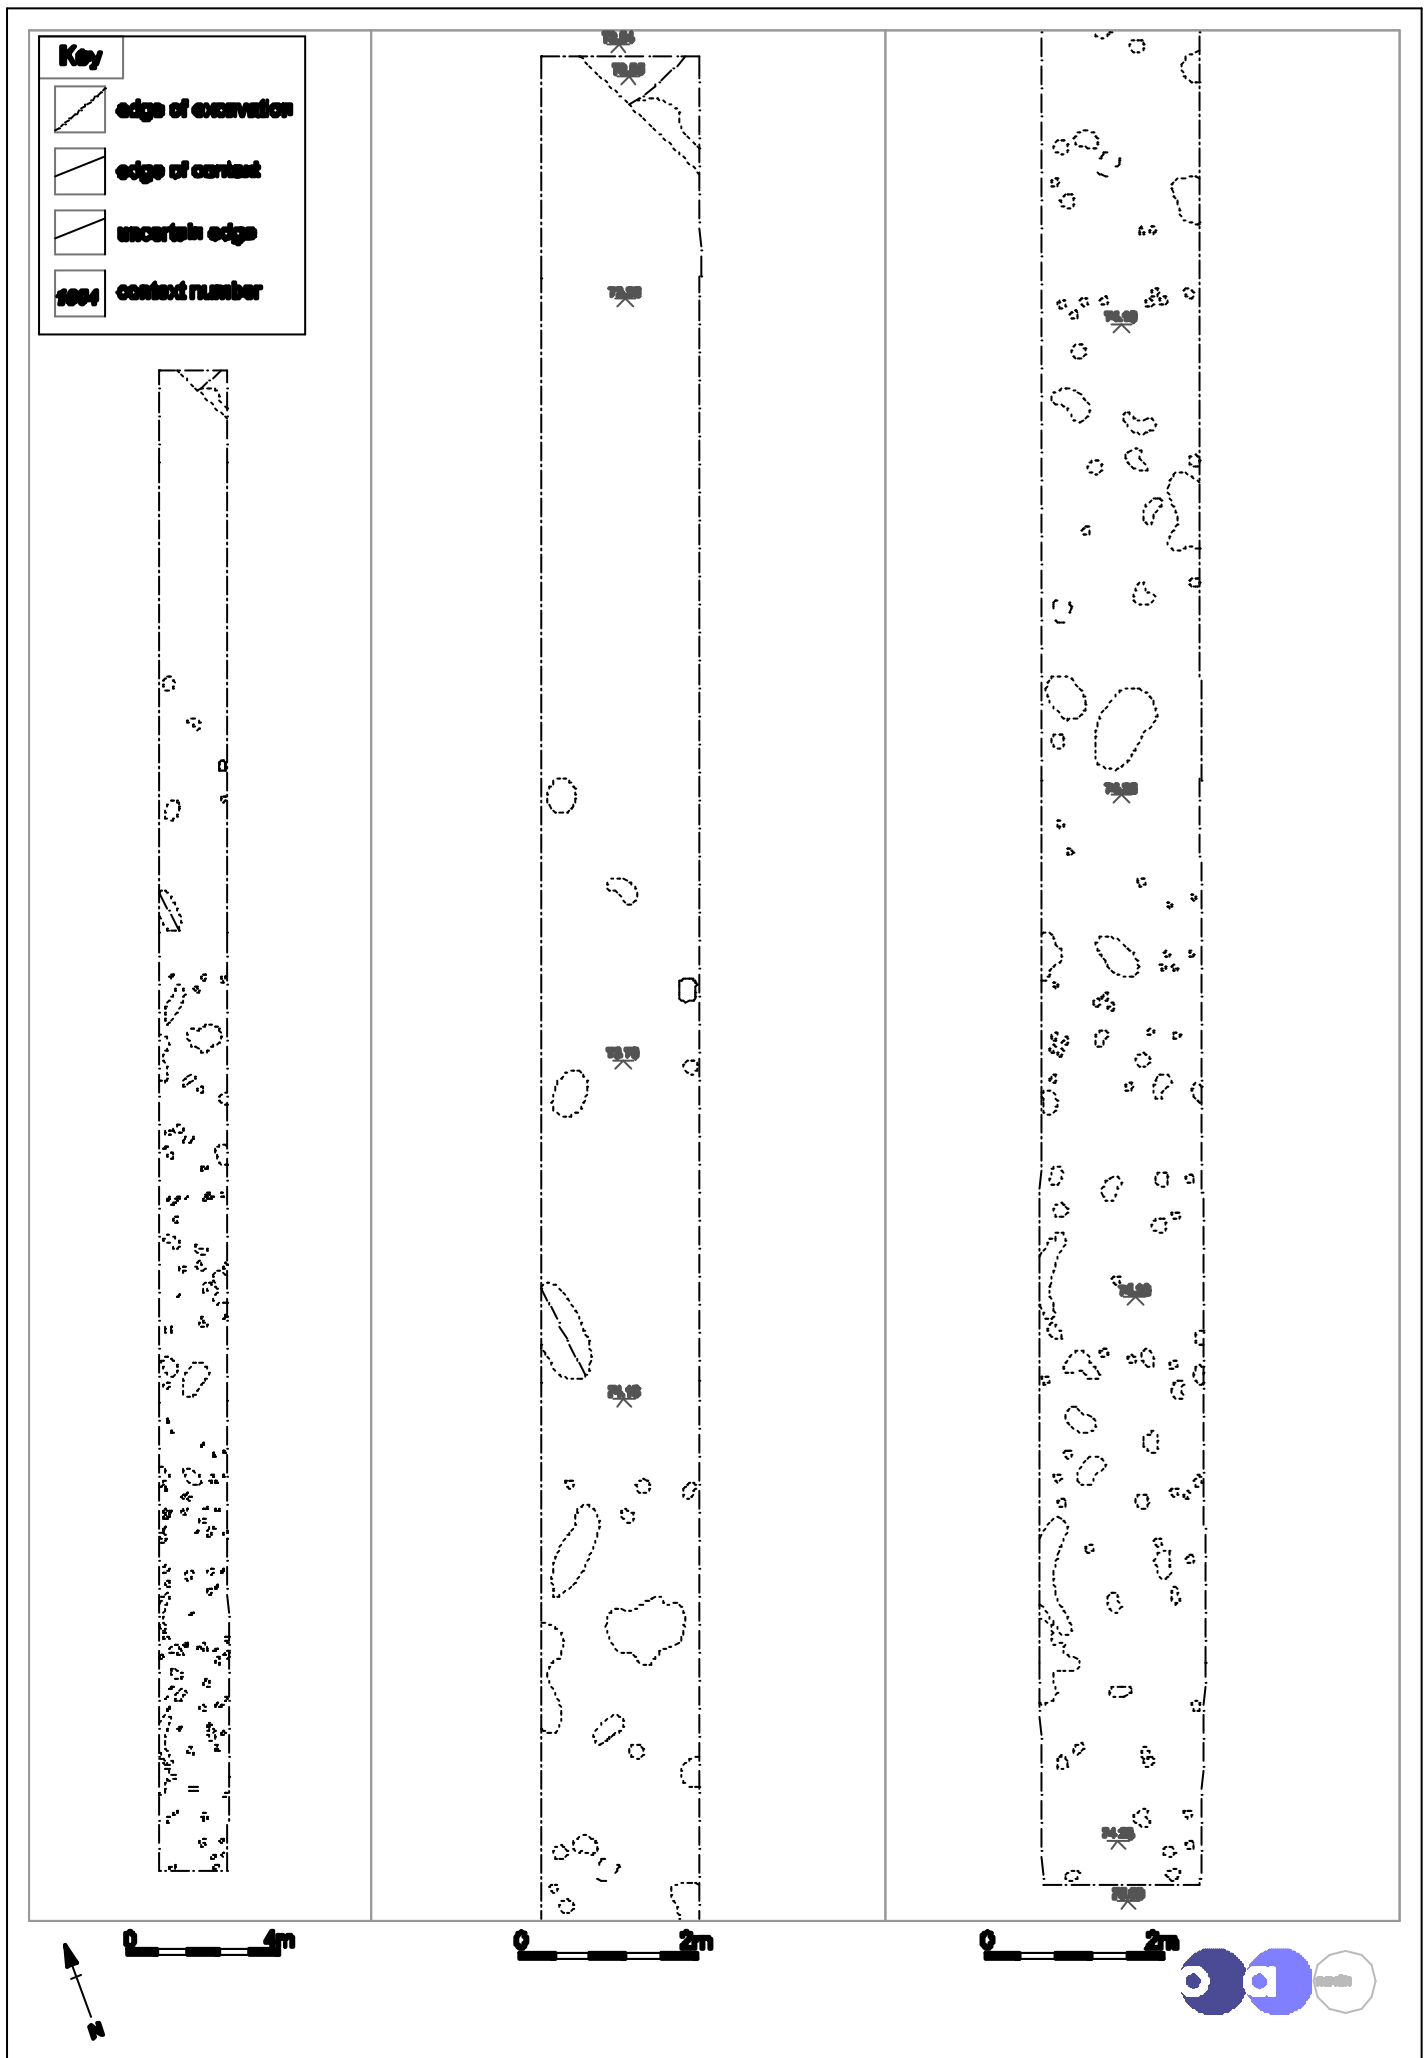
Figure 5: Plan of Trench 2

- 4.1.6 **Trench 2:** positioned parallel with and 10m to the north-west of Trench 1 within the footprint of the proposed membrane building, it was excavated to a depth of 0.65m (Plate 3). The trench revealed 0.35m of light blackish-grey clay-sand topsoil, **1005**, 0.05m of mid-greyish black clay-sand subsoil, **1006** and mid-brown-orange sand natural **1007** (Fig 8). Within the trench frequent irregular features were observed, containing a compact black soil, these were identified as tree boles and rooting (Fig 5). No archaeological features, deposits or finds were found within this trench.

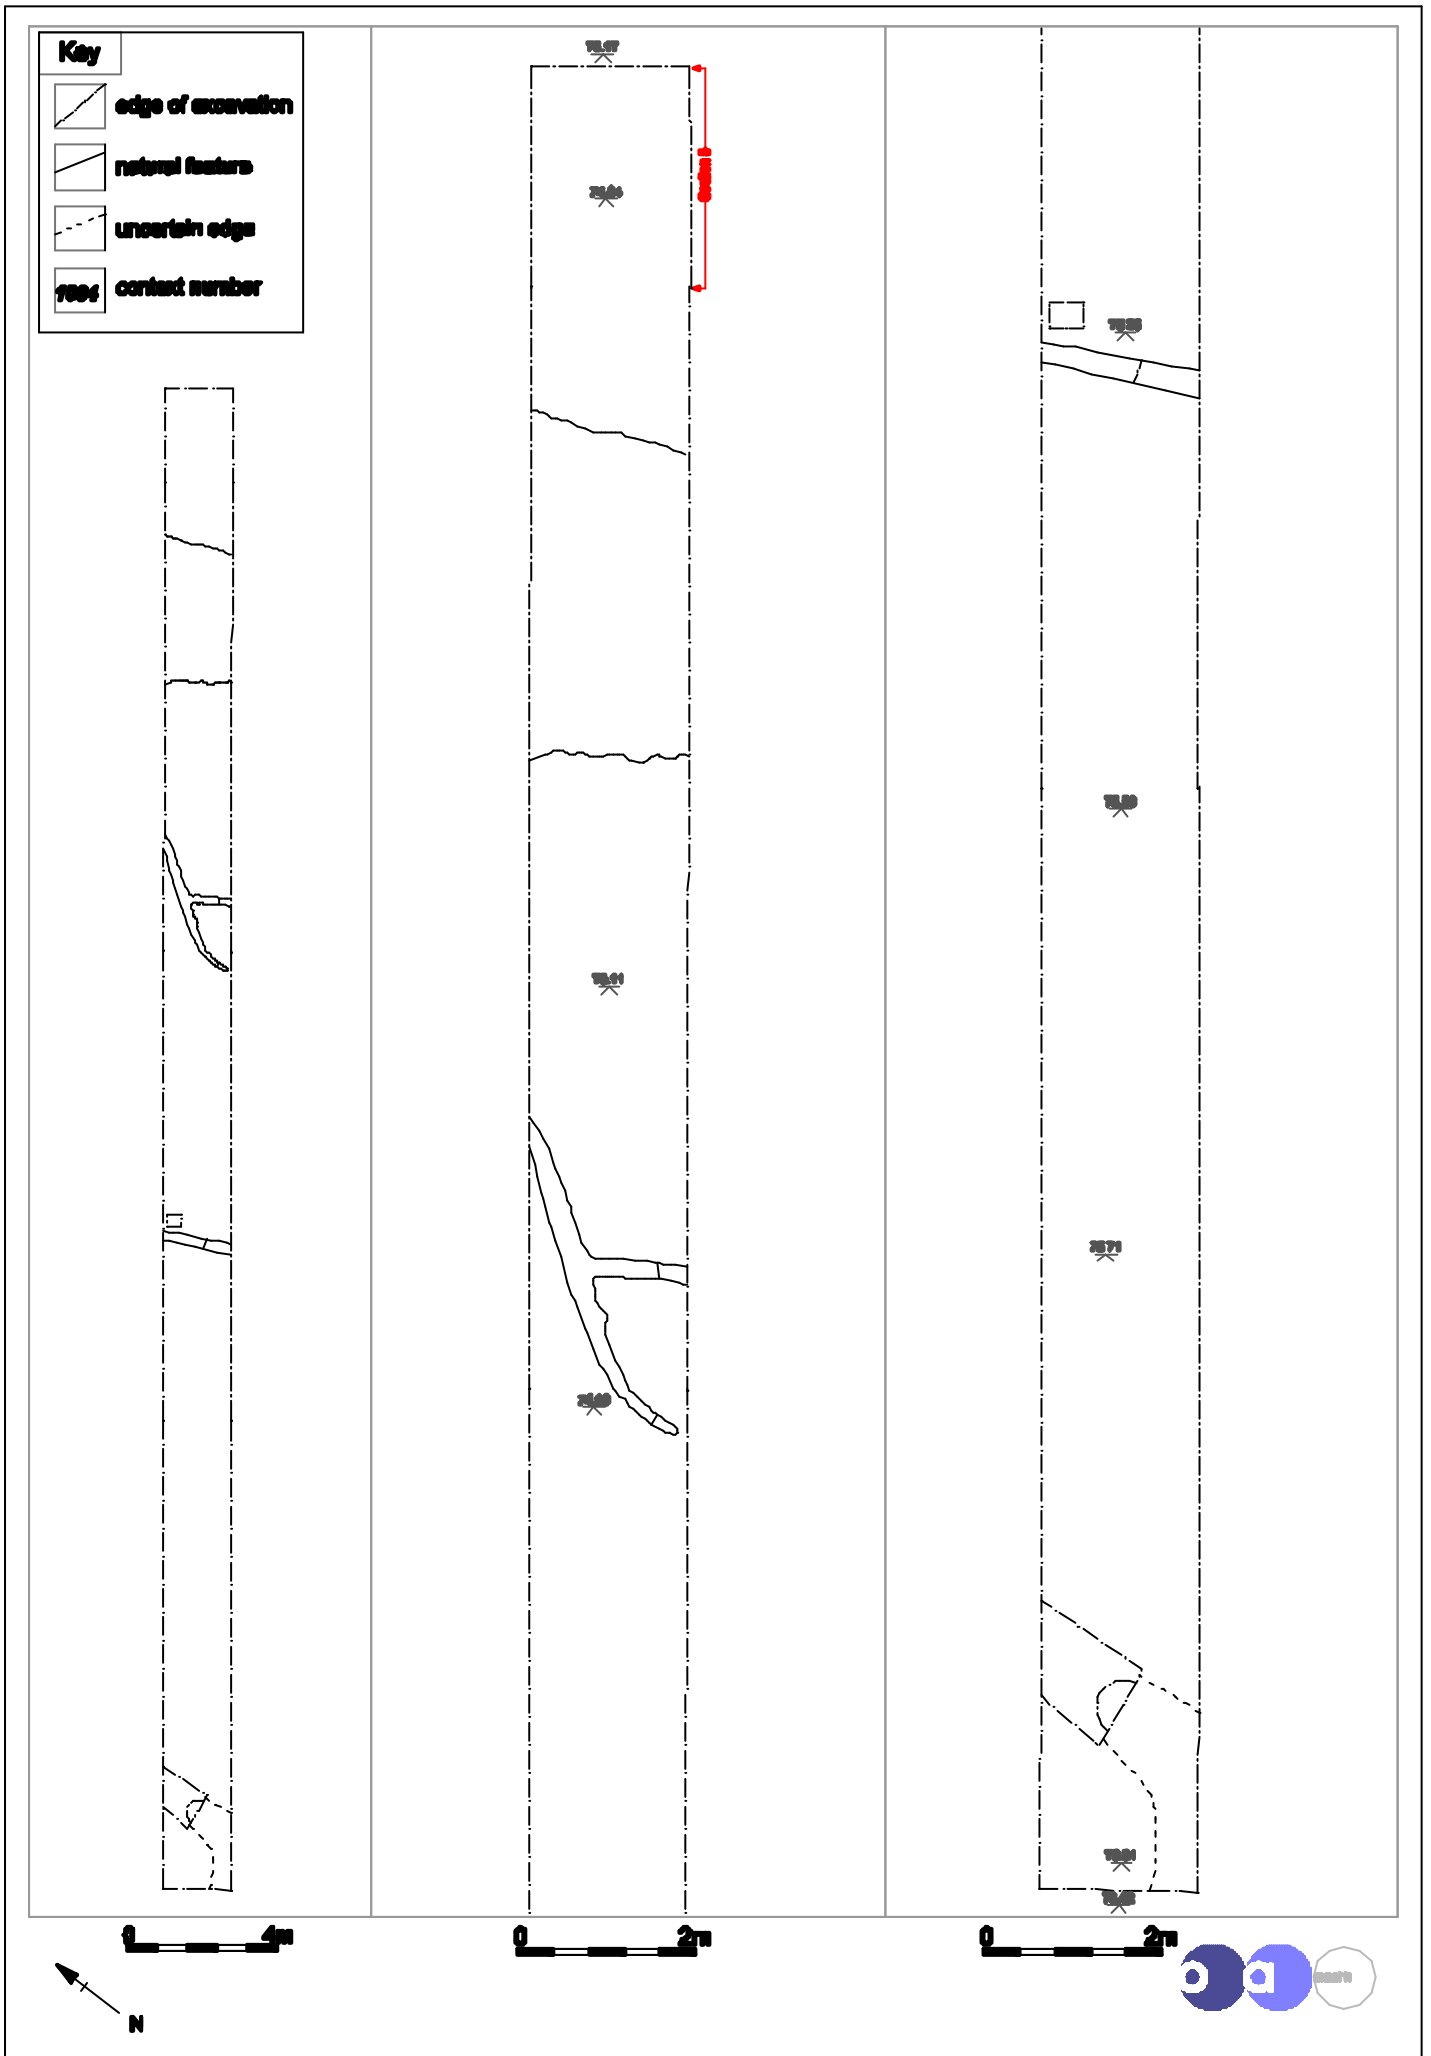
Figure 7: Plan of Trench 4

- 4.1.8 **Trench 4:** located *c.*25m from the west field boundary, aligned north-east/south-west (Fig 7), it was excavated to a depth of 0.6m (Plate 6). This trench revealed 0.3m of mid-blackish-grey sandy-silt topsoil, **1013**, overlying 0.1m of light blackish-grey sandy-silt subsoil, **1014** (Fig 8), which in turn overlay mid-grey-orange natural sand with occasional sub-rounded stone inclusions, **1015** (Plate 7). The natural becomes increasingly stoney to the north-east of the trench, due to the slope declining to the north of the field. No archaeological features or deposits were observed within this trench and no finds were recovered. Soil staining, rooting and animal burrows were seen and investigated.

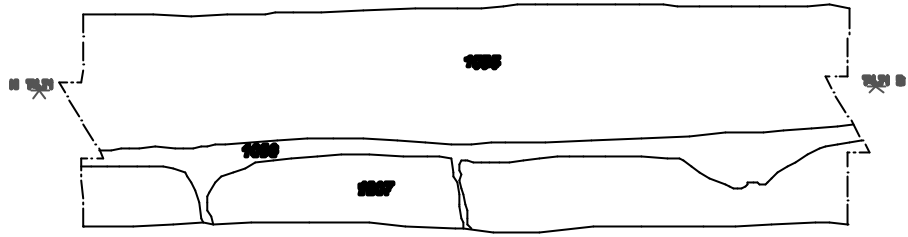
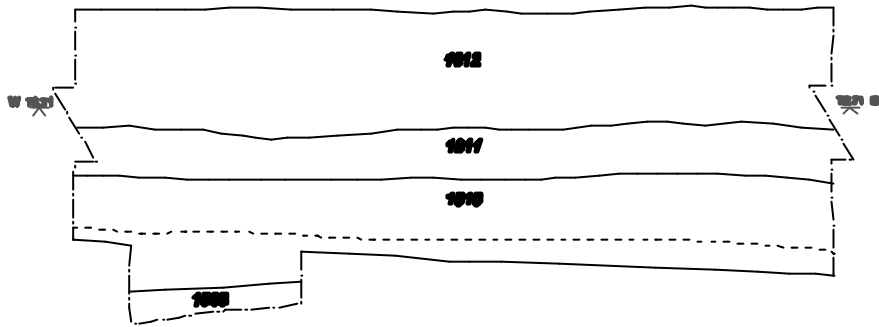
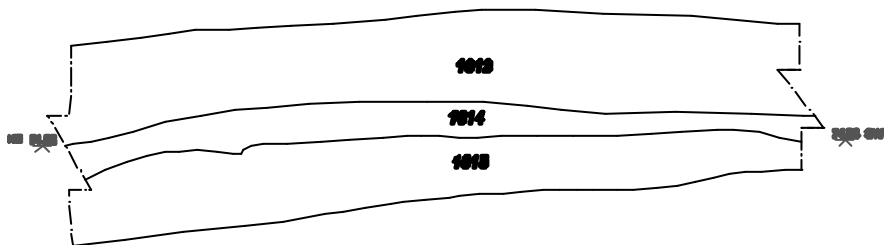
Figure 8: Sections of trenches 2, 3 and 5

Sample section from Trench 2

Sample section from Trench 3

Sample section from Trench 4

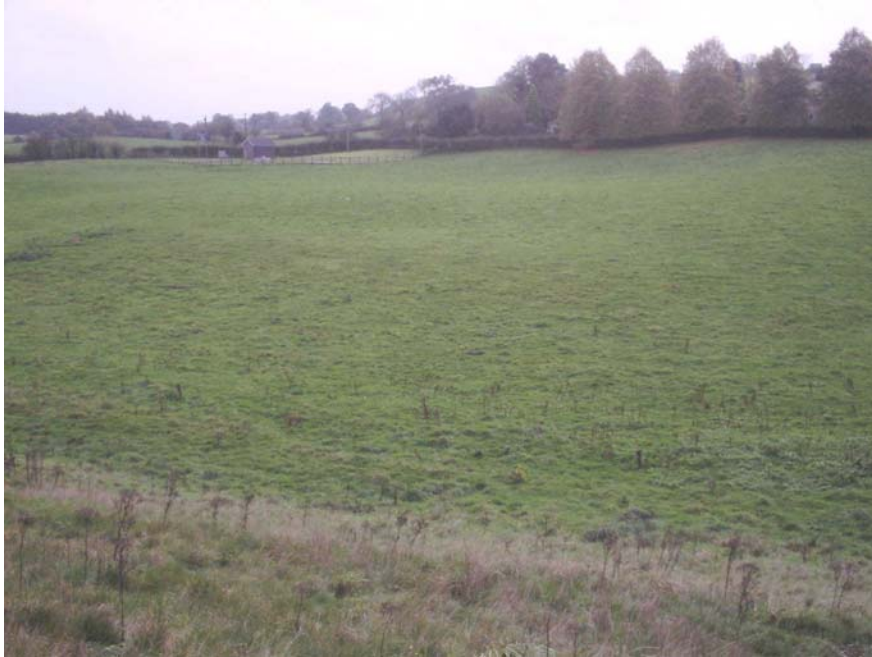
- 4.1.1 **Walkover Survey:** the walkover survey aimed to inform the position of the four evaluation trenches and to collect and record any artefact scatters. The field within which the proposed development sat and the adjoining field to the north (Field 1 and Field 2, respectively) (Fig 2) were walked in a systematic fashion. The ground conditions were good for identifying possible archaeological features with a mixture of short to medium height grass coverage (Plate 1).

Plate 1: General view of Field 1, looking south

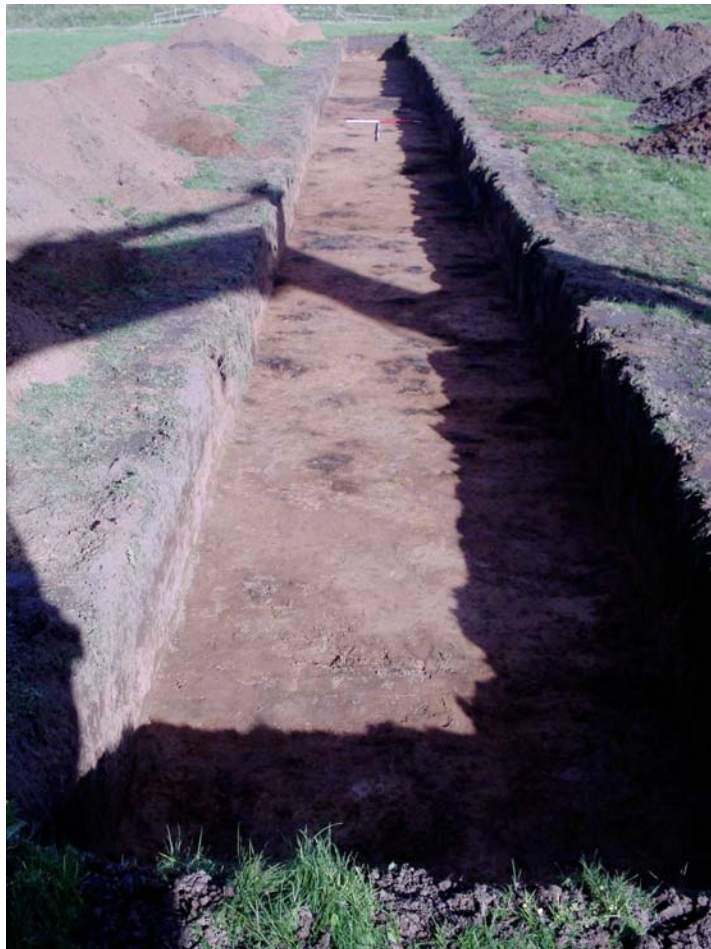
Plate 2: Plan view of Trench 1, looking north-east

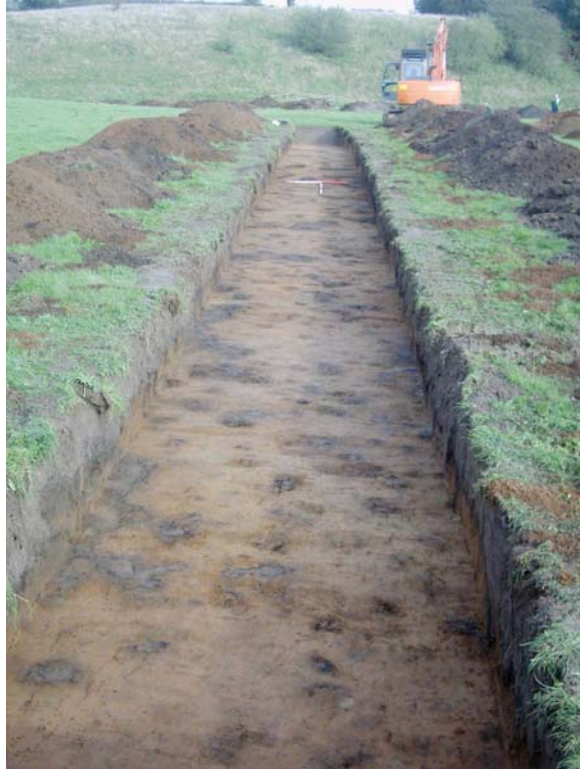
Plate 3: Plan view of Trench 2, looking north-east

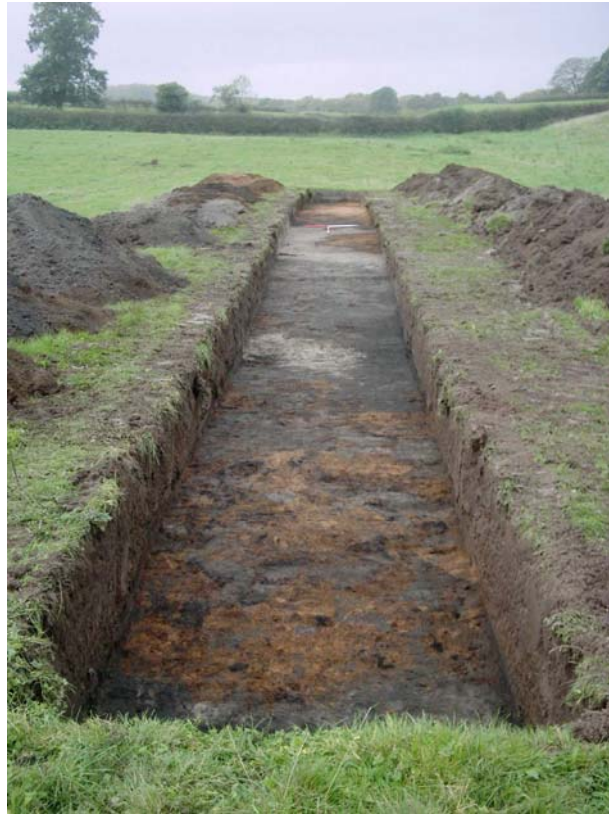
- 4.1.7 **Trench 3:** located *c.*25m to the south of the north-east field boundary (Fig 6), and positioned under the proposed development of the pumping station and generator plant, this trench was aligned north-west/south-east (Plate 4). It was excavated to a depth of 0.87m and revealed 0.38m of mid-grey-brown silty-sand topsoil, **1012**, 0.14m of light brown clay-sand subsoil, **1011**, and 0.28m of dark greyish-black mixed with orange and grey-white sand colluvial deposits **1010** (Fig 8, Plate 5). These overlay a light grey-white natural sand deposited by water action, **1008**, and in turn a mid-orange natural sand, **1009**. Three fragments of dinner ware pottery were recovered from the topsoil, **1012**, dating between the late eighteenth and early twentieth centuries.

Plate 4: Plan view of Trench 3, looking north-west

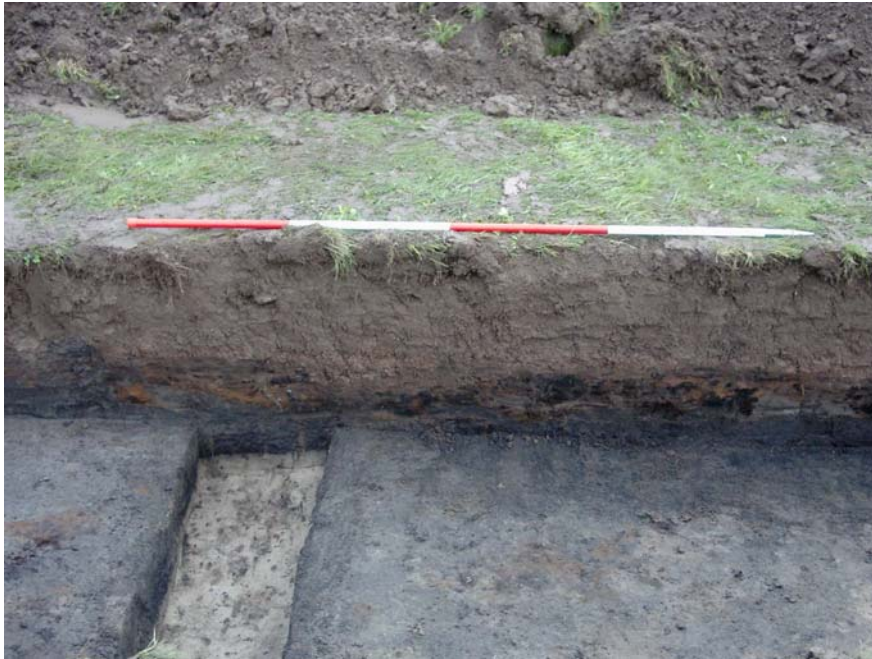
Plate 5: South-west-facing section of Trench 3

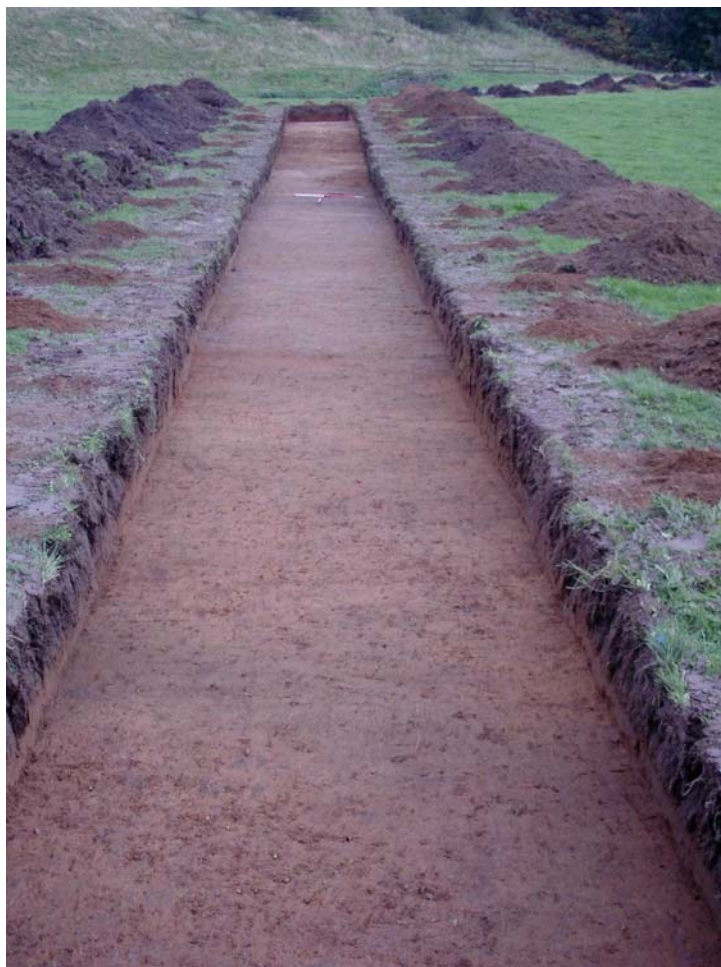
Plate 6: Plan view of Trench 4, looking north-east

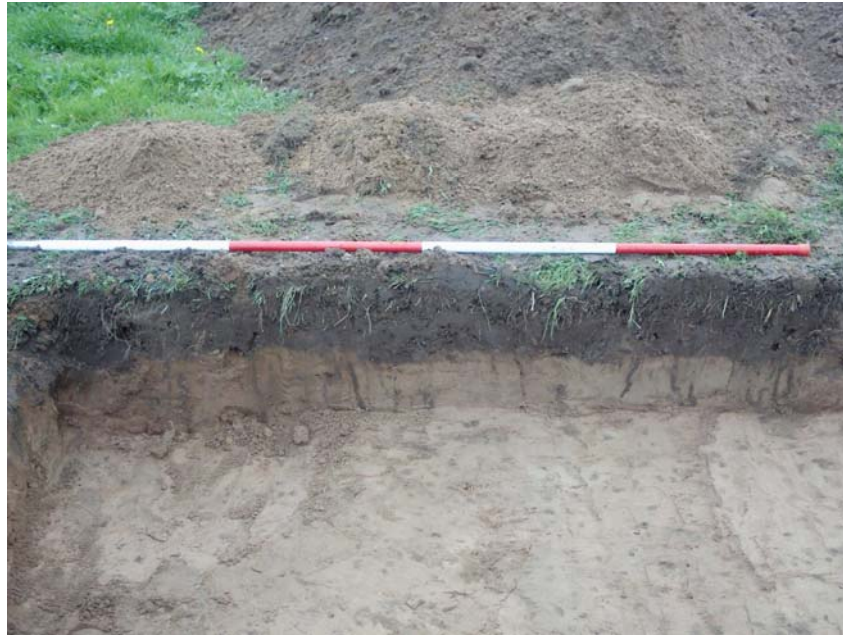
Plate 7: North-west-facing section of Trench 4
