Land off Guntons Road, Newborough, Peterborough Archaeological Evaluation Report

April 2019

Archaeological Evaluation Report

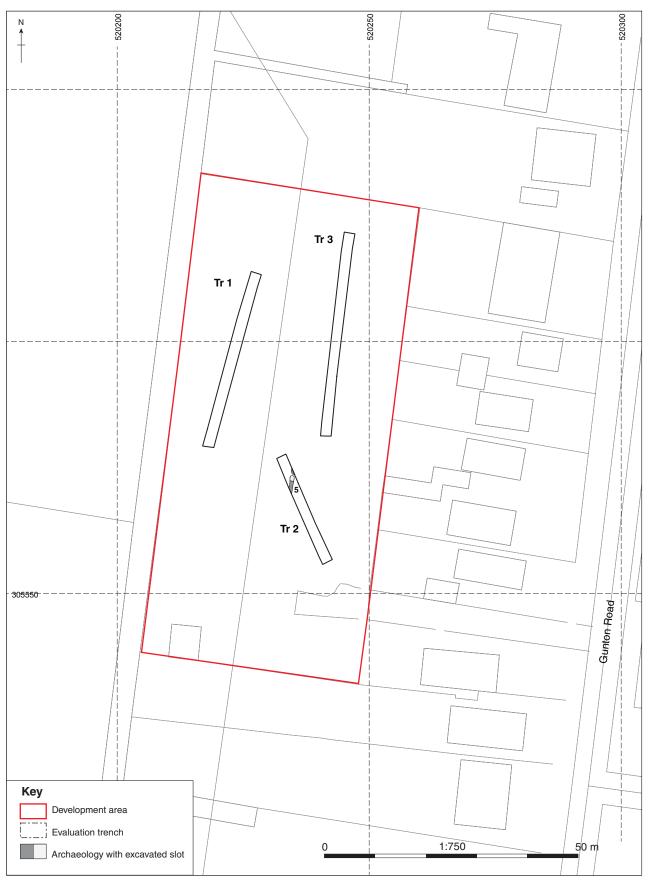
Figure 2: Evaluation trenches. Scale 1:750

- 3.2.1 The soil sequence between all trenches was fairly uniform. The natural geology of clay was overlain by a dark black brown peat subsoil (between 0.15 and 0.25m deep), which in turn was overlain by a pale brown sandy peaty topsoil.
- 3.2.2 Ground conditions throughout the evaluation were generally good except for in Trench2 where ground water immediately started to seep in. Archaeological features, wherepresent, were easy to identify against the underlying natural geology.
- 3.2.3 Archaeological features consisted of two probable marling pits which were present in Trench 2 (Fig. 2).

3.4.1 This trench contained a pair of probable marling pits, one of which was investigated (Plate 2). Pit **5** was sub-rectangular in plan, orientated north to south. It was 0.7m wide and 0.4m deep with near vertical sides and a flat base. It was filled with (4) a dark black brown peat. Another marling pit began 0.3m in a direct line to the north of it (unnumbered on Fig.2). The full size of neither of these features was visible within the trench.

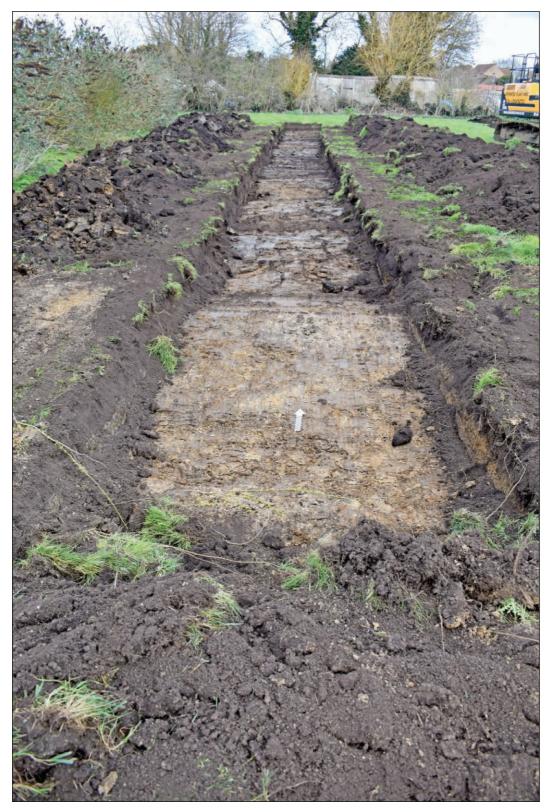
Plate 1: Trench 1 looking north

3.3.1 Trench 1 was devoid of archaeological features (Plate 1).

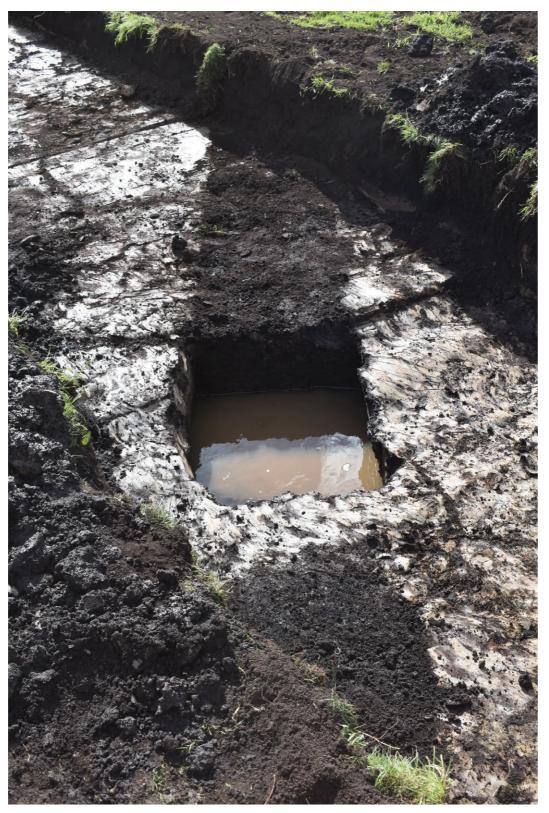
Plate 2: Marling Pits in Trench 2 looking South

4.1.1 The high groundwater caused problems in Trench 2 which led to difficulties with the recording of marling pit **5**, however the rest of the trenches exposed clean natural geology, against which any archaeological features would have shown clearly, and conditions were dry and sunny making the location of features simple.

- 4.2.1 The archaeological works have confirmed the presence of limited preserved archaeological remains across the proposed development area.
- 4.2.2 The pits in Trench 2 confirm the presence of limited marling in the area. The absence of more extensive marling is suggested by the absence of any other such pits in Trenches 1 or 3. Marling is undertaken to spread clay over sandy or peaty soils to enrich the soil and improve water retention (Bush 2014). Marling pits are often dug towards the middle of the field in large quantities in a series of lines and are generally taken to be of 19th century date. It is likely that the relatively late establishment of Newborough and its proximity to residential development meant that the marling did not proceed with the same vigour it did in other areas. This may reflect the use of infields for private gardening or small-scale stock holding, which would not have merited the substantial investment of labour required by the marling process.
