# CANAL HOUSE, BOTANY BAY, CHORLEY LANCASHIRE

## Archaeological Building Investigation

### **Mall Associates**

Issue No: 2004-5/348

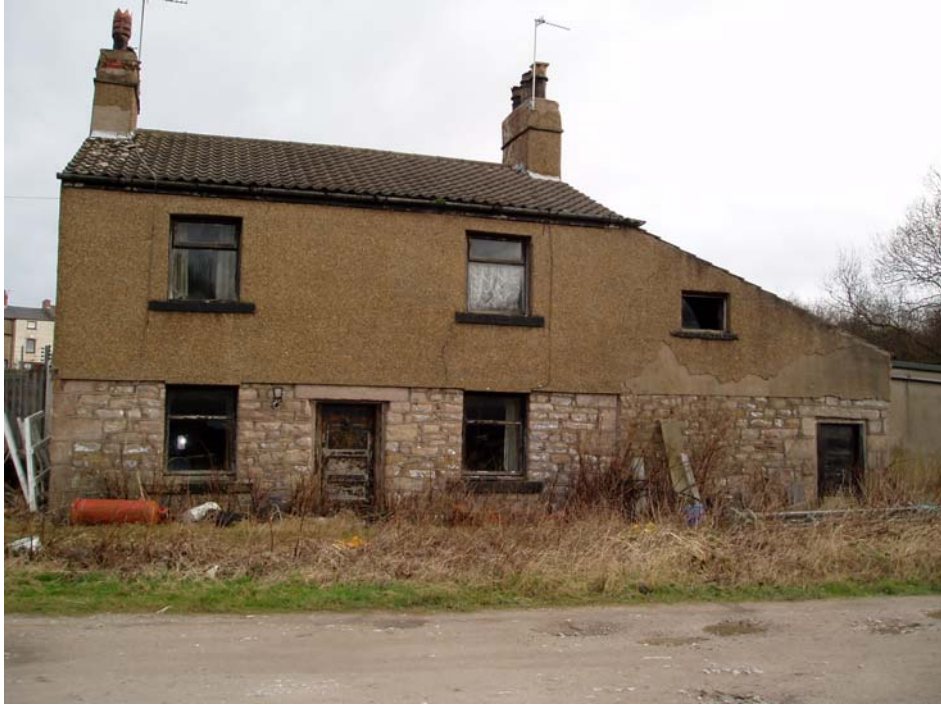
Plate 1: Front (south-west) elevation

3.4.1 **Front (south-west elevation):** (Plates 1-4) the main part of the cottage comprises a central doorway in the lower storey with a window to either side. On the second storey a further two windows are located directly above the lower windows. There is a door at the south-east end of the outshut and a window (approximately half the size of the windows on the main part of the building) in the second storey. All of the windows have stone sills, painted black, which protrude approximately 0.1m from the wall. The four larger windows each have two lights within a black wooden frame (1/4 lights above). The small window in the outshut has neither window-pane nor frame. Both doors have stone lintels above them.

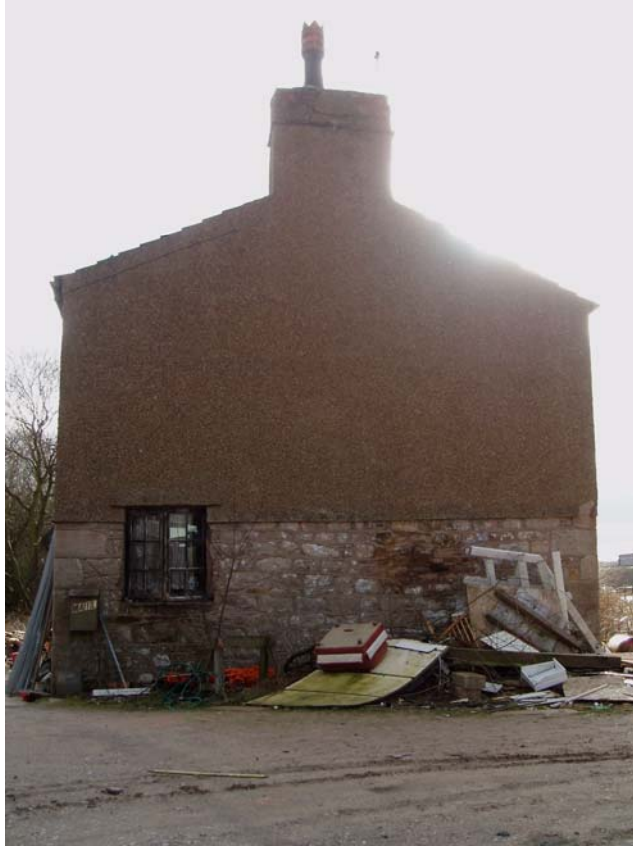
Plate 5: North-west gable

3.4.2 **North-west gable:** (Plates 5-7) there is a bow window in this wall on the lower storey and to the rear. The window consisted of two lights divided vertically into two sets of six. The window sits on a stone sill protruding 0.05m from the

wall and the lintel can be seen beneath the render projecting from the wall. A chimney was built at this end, and broken pebbledash revealed that this was of red brick. There was also a stone or slate plinth running around the chimney, approximately two thirds of the way up. On top of the chimney was one ceramic chimney-pot.

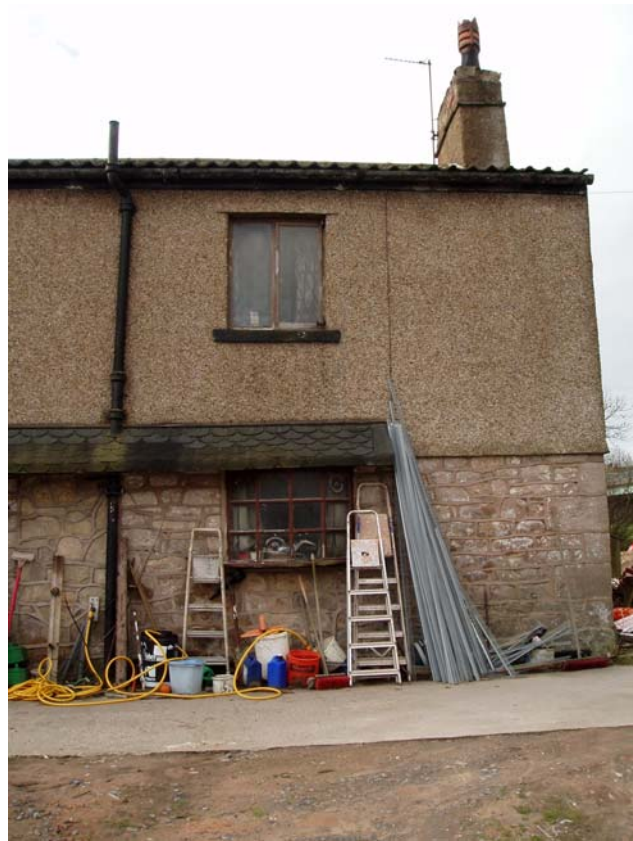
Plate 8: Back elevation (west end)

- 3.4.3 **Back (north-east elevation):** (Plates 8-11) the lower storey had three identical bow windows, two in the main part of the building, and one in the outshut. The windows each had twelve lights, four over three, in black wooden frames. A porch-type roof stretched over the three bow windows at the top of the lower storey. A fairly modern black wooden door with a frosted window panel was located in the lower storey of the outshut between two of the bow windows. On the upper storey in the main part of the building were two windows each with two lights divided vertically by wooden frames. The outshut had a further window in the same design, but approximately half the height. The two larger windows each had stone sills, flat to the wall of the house, but the smaller window had a wooden frame only.

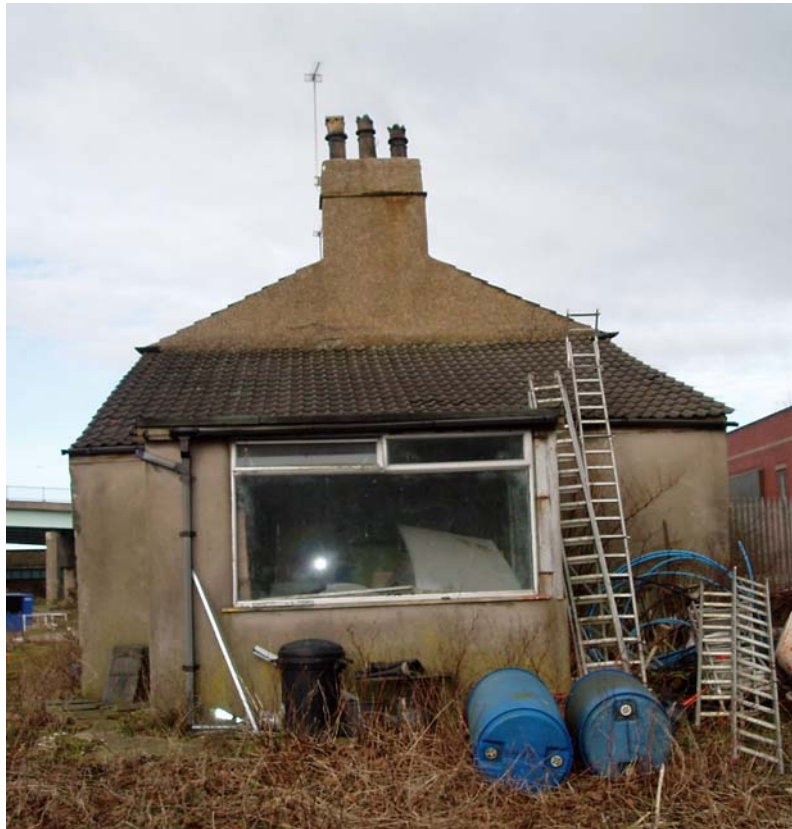
Plate 12: South-east gable

- 3.4.4 **South-east gable:** (Plates 12-13) this end of the main building was largely obscured by the outshut, which has a cat slide roof. Neither the outshut nor the main part of the building contained any windows in this elevation. There was a chimney at the apex of the gable of the same construction as the chimney on the north-east gable. This chimney had three ceramic pots of varying sizes. Most of the end of the outshut was obscured by a modern, square, flat-roofed extension (Plates 14-15). This had one large window on this end, a door on the south-west side and a window on the north-east side. The walls to this extension, plus the south-east wall of the outshut were all rendered.
