Hayley Green Farm Warfield Berkshire

Archaeological Evaluation and Building recording

Oxford Archaeology

20th May 2002

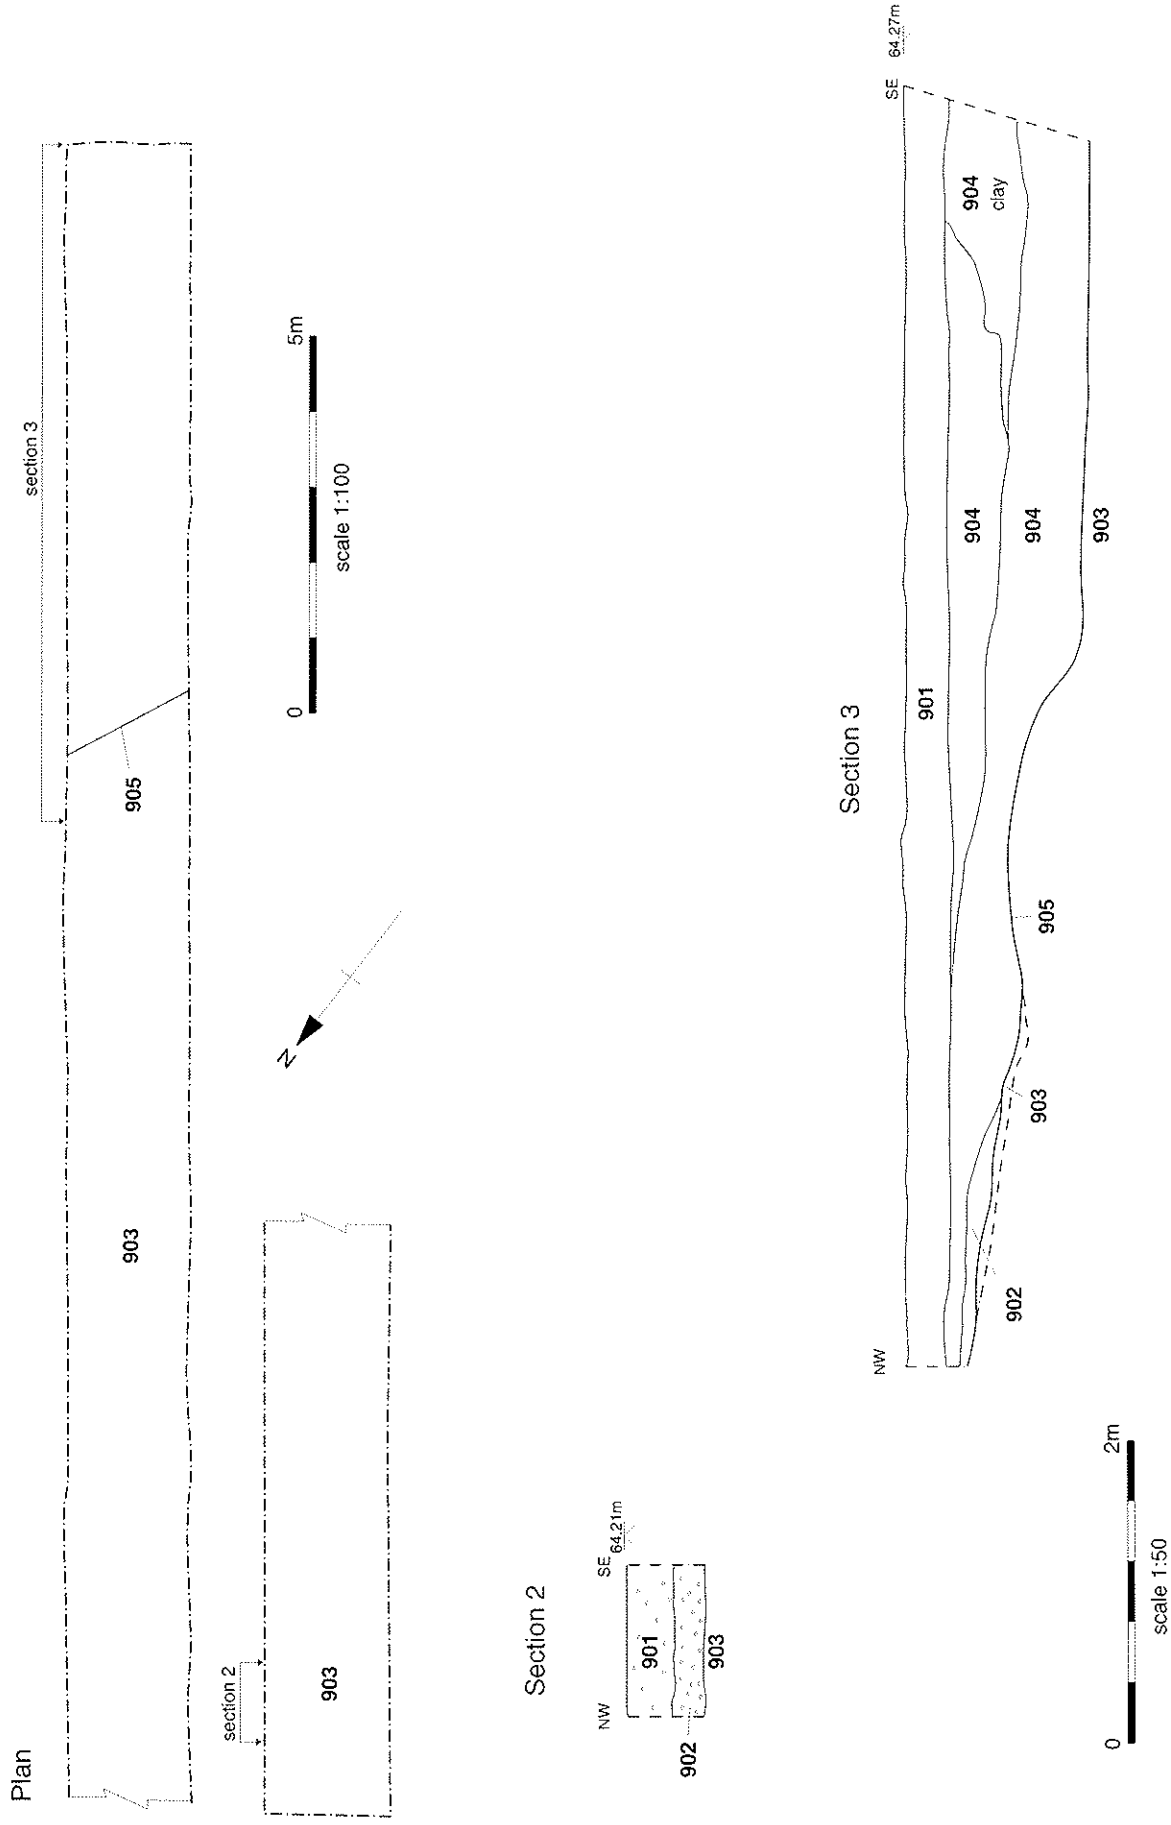
Figure 4: Trench 9, plan and sections.

Trench 9 (Fig. 2 and 4 plan and section 2 and 3)

- 5.1.9 Trench 9 was situated in the eastern part of the development site and was aligned south-east north-west. The underlying gravel geology was located at a depth of 0.60 m below the present surface at the north-west end and 1.20 m below the present surface at the south-east end (64.21 m OD and 64.27 m OD respectively). Overlying the natural was a layer of friable sandy clay with gravel inclusions (902) interpreted as subsoil / plough soil which was located mostly to the north-west end of the trench. Truncating this layer was a gently sloping feature, possibly a borrow pit (905) probably measuring 10 m across by 1.2 m deep. This feature contained a mixed deposit of garden soil, clay and modern material (904). It also included post-medieval finds of pottery and glass. Sealing this deposit and the plough soil was a friable, mid-brown clay/sand topsoil (901).

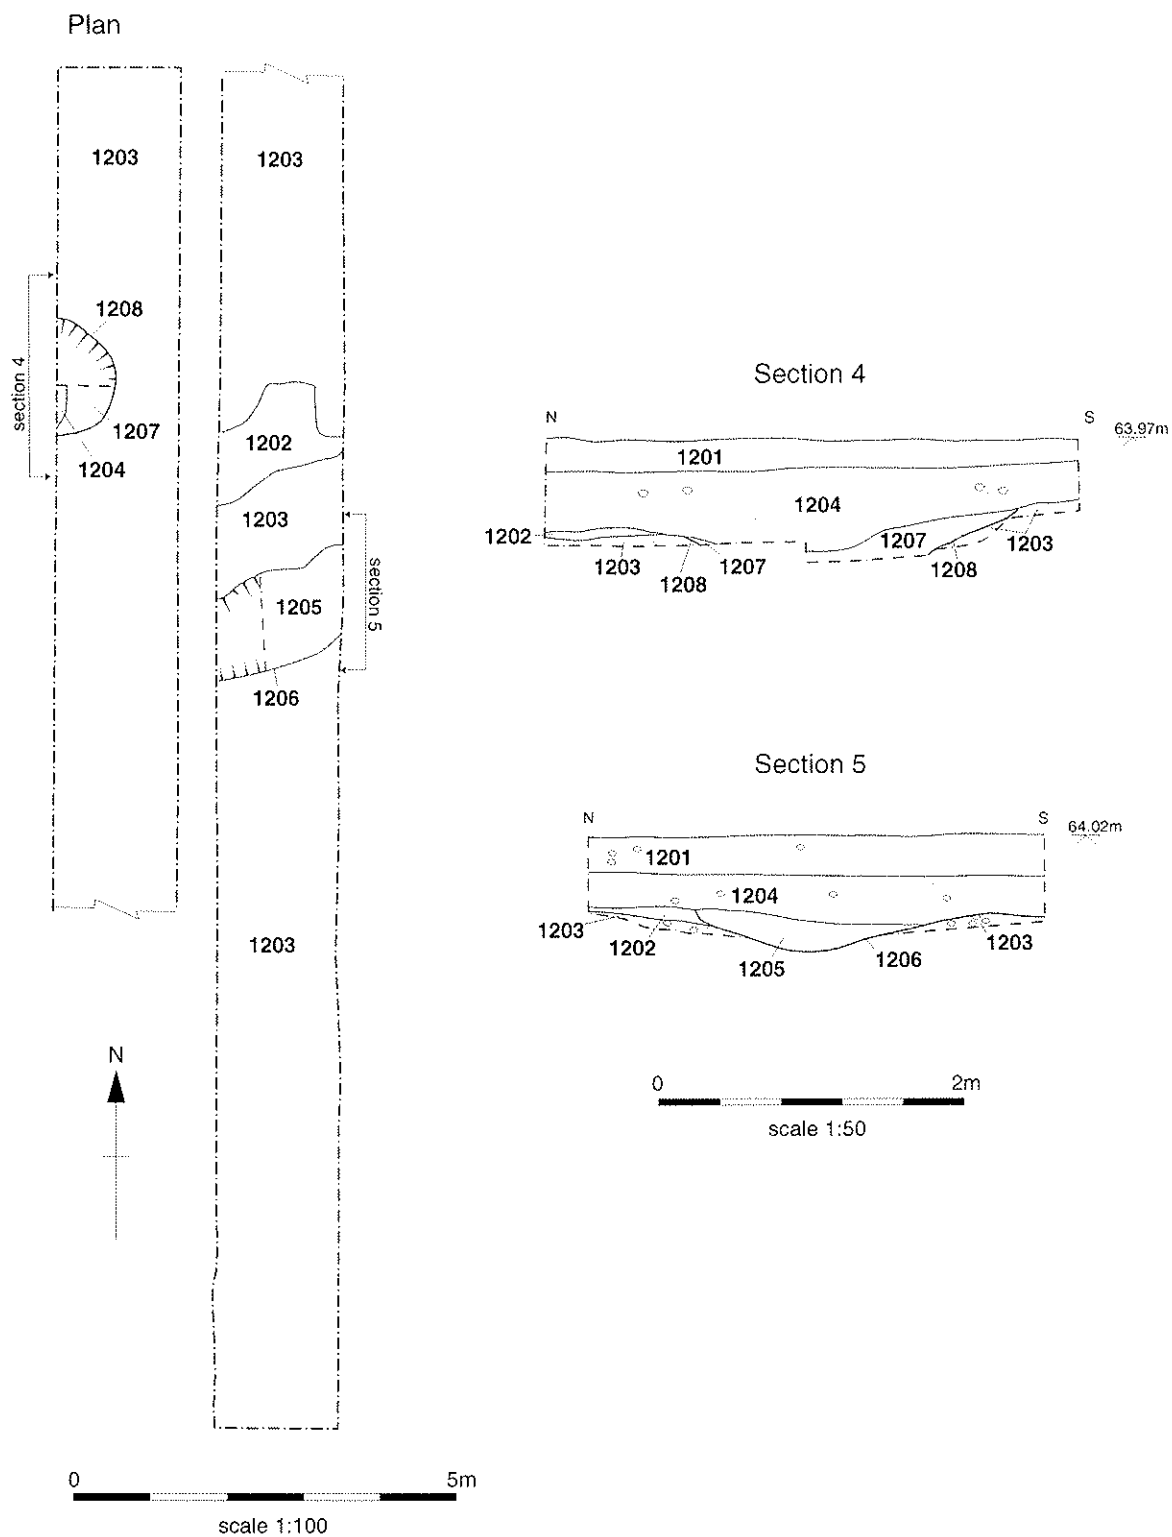
Figure 5: Trench 12, plan and sections.

Trench 12 (Fig. 2 and 5 plan and sections 4 and 5)

- 5.1.12 This trench was located running parallel to the eastern boundary of the development site and aligned north-east south-west. The gravel natural (1203) was located at a depth of 0.5 m below the present surface (64.02 m OD) and was overlain by a friable brown sandy clay with gravel inclusions (1202) interpreted as subsoil / plough soil. This layer was truncated by two irregular shaped tree-throw holes (1206 and 1208) which were filled with identical deposits of dark brown clay/sand (1205 and 1207) and contained no datable artifacts. Sealing the tree-throw holes and plough soil was a layer of light brownish yellow clay made ground (1204) that was capped by a mid-brown clay/sand topsoil (1201). Finds including pottery, glass and CBM of post-medieval date were retrieved from layer (1204).

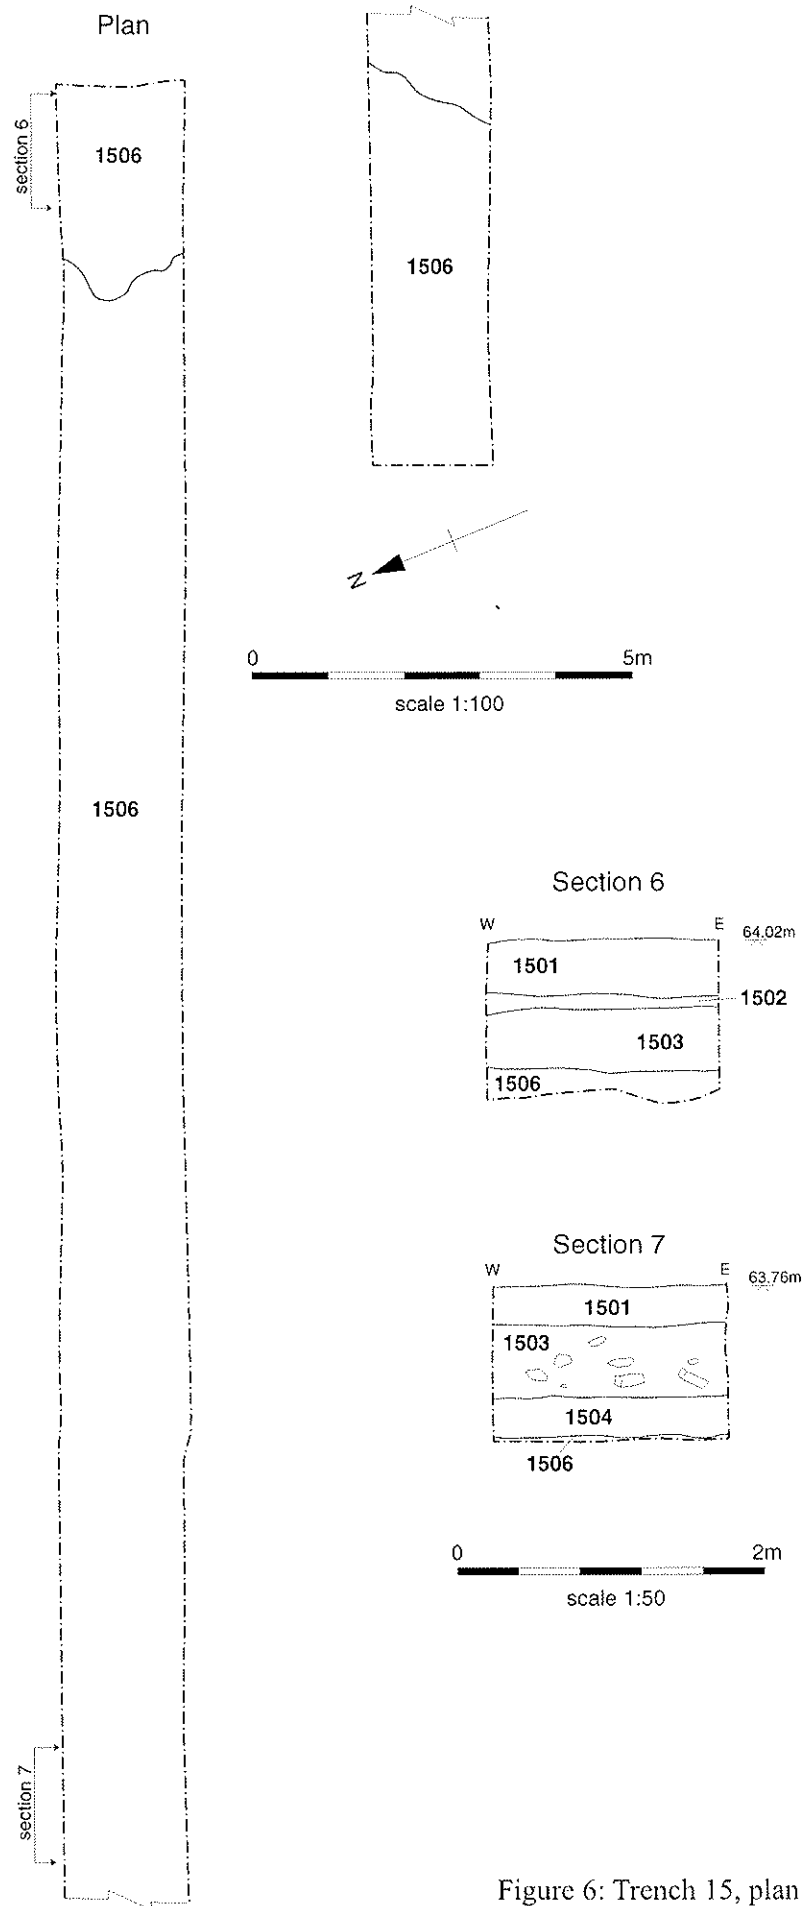
Figure 6: Trench 15, plan and sections.

Trench 15 (Fig. 2 and 6 plan and sections 6 and 7)

- 5.1.18 This trench was located in the north-east corner of the development site and had been moved slightly to avoid buried building debris. The trench was aligned roughly east-west and at the base of the trench the gravel natural (1506) was located at a depth of 1 m below the present surface (63.76 m OD). At the east end of the trench a short length of friable, brown sandy clay with inclusions of gravel (1505) interpreted as subsoil / plough soil was recorded overlying the natural gravel. Directly overlying the plough soil was a series of mixed deposits including mid-brown yellowish grey clay, silt gravel and modern building material (1502, 1503 and 1504) This was made ground and these layers were sealed by a friable, mid-brown clay/sand topsoil (1501).

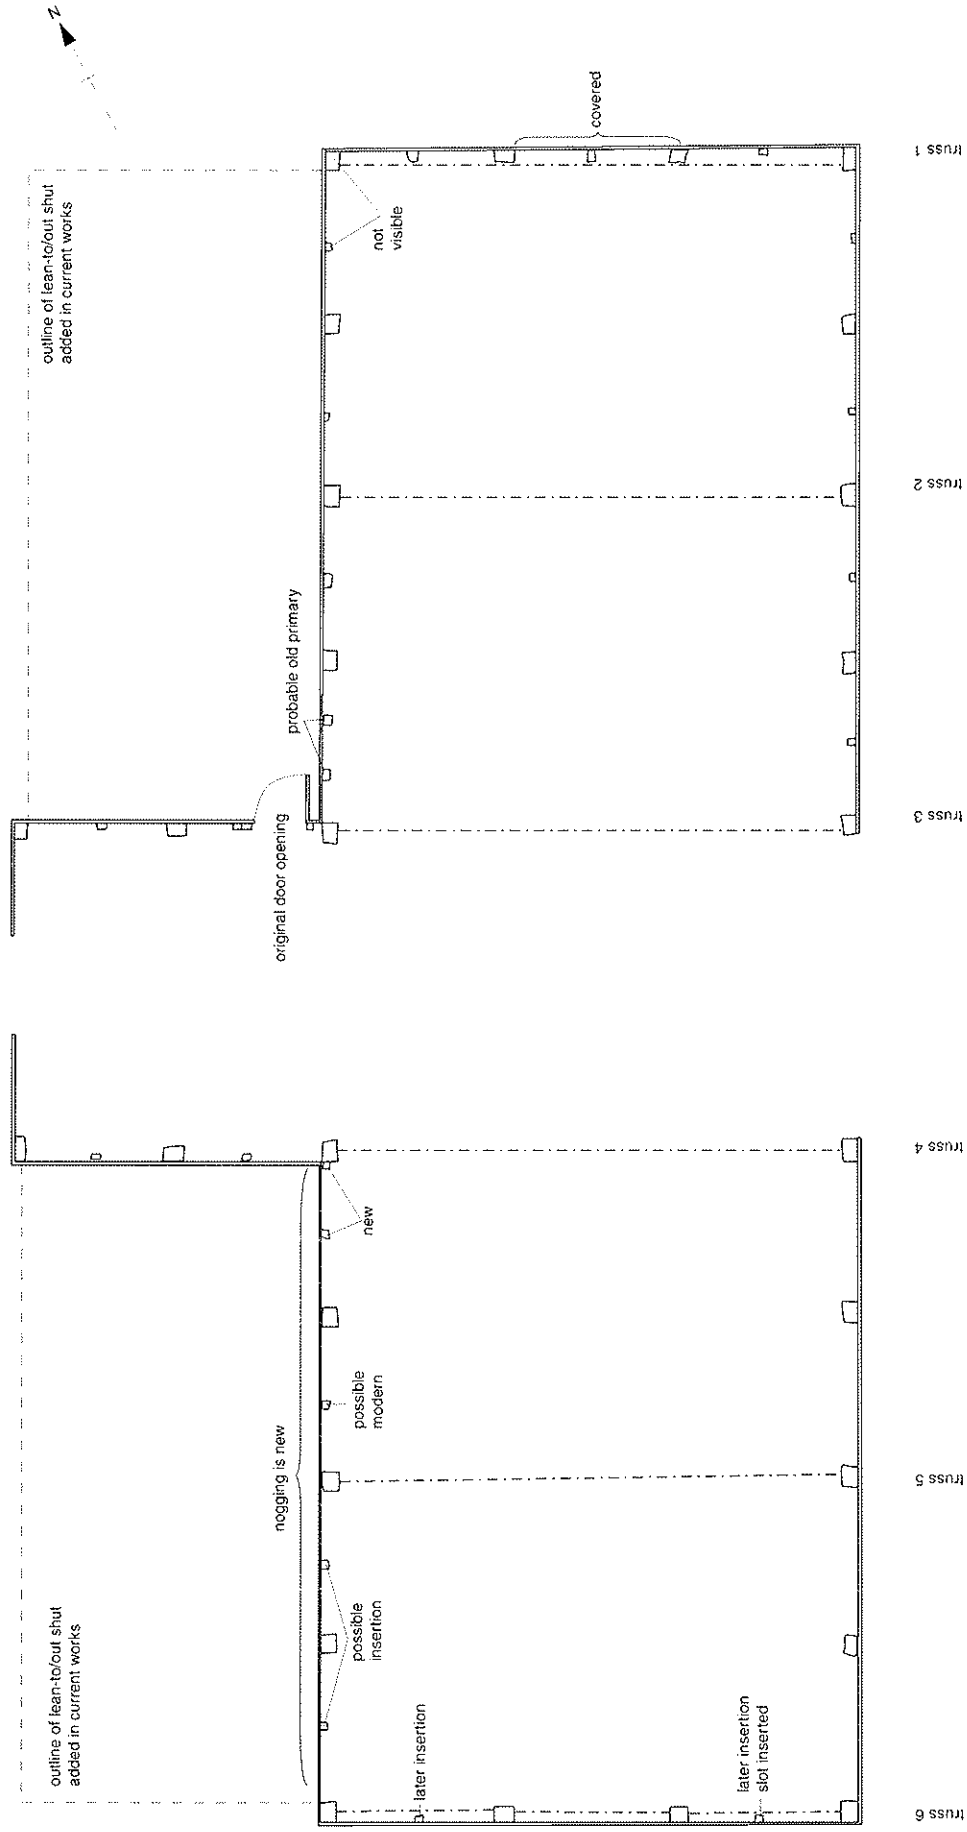
Figure 7: Ground Plan of Barn

- 6.4.1 The barn stands some 75 m south east of the farm (a brick building standing in a medieval moat).
- 6.4.2 The barn is timber-framed and weatherboarded, of five bays, with a central outshot porch on the west side (and modern lean-tos on either side of this). All the adjacent buildings are modern. Prior to the recent works there was a modern timber lean-to at the north-west, and a modern brick lean-to at the south-west.

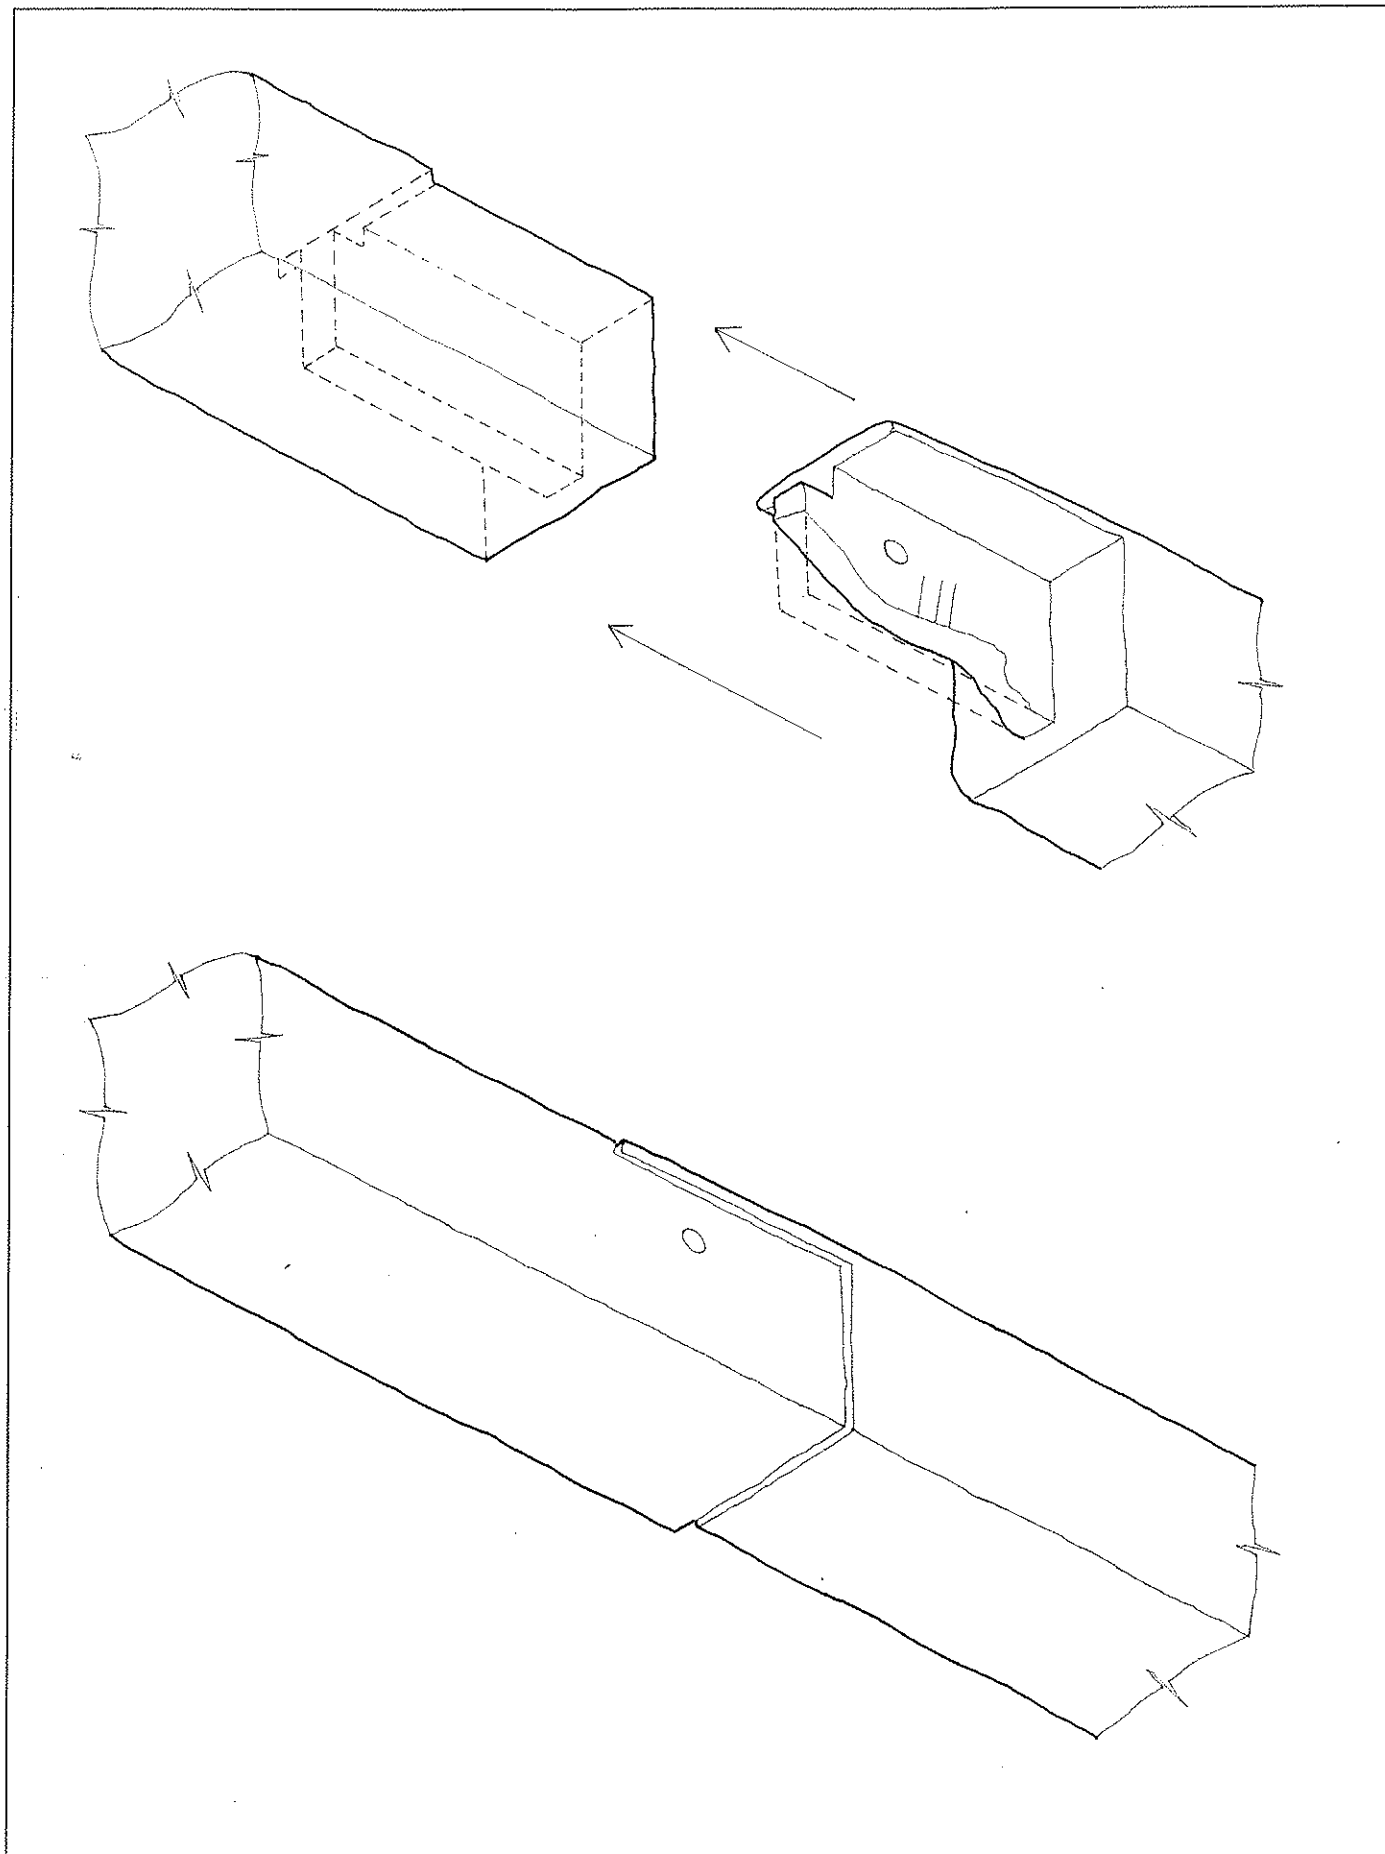
from sill to tiebeam and joined with middle rails. There are curved braces rising from the corner posts to the tiebeam, and about five studs in each half bay, tenoned (but not pegged) at the top, and resting in a groove below. The side walls also have one mid-bay storey post, and arch braces from the principal posts to the wallplate, with four studs in each half bay. One length of wallplate (second bay from south on west side) has been replaced, on an original scarf joint in the wall plate. The scarf is bladed, but is 'secret' in that the blade does not descend the full depth of the plate, and the top face was obscured by a 'lip' (see Fig. 9).

Figure 9: Secret bladed scarf joint detail in wall plate.

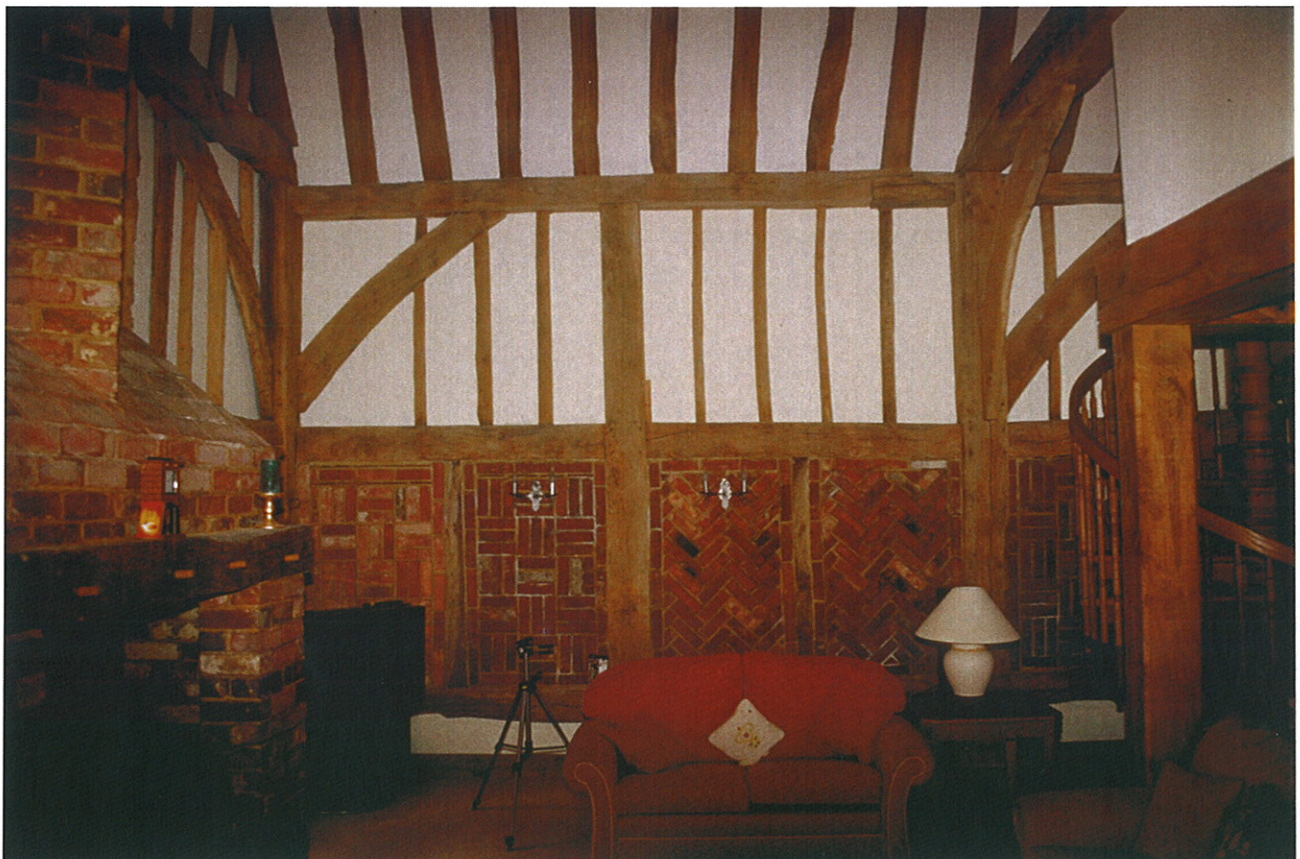
Plate 2: Interior of barn, southern end of west wall (west ends of Trusses 5 and 6). Shows primary framing in the wall and secondary stairs and post (for inserted first floor) to right

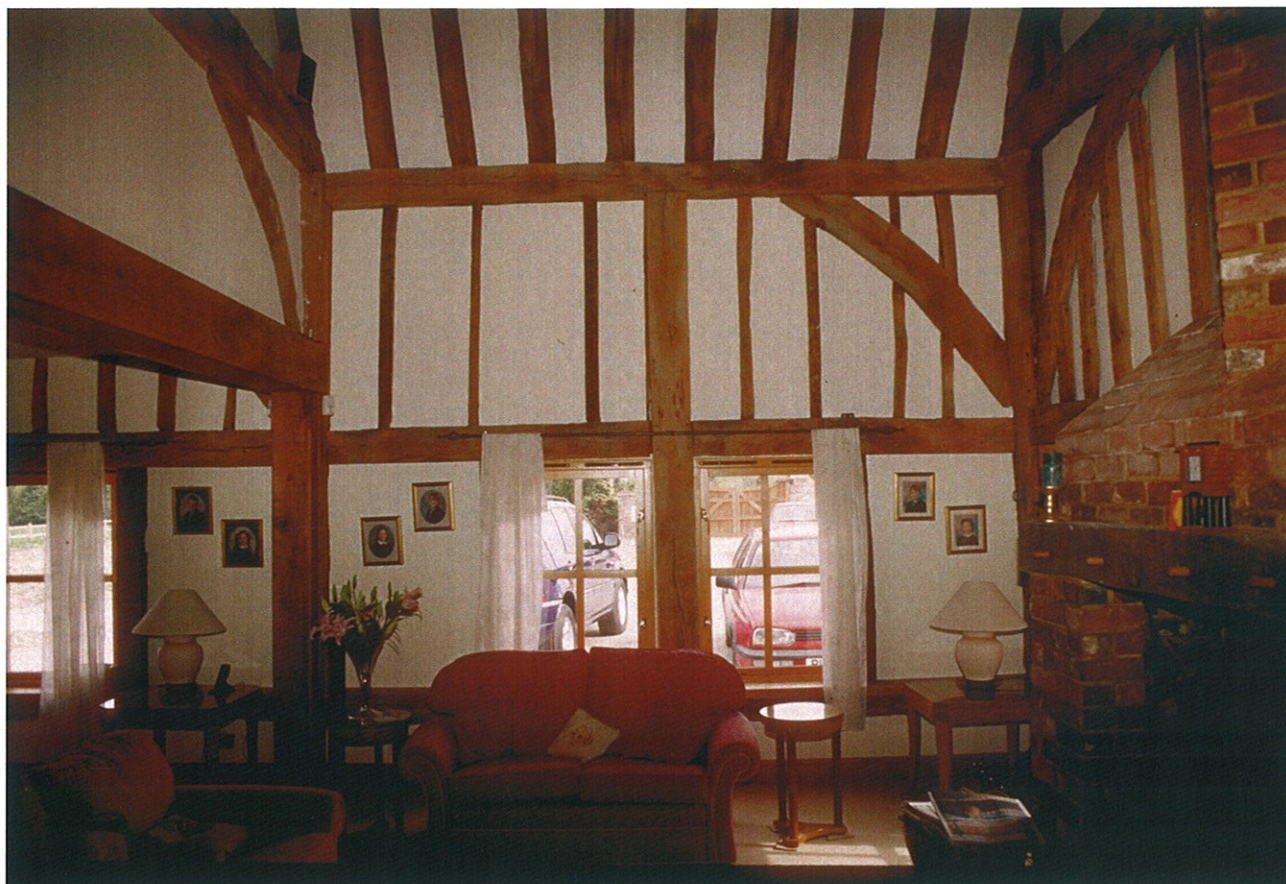
Plate 3: Southern end of east wall, with recently inserted first floor to left. East ends of Trusses 5 and 6

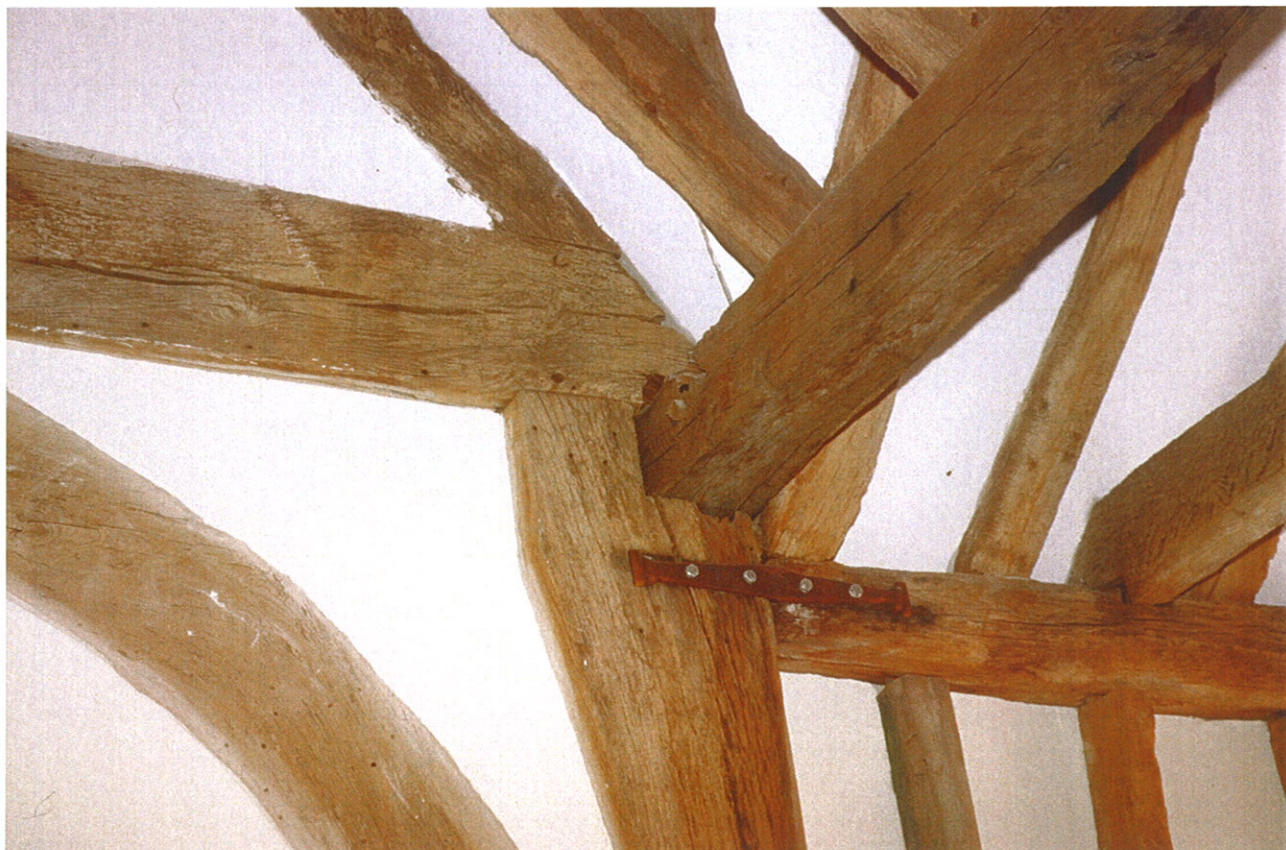
Plate 4: Wall plate and tie-beam supported by jowled head of post, secondary iron strap. North end of Truss 4

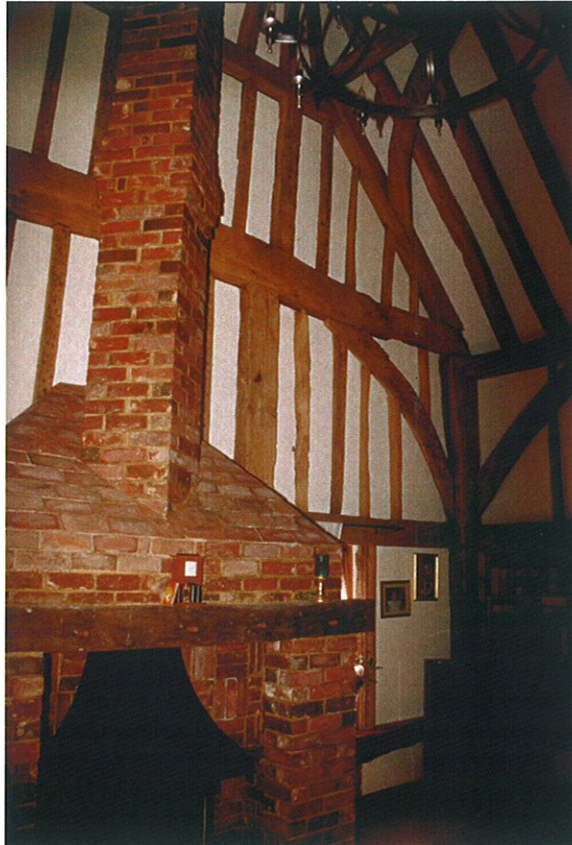
Plate 5: South end of barn, inserted fire place

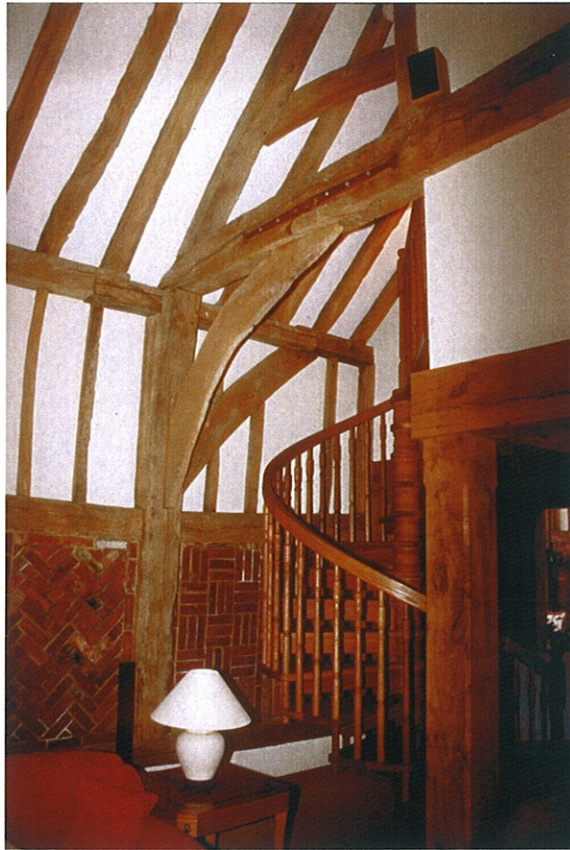
Plate 7: Typical post with jowled head and arched brace. West end of Truss 5

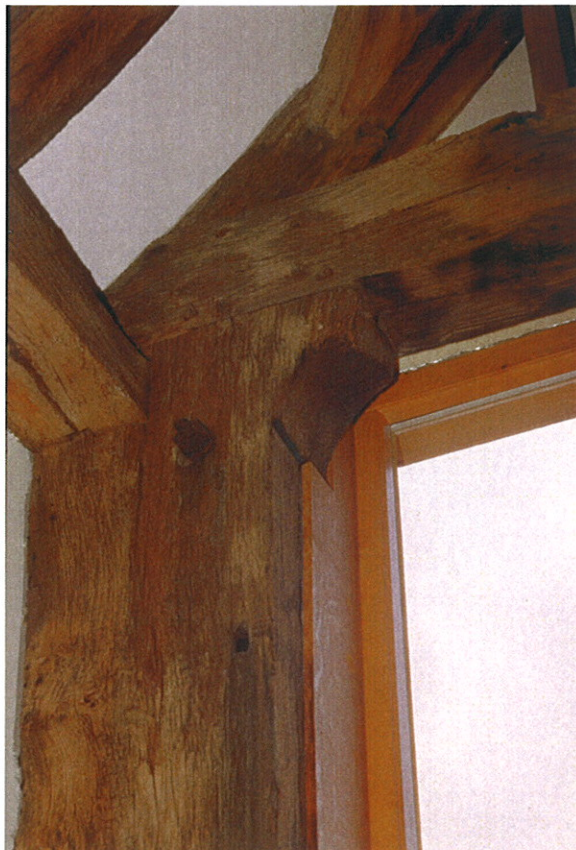
Plate 8: Short curved jowl to head of post at end of porch. Truss 4

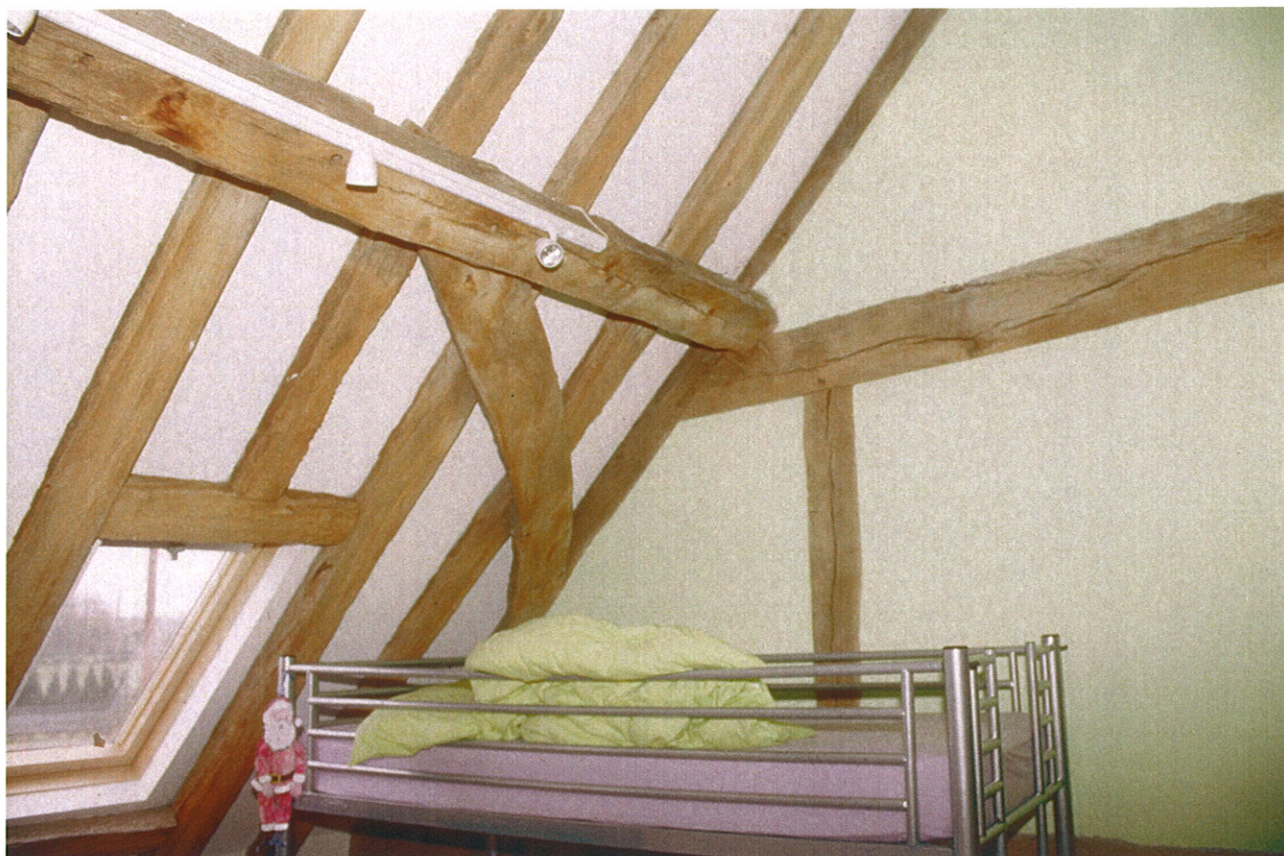
Plate 9: First floor detail showing clapsed purlin, collar, queen strut and arched windbrace

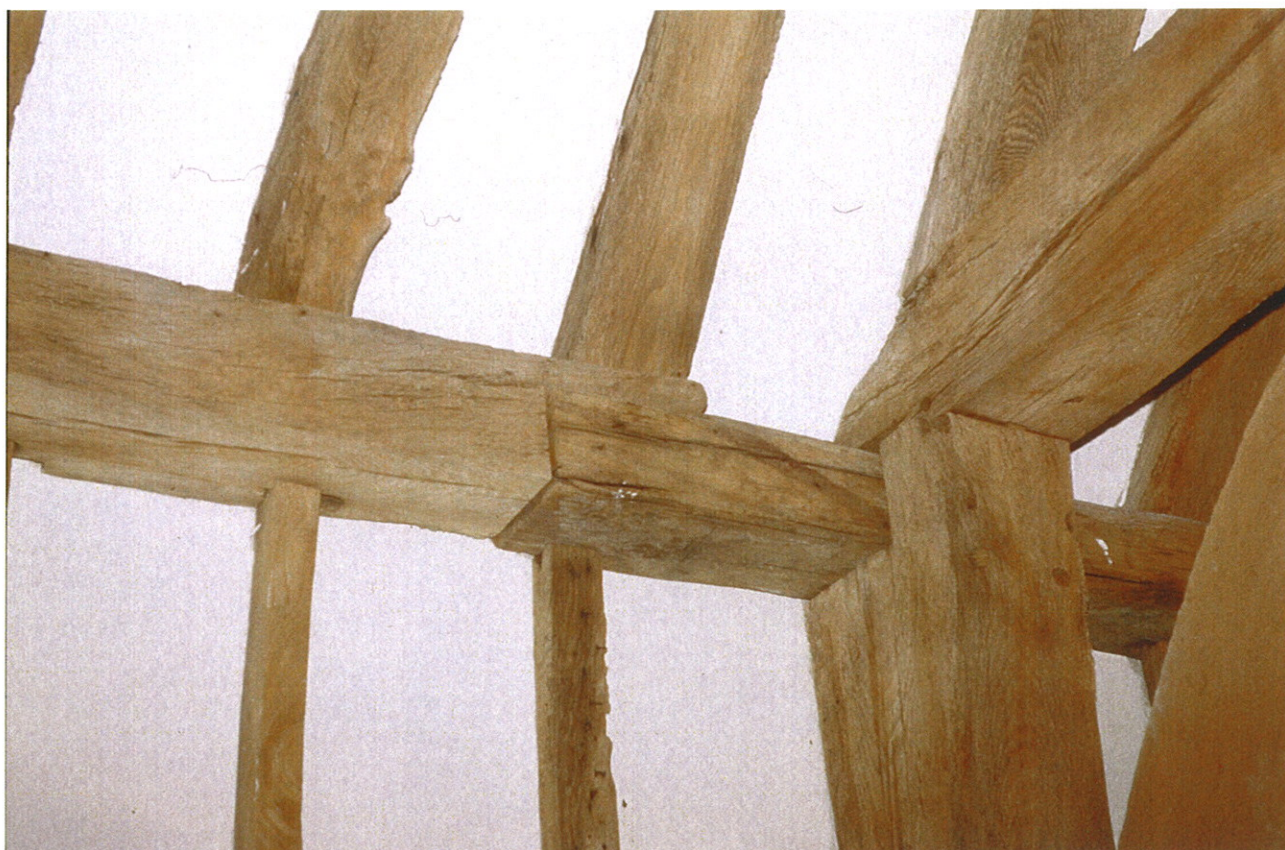
Plate 11: Bladed 'secret' scarf joint in wall plate

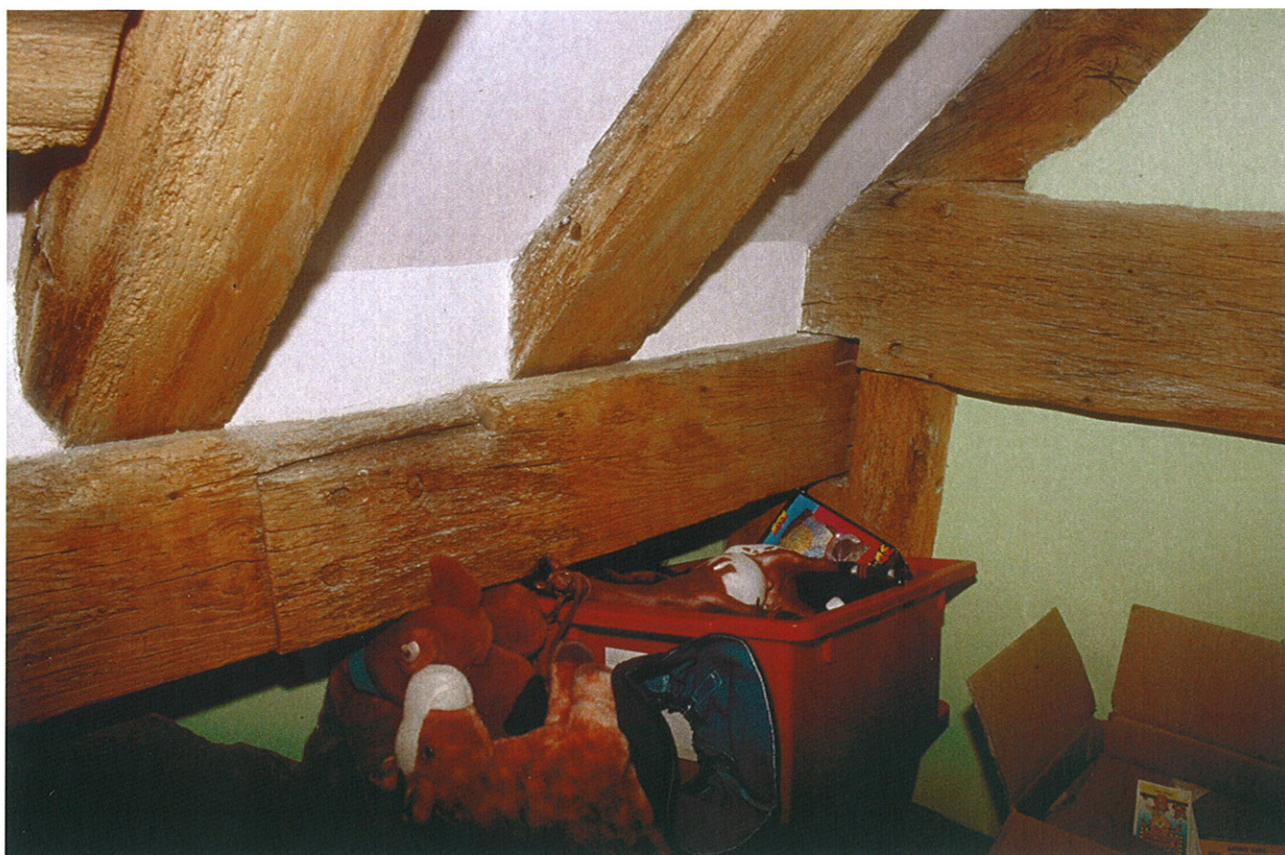
Plate 12: Bladed 'secret' scarf in wall plate
