Saint Michael's Church, Inkpen, Berkshire

Archaeological Assessment

**Oxford Archaeological Unit
September 1990**

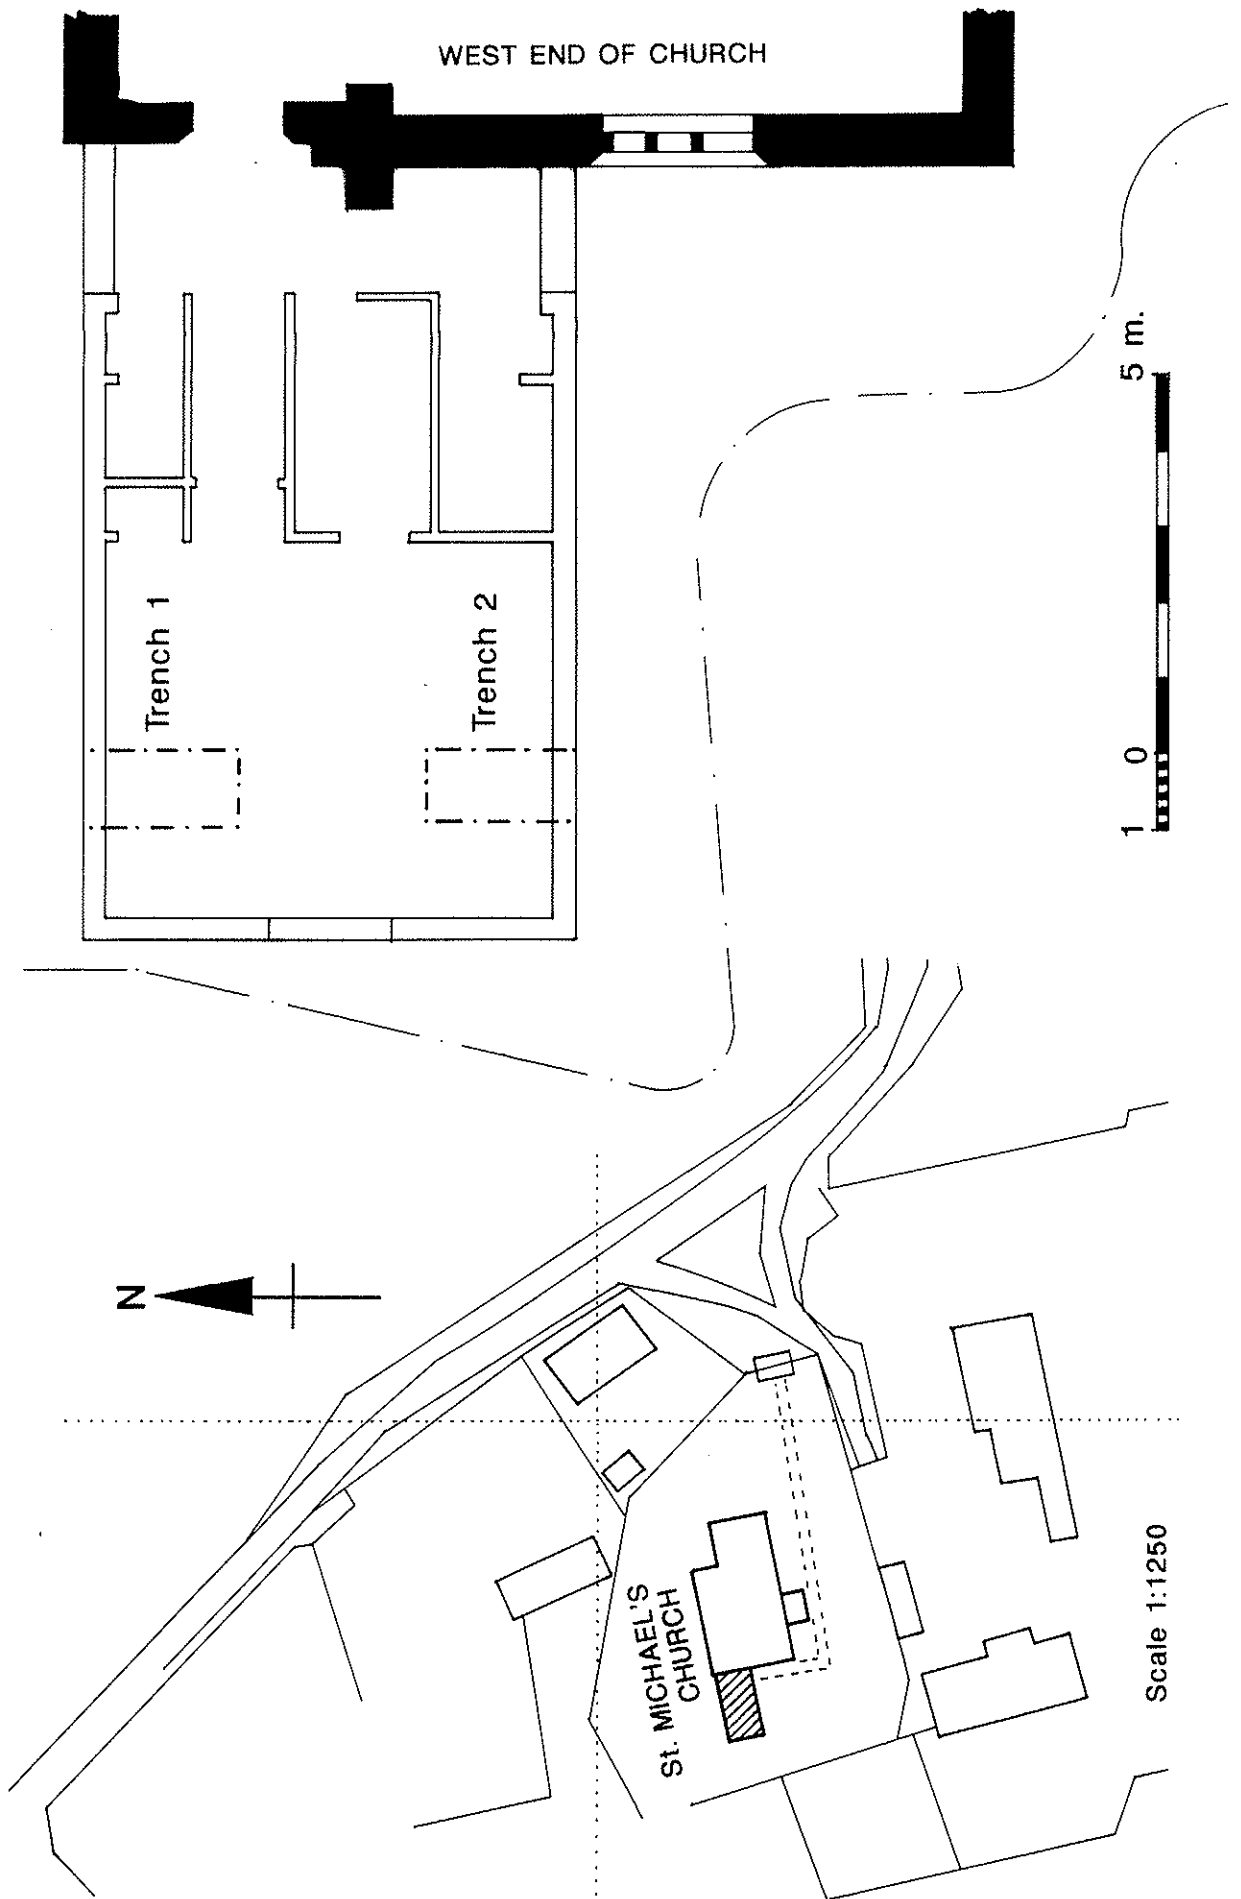
St. Michael's Church, Inkpen, Berks.
Watching brief

Two small assessment trenches were hand excavated. Each trench was 2.0 m long by 1.0 m wide. Trench 1 was set against the north edge of the proposed development area while Trench 2 was against the southern edge cutting into the higher terrace side. The long axis of both trenches was orientated north-south. The trenches were positioned c. 7.5 m from the west end of the church.
