The Norman Hall  
9 Church Street  
Sutton Courtenay  
Oxfordshire

**Archaeological  
Watching Brief Report**

**Document Title:** The Norman Hall, 9 Church Street, Sutton Courtenay,  
Oxon

**Document Type:** Watching Brief

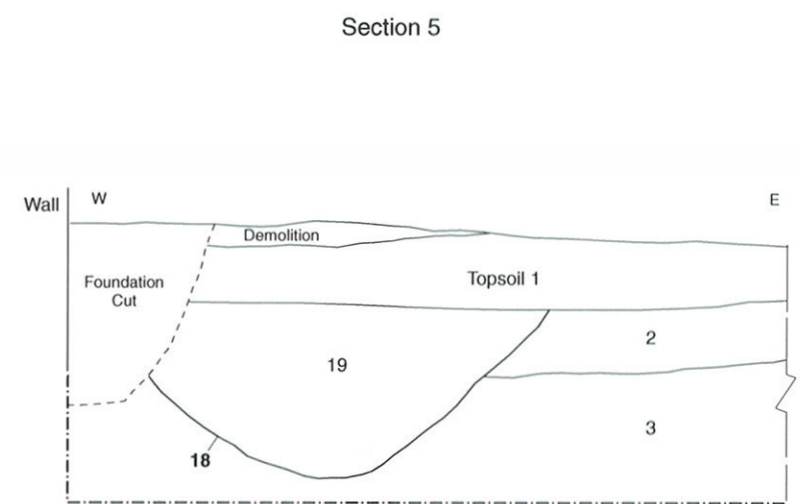
Figure 4: Sections 1 to 5

- 3.1.2 Three of the pits (10, 12 and 18) were all similar in shape and had similar fills. Pits 10 and 18 were observed in section. These had sloping sides rounding to a flat base. Pit 12 was observed in plan during the excavation of the swimming pool and was sub-rectangular in shape. The pits (10, 12 and 18) measured 1.65 m wide x 0.75 m depth, 4.3 m long x 2 m wide x 1.45 m in depth and 1.25 m wide x 0.56 m in depth respectively. These were all filled by dark grey brown silty clay (11, 13 and 19) (Fig.4, sections 2 and 5).

- 3.1.3 To the south-west of these features was a large feature (16) seen only in the section of the foundation trench. It had very steep uneven sides and a narrow concave base

and measured 0.7 m long x 1.3 m wide and 1.1 m in depth. This had been filled by a dark reddish brown silty sand (17). This was a pit of unknown purpose or date (Fig. 4, section 3).
