NETTLEBED, ST BARTHOLOMEWS CHURCH, NSB 92

The Oxford Archaeological Unit conducted a watching brief at St Bartholomews Church, Nettledbed, Oxon (SU471187), between September 29 and October 13 1992, during building alterations.

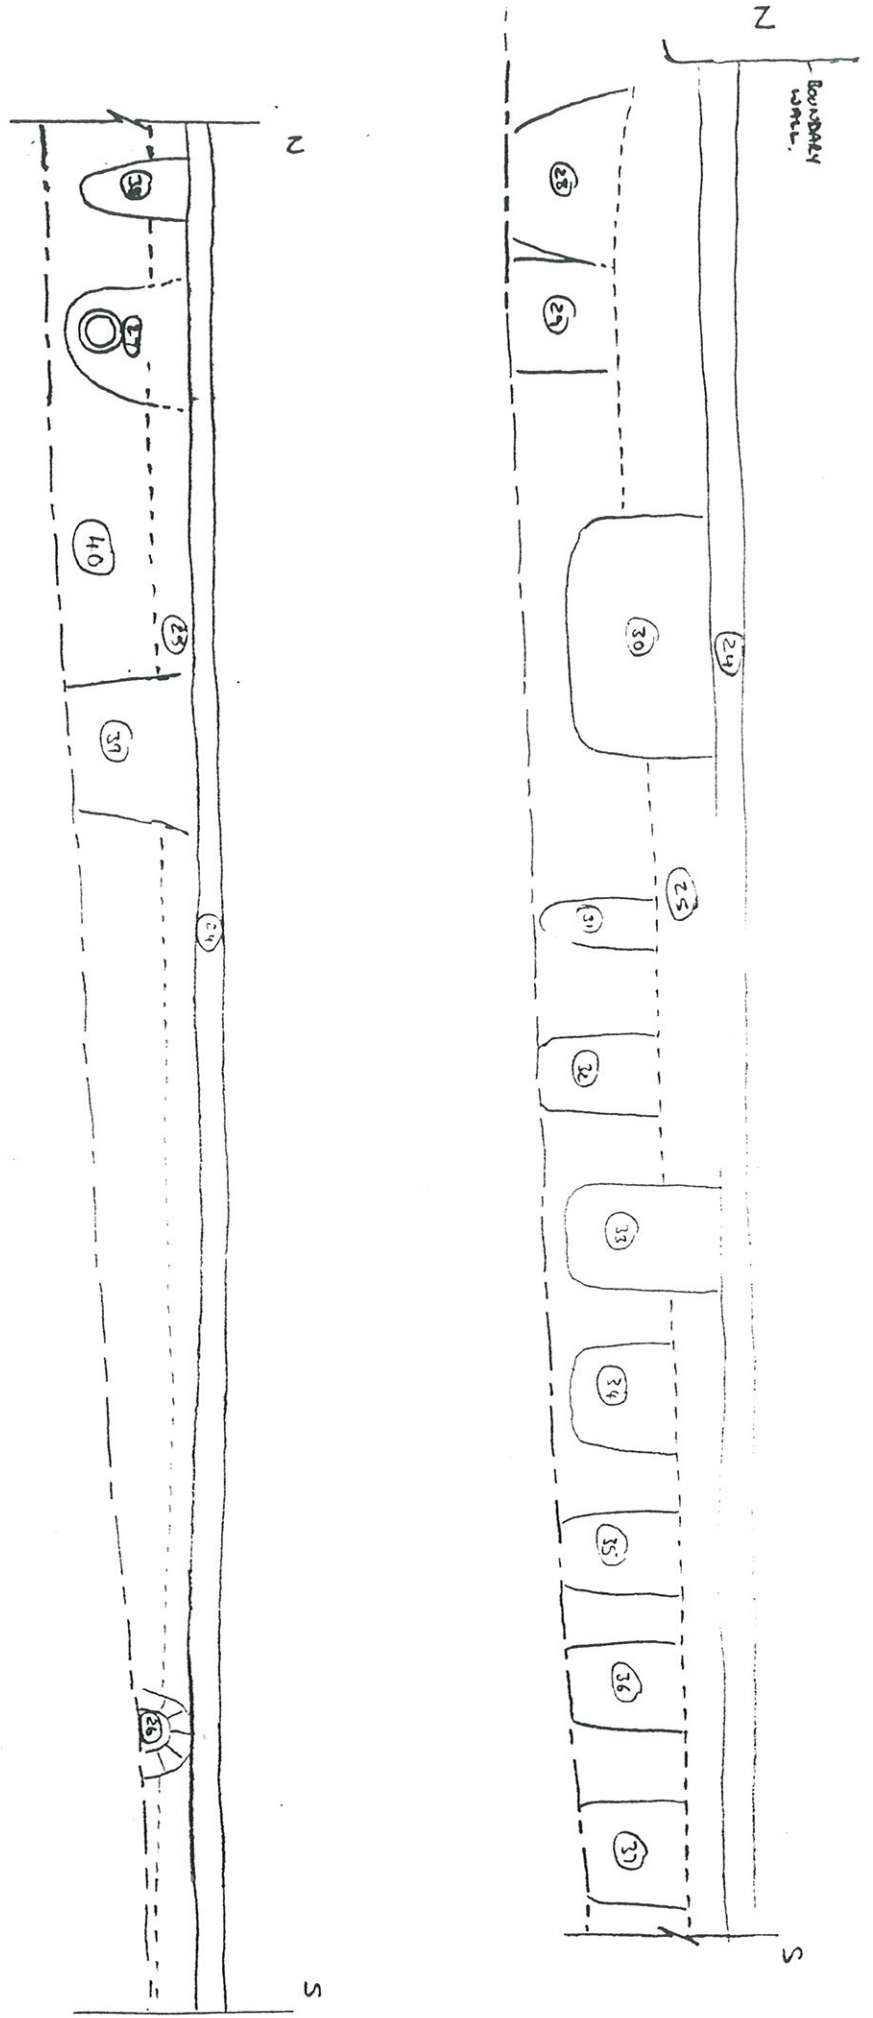
NSBC 92
SECTION 4
SCALE 1:50
DRAINAGE TRENCH

A 0.60 m wide trench was dug from the W side of the tower, parallel with the W boundary of the churchyard, to the main road drains; a distance, within the churchyard, of approximately 25 m. The depth of the trench increased from 0.50 m at its S end to 1.40 m at the point where it was cut under the churchyard wall.

Ten grave cuts were identified in section, all apparently oriented E-W. Three graves were sealed by the topsoil (24), seven were sealed by an earlier mixed layer of redeposited natural orangey clay with inclusions of flint chippings, and an earlier loamy topsoil with inclusions of tile and stone fragments (24). All but one of the graves was located in the N half of the trench.

A modern pipe trench (27), and a brick culvert (26), were also identified.

The level of the N part of the churchyard has been raised considerably by the dumping of excavated material (25), during the 1845-6 construction, but the distribution of the identified

grave cuts suggest that burials before 1845 were concentrated well to the N of the church, as they have been since.
