ALL SAINTS CE PARISH CHURCH, ORTON, Cumbria

Archaeological Desk- Based Assessment and Visual Inspection

Oxford Archaeology North

November 2004

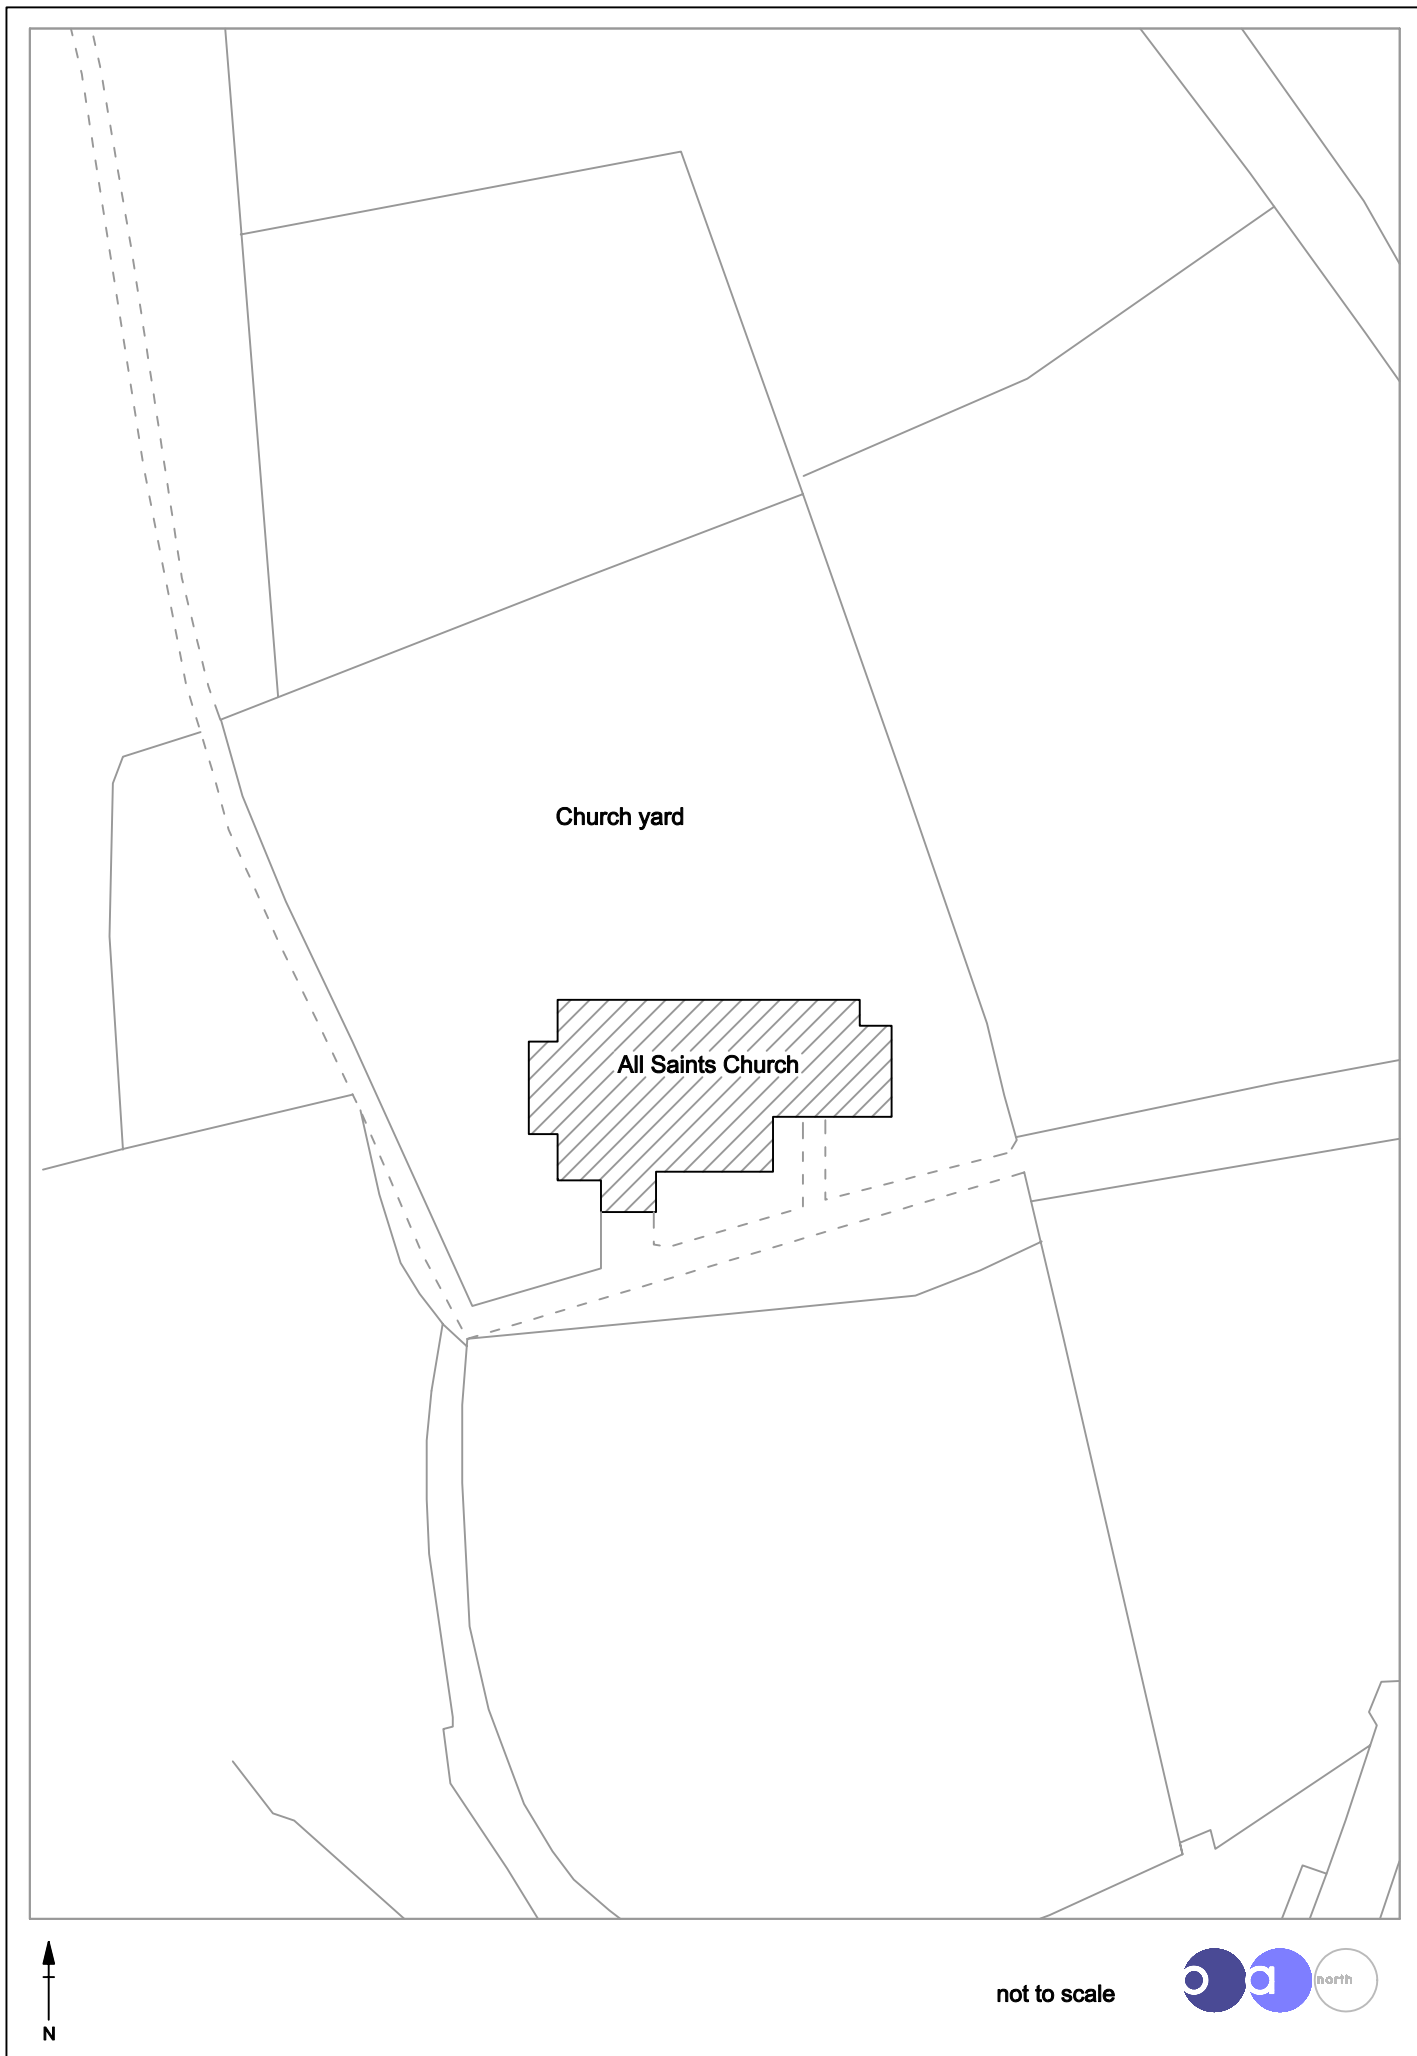
Figure 2: Plan of church

- 3.1.3 The church is situated on high ground, rising to approximately 230m OD at the north side of the village (Ordnance Survey 1984). The church yard is spread around the north, east and west sides of the church (Fig 2).
