ST SAVIOUR'S CE CHURCH, STYDD, Lancashire

Archaeological Desk- Based Assessment and Visual Inspection

Oxford Archaeology North

November 2004

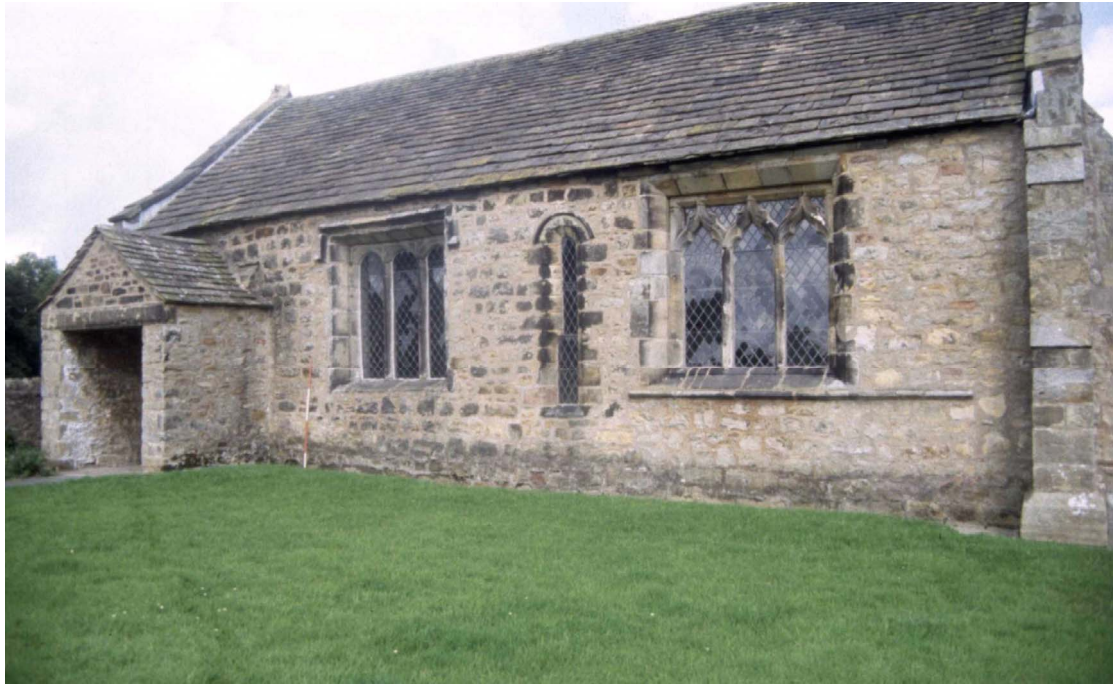
Plate 1: The south external elevation, looking north-west

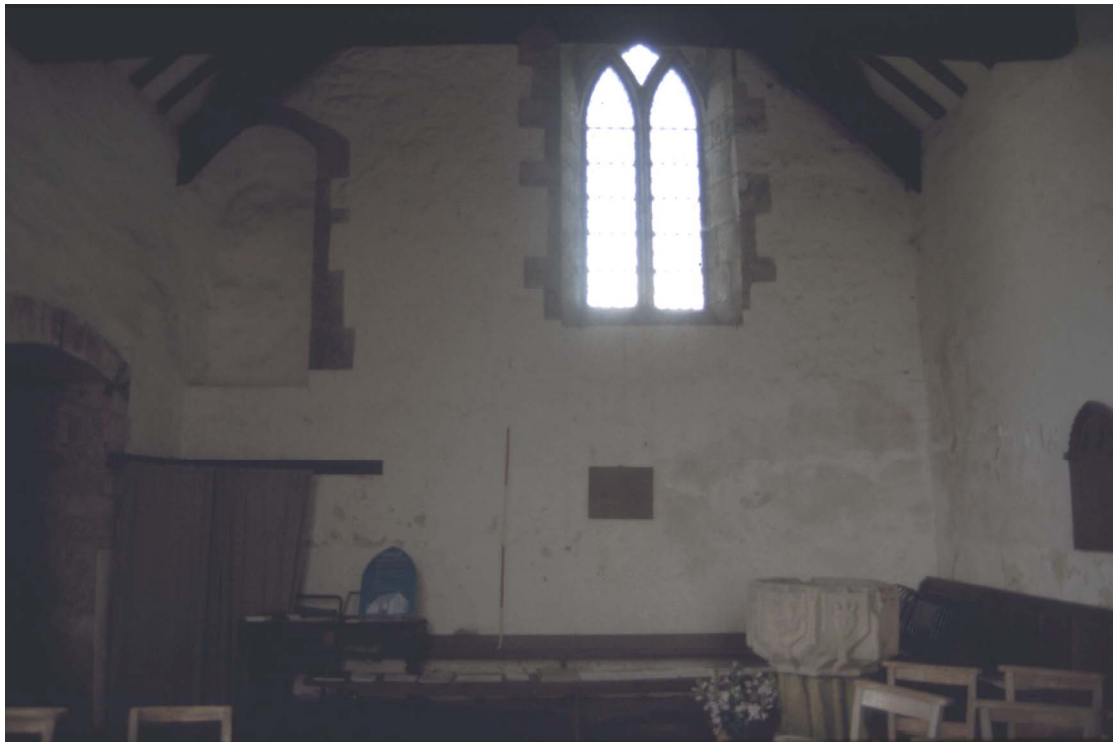
- 4.1.6 The west elevation is distinctly different to the rest; being constructed of rough courses of roughly dressed rounded stones. There is a doorway, blocked with the same type of courses at first floor level, with ashlar-chamfered surrounds and a round-headed arch. To the north of this is a window similar to that in the east elevation, but with only two panes of interlacing tracery (Plate 2).

Plate 2: West internal elevation

- 3.2.9 Subsequent to the proposed twelfth century foundation, the west and east windows (Plate 2 and Plate 3) are late thirteenth century (Pevsner 1991, 238-9), as is the *piscina* at the east end of the south wall (Ward *et al* 1986). Another later development is evidenced by the square buttresses, which have been added to each angle, probably also in the late thirteenth century (Farrer and Brownbill 1912). Two straight-headed windows in the south wall are Perpendicular in style (Pevsner 1991, 238-9), which dates them to between *c*1335-50 and *c*1530 AD (*ibid*); apparently, they are fifteenth century windows acquired from St Wilfrid's church in Ribchester, which were not installed until the seventeenth century (Ward *et al* 1986). Following the Dissolution of Monasteries, the manor was seized by the Crown and subsequently given to Thomas Holt of Gristlehurst (Farrer and Brownbill 1912) and the hospice was destroyed (Sidebotham n.d.). The church was passed into the care of the vicar of Ribchester (*ibid*) and in the following centuries it fell into dilapidation.

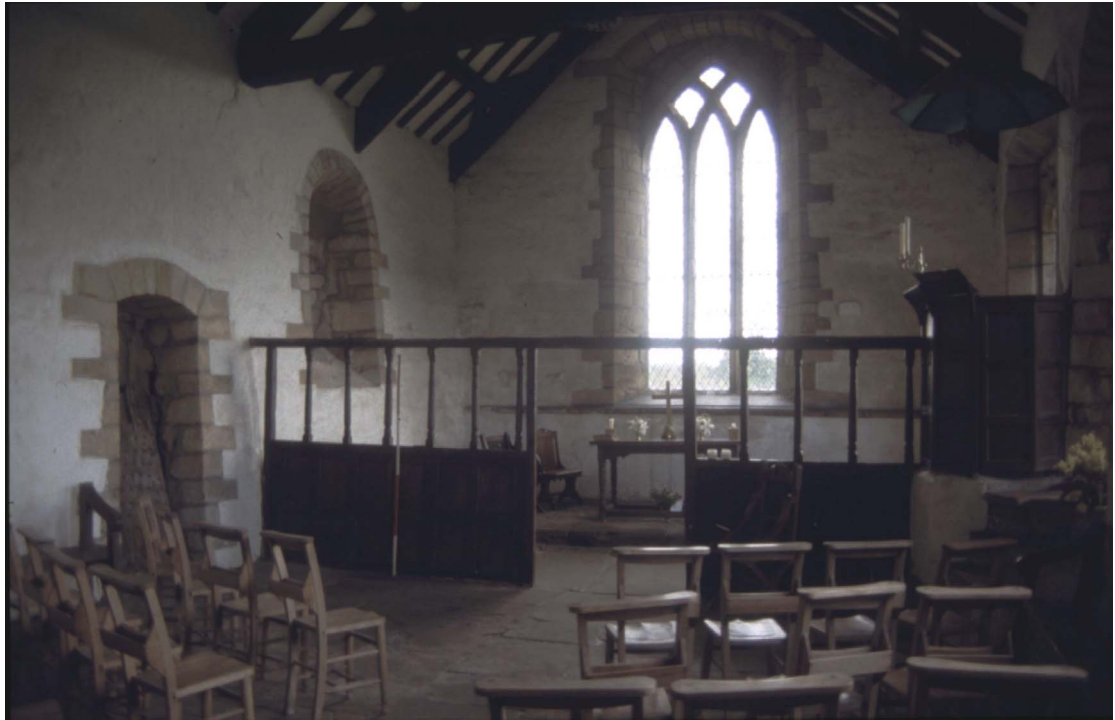
Plate 3: East window and screen

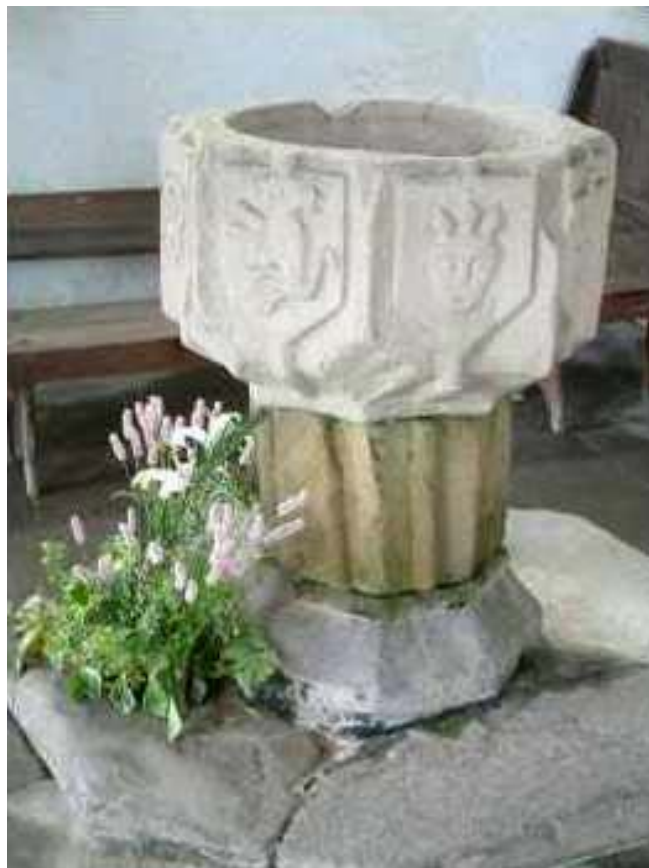
Plate 4: The font

- 3.2.10 **Late-medieval Period:** the post-Dissolution history of St Saviour's is evidenced solely by non-architectural details within the chapel. The font (Plate 4), of Perpendicular style, is described as “*very rough*” (Pevsner 1991, 238) and belongs to the first half of the sixteenth century (Farrer and Brownbill 1912, 61). It was a gift from Sir Thomas Pemberton, preceptor of the Order of St John of Jerusalem at Newland, Yorkshire, under which Stydd was a camera at the time (Ward *et al* 1986). There is a late seventeenth or early eighteenth century oak screen between the east wall and the pulpit (Farrer and Brownbill 1912), although Pevsner (1991, 238-9) and Ward *et al* (1986) place it firmly in the seventeenth century. The pulpit itself is also probably late seventeenth century (Farrer and Brownbill 1912), whilst the altar table is probably the one donated in 1703 (*ibid*) and, therefore, of probable early eighteenth century origin. At this time the long oak seat under the south window was probably also put in place (Smith and Shortt 1890, cited in Farrer and Brownbill, 1912). The tombstone of Bishop Francis Petre is set into the floor (*ibid*). He died in 1775 so this detail can readily be attributed to the late eighteenth century.

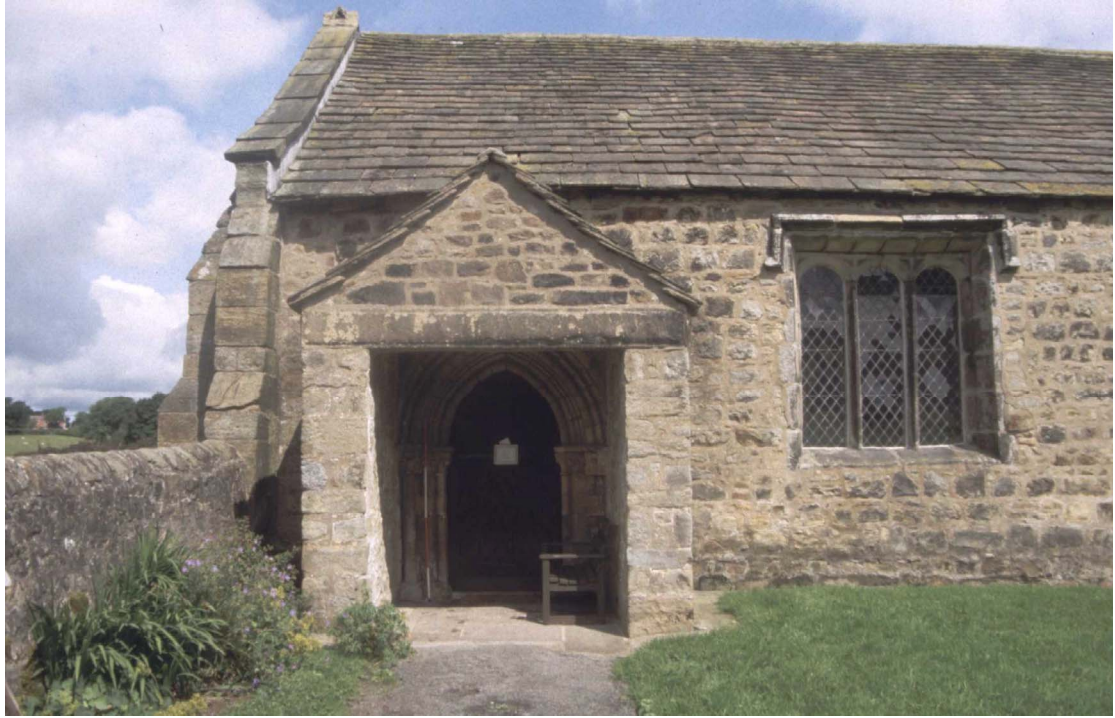
Plate 5: The porch, looking north

- 3.2.13 The porch (Plate 5) was added at a later date than the door itself, which is the original thirteenth century oak nail-studded door (*ibid*), but no record survives of when exactly (Farrer and Brownbill 1912). Farrer and Brownbill (Plate 7) suggest that it is a modern addition to the church.

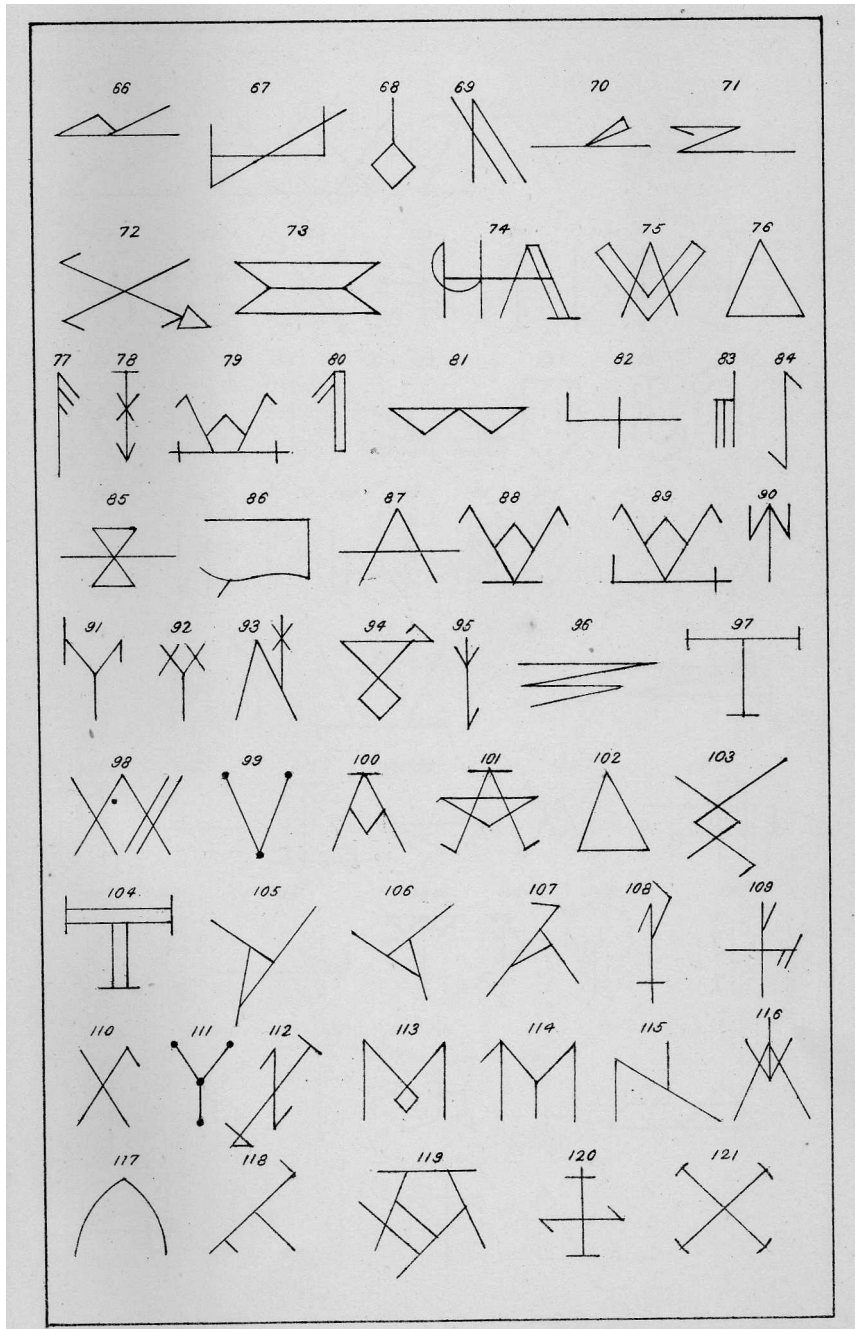
Plate 6: Masons' marks from Furness Abbey (from Fergusson 1883, Plate II). The marks at St Saviour's are the same as number 106
