## Chapter 4

# The Post-medieval and modern periods (c AD 1550-2000)

by Steven Teague

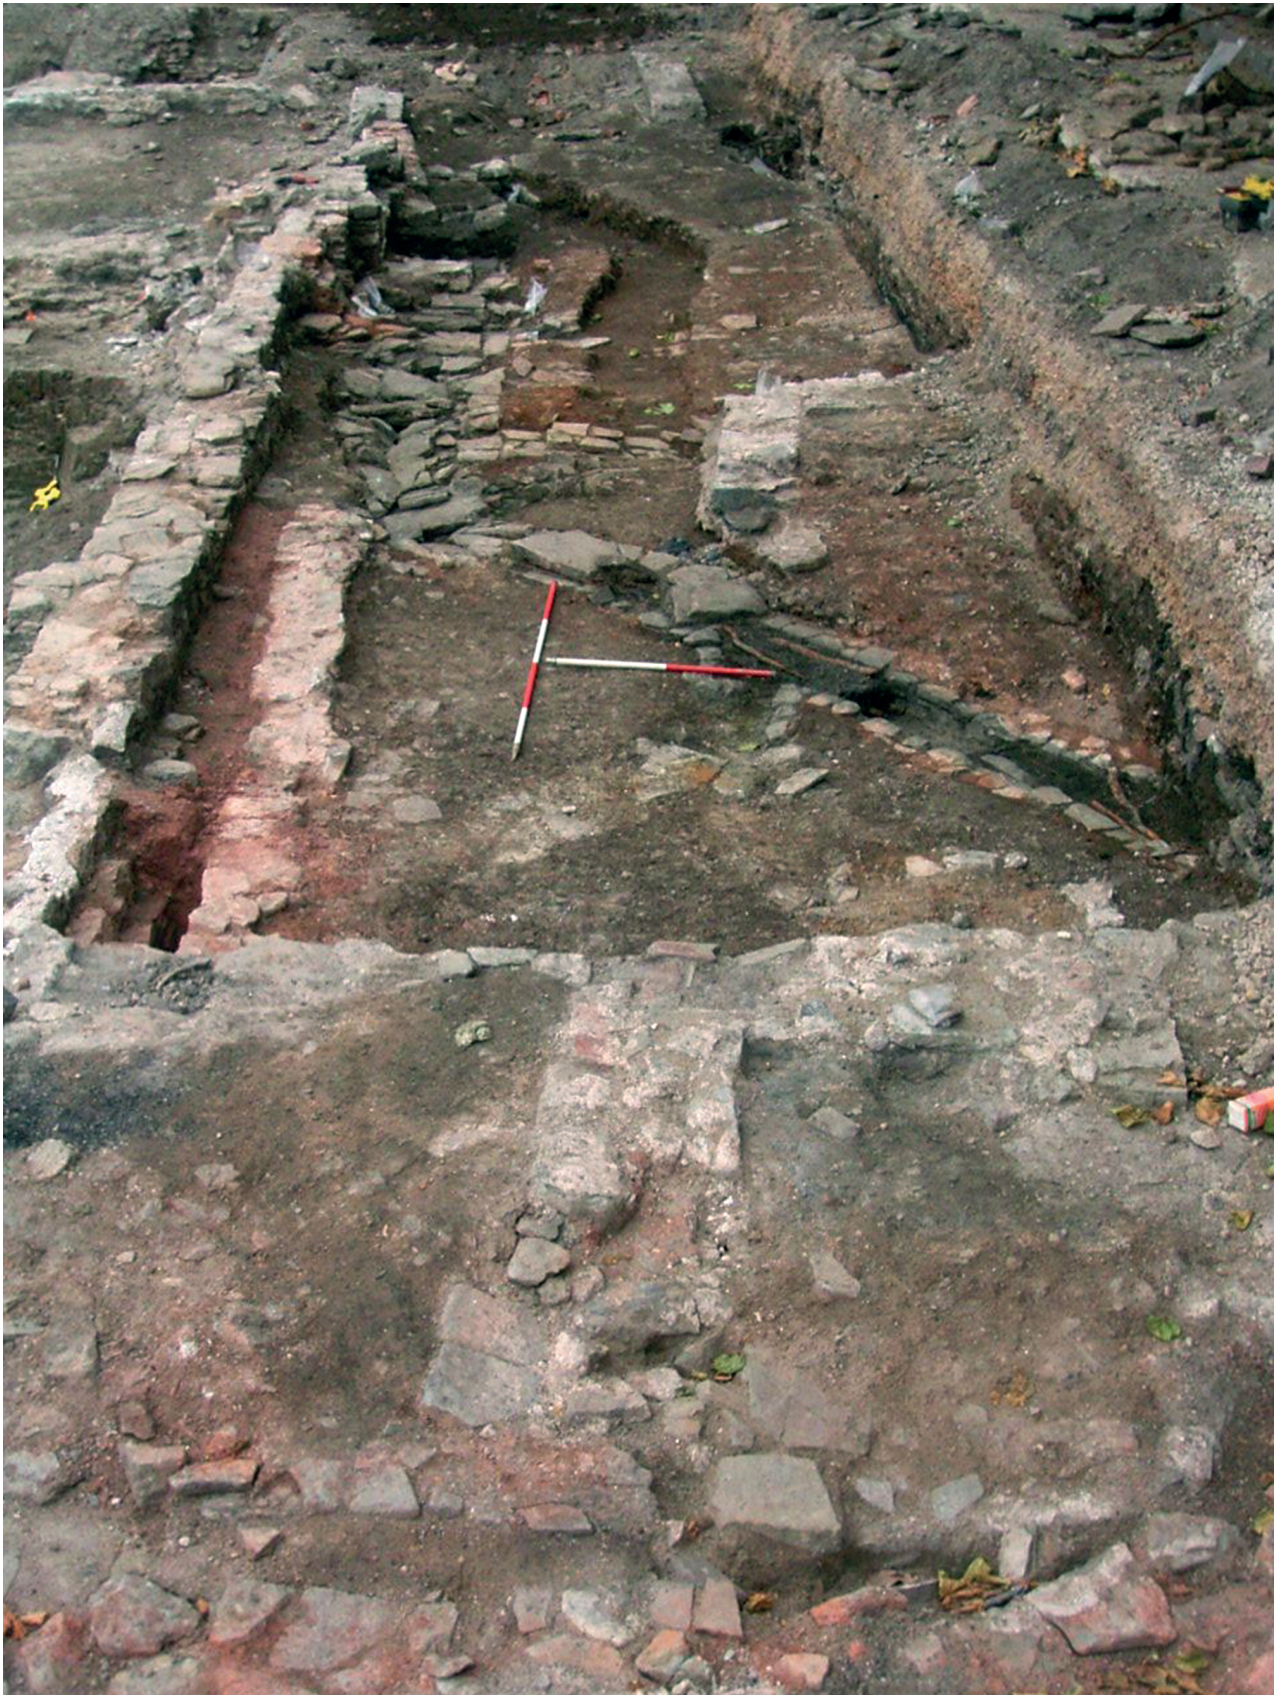
Fig. 4.6 Period 6 features in property TSE1(S), showing Buildings 20040, 20036 and the rear of Building 20034, cut by Period 7 drain 2063, looking north-east. Scales 1m and 2m

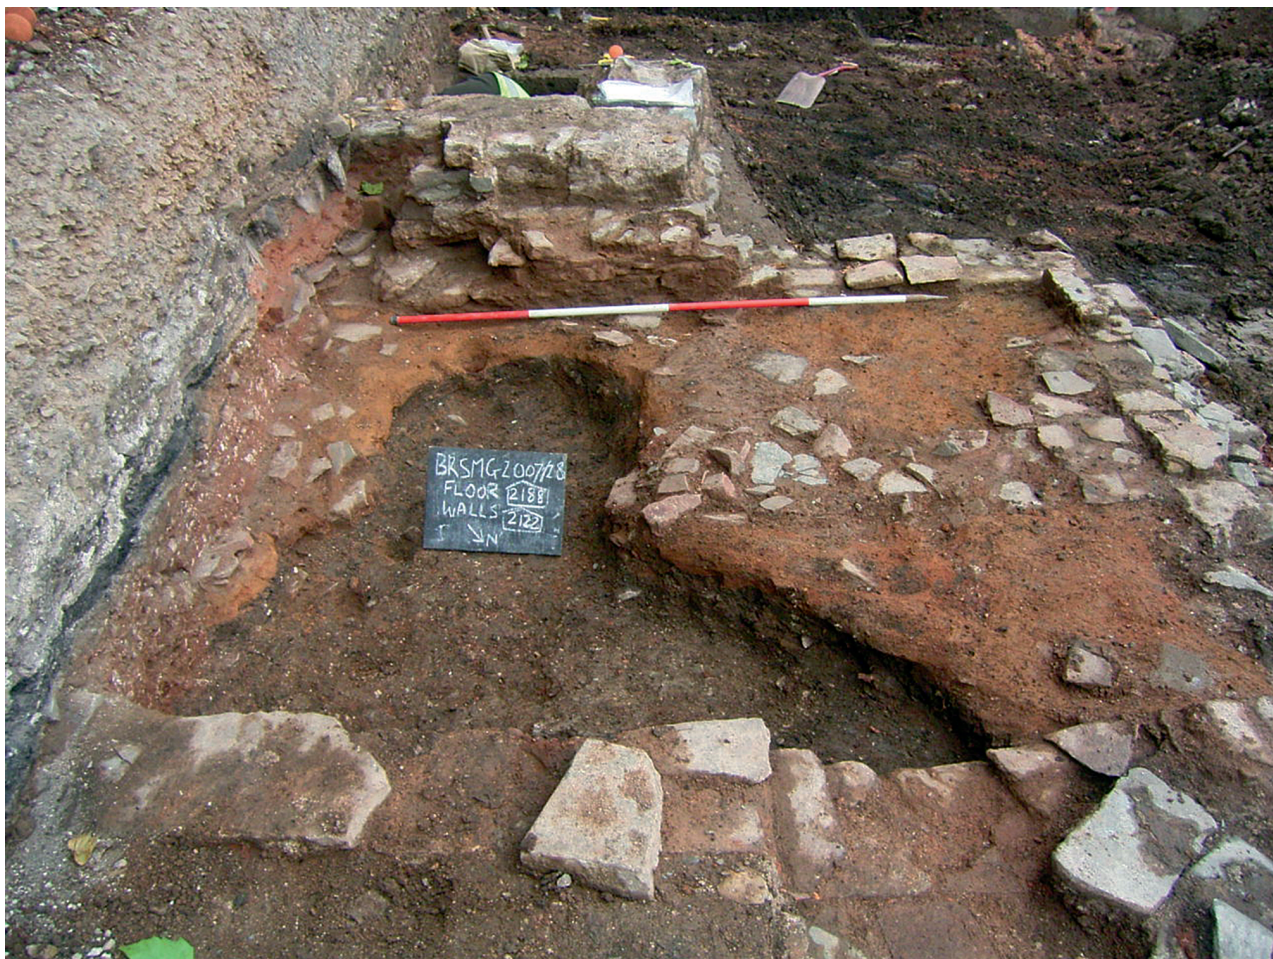
Fig. 4.8 Period 6 Building 20036, TSE1(S), looking south-west

Located 7m to the rear of the main frontage building was a small rectangular structure (20036; Figs 4.5 and 4.8) that measured 2.2 x at least 2.7m. Its northern extent had been truncated by Period 7 drain 2786 and it was built over Period 4 garden soils. It was subdivided into two approximately equal parts. Its exterior walls (2122) measured 0.40m in width and were constructed with roughly squared stone blocks bonded by red/pink mortar. The internal partition wall (2191) abutted wall 2122 and was of a similar width and construction. Fragmentary remains of a stone slab floor survived within the south-west room, supported upon a bedding of firm orange sand that extended into the north-east room and contained a clay pipe stem datable to 1610-1710. A stone step on its north-east side led to possible garden bed features separated by a slate path (2023) that measured 1.0m in width. On the south-east side of the path were at least two areas of bedding that were marked out by a rectangular arrangement of thin stone slabs (2349) that had been driven vertically into the underlying Period 4 garden soils. The north-west edge of the path was marked by a narrow and roughly built stone wall (2387).

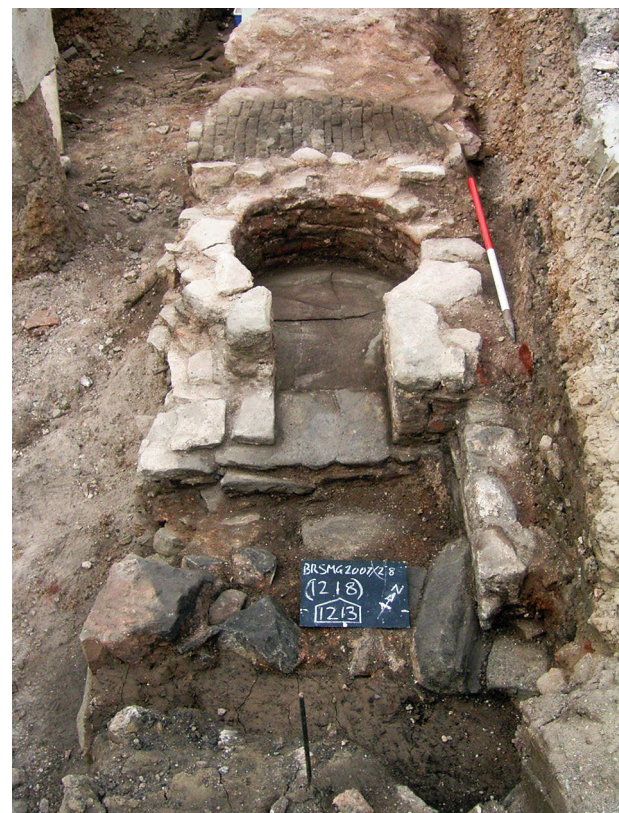
Fig. 4.11 Oven 1213 with earlier oven 1218 to the rear, Building 1139, TSE2, looking south-west

Circular oven 1218 (Fig. 4.11) was built within a pit that was 0.72m deep and which had largely been levelled with layers of compacted and coarse sand and sandstone fragments in an attempt to stabilise the underlying soft ground. This formed the base for the construction of the oven wall, which lined the edges of the pit and consisted of large rectangular Pennant sandstone blocks laid on edge on a bed of fine sand. The estimated internal diameter of the oven was about 1.3m. The floor of the oven was also constructed of small sandstone slabs set on edge and into the underlying sand base. The faces of the stones had been heavily discoloured by heat. The later oven (1213) survived almost complete and was of key-hole shape. It had cut away the north-east part of oven 1218 and was built up against the north-east wall of Period 4 Building 1139. It had an open flue at the north-east side that seemed to have been formed through an opening through the north-east wall of Building 1139. The opening was lined on the north-west side with a short stretch of wall that was of the same build but was off-set from the flue; the corresponding wall on the south-east did not survive. The walls of the oven were formed with roughly coursed Pennant sandstone blocks, poorly cemented with white mortar. Its floor comprised large flat slabs of the same stone, with a shallow circular depression caused by wear, presumably from repeated fuelling and cleaning-out. The internal faces of the oven bore evidence of heat, with

discolouration and cracking/flaking suggesting sustained or repeated exposure to very high temperatures. On the base of the opening through the wall of Building 1139 was a 0.15m-thick deposit of spent fuel (coal) and ash that contained clay pipes datable to 1650-1710 and part of a glass dish of similar date.

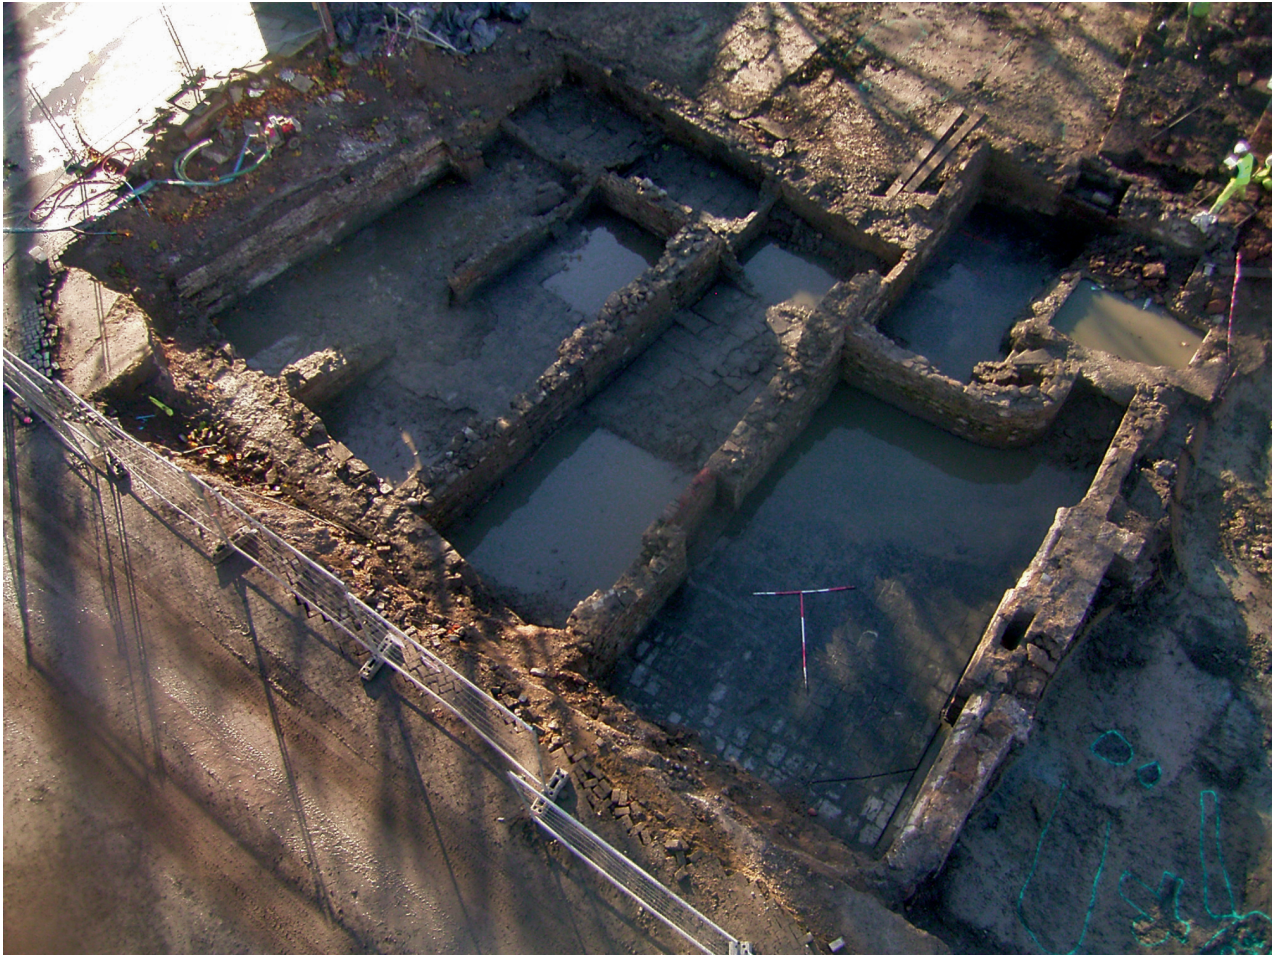
Fig. 4.15 Structure 7195, Nos 161-4 Temple Street, Period 7, looking south-west. Scales 2m

Whatever medieval or early post-medieval buildings occupied the street frontage were replaced by a range of cellared buildings, although the rear part of the earlier structure (7240) appeared to have been retained within the new design, since its walls corresponded with the arrangement depicted on the 1st Edition OS map of 1883 (Fig. 4.20). The full extent of the complex was exposed (Fig. 4.15) and comprised three identical elements (or tenements), each measuring 3.3m wide and extending back for 11.7m from the street frontage. Each structure survived to a maximum depth of 1.93m and was subdivided into two rooms, the smaller of which was located at the rear. The walls of the structures comprised roughly hewn rectangular stone blocks (sandstone where identified) bonded by grey lime mortar with large inclusions of charcoal flecks. The internal faces were rendered

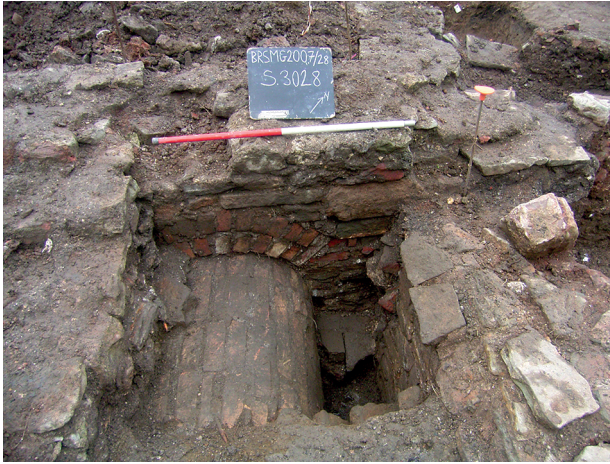
Fig. 4.21 Brick culvert 4485 inserted into the Law Ditch, looking north-west. The brick arch spanning the culvert is part of wall 3259, the foundation of a 19th century public house. Scale 1m

A brick-built culvert (4485, Group A1.97) was inserted, cutting through the base of the former stone-lined channel (4486, Figs. 2.4 and 4.21). The date of this modification was uncertain, although it was constructed with red bricks whose size (110 x 80 x 220mm) was consistent with a 19th-century date. The culvert appears to have been built before 19th-century walls 3145 and 3259 (Period 8, below), since their foundations were constructed with arches to span the culvert. The culvert was eventually infilled and its drainage function reduced to a ceramic pipe.

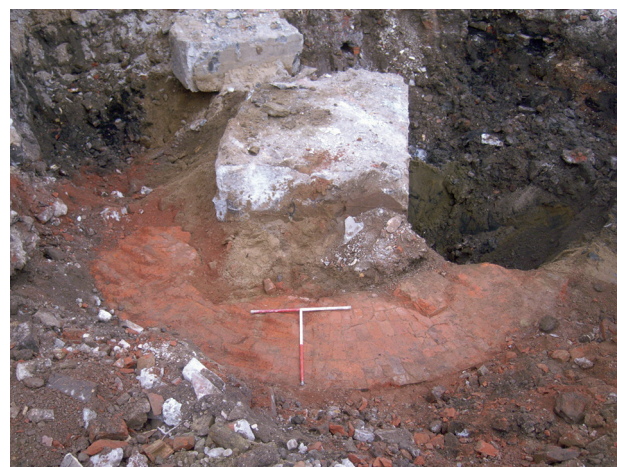
Fig. 4.24 Chimney stack base 10069, Finzels Sugar Refinery, looking east. Scales 1m

The evidence for this part of the refinery was revealed during the watching brief. The main feature revealed was the remains of a circular chimney stack (10069, Fig. 4.24) that was contained within the boiler house towards the south-west part of the refinery. The chimney was constructed with red brick supported on a concrete foundation measuring 2m deep, the timber shuttering for the construction trench of which still survived. This corresponded exactly with the circular feature labelled 'stack 150' on the 1879 survey and can also be seen on an

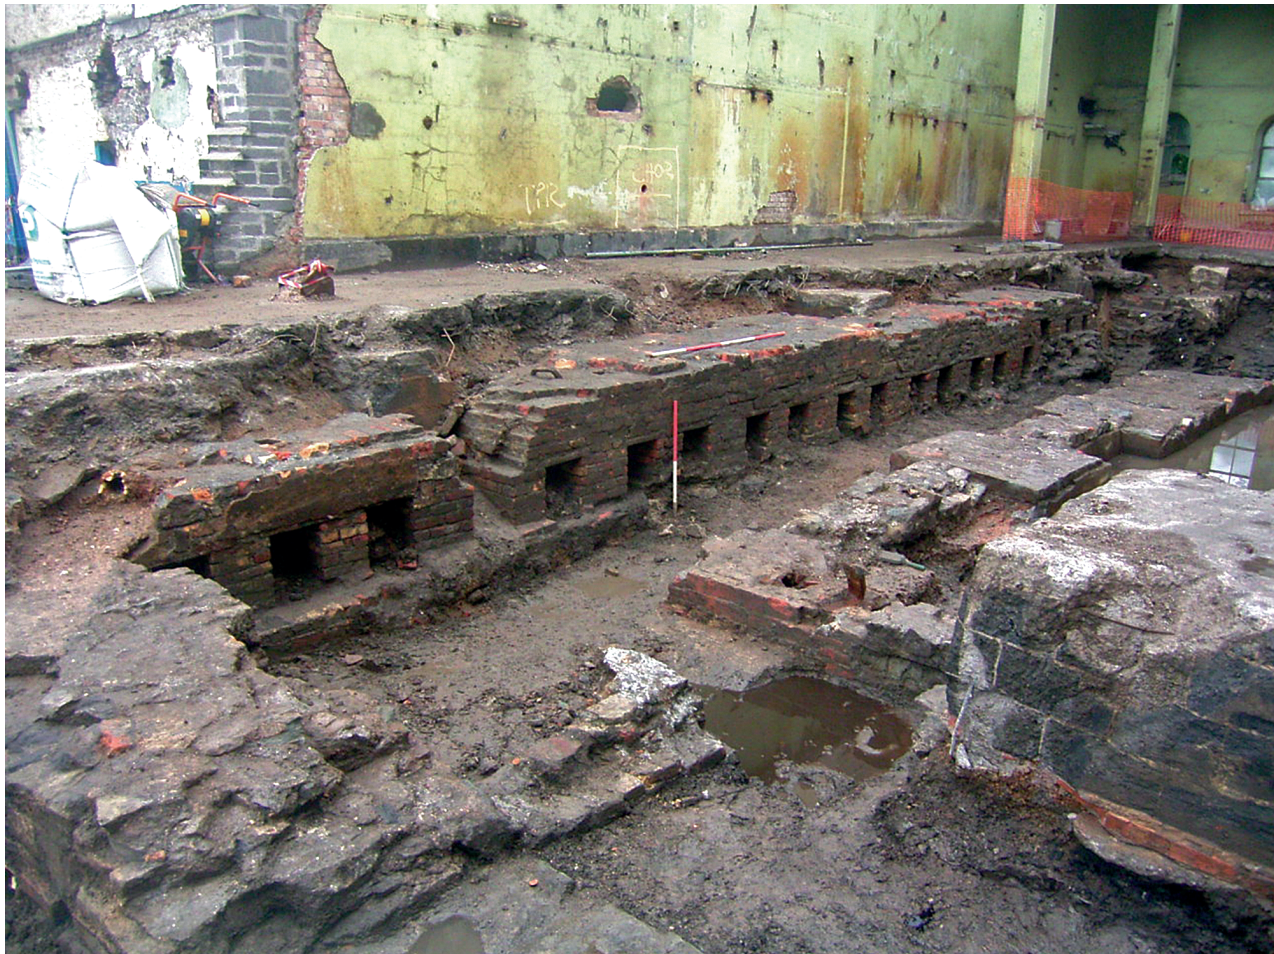
Fig. 4.25 Wall 5010 with iron fastenings (for machinery?), Finzels Sugar Refinery, looking west. Scales 1m and 2m

Within the part of the room that housed the steam engine a number of foundations that would have supported it were identified (Fig. 4.25). These included large rectangular stone blocks up to 1.5m across with small square holes and iron fittings that protruded from their upper surface, whose purpose was presumably to secure the base of the steam engine. A brick-lined culvert ran along the south-west side of the engine room and may have supplied water to the engine. There were also drains and ducts that passed through the north-west wall of the room that would have aided drainage and ventilation.
