Ingersley Vale Mill, Bollington, Cheshire

Archaeological Building Investigation

February 2011

Issue No: 2010-11/1170
OA North Job No: L10283
NGR: SJ 942 773

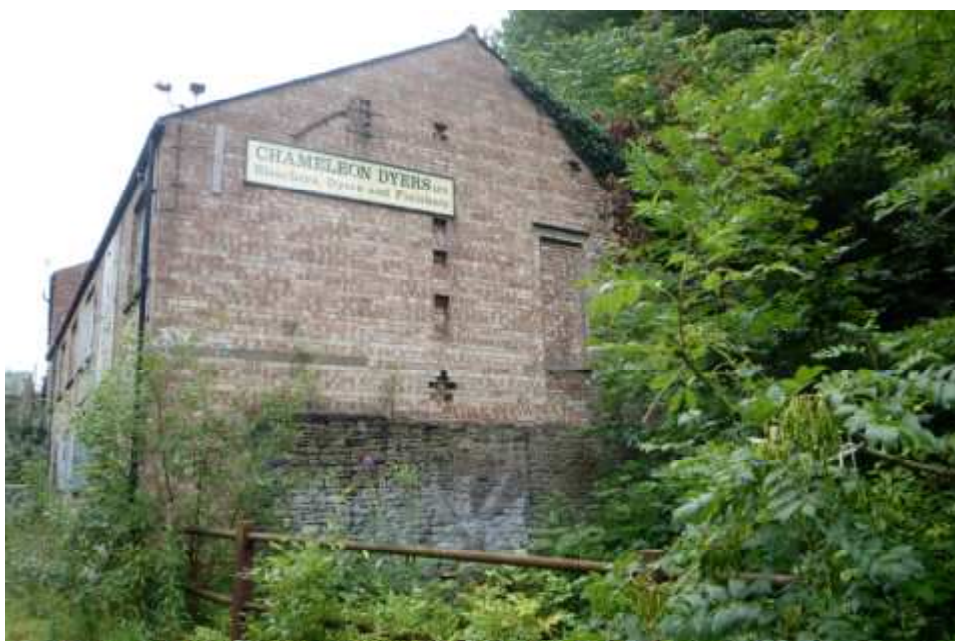
Plate 1: North elevation of Building A, with earlier stone footings at lower level

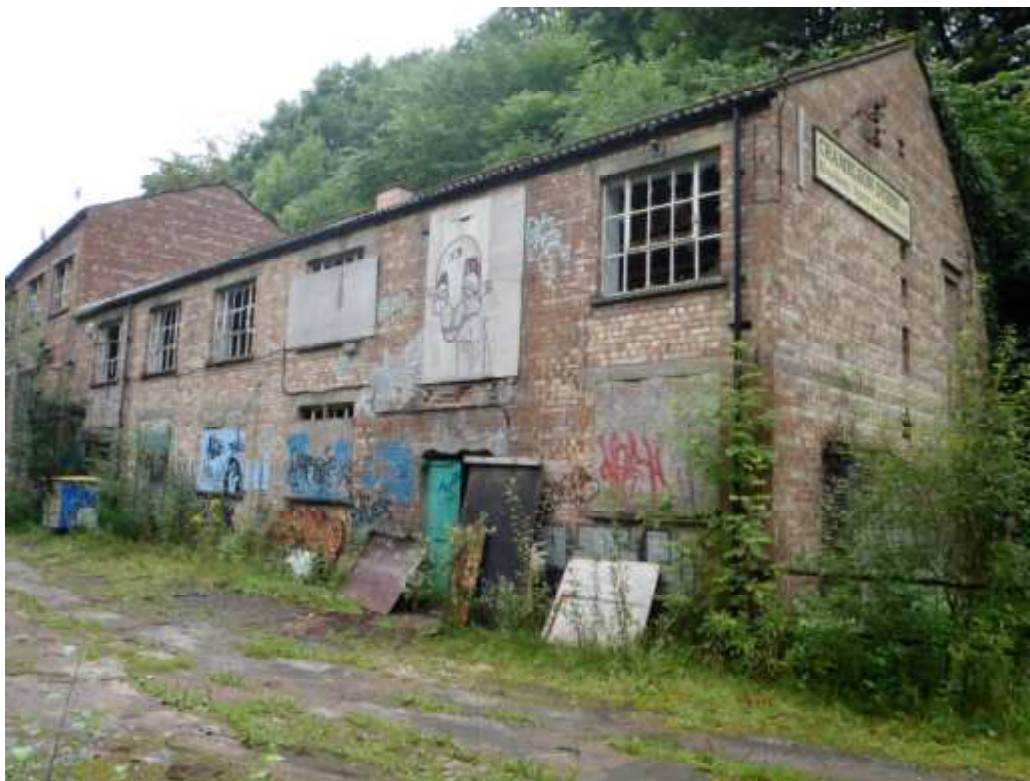
- 4.2.2 The east elevation comprised six bays, each with a louvred window with a concrete sill and lintel, within the second storey (Plate 2). At ground-floor level, the first two bays from the left of the elevation comprised doorways, with two windows in the following bays, and a further door and window at the northern end. To the south, the building butted the north elevation of Building B. The interior of the building was not accessible due to the presence of chemical drums and asbestos flooring.

Plate 2: East elevation of Building A, with Building B to the rear

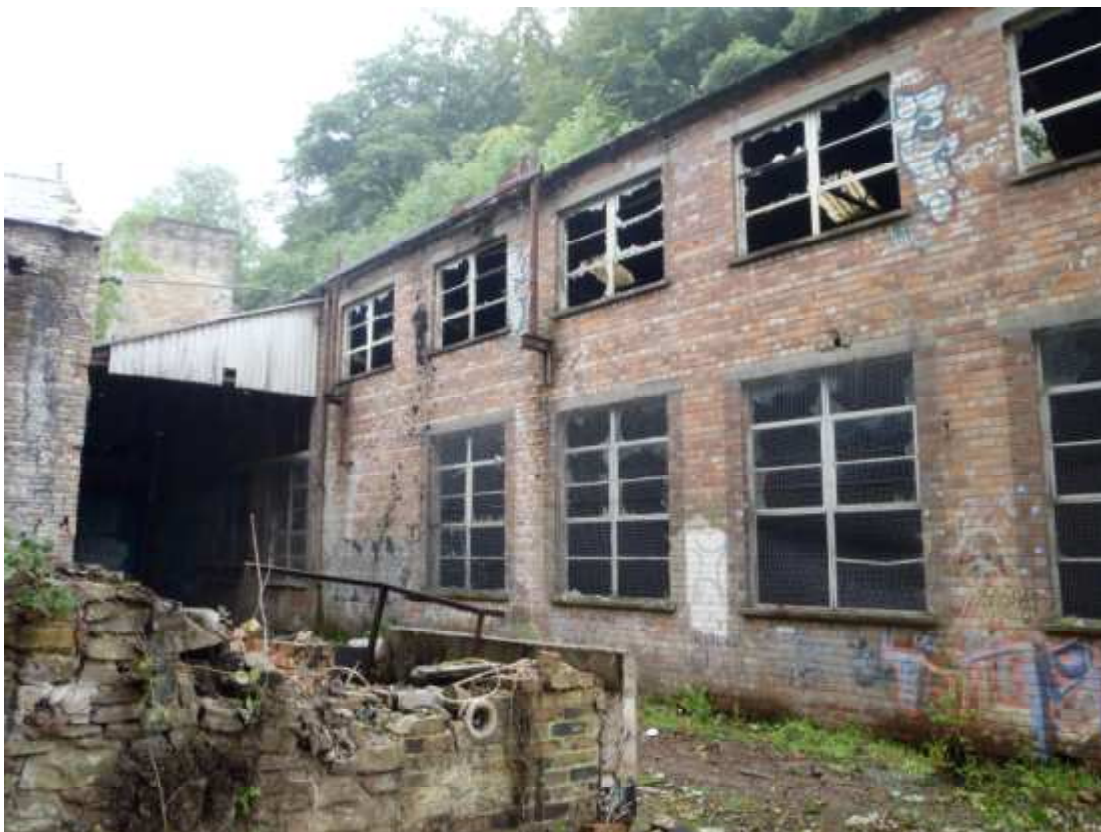
Plate 3: East elevation of Building B, with canopy to building F behind

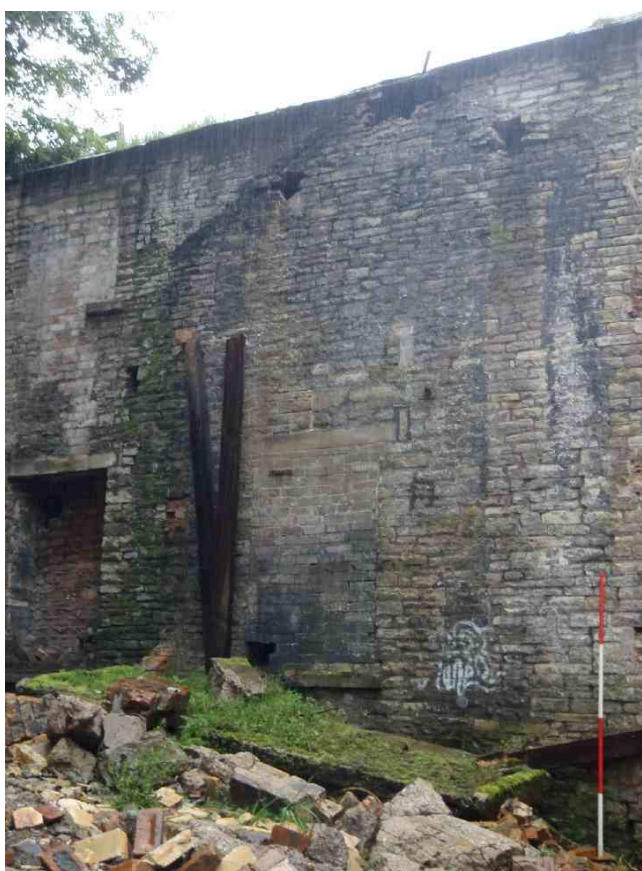
Plate 4: Wall scar of Building D on northern elevation of Building E

- 4.2.5 **Building C:** this building had been demolished by the time of the building investigation.
- 4.2.6 **Building D:** this structure had been demolished shortly before the building survey was undertaken, but the demolition rubble suggested that it was at least partially constructed of, or remodelled with machine-made brick. Furthermore, scars to the north-west corner of Building E (Fig 2) demonstrated that it was of two-storey height, with a pitched roof, and almost certainly post-dated the building to the south, as the purlins appear to have been punched into the external elevation of Building E (Plate 4).

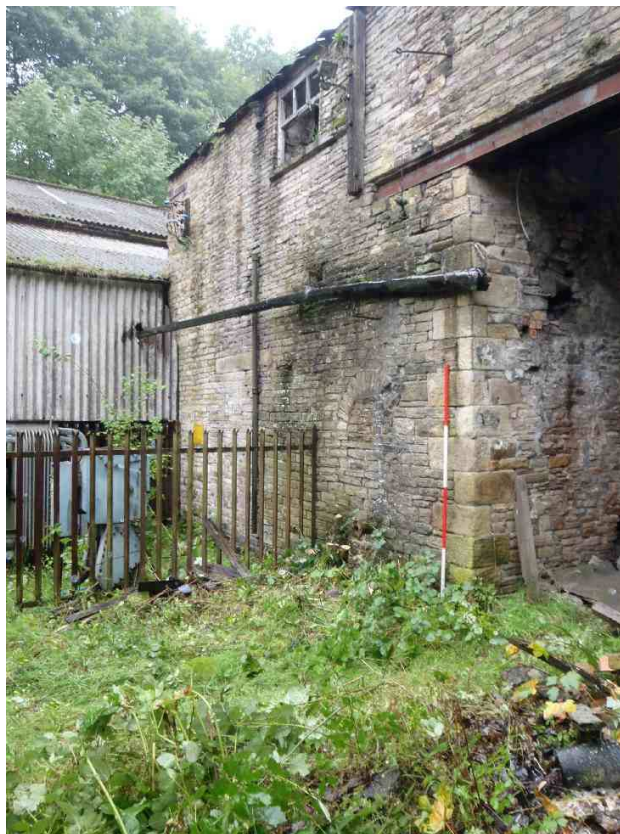
Plate 5: South wall of western part of Building E, with arched aperture to west of entrance

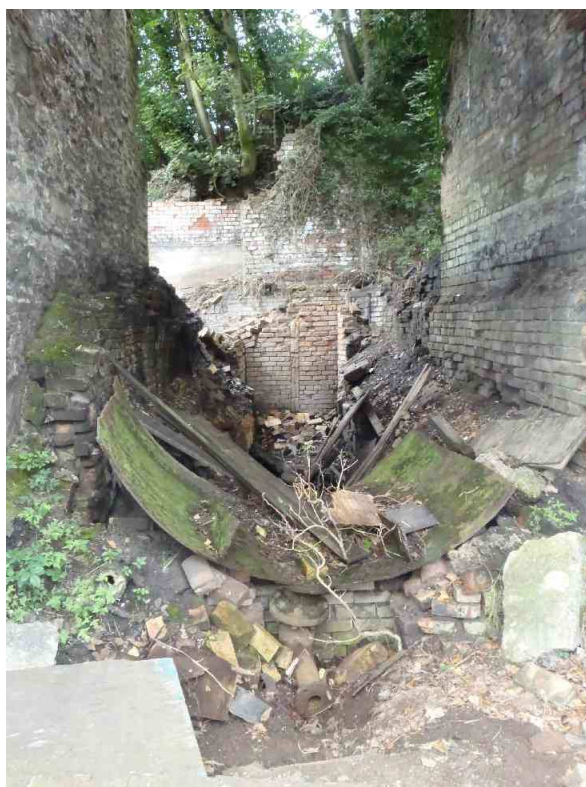
- 4.2.8 The eastern part of Building E contained a large boiler bed, of a size suitable for a Cornish boiler and an adjoining larger room to the east that possibly housed a further boiler, both of which were open to two storeys. Although parts of these had been demolished, part of the boiler bed, and fragments of a boiler, remained *in-situ* in the western bay (Plate 6). The two rooms were divided by a wall of brick and stone construction. The lower part of the wall comprised refractory brick, forming a plinth below an approximately 2m high section of red brick construction (Plate 6). Above this level the dividing wall was of rubble stone construction, possibly representing the original outer wall of the boiler house.

Plate 6: In-situ remains of a Cornish boiler, Building E

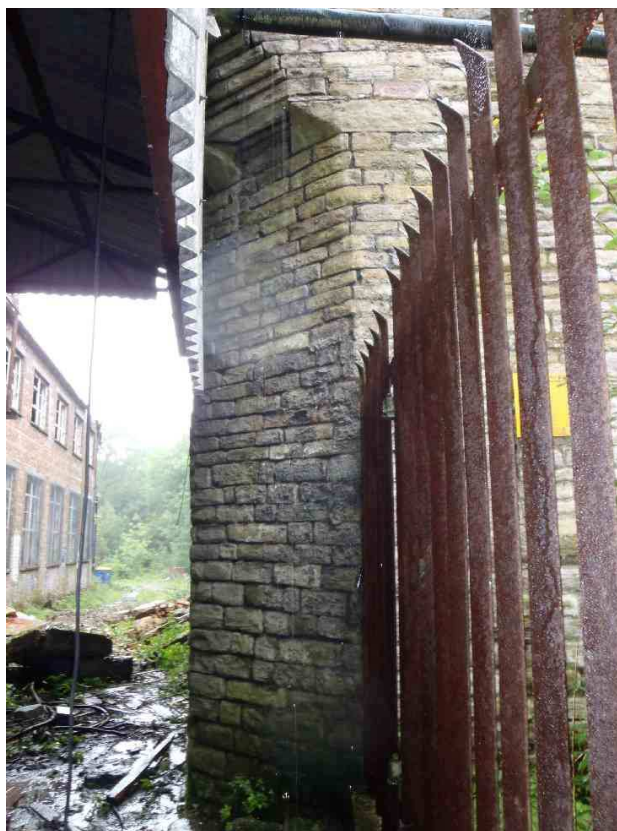
Plate 7: Chamfered ground floor return of Building E

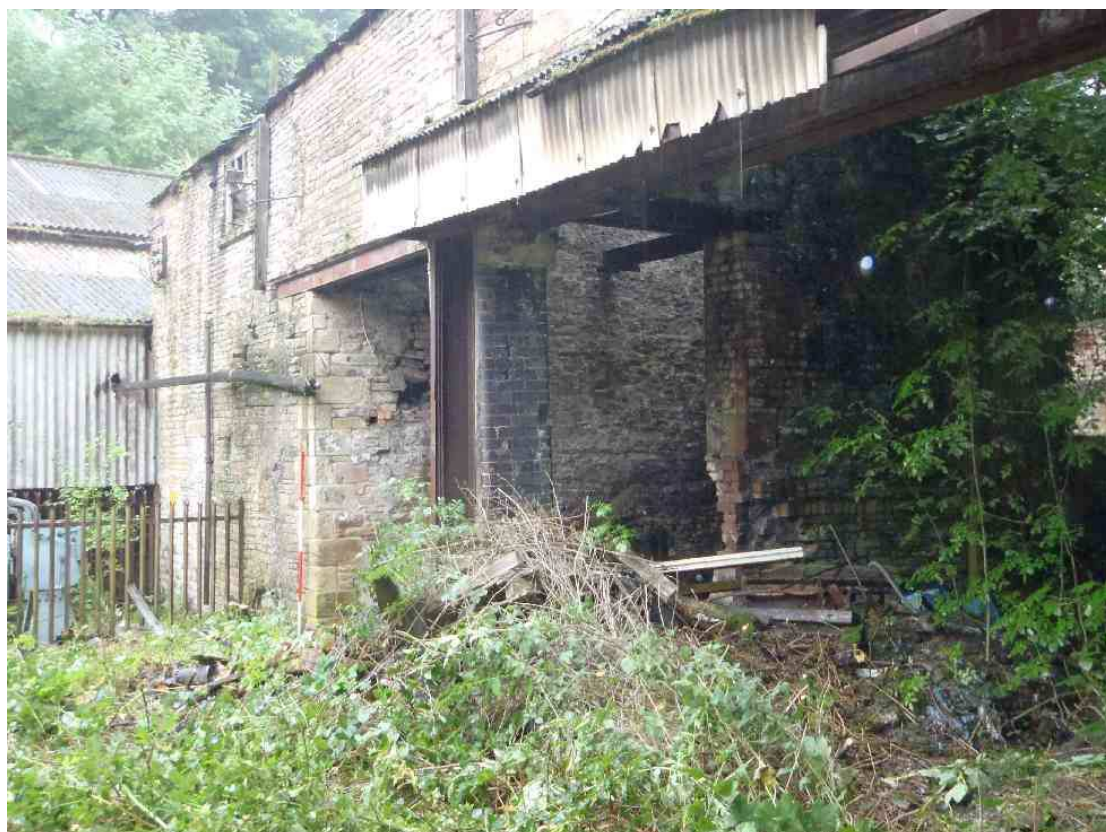
Plate 8: Open frontage of boiler house in eastern part of Building E

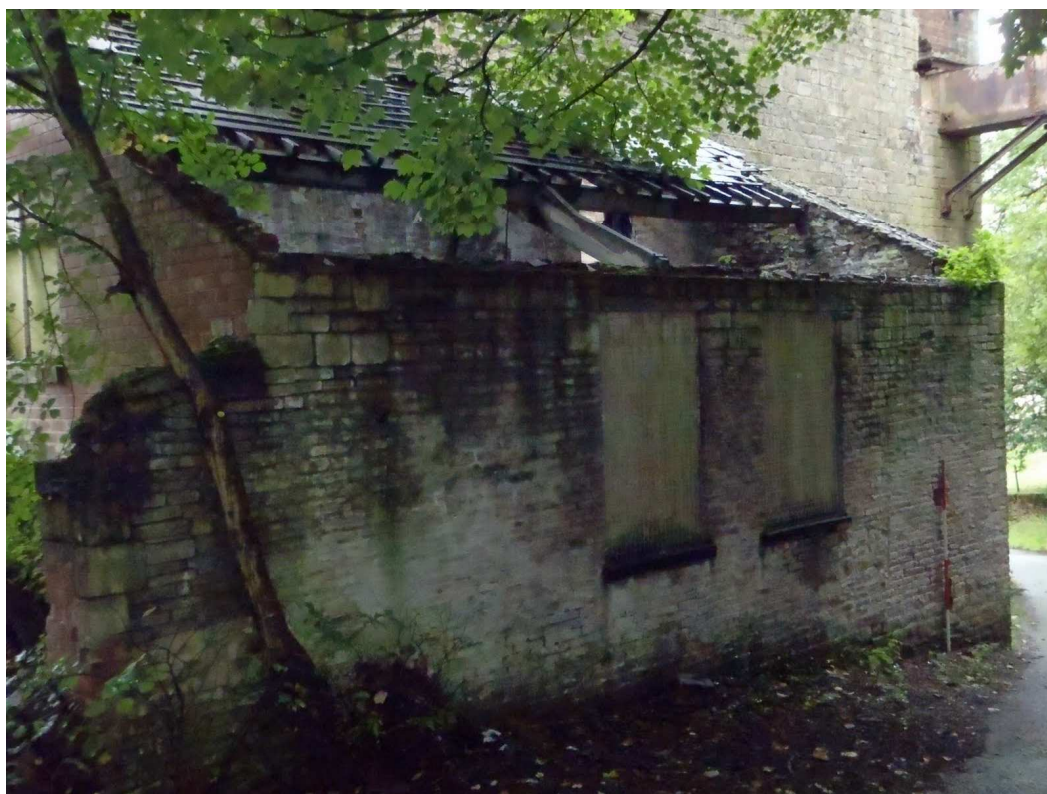
4.2.12 **Building G:** this comprised a single-storey, stone-built structure, abutting the western side of the waterwheel house. It retained the majority of a single-pitched slate roof, supported upon a central principal rafter. A roof scar on the adjacent, earlier Building H, above the present roof-line, suggests that the height of the roof had been reduced, and the upper five courses of the west wall also appeared rebuilt, as they comprised larger stone blocks (Plate 10). The building had been reduced in length at its northern end, by approximately 2m, surviving to its original extent only as a collapsed wall on the roadside, western elevation (Plate 10). The replacement north wall was constructed using machine-made brick, and housed a central four-light window within the gable. The west wall had two large central windows, both brick-blocked, with a probable stone-blocked doorway at the southern end of the wall. A larger aperture, with an I-section steel lintel comprised the entirety of the south frontage of the structure, suggesting that it was originally open-fronted. The eastern jamb of this aperture overlay a blocked arched opening within the waterwheel house (Building H; Fig 2), demonstrating the later construction of Building G (Plate 11).

Plate 10: Building G, with shortened northern extent, and blocked apertures in west elevation

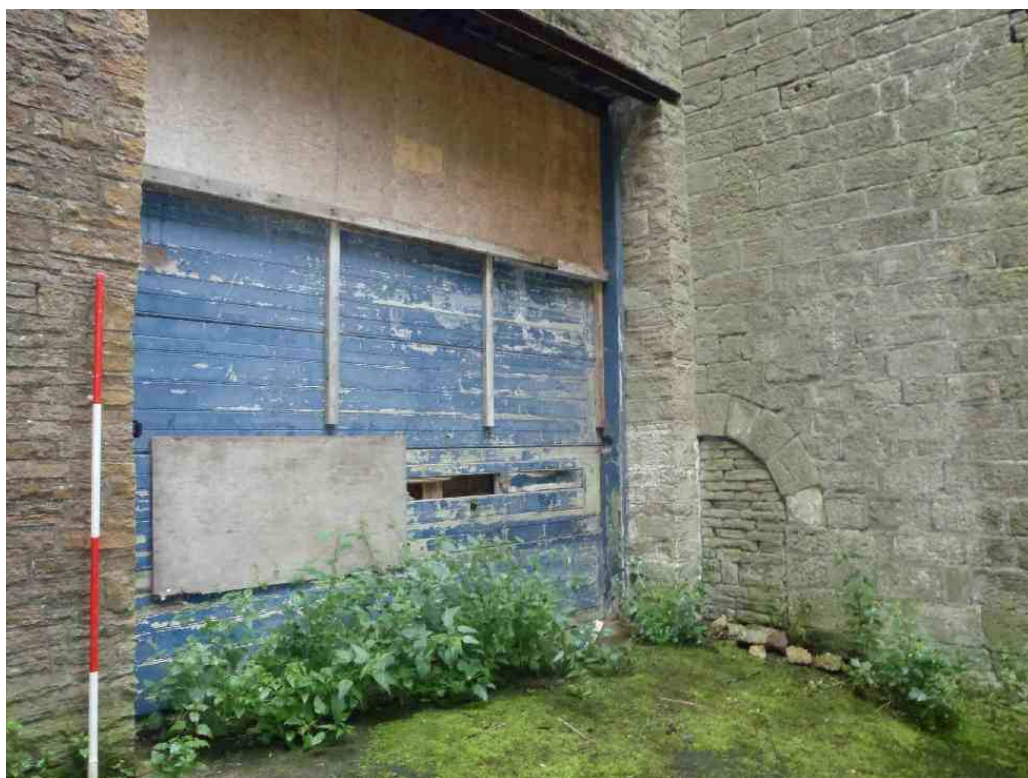
Plate 11: South elevation of Building G, with blocked aperture in west elevation of Building H

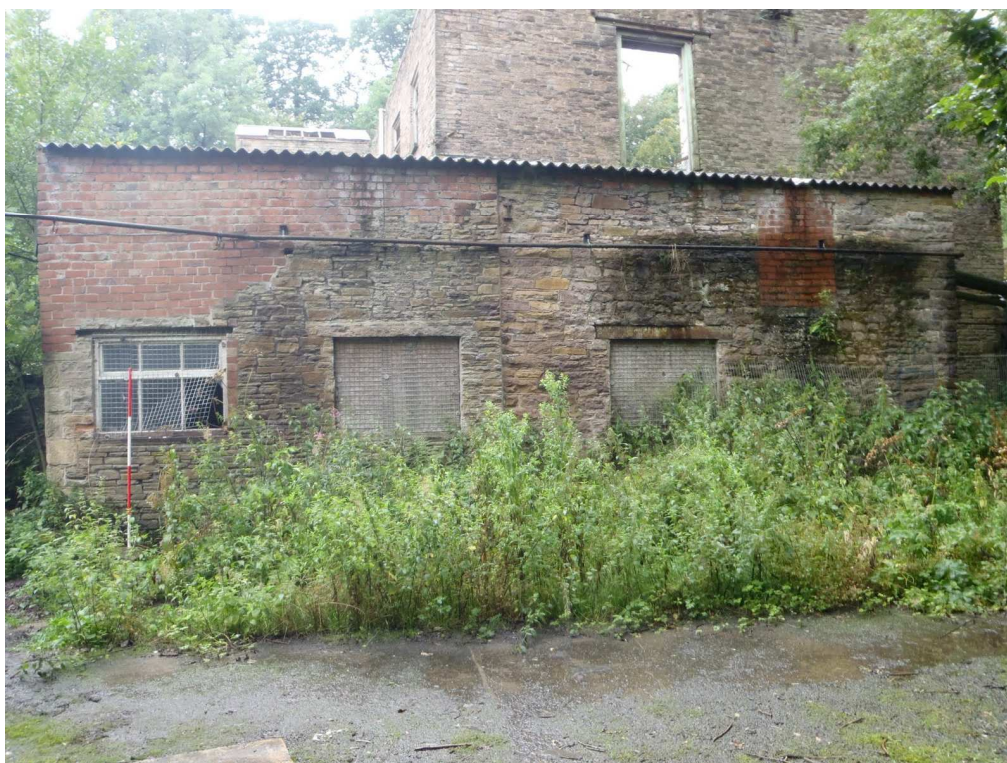
- 4.2.15 **Building L:** this comprised a single-storey shed butting the eastern side of the spinning block (Building I; Fig 2). It was of stone construction, with modifications in brick, and had a single-pitched asbestos sheet roof, supported on L-section steel members. The structure has a vertical joint in its eastern wall, flush with the south wall of Building I, suggesting that it was constructed in two phases (Plate 12). The northern part of the building may originally have extended further, quite possibly to the northern edge of the spinning block, and the latter elevation was formed in brick, with a steel lintel carrying the wall over a double doorway. The floor levels within the structure did not match those within the original layout of the spinning block, suggesting that these had also been altered within Building L. Part of a blocked doorway surviving at wall-head level in the east wall, above three blocked windows, demonstrated this change in floor level, and also that the building was originally taller.

Plate 12: East elevation of Building L, with central butt-joint within stone construction

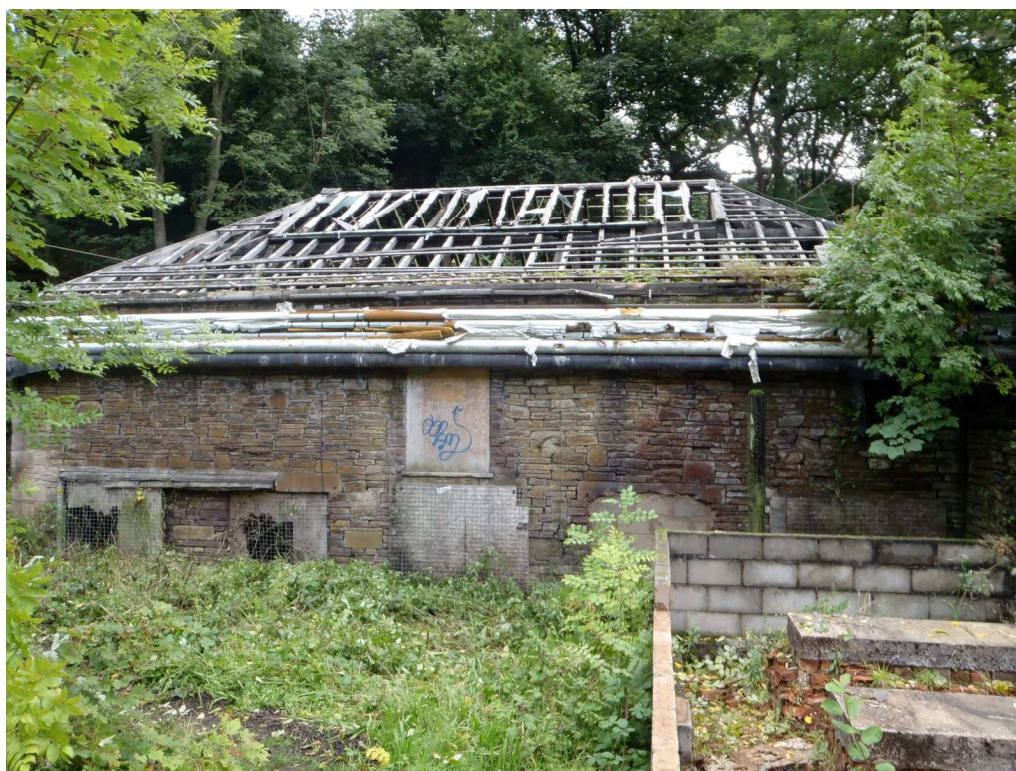
Plate 13: Front elevation of Building P, with raised ground level in the foreground

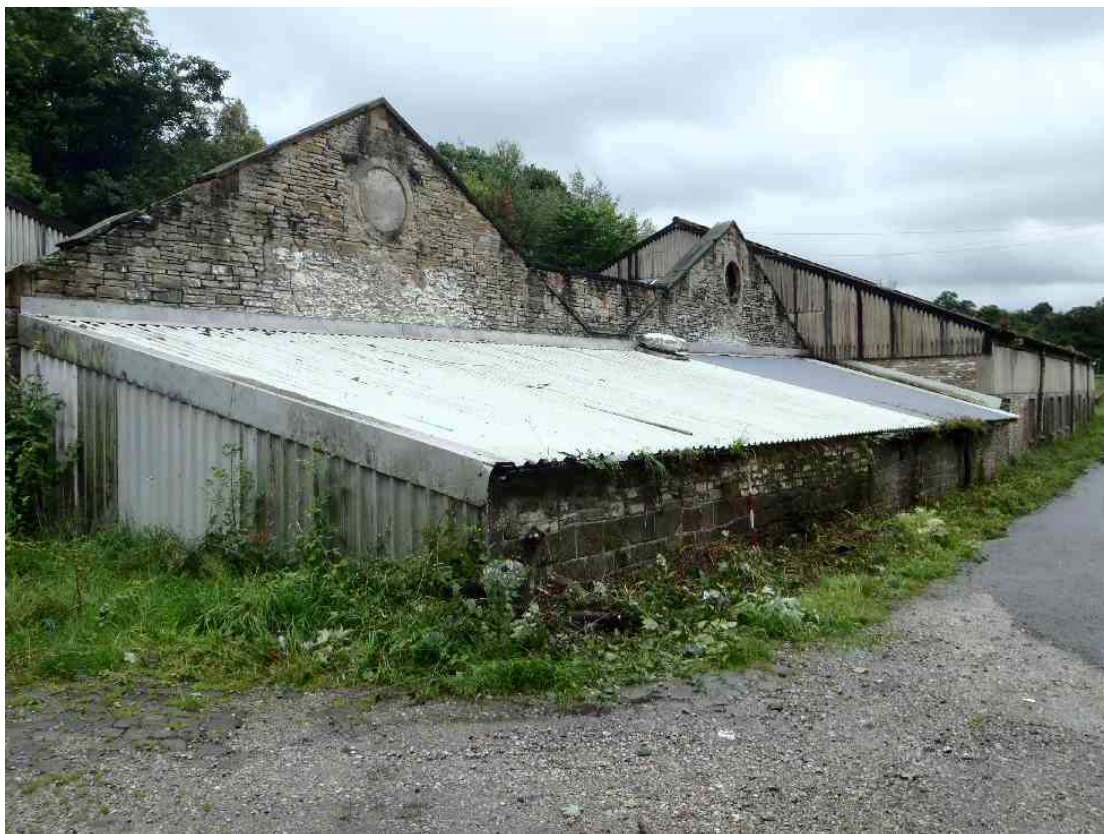
Plate 14: West elevation of Building R, western gables of Building Q above

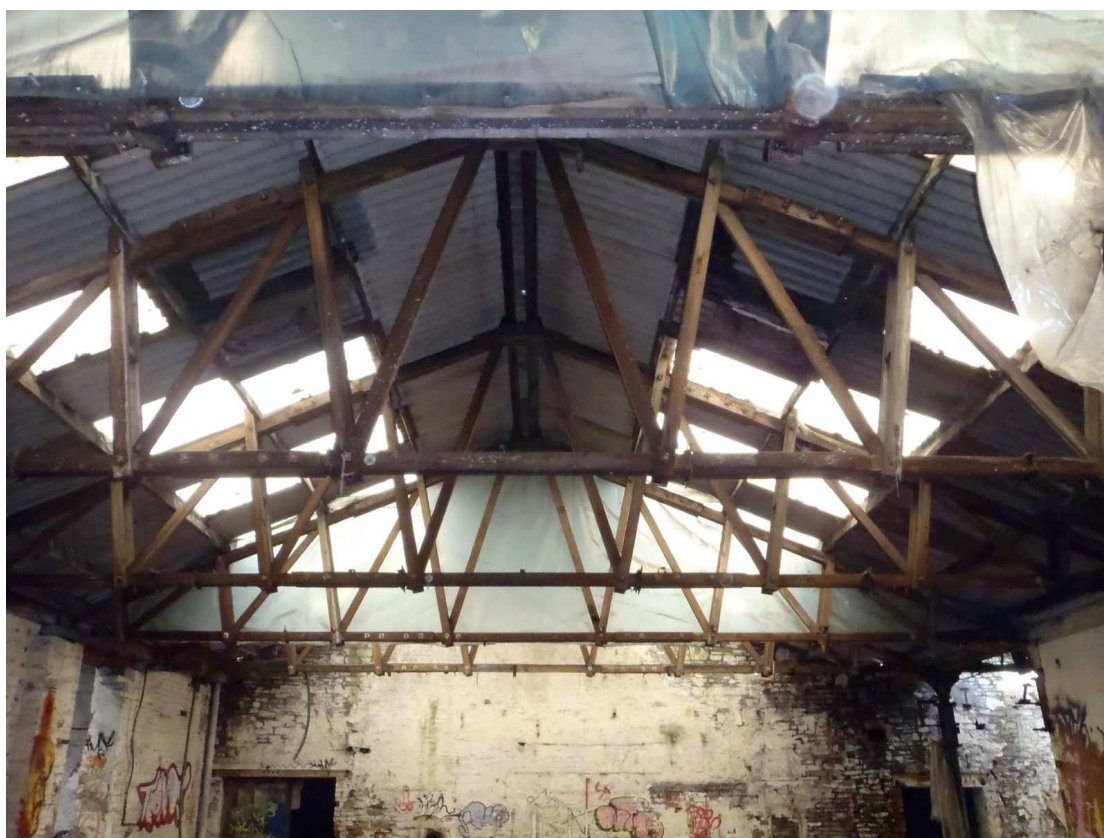
Plate 15: Rooftrusses within Building Q,

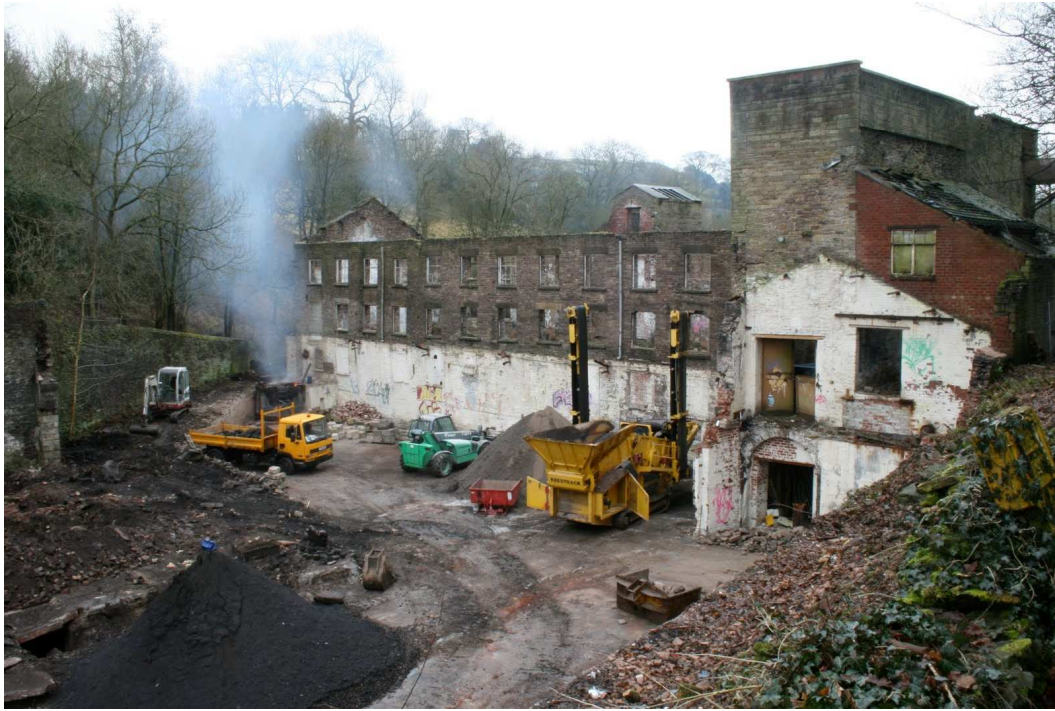
Plate 16: General view of the spinning block, Building I, and wheel house Building H

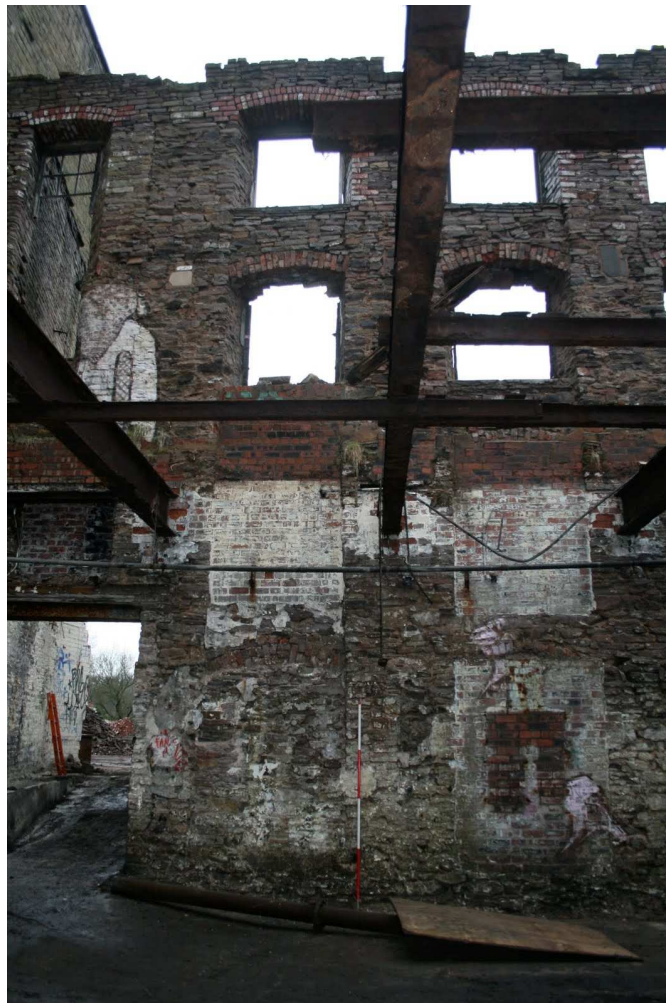
Plate 17: North internal elevation, Building I, with diminishing wall thickness and window size, blocked apertures and narrow upper Bay 1 window

- 4.3.3 The external ground level was increased subsequently on the north side of the structure, obscuring most of the original ground-floor apertures, all of which are stone-blocked, with the exception of the eastern bay (Bay 1), which has an enlarged opening with an I-section steel lintel (Plate 17). The window in the third bay was also brick-blocked at ground floor level. The windows in Bays 1 and 2 in the north wall were both also narrowed on the upper two floors (Plate 17).

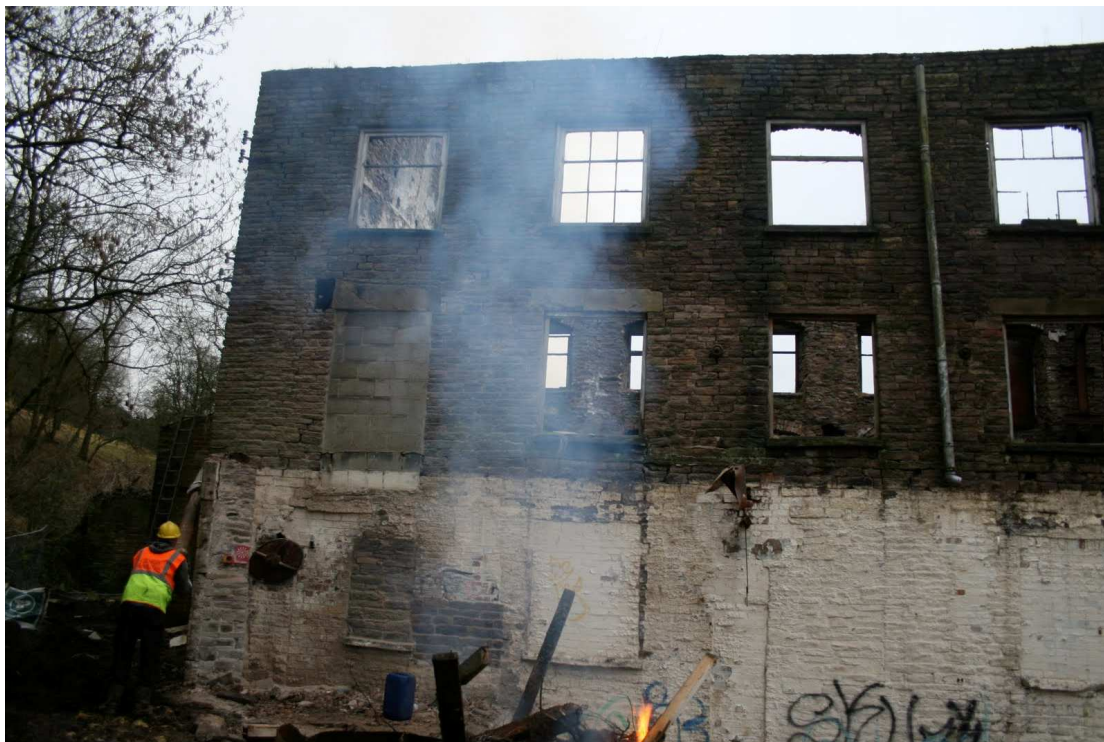
Plate 18: Eastern end of north elevation, Building I, with remodelled aperture in end bay

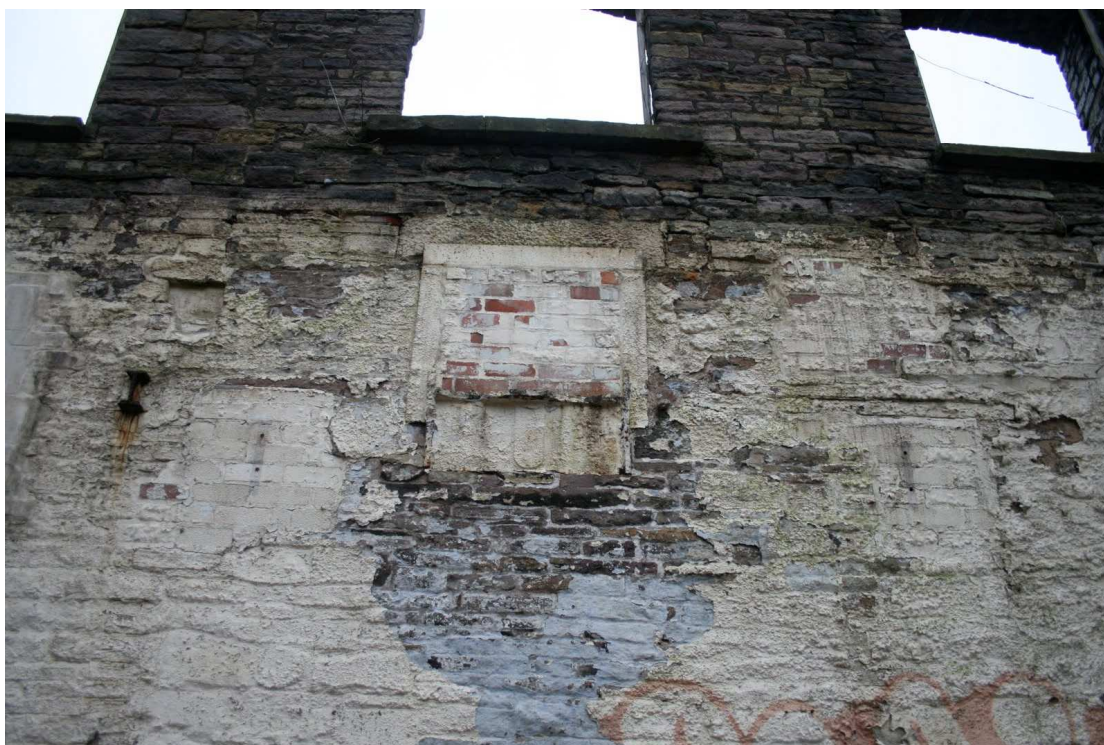
- 4.3.2 On the north external face, the windows have flat sandstone lintels of varying thickness. The eastern bay (12) at first floor level was remodelled subsequently into a door, flanked by a narrow window (Plate 18). Bay 4 has a pair of timber rails within the wall face, placed at the top of the ground floor window aperture, and probably relating to its blocking. Bay 5 has a fishplate at first-floor level, in the position where a window could be expected, but for which there was no evidence, suggesting one was not included within the original build. The two bays to the west were also devoid of windows, with a large bearing box in Bay 7, flanked by a pair of smaller boxes, set slightly lower in the wall (Plate 19).

Plate 19: Large cast-iron bearing box, Bay 7, Building I, flanked by smaller apertures

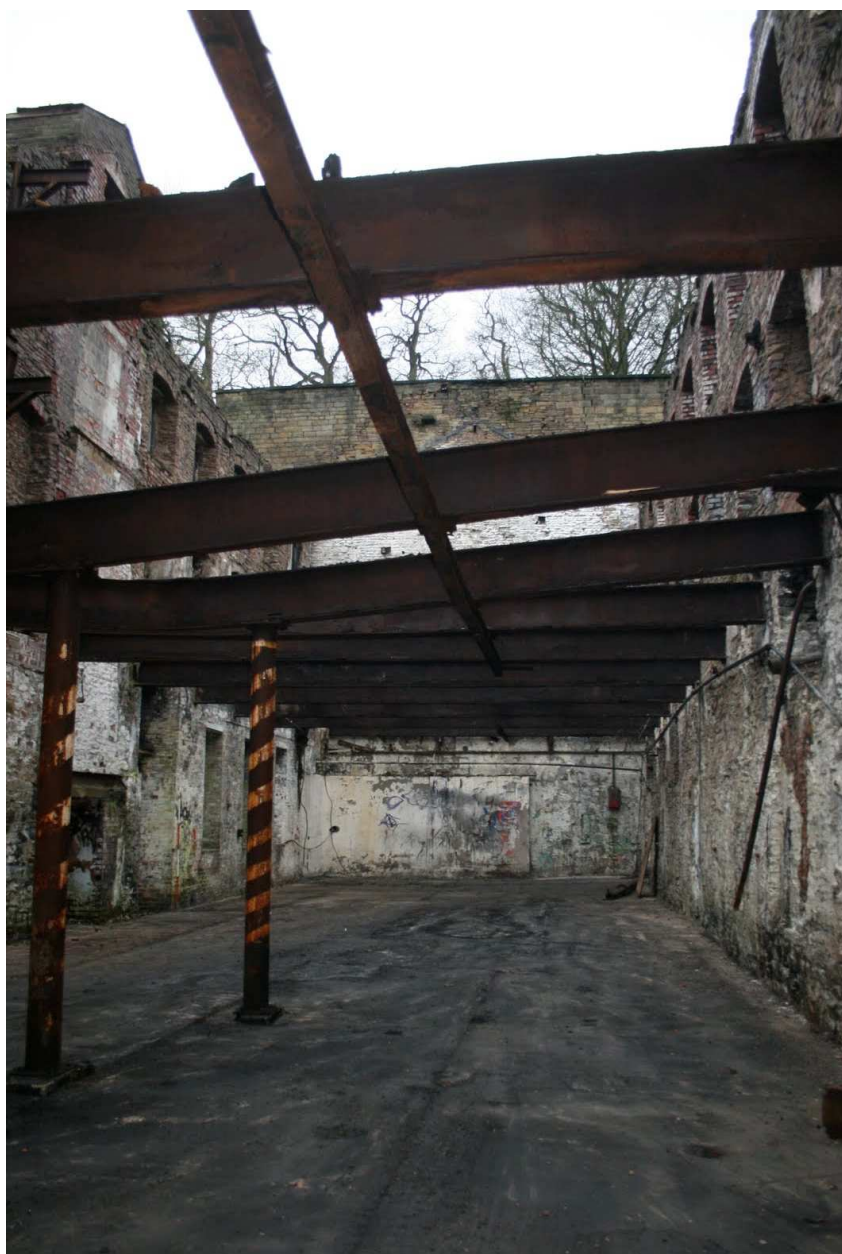
- 4.3.4 The original four floors were reduced to three taller floors, supported on I-section steel beams. The original beams were either removed, with the sockets infilled with clinker block, or were cut flush with the wall face. Two of the large I-section beams inserted to create the new first-floor level had deflected significantly, and have two supporting cylindrical cast-iron columns, each set on flagstone pads above the present concrete floor (Plate 20).

Plate 20: Inserted steel beams for the repositioned first floor level, Building I

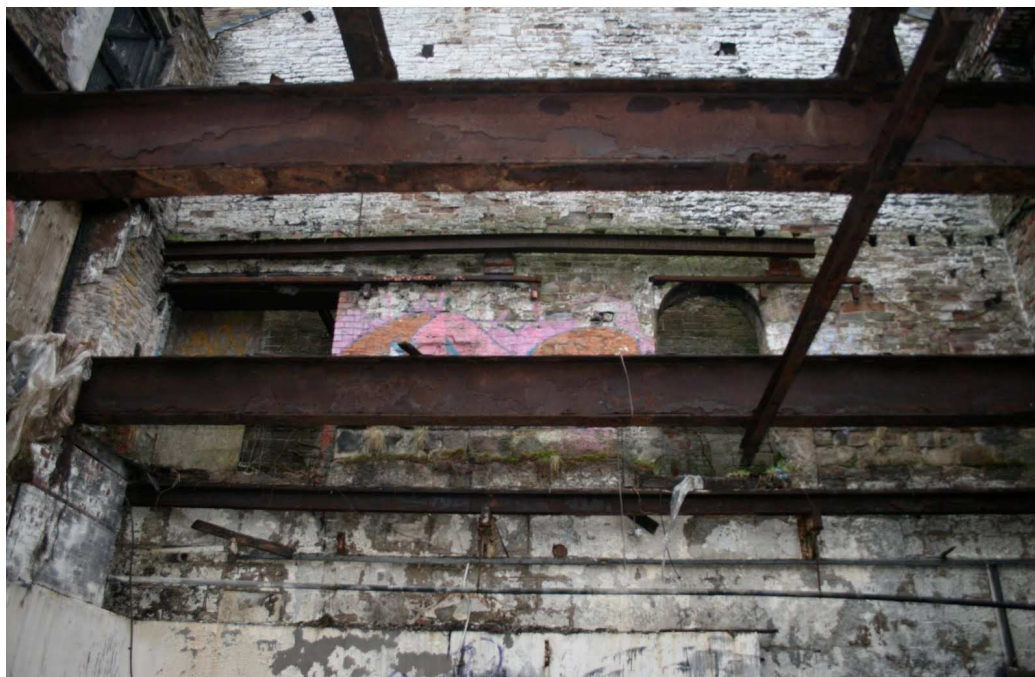
Plate 21: Apertures inserted into the western gable of the spinning block, into Building H

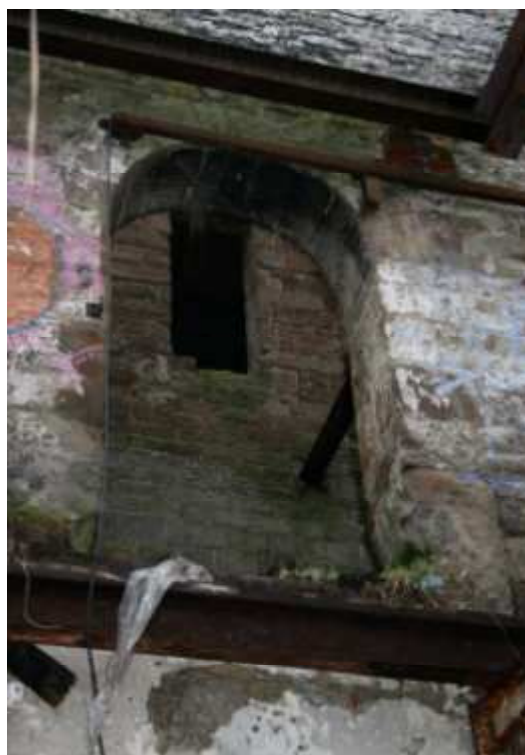
- 4.3.5 Both the north and south walls returned to form the eastern elevation of the waterwheel house, which was extended above the height of the original gable wall. A subsequently remodelled wide doorway was inserted into the partition wall between the two structures at its northern end, as was a round-headed arched opening to the south of centre (Plate 21). The base of this has been enlarged to form a doorway by cutting through the padstone of the original driveshaft bearing which it housed (Plate 22).

Plate 22: Detail of axle mount for water wheel, with cut padstone

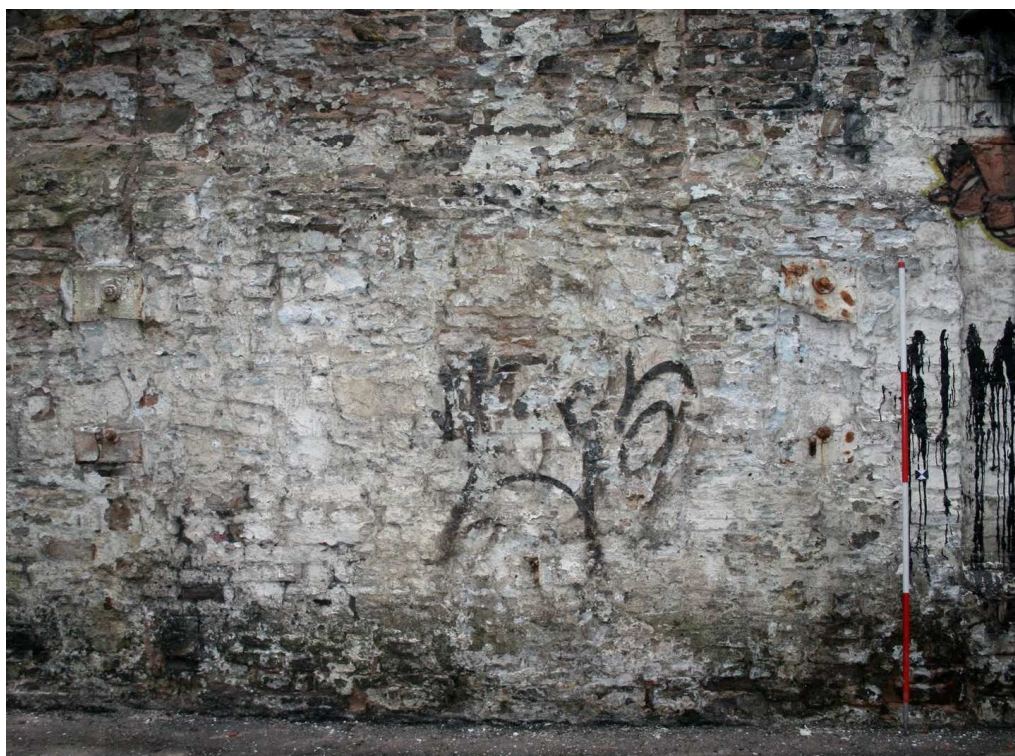
4.3.6 Internally, the north wall retains several fragments of cast-iron wall brackets (Plate 23), which presumably carried lineshafting, although the height is unusual, being only around 5' above the present concrete floor. The fifth to seventh bays have no evidence for ground-floor windows, whilst at first-floor level above, there was similarly no evidence for windows, as observed within the external elevation. The large bearing box within Bay 7 was set on a sandstone pad (Plate 24). In the eastern bay (12), there was also no window, as this lay below the external ground level, but immediately to the west of where it would have been placed was a 3 x 1' (0.92 x 0.30m) vertical rectangular aperture (Plate 25). This was blocked with bricked stamped 'BC' denoting it was made at Bradford Colliery, Manchester, and was bonded in a black sooty mortar, suggesting a late nineteenth- or early twentieth-century date for the blocking. The exact purpose of the aperture is unclear, although it may represent the housing for an end bearing for a lineshaft, which may have been placed in this position if the end bay housed a stair from the raised external ground level (Fig 2). A late clinker block stair gave access to a concrete platform above a clinker block store in the end bay, which would have also afforded external access.

Plate 23: Broken cast-iron wall brackets, north elevation, Building I

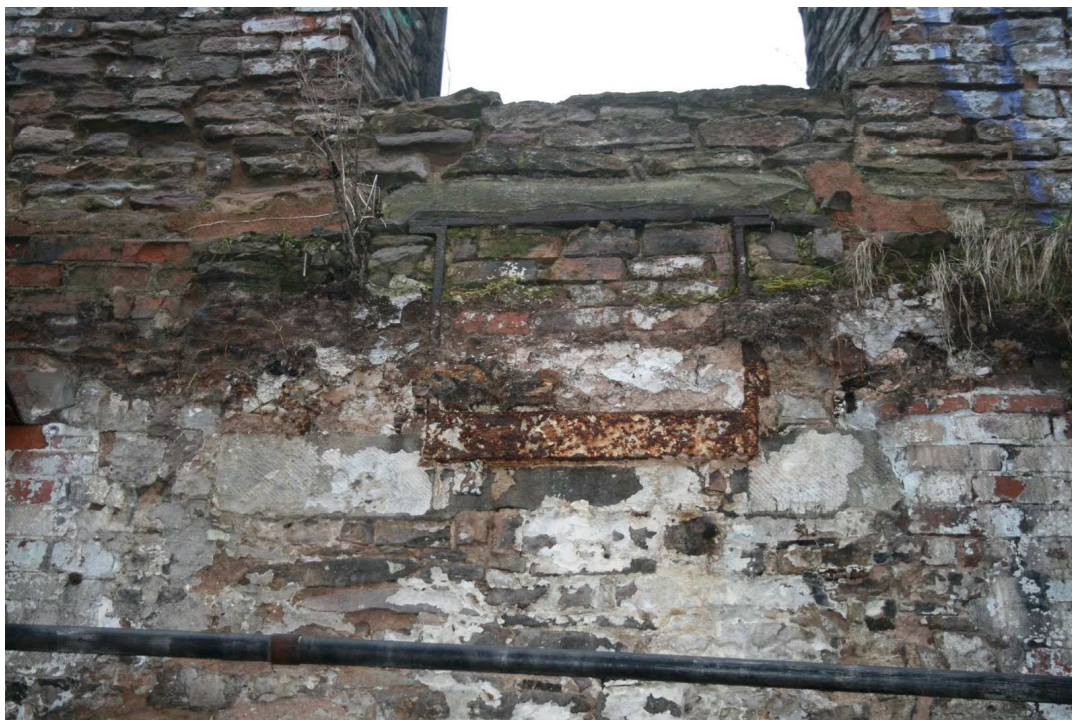
Plate 24: Large cast-iron bearing box, Bay 7, Building I, flanked by smaller apertures

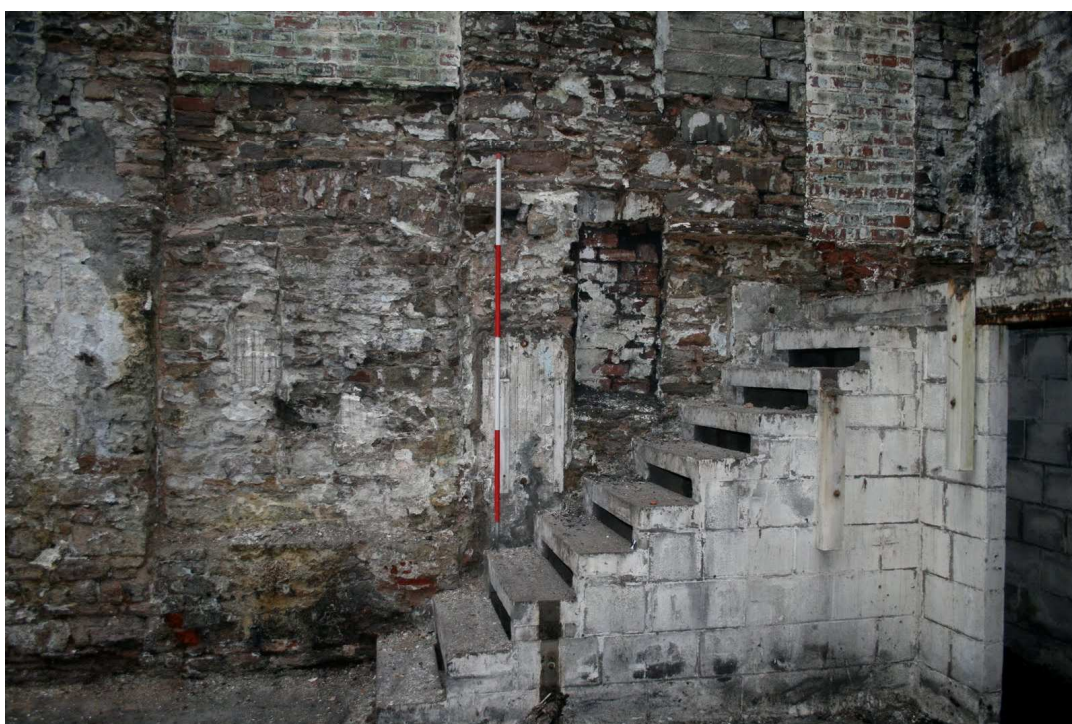
Plate 25: Blocked windows, inserted stair, and possible blocked end bearing bracket, Bay 12

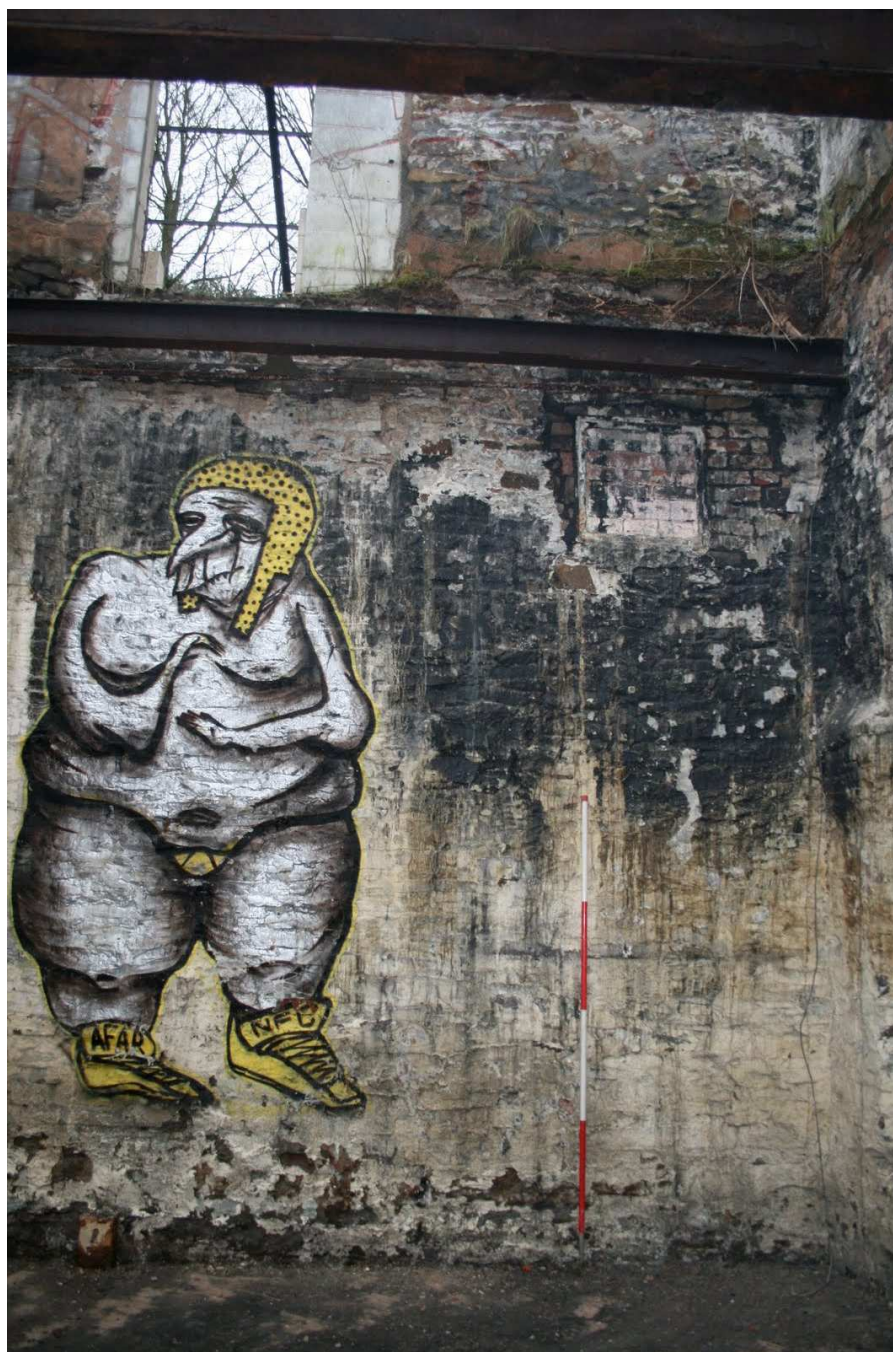
Plate 26: Blocked end bearing box, eastern gable, Building I, with remodelled doorway above

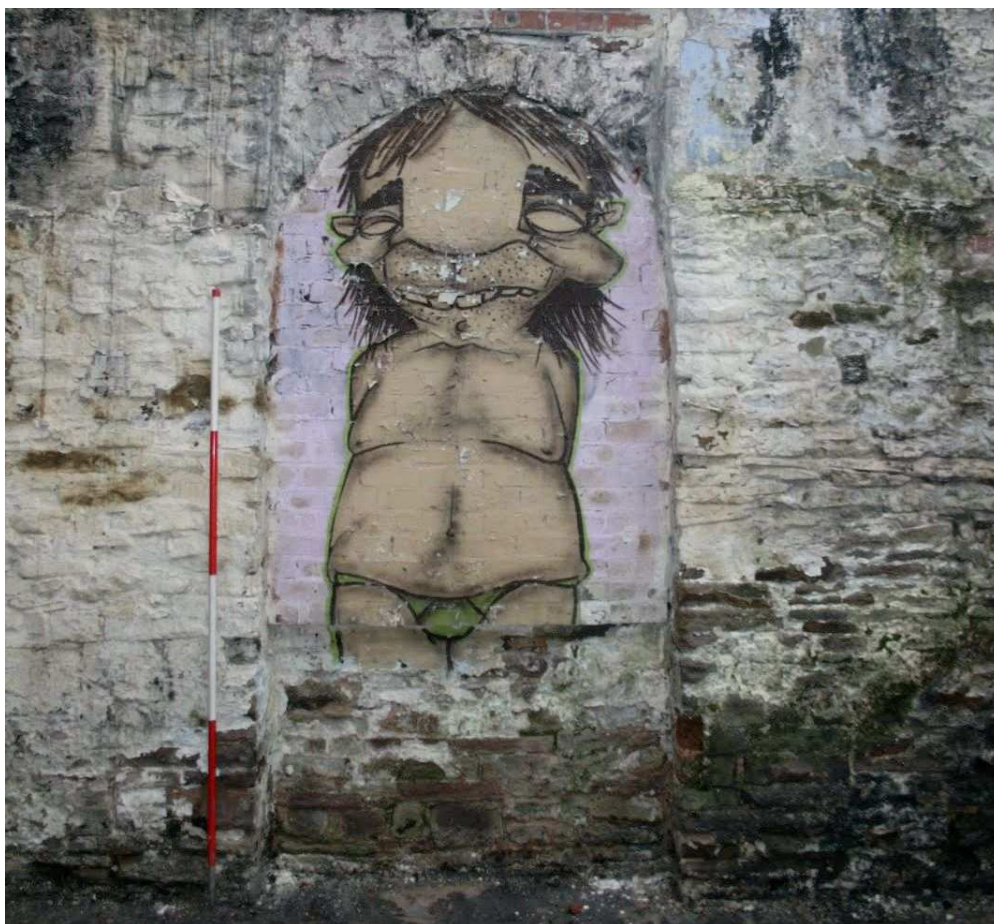
- 4.3.8 Bays 10-12 of the south wall are heavily remodelled at original ground and first floor levels, although Bay 11 retains a large segmental arch, taller than the windows elsewhere, and apparently represented an original doorway, blocked subsequently with stone (Plate 27), quite possibly during the addition of a further finishing shed, Building M (Fig 2: *Section 4.2.16*, above).

Plate 27: Blocked doorway, south elevation, Bay 11, Building I
