Ingersley Vale Mill, Bollington, Cheshire

Archaeological Building Investigation

February 2011

Issue No: 2010-11/1170
OA North Job No: L10283
NGR: SJ 942 773

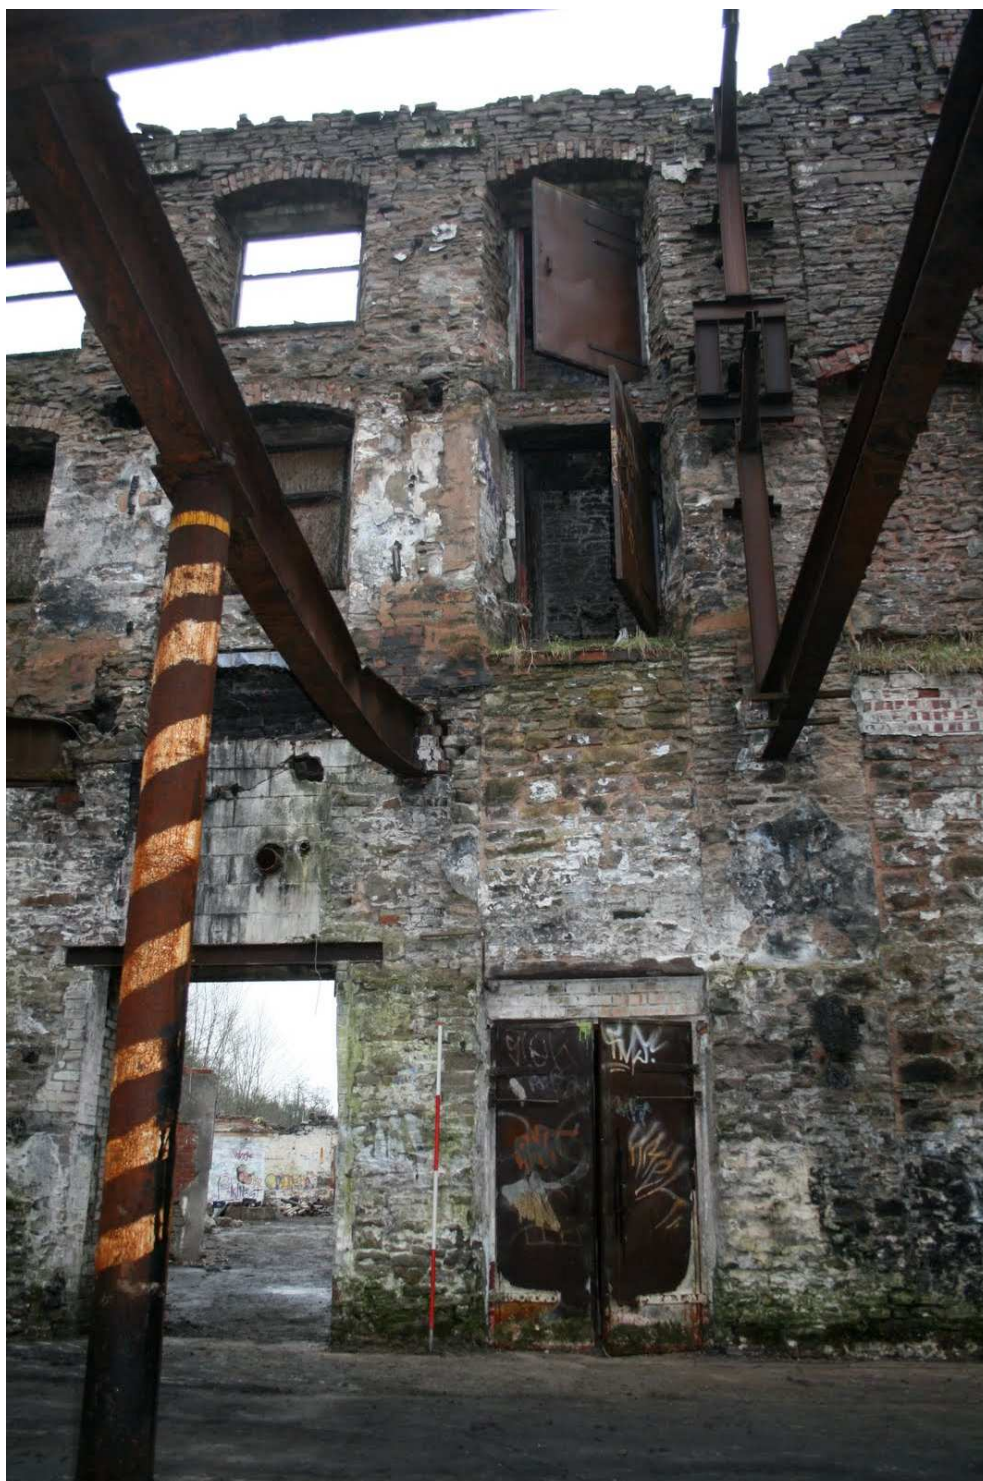
- 4.3.9 Bay 9 has an inserted doorway, possibly enlarged from a window aperture, with an extractor fan at first-floor level in the window above. Bay 8 afforded access into the original stair tower, and was latterly fitted with steel fireproof double doors. The first-floor aperture above is stone-blocked, whilst the upper two floors had single fireproof steel doors (Plate 28).

Plate 28: Bay 8, south elevation, Building I, showing doorways into stair tower J

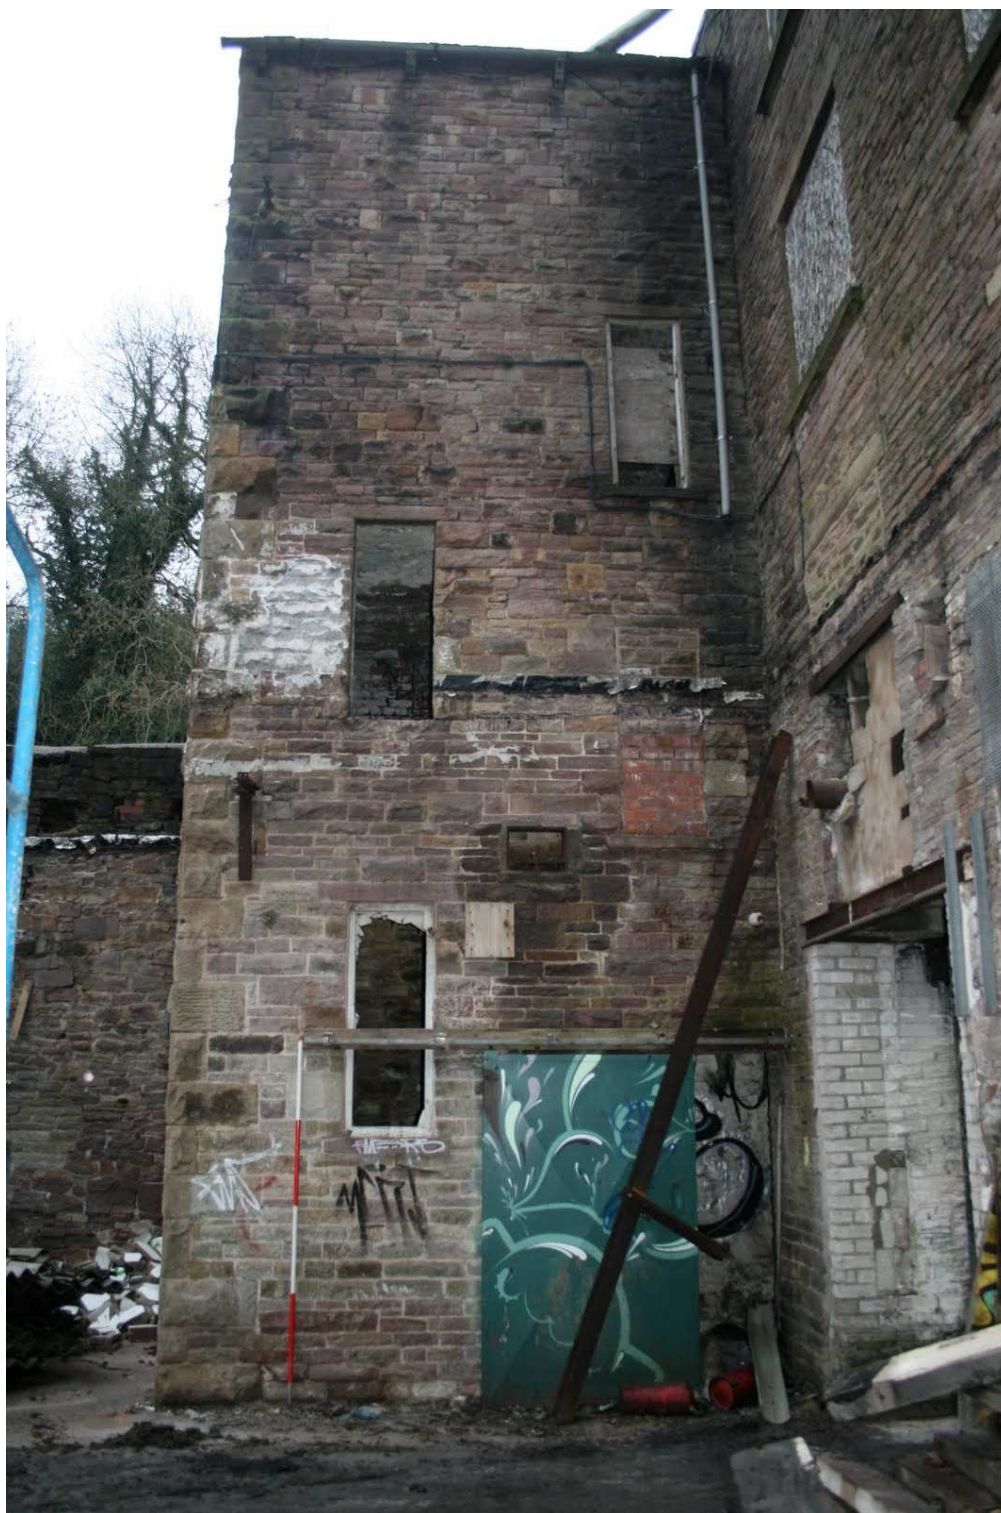
walls (Plate 29). This possibly resulted in the stone blocking of the doorway into the spinning block at this level, as its insertion would have not been possible whilst the doorway remained in use. The external east wall also houses an end-bearing box (Plate 29).

Plate 29: East wall of stair tower with landing windows and two inserted bearing boxes

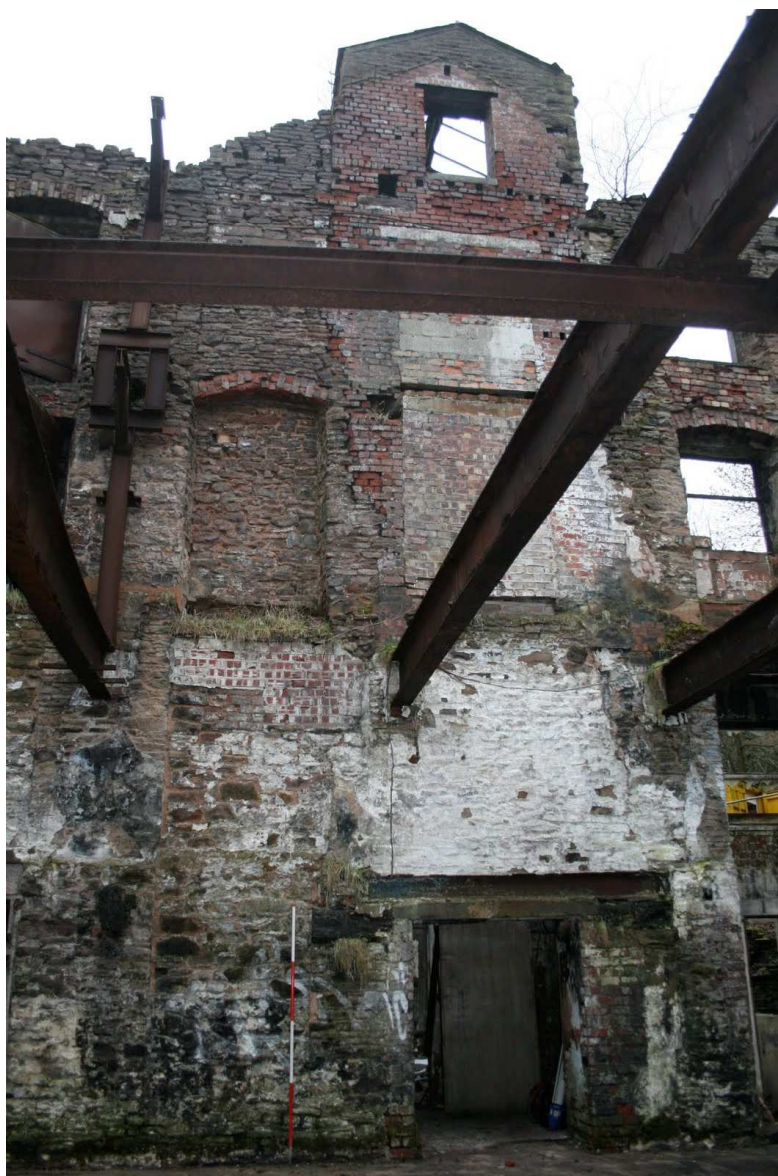
Plate 30: Bays 7 and 6, south elevation, showing blocked doorways and brick hoist tower J

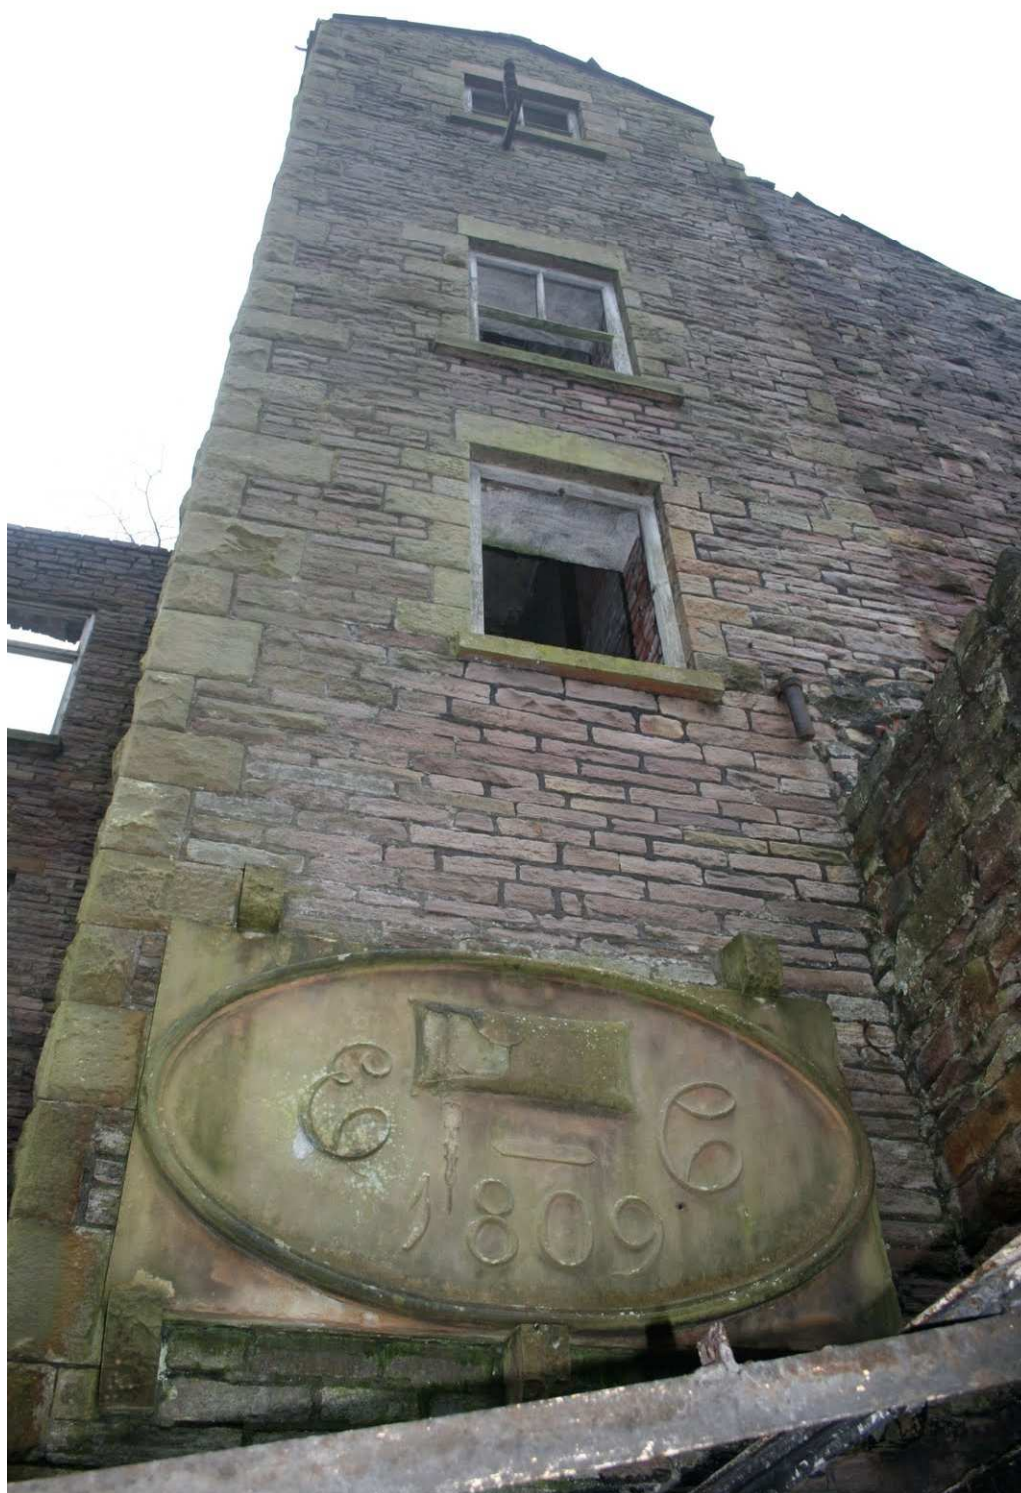
4.3.11 The apertures in Bay 7 are blocked at all levels, flush with the internal wall face on all but the second floor. These were larger than the windows elsewhere on the upper floors, suggesting that they represented doorways, almost certainly into a privy tower, which would have been removed for the insertion of a hoist tower in Bay 6 (Plate 30). This was constructed in machine-made brick, in English Garden Wall bond, using a black sooty mortar, and clad in stone, similar in size, but greener in colour than the pinkish-red sandstone of the original construction (Plate 31). It was butted onto the earlier stair tower, which presently has a single-pitched roof, possibly remodelled during the addition of the hoist tower. On its southern external face, the hoist tower has four-light windows to each floor (Plate 31), above a date stone of 1809, bearing the initials E C (Plate 31), presumably representing Edward Collier, who owned the complex at this date (UMAU 2004). This has clearly been repositioned from elsewhere within the building or complex.

Plate 31: Southern elevation of hoist tower, J, with repositioned datestone of 1809

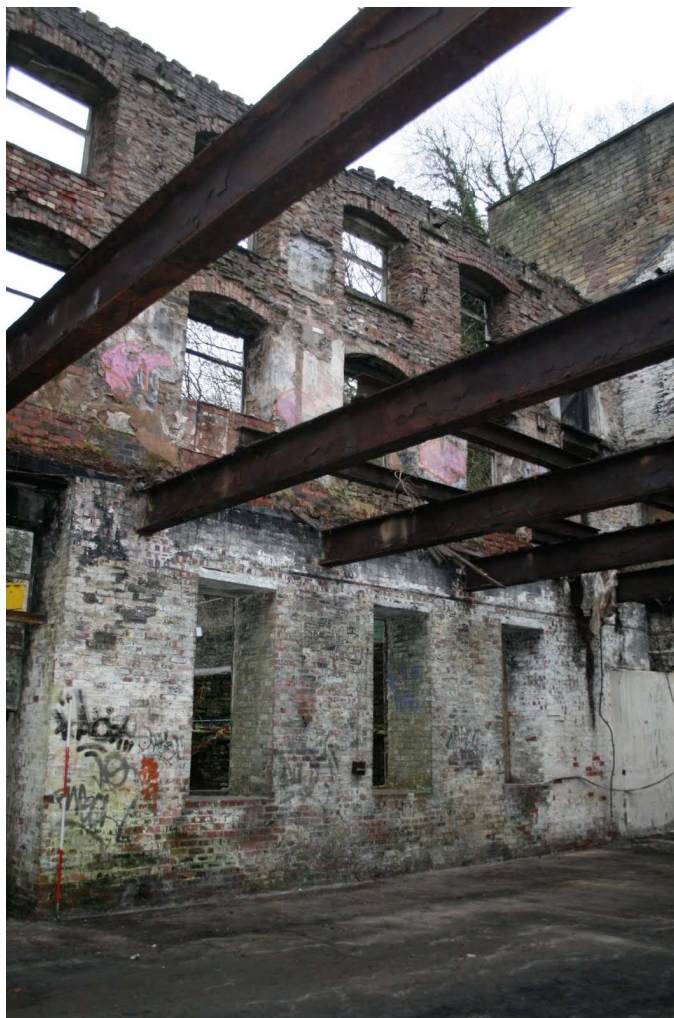
- 4.3.12 The western five bays of the south wall were refaced in machine-made brick at ground and first-floor level, projecting a full-brick thickness from the wall (Plate 32). This appears to date from the alteration of floor levels within the spinning block. Bay 1 of the south wall has doors on the upper two floors, reflecting the change in ground level adjacent to the wheel house.

Plate 32: Western bays of south elevation, Building I, showing refaced ground floor

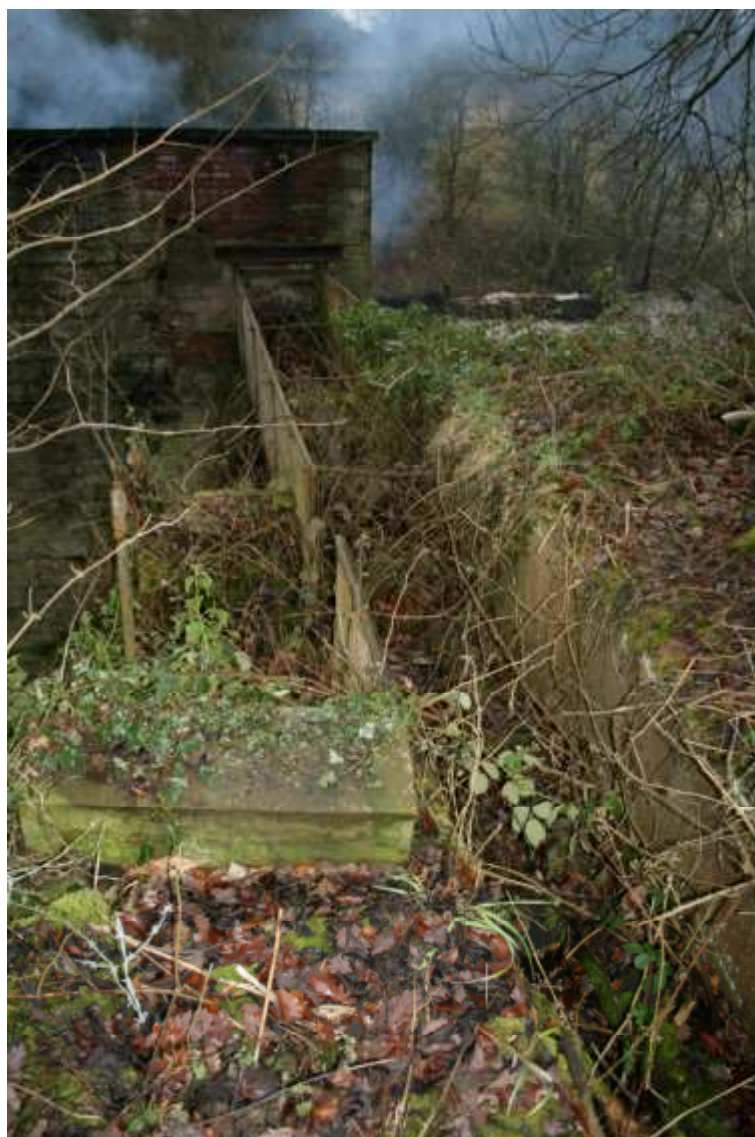
- 4.3.16 The waterwheel was fed by a long leat which ran down the western side of the valley, being fed from the River Dean at a level where a suitable head of water could be generated (Fig 2). The leat filled a header reservoir, cut into the hillside to the west of the wheel house, and still extant, although heavily overgrown. A sluice in its eastern side controlled the flow of water into an iron trough, which bridged the road below, into the wheel house (Plate 33). This is heavily overgrown (Plate 34), and inaccessible, but could be seen to comprise riveted iron sheets, each approximately 4' (1.22m) wide and 2' (0.61m) high. At each junction a strengthening or tensioning bar was bolted across the top of the trough (Plate 34). The base comprised similar sized sheets, which were carried on cast-iron rails, which had a pair of strengthening braces at either end into the wheel house and retaining wall of the reservoir (Plate 33). The aperture from the trough into the wheel house had an I-section steel lintel (Plate 34), which presumably represented a replacement to an earlier lintel, with the wall above also being rebuilt in machine-made brick (Plate 34).

Plate 34: Detail of iron-sheet trough from reservoir into wheel house

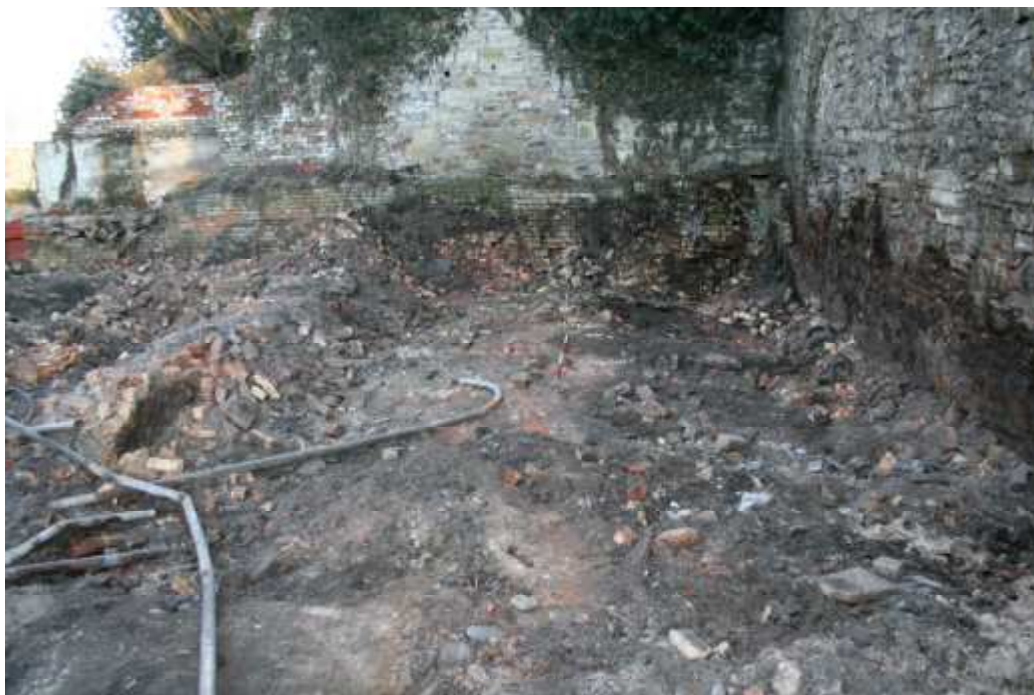
Plate 35: Footprint of Building E following demolition

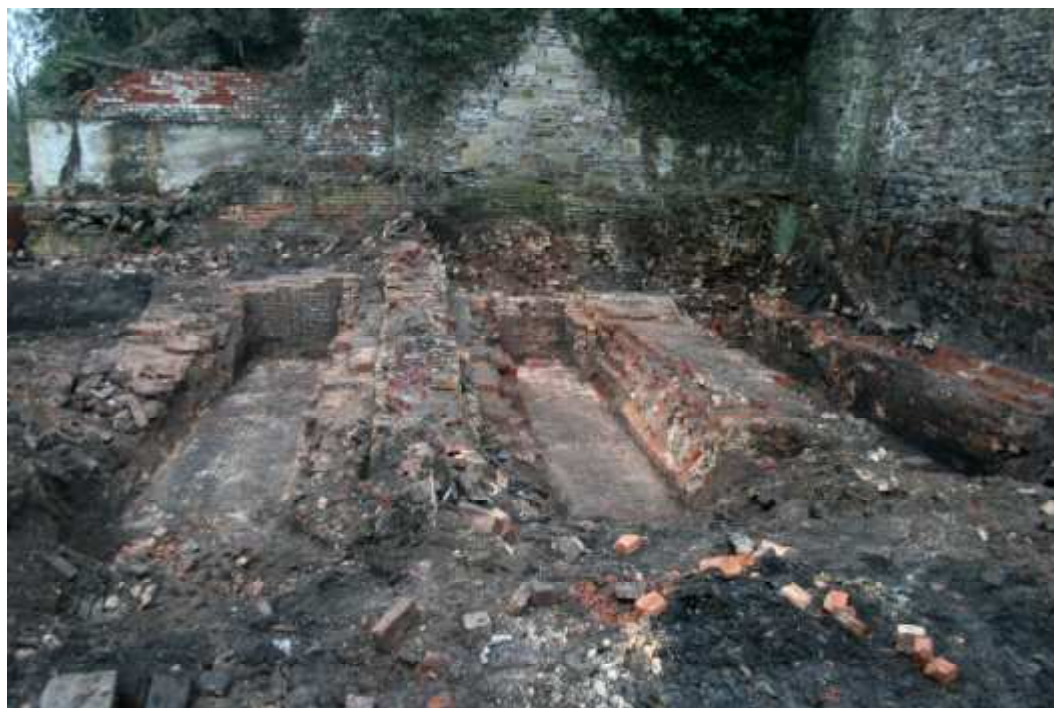
Plate 36: Three boiler beds with partially intact benches observed below Building E

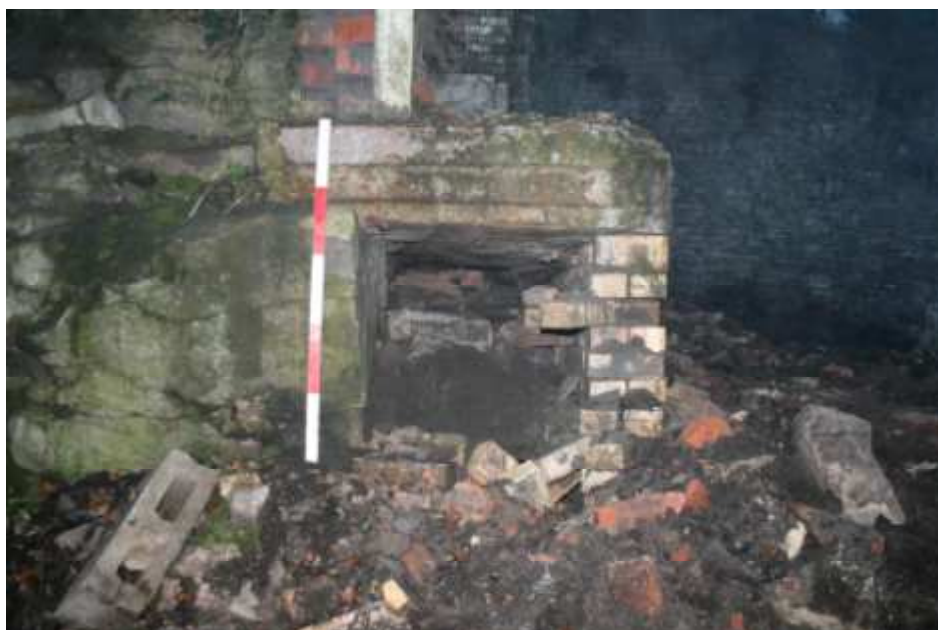
Plate 37: Flue on boiler bench, and at rear (right) of both visible beds into main flue

4.4.4 All three boilers were of Cornish-type, with part of the full length side flues clearly visible within the extant fabric (Fig 4; Plates 37 and 38). Whilst these were mainly destroyed prior to, or during the demolition of the structure, elements of associated dampers into the main rear flue were observed *in situ* (Plate 38) and within the demolition debris. Elements of damaged projecting walls, of refractory brick construction at the rear of each boiler, almost certainly relate to the channelling of air from the back of the boiler into the two side flues, which ran to the front of the boiler bench and into a single flue beneath the boiler. Whilst the benches for the boiler were all badly damaged, probably as a result of the removal of the boilers themselves, a short row of disturbed, but effectively *in-situ* mounting blocks were observed at the northern end of the western bench. Several more of these L-shaped blocks, with concave inner faces to support the curved boiler, were observed within the backfill, as were examples of convex refractory tiles, which were placed over the top of the boiler.

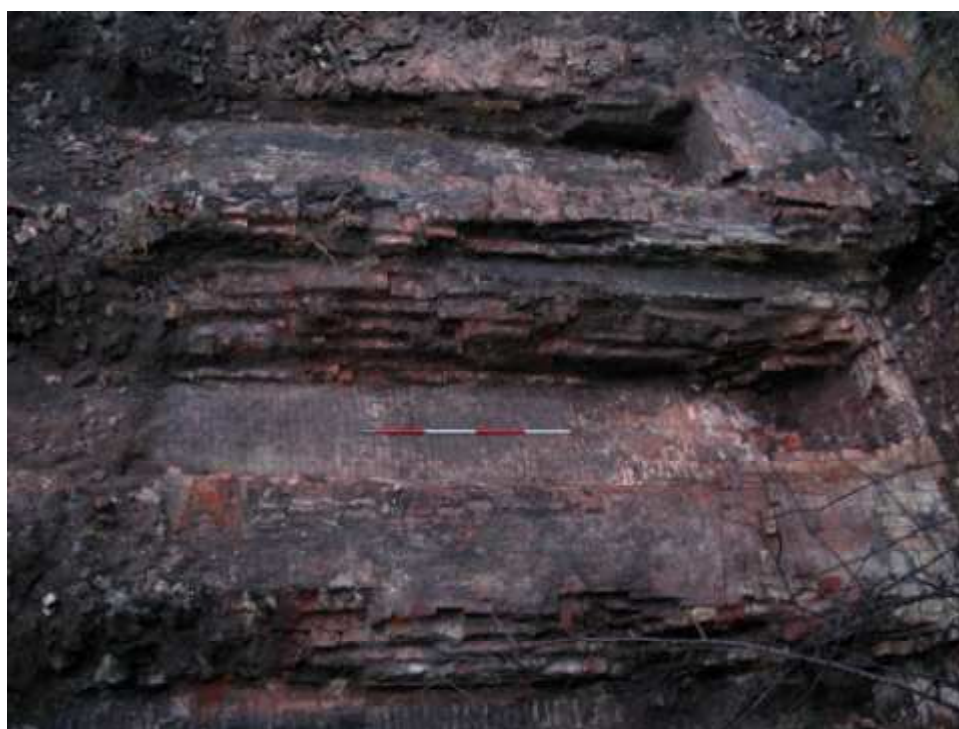
Plate 38: Detail of boiler flue, with in-situ damper framing at rear

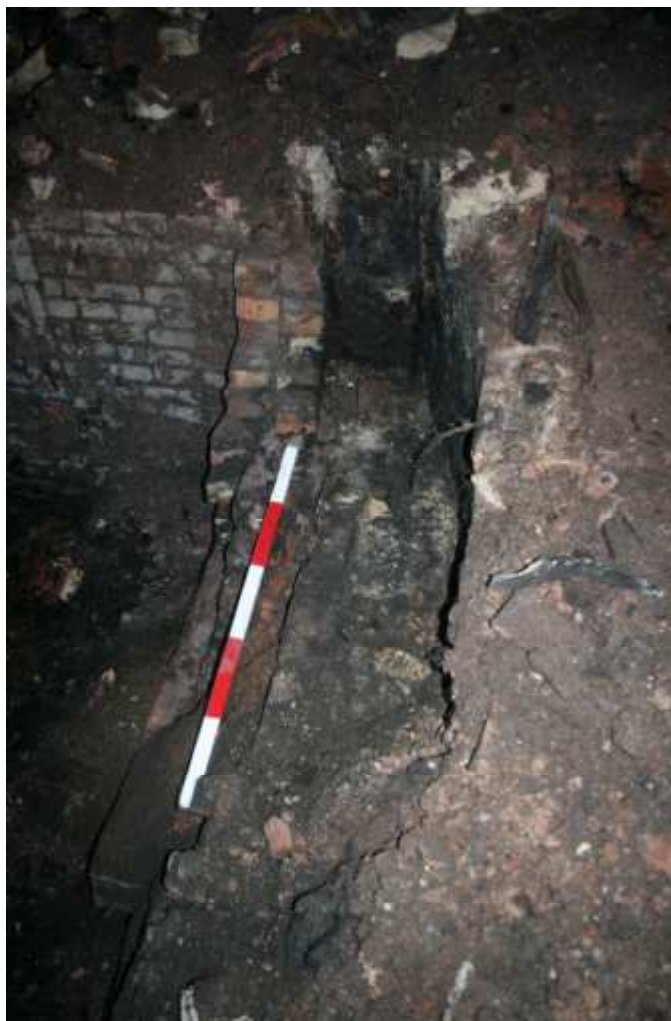
Plate 39: Boiler flue adjacent to front edge of Building E

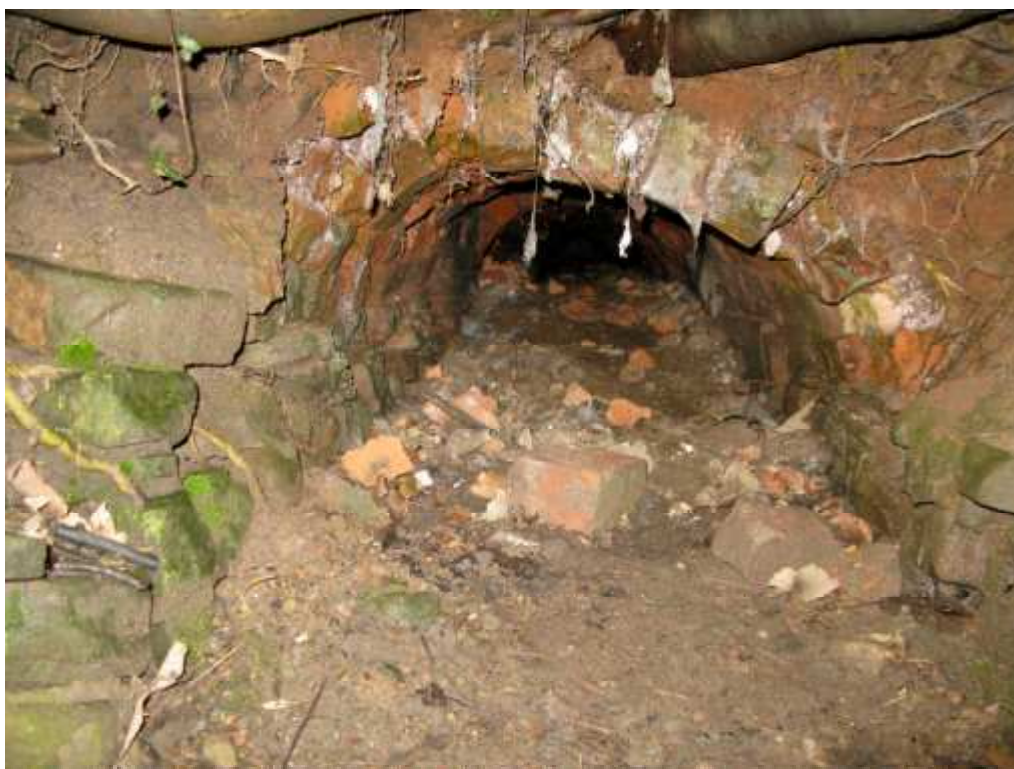
- 5.2.6 The flue for the three boilers was placed on a perpendicular alignment, along the north wall of the building, and was modified for the addition of the flue from the western boiler. It survived to the edge of the demolished Building D, from where it must have dropped below ground level, and below Building B to a steeply rising flue leading to the chimney on the slope to the west (Fig 2). A depression in the ground surface marked the position of this flue, from Building B to the chimney, presumably resulting from the collapse of the flue. However, the 1875 map also shows a chimney on the hill to the north of the boiler house, and part of a flue was observed immediately to the south of its probable location (Plate 40). This suggests that this represented the original chimney for the two boilers, being replaced subsequently by a much higher structure on the opposite side of the valley, where a greater draw could be achieved.

Plate 40: Extant section of flue from boilers within Building E to demolished chimney above
