SWINBROOK

Pebble Court  
Swinbrook  
Oxfordshire

**Archaeological  
Watching Brief Report**

**Document Type:** Watching Brief

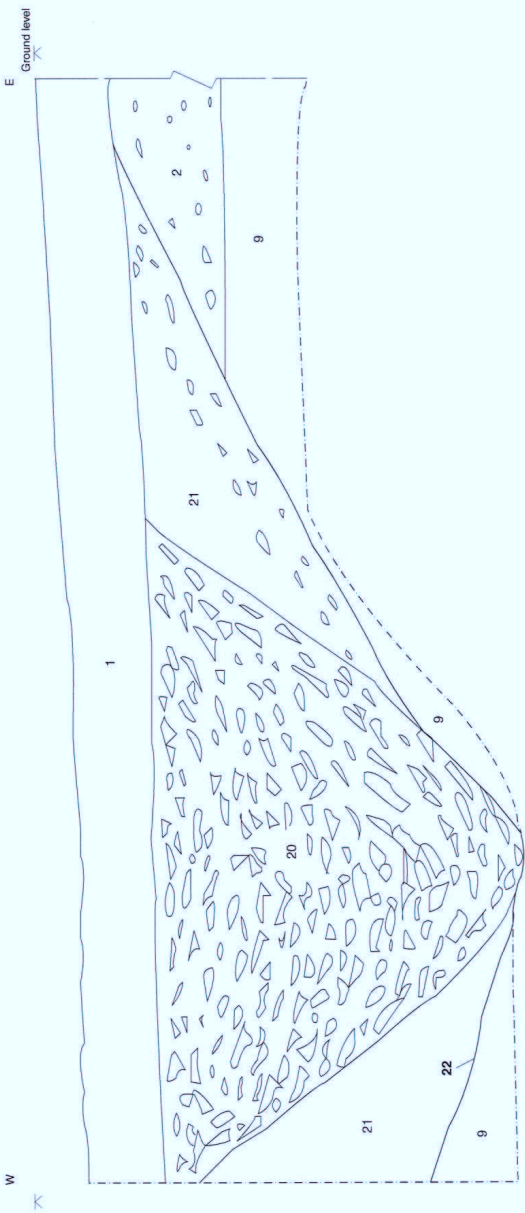
Section 3

- 3.1.4 This feature appears to extend northwards and was observed in section within the foundation trench of the new garages (Fig. 4, section 3). The sides were less steeply sloped with a concave base (22) with a primary fill of light grey silty clay (21) overlain by a light yellowish brown silty clay (20) containing over 75% limestone rubble. Two fragments of mid 16th century pottery was recovered from this fill.
