# Johnson House, Cundy Street, Belgravia, City of Westminster

## Archaeological Evaluation and Watching Brief Report

September 2011

**Client: Berkeley Homes  
(Urban Renaissance)Ltd.**

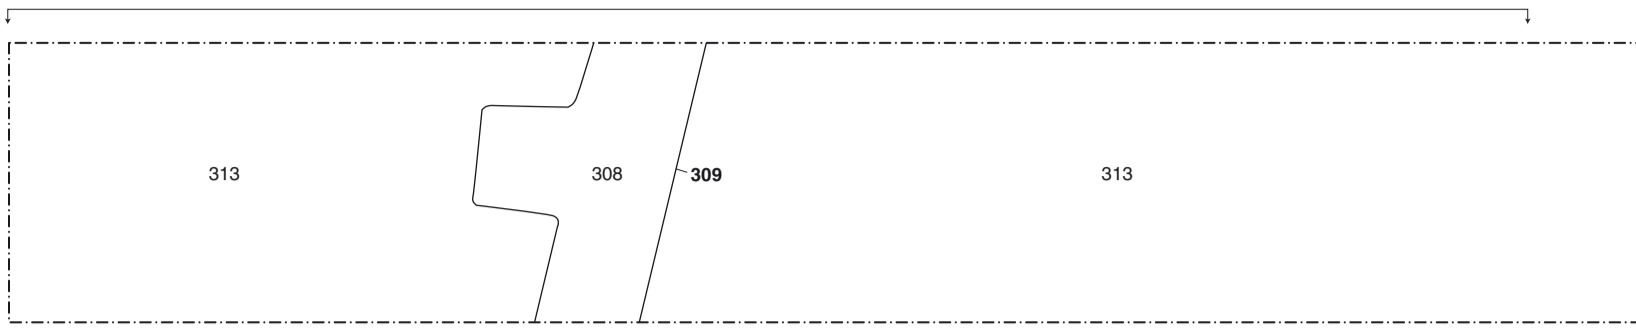
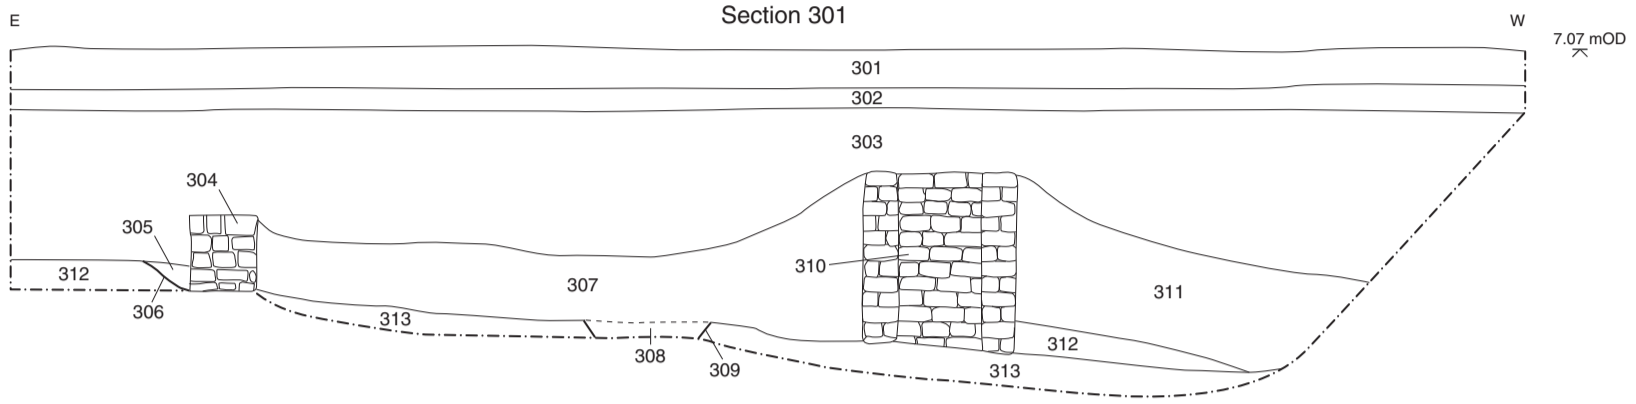
Section 301

- 3.4.5 A 0.60 m wide linear construction cut was observed in the base of the trench, cutting the natural gravels. This feature, with a square extension to its south-east side, contained a dark grey silty clay with occasional CBM fragments and flecks of mortar and is likely to be associated with walls 304 and 310 and may be the truncated remains of a wall foundation cut.

- 3.4.7 A loose dark grey silty clay deposit, with occasional CBM brick rubble fragments and occasional flecks of mortar, abutted the walls (307 and 311) infilling the cellar. Overlying this was a friable dark grey black silty clay with frequent red and yellow brick fragments, mortar and charcoal (303). This deposit also contained occasional fragments of rusted metal including a scaffold tube, the rusted remains of an iron bucket and an iron bed head frame, probably Edwardian (not retained). The charcoal and domestic finds within this trench may suggest more extensive WWII bomb damage within this area of the site.

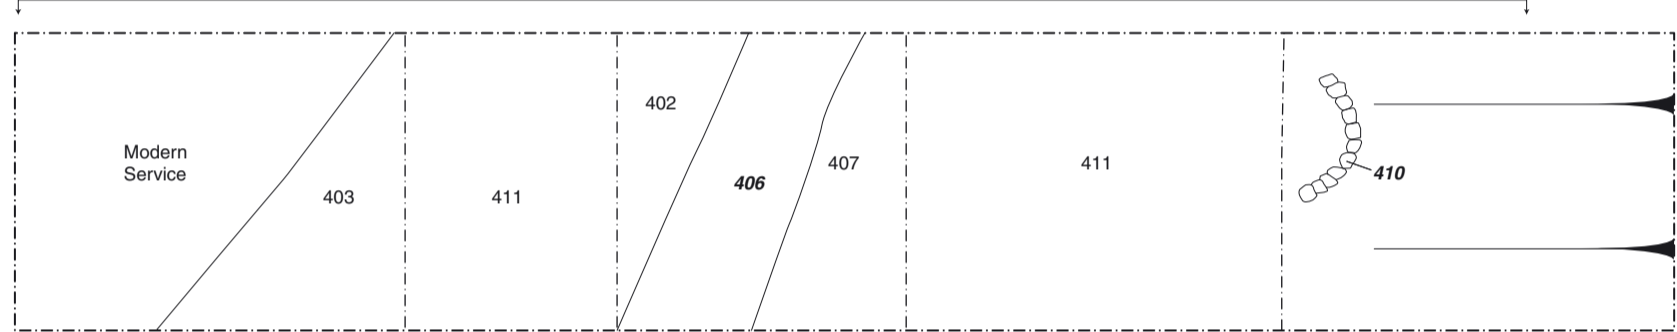
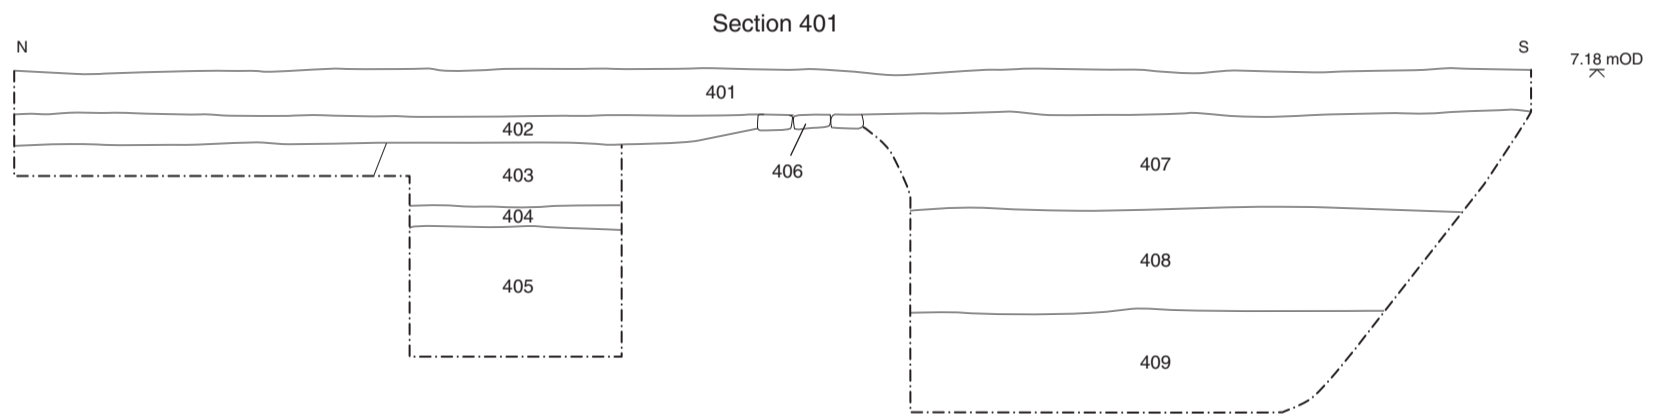
Section 401

- 3.4.11 The southern end of the trench was defined by a series of rubble deposits, 409, 408 and 407 that butt up against wall 406. These loose deposits may represent a series of levelling layers, perhaps associated with the construction of the Underground line.

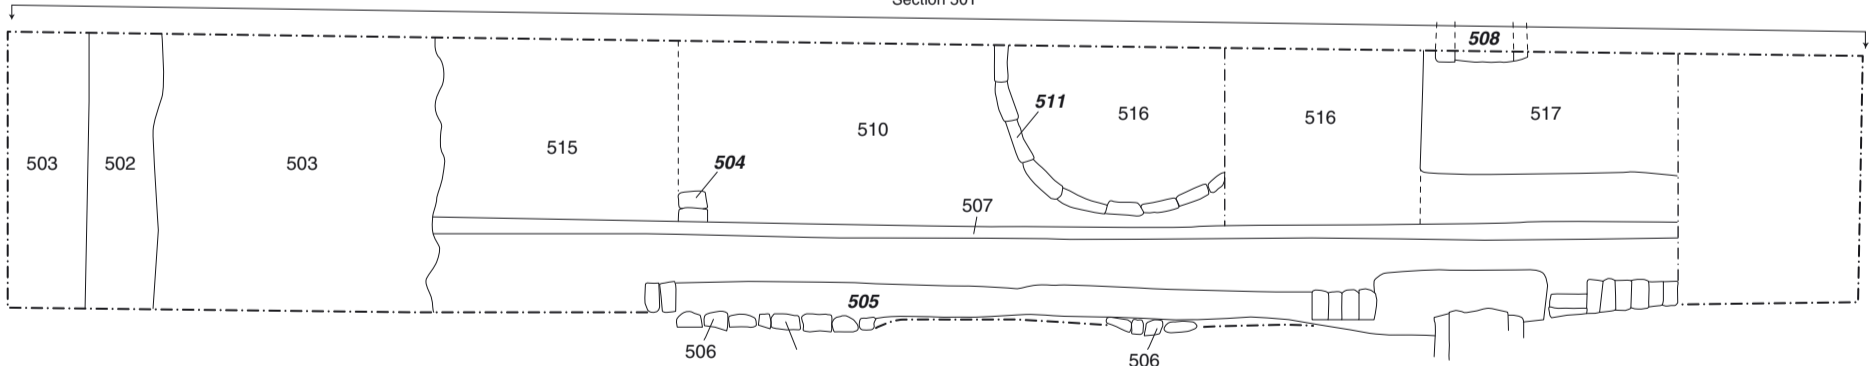
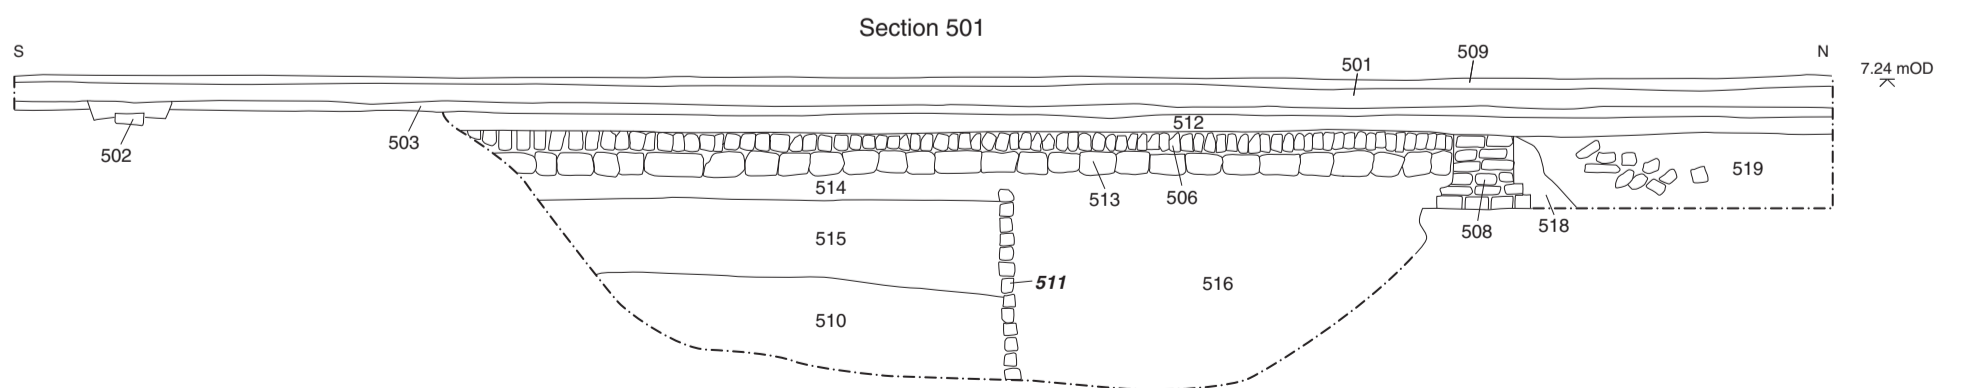
Section 501

- 3.4.14 Feature 511, a single width curved brick structure, cut through the brickearth at the base of the trench. This structure was visible to a maximum height of 1.10 m. The base of the feature was not reached within the trench due to health and safety concerns regarding the stability of the trench side and the proximity to the Underground line. The curvature of the wall in the base of the trench suggests the feature had a diameter of at least 2 m. It was filled with a loose dark grey brown silty clay with frequent gravel, CBM and slate fragments and has been interpreted as a possible soakaway.

- 3.4.16 Layer 515 butted up against the side of wall 511. This deposit consists of loose mid brown silty clay with occasional gravel, mortar and CBM and was interpreted as a backfill or levelling deposit. It was overlain by concrete layer 514. The concrete layer did not span the entire length of the trench, stopping just beyond wall 511. It is possible that the concrete layer had once been part of the capping for 511 which subsequently collapsed.
