River Chelt Flood Alleviation Scheme Cheltenham: St George's Place

Building Investigation and Recording

Oxford Archaeology

December 2005

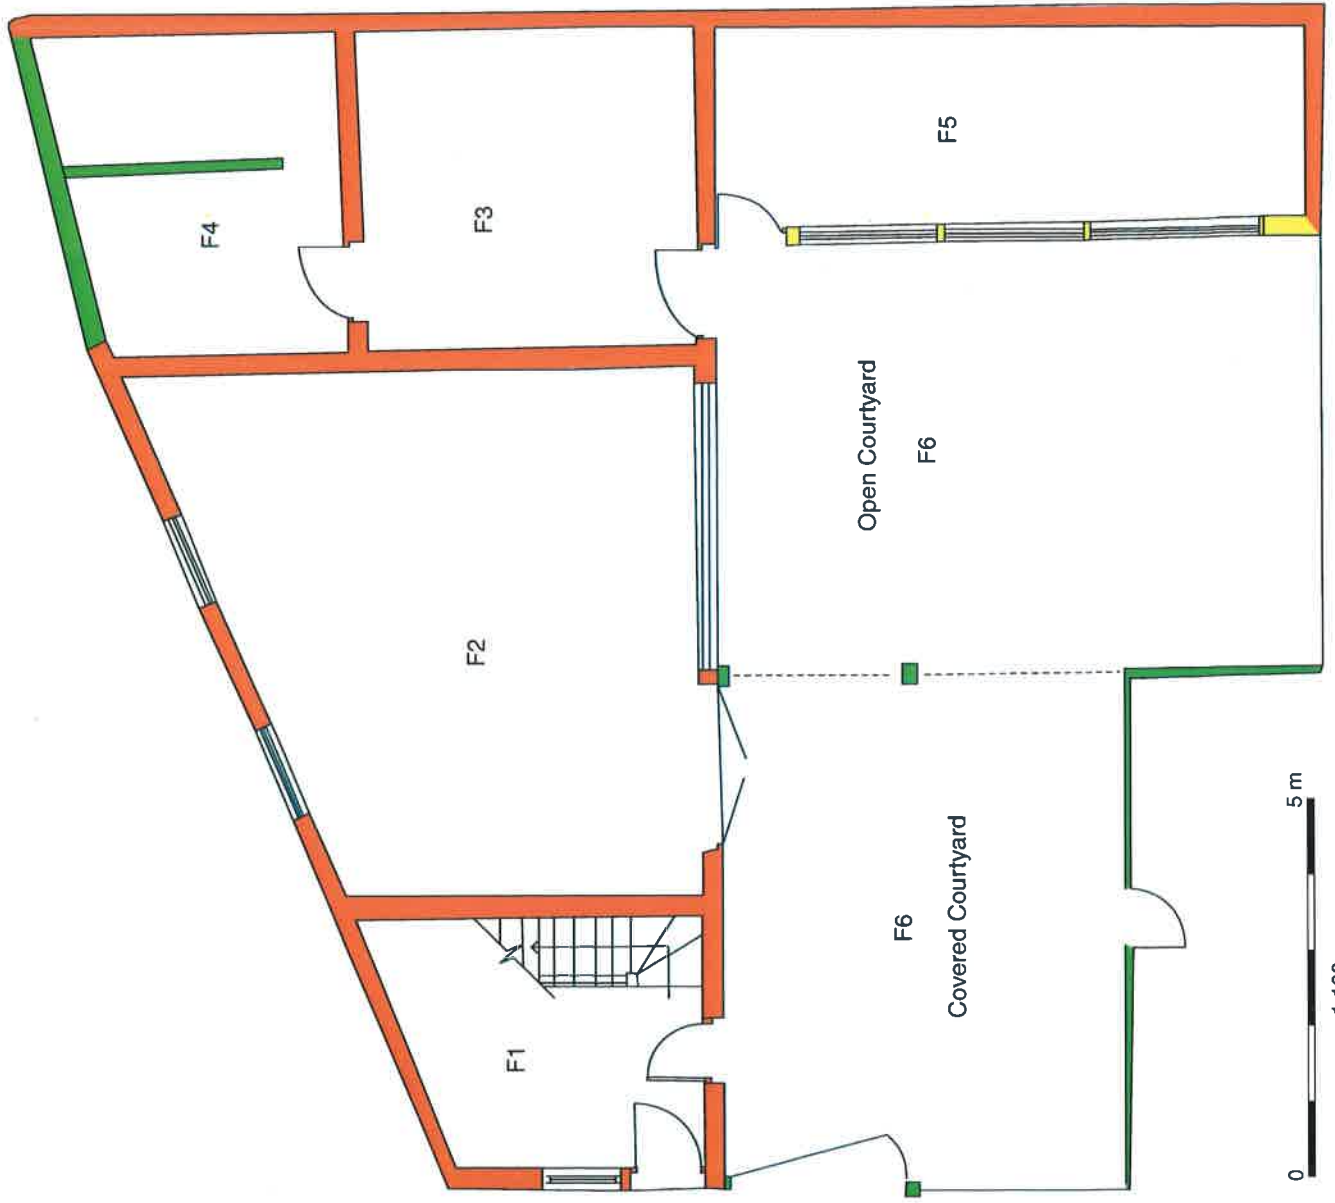
Figure 3: OA 10 phased ground plan

KEY: Phasing	
■	Mid 19th Century
■	Early 20th Century
■	Mid 20th Century

4.3.1 The main body of the two storey structure dates from the mid-19th century, although the second storey external brickwork and roof have been rebuilt in the mid-20th century.
