THE WAREHOUSE (PHASE 1 BUILDING), UNDERLEY HOME FARM, KEARSTWICK

Archaeological Building Investigation

Oxford Archaeology North

September 2010

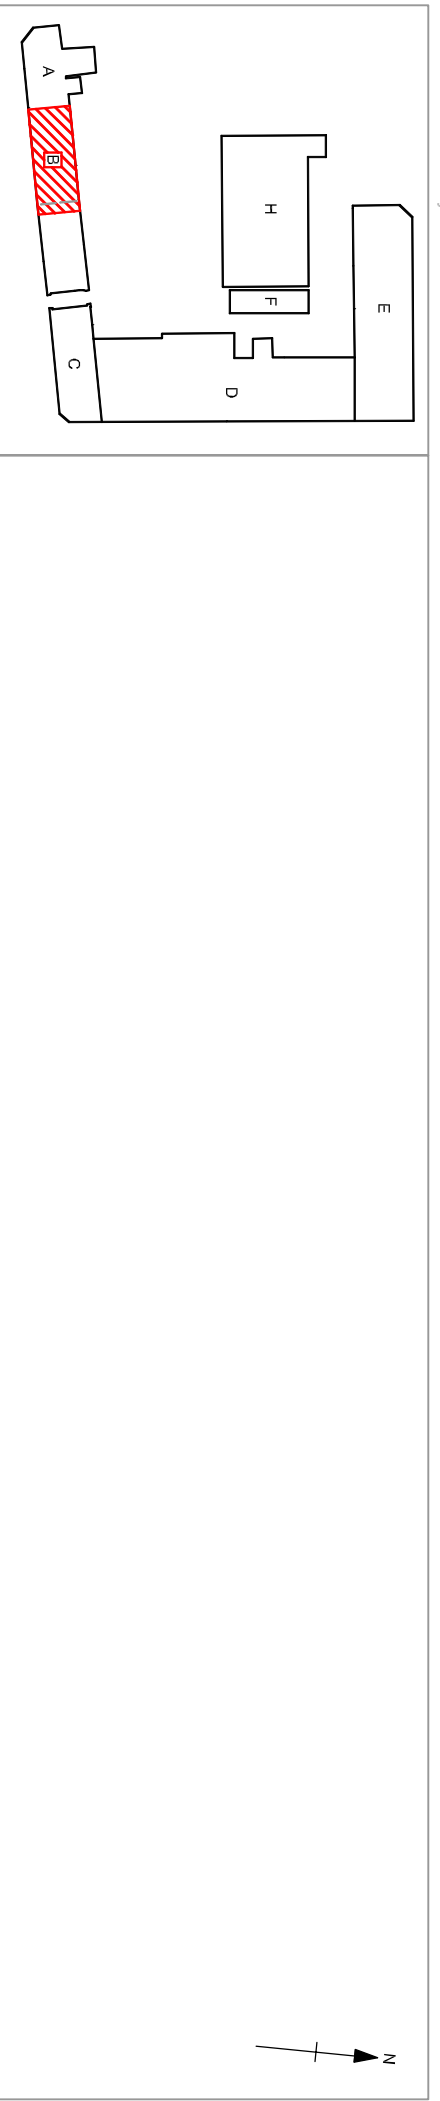
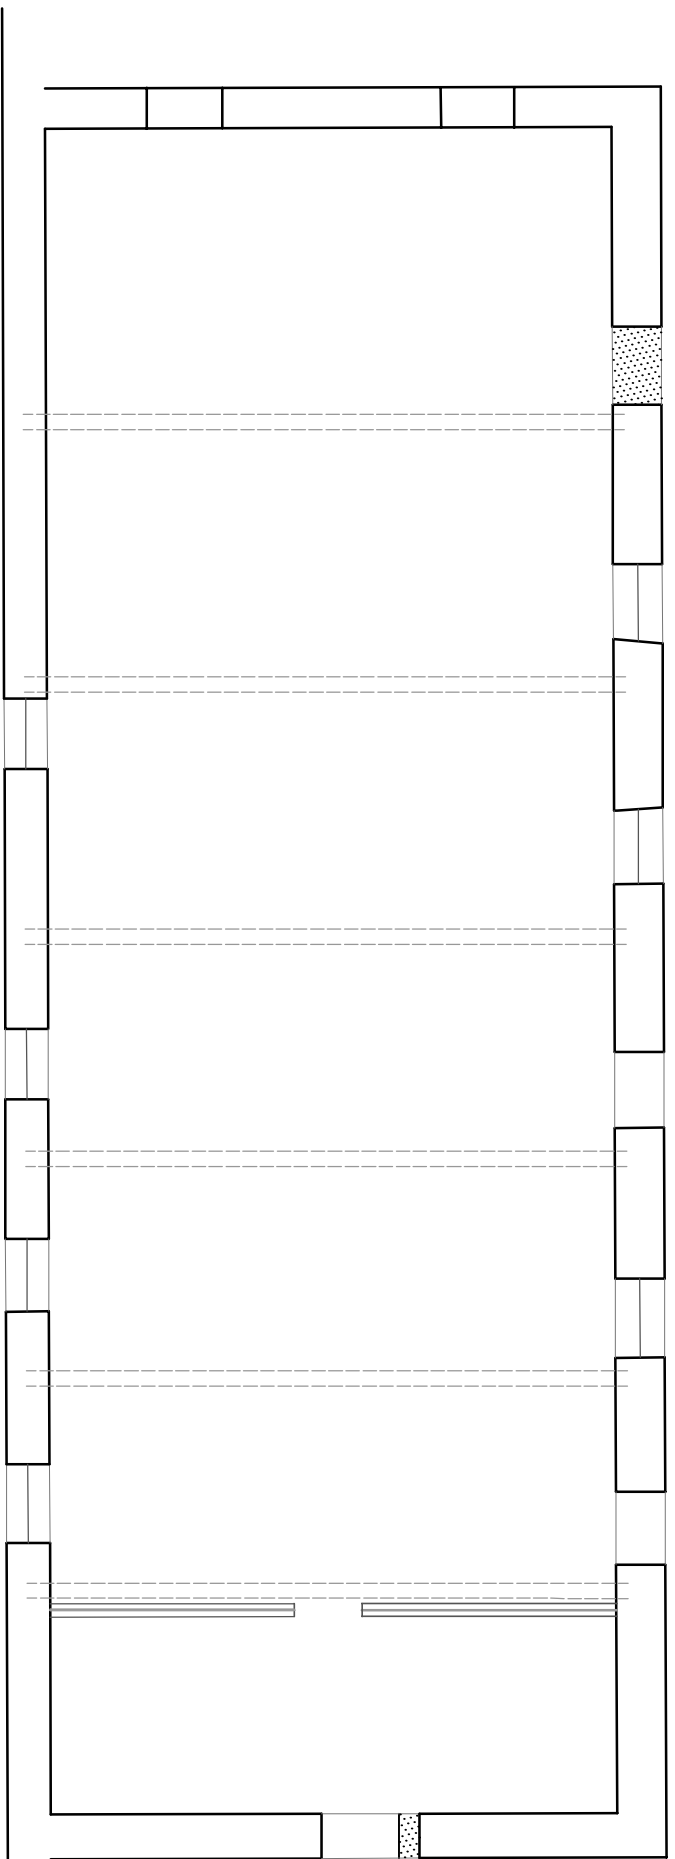
Fig 8: First floor plan of the Warehouse

- 4.3.11 Access to the western end of the first floor was via the large doorway at the west end of the front elevation (Plate 9). It appears to have been originally one large open room, punctuated by the stone pillars supporting the beam for the floor above. The two small windows seen in the rear elevation (Section 4.2.4) appear at floor level. The rear face of the large stone arch observed in the room to the east (Section 4.3.9) is exposed, and the floor level here respects the doorway.

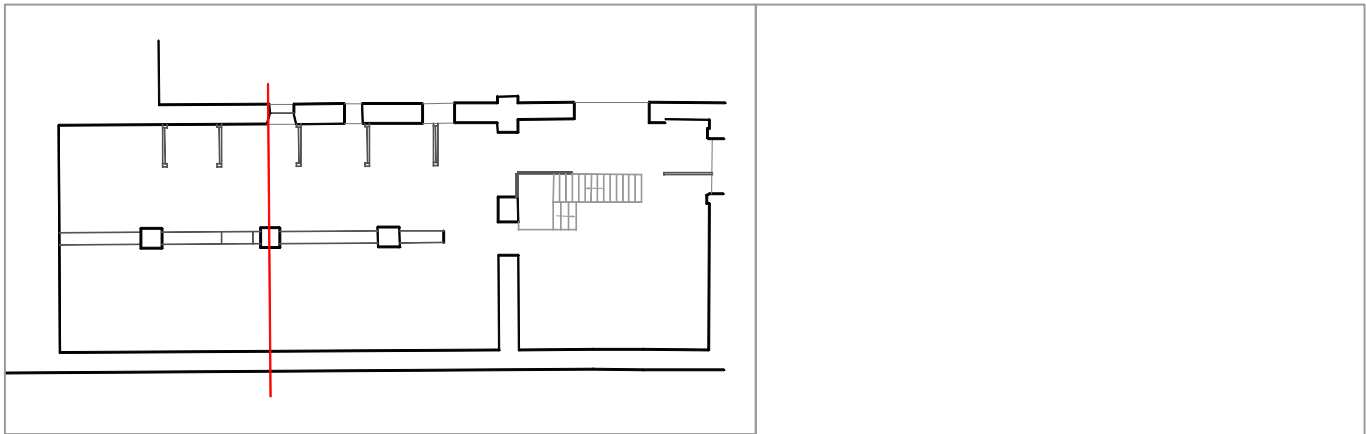
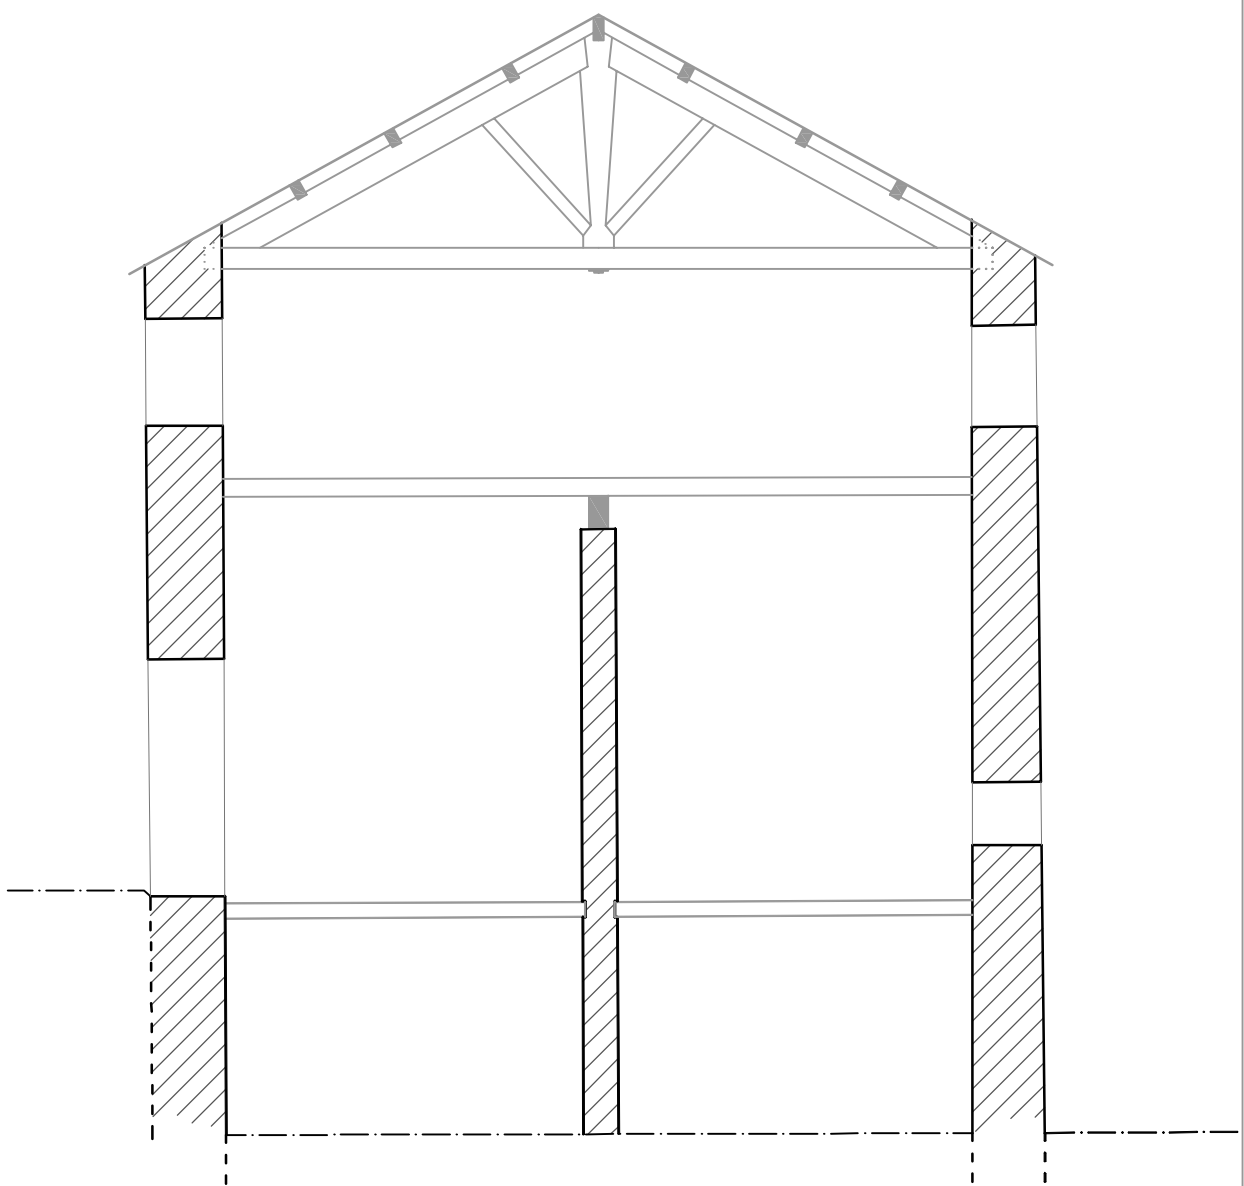
Fig 9: Second floor plan of the Warehouse

- 4.3.13 **Second Floor:** the second floor comprises an open space with a small timber partition at the east end. Access onto the second floor is through a door in the dividing wall between this building and the adjoining building to the west (Fig 9). The floor was entirely unsafe and so the observations made of this floor were minimal. The open roof is of seven bays, and is supported on six king-post trusses, which rest on the external walls (Fig 10). Within the trusses, the king-posts are bolted to the tie-beams and have diagonal struts, with a ridge board being entrenched within the king-posts. There are three entrenched purlins to each roof pitch (Plate 20).

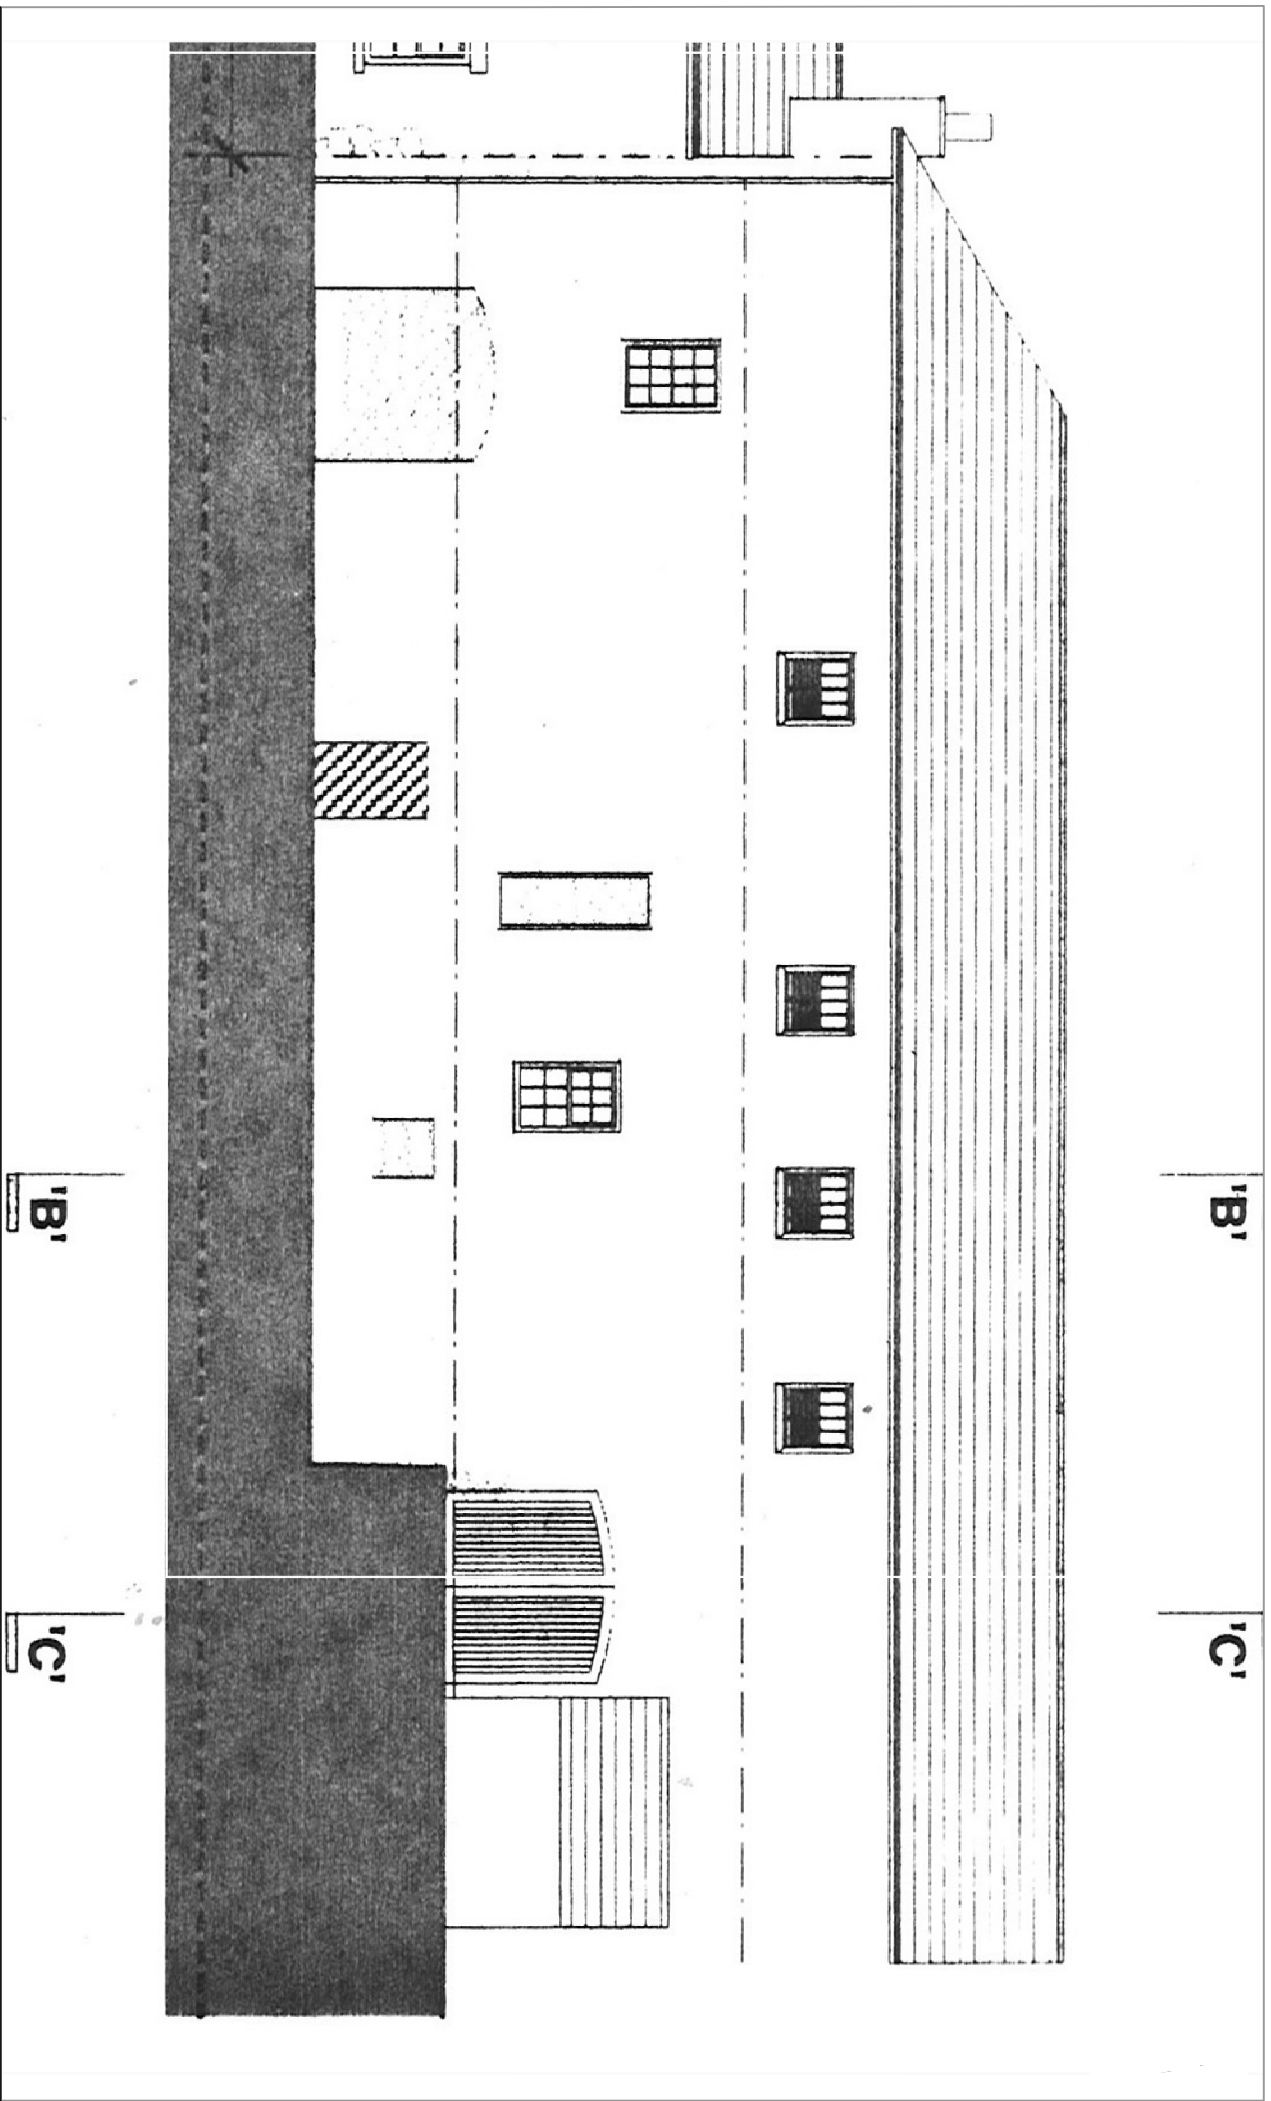
Figure 11 : North elevation of the Warehouse, reproduced from Architect's drawings

- 4.2.1 **Front (North) Elevation:** the front elevation of the building (north) faces onto the courtyard (Plate 7). There is no external evidence to distinguish between the end of the mill and the beginning of the warehouse. Access to the ground floor is through a double doorway under a large segmental sandstone arch; this is set within a much larger sandstone arch, which appears to have been infilled to allow the construction of the smaller archway. A window is placed centrally above the larger of the two arches. A blocked window and doorway (Plate 8) are evident at ground floor level, to the west of the doorway, and immediately to the west of these is a partially glazed window. The scar of a low roofline leads upwards in a westerly direction from this window, to the protruding wall of a small outshut (Plate 7), beyond which the ground level slopes upwards.

- 4.2.2 A double doorway with a sandstone segmental arch (Plate 9) provides access into the first floor from the higher end of the yard. The central area of this level comprises a blocked window, doorway and projecting concrete pad, all relating to the west range, now removed. The roof scar for the range can be seen immediately above these features extending up to the second floor (Plate 7).

- 4.2.3 There are four windows to the second floor, all of which are glazed at the top, with vertical wooden vents to the bottom. A further window to the left has been blocked. All have sandstone dressings, although the three windows to the right have larger lintels than those to the left.

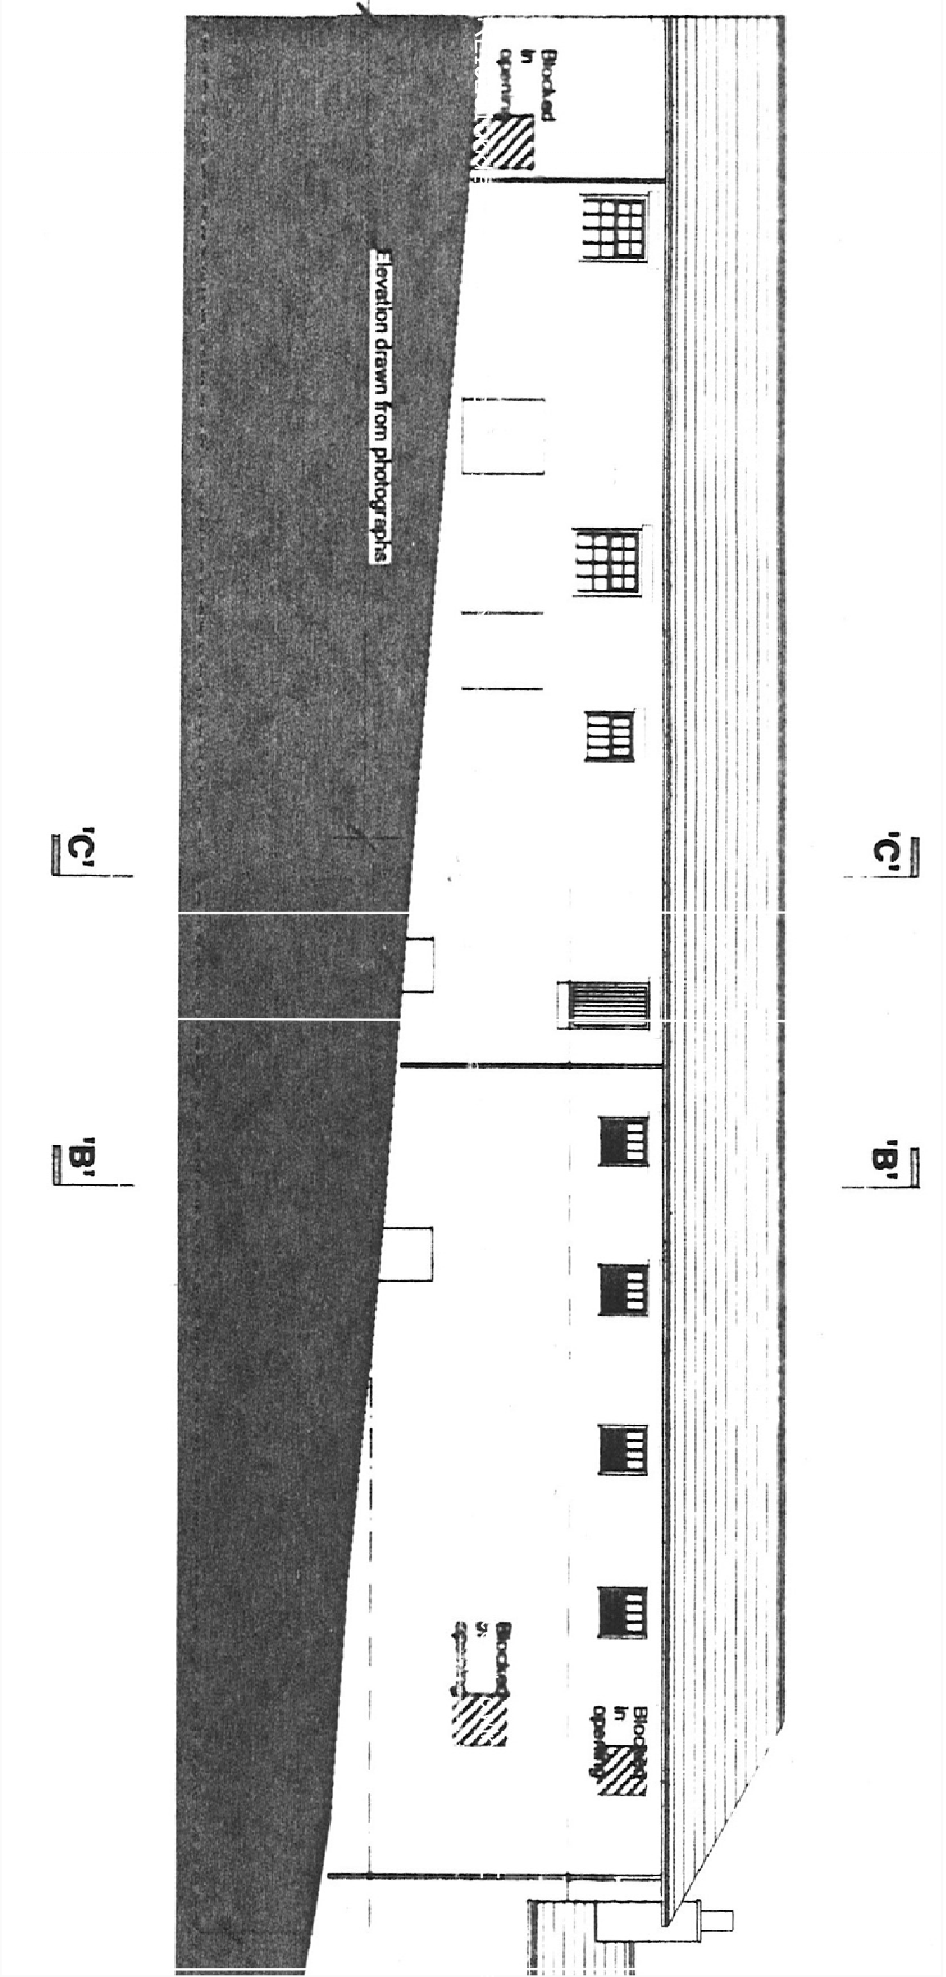
Figure 12: South elevation of the Warehouse, reproduced from Architect's drawings

- 4.2.4 **Rear (South) Elevation:** there is nothing within the external south wall to indicate the end of the mill and the beginning of the warehouse. Within this south-facing elevation (Plate 4) there are two small windows at external ground level providing light for the first floor. These have sandstone dressings and are currently unglazed. A blocked window is evident to the east end of the building; this is also within the first floor, being positioned higher than the other first floor windows. A line of slightly protruding stonework above the lower windows may represent a string course or construction break. A goods loading door and a row of four windows are present at second floor level. The windows have three fixed lights to the top with horizontal vents below. There is a further blocked window of similar dimensions to the right. A partial alignment of large blocks between the third and fourth windows (corresponding with the line of the roof truss), and extending for two stories almost certainly represents a line of repair (Plate 5).

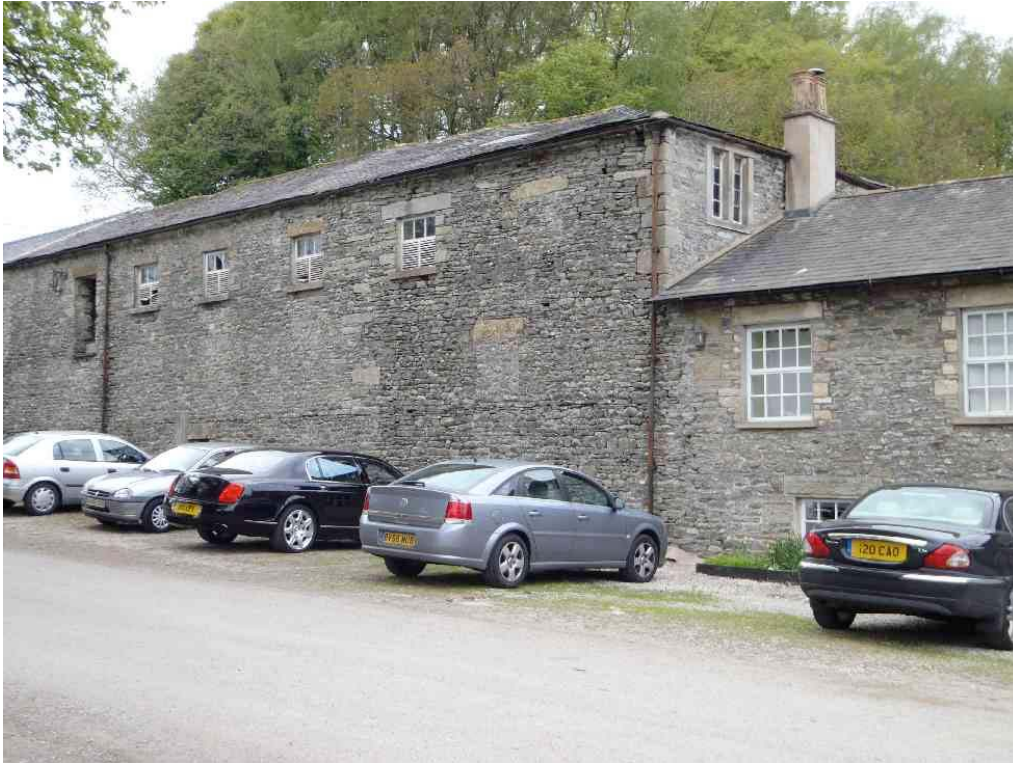
Plate 3: The south elevation of the warehouse, showing blocked windows and a central line of repair

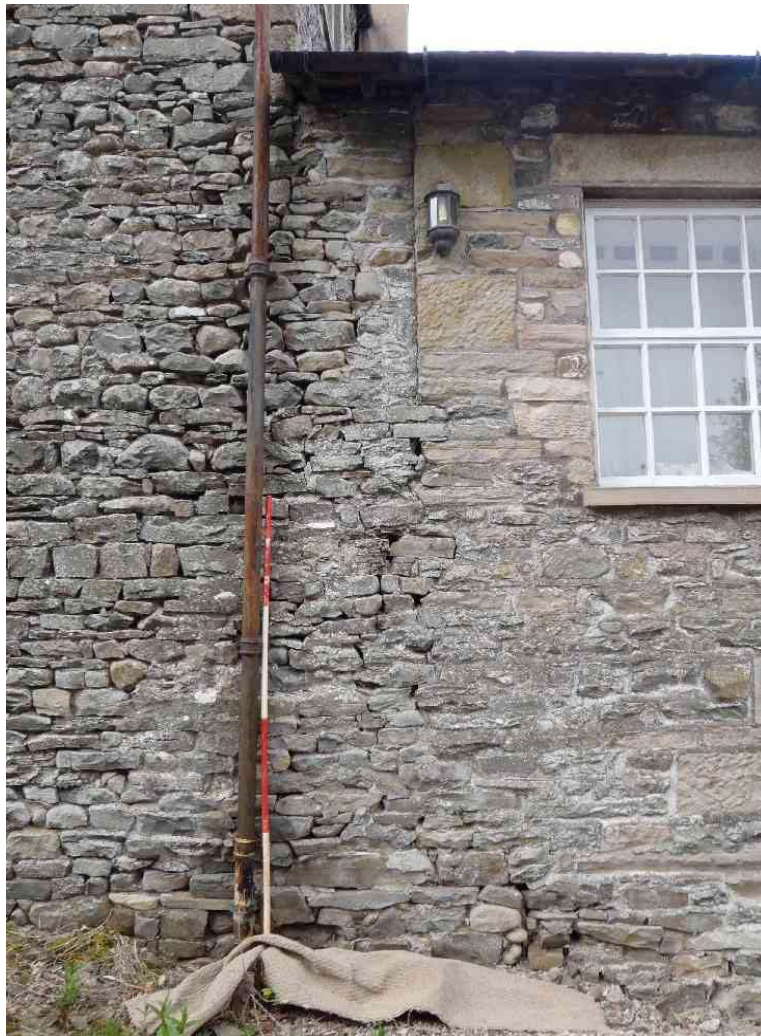
Plate 6: Quoins abutting the east end of the warehouse, suggesting it was originally detached at this end

- 4.2.5 Quoin stones are present to the top of the east end of the building, stopping at the roof line of the adjoining building. Further quoin stones are evident at window height beneath the roofline of the lower building, but these do not extend all the way down the wall (Plate 6), and are offset from the upper end wall of the warehouse. This suggests that the upper end of the warehouse has been shortened slightly, and rebuilt, and possibly relates to the repair seen between the third and fourth windows (*Section 4.2.4* above).

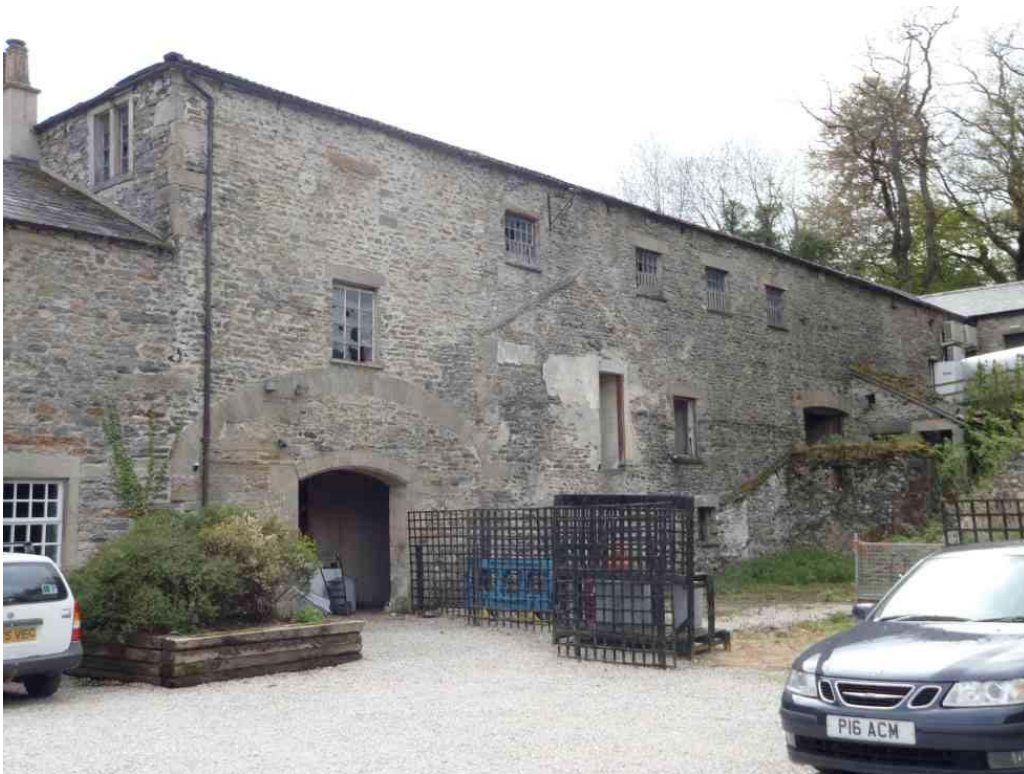
Plate 7: Front elevation (north-facing) showing doorway set within large stone arch, and scar for the former north range

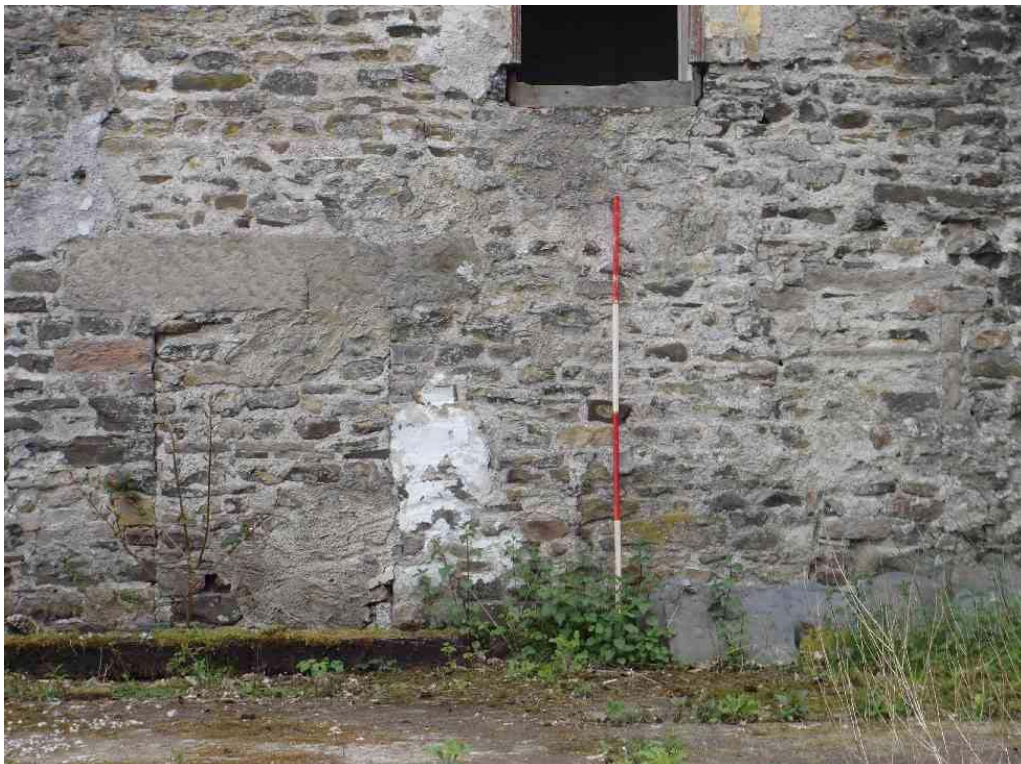
Plate 8: Blocked door and window within front elevation, with the entrance to self-contained first floor room just visible above

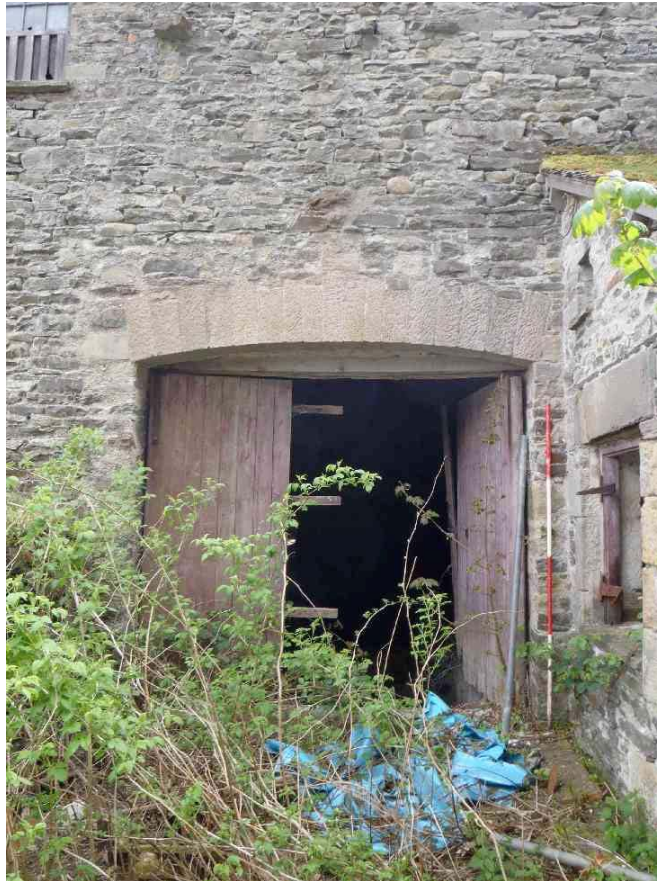
Plate 9: Segmental arch doorway into main first floor room, west end

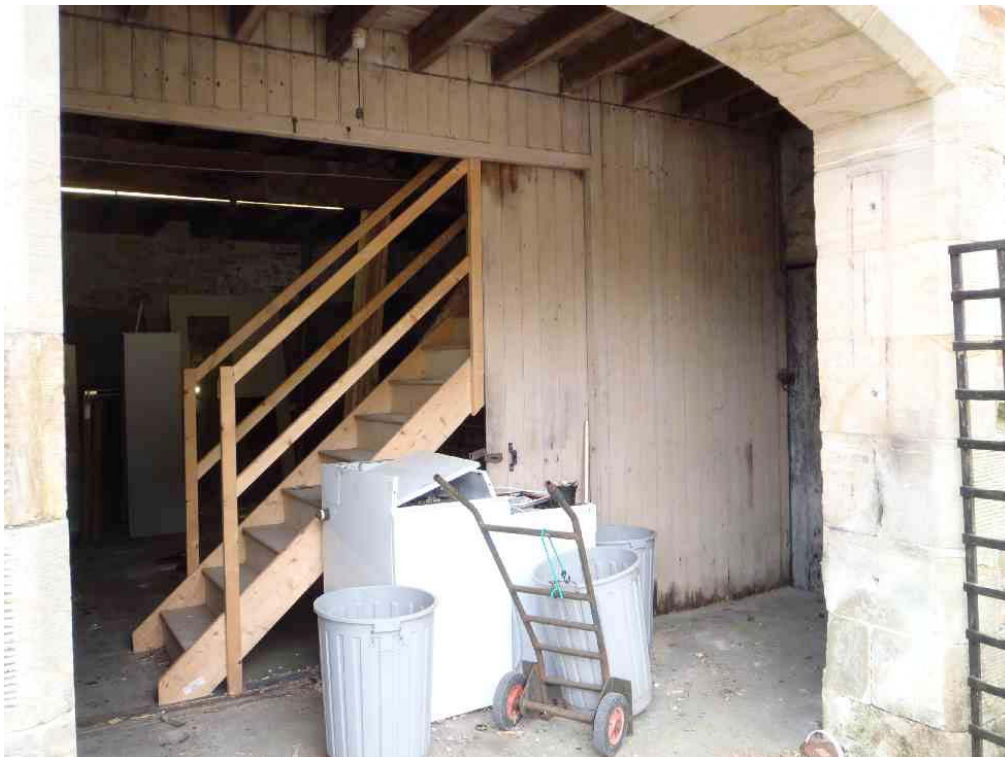
Plate 10: View through ground floor entrance to warehouse, east end

- 4.3.2 **Ground floor:** access to the ground floor is through the large doorway in the north wall (*Section 4.2.1*, above). The entrance is open, although hinge pins within the stonework suggest doors originally hung within it. Lying directly through the arch is a timber partition for the dog-leg staircase leading to the first floor (Plate 10). The room beyond the doorway is partially rendered and painted. To the east is a blocked arch beneath a large segmental arched stone surround with central keystone (Plate 11). One of the voussoirs is marked with the graffiti 'A B'. The joists for the floor above obscure the top of the arch. The shape and size of the archway suggest it provided external access rather

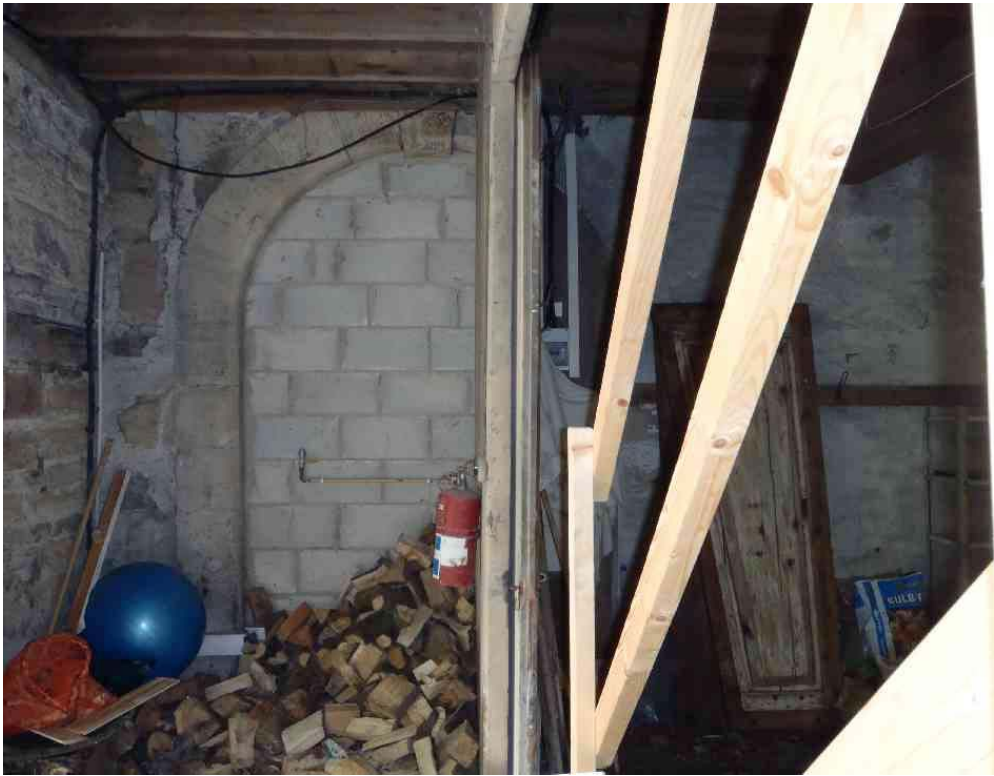
Plate 11: Blocked arch in the east elevation of the warehouse

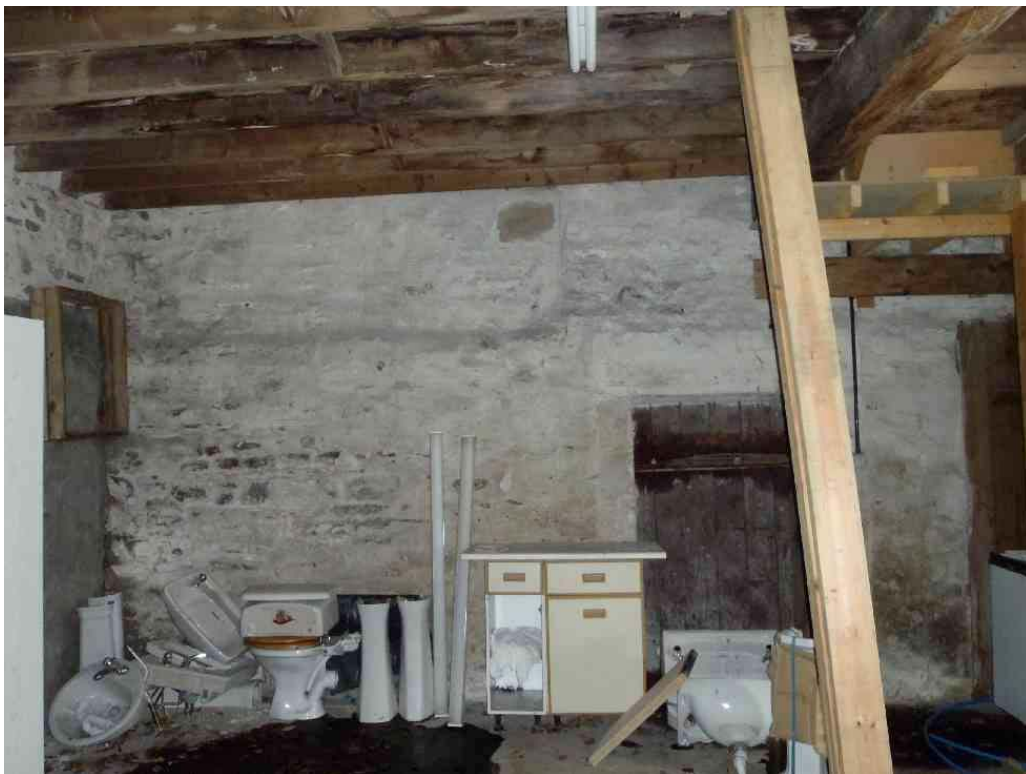
Plate 12: ground floor, west end, showing door into the eastern end

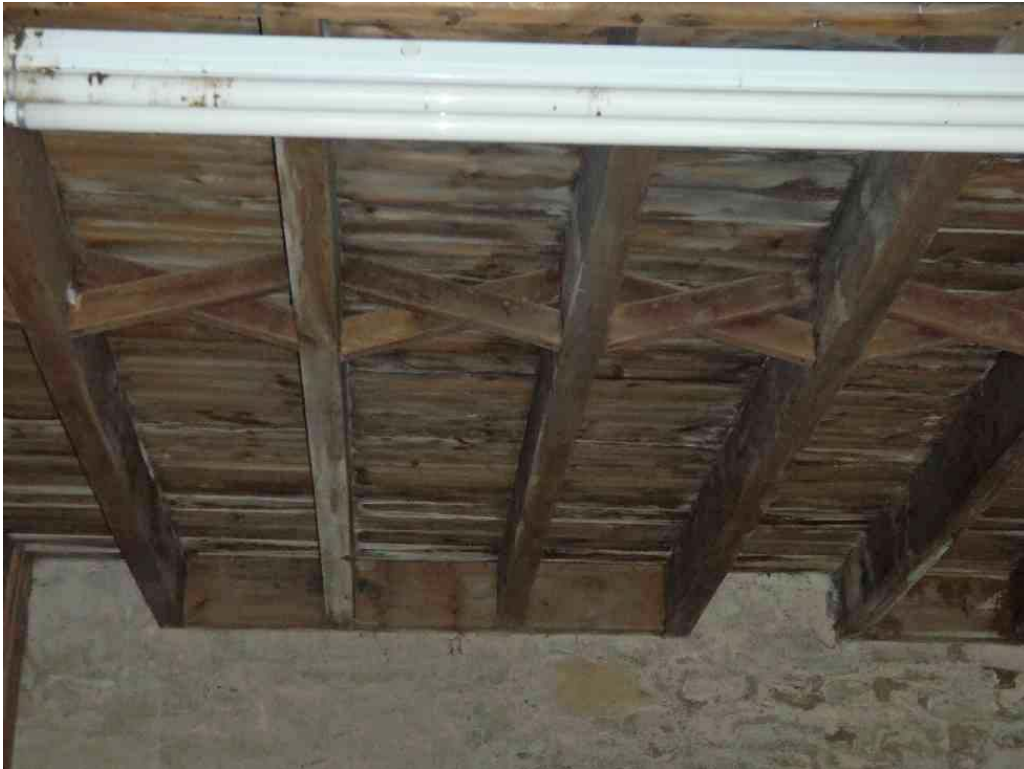
Plate 13: Herringbone struts between first-floor floor joists

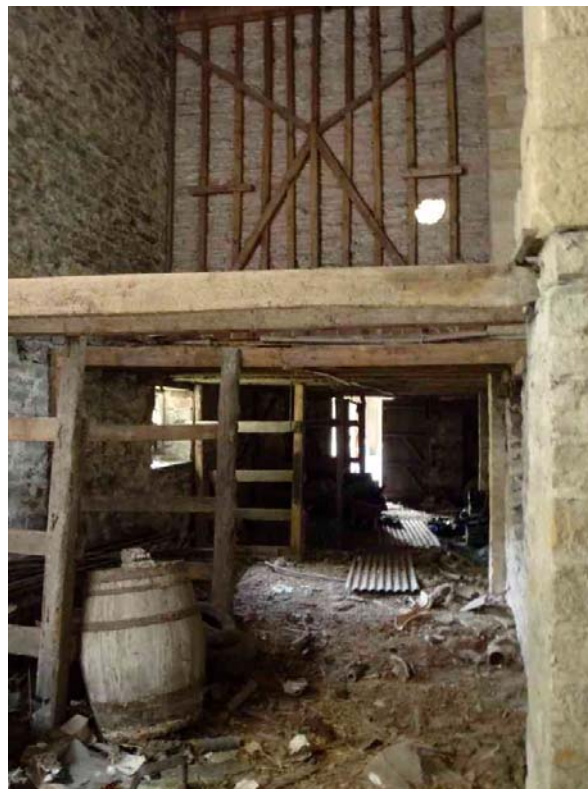
Plate 14: Northern half of the ground floor, showing timber storage bays, and the self-contained room above

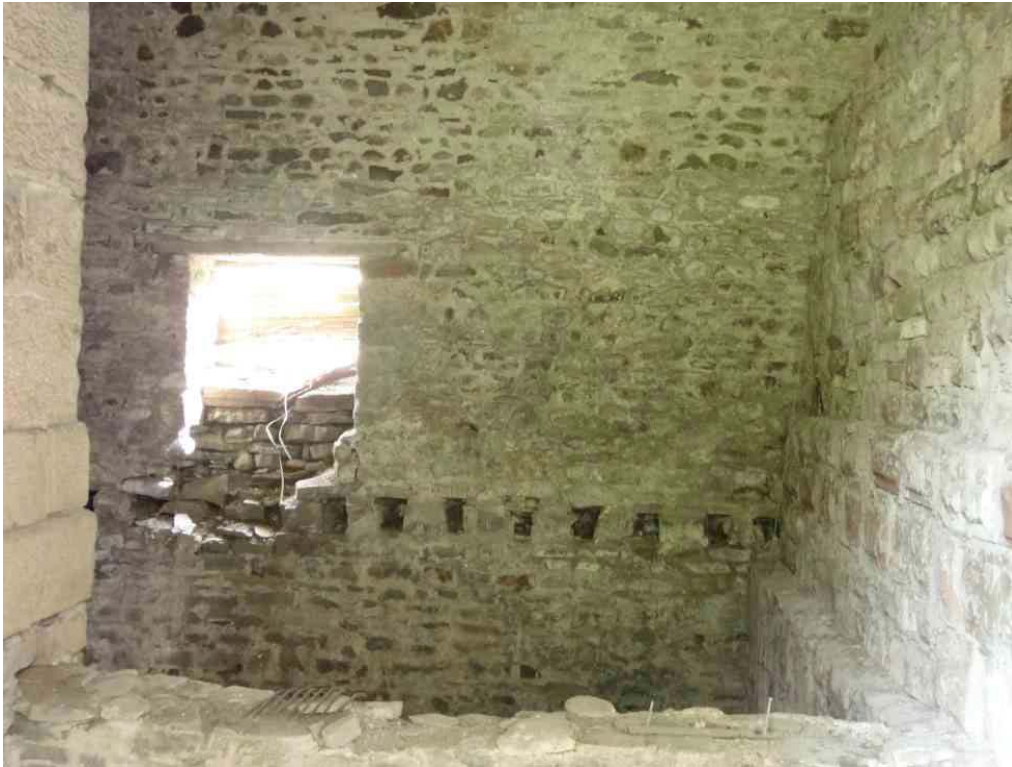
Plate 15: The joist sockets and associated sill within the adjoining wall, indicative of a former floor, first floor (east end)

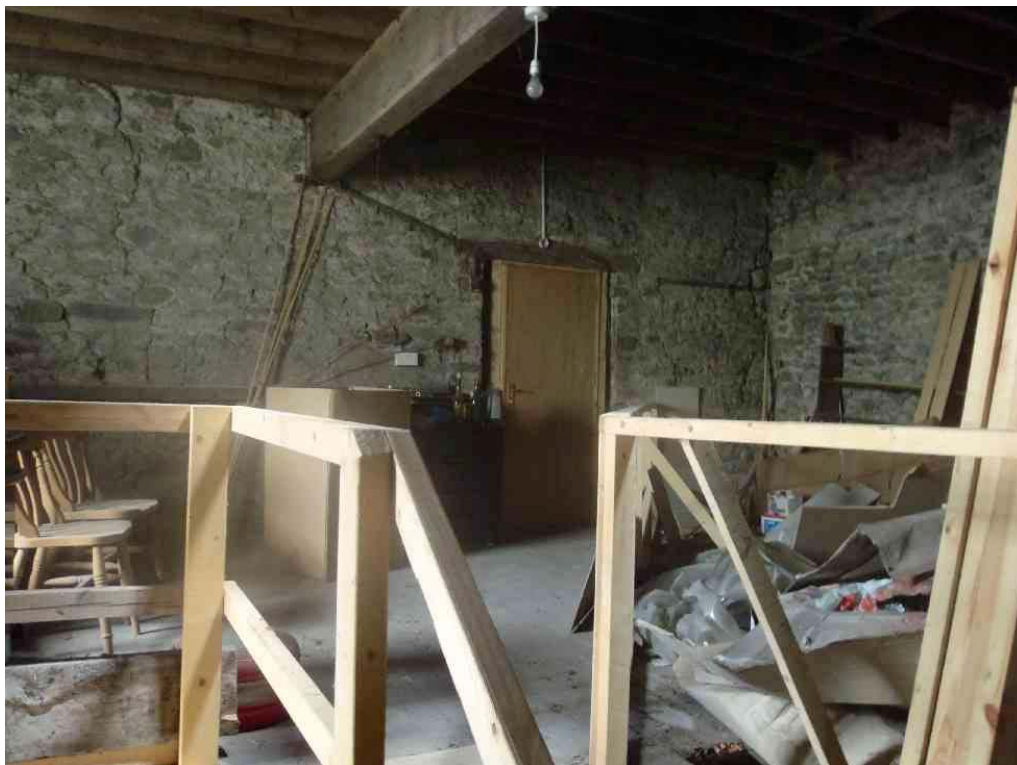
Plate 16: East end of the first floor with doorway into the adjoining building

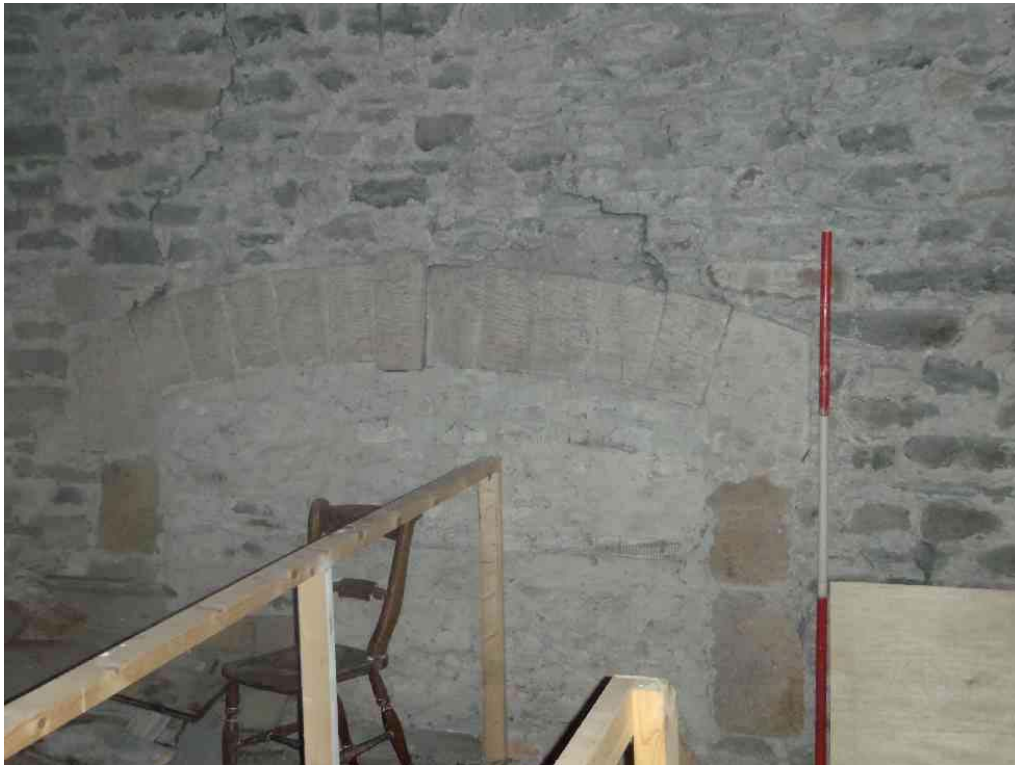
Plate 17: Voussoirs of blocked arch in the dividing wall between the east and west ends of the warehouse, at first floor height

- 4.3.10 The east elevation houses a doorway under a timber lintel just offset to the right of the centre of the wall. An ill-fitting and smaller, timber doorframe has been inserted into the aperture. A large stone lintel was observed just to the north of the doorway, which may represent the rear of a fireplace from the adjoining building, or possibly a blocked window. On the opposing wall (the dividing wall between the first two and last five bays) the upper section of a

large sandstone segmental arch was observed (Plate 17). The current floor level is such that it bisects the doorway at half height. Although the arch is flatter, it is not dissimilar in style to that on the ground floor (Section 4.3.2).

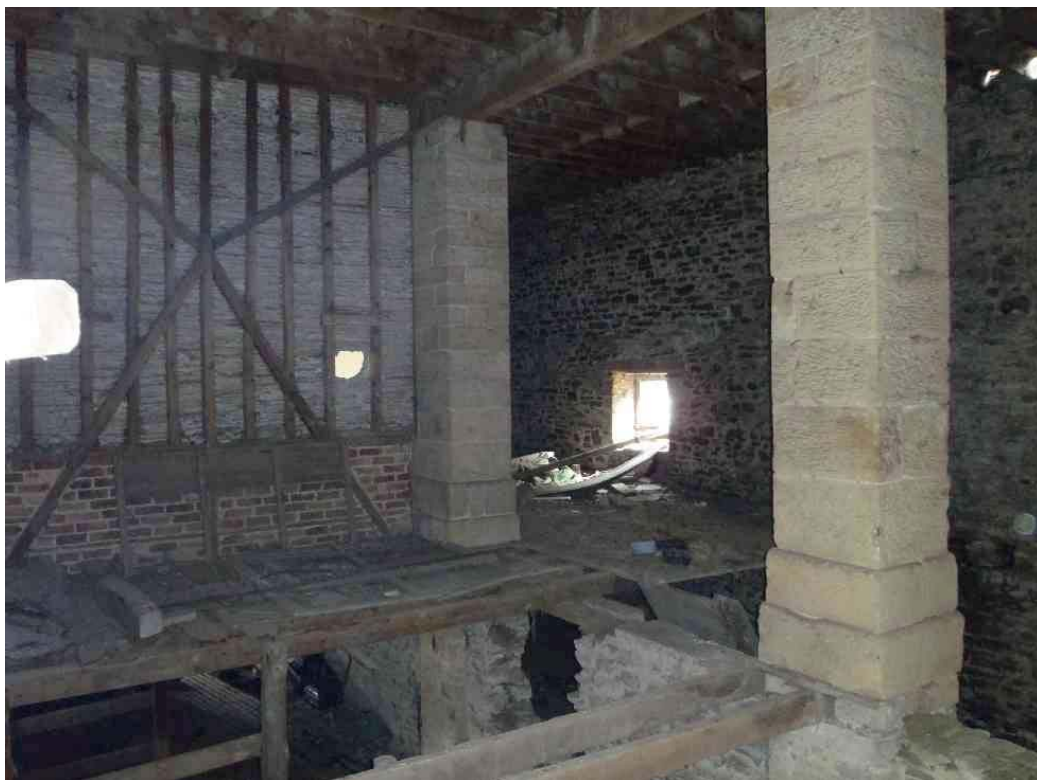
Plate 18: First floor viewed from safe access at the east end. The partition wall is part of the self-contained room relating to the former north range

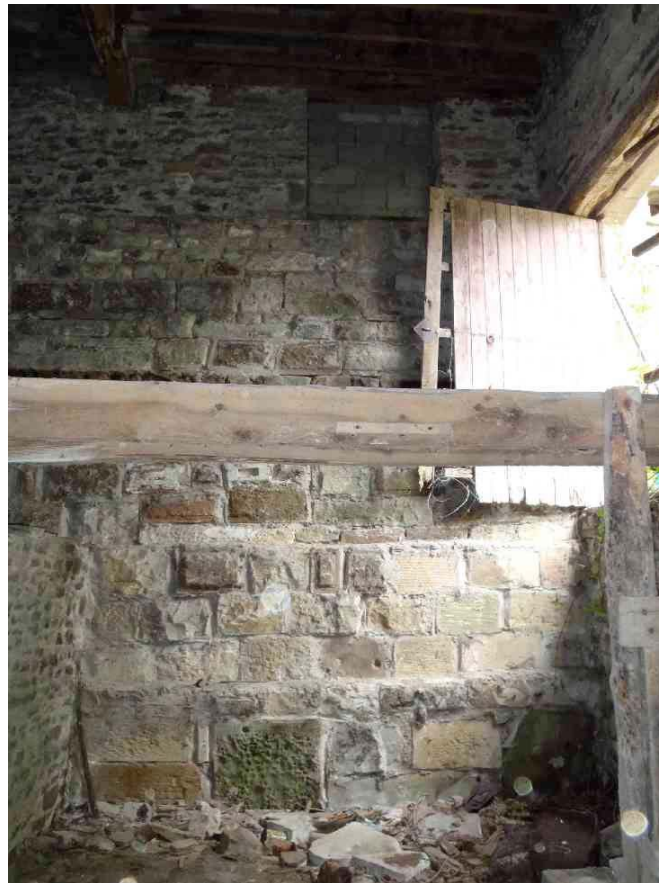
Plate 19: Large hewn stone blocks within internal 'end' (west) wall of the warehouse

- 4.3.12 A projecting sill and infilled sockets in the stonework of the upper section of the rear wall (south) were observed. This suggests that the level of the second floor above was raised. The main body of the west wall comprises large stone blocks, rather than the roughly-coursed stonework seen elsewhere (Plate 19). This steps out from the coursed stonework above, and either represents a rebuild or repair. Above this, a small aperture has been infilled with cinder blocks. This is likely to have been a window or small opening between the two buildings.

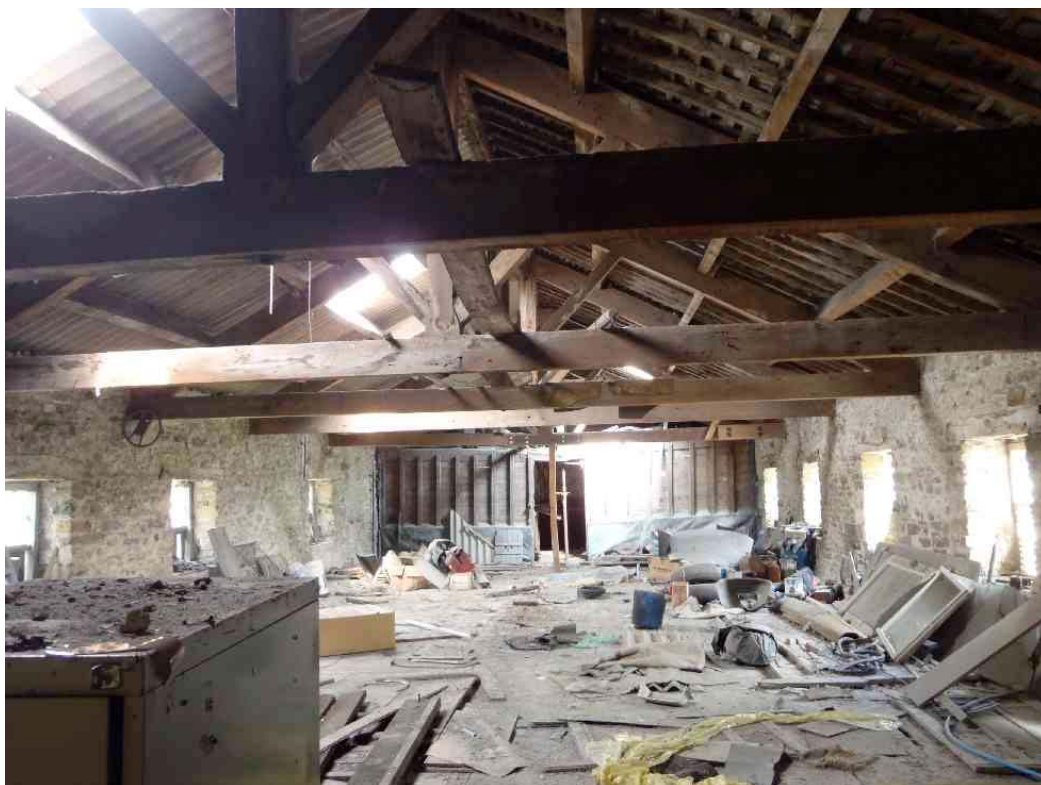
Plate 20: Second floor of the warehouse showing timber partition room at far end
