THE WAREHOUSE (PHASE 1 BUILDING), UNDERLEY HOME FARM, KEARSTWICK

Archaeological Building Investigation

Oxford Archaeology North

September 2010

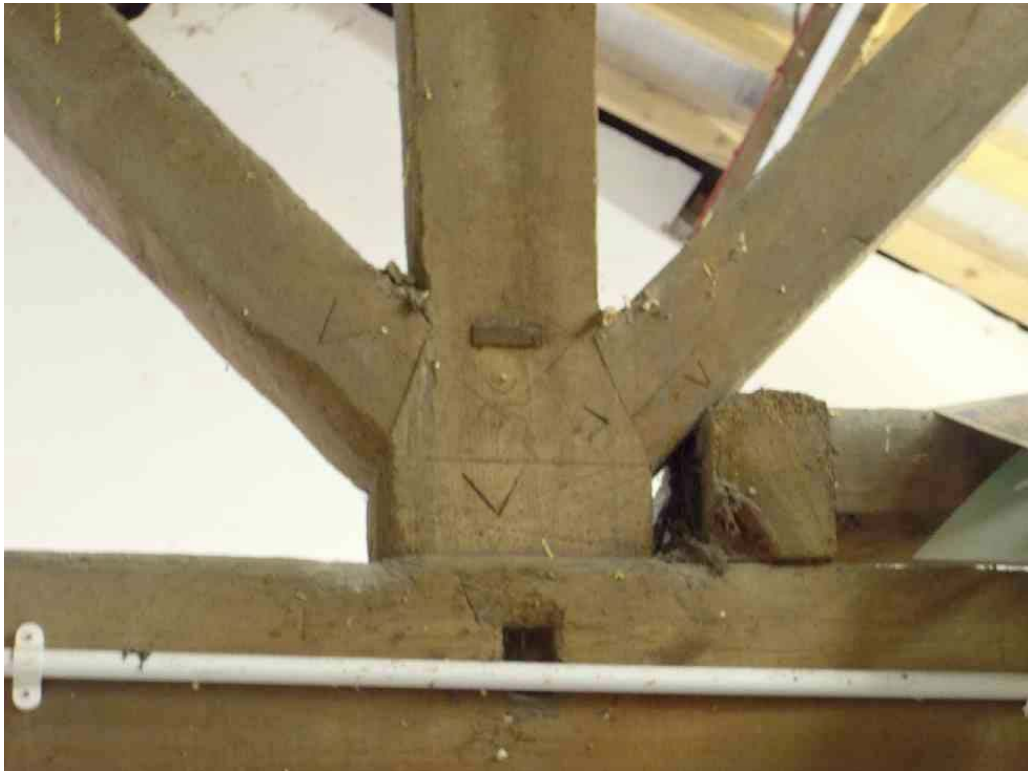
Plate 21: Truss within the mill marked on the upper face with a 'V'
