University Botanic Gardens

High Street Oxford

Document Title: The Well, Botanic Gardens, Oxford

Document Type: Historic Building Investigation and Recording

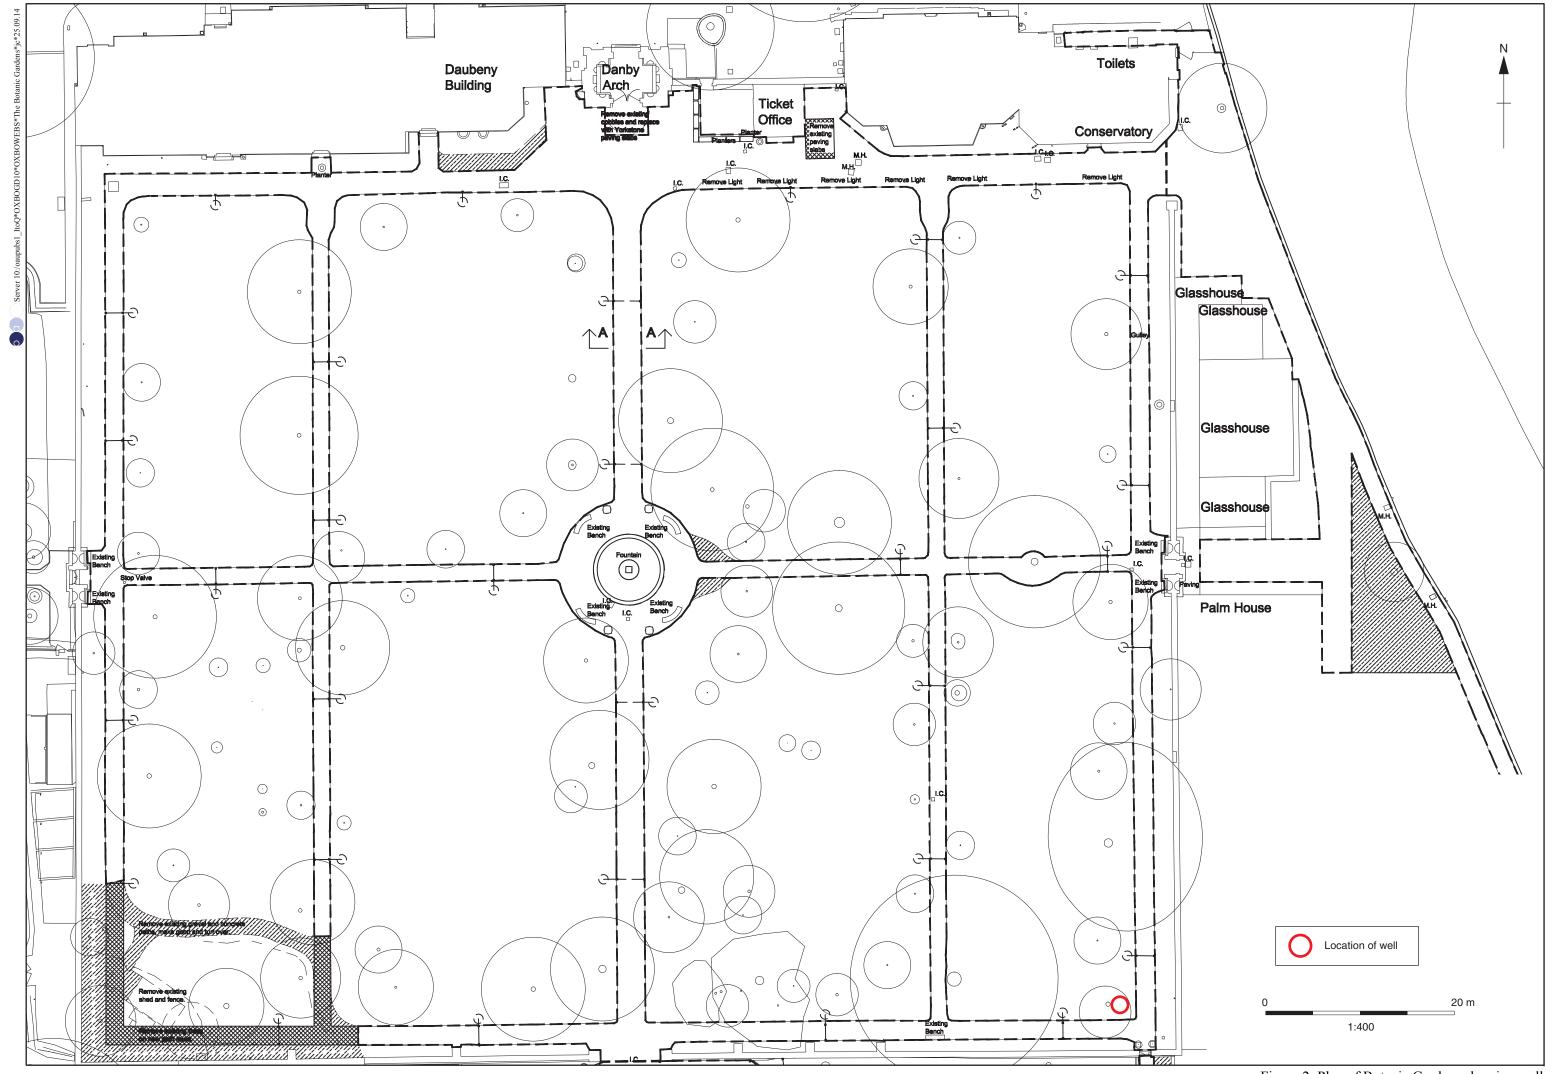
Figure 2: Plan of Botanic Gardens showing well

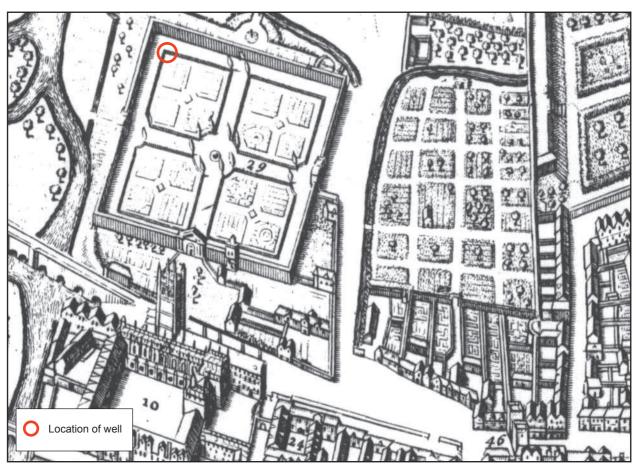
- 2.2.11 The main early map which shows the Botanic Garden is the map of Oxford by David Loggon dated 1675. This is useful in showing the overall layout of the garden with the entrance gateway and the courtyard divided into four quadrants but it does not show any well or similar feature in the southern corner of the garden which forms the main focus of the current study. The scale and nature of this map means that it is unlikely that a small feature such as a well would be shown.

Figure 4: Loggan's map of 1675

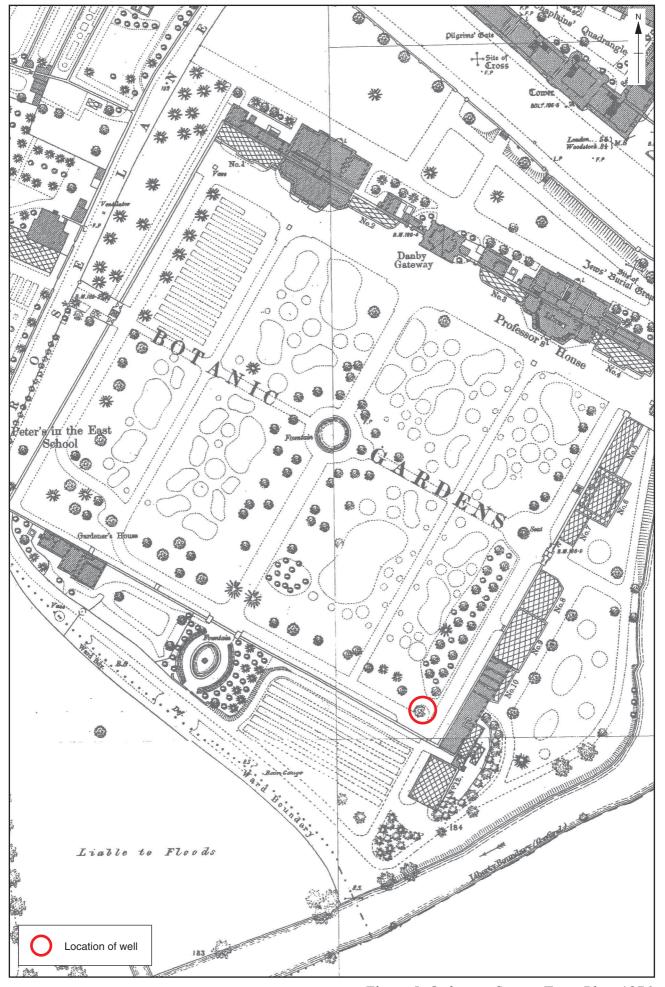
- 2.2.12 The first edition Ordnance Survey Town Plan of 1876 is of more interest in relation to the current study due to its high level of detail (1:500) and the fact that this map would normally show features such as pumps and wells. At the southern corner of the walled garden, close to the junction between the paths there is a distinct horse-shoe shaped projection where the path surface (gravel?) extends slightly into the lawn or shrubbery. This is at the location of the well uncovered in the current works and it presumably relates to it but the map shows a tree in this location. It is likely that the projection formerly extended around the well but at some point prior to 1876 the well became disused and the tree was planted at this point in its stead, possibly to form a simple cap.

Figure 5: Ordnance Survey Town Plan, 1876

- 4.1.3 The well is not shown on historic maps but the detailed Ordnance Survey Town Plan from 1876 suggests that the path extended around this point with a distinct horse-shoe shaped projection. The well itself is not shown or labelled here and instead there is a tree

marked in this location. It seems likely that the horse-shoe shaped projection was originally formed to provide a gravel surface around the well but that the well was removed at some point before 1876 and it was replaced by a tree, possibly in order to form a type of capping over the void.

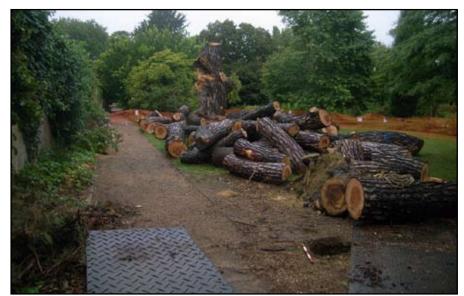
Plate 1: General view showing well in nearground and felled tree

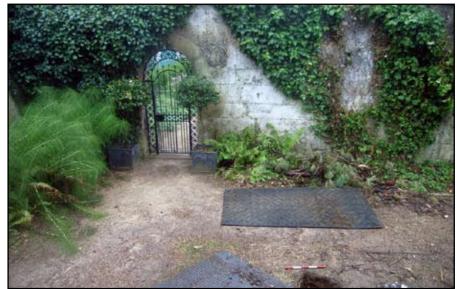
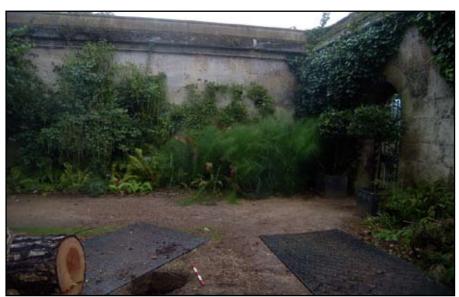
- 3.1.1 The well is located towards the southern corner of the Botanic Garden's main walled garden, to the south-east of the Black Pine tree which has recently been lost. It is within a grassed area just inside (ie to the north of) the junction between the paths at this corner. The southern edge of the well is c.3.95 m to the north of the southern garden wall and the eastern edge of the well is c.5.25 m to the west of the east garden wall. It is c.1.3 m in from the edge of the east path and c.35 cm in from the edge of the southern path.
- 3.1.2 As outlined above arboriculturalists working in this area exposed the well, the existence of which was previously unknown. Only a relatively small hole within the ground surface (40 x 40 cm) had been created but this had exposed the larger void of the well beneath.

Plate 3: Exposed well in relation to south corner of courtyard

Plate 4: Exposed well in relation to south corner of courtyard

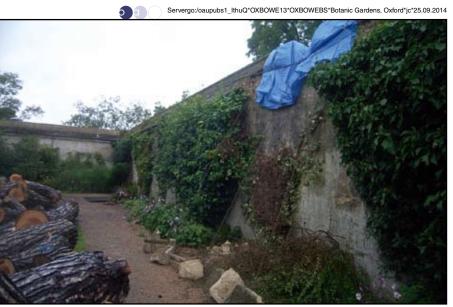
- 1.1.3 The Black Pine tree was the largest and most important tree at the Botanic Garden and it is believed to be over 200 years old. It had strong associations with JRR Tolkien and the last photograph of the author was of him standing with his hand against the trunk. The tree collapsed while a cultural event was being set up around it and while musicians were preparing beneath its branches. The main limb of the tree came away from the trunk and collapsed onto the nearby stone wall, dislodging several coping stones.

Plate 2: Wall showing damaged area where tree collapsed

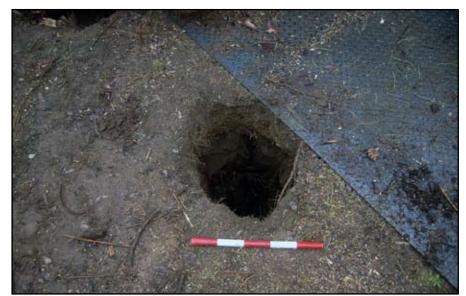
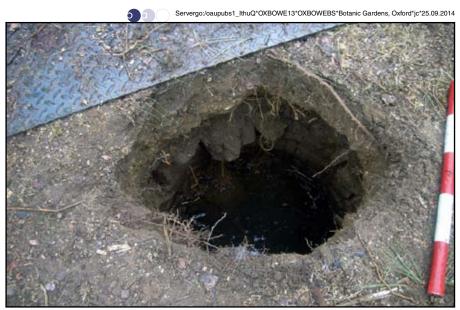
Plate 5: Hole in ground surface showing exposed well

Plate 6: Hole in ground surface showing exposed well

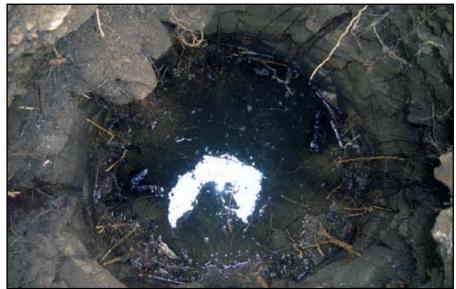
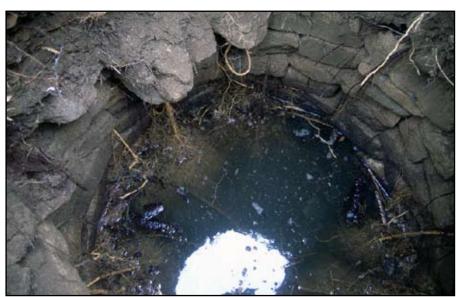
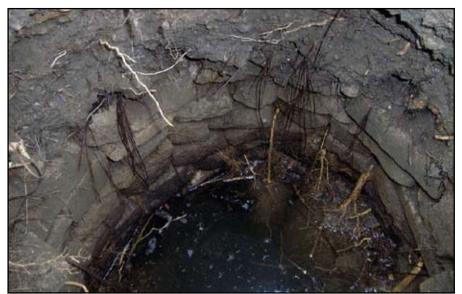
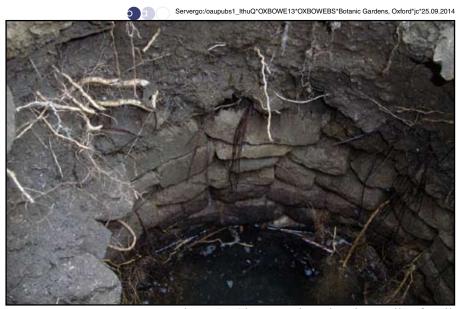
- 3.2.1 The well has an irregular, broadly circular plan form, c.85 cm in diameter, and it is lined in roughly coursed stones. A pool of water remains in the well with the surface 1.05 m below the ground level and measurements were taken to show that the water continues down to a depth of c.2.8 m below ground level. This measurement was taken by dropping a stone into the well tied to a rope. At c.2.8 m below ground level the stone reached what felt like a soft silty surface although presumably although the well is likely to be deeper the lower part is full of sediment

- 3.2.2 The stones are generally c.8-10 cm tall by c.12-15 cm long although some isolated stones are slightly longer or shorter. There were c.5-6 courses exposed above the water line.

- 3.2.3 The main coursed stonework is c.50 cm below the ground surface and above this there is a layer of rough stones which partly overhang the top of the well and which may once have formed part of a crude dome or cap over the well. Above this and below the topsoil is a layer of hardcore and pebbles.

Plate 7: Close-up view showing walls of well

Plate 8: Close-up view showing walls of well

Plate 9: Close-up view showing walls of well

Plate 10: Close-up view showing walls of well
