Yarnton Nurseries
Sandy Lane
Yarnton
Oxfordshire

**Archaeological
Evaluation Report**

Issue No: 1
OA Job No: 5562
NGR: SP 4758 1319

Evaluation report

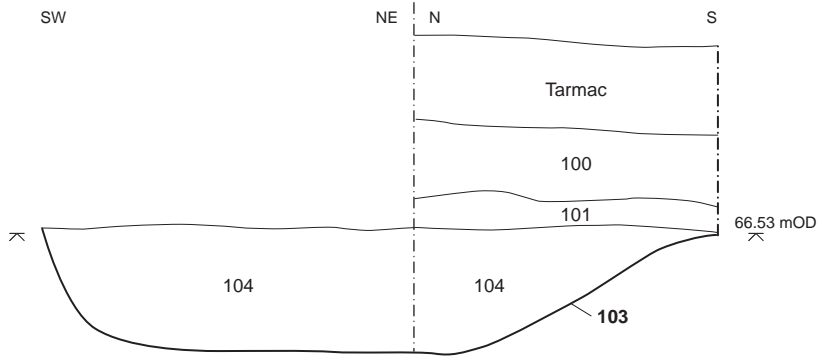
Section 100

3.4.1 Trench 1 contained a possible ditch terminus (103) (Figs 2 and 3). This was orientated NE-SW and was steep-sided with a flat base. It contained a light reddish brown fill but no artefacts were recovered.

Trench 1						
General description					Orientation	N-S
Trench contained probable ditch terminus and several natural features. No finds.					Avg depth (m)	0.52
					Width (m)	30
					Length (m)	1.6
Contexts						
Context number	Type	Width (m)	Depth (m)	Comment	Finds	Date
100	layer	-	0.2	Buried modern topsoil, dark brown clayey sand	-	modern
101	layer	-	0.08	Buried modern subsoil, reddish brown clayey, pebbly sand	-	-
102	natural	-	?	Light yellow brown to reddish brown pebble/sand 'gravels'.	-	-
103	cut	0.75	0.35	Cut of possible ditch terminus. Steep sided, 'U' shaped profile slightly inclined base.	-	-
104	fill	-	0.35	Fill of ditch 103. Reddish brown silty sand.	-	-
105	void				-	-
106	void				-	-
107	layer	-	0.09	Compacted pebbles, tarmac fragments. Car park surface.	-	modern
108	layer	-	0.16	Hardcore. Light yellow brown stones, bricks, coarse sand levelling deposit.	-	modern
