St Mary's Church Aldworth West Berkshire

Archaeological Watching Brief Report

November 2006

Document Type: Watching Brief

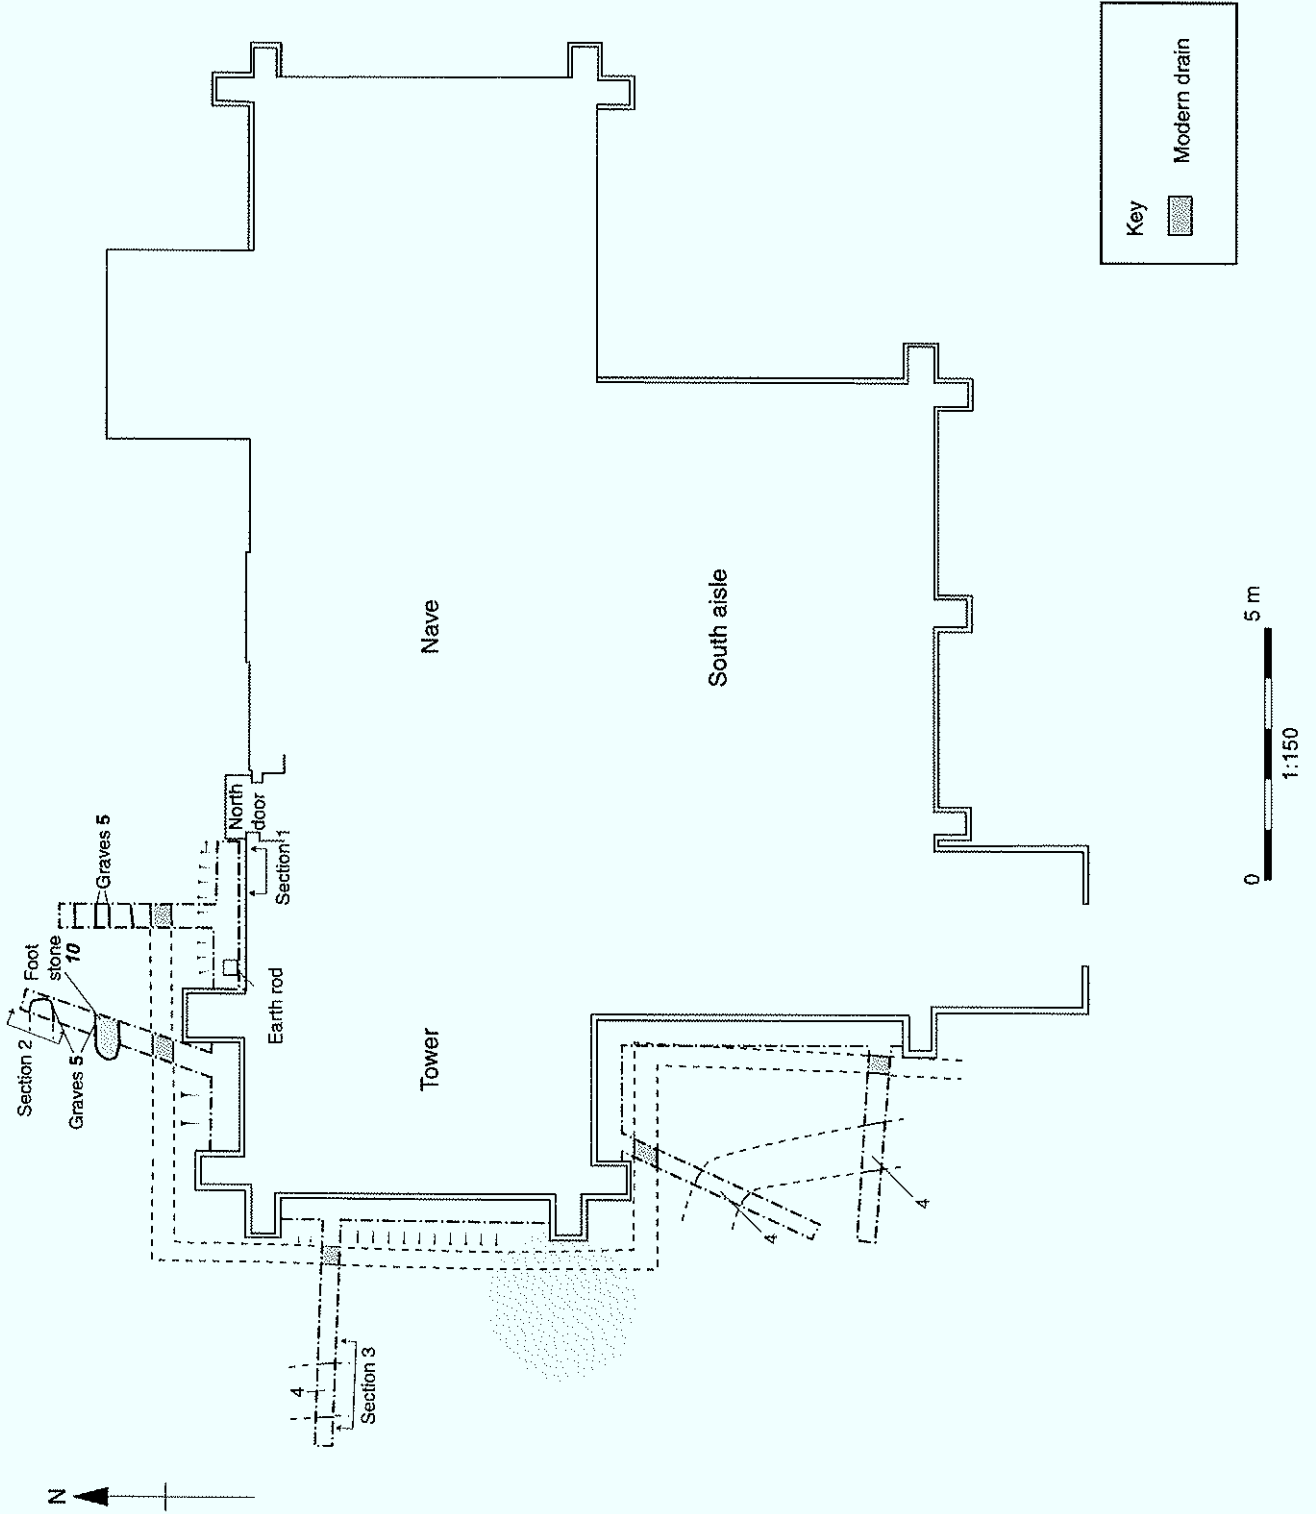
Figure 2: Site plan

- 3.1.1 The drainage channel around the north and west side of the church was 0.45 m wide and dug to a depth of 0.45 m from below the church floor level. On the north side this cut into the natural chalk (3) at 0.7 m below ground level. This was sealed below a 0.4 m to 0.5 m thick layer of disturbed graveyard soil of reddish brown silty clay (2) with chalk. This had been cut by five graves (5) partly exposed in the drain trenches but the burials lay below impact level. The graves had vertical sides and measured 0.4 m long, 0.40 - 0.45 m wide and were cut to a depth of 0.9 m with a fill of light reddish brown silty clay (6) with chalk backfill. One of the graves just north of the tower had a small foot stone (10) laid on its back on the grave, which dated to 1821.

- 3.1.2 On the west side of the church overlying the disturbed graveyard soil (2) was a compacted chalk and gravel path (4) leading from the south door to the graveyard at the rear of the church. These features had all been sealed by a 0.20 m thick very dark grey brown silty clay loam (1) topsoil.

- 3.1.3 Along the wall faces the trenches exposed the foundations of the church. These had been exposed during the re-pointing and construction of the tower buttresses in the 19th century during restoration work. The remains of a brick drain against the north church wall was exposed and a 0.20 m thick foundation (8) of trench filled mortar and flint rubble. The foundation (9) on the west side of the tower was different with a 0.10 m wide off set and 0.20 m flint and mortar construction similar to the wall (7) above.
