# **NEWLAND FURNACE, NEWLAND, Cumbria**

## **Archaeological Survey**

**Oxford Archaeology North**

February 2008

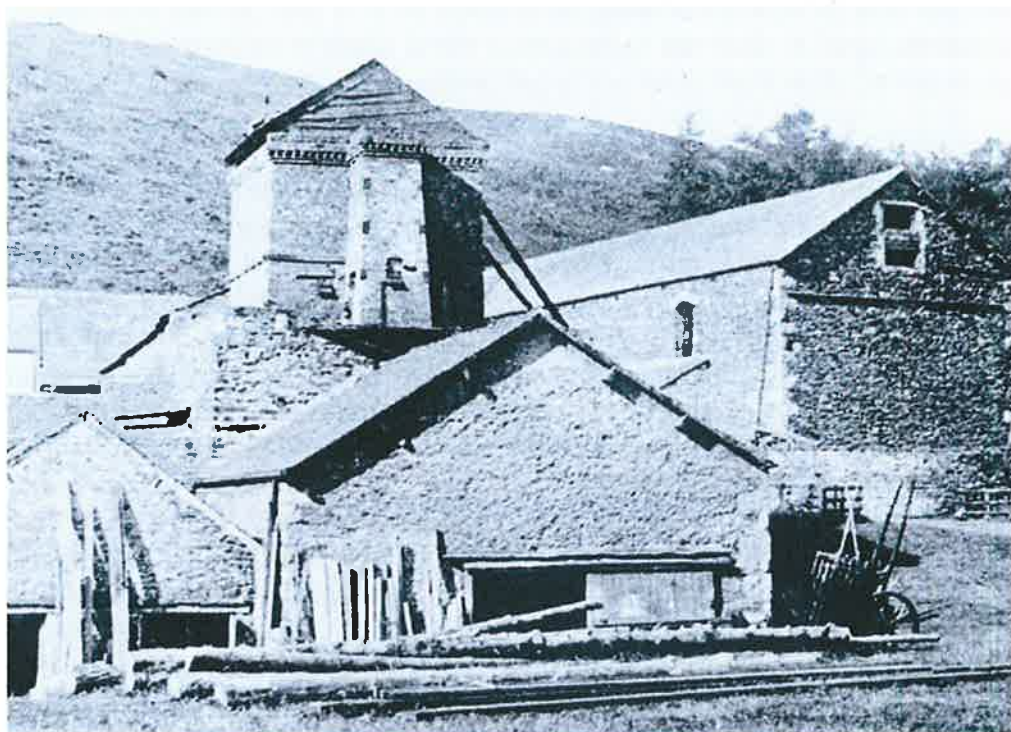
*Photograph of the Newland Furnace published in the North Lonsdale Magazine, 1897*

- 4.2.3 Elements of what was probably the heat exchanger mechanism are shown clearly on the late nineteenth-century photograph of the furnace, abutting the eastern side of the stack. Physical evidence identified during the survey included butt joints in both the stack wall and the parapet wall (Plate 8). The basal course of its southern elevation was also exposed, cutting through the parapet wall, demonstrating that it was a later addition.

- 3.2.8 There is evidence to show that the furnace underwent some modification and that different fuels were experimented with towards the end of the nineteenth century, suggesting that some problems were experienced in securing an adequate supply of charcoal. Modifications to the furnace included the installation of iron blowing cylinders, perhaps during the early nineteenth century (Marshall *et al* 1996, 199), an extension to the upper furnace stack, and the installation of a water-powered charging hoist. In 1873, the furnace was described as being in the process of 'converting into hot blast' (Griffiths 1873, 267), a system for the re-heating of furnace gases. The *Barrow Times* of 15 November 1879 noted that 'compressed turf, etc' had been tried by the Newland Company as a fuel, although it would seem that this experiment was unsuccessful as in 1875 it was observed that the Newland furnace 'has undergone considerable repairs, and coal and coke have been substituted for charcoal' (Mannex 1876, 163). In a slightly later trade directory, Mannex states that the 'considerable alterations' were begun in 1874 (1881, 249); the external appearance of the furnace subsequent to these modifications was captured on a photograph taken several years after the closure of the works, and published in the *North Lonsdale Magazine*, October 1897 (Section 4.2.3 below). This photograph shows the extension to the upper furnace stack.

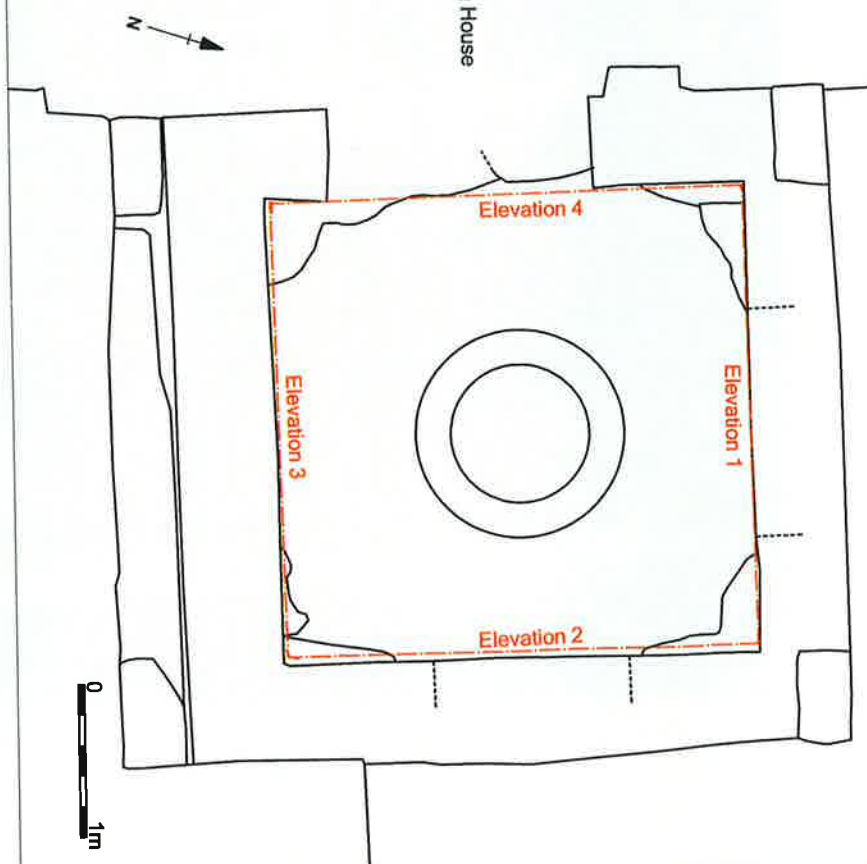
Figure 2: Elevations of the exposed stack walls

Elevation 1: North elevation

Elevation 2: East elevation

Elevation 3: South elevation

Elevation 4: West elevation

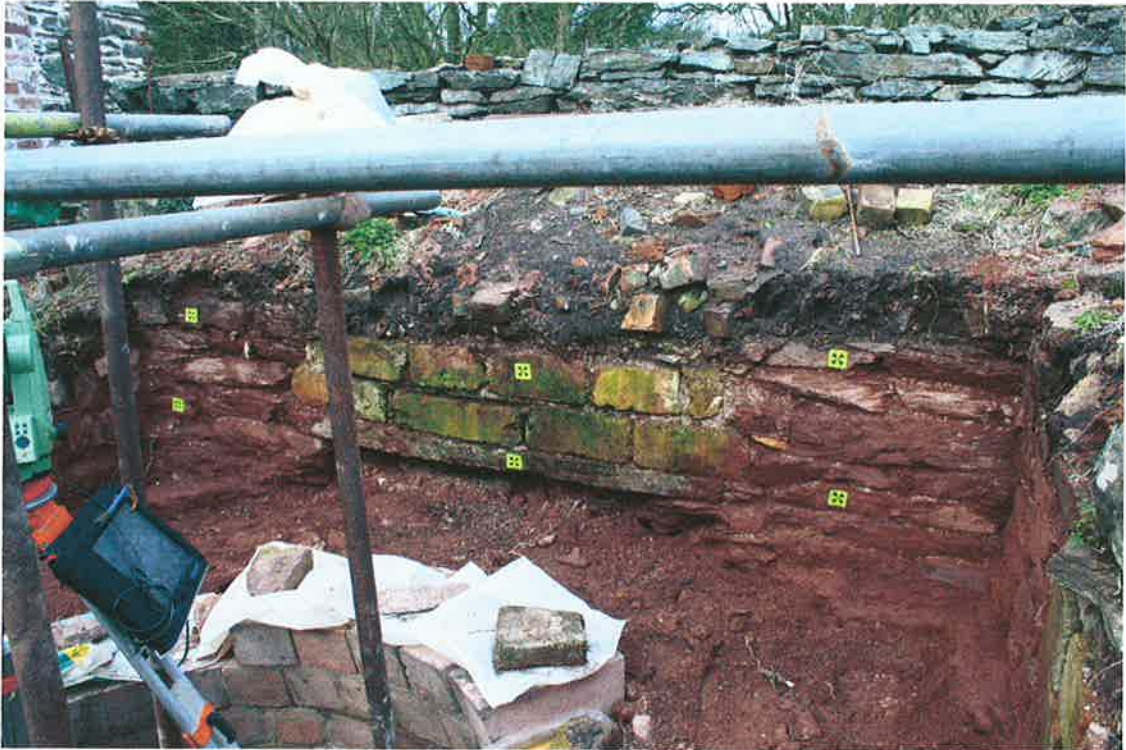
Plate 1: North elevation of the furnace stack, showing the overburden atop the wall

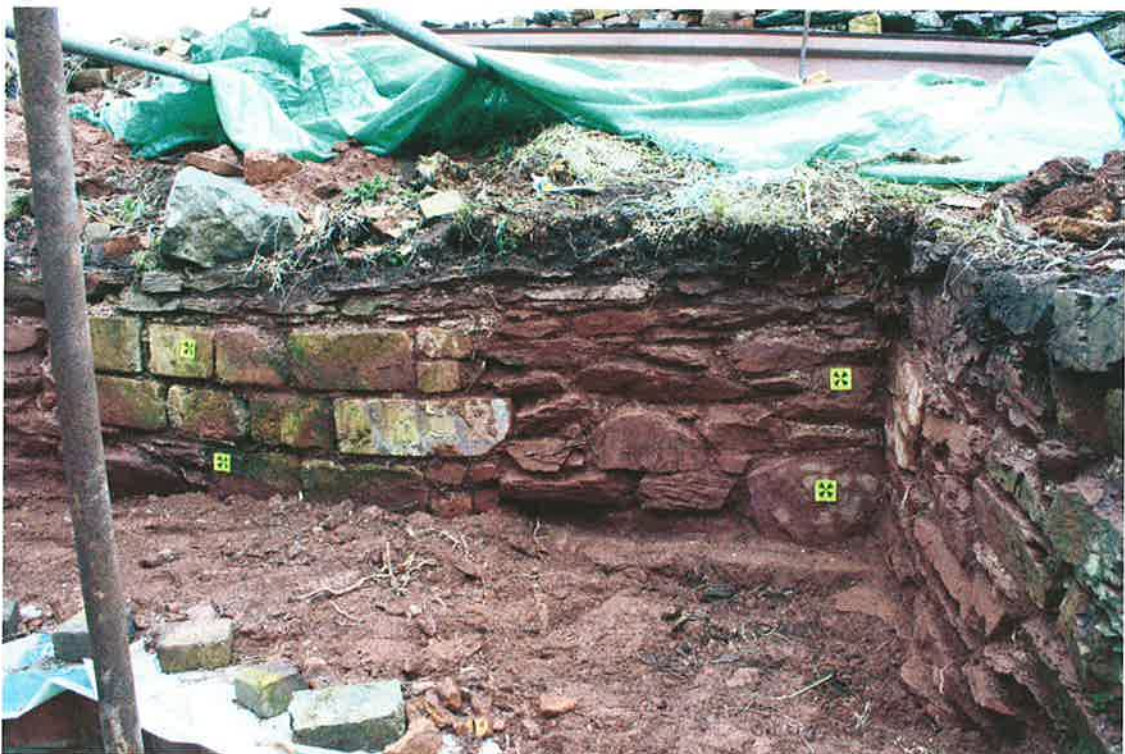
Plate 2: Remodelled section of wall in central part of eastern elevation, also showing the top of the stone slab bridging the corner of the stack

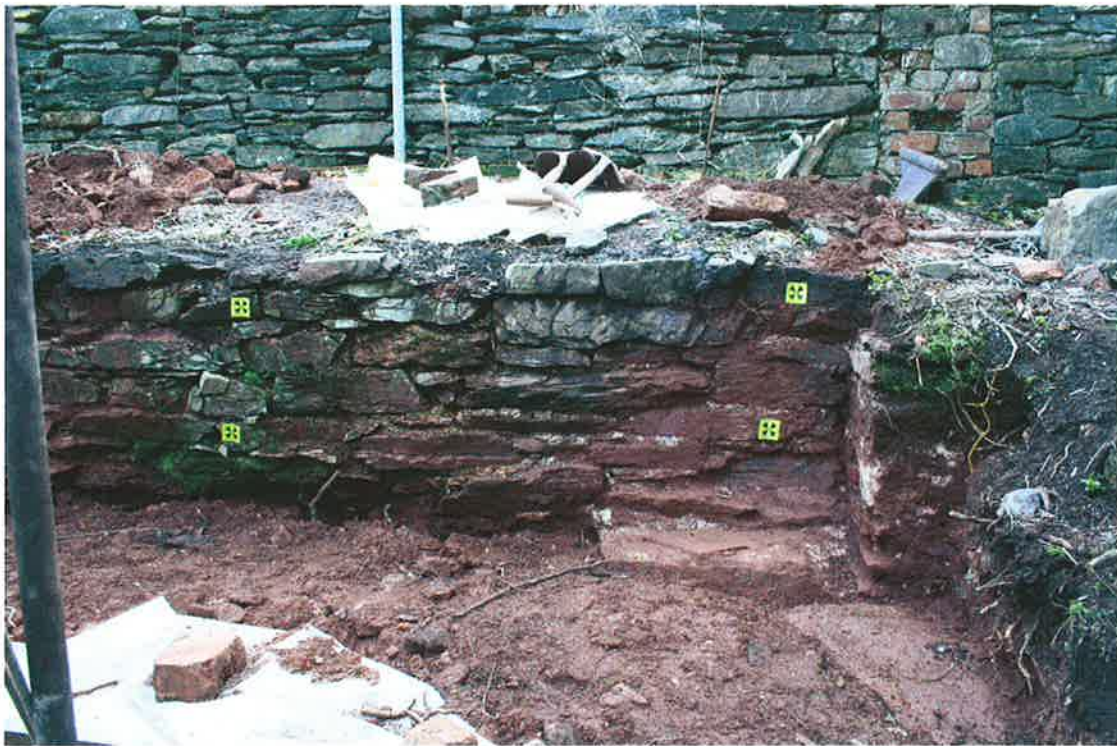
Plate 3: South elevation of the stack, with projecting stone slabs at western end

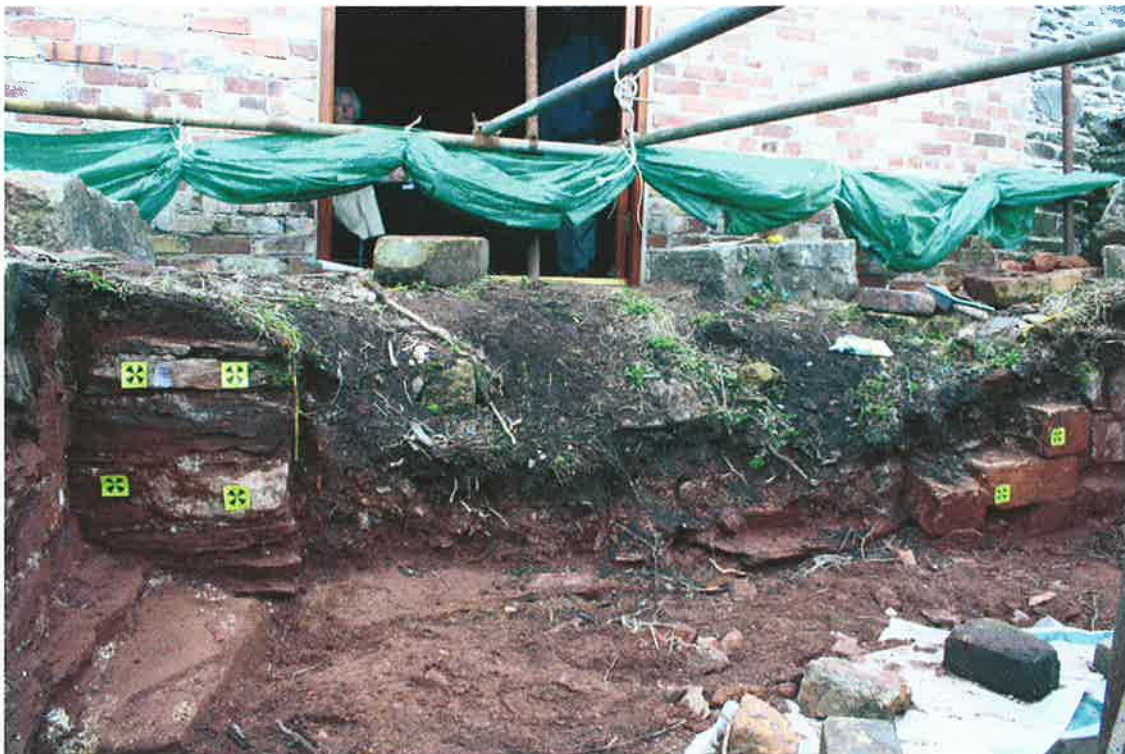
Plate 4: Doorway in western elevation, providing access to charging house

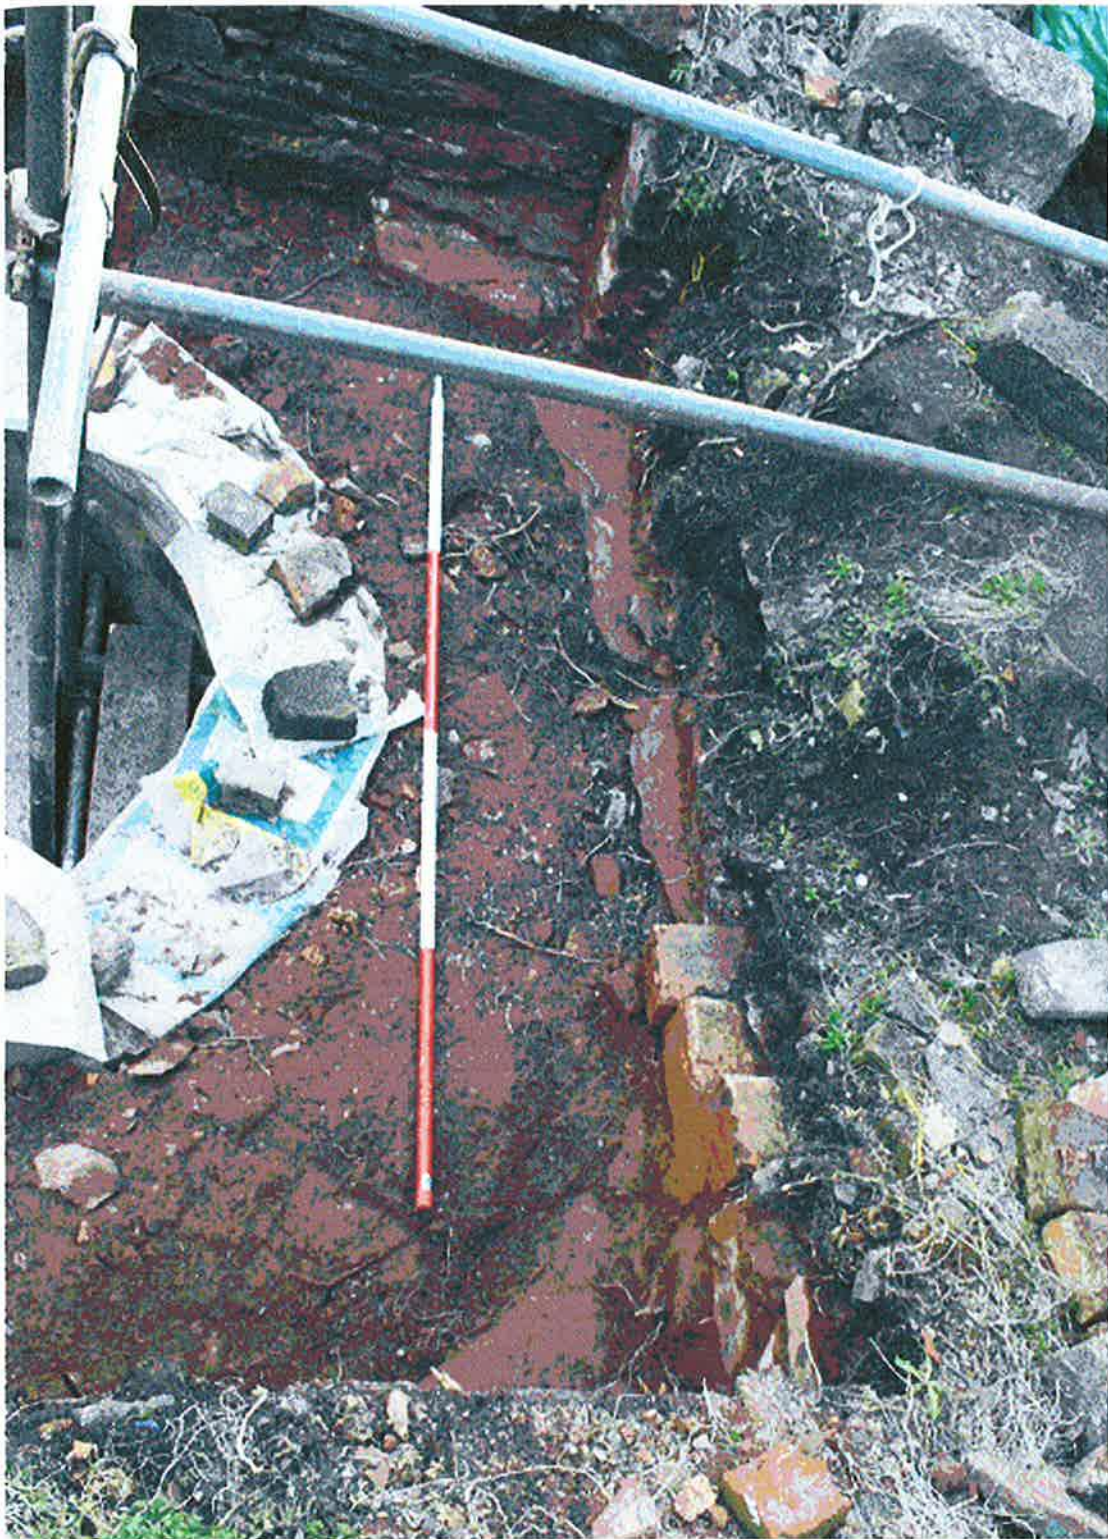
Plate 5: Detail of projecting stones in the west elevation

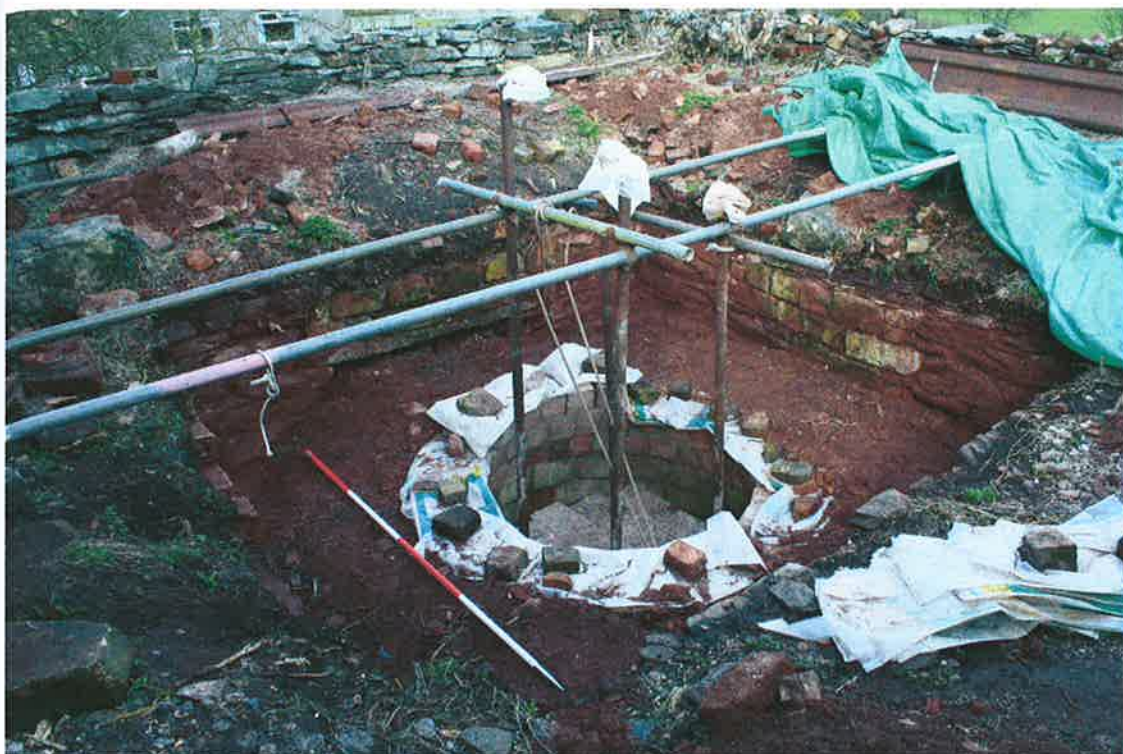
4.2.2 Evidence for modifications to the furnace was provided by several episodes of localised remodelling of the original fabric, including an aperture that had been inserted in the base of the exposed northern elevation of the stack wall (Plate 6). It measured 4' (1.21m) wide, and was exposed only to a depth of 0.1m below a cast-iron lintel, which comprised a 5' (1.52m) length of solid rectangular-section, 4" (0.1m) deep. The aperture below was largely inaccessible, but was revealed to be of at least 0.45m depth. The section of the stack wall above the lintel was rebuilt, and contained refractory brick within its fabric. Another area of rebuilt fabric, which also incorporated refractory bricks, was observed in the eastern elevation (Plate 2). It is tempting to associate these rebuilt sections of wall with the documented modifications to the furnace carried out during the 1870s, and particularly the installation of 'hot blast' technology (*Section 3.2.8 above*). The precise nature of the 'hot blast' system employed at Newland is by no means clear although it probably

Plate 6: View across the top of the furnace in April 2007, showing iron lintel in the north elevation of the stack wall

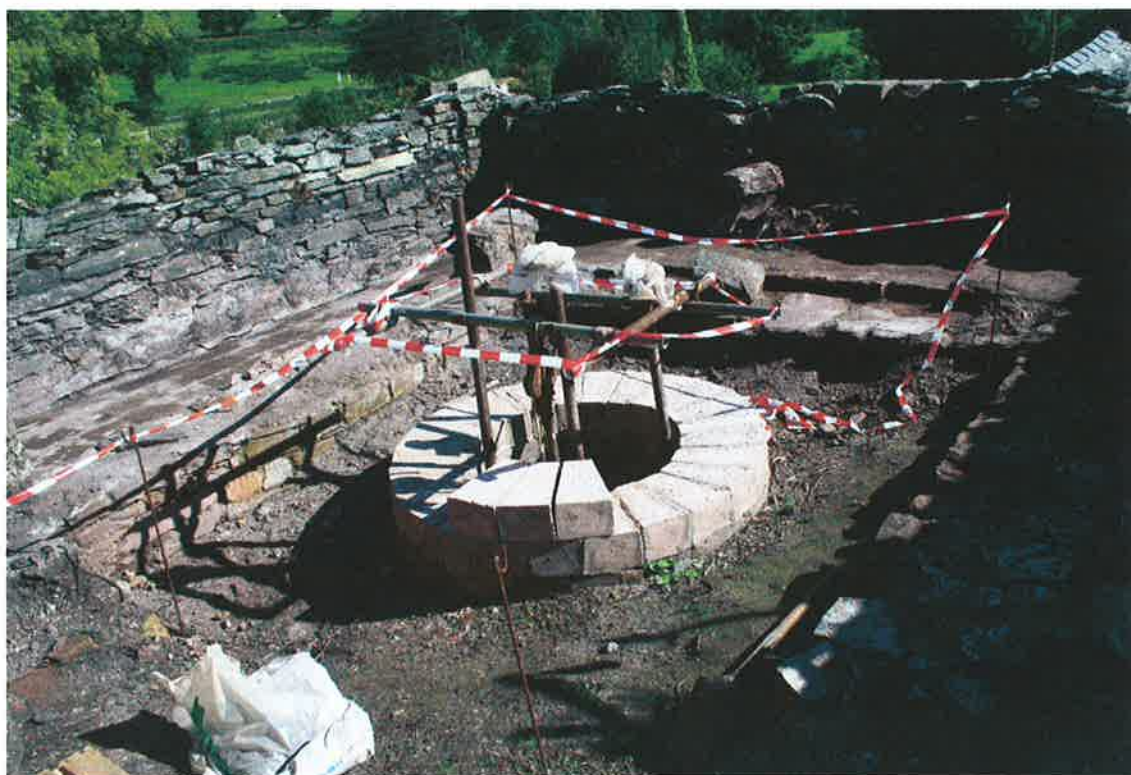
4.2.1 The walls of the furnace stack are of local roughly coursed stone construction, with face-work only surviving to depth of 0.6m, which coincided with the limit of excavation for the emergency repair work within most of the interior of the stack. Removal of the loose material and debris overlying the top of the furnace stack walling (Plate 1) revealed it to be of double-faced construction, 2' (0.61m) thick, with a rubble core bonded in pale lime mortar. Large quoin stones, both approximately 2 x 1' (0.61 x 0.30m), projected 1' (0.30m) above the wall top in the outer north-east and north-west corners of the stack (Fig 1), implying it to have been quoined returned, a detail unclear on the only known contemporary photograph of the extant stack (*North Lonsdale Magazine*, October 1897). Large stone slabs were revealed at a depth of c 0.8m below the top of the stack walls, projecting from the wall face by up to 0.4m, bridging each corner of the stack (Plates 2 and 3). These were presumably intended for the structural strengthening of the walls. Further stone slabs were exposed at a similar level along part of the western elevation of the furnace stack, which probably represented the floor of the furnace bridge, providing access between the charging house and the furnace throat. This was also marked by squared jambs on either side, providing an entrance to the furnace stack that was 1.72m wide (Plates 4 and 5). The area between the stack wall and the parapet was, however, infilled with flooring on all but the western side, creating a walkway around the top of the furnace stack (Plate 6 and 7).

Plate 7: View looking north across the top of the furnace in September 2007, following the removal of overburden from the walkway

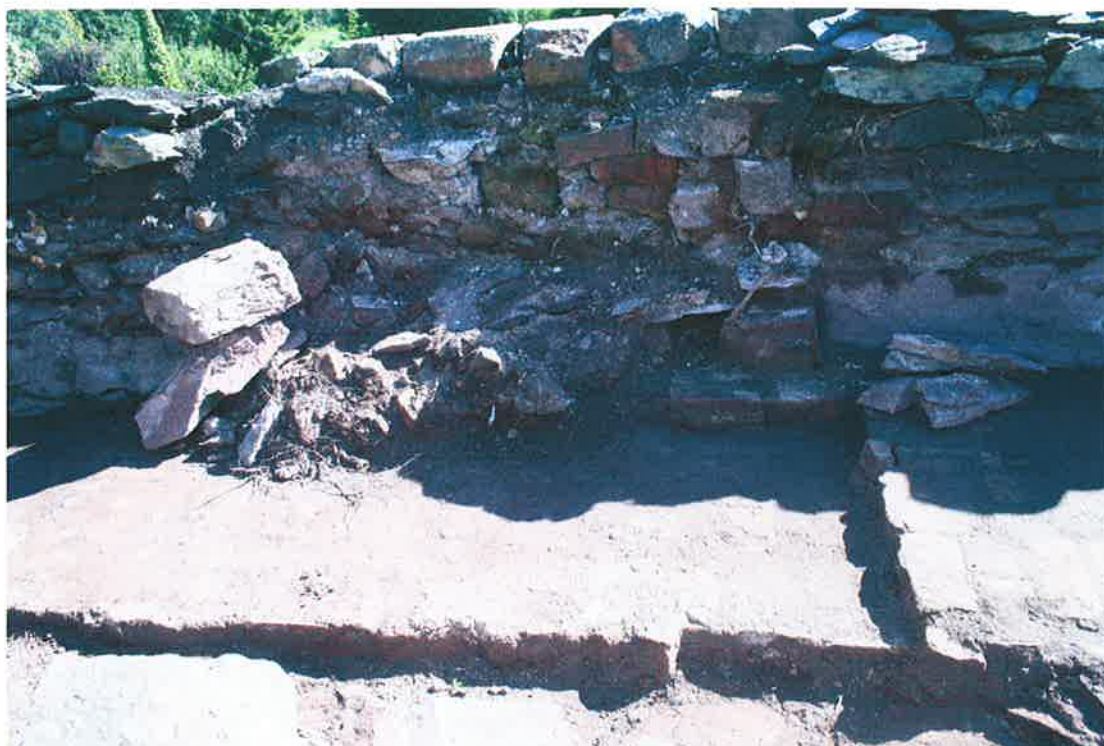
Plate 8: Evidence of heat-exchange structure, east parapet wall

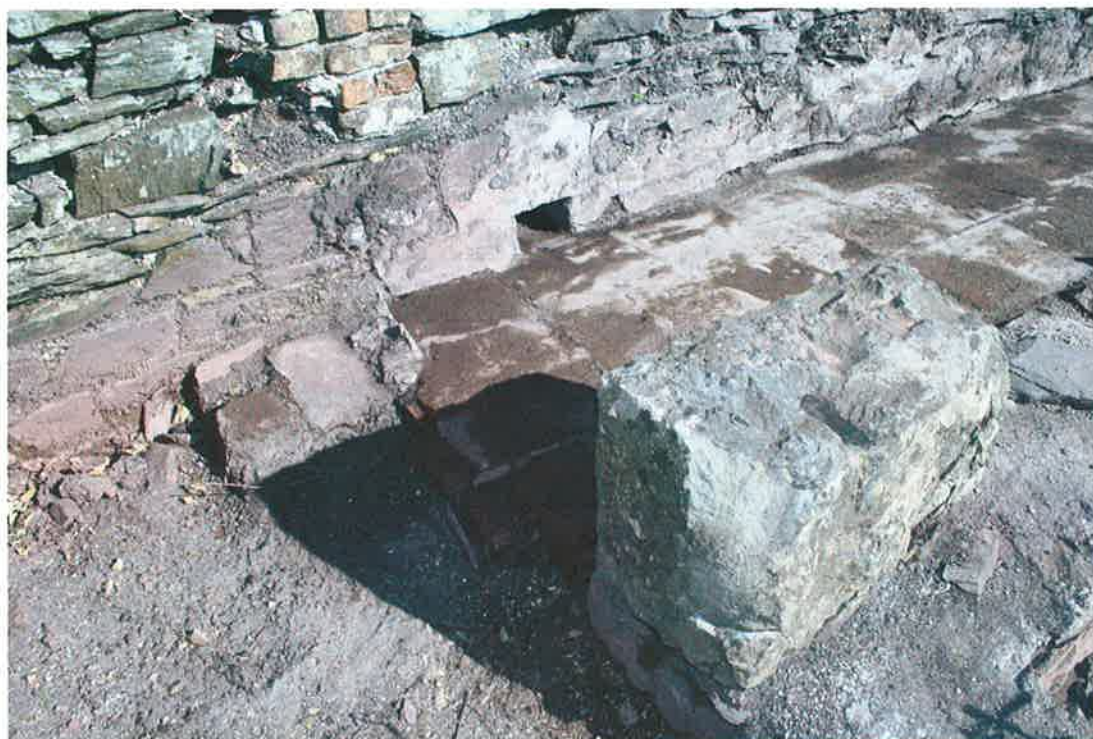
- 4.2.6 The floor level of the parapet walkway was at that of the surviving wall top (Plate 9), typically around 6" (0.15m) below that within the charging house. The northern part of the floor sloped markedly to the north, providing run-off to the drains in the north parapet wall. It was constructed of three rows of refractory voussoir bricks, similar to those used within the furnace stack, the large gaps between the individual bricks infilled with hard, cement-based mortar (Plate 10). The southern part of the floor had clearly been rebuilt, and comprised an additional course of horizontally-laid bricks, both red and refractory, all hand-made. The size of individual bricks was typically 9 x 4½ x 2½" (229 x 114 x 64mm), conforming to standard late nineteenth-century dimensions. This course appeared to overly the larger refractory bricks at its northern boundary, implying that they were of a later construction. Nevertheless, the surface almost certainly represents the original floor level of this part of the walkway, as it is flush with drain apertures through the parapet wall in its southern elevation (Fig 1). The southern section of the walkway was significantly narrower than those bordering the eastern and northern sides of the stack, due to the existence of the 18" (0.46m) wide additional wall in this position. The purpose of this wall remains unclear.

Plate 9: North-western corner of the walkway, showing the projecting quoin and drain hole in the parapet wall

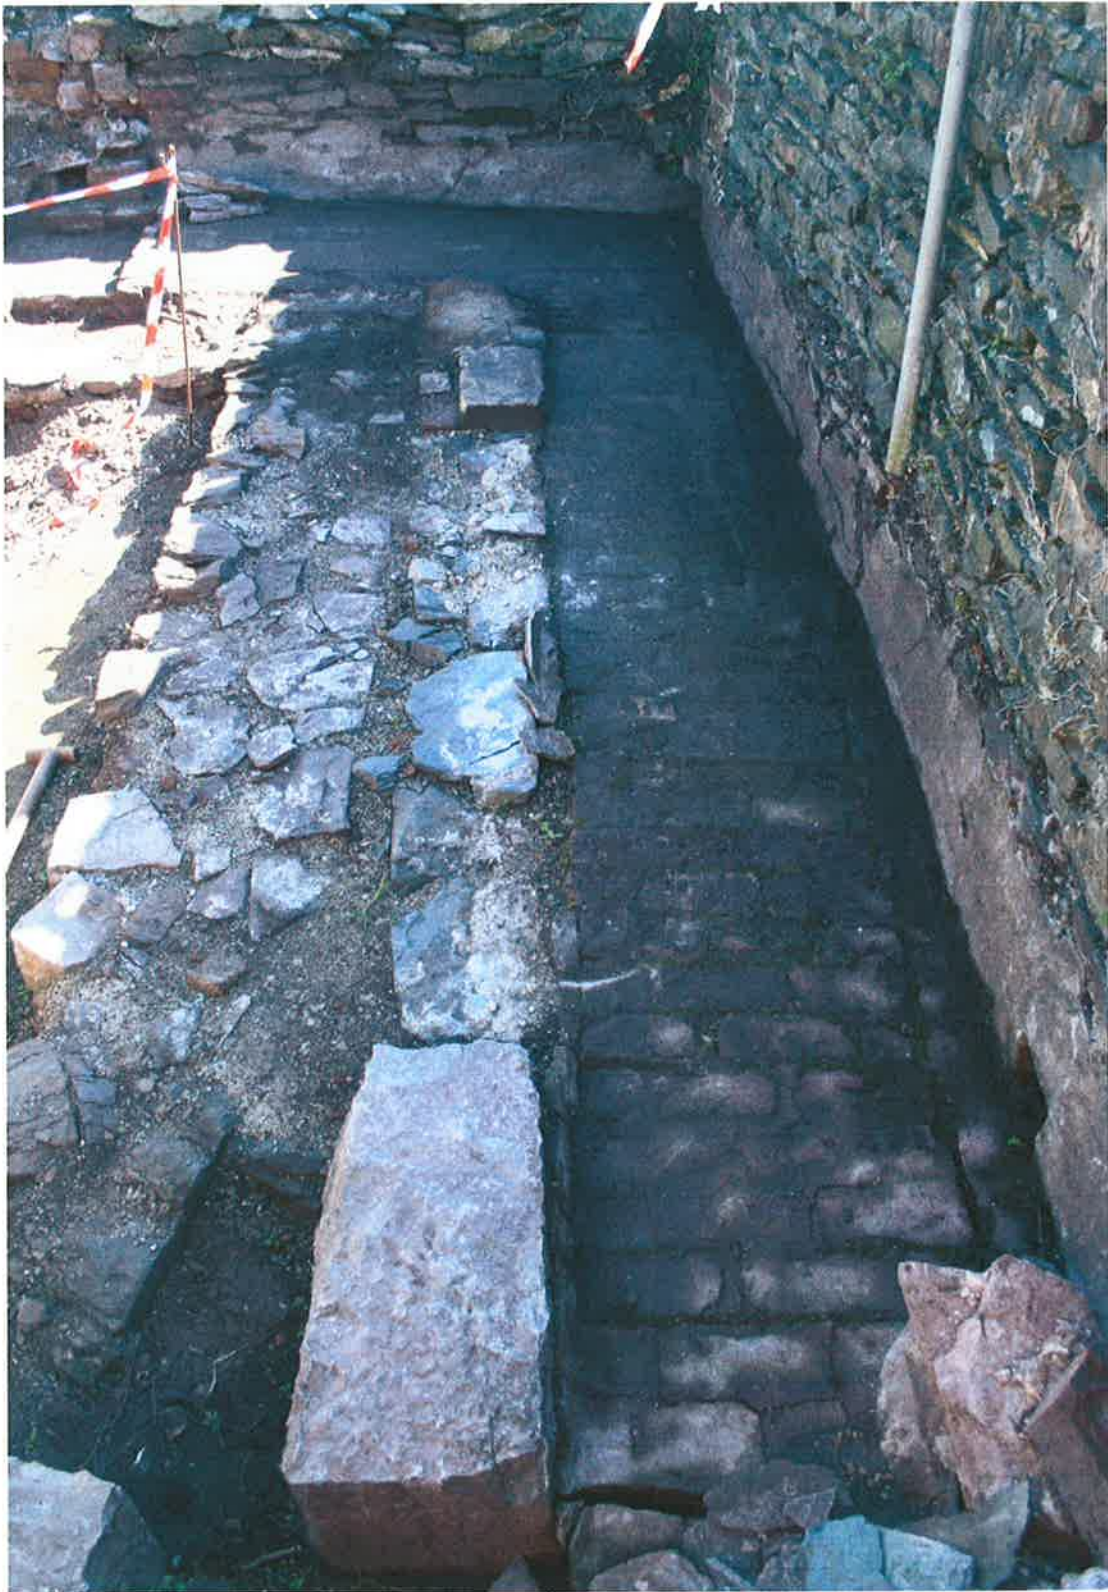
Plate 10: Southern side of the stack, showing walkway and additional single-skin wall
