NEWLAND FURNACE, NEWLAND, Cumbria

Archaeological Watching Brief

Oxford Archaeology North

July 2009

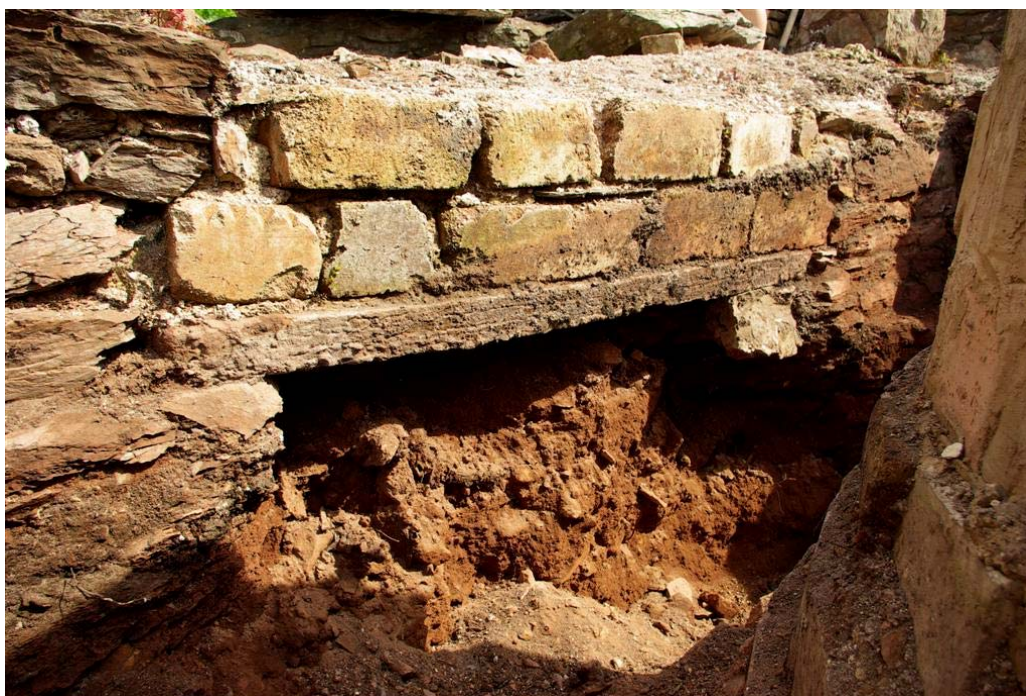
Plate 3: Aperture in the north elevation (Elevation 1) of the interior of the stack wall showing collapsed material

- 4.2.3 All of the elevations recorded during the initial element of repair works in 2007 were revealed during the present phase of work, including an aperture in the north elevation (Elevation 1) of the furnace stack (Fig 2). This aperture was 1.21m wide, and was situated below a cast-iron lintel that comprised a 1.52m length of solid rectangular-section, 0.1m deep (Plate 3). The section of the stack wall above the lintel was rebuilt, and contained refractory brick

within its fabric, demonstrating the aperture and lintel to have been later insertions. Similar apertures were exposed in the east (Elevation 2; Plate 5) and south elevations (Elevation 3; Plate 6) of the furnace stack. Both apertures were of similar dimensions to that exposed in Elevation 1, each measuring *c* 1.2m wide, and also contained evidence of rebuilding in the overlying stonework. All of the apertures in the stack wall continued below the excavated depth of 1.2m, and were thus not fully exposed.

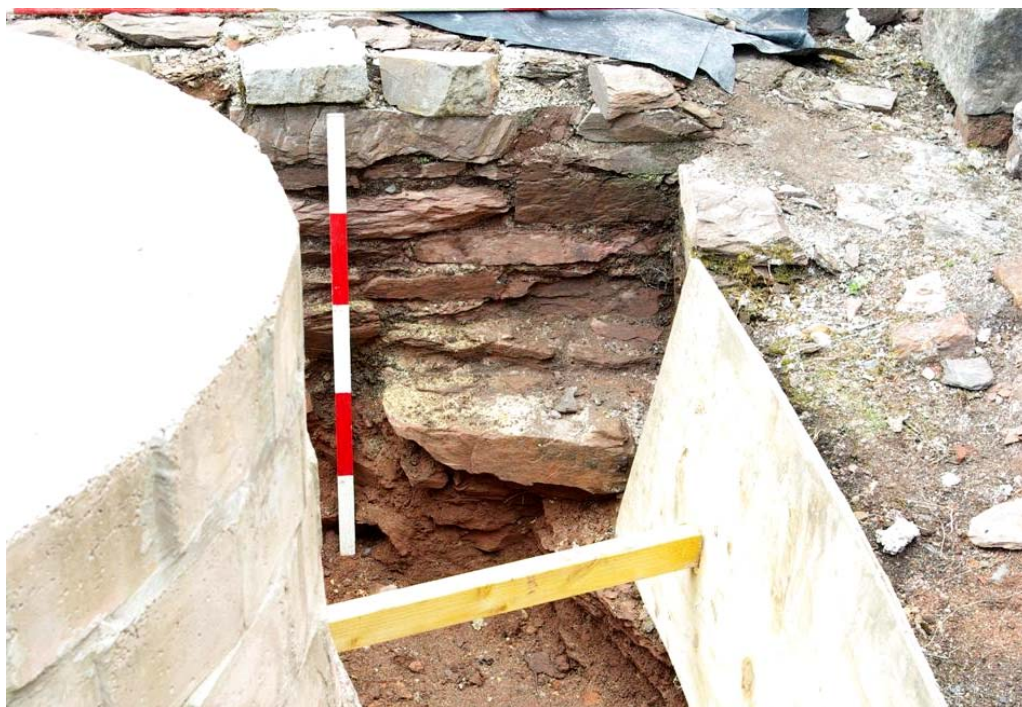
- 4.2.2 The exposed walls of the furnace stack are of local, roughly coursed stone construction, with face-work only surviving to depth of *c* 0.6m. The wall is of double-faced construction, 0.61m thick, with a rubble core bonded in pale lime mortar. Large quoin stones, both measuring approximately 0.61 x 0.30m, projected 0.30m above the wall top in the outer north-east and north-west corners of the stack (Fig 1), implying it to have been quoined returned. Large stone slabs were revealed at a depth of *c* 0.8m below the top of the stack walls, projecting from the wall face by up to 0.4m, bridging each corner of the stack. These were presumably intended for the structural strengthening of the walls; they did not appear to form part of any further structure (Plate 4).

Plate 4: One of the exposed stone slabs bridging a corner of the furnace stack

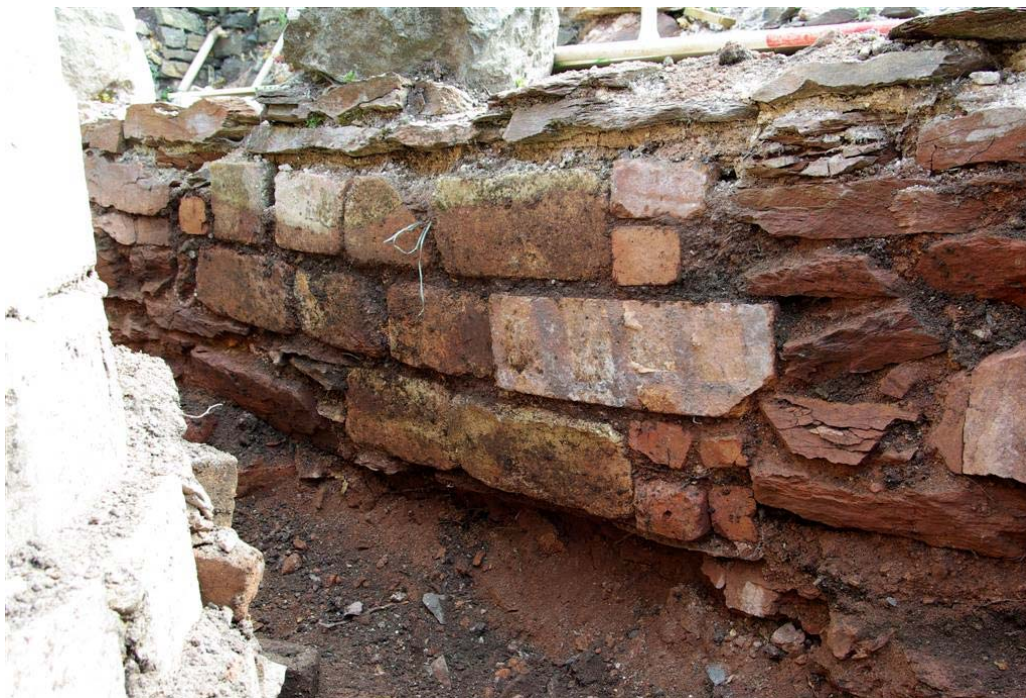
Plate 5: Aperture in the east elevation (Elevation 2) of the interior of the stack wall

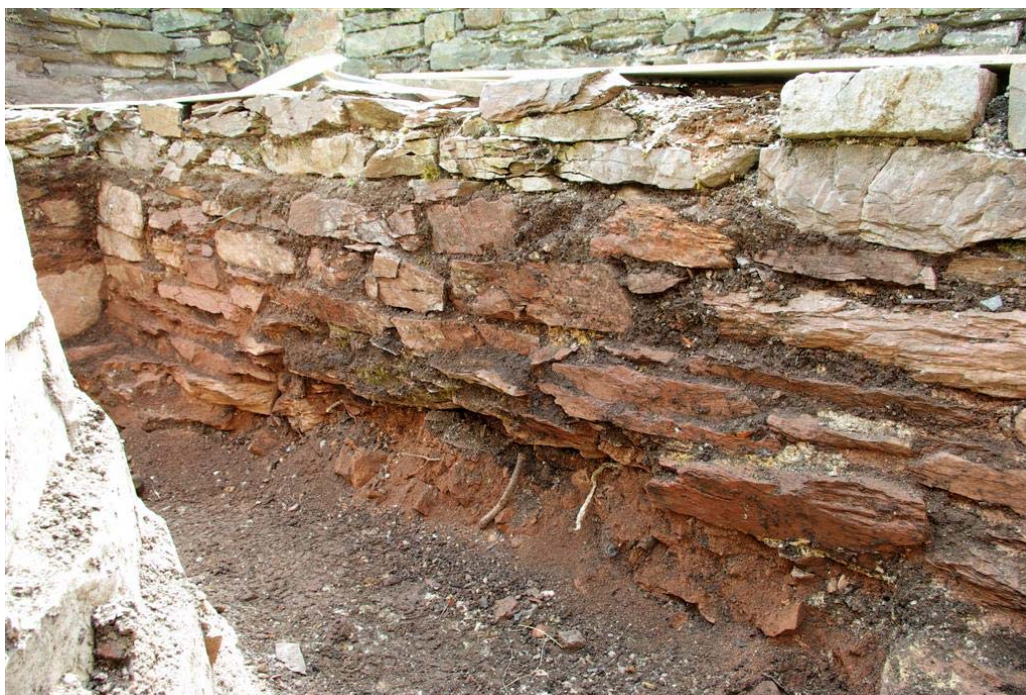
Plate 6: Aperture in the south elevation (Elevation 3) of the interior of the stack wall

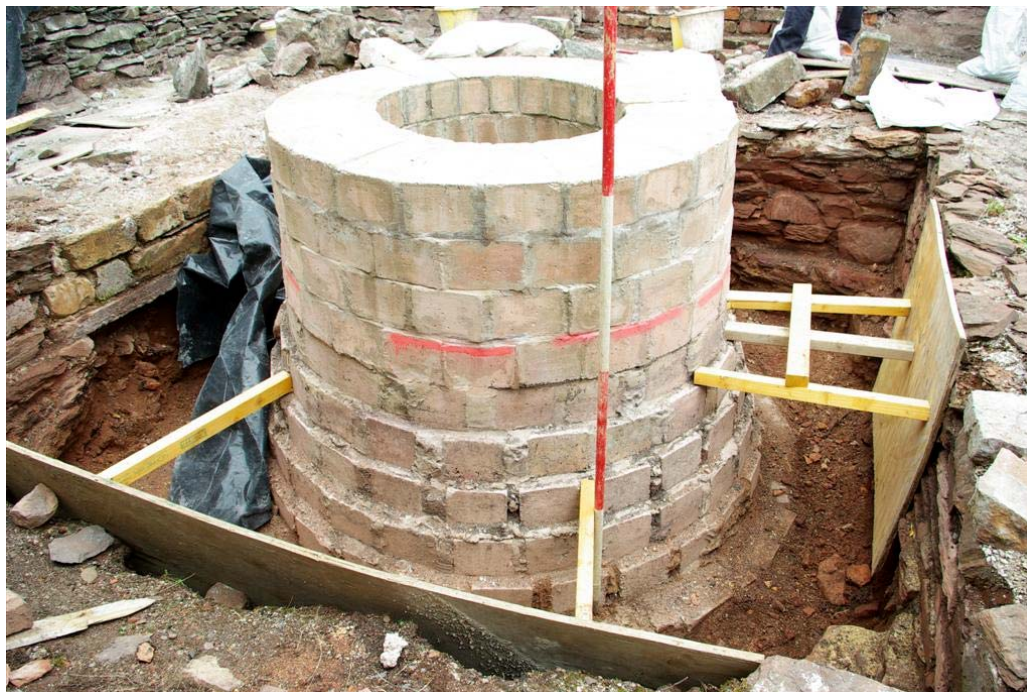
- 4.2.4 The throat of the flue was also revealed during the excavations, the shoulder being clearly visible (Plate 7). Much of the exposed elements of the furnace throat had been rebuilt as part of the repair work carried out in 2007, although historic fabric was visible at the base of the excavated area. No other features were exposed during the course of the works.

Plate 7: Excavated extent of the furnace throat showing the top of the shoulder

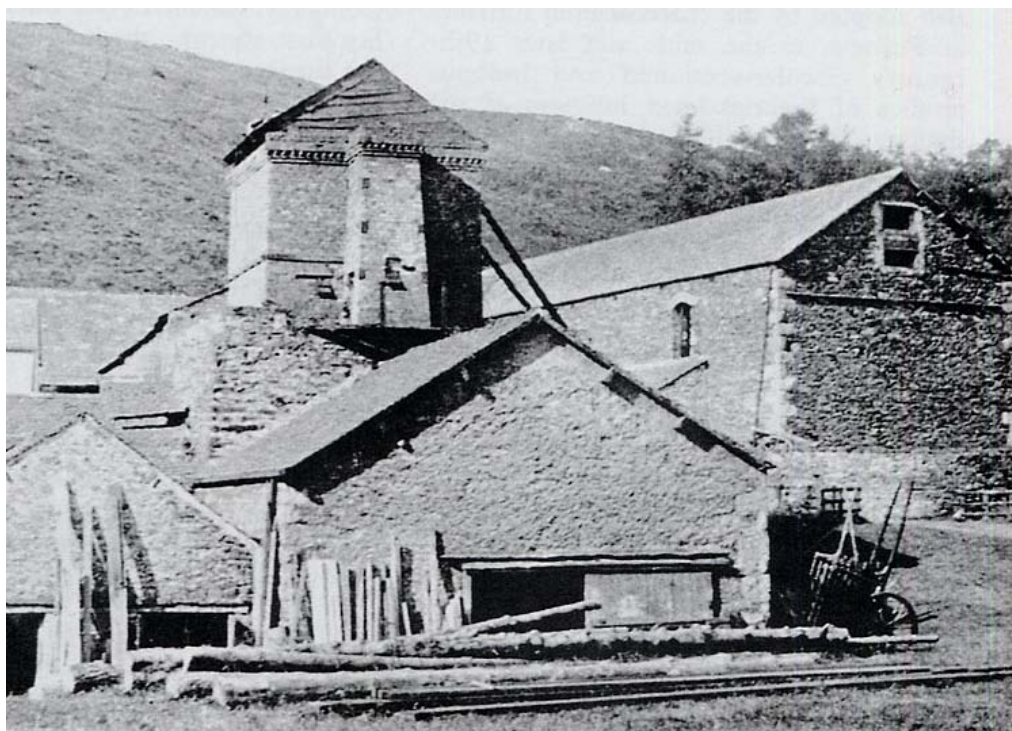
- 5.3 The precise nature of the ‘hot blast’ system employed at Newland is by no means clear although it probably relied on a heat exchange mechanism, recycling exhaust gases to pre-heat air entering the furnace. Elements of what was probably the heat exchanger mechanism are shown clearly on the late nineteenth-century photograph of the furnace, abutting the eastern side of the stack (Plate 8). It is of note that the position of the aperture exposed in the east elevation corresponds broadly with the location of the probable heat exchanger seen on the photograph of 1897.

Plate 8: View of the Newland Furnace published in the North Lonsdale Magazine, 1897

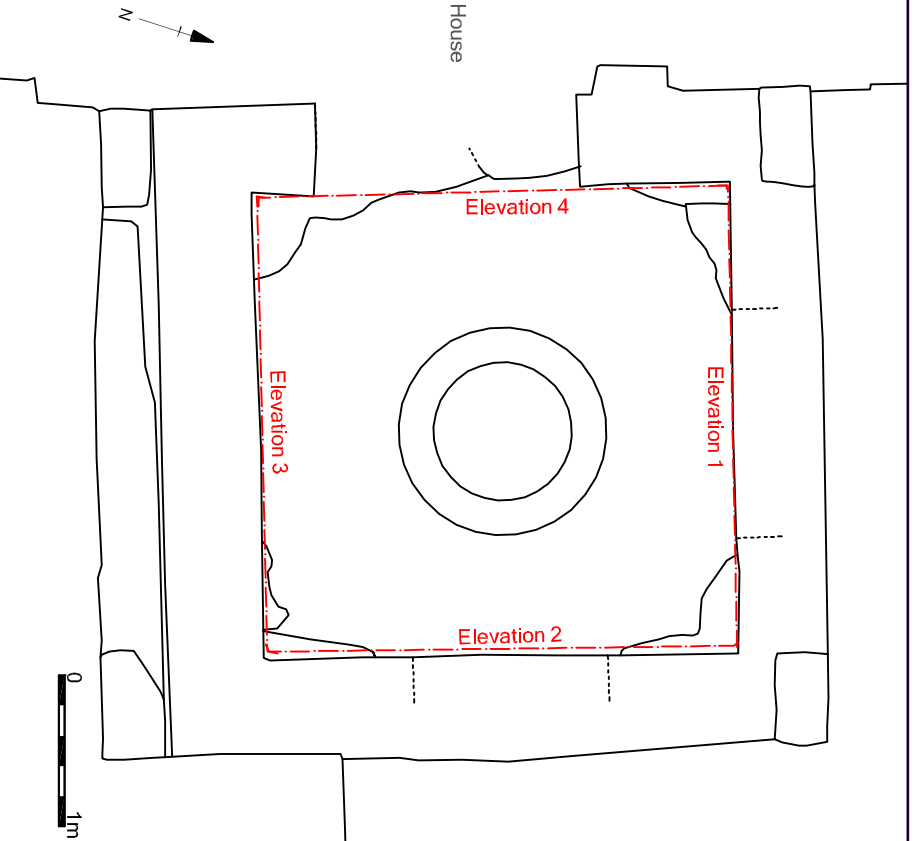
Figure 2: Elevations of the exposed stack walls

- 4.1.2 The watching brief commenced in June 2009, and initially monitored manual excavation of the packing material on the north side of the furnace throat. This material was excavated for a depth of *c* 1.2m, and revealed the large aperture recorded in Elevation 1 in 2007 (Fig 2). Material infilling this aperture collapsed (Plate 3), and further excavation was suspended pending a revision of the methodology by the structural engineers. Following this, it was decided to excavate the area to a lesser depth, and to shore any further apertures discovered.
