# ULVERSTON ROPE WALK, CUMBRIA

## Evaluation Report

**Oxford Archaeology North**

**October 2005**

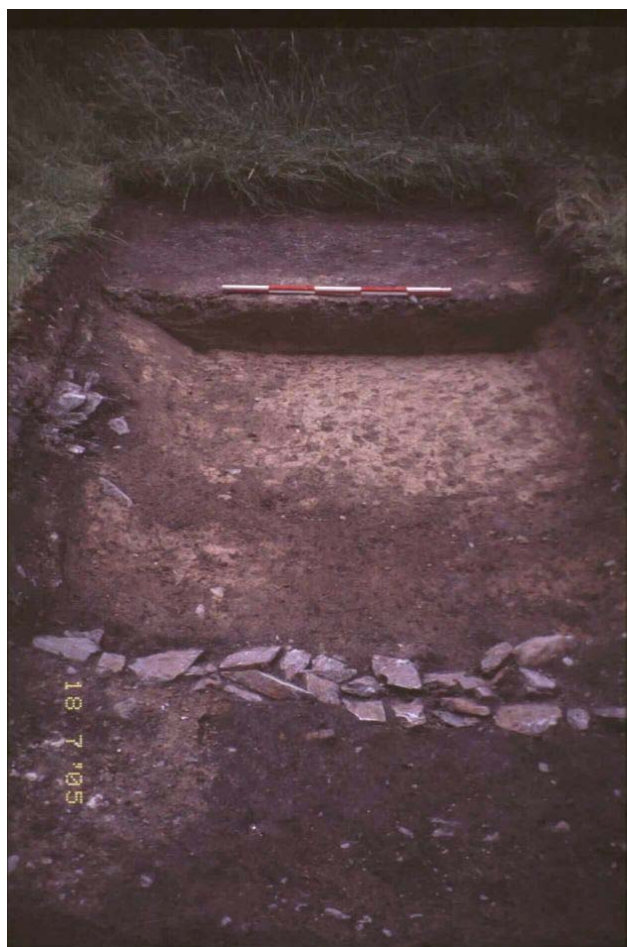
Plate 3: Trench 3, looking north

- 4.2.18 **Trench 3:** was positioned at the east end of the rope walk, it was aligned north/south and measured 6m by 2m. It was excavated to a maximum depth of 0.46m. The plan is seen as Figure 3 and the section as Figure 4. The stratigraphic sequence of events is represented below and the trench can be seen in Plates 3 and 4.

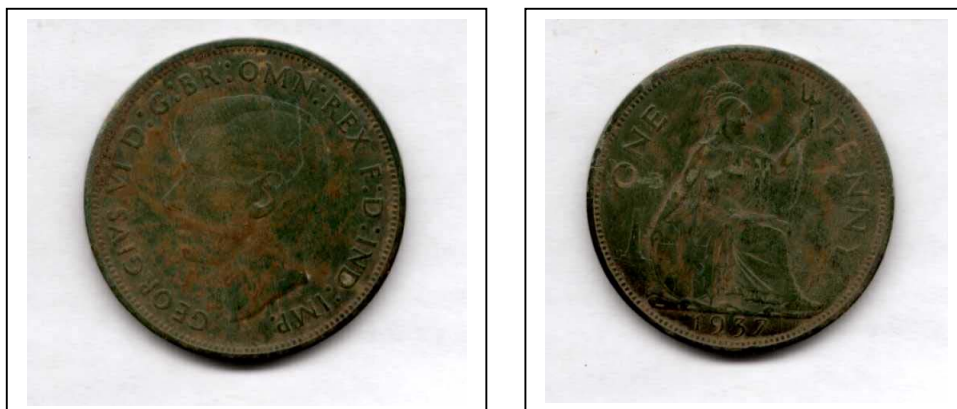
Plate 5: The 1937 penny found in Trench 3,  
(the obverse is on the left the reverse on the right)

- 4.3.7 **Copper alloy coin:** a single copper alloy coin, in good condition, was retrieved from the topsoil in Trench 3 (**302**). It was identified as a King George VI penny from 1937 (Plate 5).

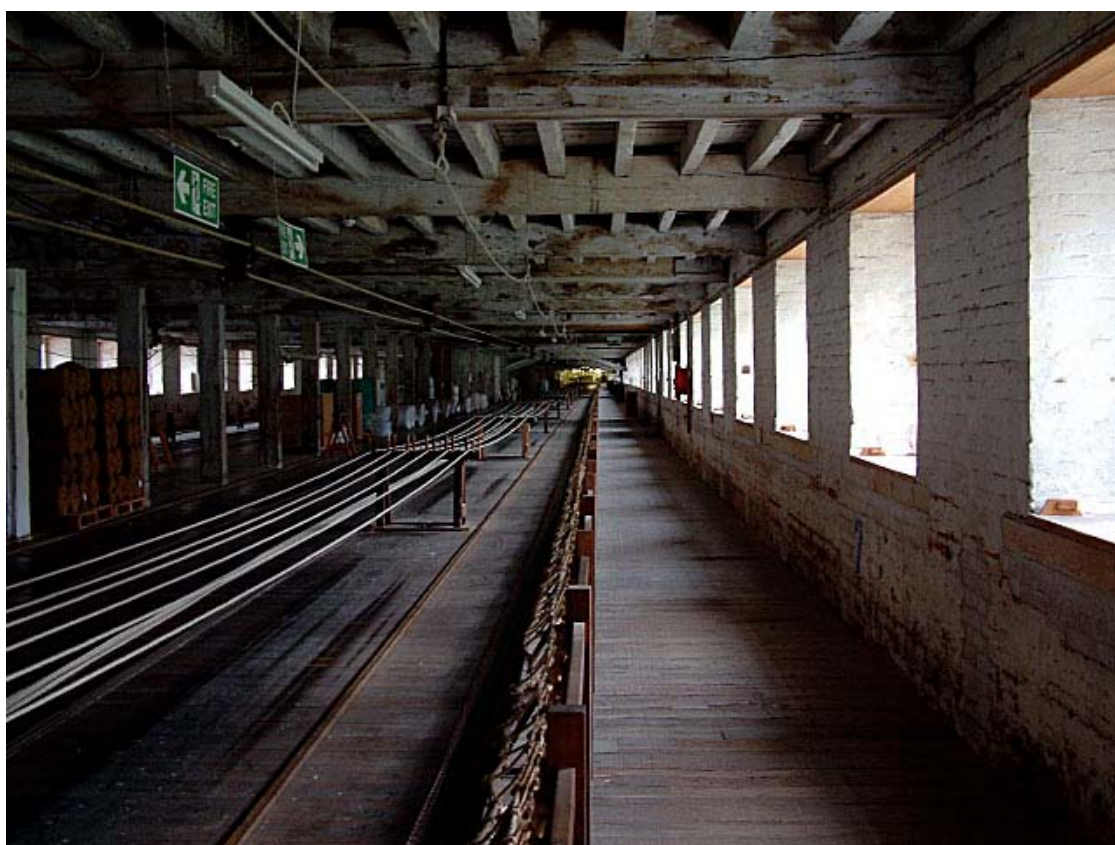
Plate 6: The Ropery at Chatham Dockland, Kent

- 5.1.3 There are numerous known sites of rope walks throughout Britain and there appear to be two main variations, those which were simply open areas and those which were encompassed in long sheds. The sheds obviously gave protection from the elements and demonstrate a level of wealth and investment in the process and potentially indicate that they may have been used to produce rope on a larger scale. Examples of this type are known from Dursely in Stroud, Newton Abbot in Teignbridge and Bridport in Dorset (ADS) and Chatham Docklands (Plates 6 and 7), where the sites were block-built warehouses set end on to the street.

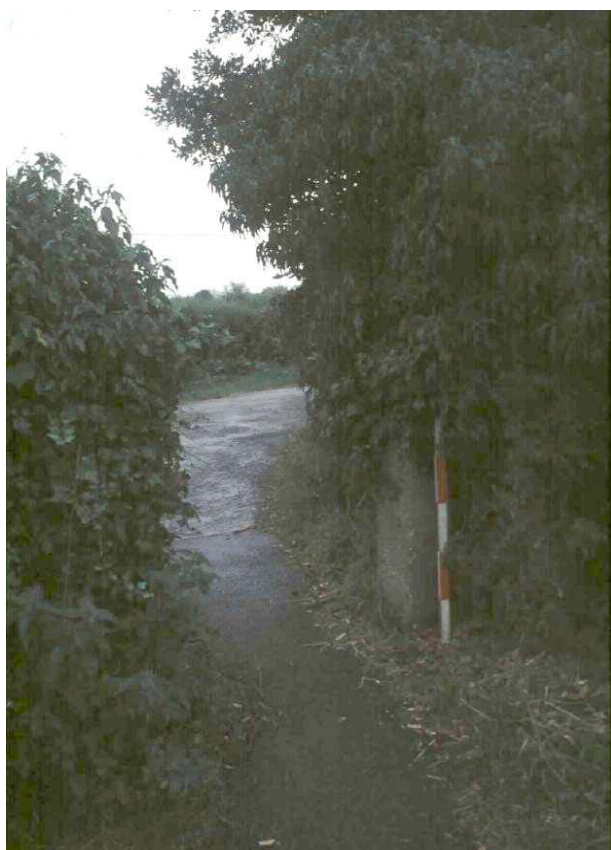
Plate 9: Site **11**, pair of gate posts, prior to vegetation removal

- 4.4.2 Site **11** was a pair of gate posts, located at SD 29625 77825, at the west end of rope walk near Dragley Beck. The pair of stone gate posts were set into a stone wall with iron fittings and were post-medieval in date. The site was identified during the walk-over survey and lies within the proposed development area which will be affected. The gate posts would need temporary removal during the works for the proposed greenway. Therefore they were photographed from both the east and west sides, using a measured scale. Further photographs were taken after the vegetation had been removed from the surrounding wall. Examples of the photographs are given in Plates 9 and 10.

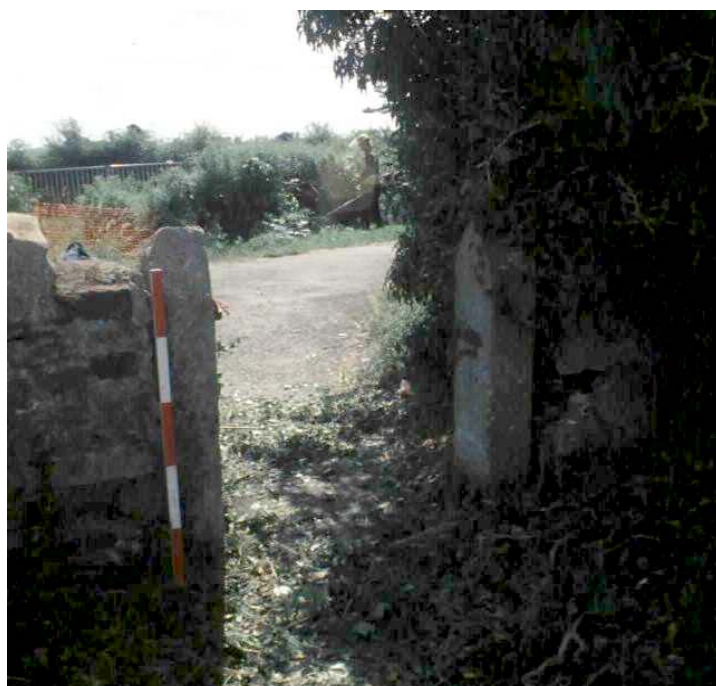
Plate 10: Site **11**, pair of gate posts, after vegetation removal
